GUIDELINES FOR ATTACHMENTS TO BRIDGE RAILS AND MEDIAN BARRIERS

MwRSF Research Report No. TRP-03-98-03

February 26, 2003

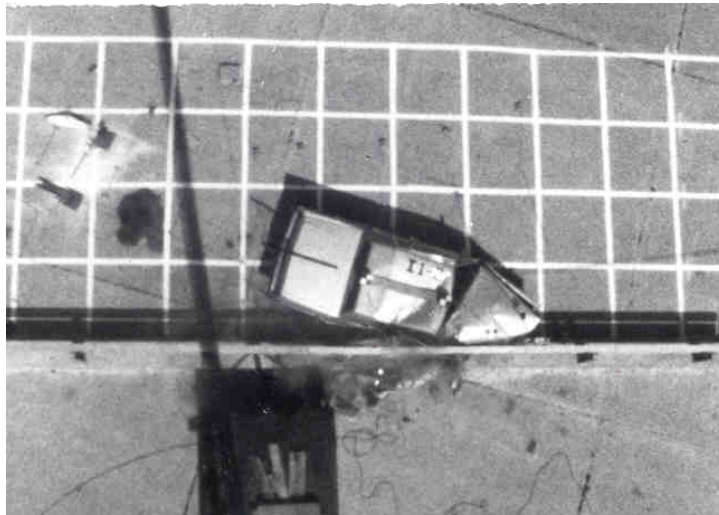
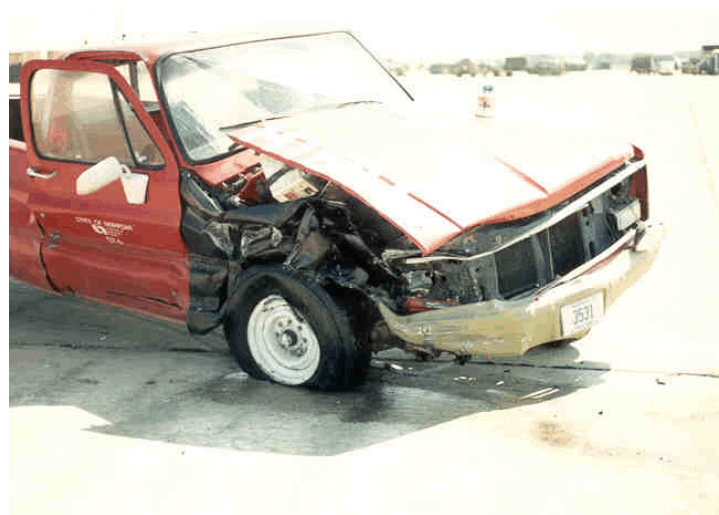
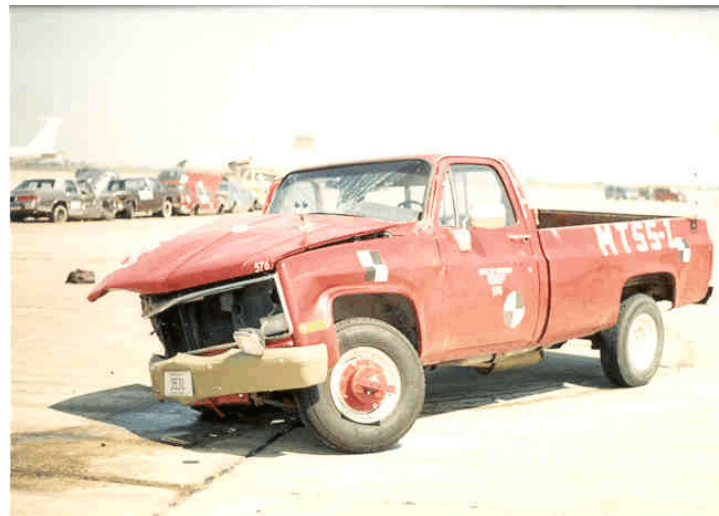
Figure 1. Vehicle Hood Snagging

The ZOI for TL-2 barriers is defined by an impact with a $\frac{3}{4}$ -ton pickup truck at a speed of 70 km/hr (43.5 mph) and at an angle of 25 degrees. This vehicle's maximum intrusion was found to occur near the impact point where the lower portion of the vehicle crushed inward sufficiently to

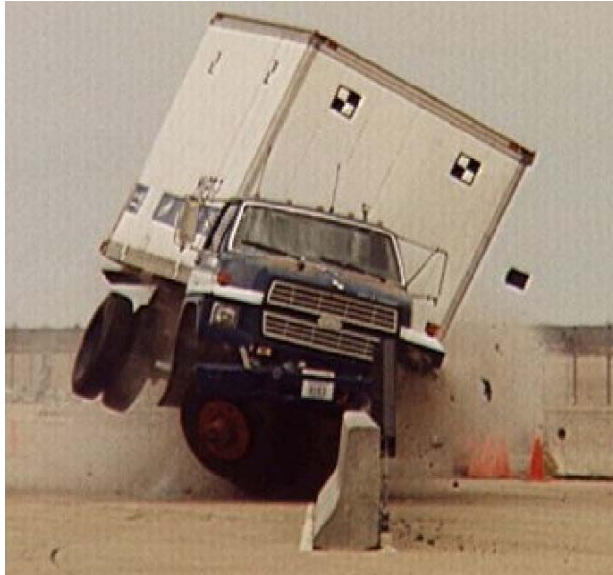
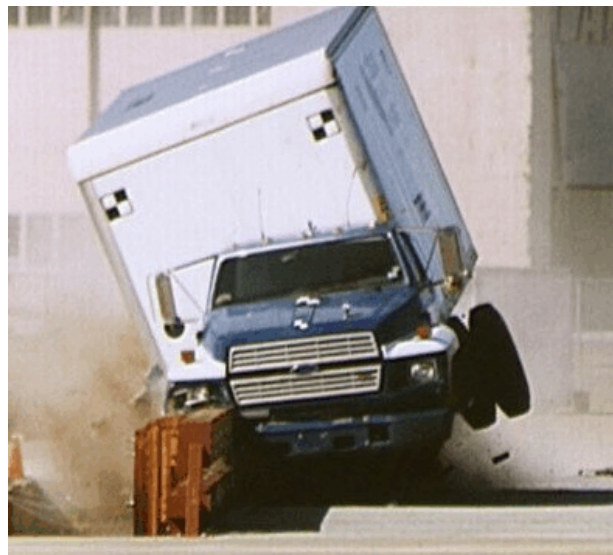
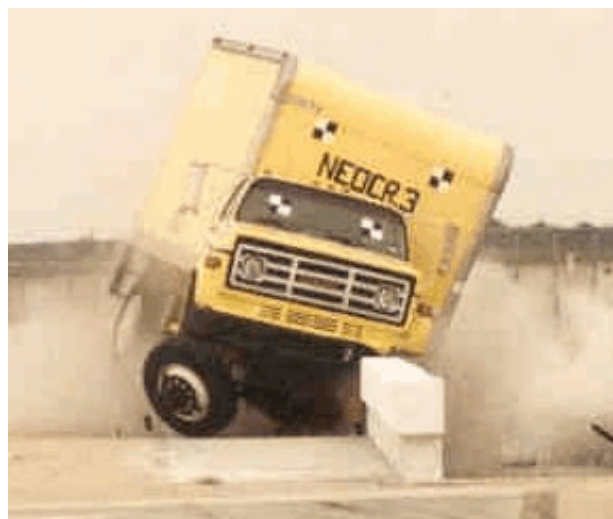
Figure 2. Single-Unit Truck Roll Motion Behavior

was usually displaced laterally and longitudinally. During many of these tests, the front wheel on the impact side of the vehicle was pushed under the vehicle, often nearly to its centerline. Depending on the height of the barrier and the degree of wheel climb on the barrier's front face, the vehicle's front bumper would either crush or ride up over the top of the barrier. The test vehicle's front fender generally extended well over the top of the barrier, regardless of the action of the bumper and front tire. As the test vehicle was redirected, the rear of the truck typically rotated around and slapped the barrier. Since the bottom of the truck's cargo box was always higher than the top of the barrier, the rear wheels contacted the barrier instead of the cargo box or frame. The high lateral load on the rear wheels caused both the truck's cab and its cargo box to roll toward the barrier and generally extend well beyond the front face of the barrier. The extent of roll associated with the truck box and cab was found to vary significantly. Sometimes the two rolled approximately the same amount, while in other cases, the cargo box roll was much greater than that of the cab.

Much of the variation in vehicle behavior can be attributed to the torsional rigidity of the truck frame as well as the strength of the cargo box/frame connection. A stiff frame with a good connection would cause the truck cab and cargo box to roll simultaneously. In this case, the windshield and the top of the cab would usually extend well past the front face of the barrier. This behavior exposes the upper corner of the truck cab to an impact with barrier attachments. The cab roll also lowers the height of the truck cab to a level where shorter attachments may impact and penetrate it. A more flexible truck frame or a weak cargo box/frame connection allows the cargo box to roll more than the truck cab. In this case, the truck cab generally did not extend far beyond the front face of the barrier. Regardless of the behavior of the truck cab, the cargo boxes were observed to extend well beyond the barrier's front face. The primary difference between the cab and

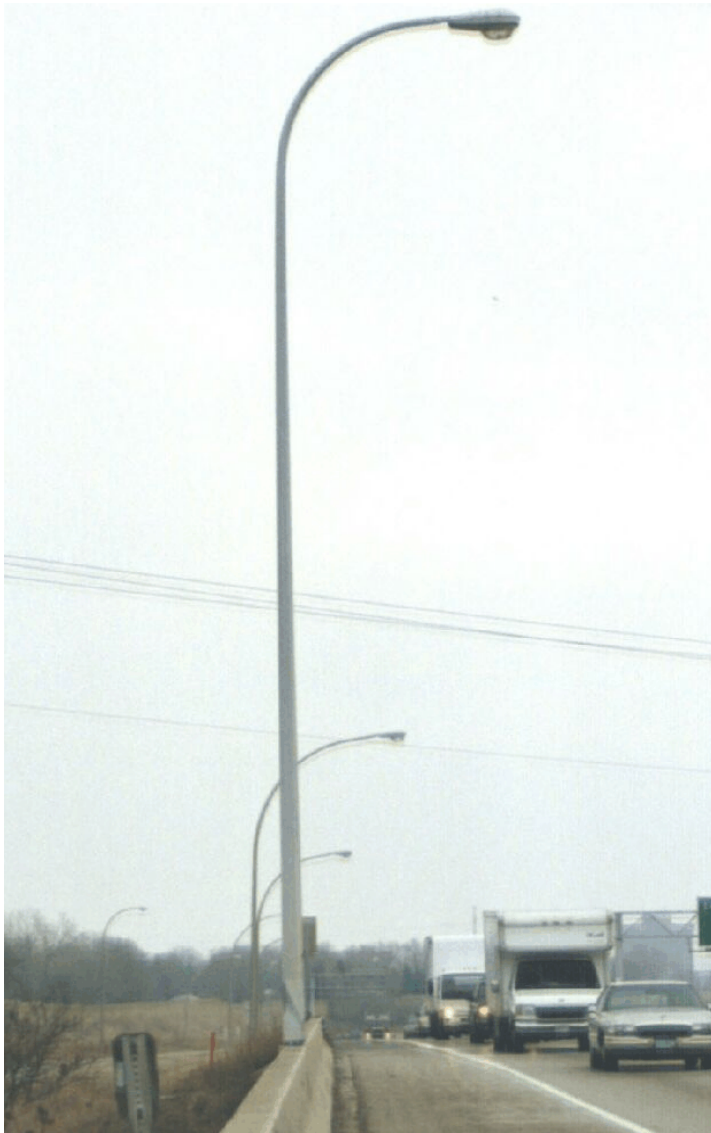
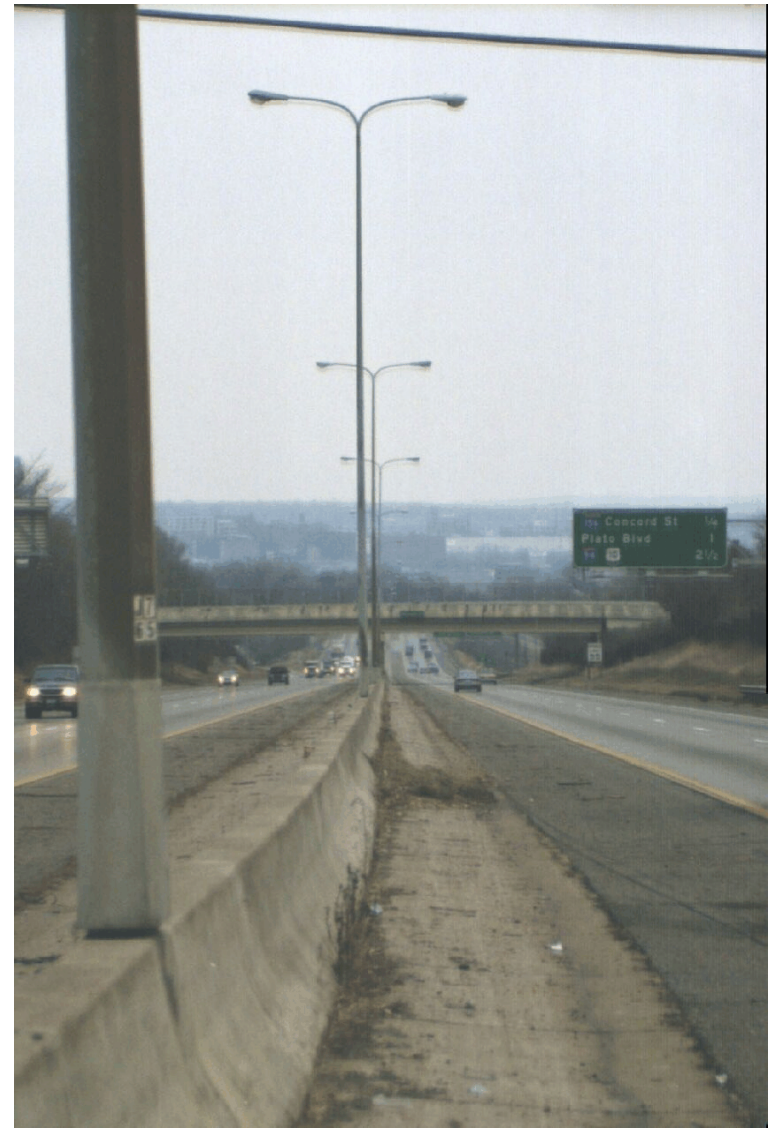
Figure 9. Luminaire Supports Mounted on Top of the Traffic Barrier

Luminaire supports were by far the most numerous of the attachments found in the field. These supports were either mounted on top of the barrier or on an extension behind the traffic barrier. Signs for traffic passing under the structure on grade-separated intersecting roadways generally involved very large informational signs consisting of large panels with a significant number of wind beams to support the portion that extends above the top of the traffic barrier. Large

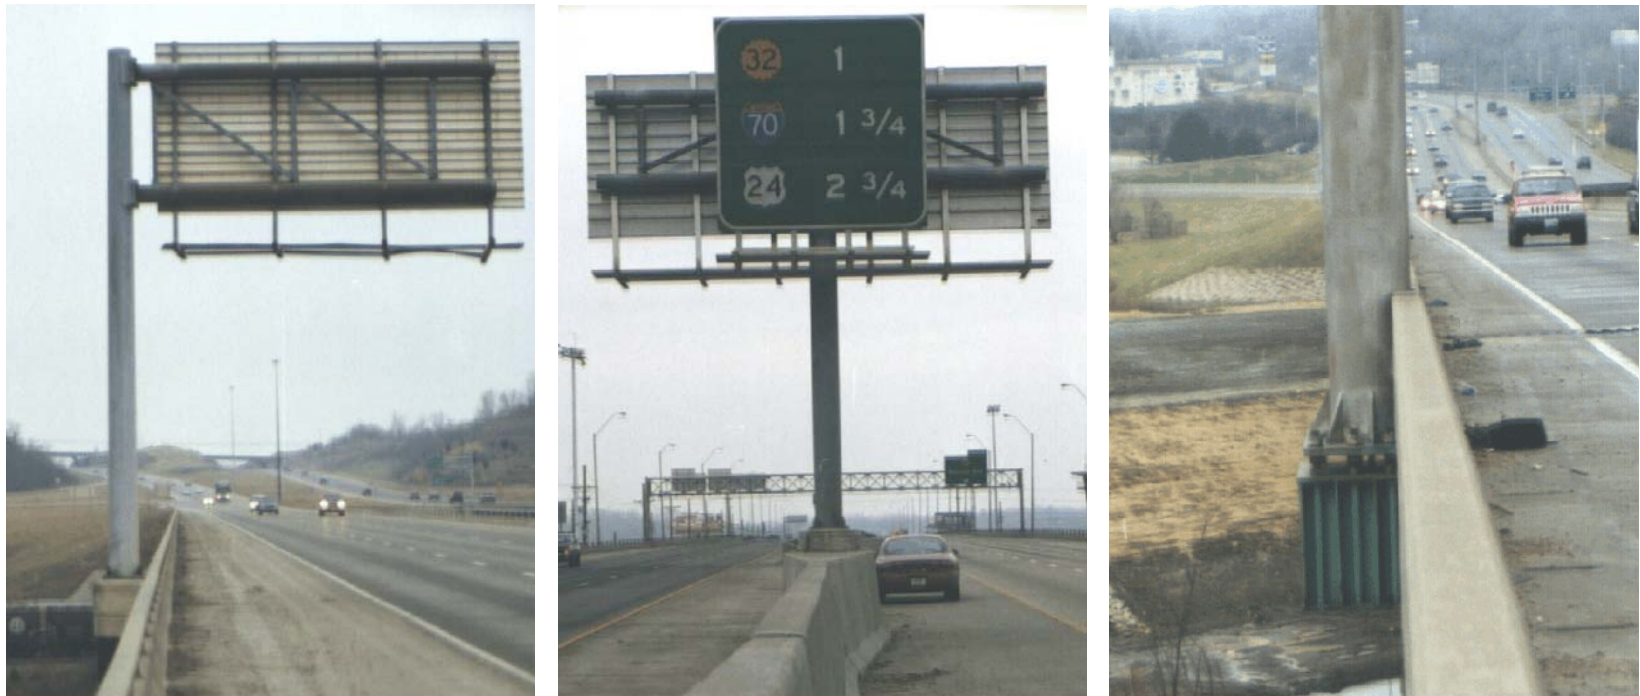
Figure 12. Large Single Support Signs and Overhead Sign Support Structures

single support signs and large overhead sign support structures span the roadways. The size of small to medium signs range from a mile marker to a 1.22-m x 1.83-m (4-ft x 6-ft) regulatory or warning sign. Fences and screens are continuous obstacles with periodic posts and longitudinal railings or metal fabrics. Pedestrian/bicycle railings are used to provide further separation between walkways and the traveled-way and are often attached to the top of traffic barriers generally lower than the recommended minimum heights for pedestrian/bicycle railings. Miscellaneous attachments, including small delineators, entrance ramp meter signals, old bridge rail installations behind retrofit new rails, and decorative concrete spires, do not easily fit in with the other attachment types.

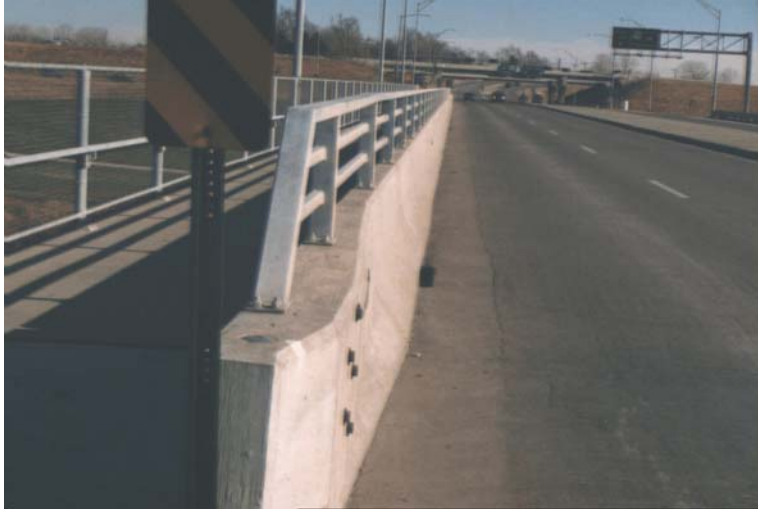
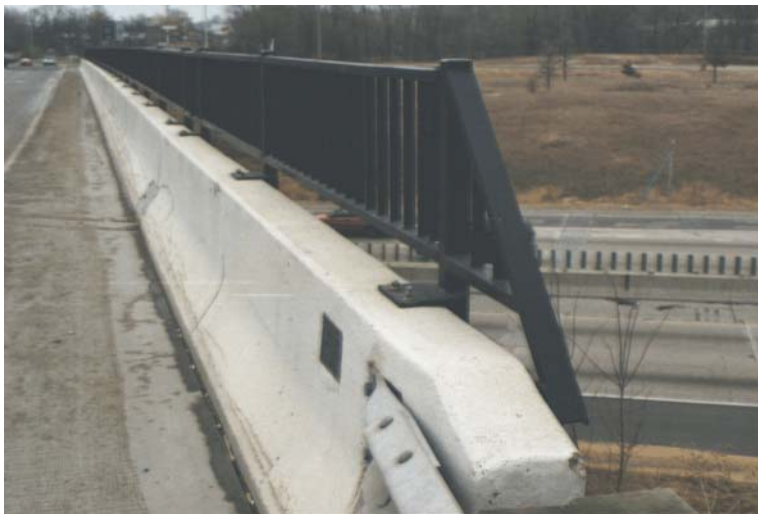
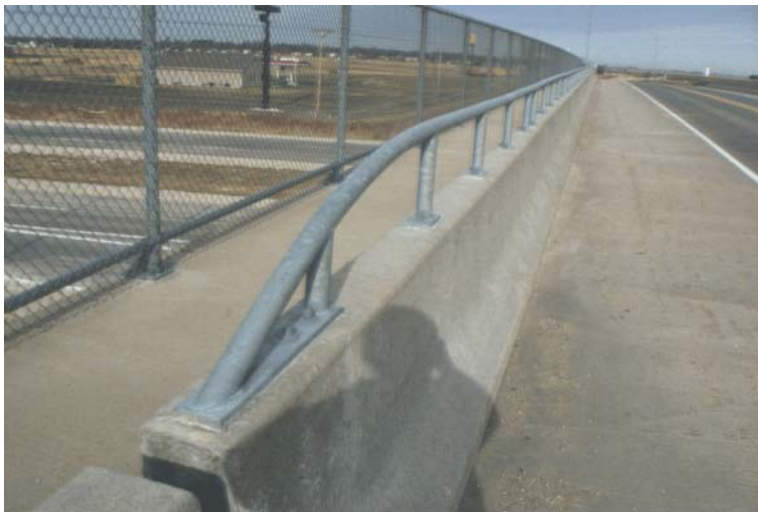
Figure 15. Pedestrian/Bicycle Railings

To date, there has been limited evaluation of transitions in height of attachments adjacent to the ends of the attachment. As shown in Figure 15, attachments typically transition from the end of the bridge rail section. Prudent design criteria involving installation in the ZOI is similar to considerations previously discussed, i.e. having posts that will breakaway allowing the system to deflect. Previous testing has shown that tapers of 8:1 or greater are advisable for concrete barrier end treatments (18). This recommendation for non-breakaway rail mounted to the top of the barrier is appropriate if the attachment design takes snag potential into consideration.

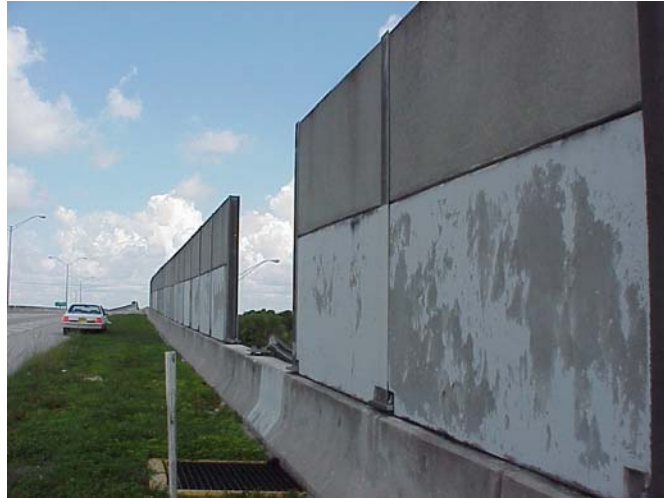
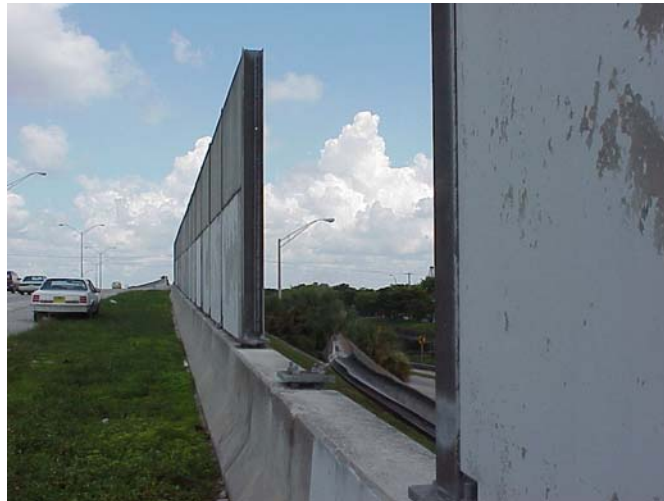
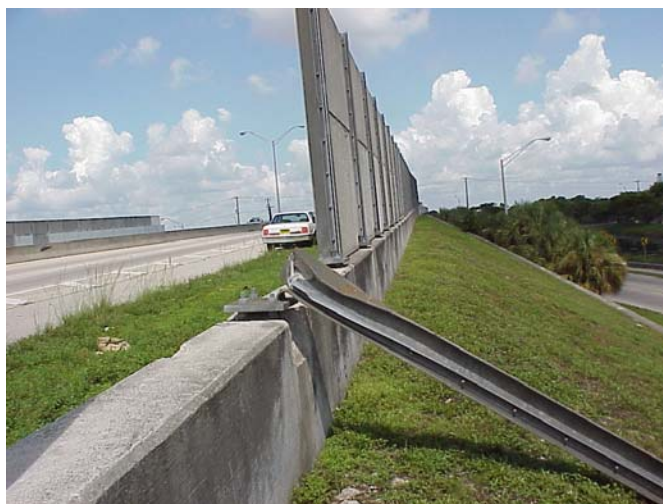
Figure 18. Failure of a Smooth Continuous Attachment

For installations where the longitudinal structure (i.e. rails) of the attachment shields the posts, it is critical that this structure have adequate continuity and tensile capacity to prevent vehicular impact with the posts. As shown in Figure 18, the apparently continuous wall section had inadequate capacity to redirect the impacting vehicle. As shown in this example, there is no connection between adjacent wall panels in this system, but this performance is also replicated in systems where the longitudinal elements do not have sufficient bending strength to prevent bending (pocketing) adjacent to the posts. This situation is obviously exacerbated by stiff posts.
