DYNAMIC IMPACT TESTING OF CRT WOOD POSTS IN A RIGID SLEEVE

MwRSF Research Report No. TRP-03-198-08

April 11, 2008

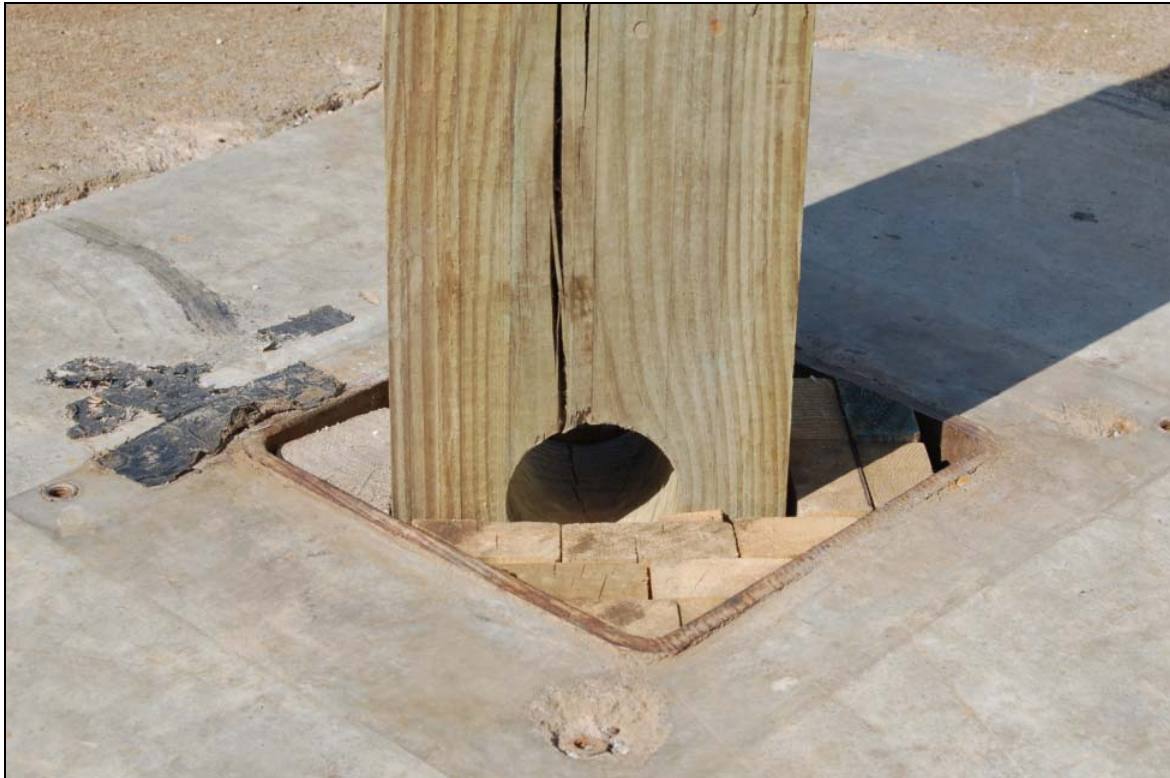
Figure 3. Shimmed CRT in Rigid Sleeve

For all nine tests, a rigid sleeve was utilized to anchor the post. The post was fitted into the sleeve with wood blocks and shims to rigidly hold the post upright. The rigid placement of the posts in the sleeve allowed for the determination of the dynamic wood properties before and

during fracture. It should be noted that there was no post interaction with soil. An example of a post placed in the rigid sleeve with a 45 degree orientation is shown in Figure 3.

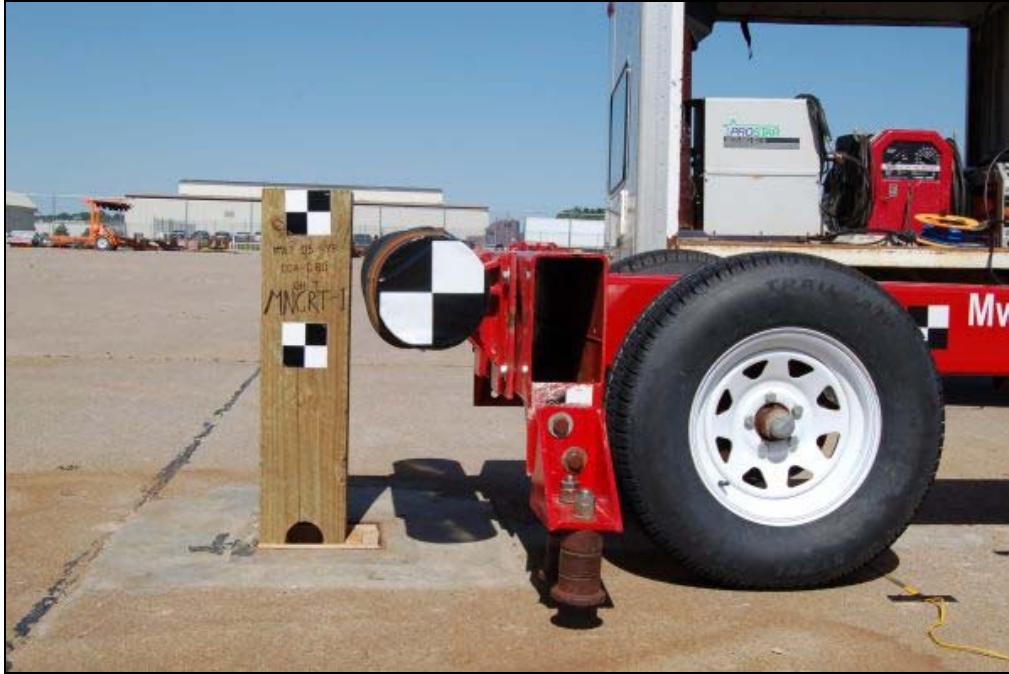
Figure 4. Bogie and Test Setup

A rigid frame bogie was used to impact the posts. The bogie impact head was constructed of 203-mm (8-in.) diameter by 12.5-mm (0.5-in.) thick, standard steel pipe, with 19-mm (0.75-in.) thick, neoprene belting wrapped around the pipe to prevent local damage to the post from the impact. The bogie with the impact head is shown in Figure 4. The mass (weight) of the bogie, with the addition of the mountable impact head, was 728 kg (1,605 lbs). The impact height was 632 mm (24.875 in.) above the ground. The target speed for the tests was 24.14 km/h (15 mph).

In all tests, a pickup truck with a reverse cable tow and guide rail system was used to propel the bogie. The bogie was accelerated toward the post along the guidance system, which consisted of a steel pipe anchored above the tarmac. In all of the tests, the bogie wheels were aligned for caster and toe-in values of zero so that the bogie would track properly. When the bogie reached the end of the guidance system, it was released from the tow cable, allowing it to be free rolling when it impacted the post. A remote braking system was installed on the bogie, thus allowing it to be safely brought to rest after the test.
