EVALUATION OF BOX BEAM STIFFENING OF UNANCHORED TEMPORARY CONCRETE BARRIERS

NEW YORK STATE DEPARTMENT OF TRANSPORTATION
50 Wolf Road, 6th Floor
Albany, New York 12232

MwRSF Research Report No. TRP-03-202-08

March 14, 2008

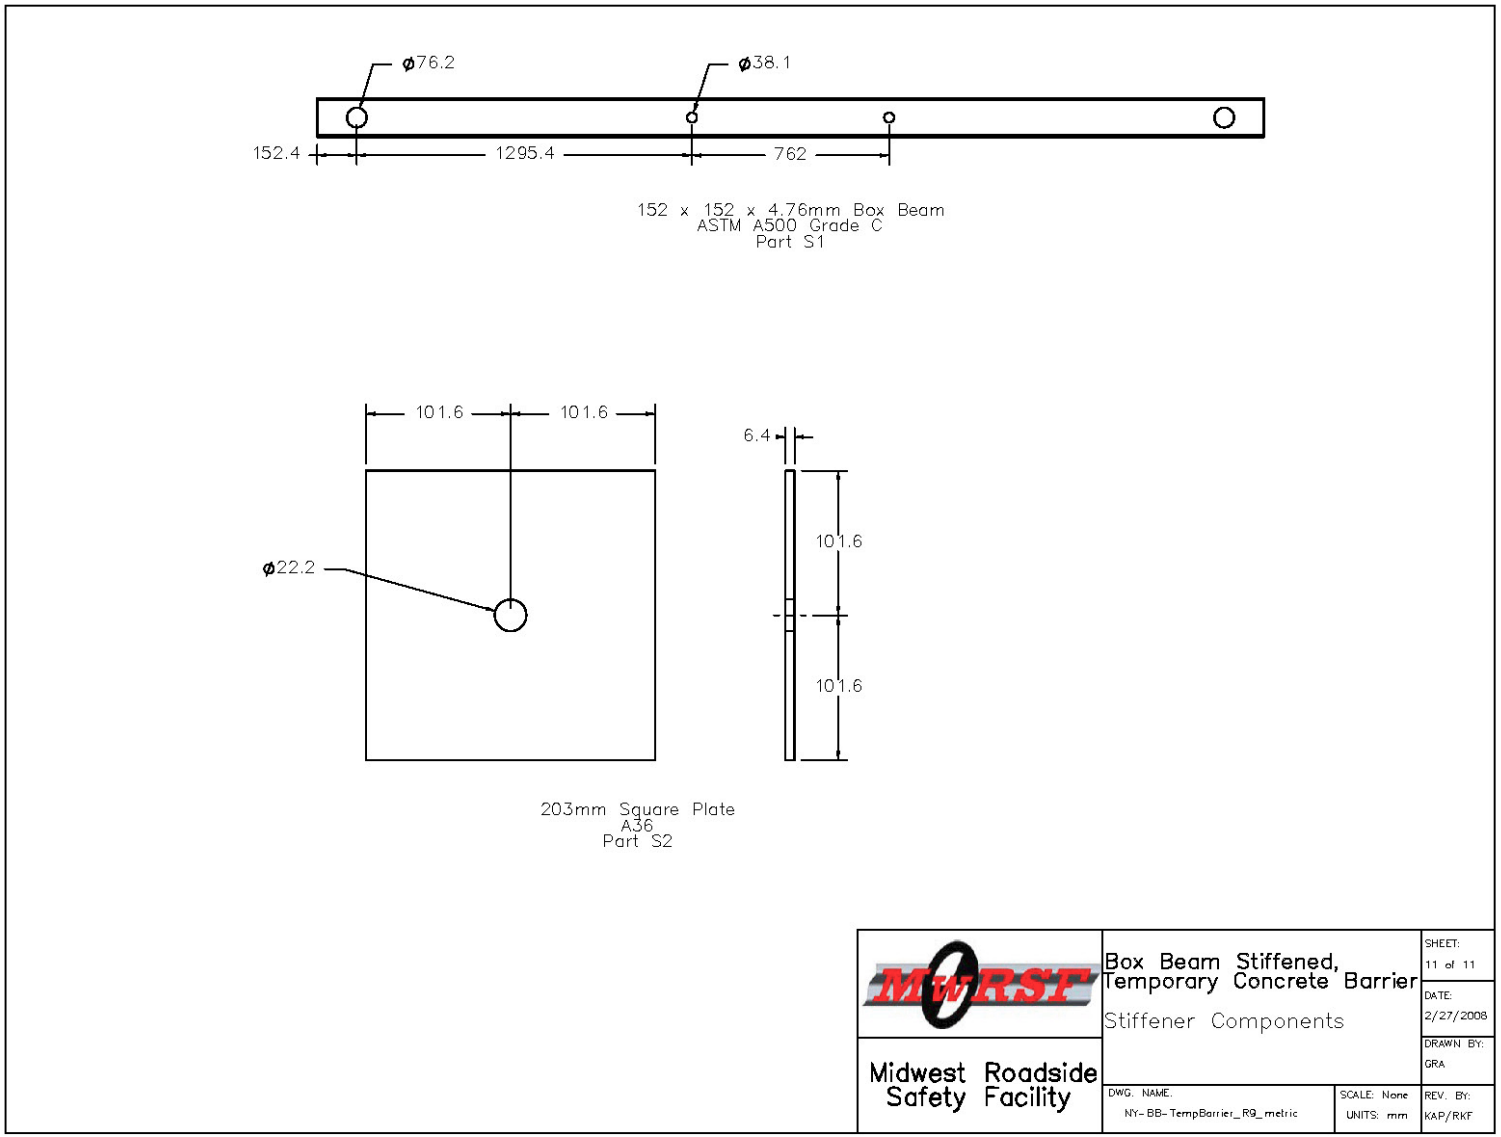
Figure 23. Box Beam Stiffener Details, Test NYTCB-1

As shown in Figure 23, the holes placed within the ends of the box beam stiffening rails were oversized. The oversized holes were utilized to allow for vertical alignment changes in the barrier system. For horizontal alignment changes, shim washers were designed for use when placed between the box beam rail and the back-side face of the temporary concrete barrier sections, as shown in Figure 21. Threaded rods were used to attach the box beam rails to the barrier sections. The length of the rods, or alternative hex head or dome head bolts, should possess sufficient length to allow for the placement of shims, if needed. As depicted in Figures 13, 21, and 23, large plate washers were used to retain the box beam rails and transfer the rod load to the top and bottom webs of each stiffening rail, rather than allowing the rod and nut to bend the washer into each beam's bearing flange. Finally, the size of the box beam stiffening rail was selected to be consistent with the standard sizes used for the NYSDOT's box beam guide rail and median barrier.

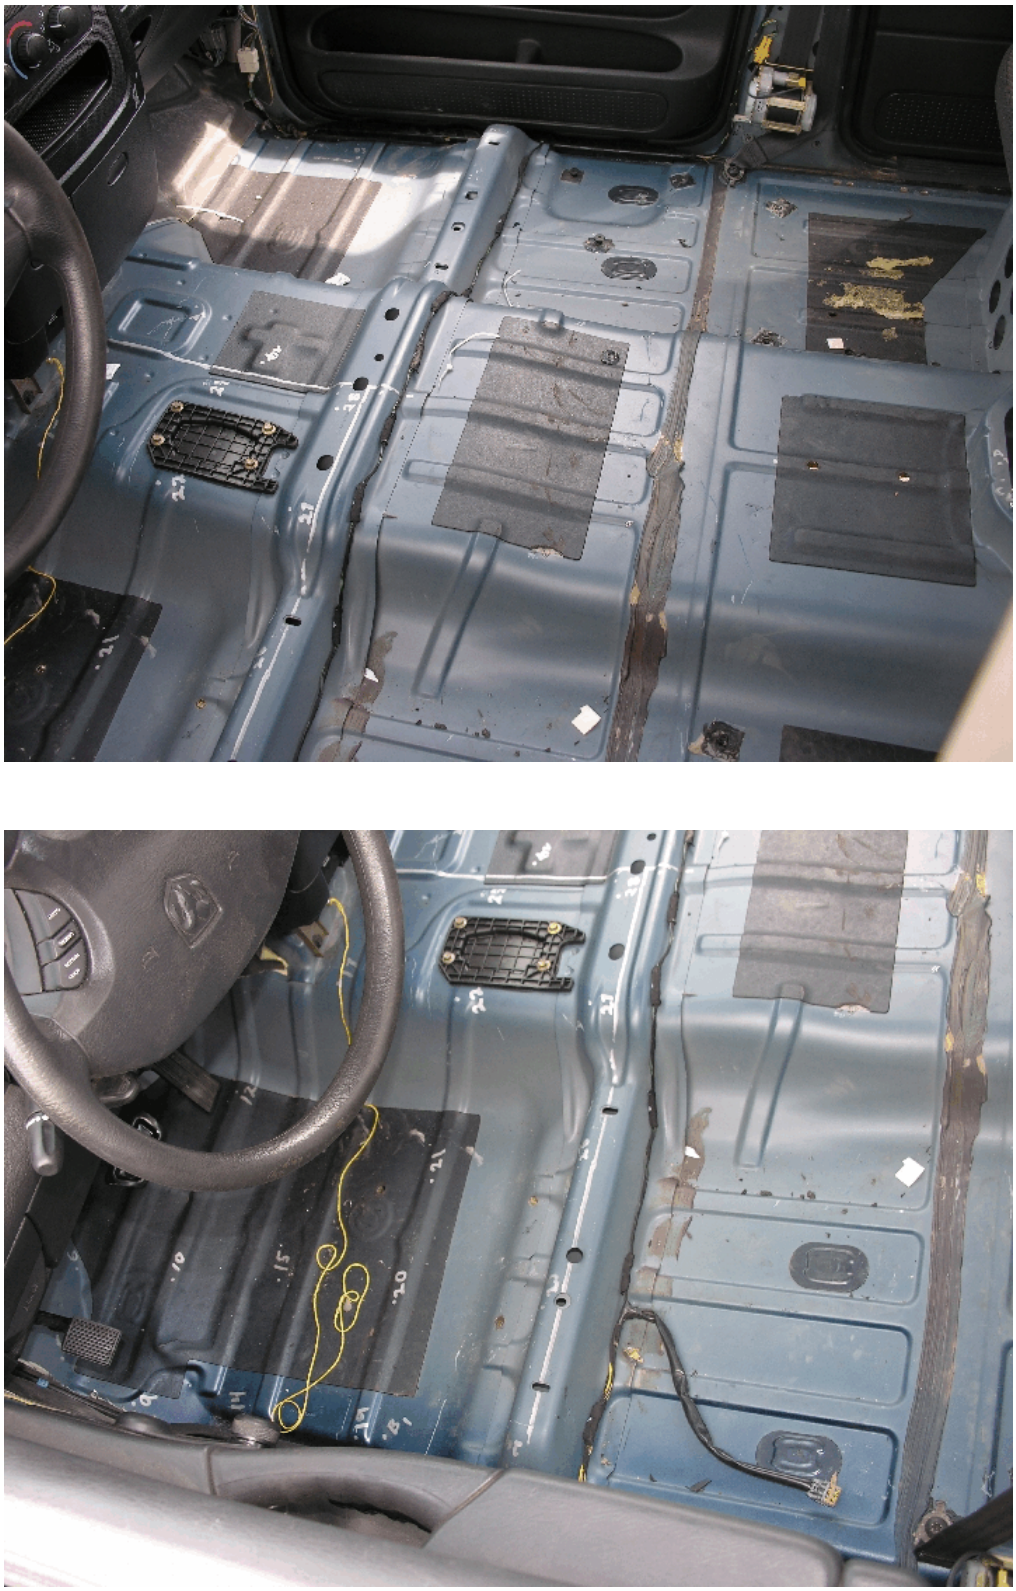
Figure 64. Occupant Compartment Deformation, Test NYTCB-2

cause serious injury to the vehicle occupants, as shown in Figure 64. Maximum longitudinal deflections of 76 mm (3 in.) were located near the left-front corner of the left-side floor pan. Maximum lateral deflections of 25 mm (1 in.) were located near the front center of the left-side floor pan. Maximum vertical deflections of 70 mm (2.75 in.) were located near the middle-front area of the left-side floor pan. Complete occupant compartment deformations and the corresponding locations are provided in Appendix C.
