U.S. Department
of Transportation
**Federal Highway
Administration**

Publication No. FHWA-RD-96-032
January 1997

Crash Testing and Evaluation of Retrofit Bridge Railings and Transition

VANDAL PROTECTION FENCE ON NEW JERSEY SAFETY SHAPE BRIDGE RAILING

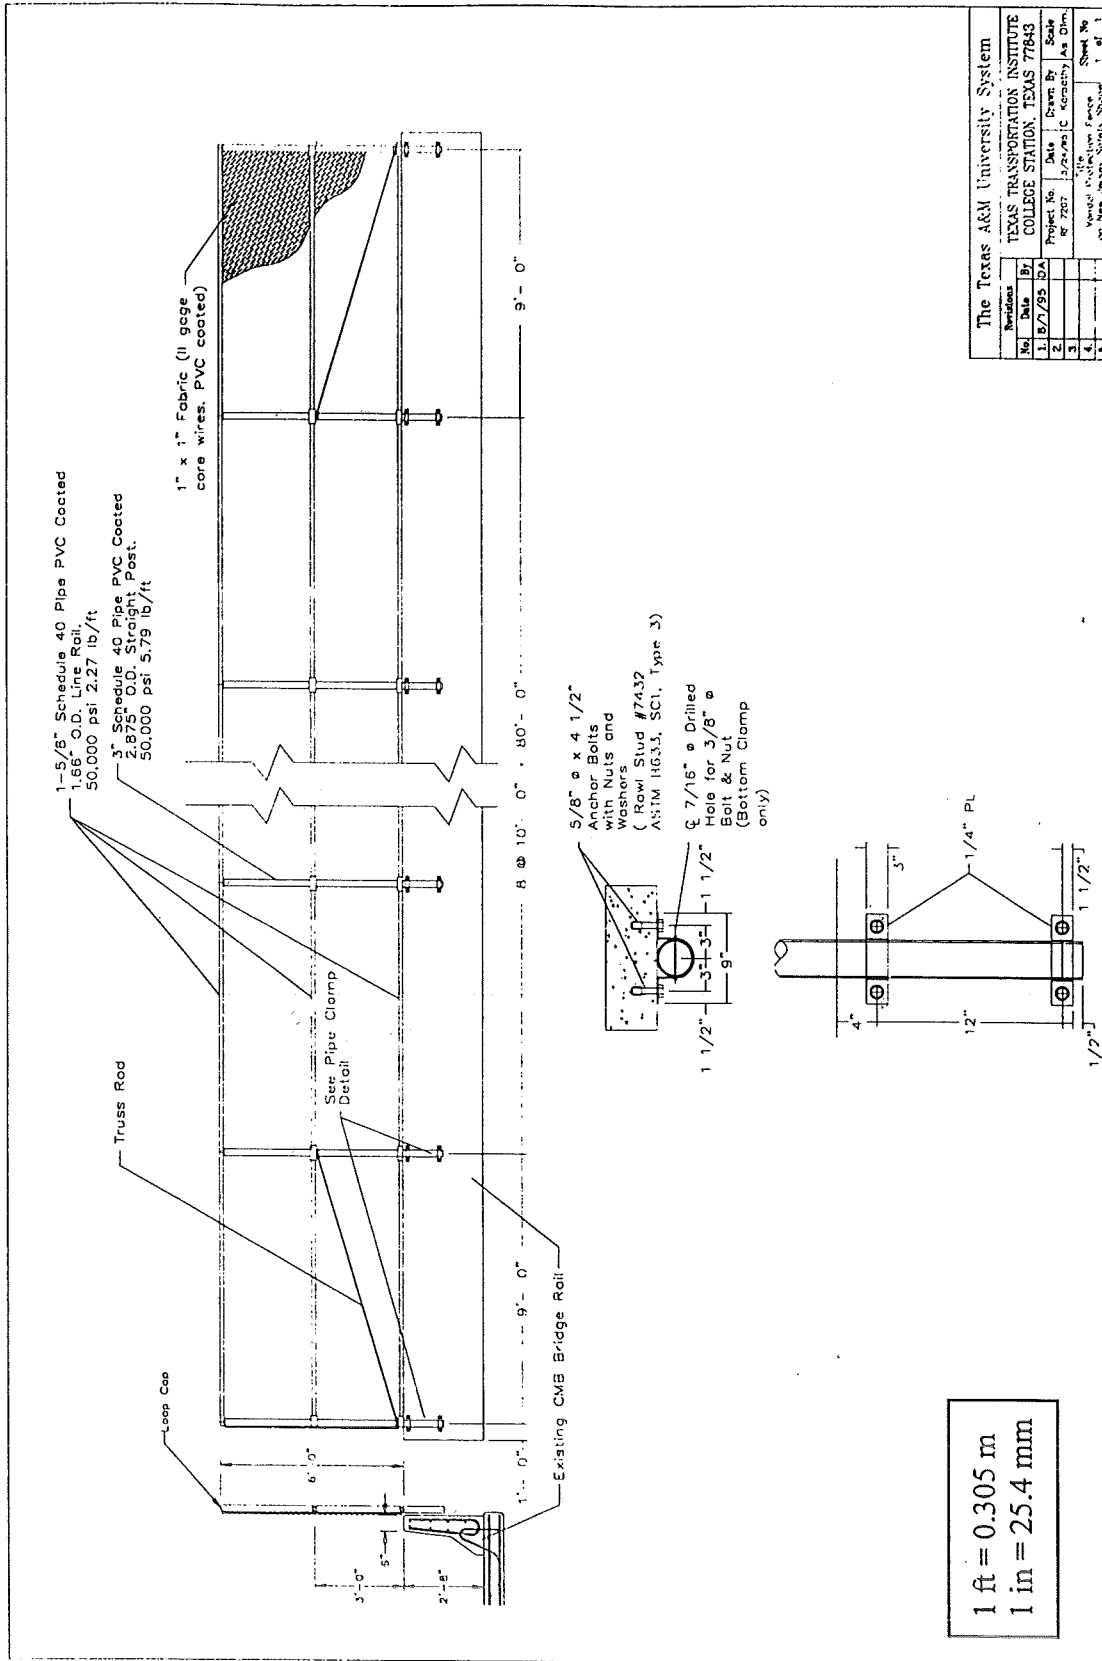
Figure 40. Details of vandal protection fence on New Jersey safety shape bridge railing.

The total height of the New Jersey safety shape is 813 mm (32 in). Thickness of the unit is 381 mm (15 in) at its base and varies along the height, tapering to a minimum of 152 mm (6 in) at the top. Eight 13 mm (#4) longitudinal bars were used in the safety shape. The vertical steel was 16 mm (#5) stirrups at 203 mm (8 in) spacing. Specified concrete strength was 24 804 kPa (3600 psi) at 28 days, and specified steel yield was 413 400 kPa (60,000 psi). The cantilevered deck was supported on a foundation so that the deck overhang was 991 mm (39 in).

The vandal protection fence was mounted on 2.2 m (7.3 ft) long by 73 mm (2.875 in) OD (schedule 40 pipe) straight posts mounted to the back of the safety shape with two clamps and anchored with 0.625 m by 76 mm (5/8 in by 3 in) anchor bolts. The clamps were formed from 76 mm (3.0 in) wide by 6.35 mm (0.25 in) flat steel. The first post is placed 0.3 m (1 ft) from the end of the safety shape with the next post at 2.7 m (9.0 ft), then 8 spaces at 3.0 m (10.0 ft), and ending with one spaced at 2.7 m (9.0 ft). Attached to these posts are three 42 mm (1.66 in) OD (schedule 40 pipe) horizontal line rails spaced at 0.9 m (3.0 ft) with 25 mm by 25 mm (1 in by 1 in) wire fabric (11 gage core wires, PVC coated). Height to the top of the fence is 1.8 m (6.0 ft) above the safety shape. Total height of the installation is 2.6 m (8.7 ft) above the roadway surface.

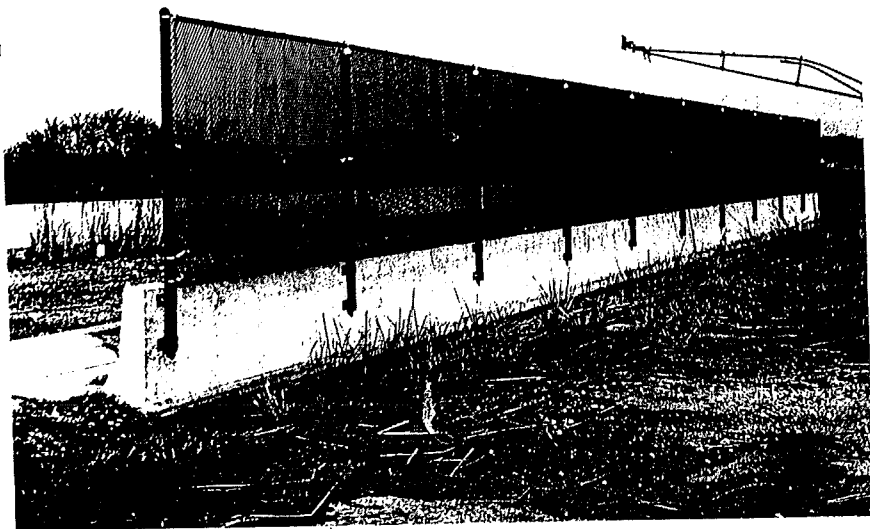
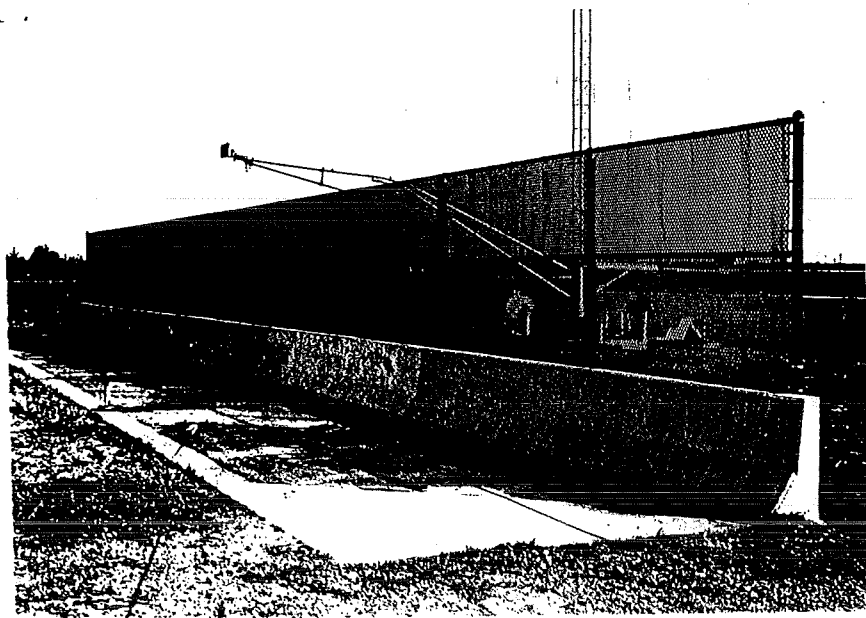
Figure 41. Vandal protection fence on the New Jersey safety shape bridge railing.

The New Jersey safety shape bridge railing used during a previous contract was used as the retrofit railing. The vandal protection fence was attached to the existing bridge railing. Total installation length was 30 m (100 ft). A cross section of the prototype test installation is shown in figure 40 and photographs of the completed installation are shown in figures 41 and 42.

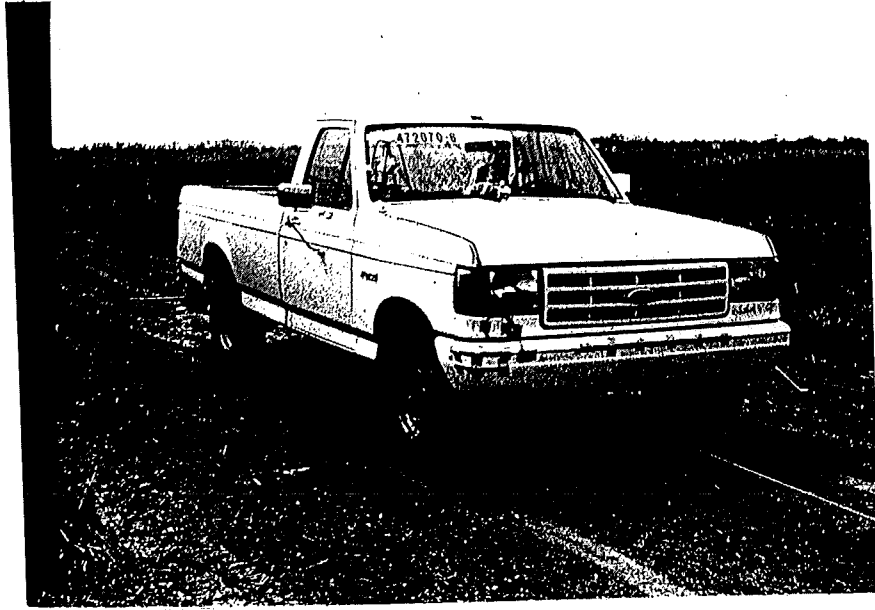
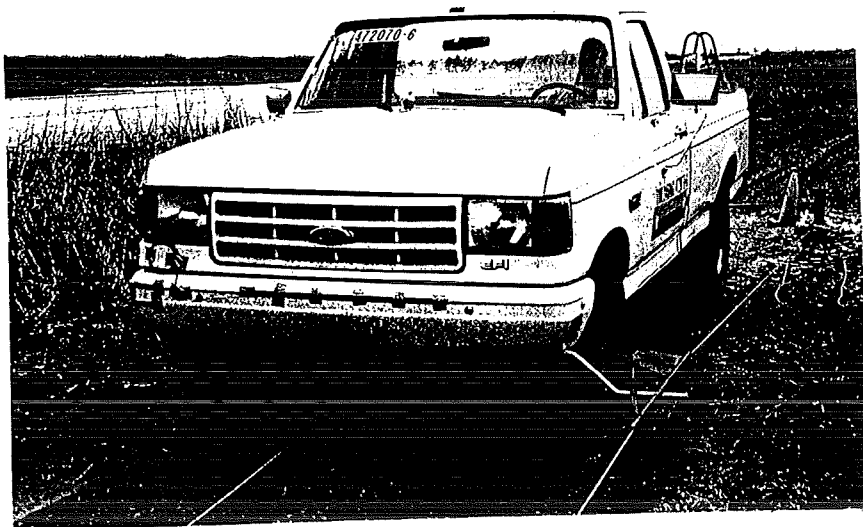
Figure 44. Vehicle prior to test 472070-6.

A 1991 Ford F250 (shown in figures 43 and 44) with a test inertia weight of 2540 kg (5397 lb) was used for the crash test. The gross static weight of the vehicle was 2525 kg (5562 lb) which included a restrained 50th percentile male anthropomorphic dummy placed in the driver's position of the vehicle. The heights to the upper and lower edges of the vehicle bumper were 740 mm (29.1 in) and 450 mm (17.7 in), respectively. Additional dimensions and information on the vehicle are given in appendix B, figure 64. The vehicle was directed into the installation using the cable reverse tow and guidance system, and was released to be free-wheeling and unrestrained just prior to impact.
