1. REPORT NUMBER FHWA/CA10-0515	2. GOVERNMENT ASSOCIATION NUMBER	3. RECIPIENT'S CATALOG NUMBER
4. TITLE AND SUBTITLE DEVELOPMENT OF WEED CONTROL BARRIER BENEATH METAL BEAM GUARDRAIL		5. REPORT DATE January 2011

**DEVELOPMENT OF WEED CONTROL BARRIER BENEATH METAL
BEAM GUARDRAIL**

January, 2011

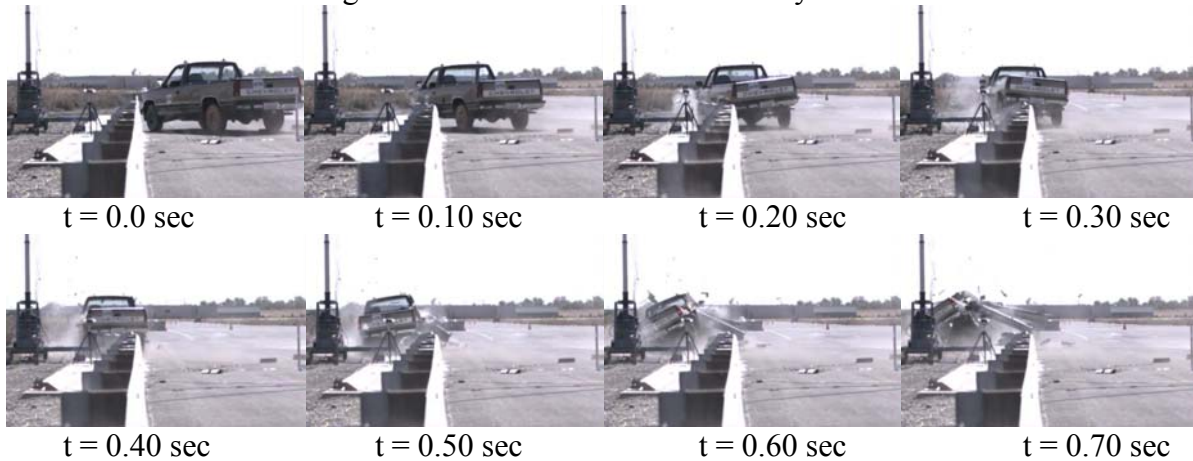
Figure 2-24 – Test 658 Data Summary Sheet

Barrier Damage: The W-beam ruptured, allowing the vehicle to penetrate beyond the guardrail.

The main damage was the rupture of the w-beam rail. Secondly, the upstream SFT deflected toward the impact point, likely because the soil surrounding the metal tube was not adequately compacted. The rail stretched upstream of the impact point and compressed downstream of the impact point, as evidenced by movement of as much as ¼ inch at the lap splices. Every post twisted counterclockwise, possibly also because of the inadequate anchoring of the upstream end treatment. As the rail shifted laterally (in the downstream direction), the wood post at the downstream SFT fractured (see Figure 2-22). Several blockouts also fractured during impact and were thrown from the point of impact toward the field. The blockout nearest the point of impact appeared to fracture upon impact, possibly before the post was able to rotate. Thus the reaction point of the rail would not have been raised, possibly contributing to the system failure. At the rupture point, the bottom of the w-beam element appears to have failed in shear due to contact with the top of the post at that location while the upper portion appears to have failed in tension.

Because of the results of Test 658, several design changes were made to the test article before re-testing. The test article for Test 658 was removed and replaced with a new test article. A 193.25-foot section (including end treatments) of MBGR with W6x9 steel posts was used. Again, all steel posts were driven into place without pilot holes. A 100-ft long x 4 ft-8 in section of CRMCrete was placed around 16 posts in the vicinity of impact (from the fifth post upstream of the impact point to the eleventh post downstream of the impact point). The first change made was to use an SRT end terminal instead of an SFT at the upstream end for additional anchorage. Wood posts at the SRT were driven into undersized pilot holes. An SFT was again used at the downstream end. A second significant change was to install the entire test article in native soil rather than in the AASHTO Grade A Standard Soil Pit. The native material is not as stiff as the AASHTO Standard Soil. A less stiff soil would be less likely to resist post rotation, thus making any effect the CRMCrete had on post rotation more pronounced. Third, the rubber boots used in Test 658 were replaced with expanded polystyrene foam (EPF) covered by ½ in of CRMCrete flash over. The EPF had a flexural strength of 33 psi and a compressive strength of 13 psi at 10% deformation. Last, the amount of crumb rubber in the mix was reduced from 4% to 3%. This mix design had a higher 28-day strength (1863 psi, 12.84 MPa) and created a more durable section to withstand cracking. The increase in compressive strength had only a minimal effect on the strength of the leave-out area with EPF since the leave-out section consisted of only ½ in (13 mm) of flash over.

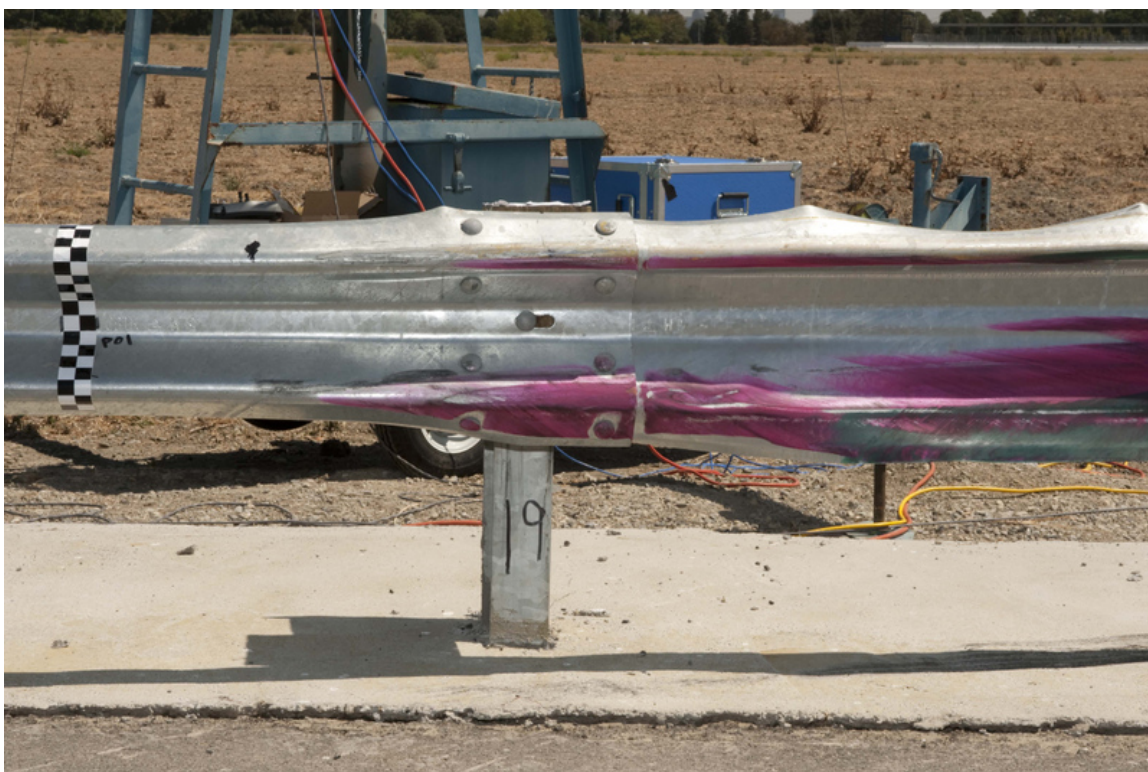
Figure 2-39 – Impact Point after Test 659

Barrier Damage: Permanent deflection at posts 19-23, with the CRMCrete in the leave-out area broken out as expected. Posts 20-22 yielded and were bent over. The W-Beam rail was deflected and deformed but intact. Maximum dynamic deflection was estimated at 40 inches (1016 mm). Maximum permanent deflection of the rail was 1.9 feet (579 mm) at approximately 14.2 feet (4.33 m) downstream of impact.
