TEST REPORT No. 2

ALUMINUM BRIDGE RAIL SYSTEMS

Texas A&M Research Foundation

March 1980

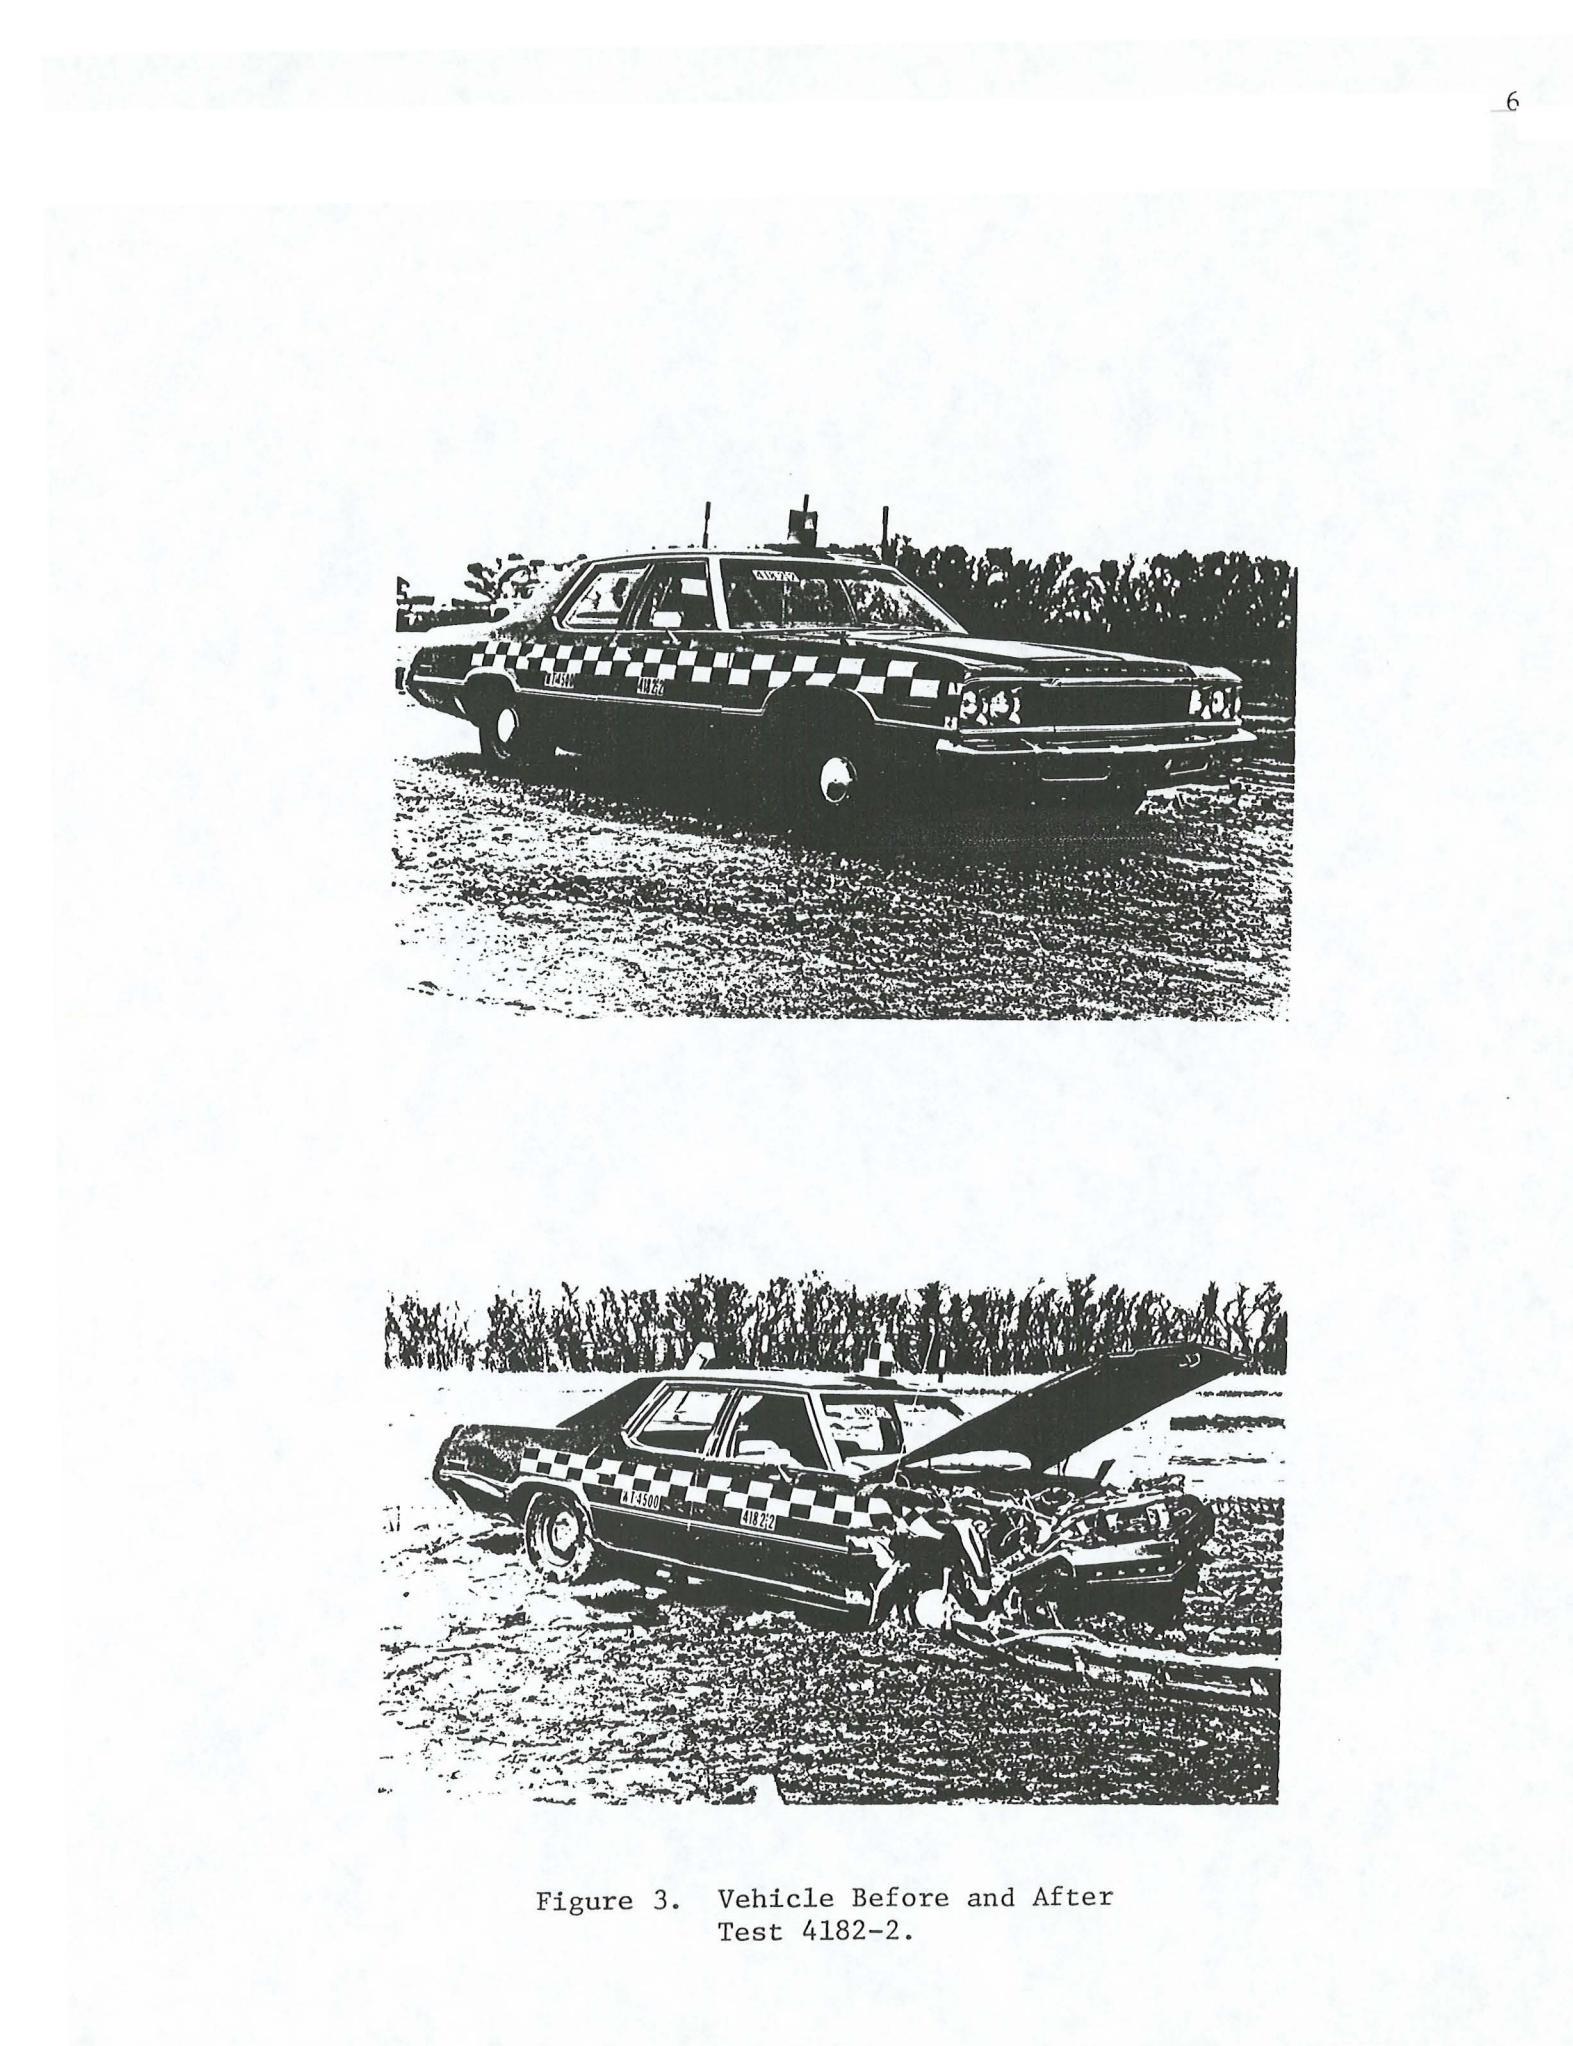
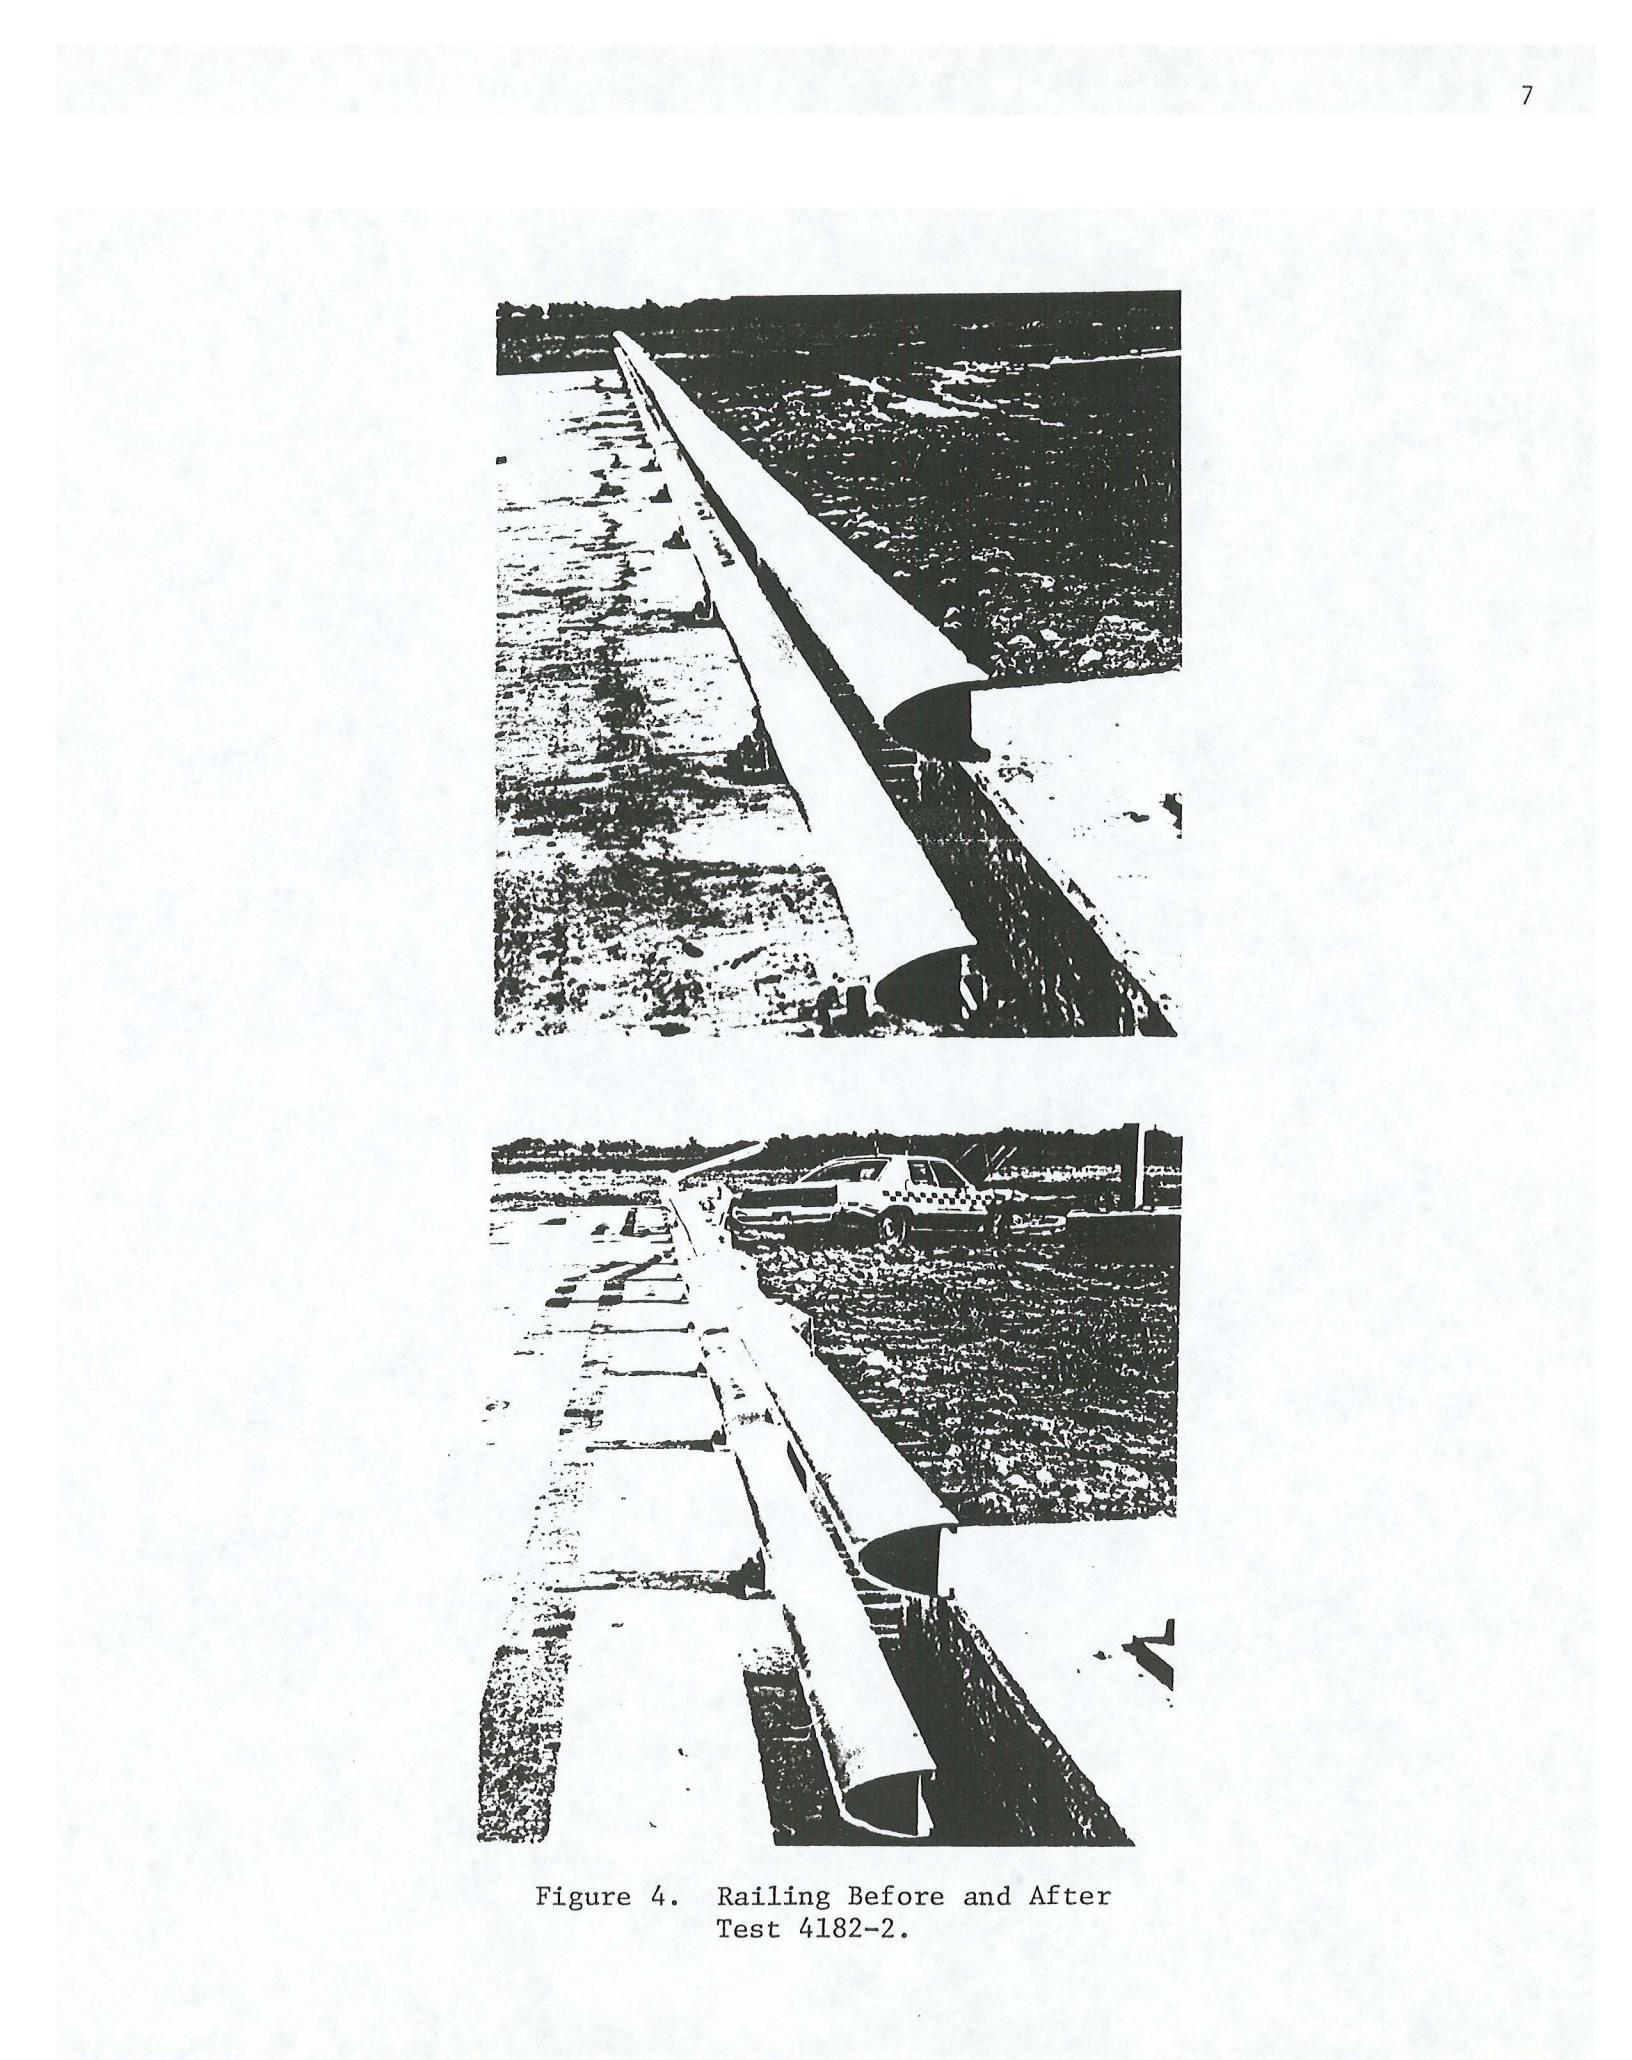
Figures 3 and 4 depict the vehicle and test area before and after the impact. Figure 5 includes overhead and oblique views of the impact area. It can be seen that posts 7, 8 and 9 were separated from their base-plate flanges. The overhead view shows a detached section of rail from posts 8 and 9. A section of the top rail from posts 7 and 8 was thrown about 46 m (150 ft) from the point of impact approximately in the direction of initial vehicle travel.

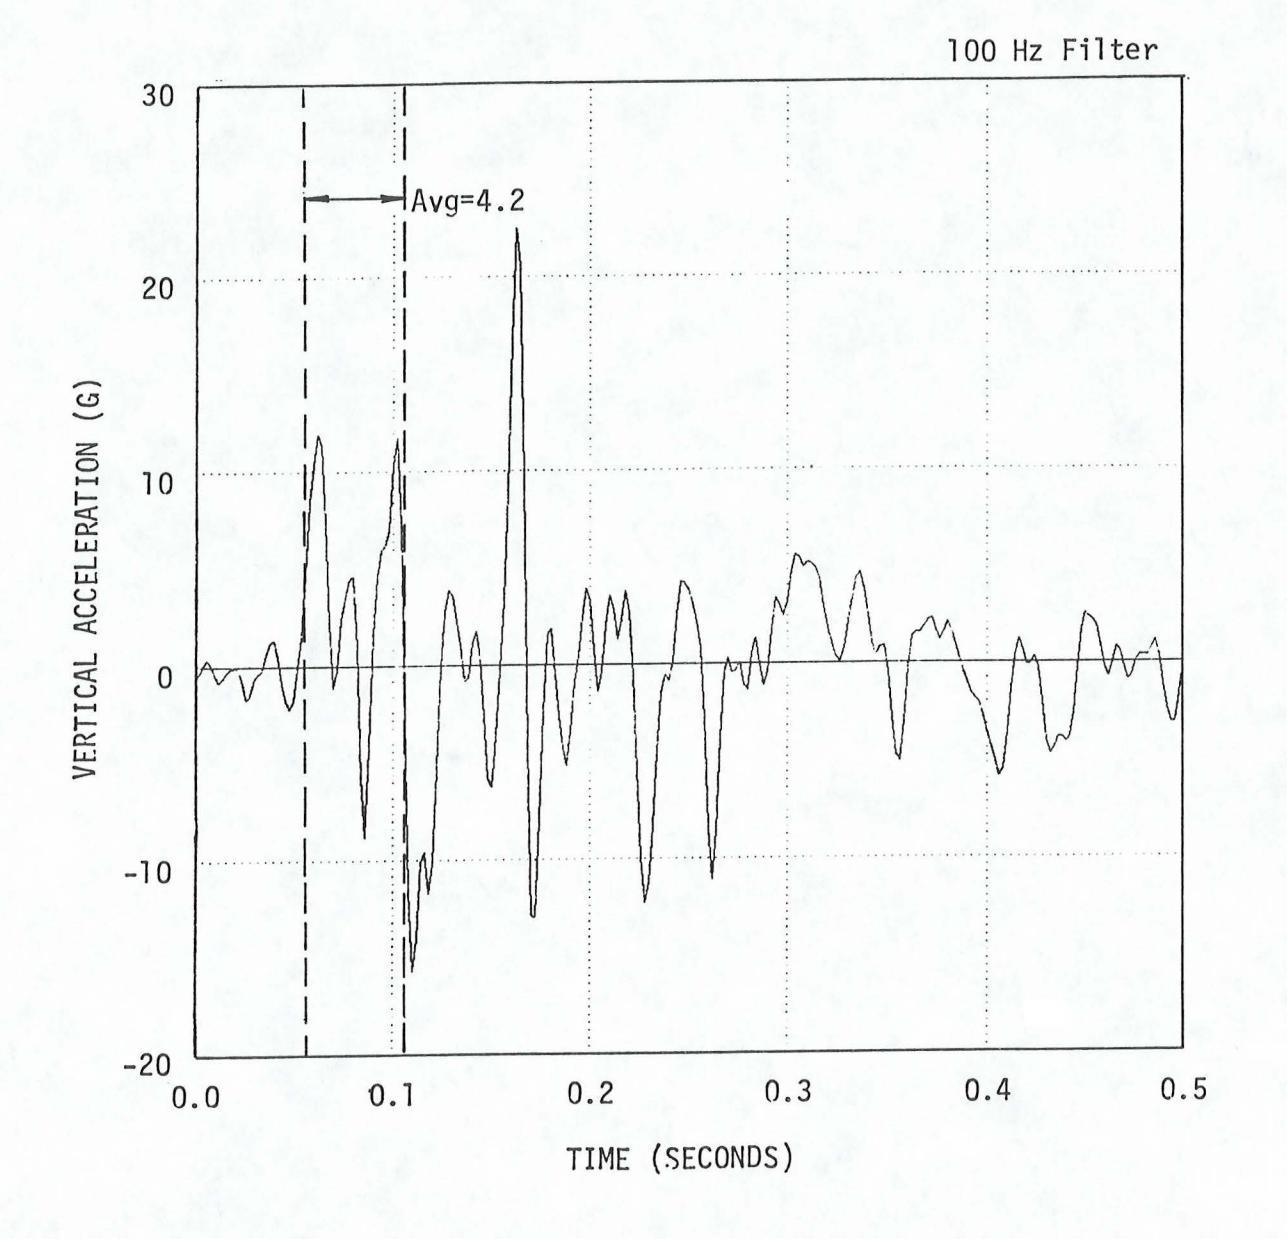
Figure 11. Vehicle Vertical Accelerometer Trace for Test 4182-2.

Sequential photographs and a summary of test data are shown in Figures 7 and 8. Figures 9, 10 and 11 are analog reproductions of the vehicle triaxial accelerations as a function of time.

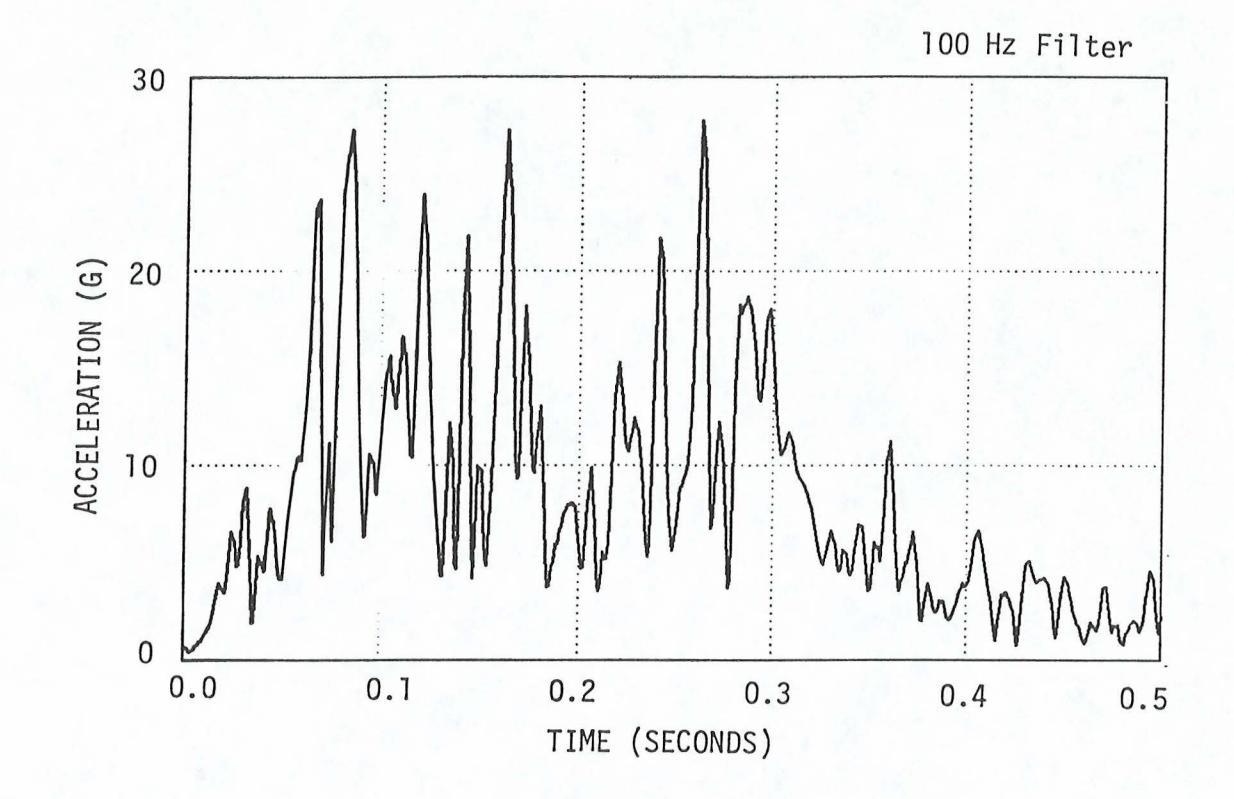
Figure 12. Resultant Acceleration Trace for Test 4182-2.

Figure 12 represents the resultant absolute acceleration which had a maximum 50-millisecond-interval average of 11.91 g's. The triaxial acceleration traces indicate the individual maximum 50-millisecond-interval values.
