DETERMINATION OF THE MAXIMUM MGS MOUNTING HEIGHT – PHASE I CRASH TESTING

MwRSF Research Report No. TRP-03-255-12 Revision-1

November 30, 2015

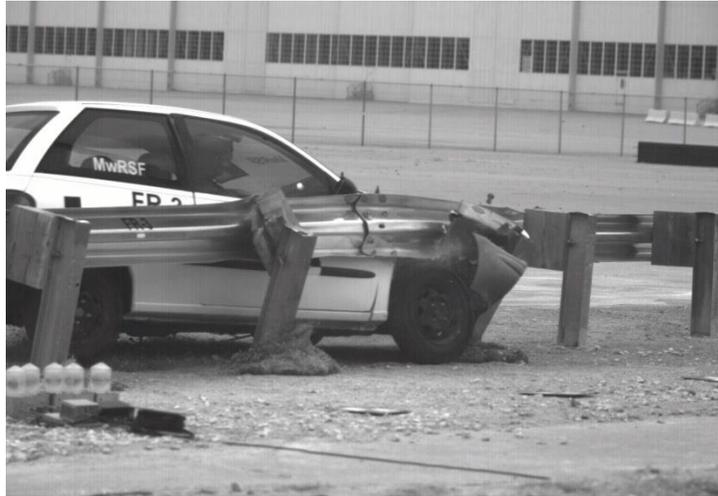
Figure 1. Test No. FR-3, Potential for Wheel Snag

Two concerns arise when wheel snag occurs: (1) the wheel is pushed rearward against the wheel well, which could deform the floorpan and (2) the longitudinal forces on the wheel increase the occupant risk values. Test no. FR-3 showed the propensity for wheel snag, as shown in Figure 1. Additionally, the small car utilized in test no. FR-5 encountered wheel snag on post no. 15, as shown in Figure 2. These flare rate tests, however, were more severe than a standard W-beam test, as the small car impacted at a higher effective angle of 31.8 degrees. As stated before, both of these tests passed the NCHRP Report No. 350 test criteria, and experienced acceptable floorpan deflections and occupant risk values. Thus, wheel snag may not pose a critical risk to the small car at higher rail heights. In test no. 2214MG-3, slight wheel snag occurred that did not abruptly stop the vehicle but caused it to yaw toward the barrier, as shown in Figures 3 and 4.

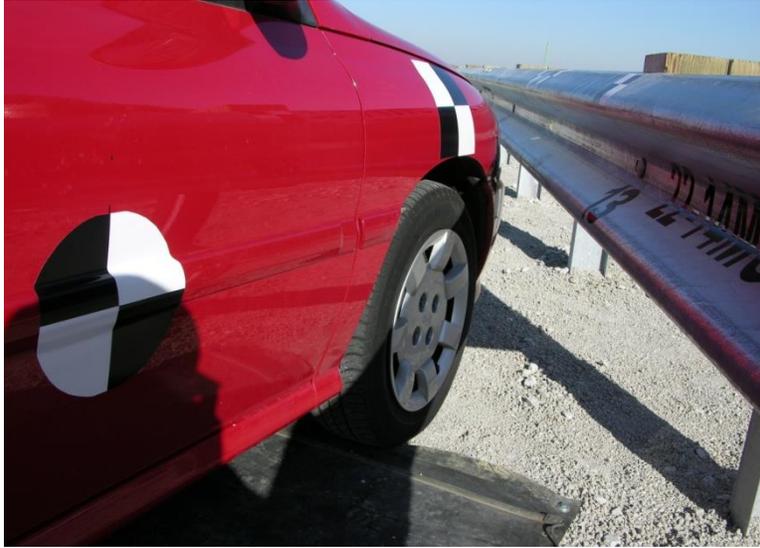
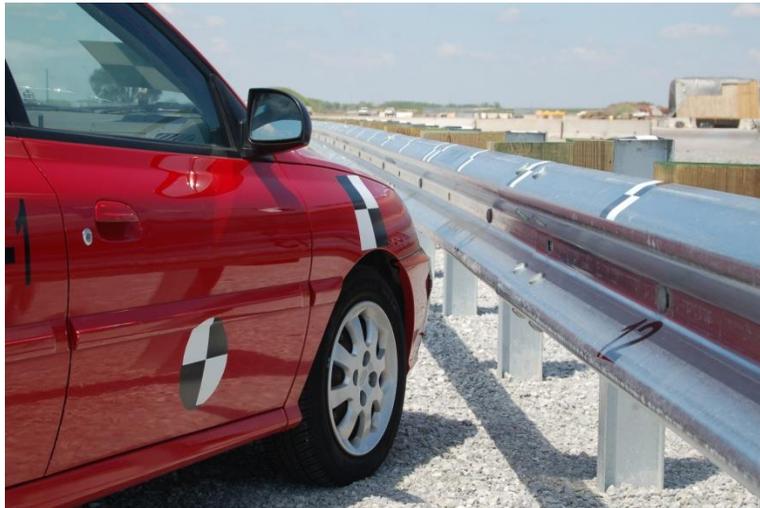
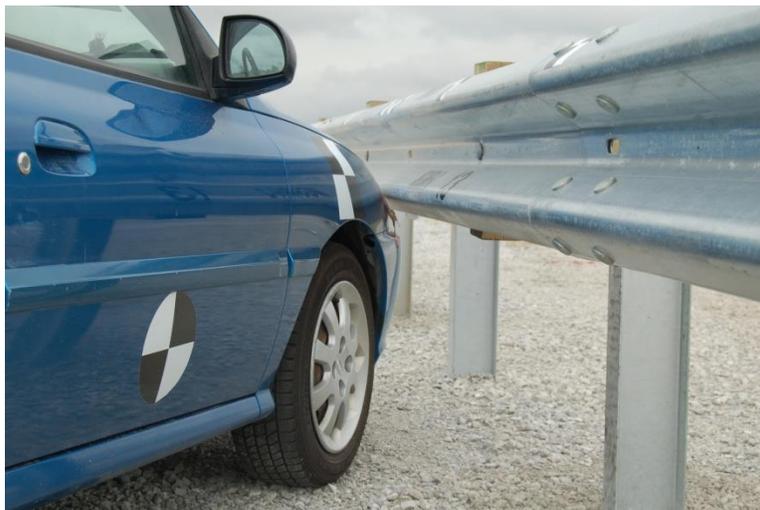
Figure 8. 1100C Next to 32-, 34-, and 36-in. (813-, 864-, and 914-mm) MGS – Rear View

Another key geometric factor is the vehicle to rail relationship, as shown in Figures 8 and 9. When the rail is mounted at a height of 32 in. (813 mm), the rail no longer contacts the bumper—its contact is primarily with the hood and side quarter panel of the vehicle. Because several tests have successfully passed with that type of contact, the height of the rail may be increased several inches and still successfully capture the vehicle. As shown in Figure 6, the distance between the

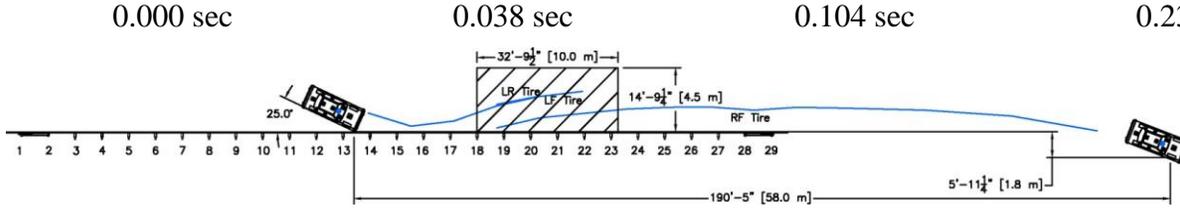
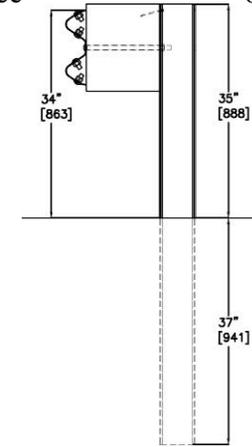
Figure 29. Summary of Test Results and Sequential Photographs, Test No. MGSMRH-1

The analysis of the test results for test no. MGSMRH-1 showed that the 34-in. (864-mm) tall MGS adequately contained and redirected the 1100C vehicle with controlled lateral displacements of the barrier. There were no detached elements nor fragments which showed potential for penetrating the occupant compartment nor presented undue hazard to other traffic. Deformations of, or intrusions into, the occupant compartment that could have caused serious injury did not occur. The test vehicle did not penetrate nor underide the barrier and remained upright during and after the collision. Vehicle roll, pitch, and yaw angular displacements were deemed acceptable because they did not adversely influence occupant risk safety criteria nor cause rollover. After impact, the vehicle exited the barrier at an angle of 12.3 degrees and its trajectory did not violate the bounds of the exit box. Therefore, test no. MGSMRH-1 conducted on the 34-

in. (864-mm) tall MGS was determined to be acceptable according to the MASH safety performance criteria for test designation no. 3-10.

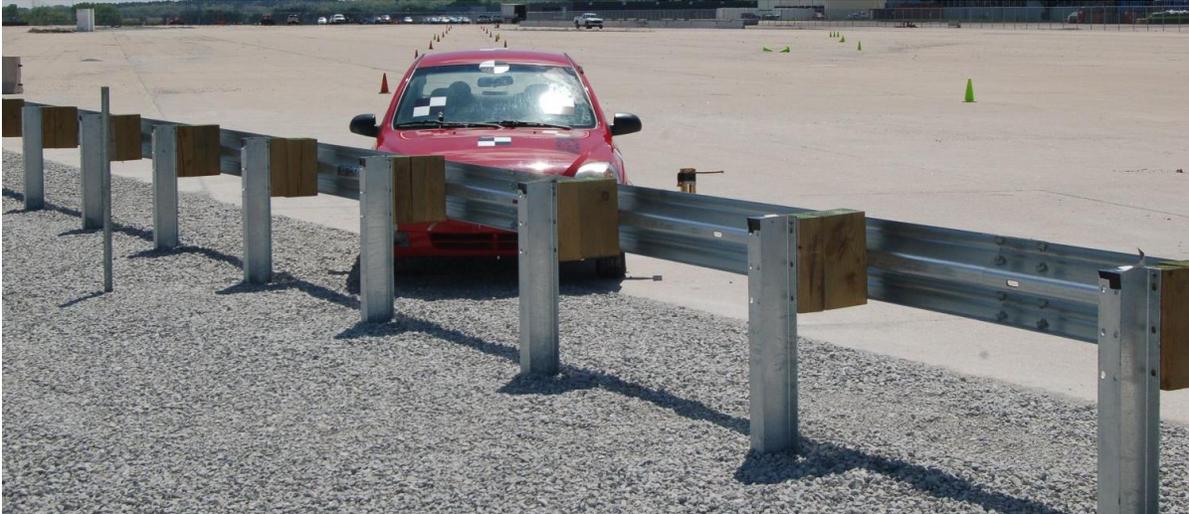
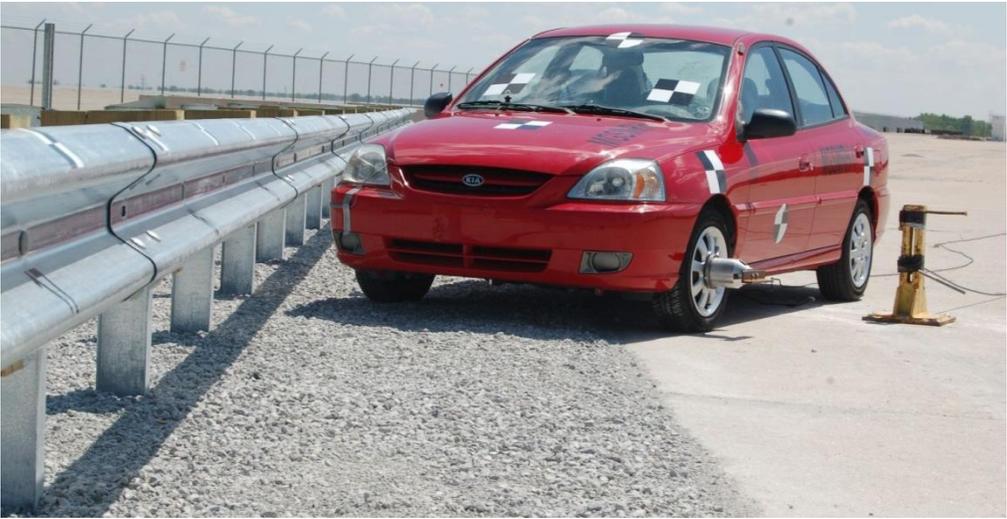
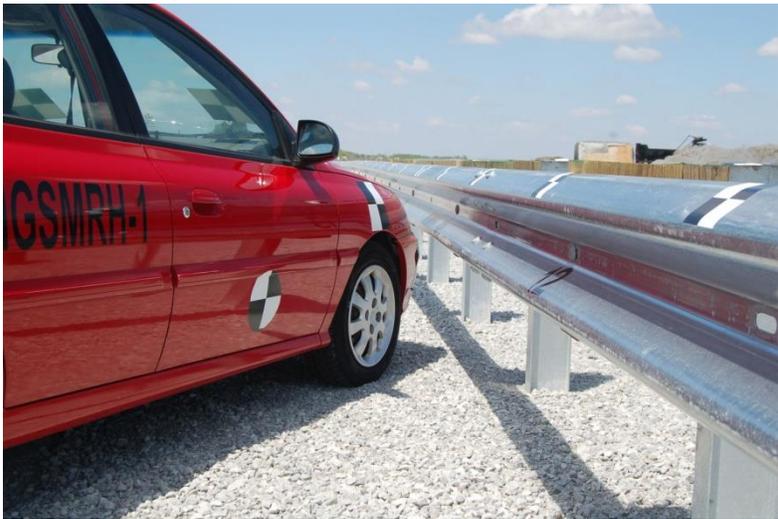
Figure 34. Impact Location, Test No. MGSMRH-1

Initial vehicle impact was to occur 10 ft (3.0 m) upstream of the centerline of post no. 15, as shown in Figure 34, which was selected using the critical impact point (CIP) plots found in Section 2.3 of MASH. The actual point of impact was 10 ft – 1 in. (3.1 m) upstream from the centerline of post no. 15. A sequential description of the impact events is contained in Table 6. The vehicle came to rest facing downstream, located 190 ft – 5 in. (58.0 m) downstream from impact and 5 ft – 11¼ in. (1.8 m) laterally behind the front face of the guardrail. The vehicle trajectory and final position are shown in Figures 29 and 35.

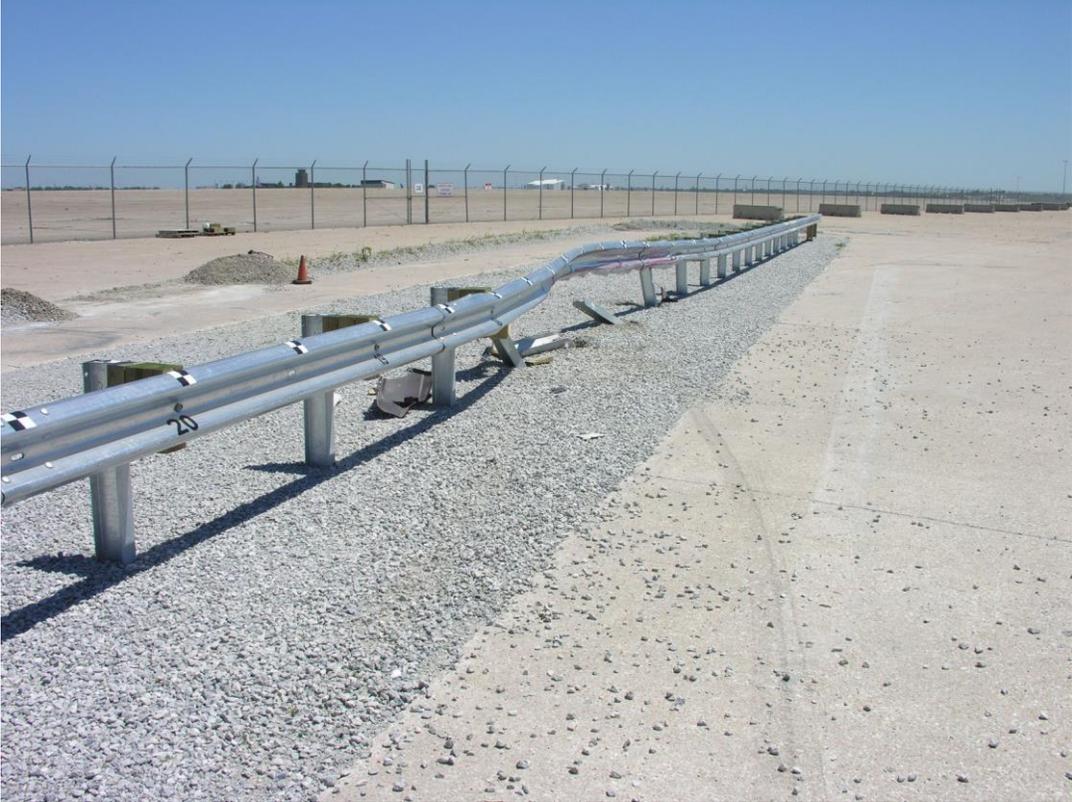
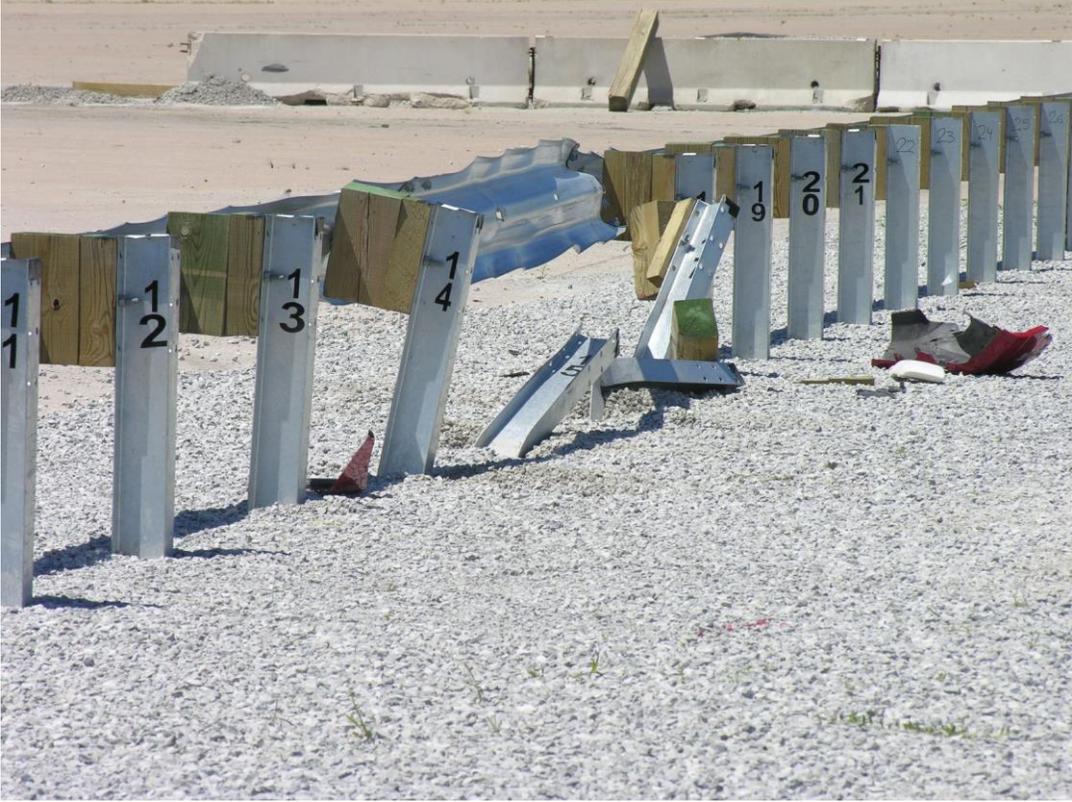
Figure 36. System Damage, Test No. MGSMRH-1

Damage to the barrier was moderate, as shown in Figures 36 through 45. Barrier damage consisted of deformed guardrail posts, disengaged wooden blockouts, contact marks on posts and guardrail, and deformed W-beam rail. The length of vehicle contact along the barrier was approximately 25 ft – 10½ in. (7.9 m) which spanned from 10 ft – 1 in. (3.1 m) upstream of the centerline of post no. 15 to 35½ in. (902 mm) upstream of post no. 18.

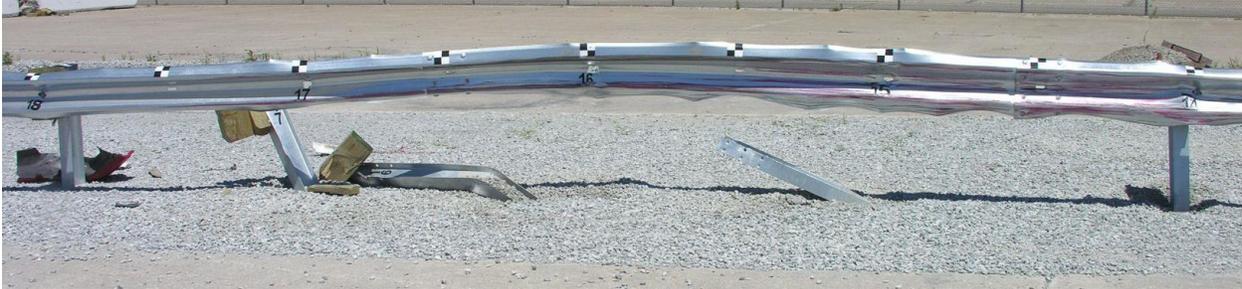
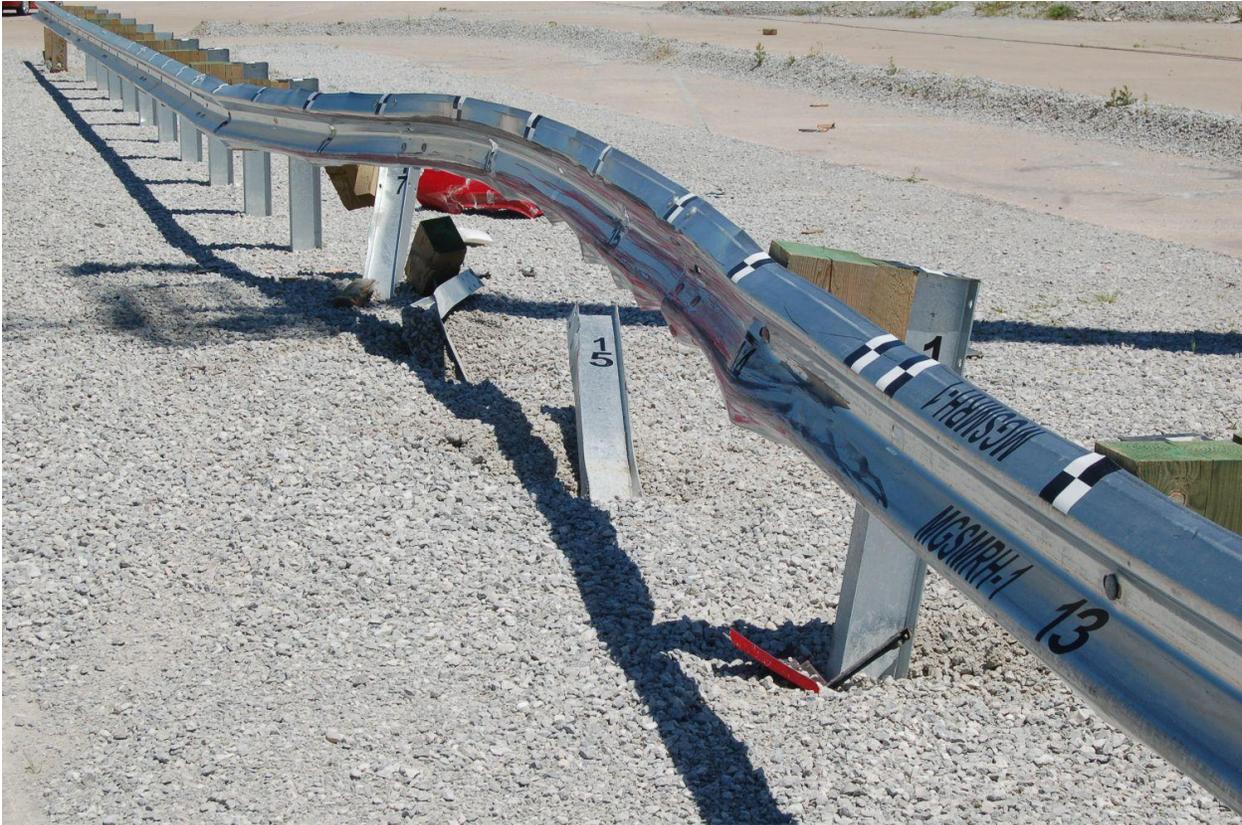
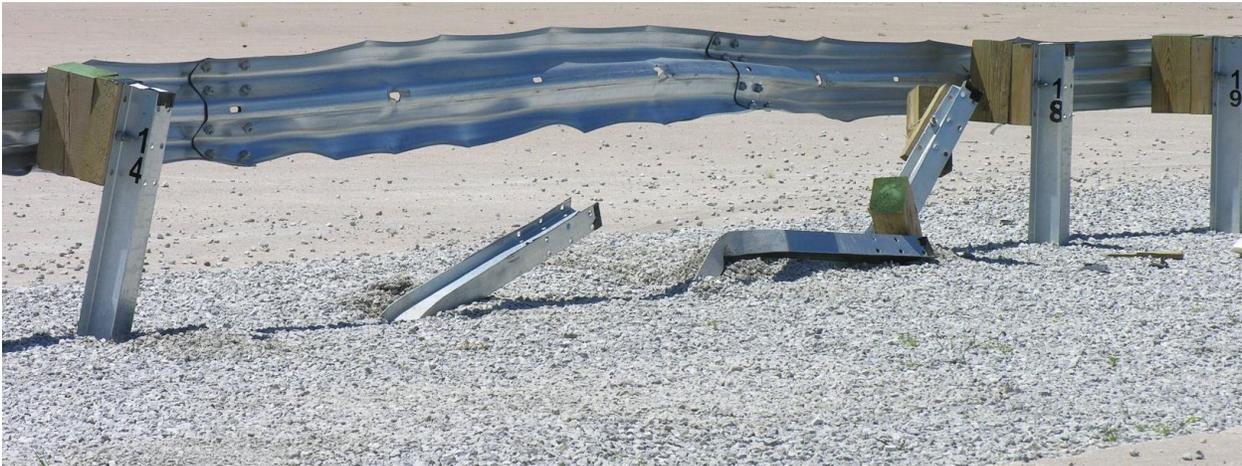
Figure 38. System Damage, Test No. MGSMRH-1

Red paint transfer was found on the rail between the impact location and post no. 18. Minor kinks in the top and bottom corrugations of the rail were found between post nos. 12 and 19, as shown in Figure 38. Flattening and deformation of the rail occurred between post nos. 13 and 18. The bottom corrugation was flattened between post nos. 14 and 16. The bottom edge of the rail was folded upward at post no. 14.

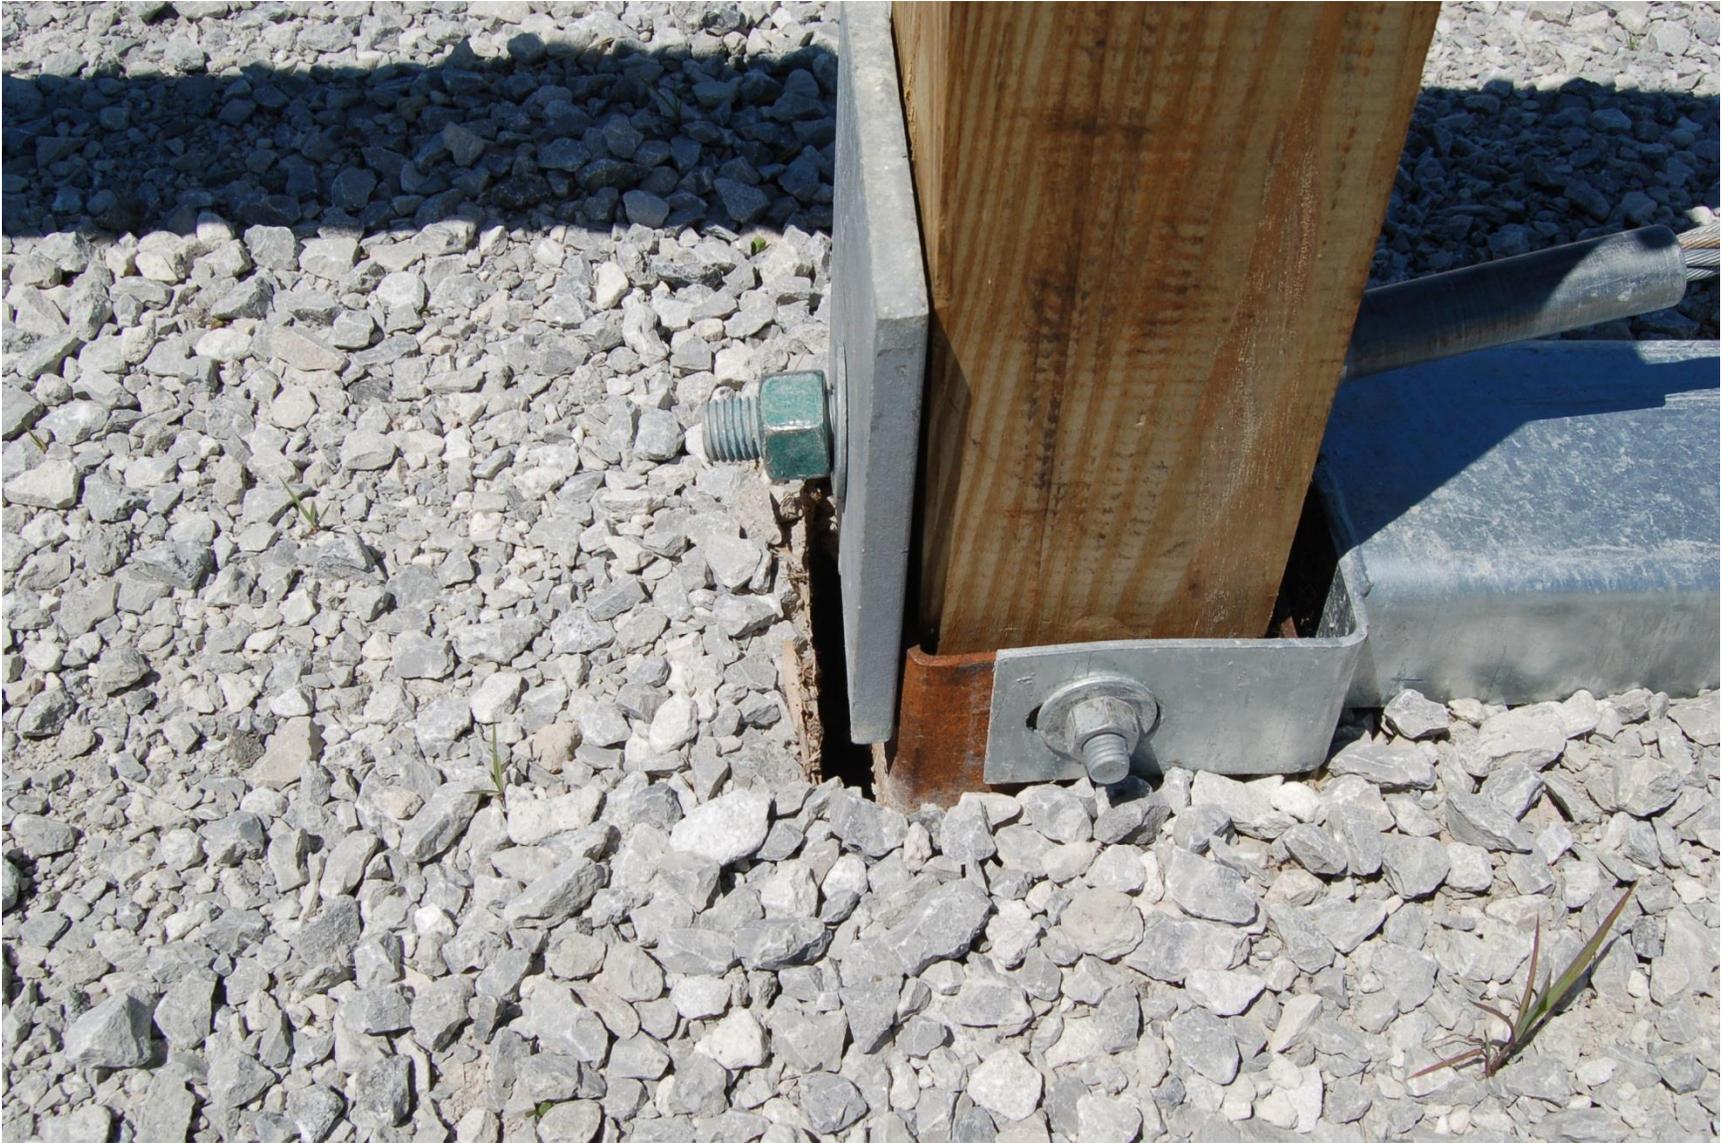
Figure 40. Soil Gap at Upstream End Anchor, Test No. MGSMRH-1

A soil gap measuring $1\frac{1}{2}$ in. (38 mm) was present on the upstream side of post no. 1, as shown in Figure 40. A soil gap measuring $\frac{3}{8}$ in. (10-mm) was present on the downstream side of post no. 2. A $\frac{1}{16}$ -in. (2-mm) soil gap was present on the front face of post nos. 12 and 18. A $1\frac{1}{4}$ -in. (32-mm) soil gap was present on the front face of post no. 13. Soil gaps measuring $2\frac{1}{2}$ in. (64

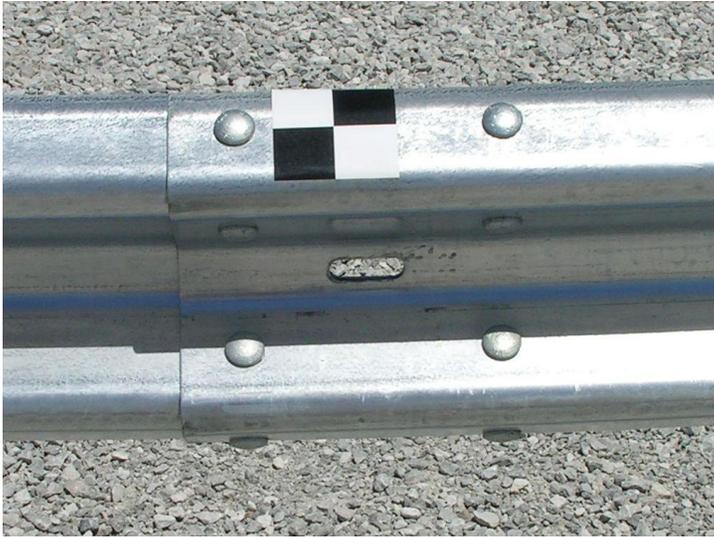
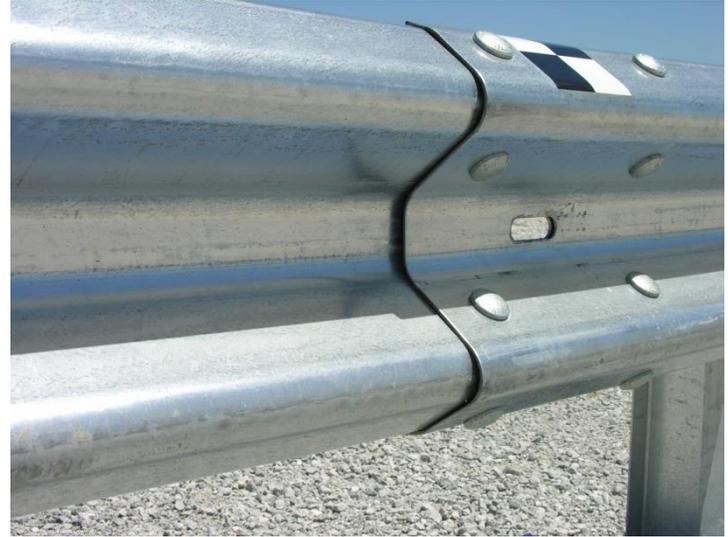
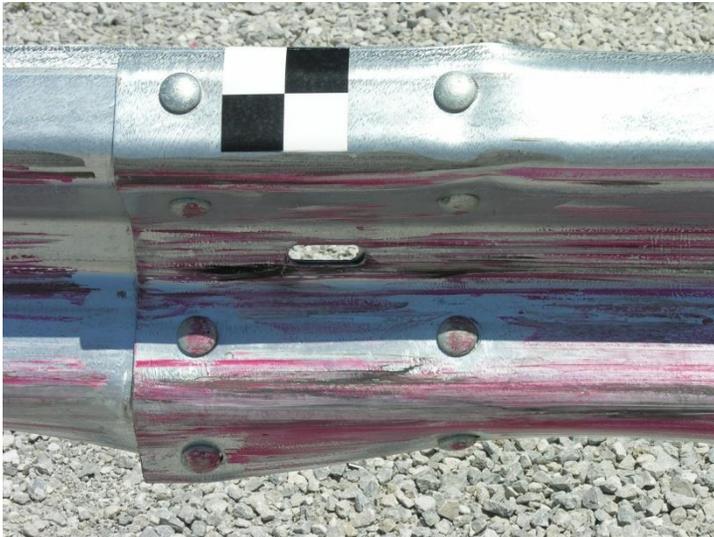
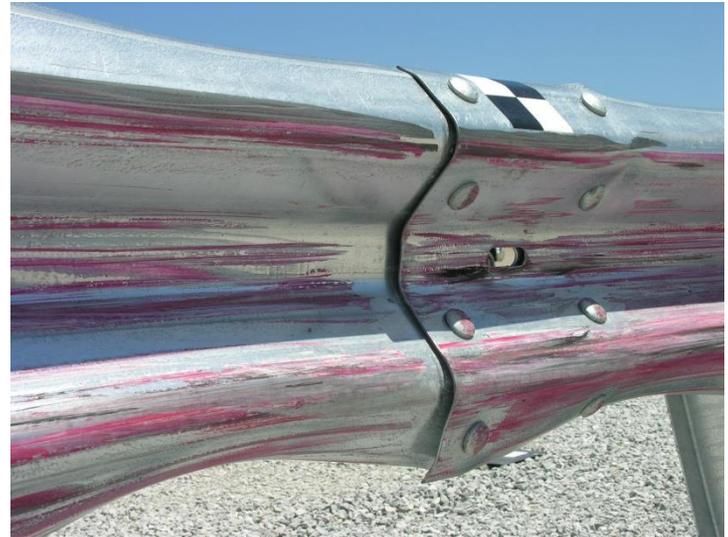
Figure 41. Splice Damage, Test No. MGSMRH-1

The post bolt pulled through the slots in the rail at post nos. 15 through 17. There was a $\frac{3}{4}$ -in. (19-mm) long tear in the bolt slot at post no. 15. There was a $2\frac{1}{4}$ -in. (57-mm) long tear and a $1\frac{1}{2}$ -in. (38-mm) long tear on the upstream and downstream sides, respectively, of the bolt slot on post no. 16. There was a $1\frac{1}{4}$ -in. (32-mm) long tear and a 1-in. (25-mm) long tear on the upstream and downstream sides, respectively, of the bolt slot on post no. 17. There was a $\frac{3}{8}$ -in. (10-mm) lateral separation between the W-beam sections in the splices between post nos. 12 and 13 and between post nos. 14 and 15. The splices between post nos. 14 and 15, 16 and 17, and 18 and 19 were extended $\frac{1}{8}$ in. (3 mm) longitudinally. The splice damage is shown in Figures 41 and 42.

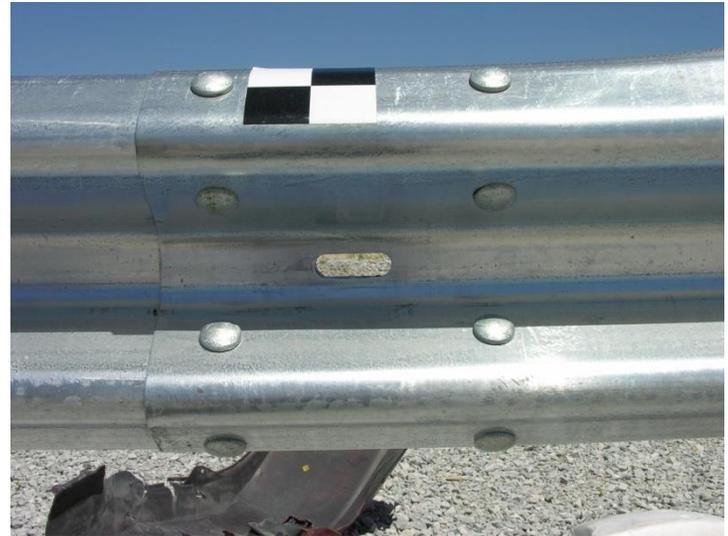
Figure 42. Splice Damage, Test No. MGSMRH-1

Splice Between Post Nos. 18 and 19

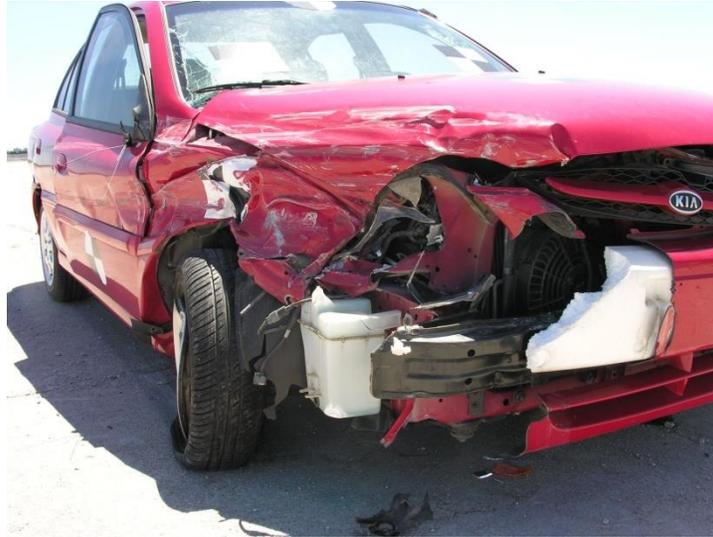
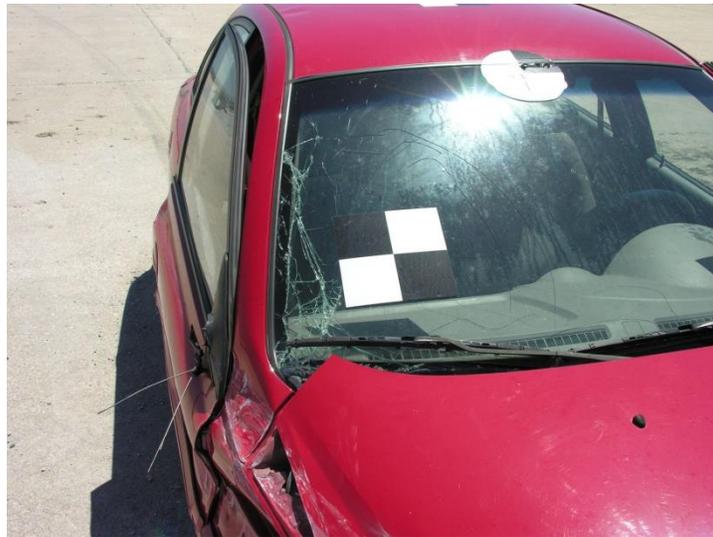
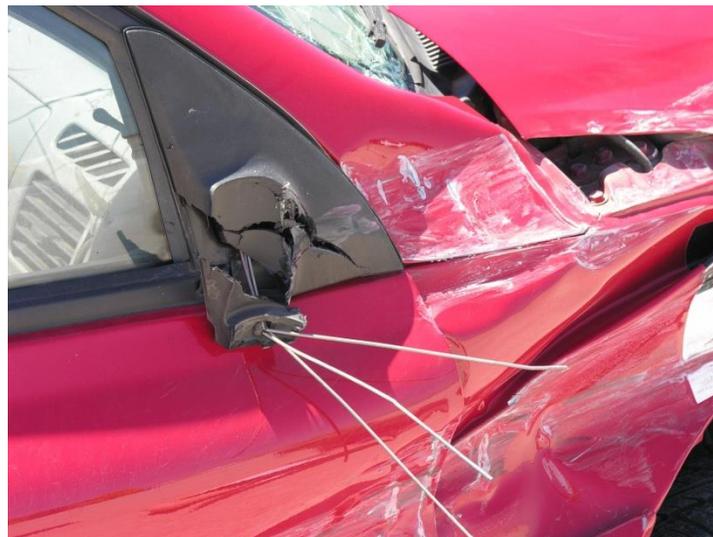
Figure 47. Vehicle Damage, Test No. MGSMRH-1

The damage to the vehicle was moderate, as shown in Figures 46 through 49. The maximum occupant compartment deformations are listed in Table 7 alongside the deformation limits established in MASH for various areas of the occupant compartment. It should be noted that none of the MASH established deformation limits were violated. Complete occupant compartment and vehicle deformations and the corresponding locations are provided in Appendix D.

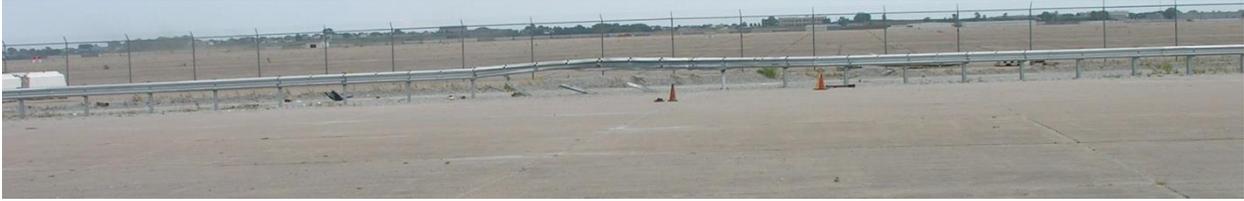
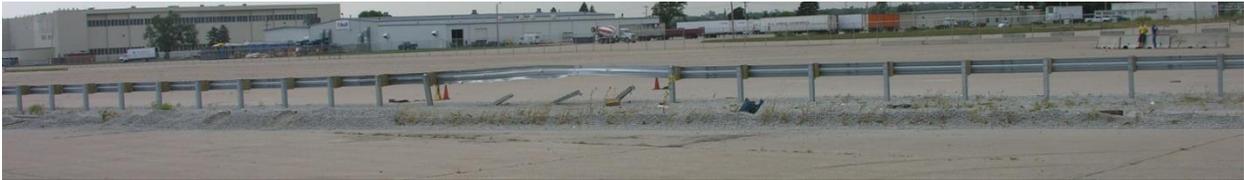
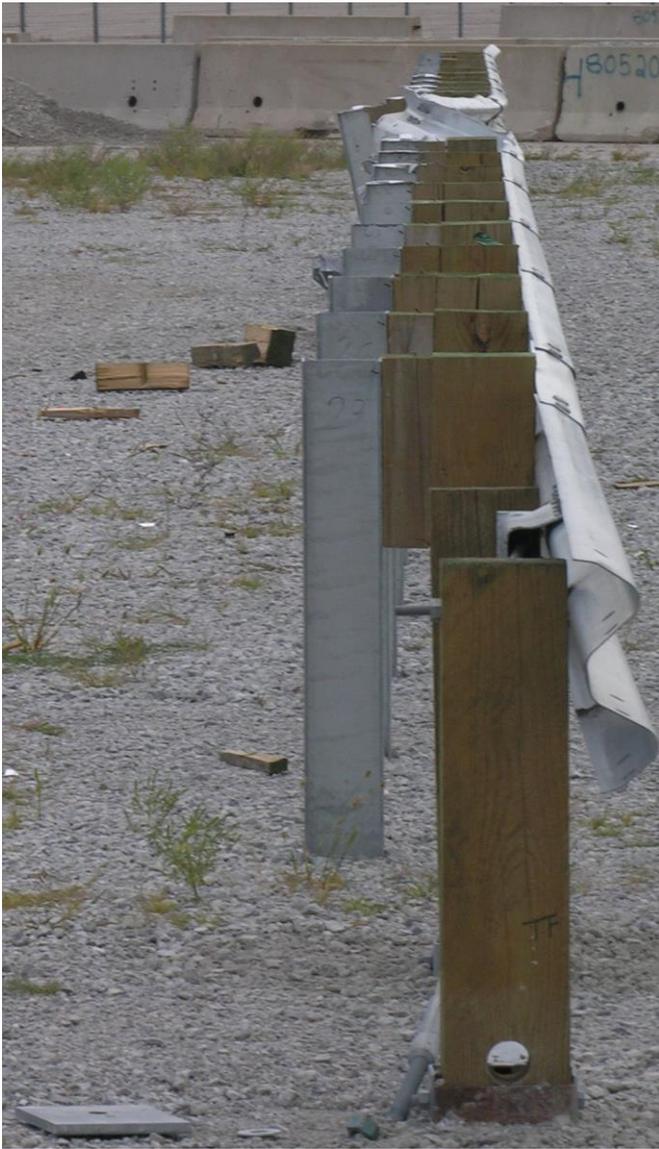
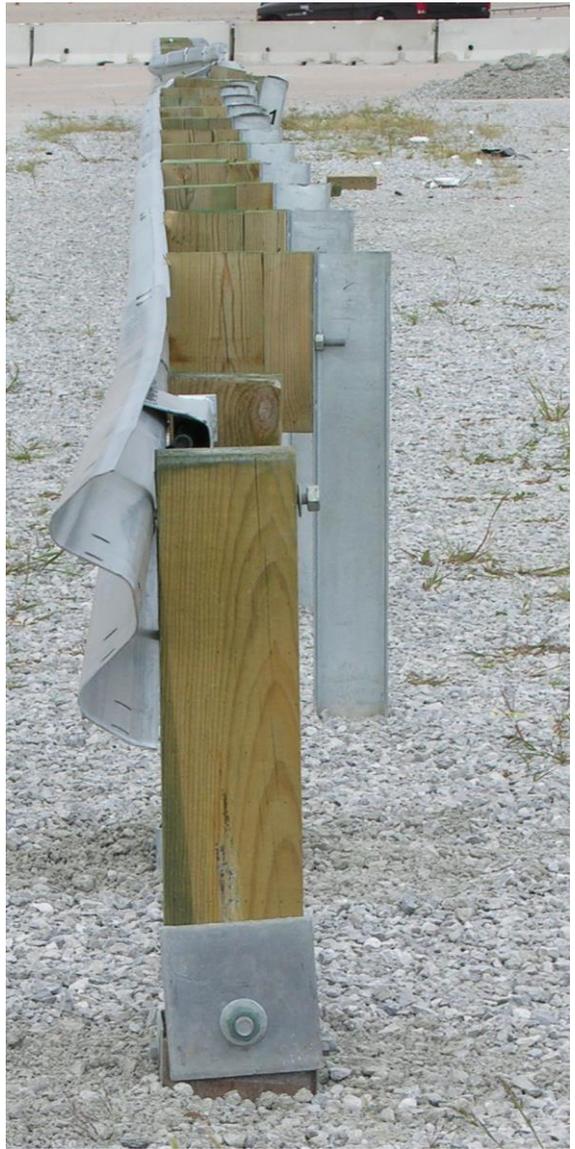
Figure 61. System Damage, Test No. MGSMRH-2

Damage to the barrier was moderate, as shown in Figures 61 through 67. Barrier damage consisted of deformed W-beam rail, contact marks on the sections of guardrail and posts, and deformed steel posts. The length of vehicle contact along the barrier was approximately 28 ft – 3 in. (8.6 m) which spanned from 9 ft – 8 in. (2.9 m) upstream of the centerline of post no. 15 through 2 in. (51 mm) upstream of the centerline of post no. 18.

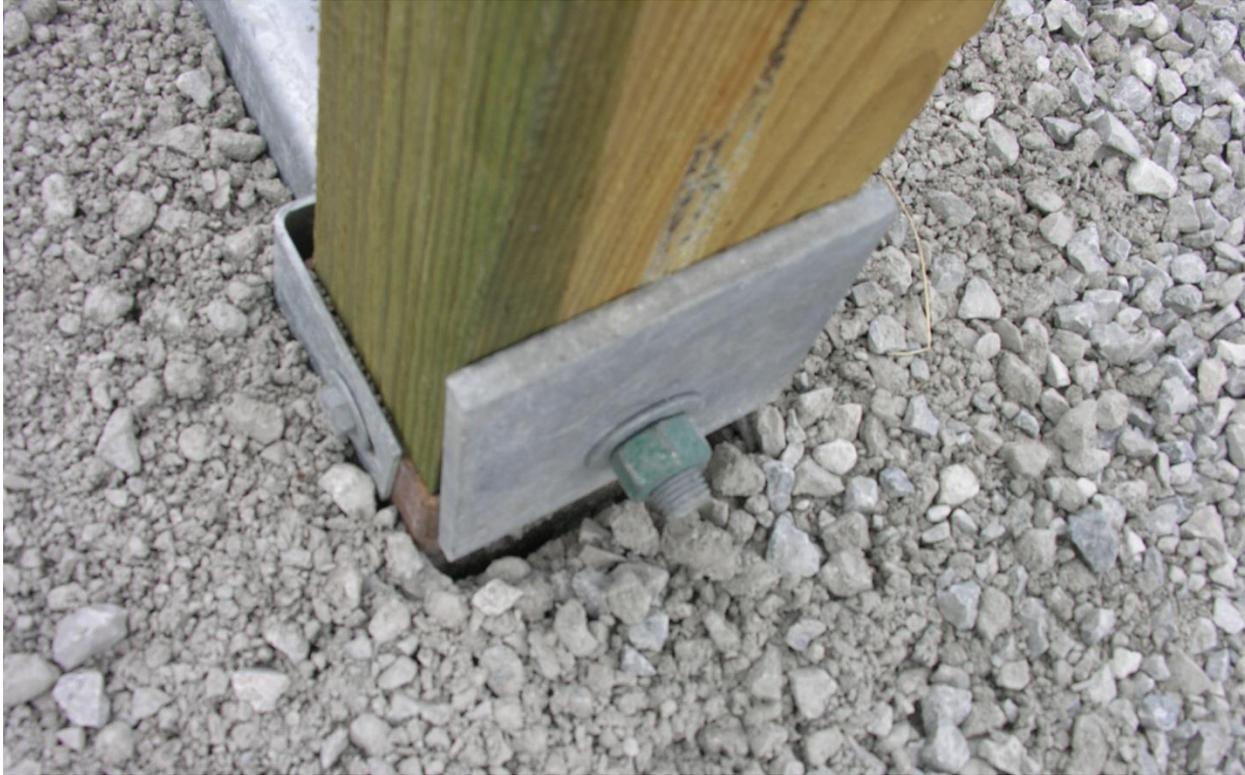
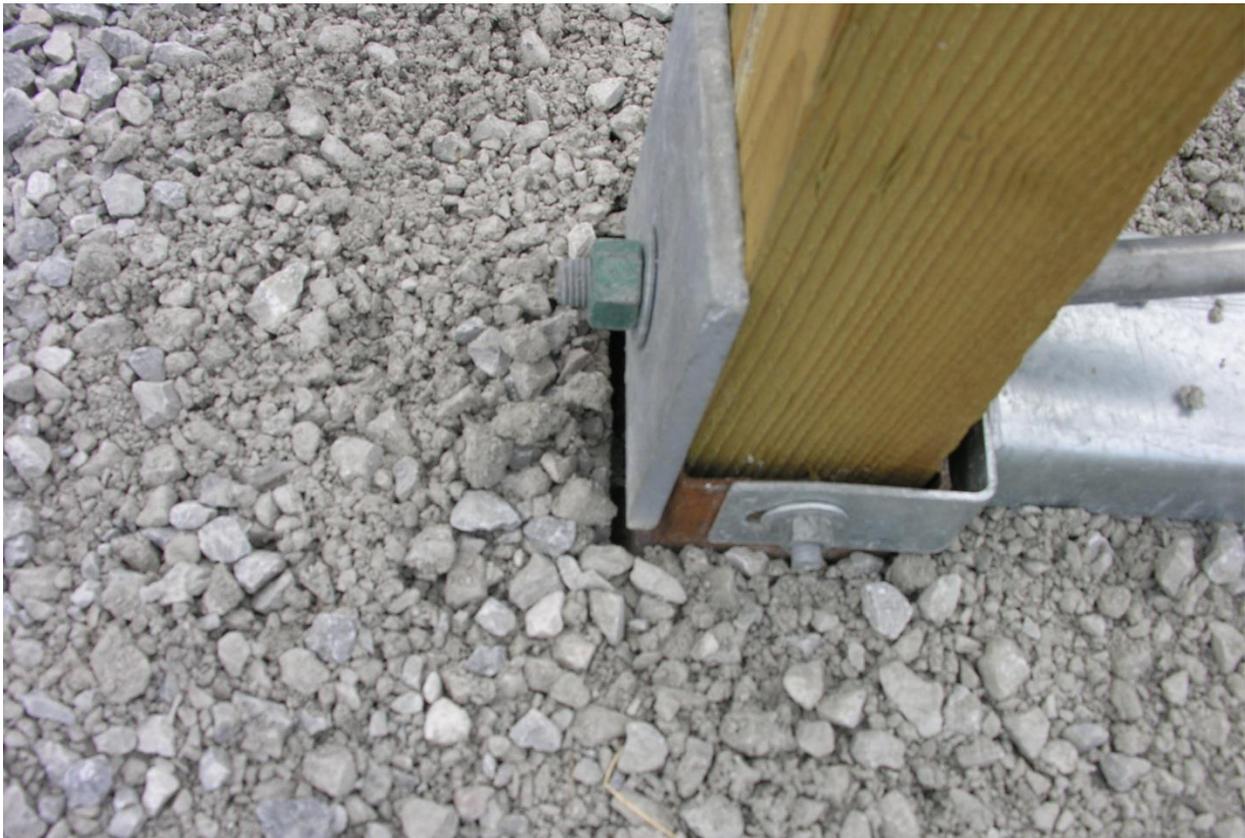
Figure 63. Soil Gap at Upstream End Anchor, Test No. MGSMRH-2

A ¾-in. (19-mm) soil gap was present at the upstream face of post no. 1, as shown in Figure 63. A ⅛-in. (3-mm) soil gap was present on the front face of post no. 12. A ¼-in. (6-mm) soil gap was present on the back face of post no. 13 and the front face of post no. 18. A 1-in. (25-mm) soil

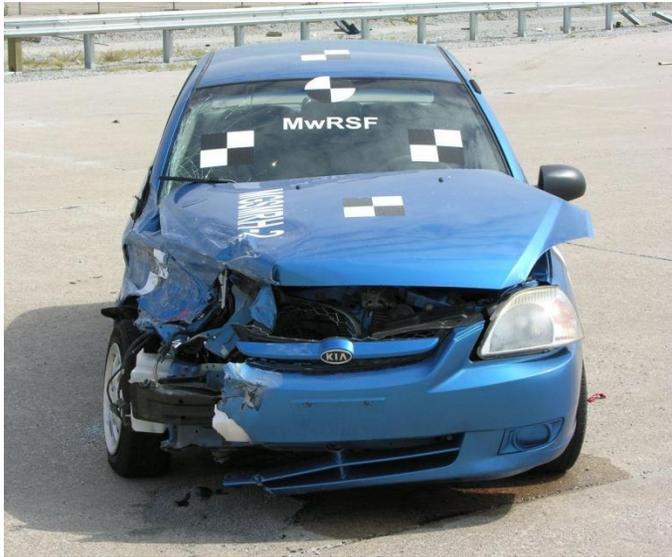
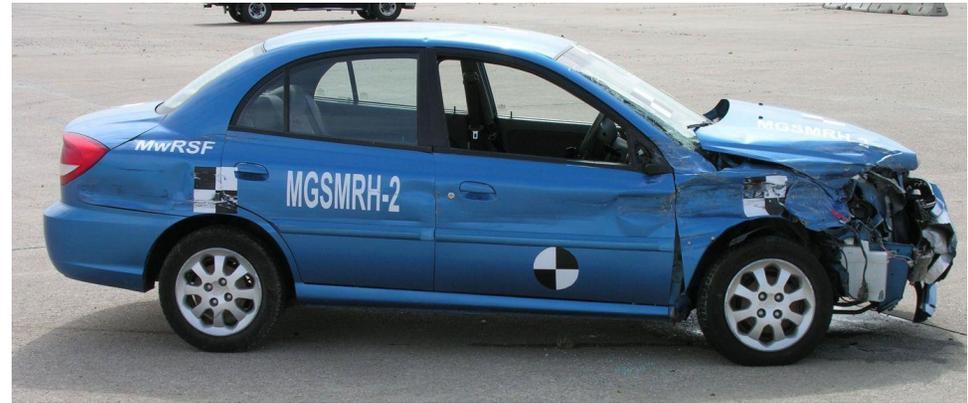
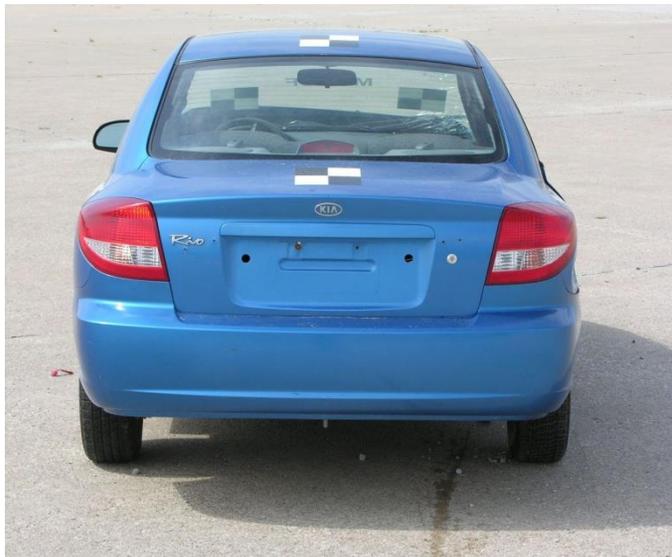
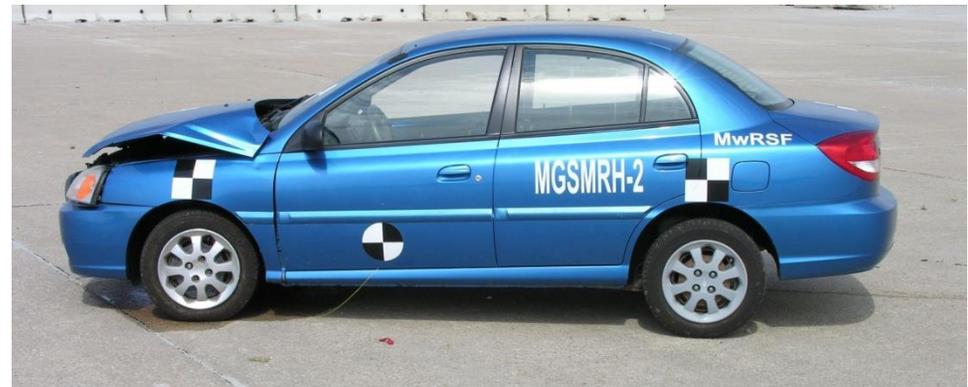
Figure 68. Vehicle Damage, Test No. MGSMRH-2

The damage to the vehicle was moderate, as shown in Figures 68 through 71. The maximum occupant compartment deformations are listed in Table 11 with the deformation limits established in MASH for various areas of the occupant compartment. It should be noted that none of the MASH established deformation limits were violated. Complete occupant compartment and vehicle deformations and the corresponding locations are provided in Appendix D.

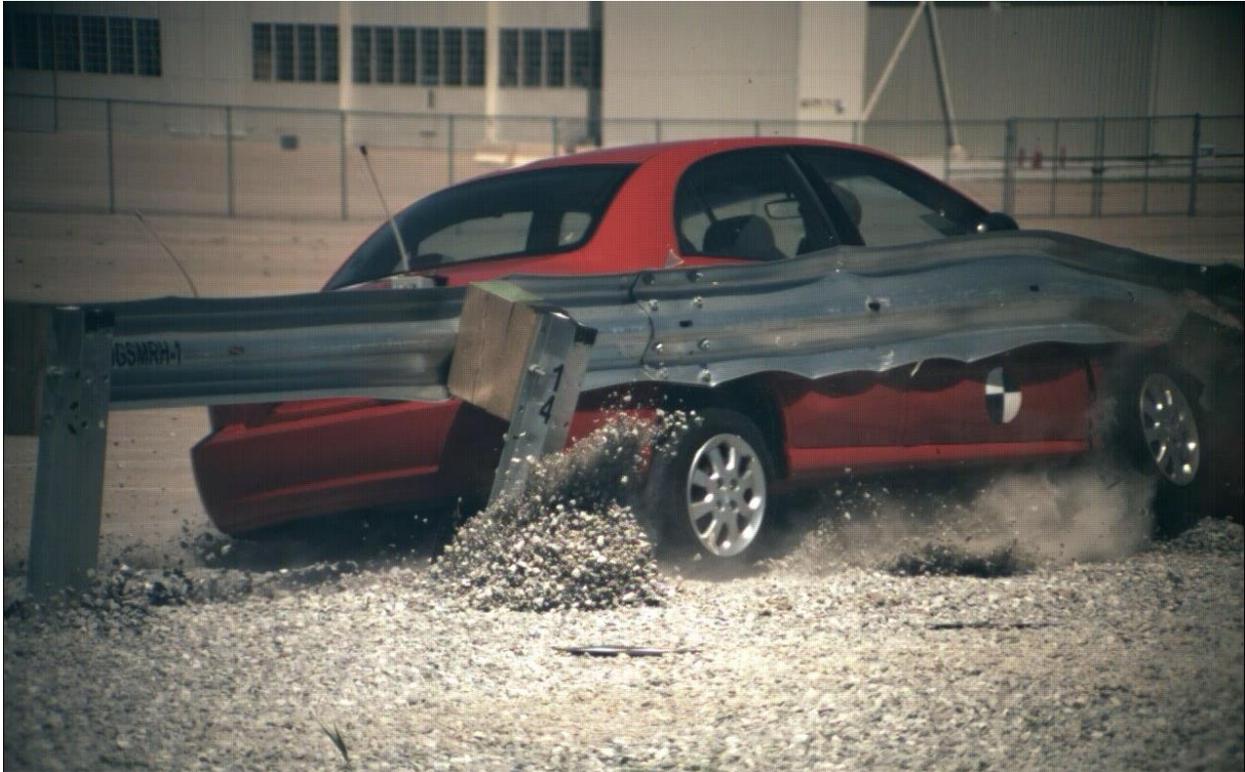
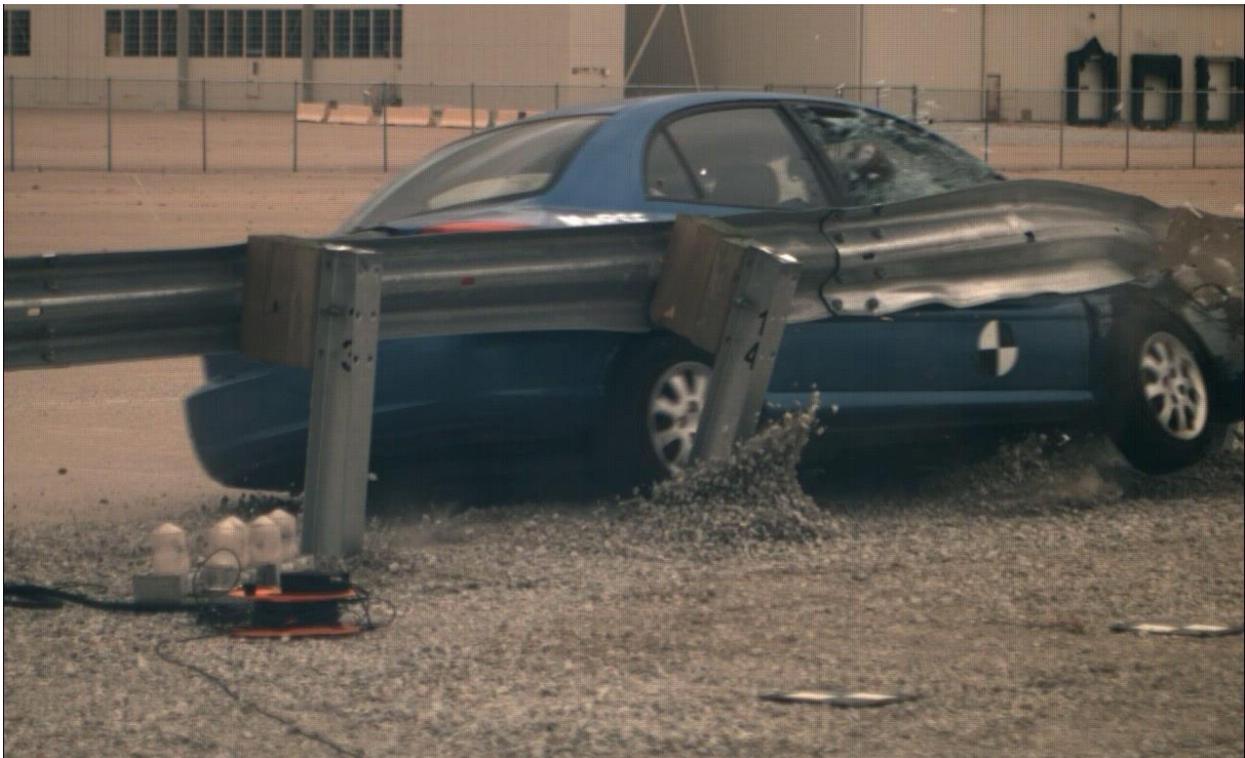
Figure 72. Vehicle-to-Rail Interaction

During redirection, the rail deflected upward as it released from the posts and slid up the side of the vehicle. The vehicle contacted the detached posts and overrode them, which caused the vehicle to pitch upward and roll away from the barrier, as shown in Figures 72 and 73. In both tests, the vehicle reached a maximum roll angle of about 11 degrees and pitched upward about 2 degrees. As the vehicle rolled away from the barrier, the right side of the vehicle that was in contact with the rail moved upward. As a consequence, the rail slid up the vehicle, contacted the base of the A-pillar, and did not slide any higher. At this same time, the rail was applying a downward force on the vehicle which counteracted the vehicle roll.
