DETERMINATION OF THE MAXIMUM MGS MOUNTING HEIGHT – PHASE I CRASH TESTING

MwRSF Research Report No. TRP-03-255-12 Revision-1

November 30, 2015

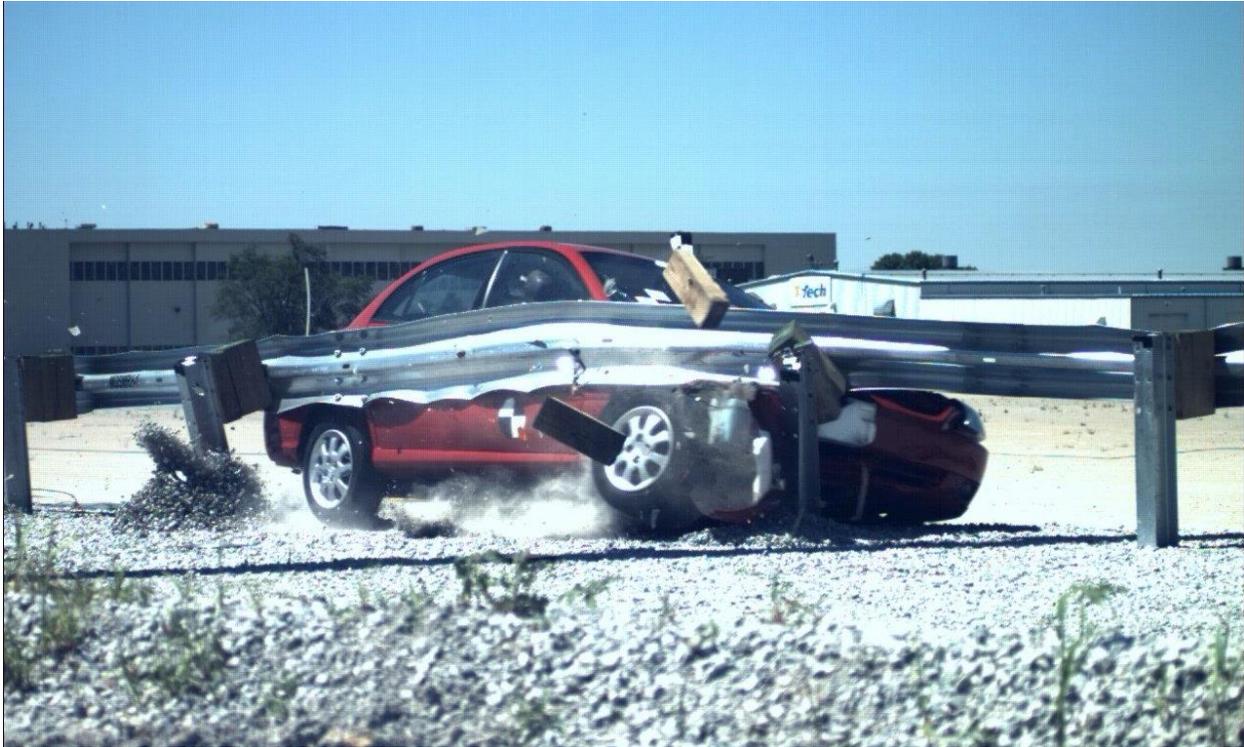
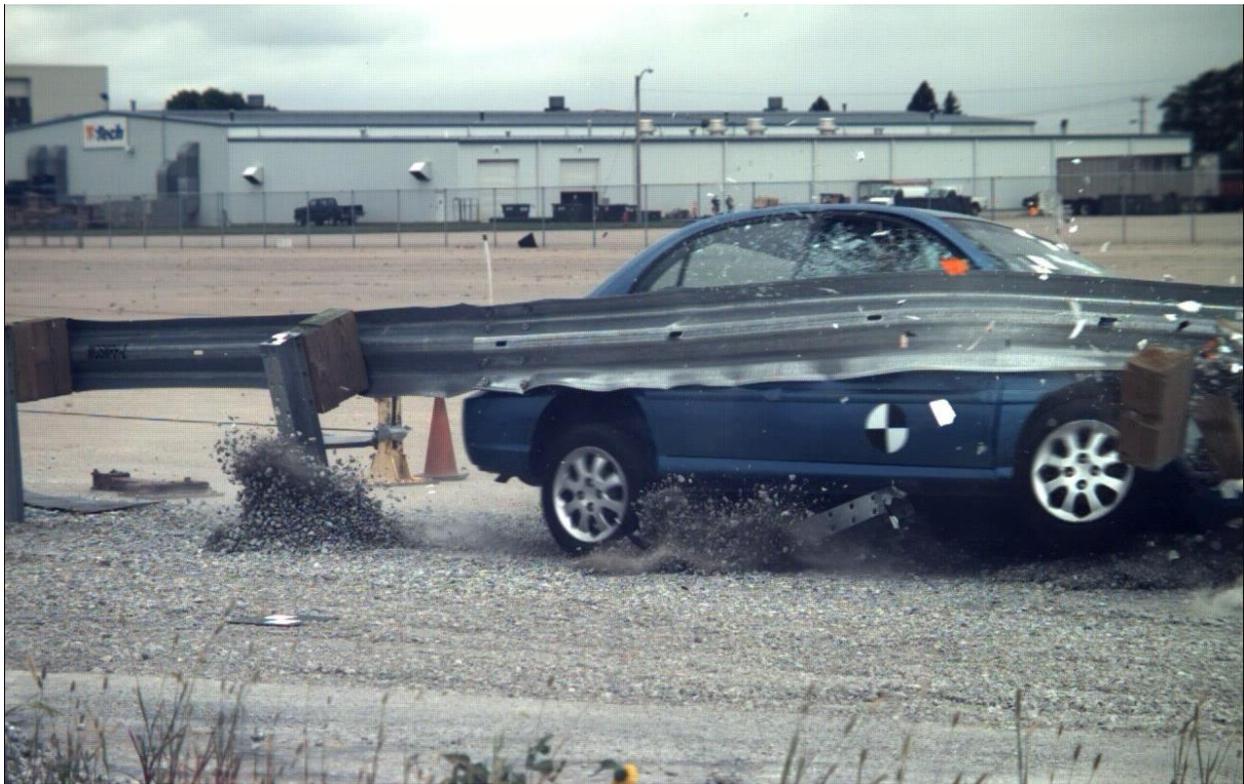
Figure 73. Vehicle-to-Rail Interaction

During redirection, the rail deflected upward as it released from the posts and slid up the side of the vehicle. The vehicle contacted the detached posts and overrode them, which caused the vehicle to pitch upward and roll away from the barrier, as shown in Figures 72 and 73. In both tests, the vehicle reached a maximum roll angle of about 11 degrees and pitched upward about 2 degrees. As the vehicle rolled away from the barrier, the right side of the vehicle that was in contact with the rail moved upward. As a consequence, the rail slid up the vehicle, contacted the base of the A-pillar, and did not slide any higher. At this same time, the rail was applying a downward force on the vehicle which counteracted the vehicle roll.

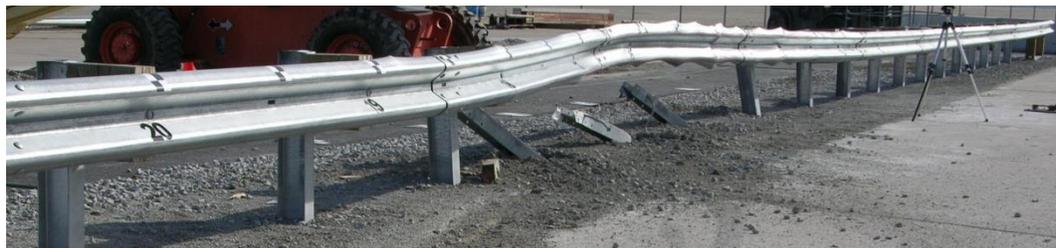
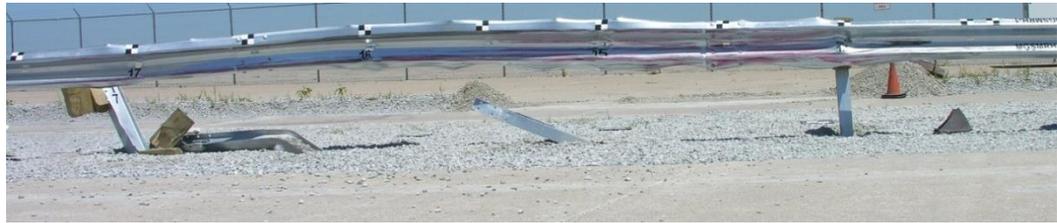
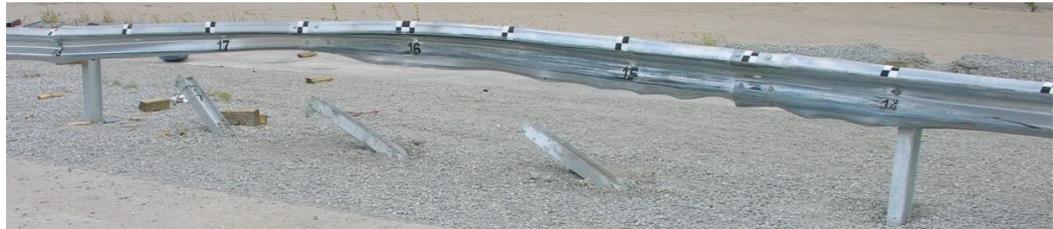
Figure 74. System Damage Comparison

System damage differed between the 32-, 34-, and 36-in. (813-, 864-, and 914-mm) tall MGS, as shown in Figure 74. In test no. 2214MG-3, the 32-in. (813-mm) tall MGS rail did not fully flatten, although rail kinking occurred between post nos. 13 and 17 and the rail lifted approximately 1½ in. (38 mm). In test no. MGSMRH-1, the 34-in. (864-mm) MGS rail was not fully flattened, but the corrugations were compressed between post nos. 14 and 17, and the rail lifted approximately 2½ in. (64 mm). In test no. MGSMRH-2, the lower corrugation of the 36-in. (914-mm) tall MGS was flattened beginning at the splice between post nos. 14 and 15 and ending at the splice between post nos. 16 and 17. The rail was lifted approximately 3 in. (76 mm), and the degree of rail twist was greater than the twist in the 32- and 34-in. (813- and 864-mm) tall MGS.
