EVALUATION OF A MODIFIED THREE CABLE GUARDRAIL ADJACENT TO STEEP SLOPE

MwRSF Research Report No. TRP-03-192-08

March 4, 2008

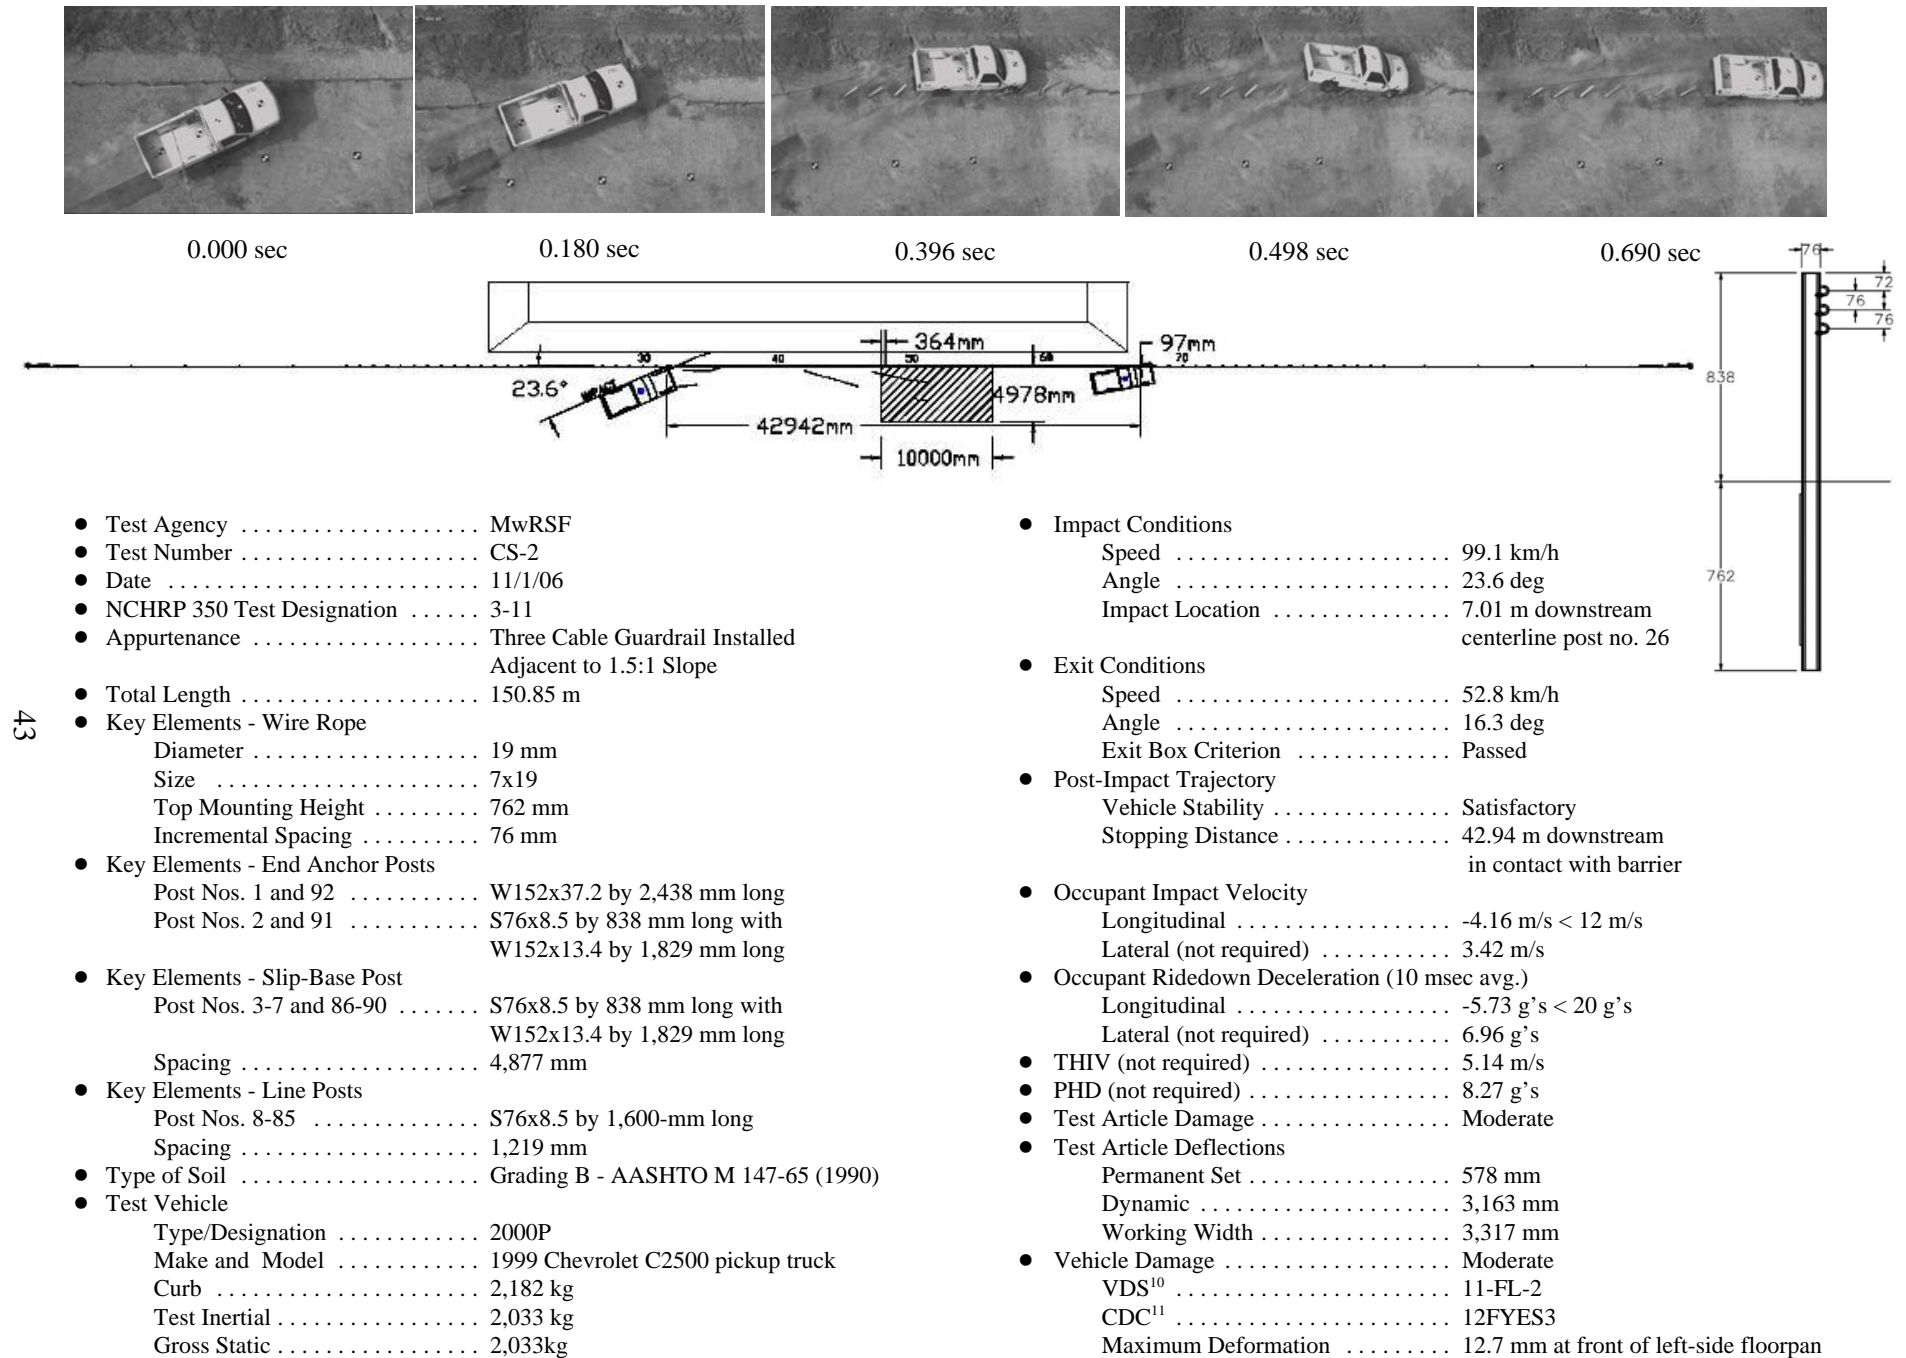
Figure 23. Summary of Test Results and Sequential Photographs, Test CS-2

The 2,032-kg (4,481-lb) pickup truck impacted the three cable guardrail system at a speed of 99.1 km/h (61.6 mph) and at an angle of 23.6 degrees. A summary of the test results and the sequential photographs are shown in Figure 23. The summary of the test results and sequential photographs in English units are shown in Appendix B. Additional sequential photographs are shown in Figures 24 through 26. Documentary photographs of the crash test are shown in Figure 27.

The analysis of the test results for test no. CS-2 showed that the three cable barrier system with quarter-post spacing and located 1,219 mm (4 ft) in front of a 1.5:1 slope impacted with the 2000P vehicle adequately contained and redirected the vehicle with controlled lateral displacements of the barrier system. There were no detached elements nor fragments which showed potential for penetrating the occupant compartment nor presented undue hazard to other traffic. Deformations of, or intrusion into, the occupant compartment that could have been caused serious injury did not occur. The vehicle did not penetrate nor ride over the barrier and remained upright during and after the impact. The vehicle's post impact trajectory revealed no intrusion into adjacent traffic lanes. The vehicle's exit angle was 16.3 degrees, as determined by high-speed film analysis, which was slightly higher than the preferable exit angle of 14.2 degrees. The longitudinal occupant impact velocity and ridedown deceleration were within the required limitations. Therefore, test no. CS-2 was determined to be acceptable according to the TL-3 safety performance criteria found in NCHRP Report No. 350.

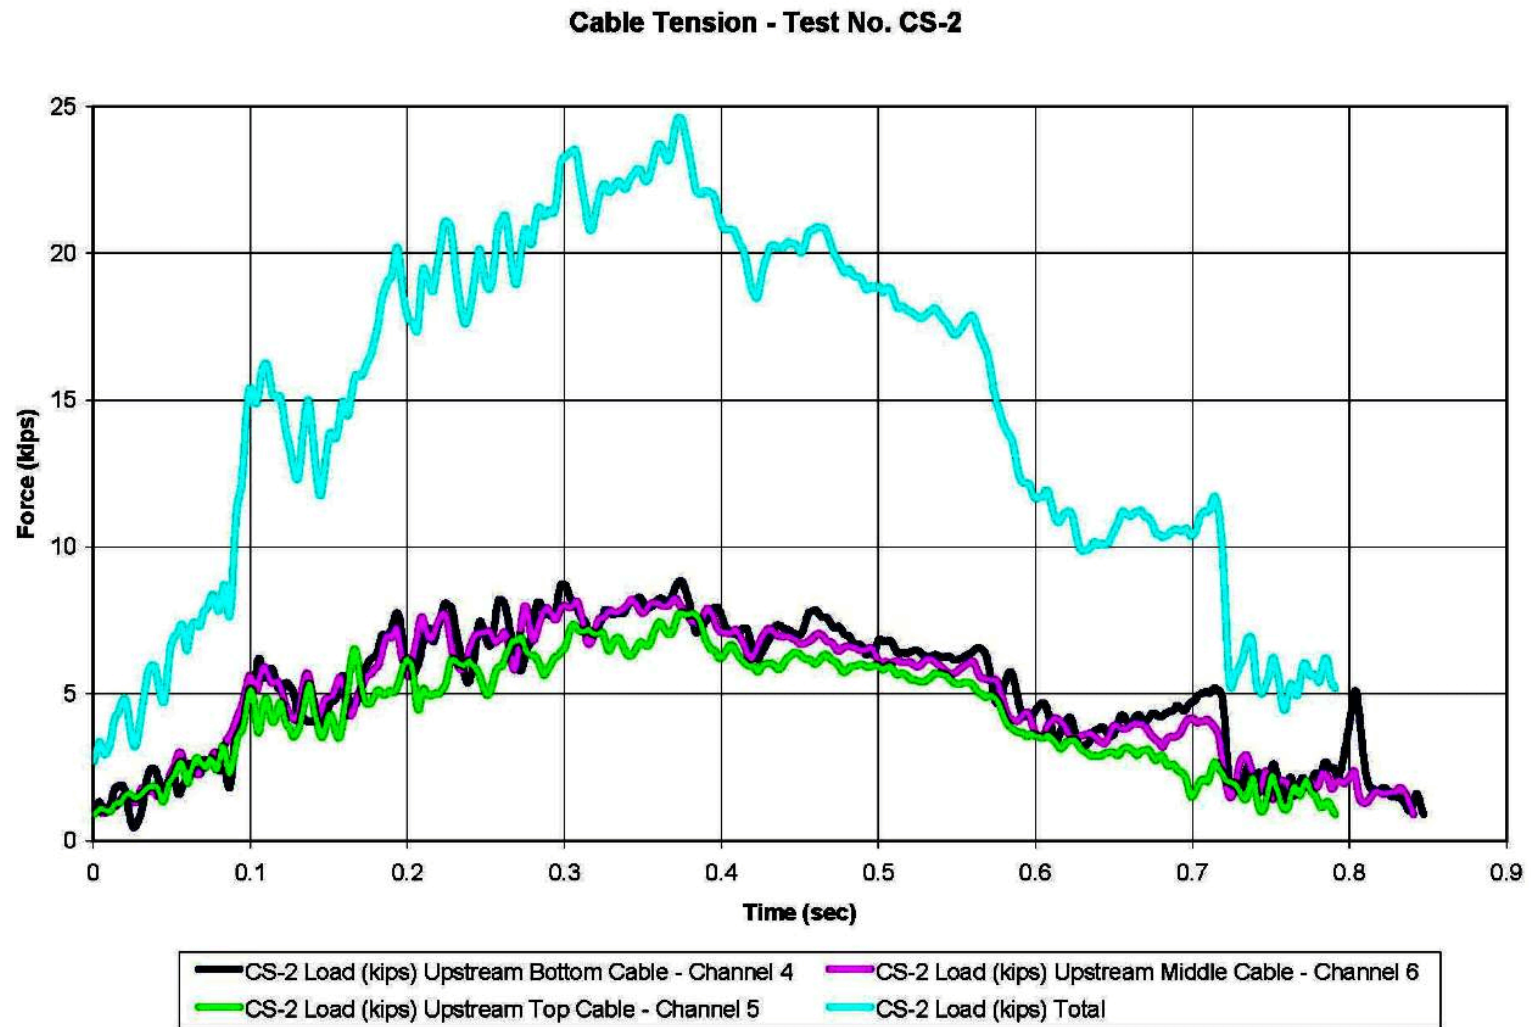
Figure 39. Force-Time History for the Cables at the Upstream Anchor, Test CS-2

The total cable load was summed and plotted, as shown in Figure 39. The maximum force acting on the upstream anchor was 109.60 kN (24.64 kips). The dissection of the total cable loading to the contribution of each individual cable is also shown in Figure 39. The top cable at the upstream anchor sustained a maximum load of 34.56 kN (7.77 kips). The middle cable experienced a maximum load of 36.79 kN (8.27 kips). The resultant force applied to the bottom cable at the upstream anchor was determined to be 39.41 kN (8.86 kips).

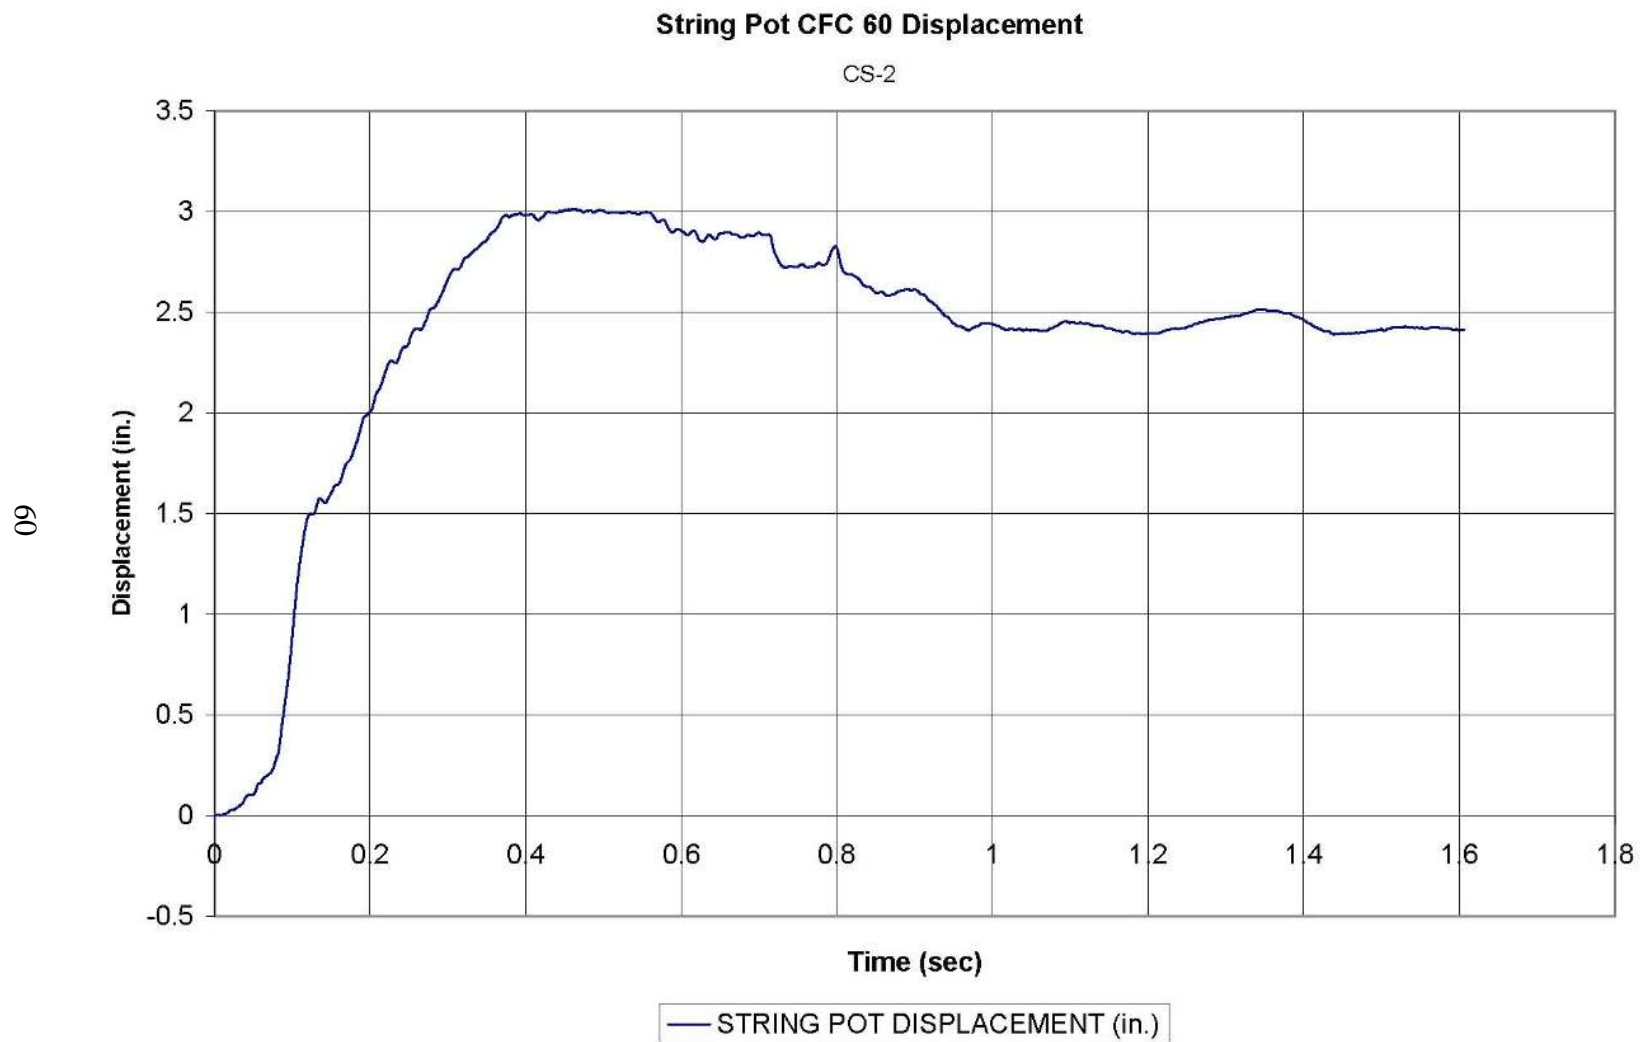
Figure 40. Displacement-Time History Plot for Upstream Anchor, Test CS-2

Anchor displacement was also of primary concern in the evaluation of the three cable system. The displacement time history of the upstream anchor is shown in Figure 40. The driven steel post

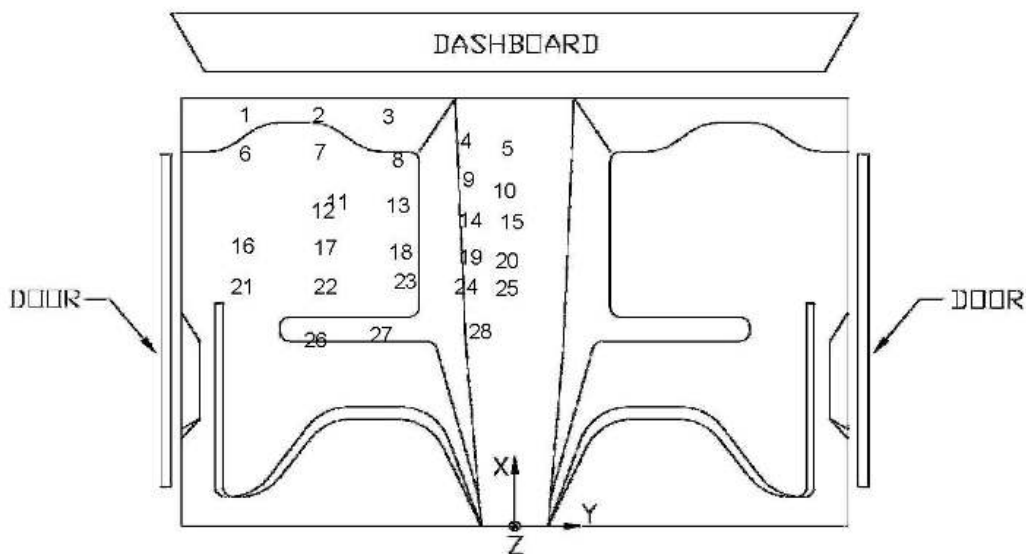
Figure C-1. Occupant Compartment Deformation Data - Set 1, Test CS-2

Exterior vehicle damage was moderate as shown in Figures 35 through 38. Occupant compartment deformations to the left side of the floorboard were judged insufficient to cause serious injury to the vehicle occupants as shown in Figure 38. Maximum longitudinal deflections of 6.35 mm (0.25 in.) were located along the front of the driver's side floor panel. A maximum lateral deflection of 13 mm (0.5 in.) was located on the right-front corner of the driver's side floor panel.
