Phase III Development of a Short-Radius Guardrail for Intersecting Roadways

MwRSF Research Report No. TRP-03-183-07

December 6, 2007

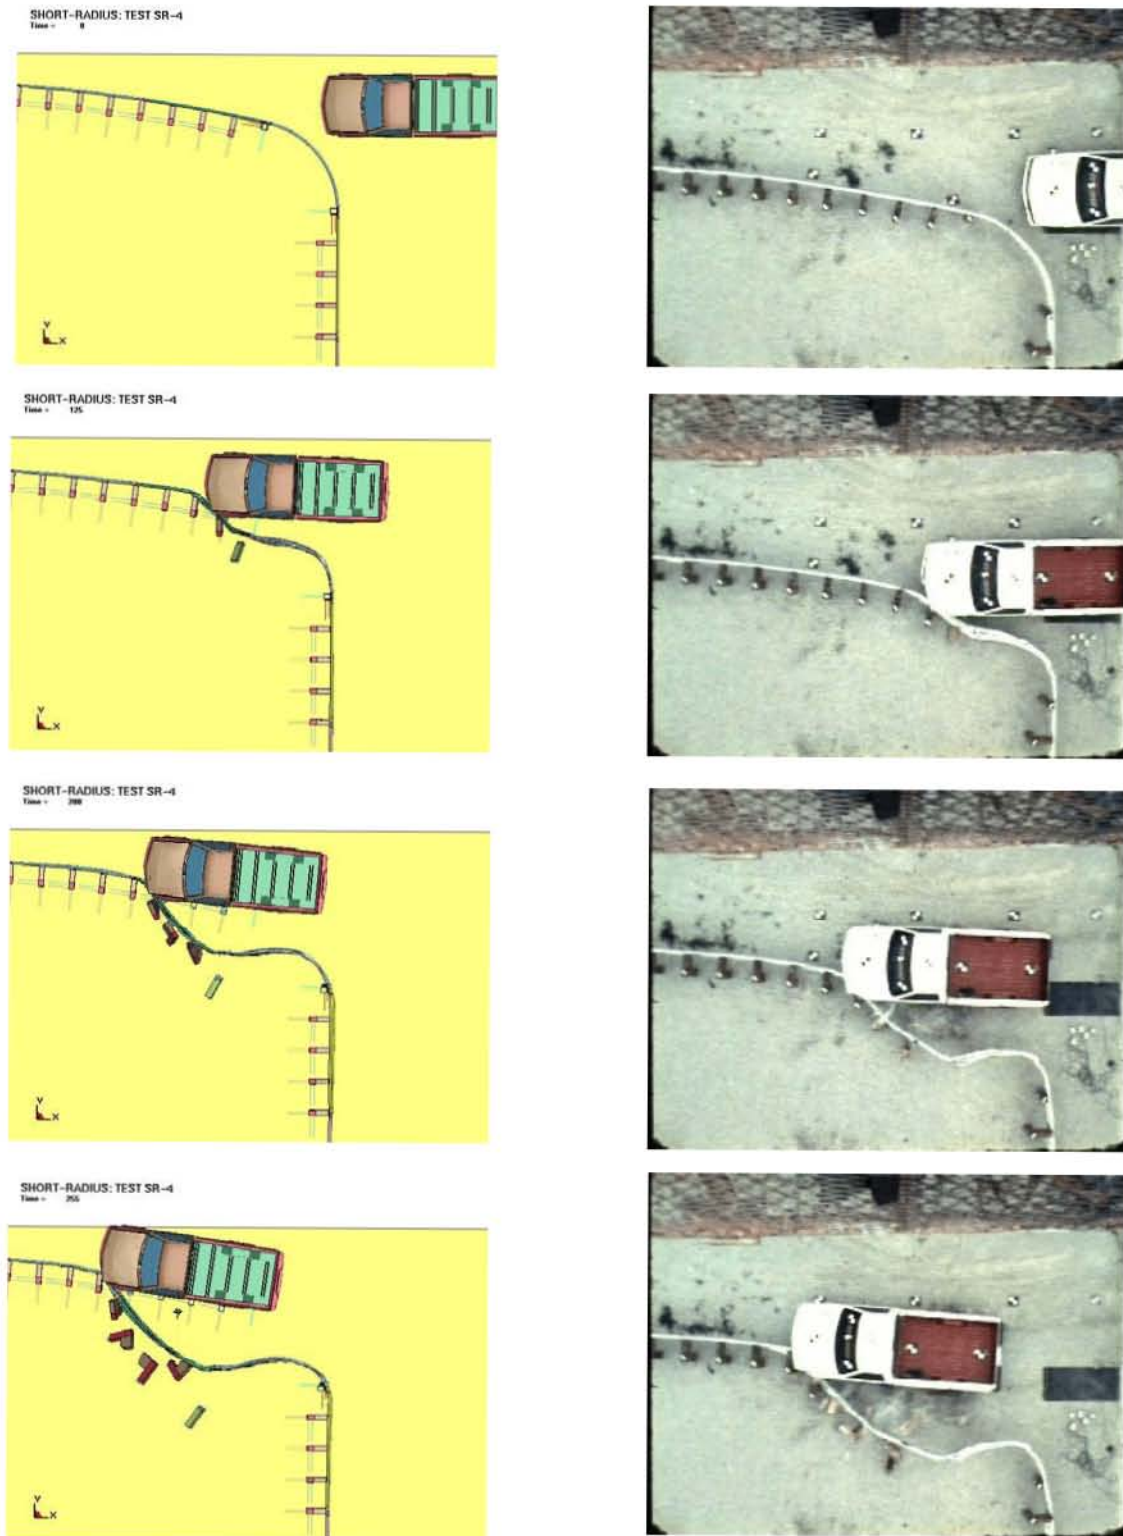
Figure 10. Comparison of Full-Scale Test and LS-DYNA Simulation Model, Test No. SR-4

Prior to conducting full-scale test no. SR-5, the researchers reviewed the results of the previous failed test, test no. SR-4, in order to determine design changes that would improve the performance of the system. The failure of test SR-4 to meet the safety performance criteria was directly attributed to the intrusion and snagging of the thrie beam guardrail into the wheel well region of the pickup truck. Through the initial portion of the impact, the thrie beam guardrail was impacted by the left-front corner of the vehicle and deflected toward the inside of the short-radius guardrail system. After approximately 0.300 sec, the leading edge of the impacted guardrail slid past the left-front corner and into the wheel well. The intruding guardrail punched a large hole in the floor pan of the occupant compartment, thus causing a rapid deceleration and yaw of the vehicle. The intrusion of the thrie beam was caused by the combination of the orientation of the impact vehicle, the geometry of the system, and the lack of upstream tension in the guardrail. Because the cable anchorage at post no. 1P was disengaged almost immediately, there was little or no upstream tension in the flared guardrail section. Therefore, the vehicle moved downstream along the system with very little redirection. This in turn led to the intrusion of the thrie beam into the wheel-well region.

LS-DYNA computer simulation was conducted in order to evaluate the potential effectiveness of a redesigned anchorage that developed upstream tension throughout the impact event. The first step in that analysis was to conduct a simulation of test no. SR-4 and compare the simulation results with the physical test. Sample results from that analysis are shown in Figure 10. The results showed that the simulation model compared well with the physical test in terms of the system deformation and truck redirection. The model captured the loss of tension and the vehicle pocketing within the guardrail that was observed in test no. SR-4. The model became unstable prior to the time in the impact where the guardrail knee entered the wheel well and impacted the firewall in the test, but the results demonstrated that the model could effectively reproduce the correct behavior of the short-radius system with the existing anchorage design.

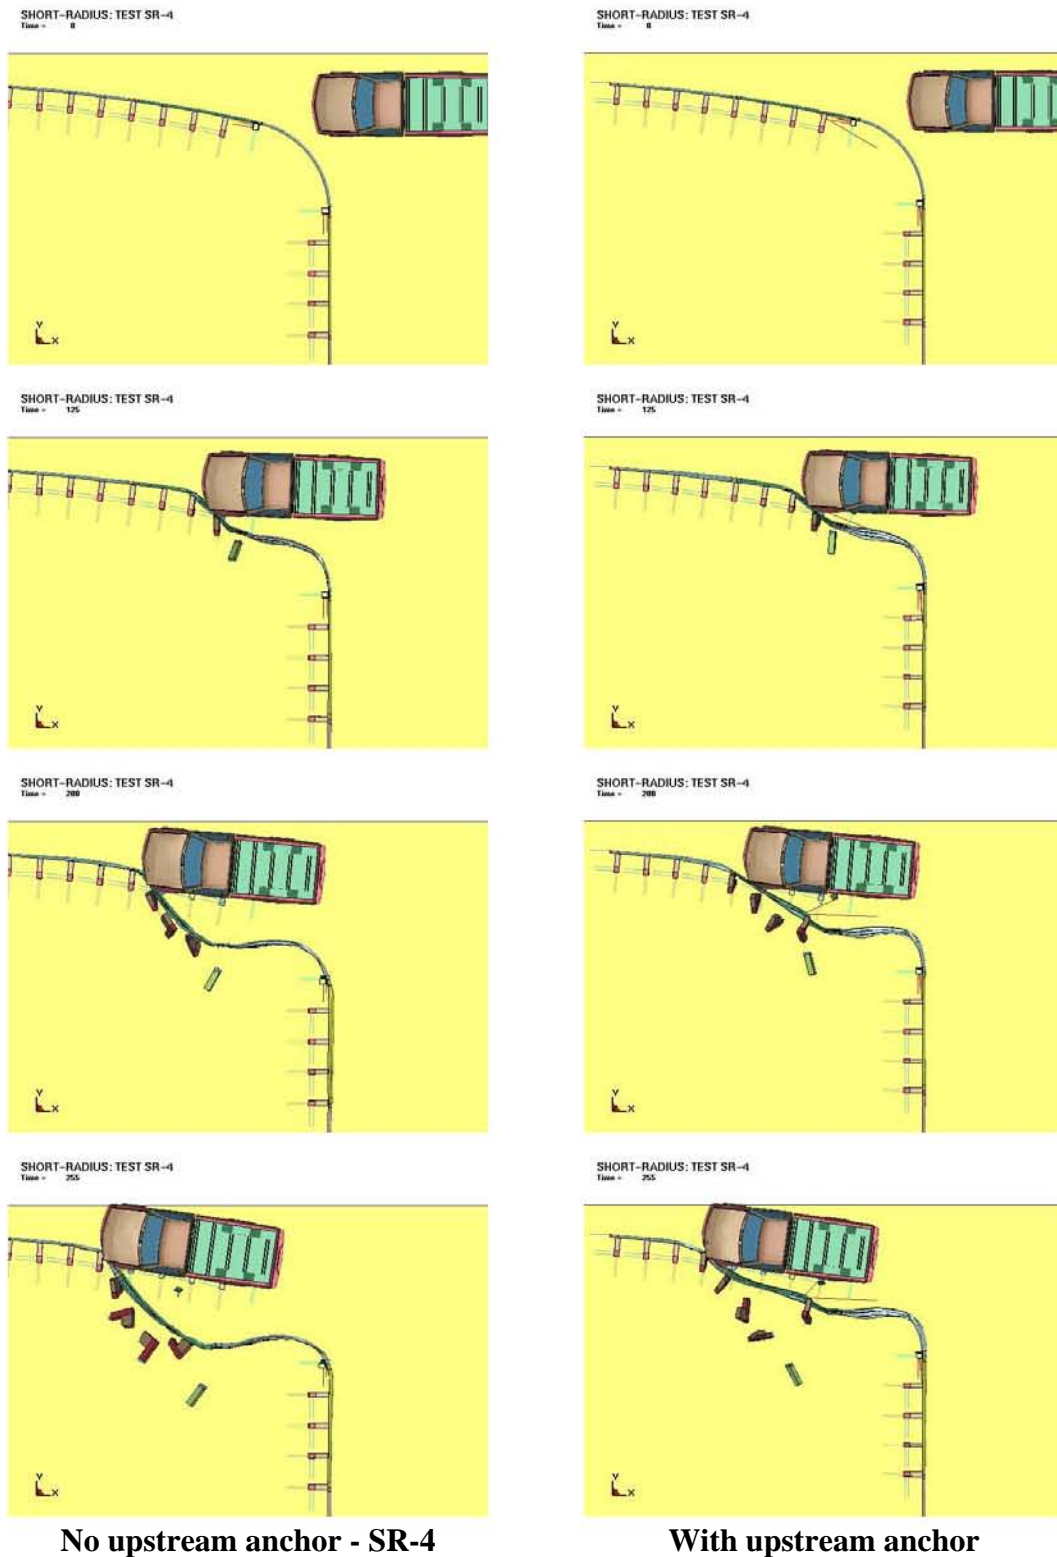
Figure 11. LS-DYNA Simulations of Test SR-4 and SR-5

The second step in the analysis was to compare the results from the SR-4 simulation with the results from a computer simulation where the upstream anchorage remained intact. Thus, a second model was simulated with an upstream anchorage on the primary side that would not release when post no. 1P fractured. The results of that simulation and comparison with the simulation of test no. SR-4 are shown in Figure 11. The comparison of the two computer models showed a clear improvement in the behavior of the system with the anchorage remaining intact. The model with the intact anchorage demonstrated improved upstream tension in the rail and much lower evidence of the pocketing that caused the failure in test no. SR-4.

primary side of the short-radius system that was connected to a release lever placed in front of the nose of the system. The design allowed the anchor to be released during impacts on or near the nose of the system while remaining in place during impacts on the side of the system. Full-details for the secondary anchor are provided in a subsequent section.

The researchers also decided to lower the top height of the thrie beam rail in the short-radius system from 854 mm (31.625 in.) to 787 mm (31 in.). The thrie beam rail height had been raised to 854 mm (31.625 in.) prior to test no. SR-4 in order to improve the capture of the pickup truck and to aid the pickup truck in smoothly redirecting near the splice in the thrie beam at post no. 1P. However, review of the results of test no. SR-4 showed that the increased height did not significantly improve the capture of the pickup truck, and that the addition of the flare to the primary side of the system eliminated any issue with the redirection and/or interlock of the pickup truck with the splice at post no. 1P. In addition, it was believed that returning the height of the system to a more standard 787 mm (31 in.) would improve the compatibility of the system with the recently developed MGS system and existing 813-mm (32-in.) high bridge rail designs.

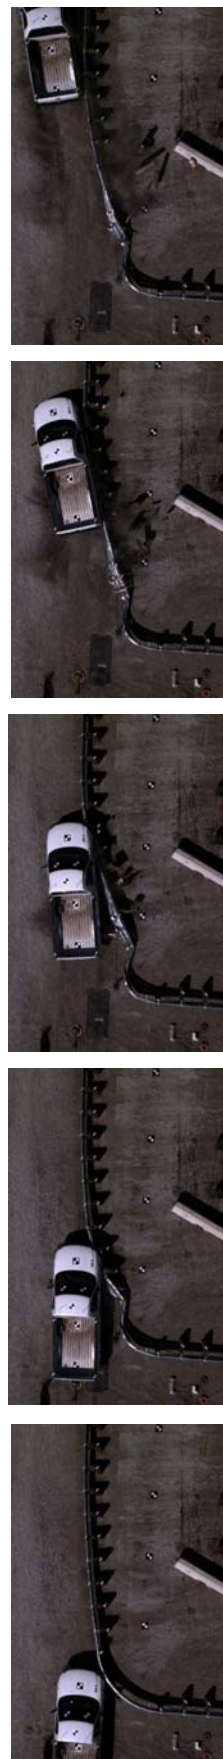
Figure 41. Summary of Test Results and Sequential Photographs, Test SR-5

● Test Number	SR-5	● Vehicle Angle	
● Date	4/4/2005	Impact	0.9 deg
● Test Article		Exit	12.6 deg
Type	Short-Radius Guardrail	● Vehicle Stability	Satisfactory
Key Elements . . .	Four 3,810-mm long curved and slotted three beam guardrail sections (parabolic flare)	● Occupant Ridedown Deceleration (10 msec avg.)	
	One 3,810-mm long straight three beam guardrail section	Longitudinal	5.72 Gs < 20 Gs
	787 mm top rail height	Lateral (not required)	5.37 Gs < 20 Gs
	18 breakaway posts	● Occupant Impact Velocity	
	Iowa steel post transition	Longitudinal	4.07 m/s < 12 m/s
	Simulated tangent W-beam guardrail end terminal	Lateral (not required)	3.18 m/s < 12 m/s
	Additional upstream anchor for primary side	● THIV (not required)	4.96 m/s
	Centerline truck with back of post no. 13P	● PHD (not required)	7.35 Gs
Orientation	Grading B - AASHTO M 147-65 (1990)	● Vehicle Damage	
● Soil Type	1997 Ford F-250 pickup truck	TAD ²⁰	1-FR-3

● Vehicle Model	1,862 kg	SAE ²¹	1-FRAW5
Curb	2,001 kg	● Vehicle Stopping Distance 41.92 m downstream	10.84 m right
Test Inertial	2,001 kg	● Test Article Damage	Moderate
Gross Static	2,001 kg	● Maximum Deflections	
● Vehicle Speed		Permanent Set	1,483 mm
Impact	101.8 km/h	Dynamic	2,219 mm
Exit	85.4 km/h	Working Width	2,260 mm laterally from primary side

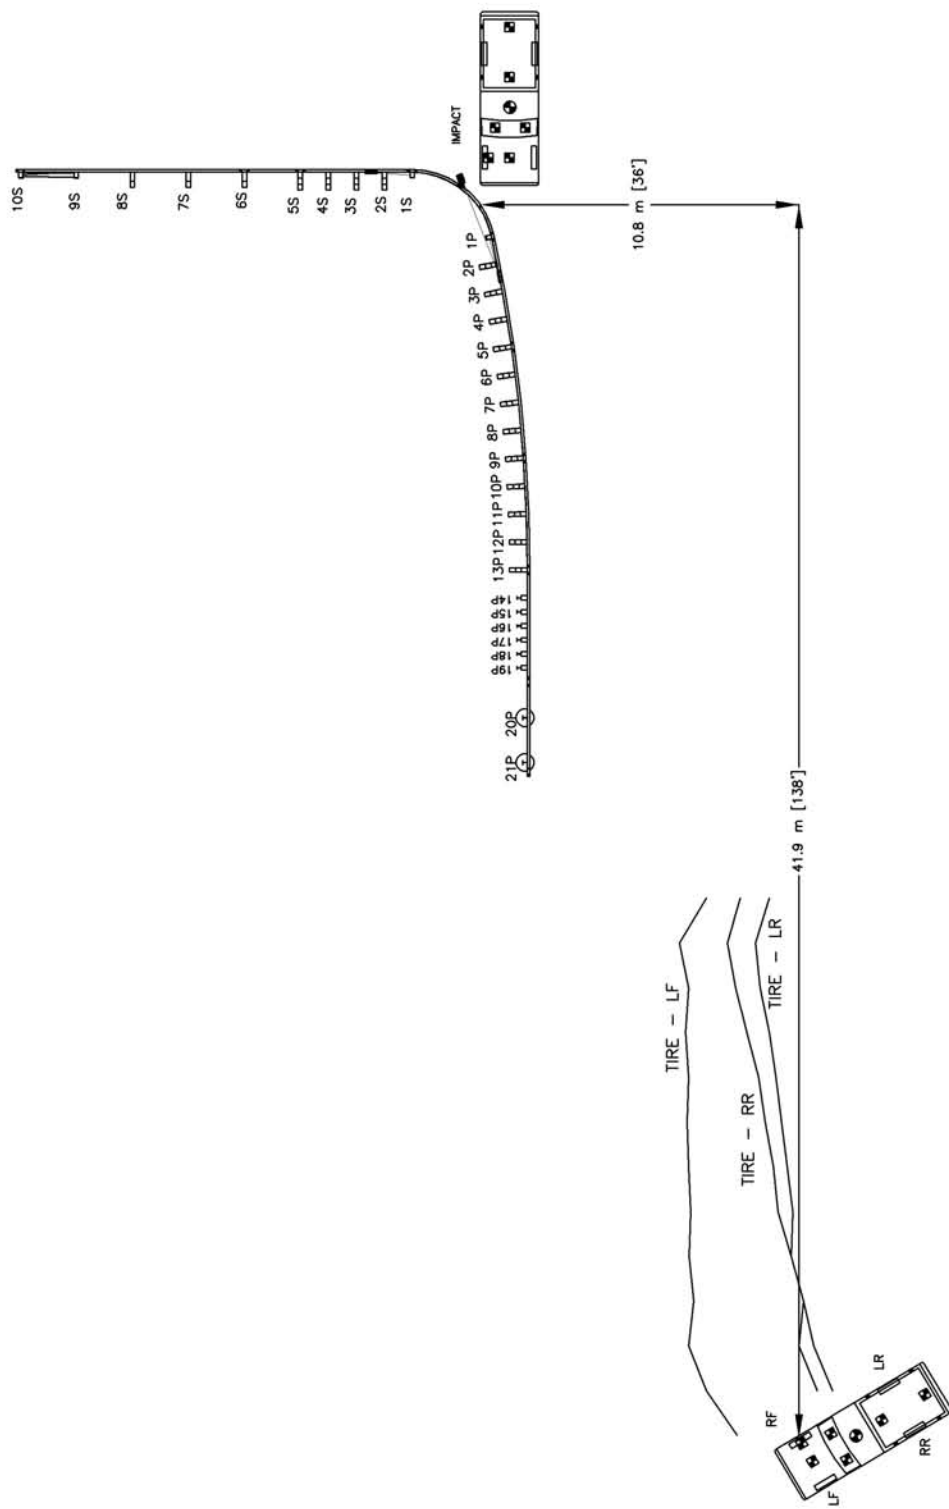
Figure 42. Vehicle Trajectory and Final Position, Test SR-5

quarter panel, and the right-front corner of the bumper continued to deform as the rail continued to flatten. At 0.182 sec, the pickup truck contacted post no. 4P which rotated slightly backward in the soil. At 0.190 sec, a gap between the right-front corner of the hood and the quarter panel formed, and the pickup truck rolled slightly counter-clockwise away from the system. At 0.216 sec, the top of the right-side door separated from the frame and bent outward at the door trim. At 0.276 sec, vehicle continued to be redirected, and the front bumper was located at post no. 7P. At 0.468 sec, the pickup truck exited the system with a resultant velocity of 85.4 km/h (53.1 mph) and at an angle of 12.6 degrees. The pickup truck came to rest 41.9 m (137 ft - 6 in.) downstream from impact and 10.8 m (35 ft - 6 in.) laterally away from the primary side, as shown in Figure 42. It should be noted that the secondary anchor remained in place throughout the vehicle contact and successfully developed upstream tension necessary to redirect the vehicle. The trajectory and final position of the pickup truck are shown in Figure 50.

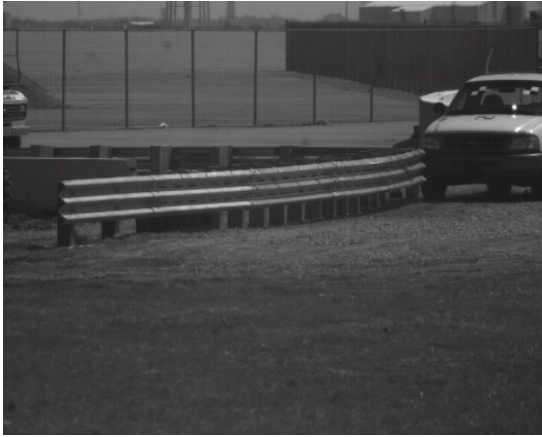
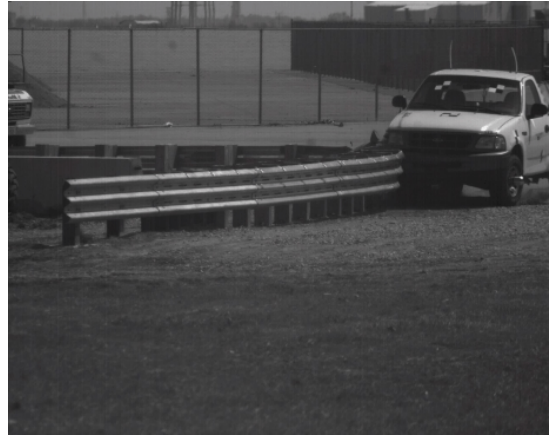
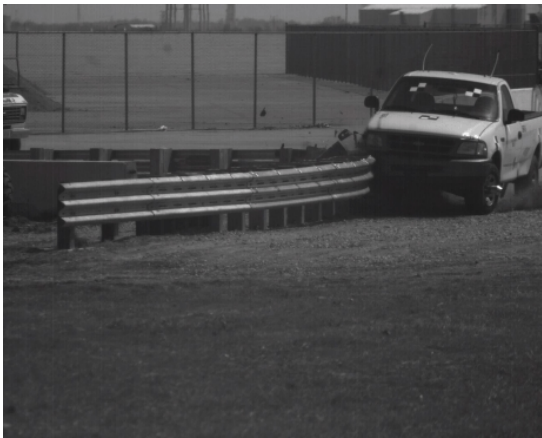
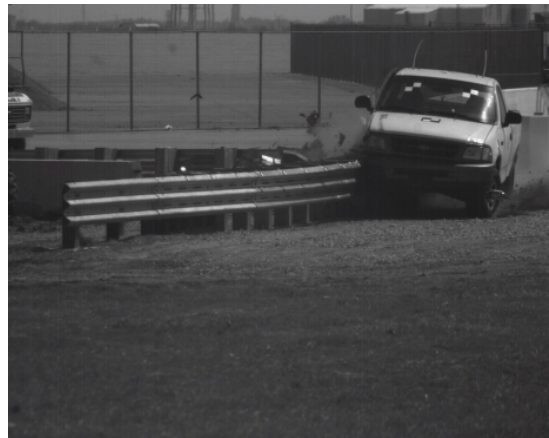
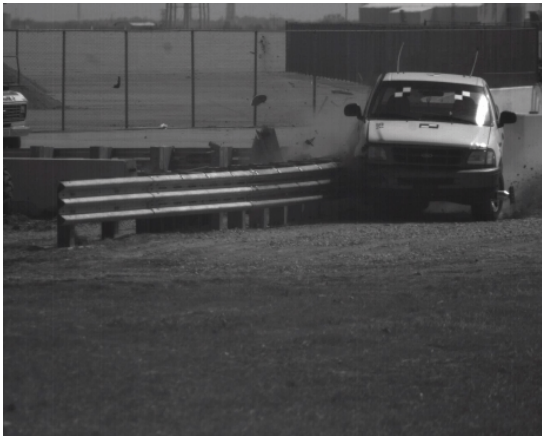
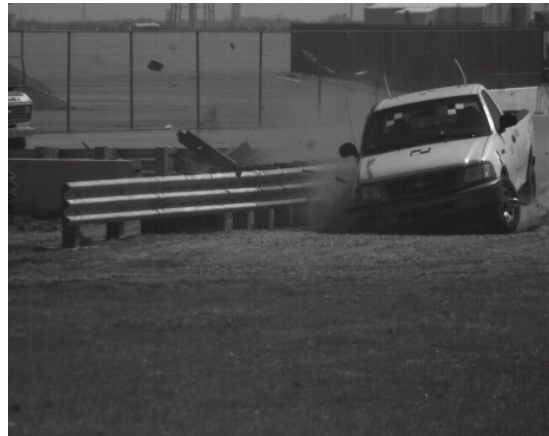
Figure 44. Additional Sequential Photographs, Test SR-5

The right-front corner of the test vehicle impacted the curved nose section of the short-radius guardrail system just upstream of post no. 1P, as shown in Figure 49. Upon impact, the front of the pickup truck deformed the curved nose section inward. At 0.034 sec, the three beam guardrail around the right-front corner of the bumper deformed upward and wrapped around the front of the pickup truck. At this same time, the right-front quarter panel crushed inward due to rail contact. At 0.062 sec, the right-front corner of the pickup truck contacted post no. 1P which fractured at the ground. At 0.086 sec, the guardrail continued to capture the pickup truck's front bumper. At this same time, post no. 2P deflected backward. At 0.102 sec, the pickup truck contacted post no. 2P which fractured at the ground. By 0.120 sec, the right-front corner of the pickup truck's hood deformed upward, and the quarter-panel continued crushing below it. At this same time, the pickup truck began to redirect. At 0.156 sec, the pickup truck contacted post no. 3P which deflected backward. At this same time, post no. 1P was still attached to the rail. At 0.170 sec, the hood's right-front corner, the right-front

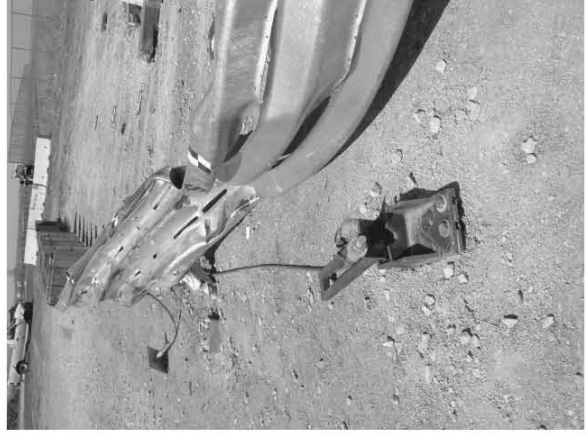
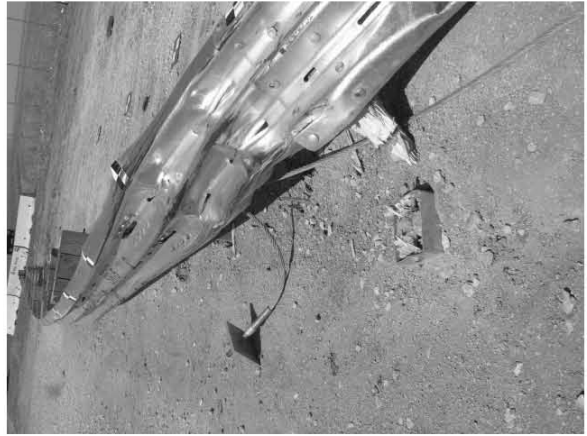
Figure 52. System Damage, Test SR-5

Damage to the short-radius system was moderate, as shown in Figures 51 through 61. Post no. 1P fractured at the foundation tube but remained attached to the rail. Post nos. 2P through 3P fractured at ground level and disengaged from the rest of the system. The tapered blockout at post no. 2P disengaged from the post. Post no. 4P fractured approximately 178 mm (7 in) below the groundline and disengaged from the system. Post no. 5P cracked at the groundline and rotated backwards in the soil. Post no. 6P sustained a 229-mm (9-in.) long crack through the transverse hole and rotated backward in the soil. Post no. 7P also rotated backward in the soil.

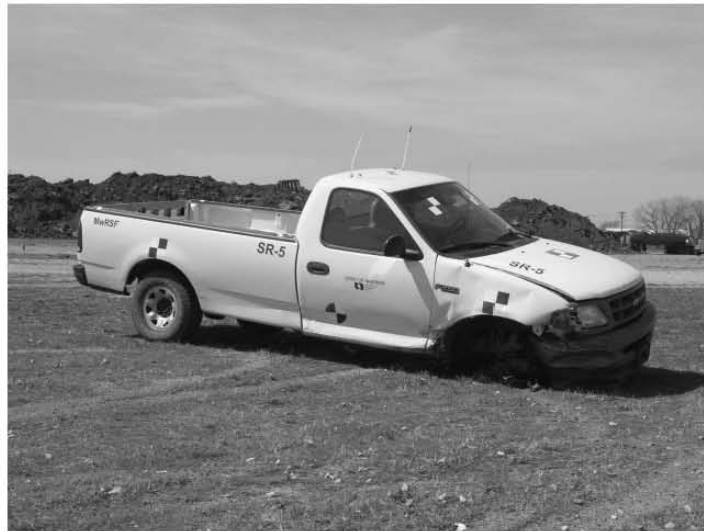
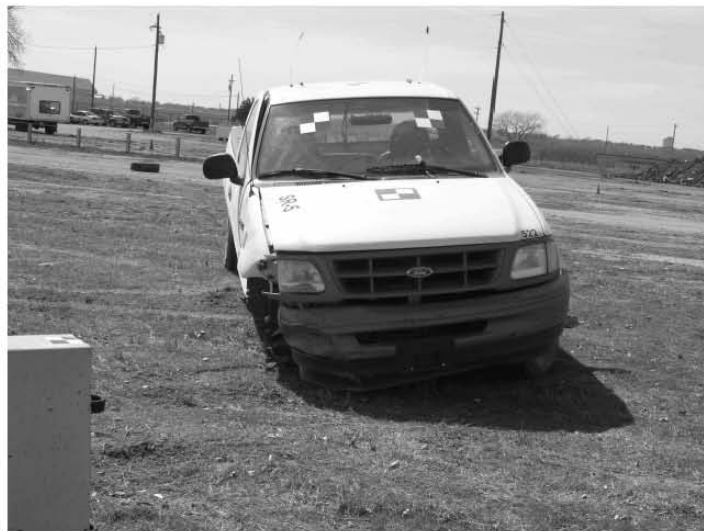
Figure 62. Vehicle Damage, Test SR-5

Exterior vehicle damage was minimal, as shown in Figures 62 through 64. Occupant compartment deformations to the right side and center of the floorboard were judged insufficient to cause serious injury to the vehicle occupants. Maximum longitudinal deflections of 13 mm (0.5 in.) were located near the left side of the right-side floorboard. Maximum lateral deflections of 25 mm (1 in.) were located near the right-front corner of the right-side floor pan. Maximum vertical deflections of 38 mm (1.5 in.) were located near the center of the right-side floorboard. Complete occupant compartment deformations and the corresponding locations are provided in Appendix C.

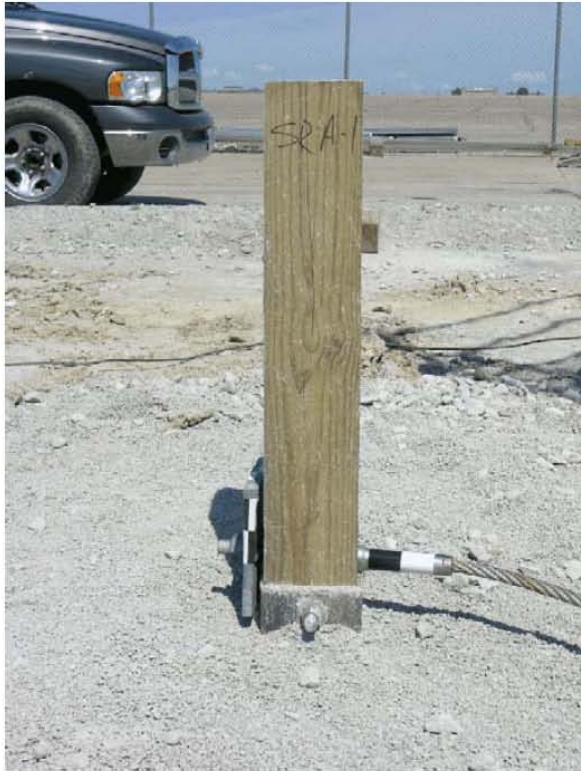
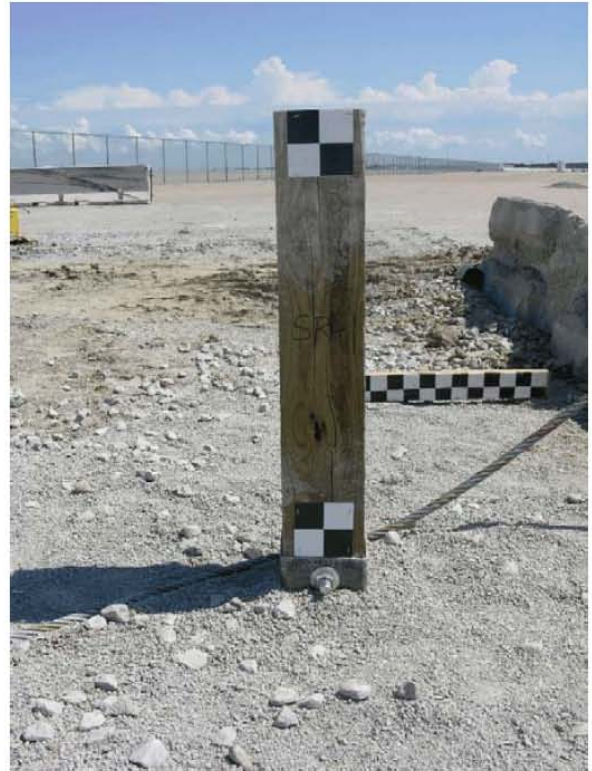
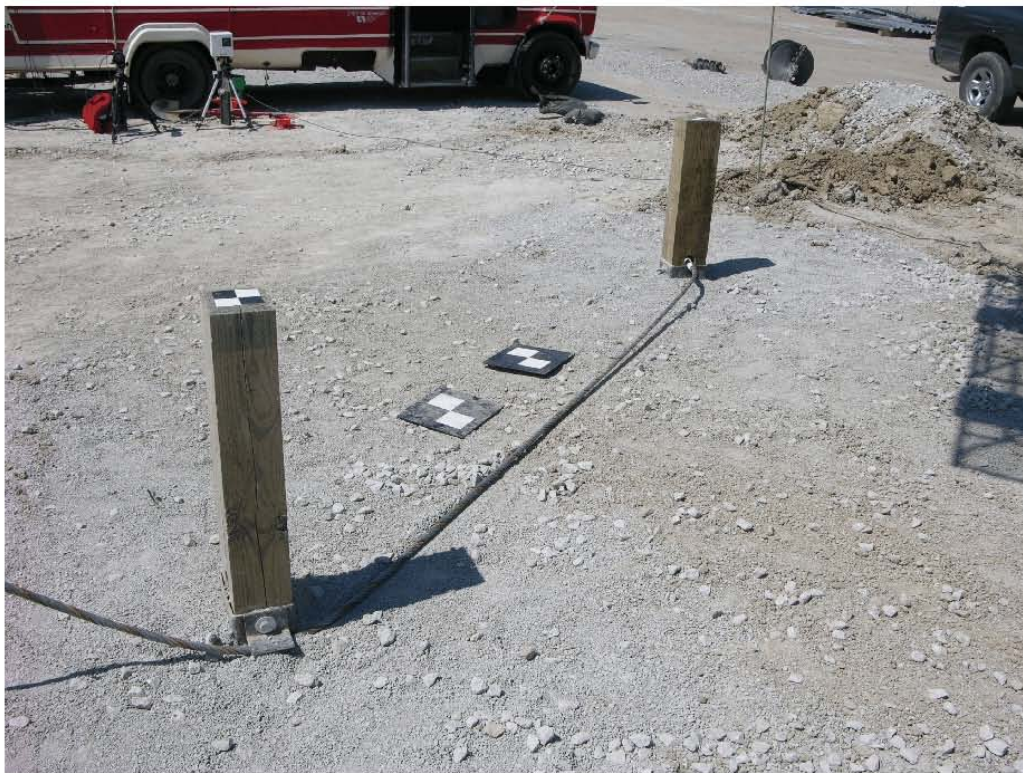
Figure 65. Bogie Test Setup, Test No. SRA-1

to determine the amount of load the new design could withstand. The first post on both the primary and secondary sides was installed with the cable anchor bracket and cable attached as shown in Figure 65.

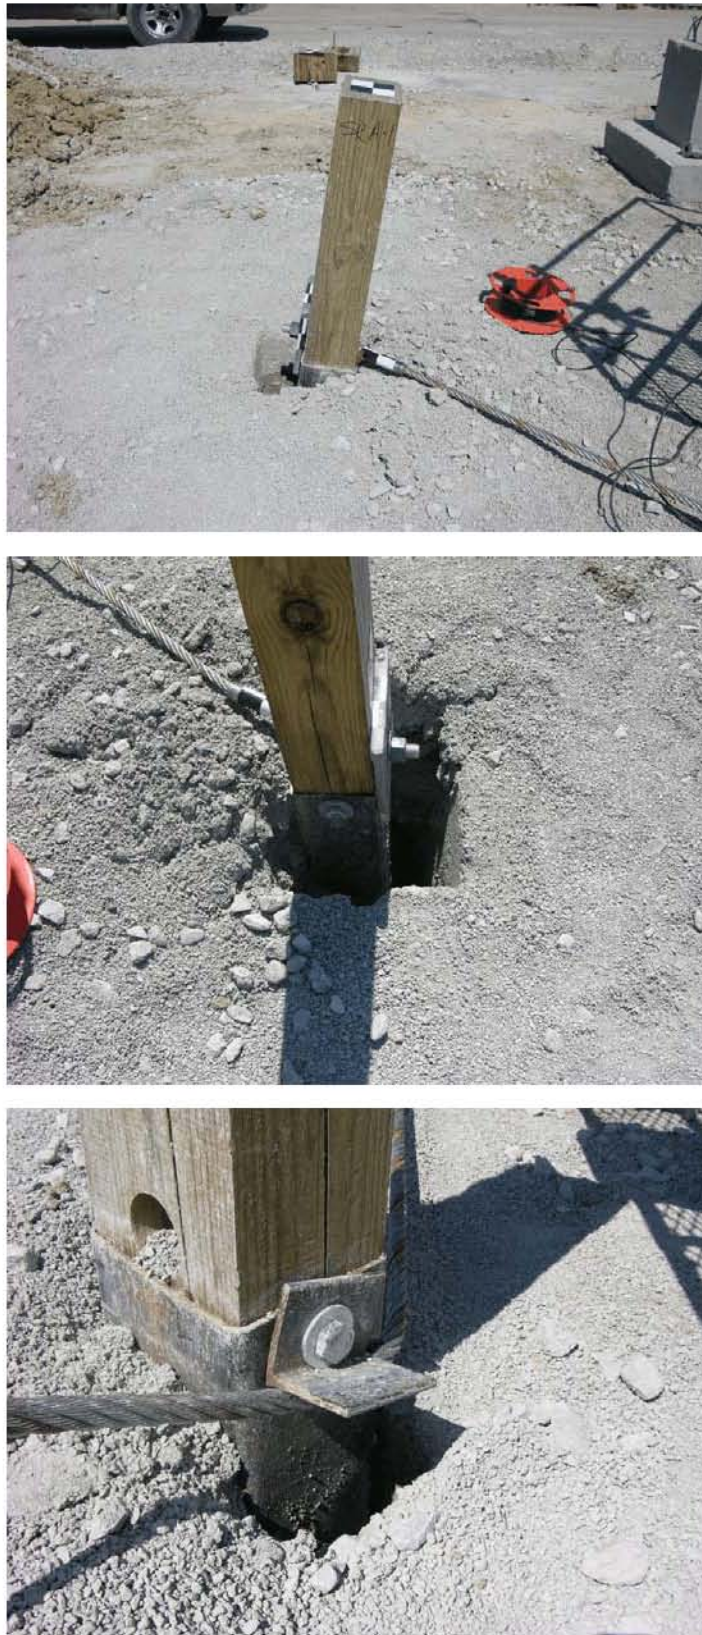
Figure 66. Bogie Test Results, Test No. SRA-1

The 2,082-kg (4,589-lb) bogie, attached to the cable, was pulled away from the installed posts to determine the maximum load the system could withstand and the amount of deformation imparted to the cable anchor bracket at the bottom of the primary-side post. The bogie speed was 34.66 km/h (21.54 mph). The posts experienced moderate movement in the soil as shown in Figure 66. In addition, the cable anchor bracket did not experience any deformations. The maximum load was found to be approximately 35 kips as shown in the load curve in Figure 67. Previous experience and testing of guardrail cable anchorages has demonstrated that the loads found for the new SR anchorage were consistent with past guardrail anchorage loads in the 35 kip range. This suggested that the revised short-radius anchorage would be sufficient for redirective impacts on the primary side of the system. Test results are shown in Table 2.

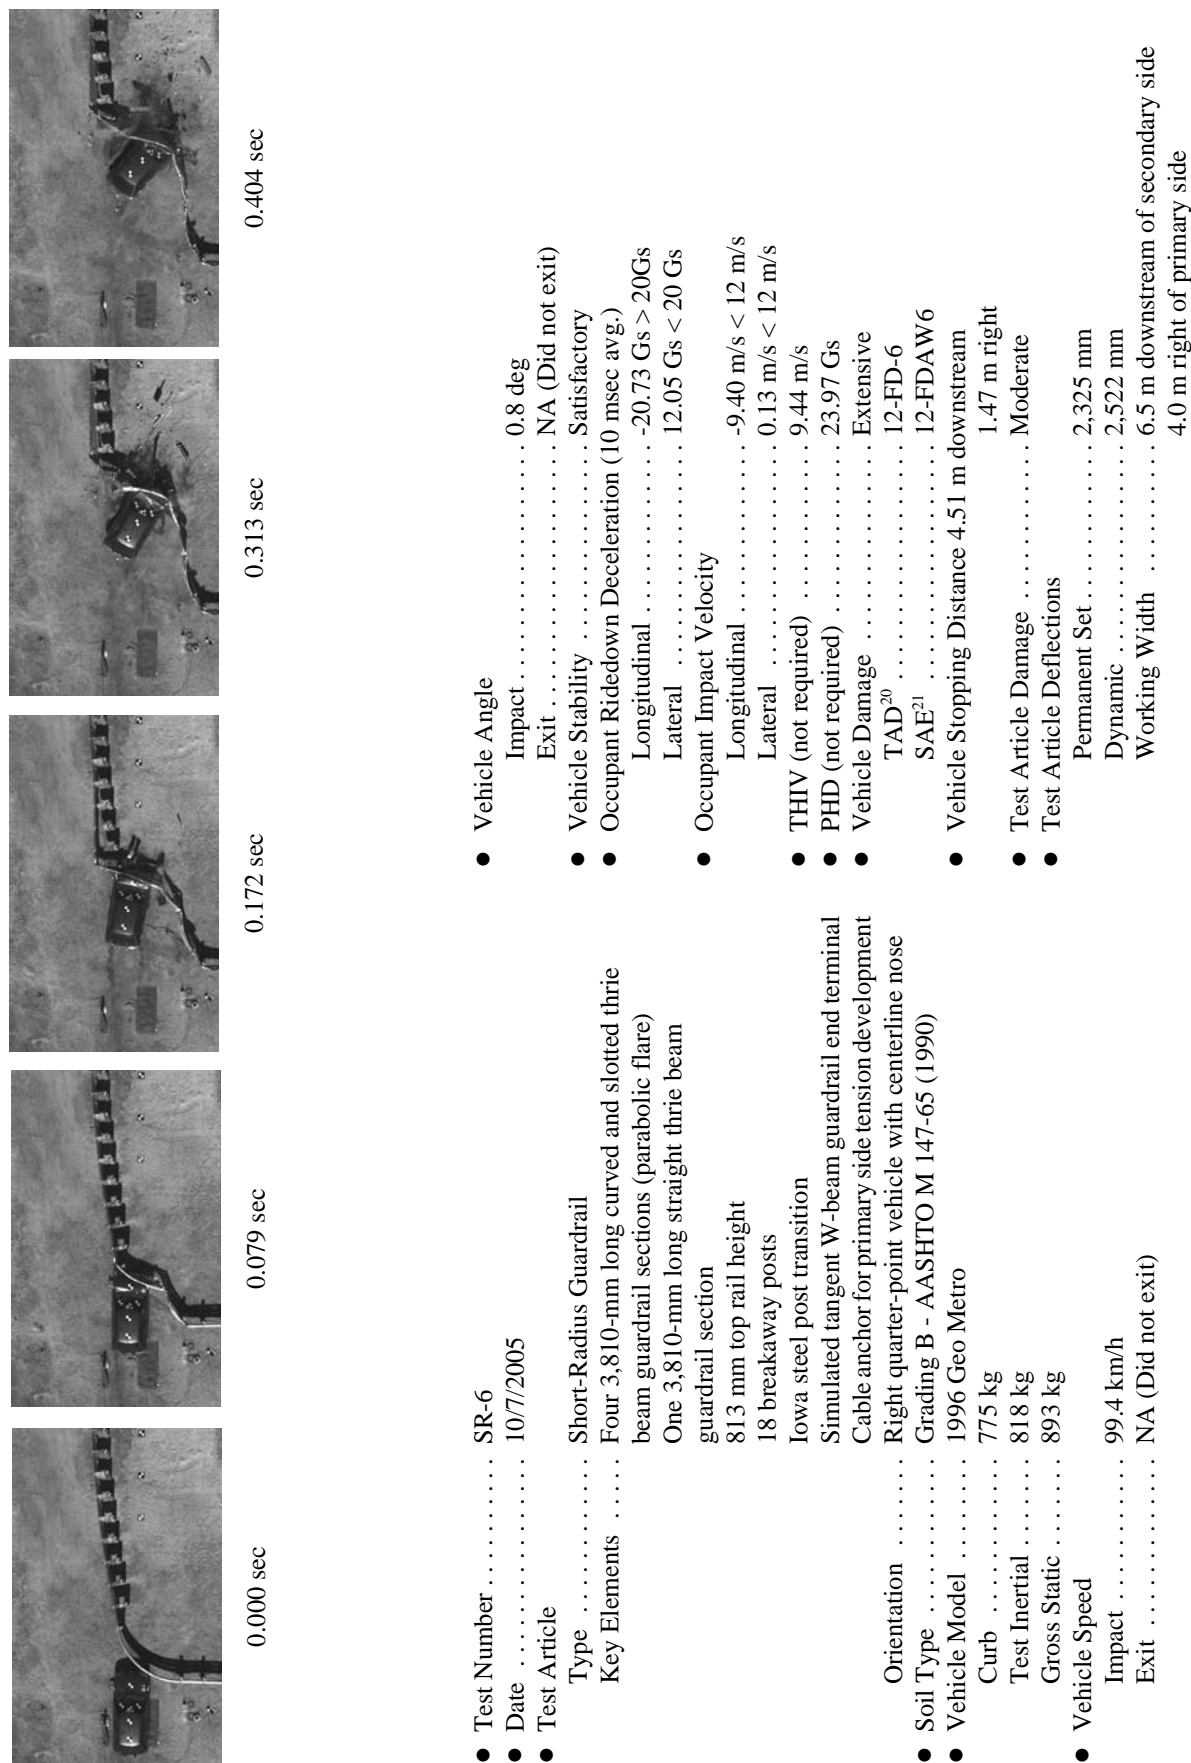
Figure 78. Summary of Test Results and Sequential Photographs, Test SR-6

impacted with the 820C vehicle adequately contained the vehicle and brought the vehicle to a stop. Detached elements and fragments did not penetrate nor presented undue hazard to other traffic but showed potential for penetrating the occupant compartment. Deformations of, or intrusion into, the occupant compartment that could have caused serious injury did occur due to the penetration of the hood through the windshield which was crushed inward greater than 76 mm (3 in.). The test vehicle remained upright during and after the collision. Vehicle roll, pitch, and yaw angular displacements were noted, but they were determined acceptable because they did not adversely influence occupant risk safety criteria nor cause rollover. After collision, the vehicle's trajectory did not intrude into adjacent traffic lanes. The longitudinal occupant ridedown decelerations were not within the maximum limits provided in NCHRP Report No. 350. Therefore, test no. SR-6 conducted on the short-radius guardrail system was determined to be unacceptable according to the TL-3 safety performance criteria found in NCHRP Report No. 350 due to the excessive longitudinal occupant ridedown deceleration and excessive windshield crush and penetration.

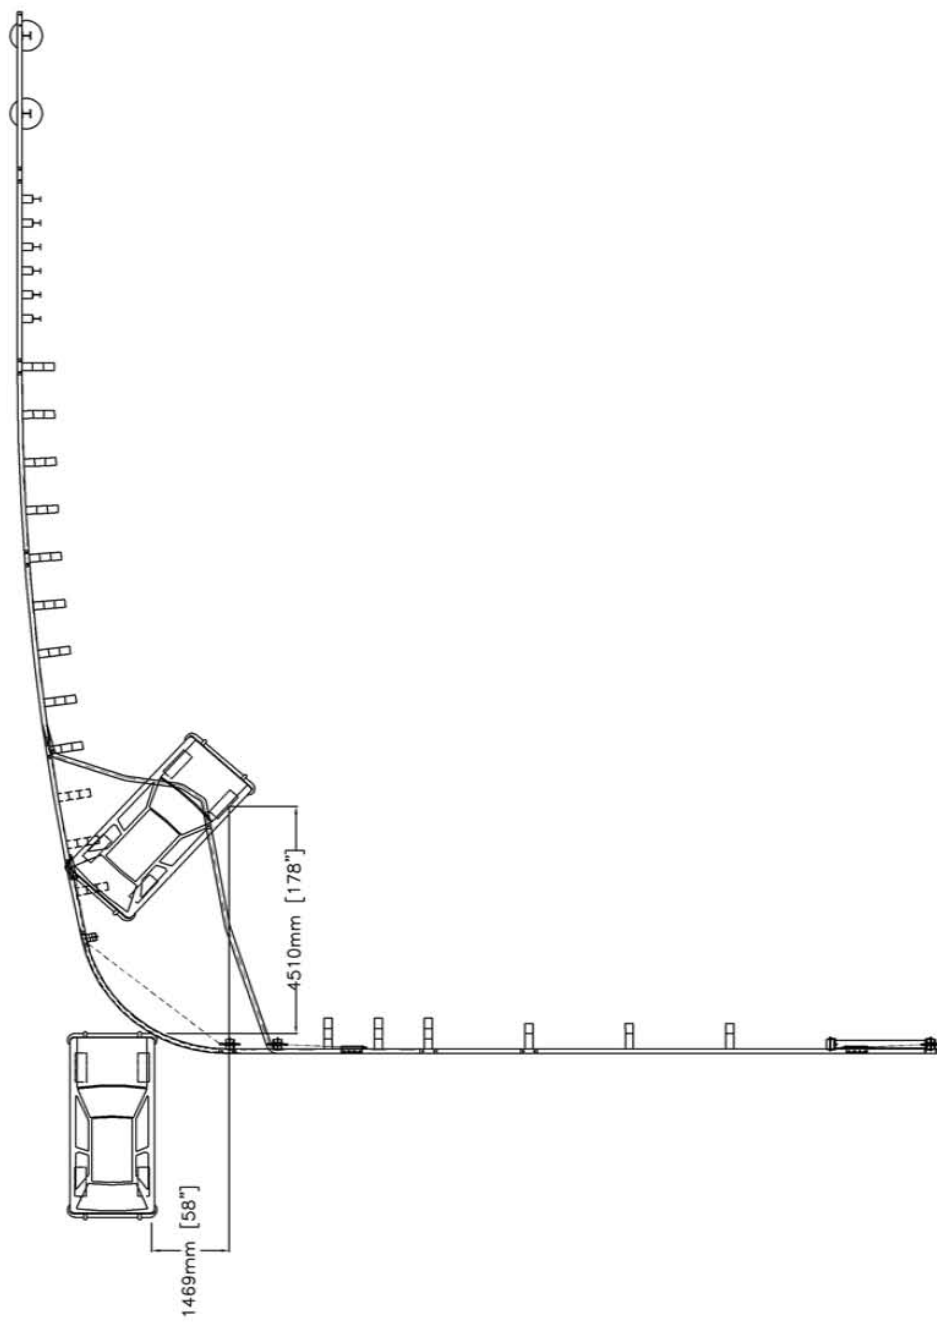
Figure 79. Vehicle Trajectory and Final Position, Test SR-6

the small car impacted post no. 2P which bent downstream and twisted away from the rail. At 0.146 sec, post no. 2P fractured completely, and the thrie beam rail had spread across the entire front end of the small car. At 0.160 sec, the hood of the car bent completely in half. At this same time, the rail disengaged from post nos. 3P and 4P. Also at this same time, the small car yawed clockwise, and the vehicle began to be captured in the system. At approximately 0.180 sec, the thrie beam rail was pushed up and over the front face of the vehicle as the small car continued into the short-radius system. The capture of the system was reduced to the interlocking of the thrie beam with the hood and “A” pillars of the small car. At 0.196 sec, the blockout at post no. 2P fractured and disengaged from the system. At 0.236 sec, the front of the car continued to crush and yaw. At 0.288 sec, post no. 3P fractured and disengaged from the system. At 0.314 sec, the blockout at post no. 3P contacted post no. 4P, and additional rail kinks and buckle points formed. At 0.436 sec, the car’s hood contacted the windshield. At 0.510 sec, all rail deformation ceased, and the car continued to travel under the rail. At 0.546 sec, major windshield cracking occurred. At 0.678 sec, the hood collapsed onto the windshield. At this same time, the car came to a stop due to resistance by the rail. At 0.770 sec, the small car came to rest 4.51 m (14 ft - 10 in.) downstream from impact and 1.47 m (4 ft - 10 in.) right from the impact point, as shown in Figure 79. The trajectory and final position of the small car are shown in Figure 87.

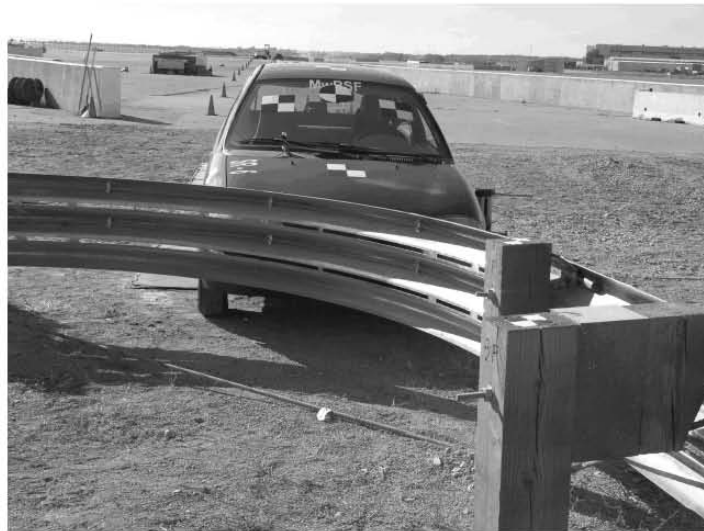
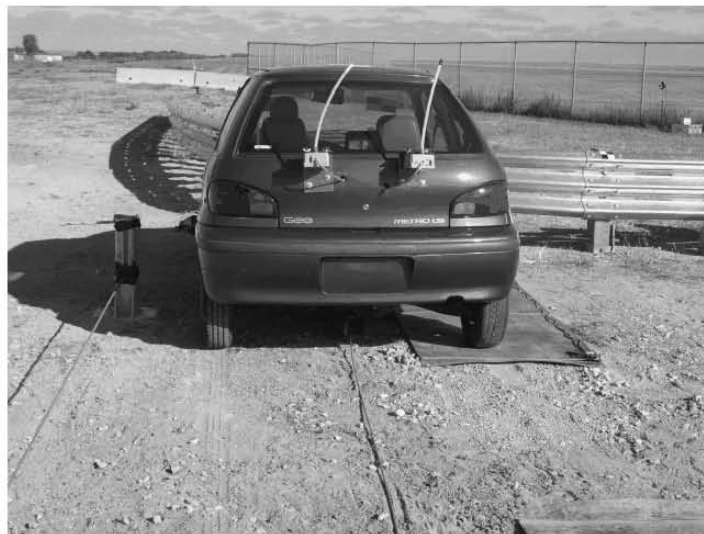
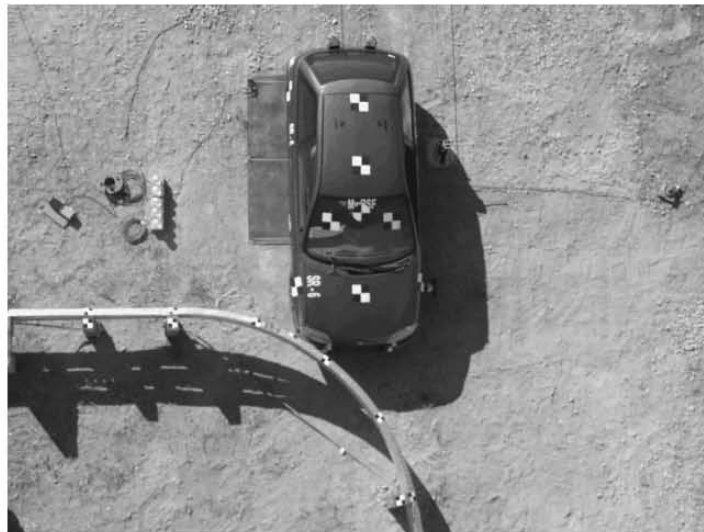
Figure 86. Impact Location, Test SR-6

The test vehicle impacted the curved nose section of the short-radius guardrail system, as shown in Figure 86. Upon impact, the right-front corner of the small car deformed as well as the curved nose section. At 0.022 sec, a buckle point formed at the quarter point on the secondary side of the curved nose section. At 0.032 sec, the curved nose section buckled near its midpoint, and the front of the hood was pushed up. At this same time, post no. 1S bent back in the sleeve. At 0.044 sec, the right-front corner of the hood deformed inward. As the vehicle continued downstream, a tear propagated through one of the slot tabs of the nose section, and the rail continued to crush and flatten. At 0.052 sec, buckle points occurred at both quarter points of the first section of rail on the primary side and at post nos. 1P and 3P. At 0.070 sec, the hood deformed, and a crease formed near the middle of the hood. At this same time, buckle points formed at post nos. 1S and 1P. At 0.082 sec, post no. 1P fractured at ground level and rotated downstream. At 0.104 sec, post no. 1S fractured at ground level, and the primary side cable anchor was released. At 0.124 sec, the front bumper of

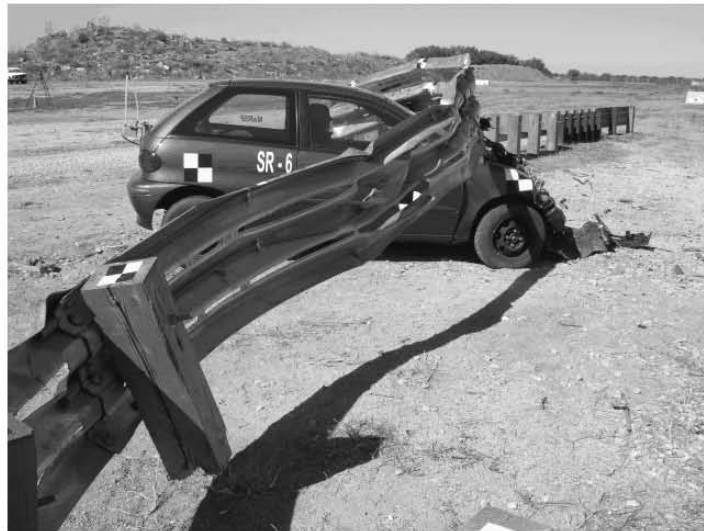
Figure 88. System Damage, Test SR-6

Damage to the short-radius system was moderate, as shown in Figures 88 through 92. Post nos. 1P and 1S fractured at the foundation tube. Post no. 1P disengaged from the rest of the system and post no. 1S remained attached to the rail. Post no. 2P fractured at ground level and disengaged from the rest of the system. Post nos. 3P and 4P also fractured at ground level and disengaged from

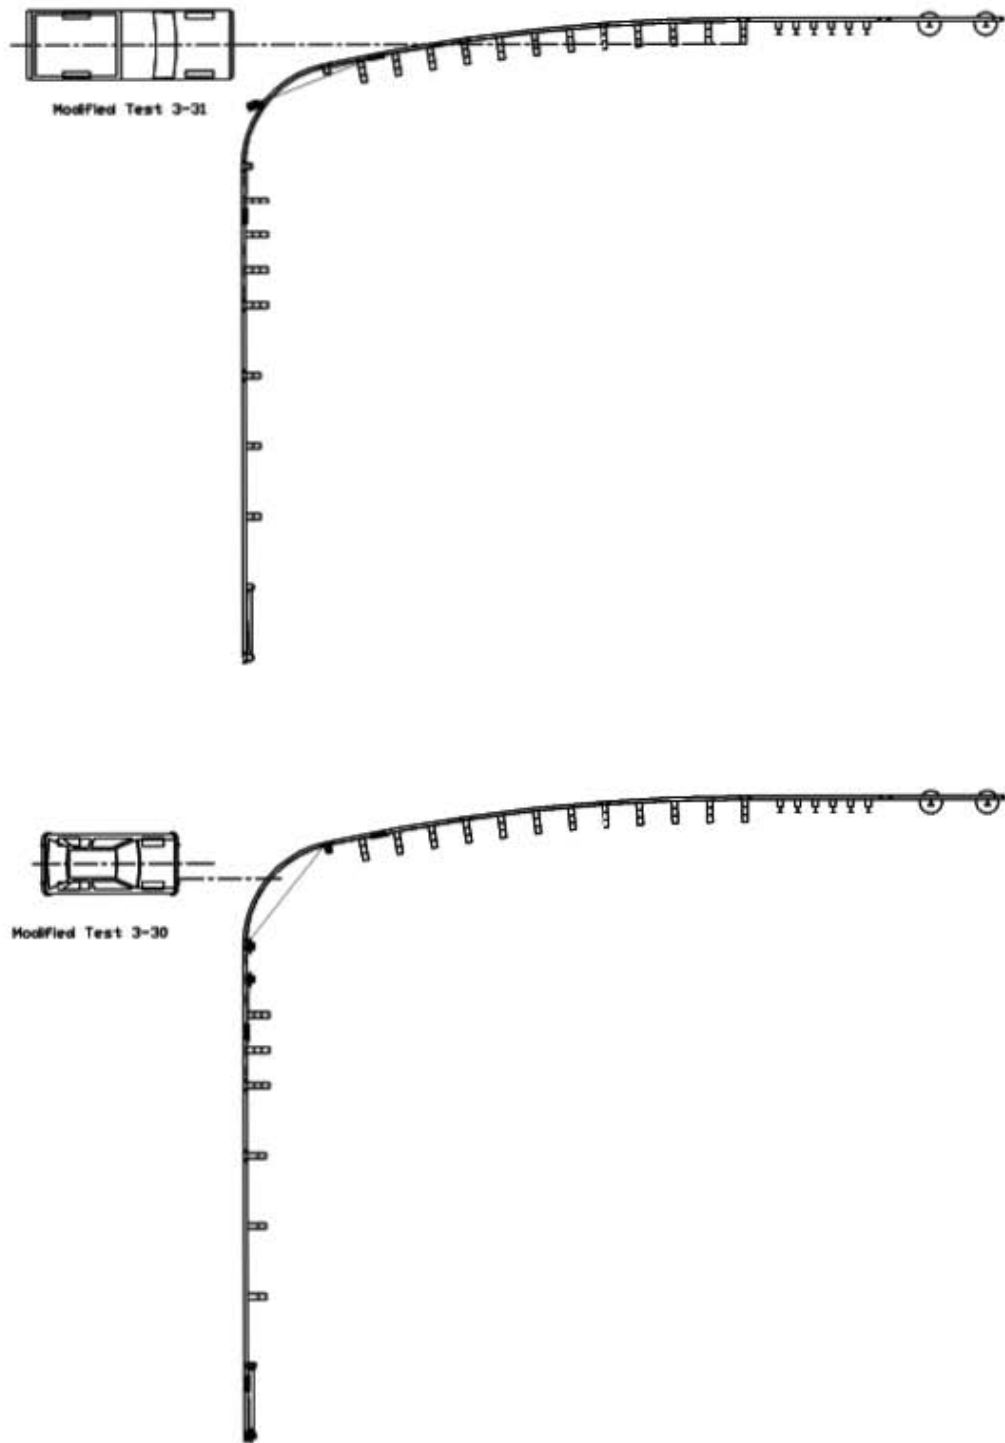
Figure 97. Summary of Short-Radius Guardrail Impacts

Test SR-6 was conducted according to NCHRP Report No. 350 Test Designation 3-30. The impact location for this test aligned the right-front quarter pont of the small car with the centerline of the nose of the short-radius system. In this test, an 893-kg (1969-lb) small car impacted the short-radius guardrail system at a speed of 99.4 km/h (61.8 mph) and at an angle of 0.8 degrees. During this test, the thrie beam guardrail partially captured the small car, and caused rapid deceleration which resulted in excessive occupant ridedown decelerations. In addition, the hood penetrated and caused the windshield to intrude into the occupant compartment. Therefore, based on these results, test SR-6 was deemed unacceptable according to NCHRP Report No. 350 criteria.
