Midwest Guardrail System for Long-Span Culvert Applications

MwRSF Research Report No. TRP-03-187-07

November 16, 2007

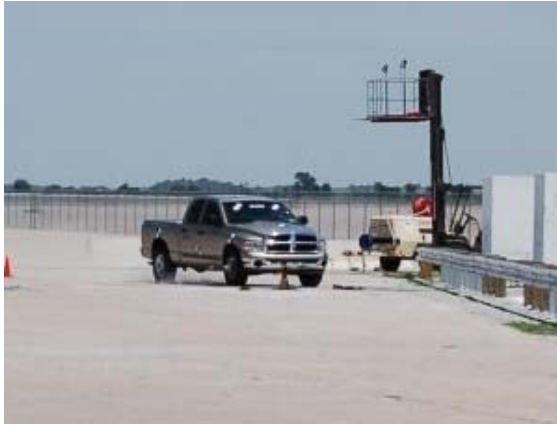
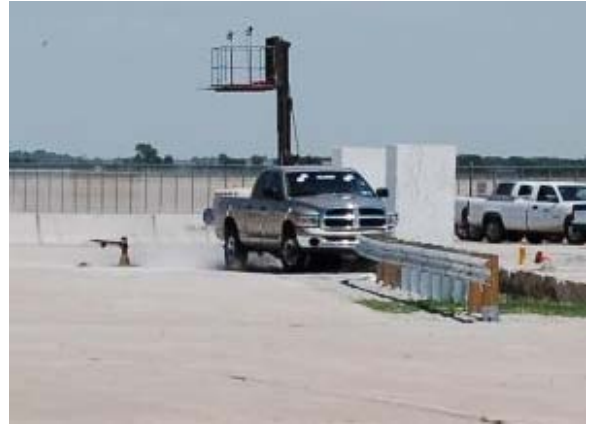
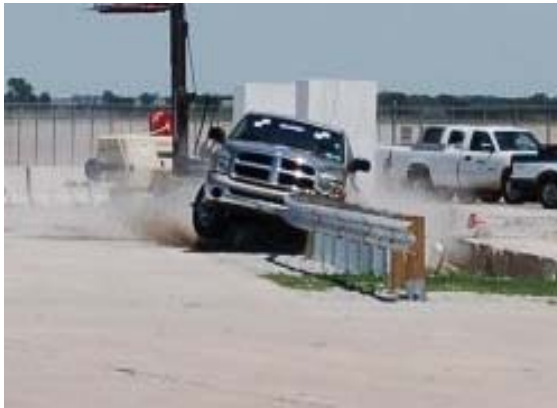
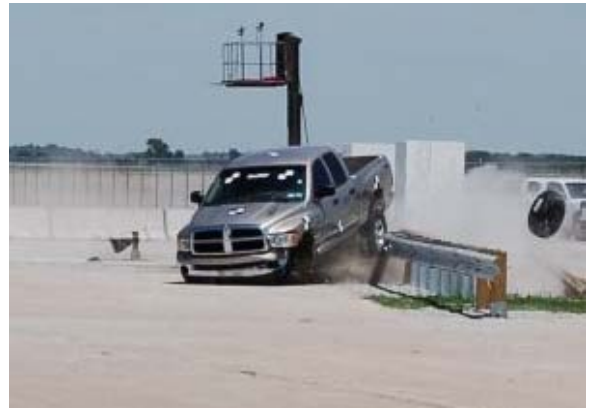
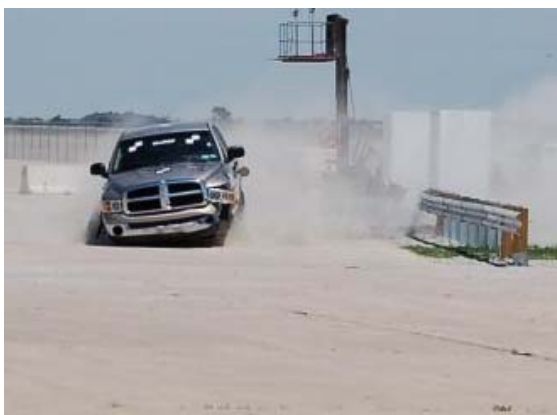
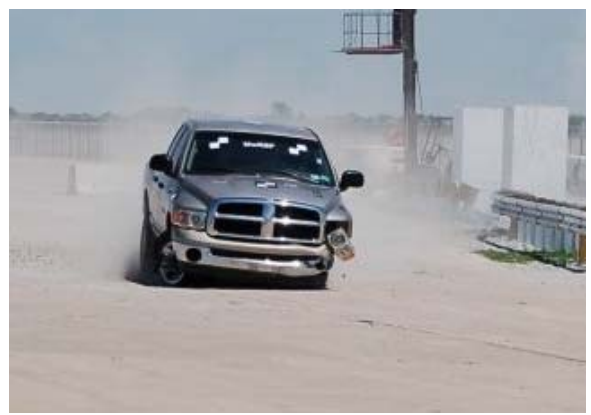
Figure 53. Additional Sequential Photographs, Test No. LSC-2

For test no. LSC-2, a 2,261-kg (4,984-lb) pickup truck impacted the MGS long-span guardrail system at a speed of 99.6 km/h (61.9 mph) and at an angle of 24.9 degrees. A summary of the test results and the sequential photographs are shown in Figure 52. The summary of the test results and sequential photographs in English units is shown in Appendix F. Additional sequential photographs are shown in Figure 53. Documentary photographs of the crash test are shown in Figures 54 and 55.

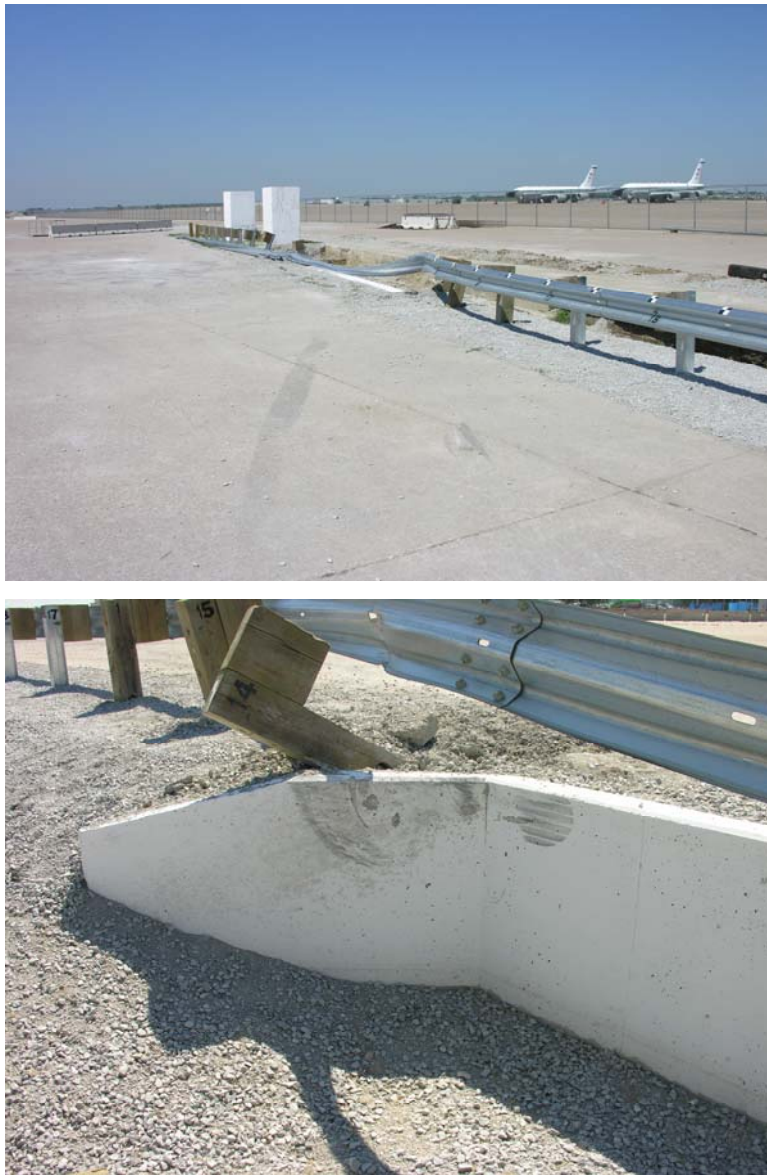
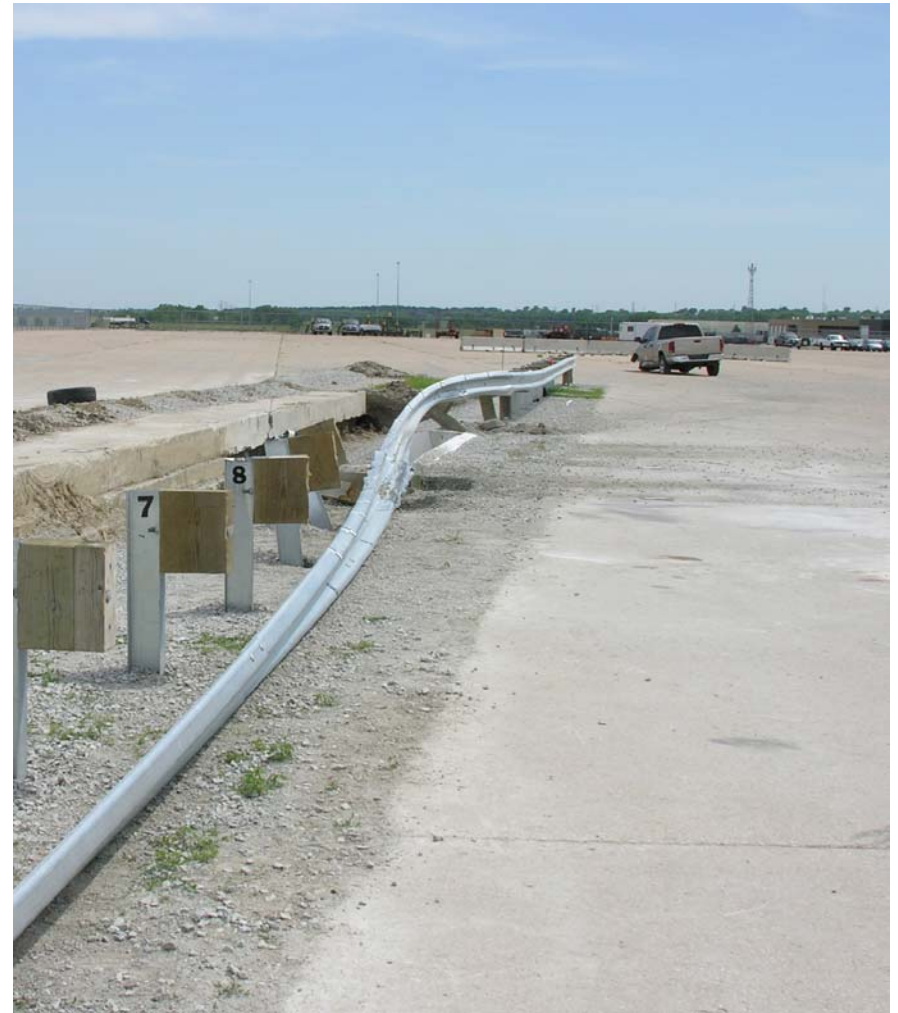
Figure 56. Impact Location, Test No. LSC-2

Initial vehicle impact was to occur between post nos. 10 and 11, or 12.67 m (41.6 ft) upstream from the centerline of post no. 14, as shown in Figure 56. Actual vehicle impact occurred 12.57 m (41.24 ft) upstream from the centerline of post no. 14. By 0.170 sec, the pickup truck had moved downstream and began redirecting which caused post nos. 11 through 13 to deflect backward and post no. 13 to fracture at its base. At 0.252 sec, the left-front tire rolled off of the culvert wingwall, and the pickup truck continued to redirect. At 0.368 sec after impact, the vehicle became parallel to the guardrail with a speed of 77.6 km/h (48.2 mph), and the left-front quarter panel and left-front wheel of the vehicle continued to drop vertically into the area behind the culvert. The pickup continued to redirect with both the left-front and left-rear tires extended over the edge of the culvert. At 0.470 sec, the left-front tire contacted the side of the downstream culvert wingwall, causing the left-front wheel to completely disengage from the vehicle suspension and steering. The vehicle continued to redirect in a stable manner after the disengagement of the left-front wheel until it exited the system at 0.992 sec with a speed of 54.3

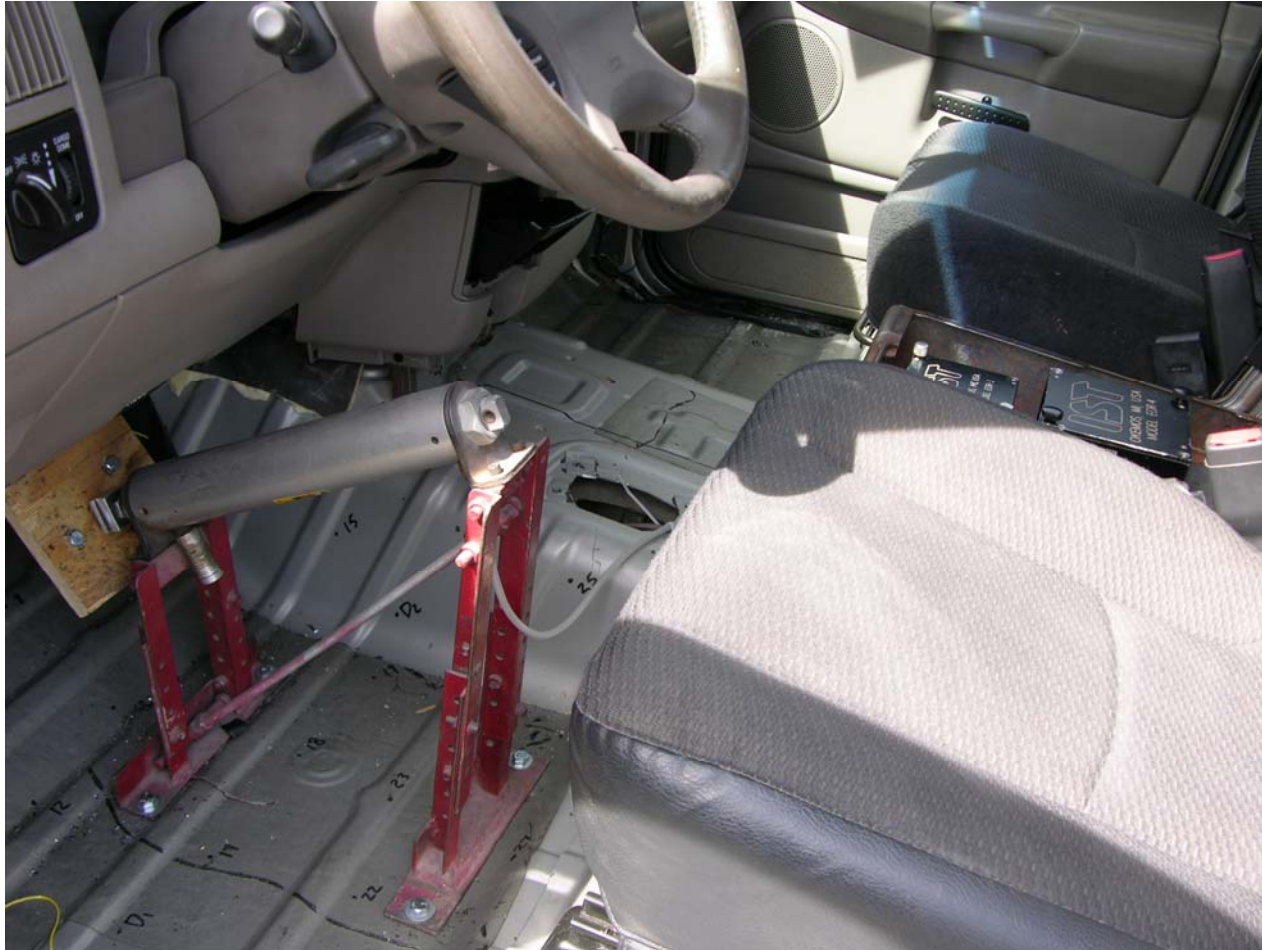
Figure 66. Vehicle Damage, Test No. LSC-2

Exterior vehicle damage was moderate, as shown in Figures 64 through 66. The left-front quarter panel was crushed inward, and the left side of the front bumper was also bent back toward the engine compartment. The left-front wheel assembly was completely disengaged from the axle, suspension, and steering systems. Some deformation and damage were noted on the left-front suspension components, including the upper and lower control arms, the stabilizer bar, and the joints connecting the suspension components. Contact marks and minor deformation were found along most of the lower-left side of the pickup truck. The left-rear quarter panel and the left corner of the rear bumper were dented as well. The left-rear tire was deflated, and the right-front tire de-beaded from the rim. Interior occupant compartment damage was minimal, as shown in Figure 67, with maximum lateral deformations of 19 mm (0.75 in.) measured near both the right and left sides of the driver-side footwell on the floorpan.
