NCHRP Report 350 Compliance Testing of the BEST System

Midwest Roadside Safety Facility
Civil Engineering Department
1901 "Y" St., Bldg. 'C'
P.O. Box 880601
University of Nebraska-Lincoln
Lincoln, NE 68588-0601
(402) 472-9198

TRANSPORTATION RESEARCH REPORT TRP-03-63-96

December 4, 1996

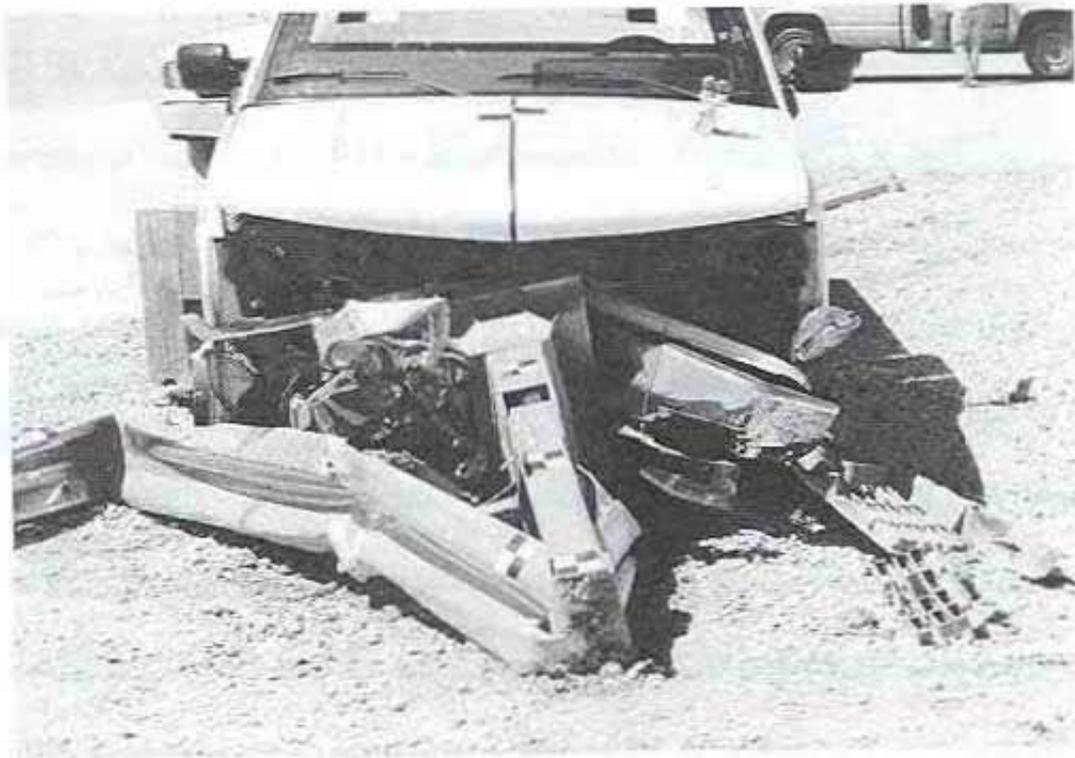
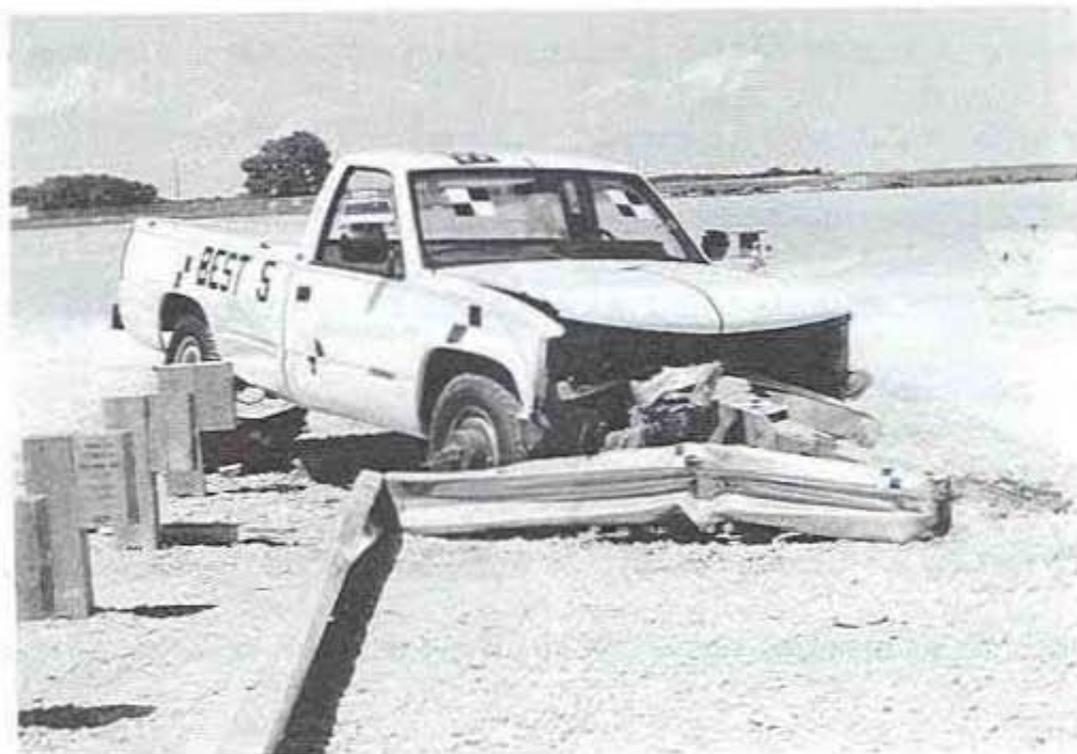
Figure 28. Post-test Photographs of Test BEST-5.

Upon impact with the system, the front bumper of the pickup began to crush inward, interlocking with the head. This bumper deformed considerably, and the head became lodged between the two frame members which supported the bumper. The first post broke away cleanly, and the anchor box separated as designed. However, the test vehicle's bumper wrapped around the head sufficiently to occlude the outlet region where the cut strips of guardrail are pushed out of the system. The W-beam continued to feed through the cutting mechanism while the cut portions of the rail accumulated inside the head. After cutting 3.3 m (10 ft - 10 in.), the impact head was filled with cut strips of W-beam, causing the rail to buckle in front of the impact head. At this point the vehicle had already slowed to approximately 53 km/h (33 mph) and it began to move toward the traffic side of the system. As the vehicle began to push the rail away from the posts, the load in the rail caused a number of posts downstream to split in half, and the rail slipped off the bolts on the remaining posts. This resulted in the entire length of W-beam being separated from the posts and falling to the ground as the vehicle came to a stop. Post-test photographs of this test can be seen in Figure 28.

were still satisfied. The normalized longitudinal OIV and ridedown accelerations were determined to be 7.6 m/s (25.0 fps) and 10.7 Gs, respectively. There was no measurable occupant compartment deformation. Although this test did meet all of the safety criteria required by NCHRP Report 350 (3), it was decided to redesign the impact head to prevent this jamming phenomenon.

This redesigned head, shown in Figures 6 and 7, redirects the cut W-beam further away from the impacting vehicle, reducing the chance of the W-beam interacting with the vehicle. Moving the outlet farther from the impact plate has the added advantage of accommodating deformation of the impact plate that sometimes occurs during severe accidents without compromising the outlet geometry.

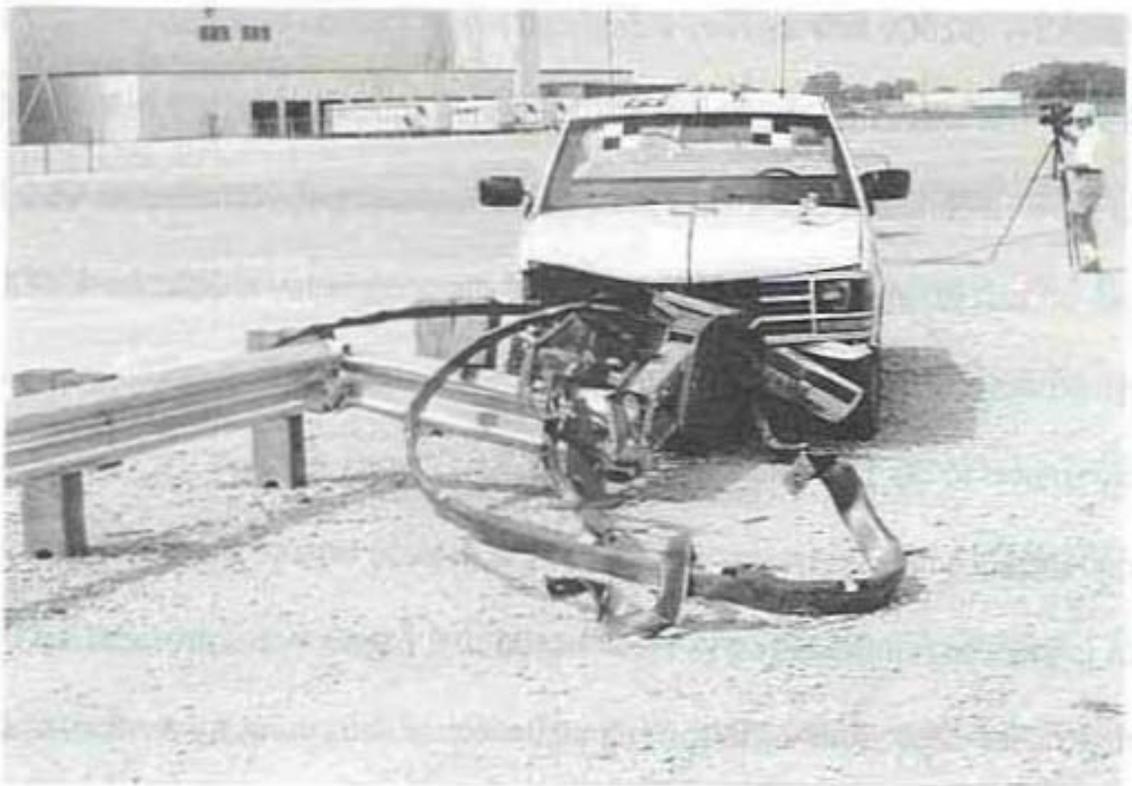
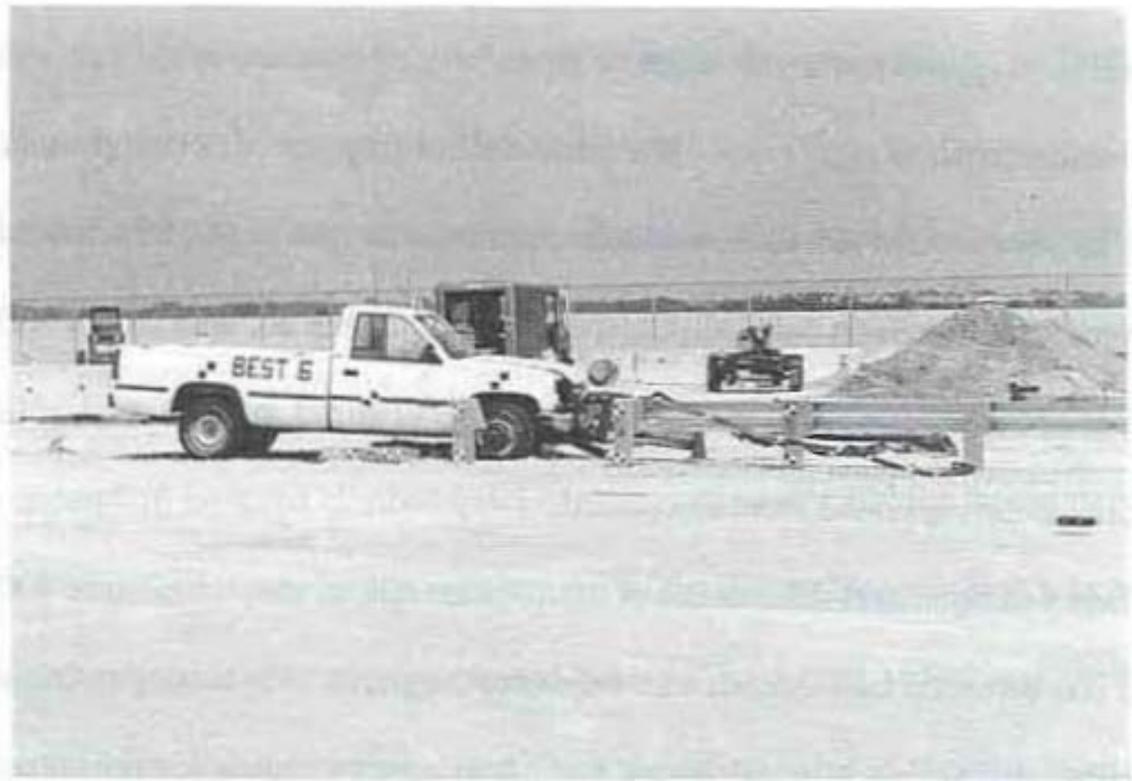
Figure 29. Post-test Photographs of Test BEST-6.

The BEST system with the redesigned head was impacted with a 1990 Chevy $\frac{3}{4}$ ton pickup at 101.3 km/h (62.9 mph) and 0.2 degrees toward the back of the rail. The system performed very well, as shown in Figure 29. The pickup was brought to a controlled stop after cutting through 7.44 m (24 ft - 5 in.) of W-beam guardrail. All of the posts broke off cleanly, and the head cut evenly throughout the test. The damage to the test vehicle was minimal, considering the severity of the impact, with a maximum front end crush of 35.6 cm (14 in.). There was no measurable occupant compartment deformation. Although the bumper wrapped around the front of the head in a manner similar to that observed in BEST 4, the revised outlet geometry prevented the outlet from being obstructed in anyway.

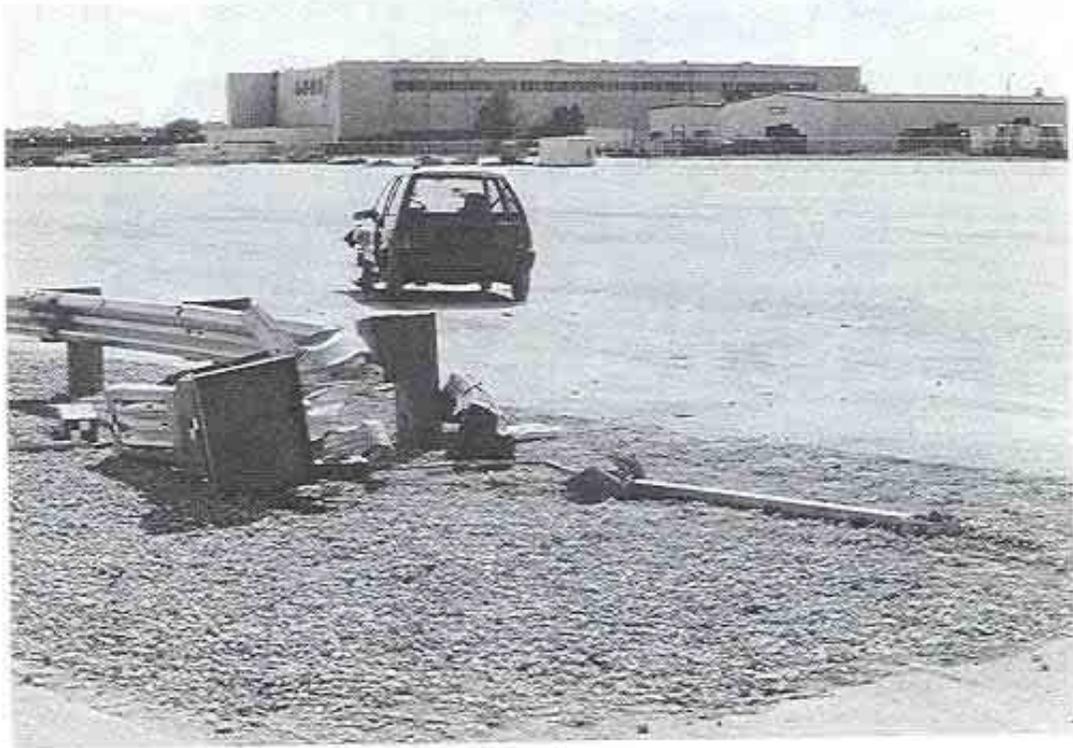
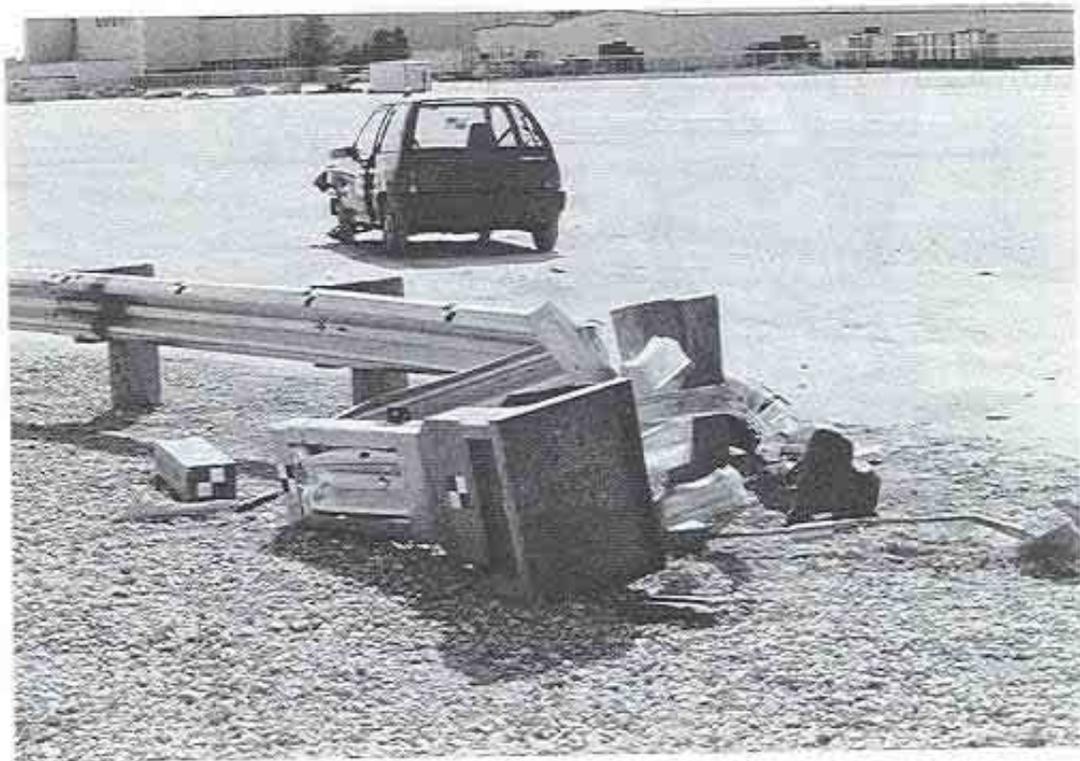
Figure 34. Vehicle Trajectory, Test BEST-8.

The test vehicle impacted the system with an angle of 0.6 degrees toward the back of the guardrail system. At 22 ms after impact the post breaker on the impact head contacted the first post, and by 34 ms the end of the chute contacted the cable anchor box which released from the rail immediately thereafter. At 54 ms after impact the yawing of the impact head caused the W-beam rail to pull off of the bolt at the second post, and the end of the chute reached this point on the W-beam at approximately 72 ms. At approximately 112 ms after impact, after the system had cut 1.83 m (6 ft) of W-beam, the rail stopped feeding into the chute. When this feeding action stopped, the rail buckled out of the way and the vehicle yawed out slowly, coming to rest as shown in Figures 32 and 34.

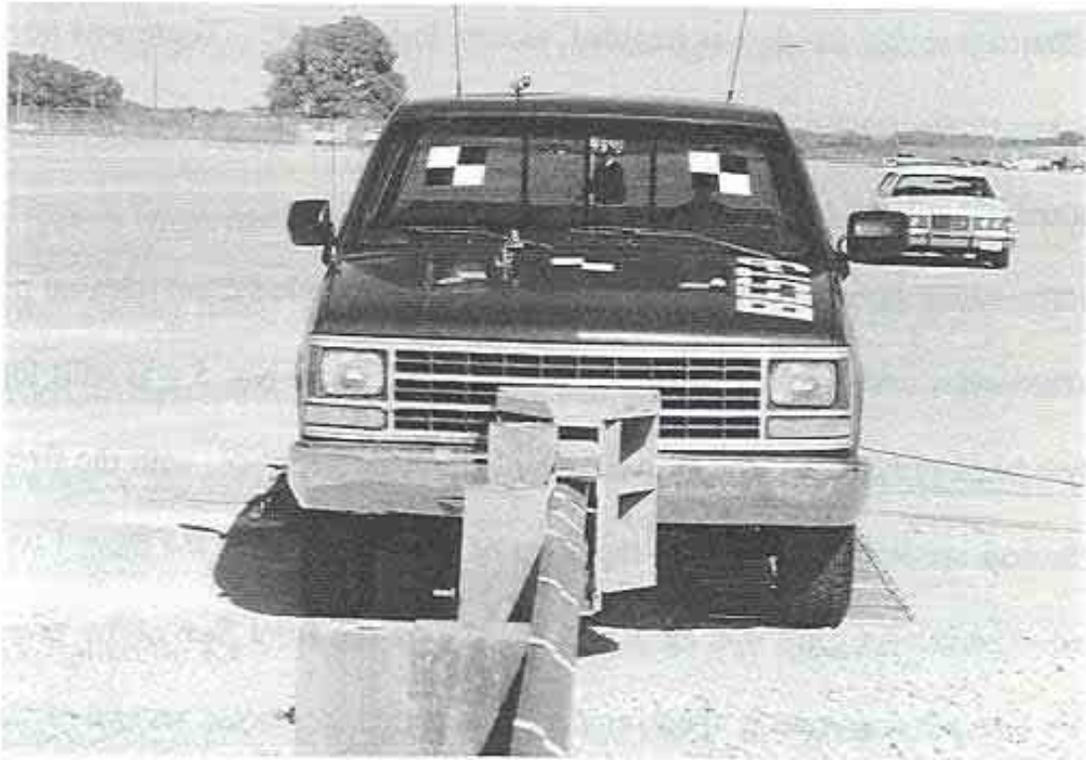
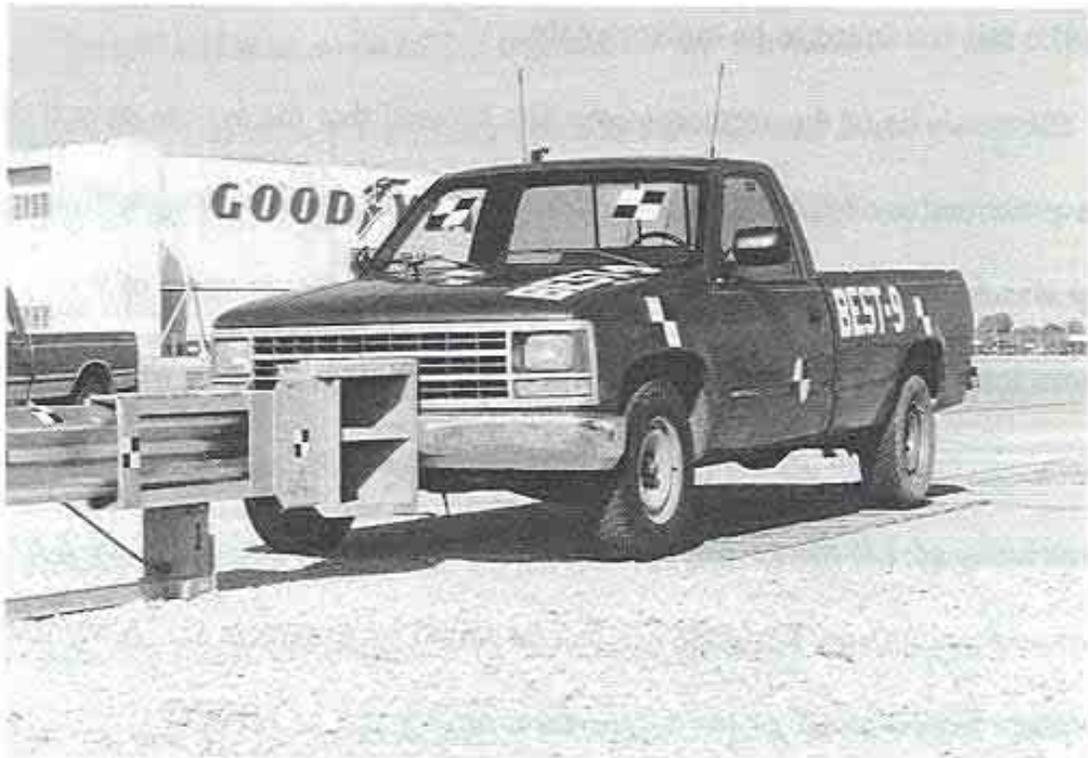
Figure 37. Impact Location, Test BEST-9.

In this test a 1990 Chevrolet $\frac{3}{4}$ ton pickup was directed into the BEST impact head at 101.0 km/hr (62.8 mph) and at an angle of 1.2 degrees toward the back of the rail. The front of the vehicle began to deform immediately after contact, and the head began to cut the W-beam. At 18 ms after impact the post breaker contacted the first post and began to push it over. By 30 ms after impact the first post had failed and the end of the chute contacted the anchor box, causing it to release immediately. At 60 ms after impact the end of the chute contacted post no. 2, and by 64 ms the rail had released from the post. The impact head continued traveling down the rail, with the post breaker impacting post no. 2, 90 ms into the test. This sequence continued as the impact head was pushed down the system, with the end of the chute reaching post nos. 3, 4, and 5 at 148 ms, 248 ms, and 372 ms respectively. The W-beam splice at post no. 5 fed through the cutting blades and the impact head came to rest with the end of the chute resting against post no. 6. The total cutting distance for this test was 8.91 m (29 ft - $2\frac{3}{4}$ in.). The vehicle final resting position

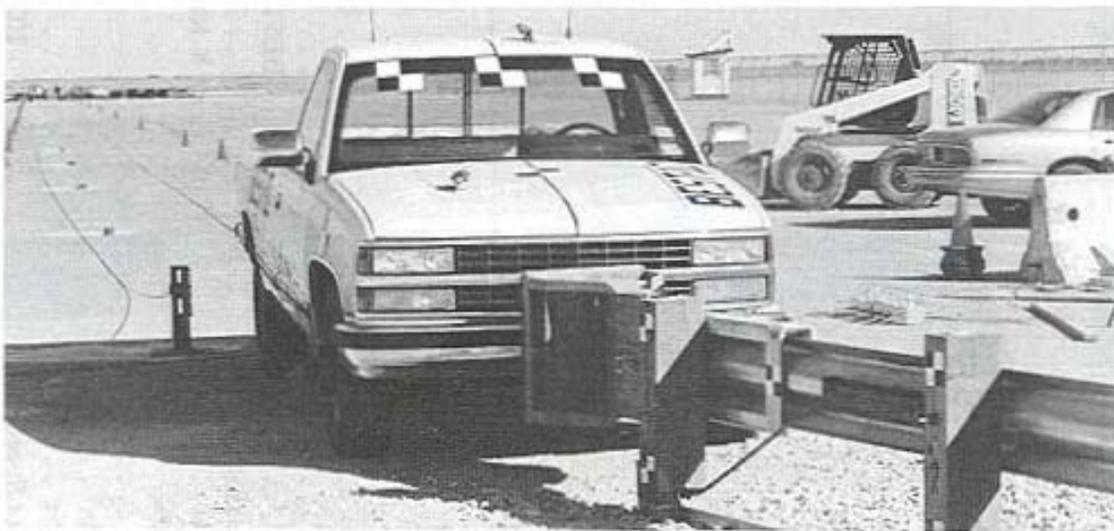
Figure 43. Impact Location, Test BEST-10.

NCHRP Report 350 (3) test 3-33 was conducted with a 1990 Chevy ¾ ton pickup impacting the system head-on at 102.1 km/hr (63.4 mph) and 14.3 degrees toward the traffic side of the system. The impact configuration for this test is shown in Figure 43. A summary of the test results is shown in Figure 44 and additional sequential photos are shown in Figure 45.

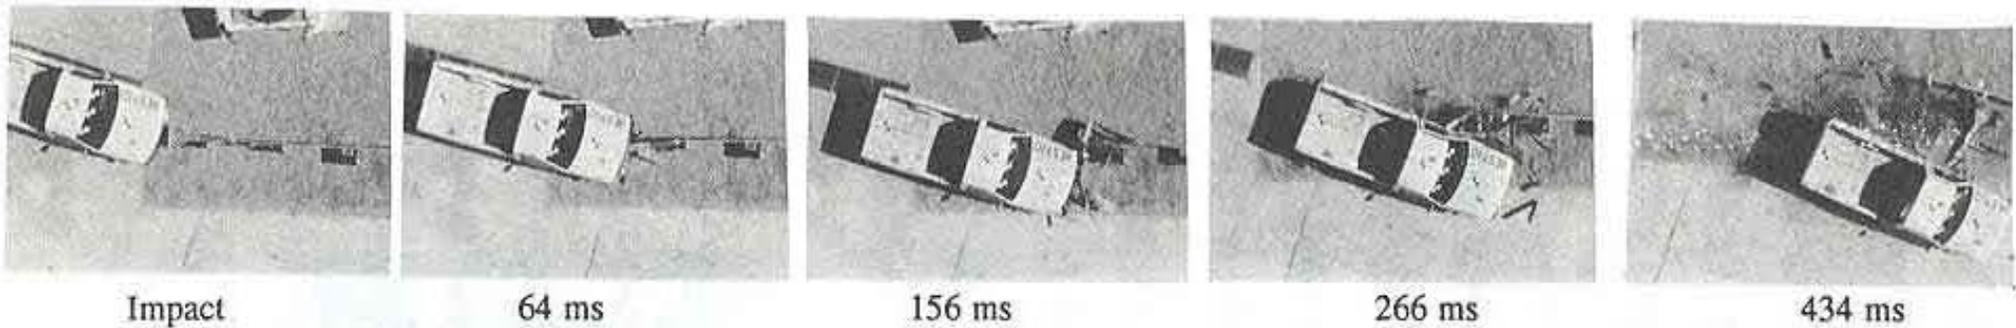
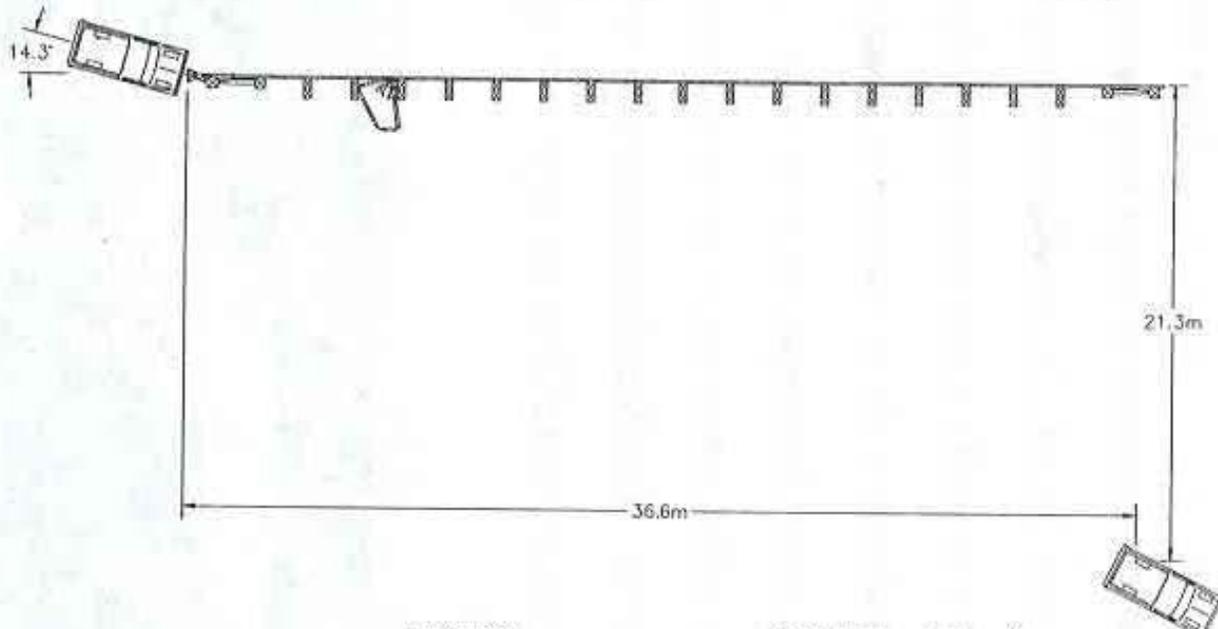
Figure 44. Summary of Test BEST-10.

Test Number	BEST-10
Date	10/11/96
Installation	BEST System
Length of Installation	46 m
Vehicle Model	1990 Chevy ¾ ton pickup
Vehicle Weight	
Curb	1924 kg
Test Inertial	2003 kg
Gross Static	2003 kg
Vehicle Impact Speed	102.1 km/h
Vehicle Impact Angle	14.3 deg

Vehicle Impact Location	Center of Impact Head
Normalized Occupant Impact Velocity	
Longitudinal	6.2 m/s
Lateral	2.3 m/s
Occupant Ridedown Accelerations	
Longitudinal	17.5 Gs
Lateral	10.0 Gs
Vehicle Damage Classification	
TAD	01FCEN1
VDI	1-FC-3
Amount of rail fed through cutter	2.16 m

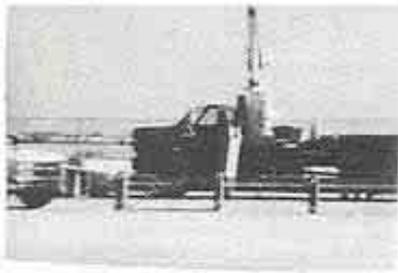
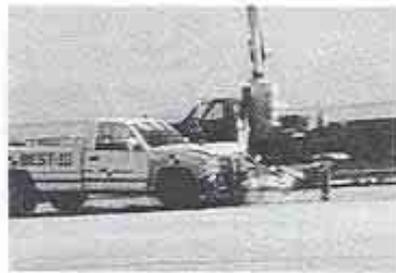
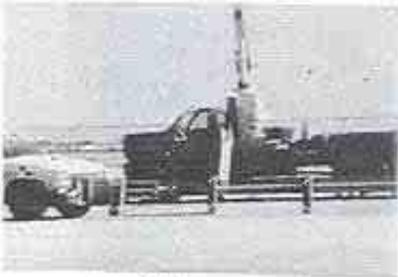
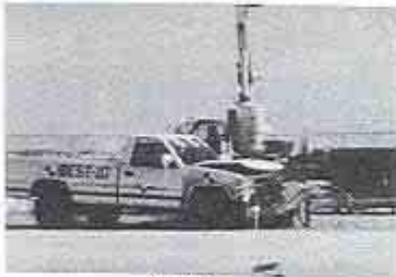
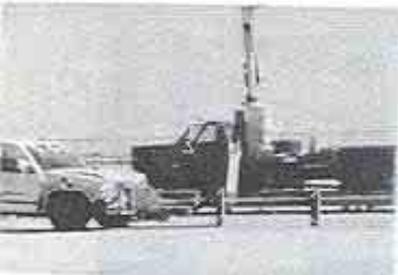
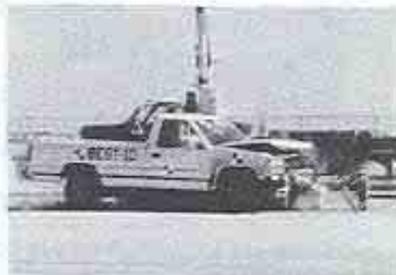
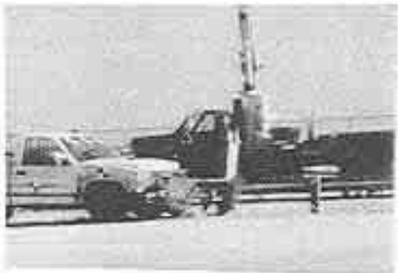
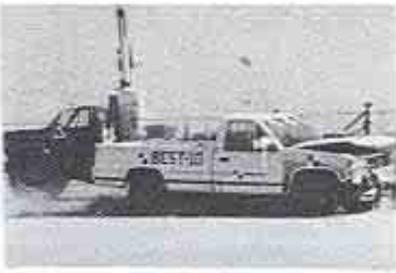
Figure 45. Sequential Photographs, Test BEST-10.

Upon impact with the system, the front of the vehicle began to crush inward and then push the head down the W-beam. At 12 ms after impact the post breaker contacted post no. 1, and by 34 ms the end of the chute contacted the anchor box, causing it to release and drop to the ground. At 66 ms after impact the end of the chute reached post no. 2 and at 106 ms, after feeding 2.16 m (7 ft - 1 in.), the W-beam buckled at the end of the chute and the impact head began to rotate around with the vehicle. The vehicle continued to travel through the system and as the impact head rotated around, the end of the chute contacted the driver's side door at approximately 226 ms after impact. The vehicle continued through the system and was braked to a stop approximately 120 ft downstream of impact and 70 ft behind the rail, as shown in Figure 44 and 46.

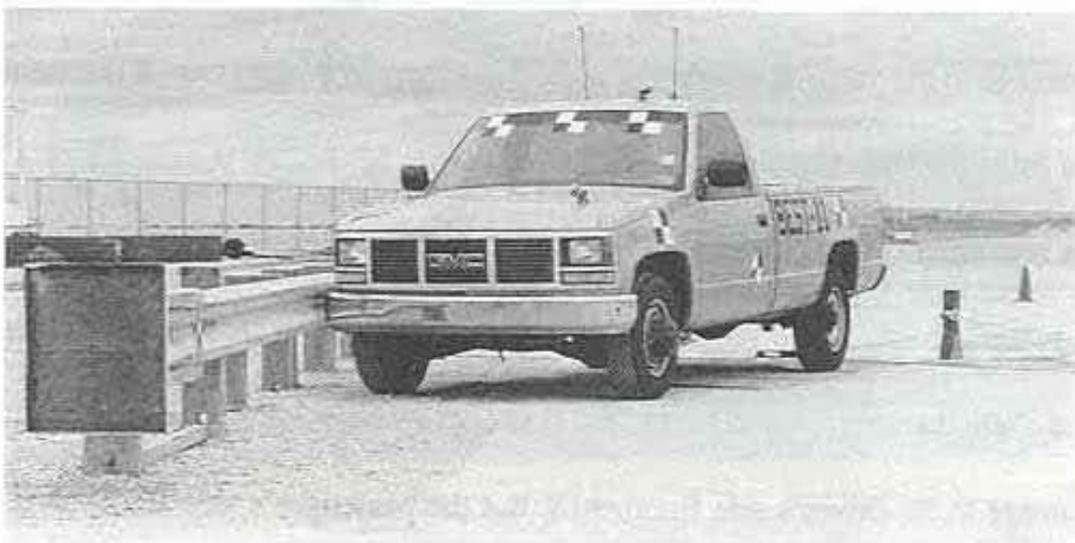
Figure 49. Impact Location, Test BEST-11.

This test was conducted to satisfy the requirements of NCHRP Report 350 (3) test 3-39 which requires that the terminal be impacted from the reverse direction at the midpoint of the terminal length with a $\frac{3}{4}$ ton pickup impacting at 20 degrees and 100 km/hr (62.1 mph). The test vehicle impacted the guardrail at the midpoint between post nos. 3 and 4 at 101.6 km/hr (63.1 mph) and 20.5 degrees. The impact configuration for this test is shown in Figure 49. A summary of the test results is shown in Figure 50 and additional sequential photos are shown in Figure 51.

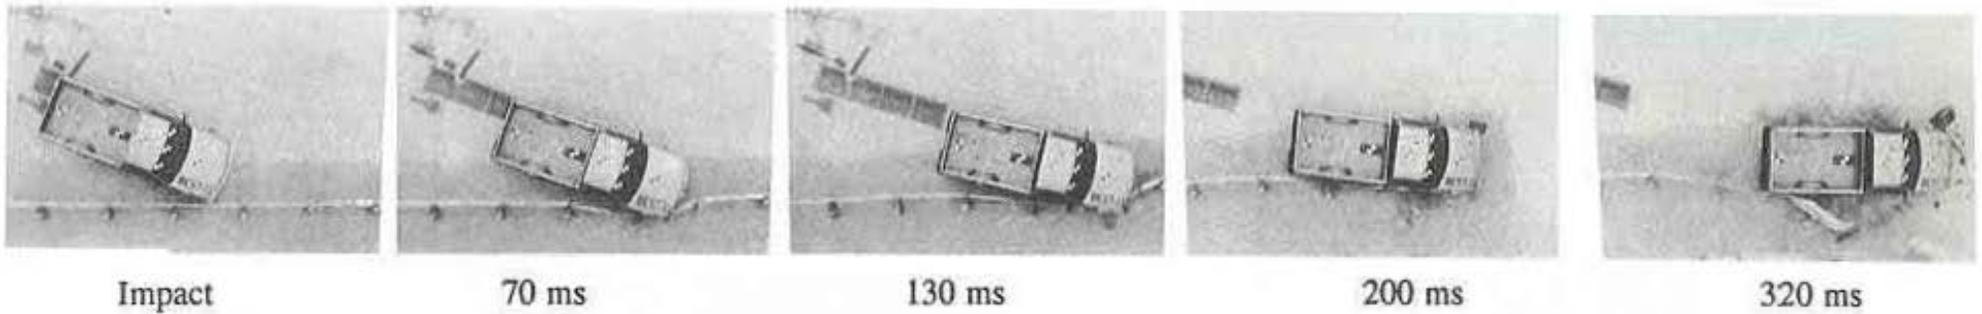
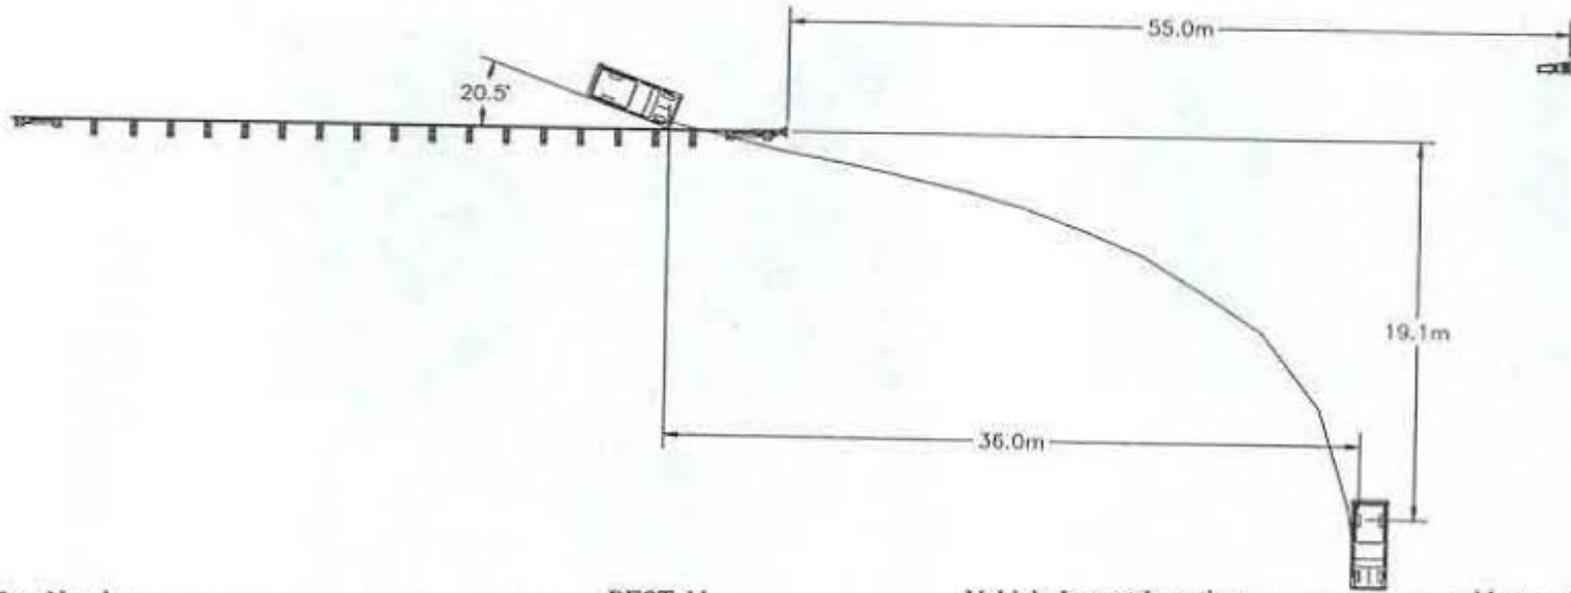
Figure 50. Summary of Test BEST-11.

Test Number BEST-11
 Date 10/17/96
 Installation BEST System
 Length of Installation 46 m
 Vehicle Model 1990 GMC ¾ ton pickup
 Vehicle Weight
 Curb 1780 kg
 Test Inertial 2000 kg
 Gross Static 2000 kg
 Vehicle Impact Speed 101.6 km/h
 Vehicle Impact Angle 20.5 deg

Vehicle Impact Location midspan of posts 3 and 4
 Normalized Occupant Impact Velocity
 Longitudinal 7.2 m/s
 Lateral 4.1 m/s
 Occupant Ridedown Accelerations
 Longitudinal 10.5 Gs
 Lateral 4.1 Gs
 Vehicle Damage Classification
 TAD 01RFES2
 VDI I-RFQ-4

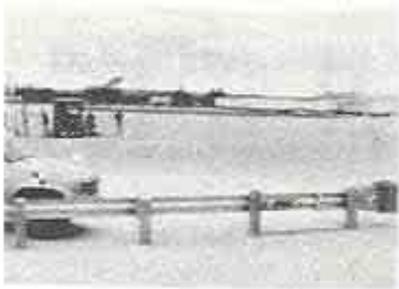
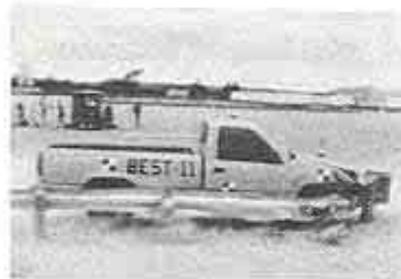
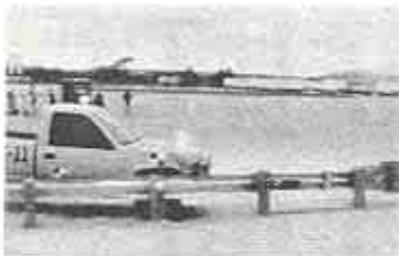
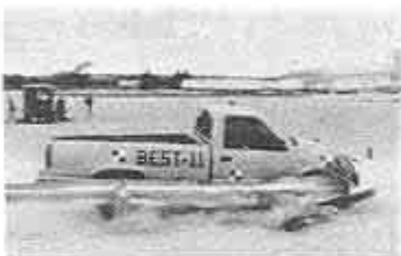
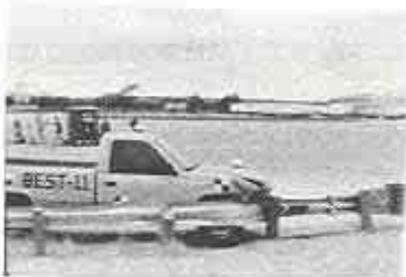
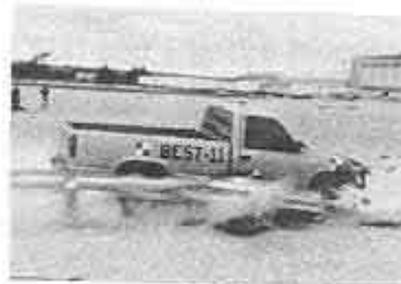
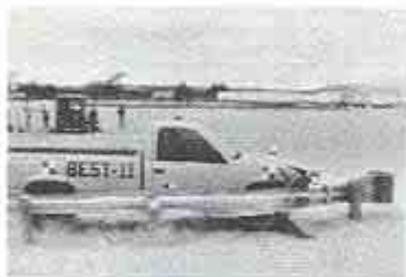
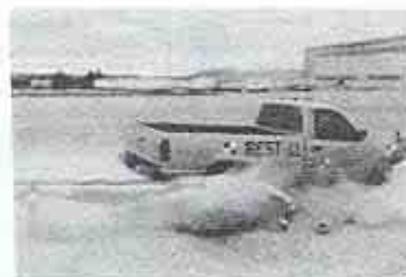
Figure 51. Sequential Photographs, Test BEST-11.

Upon impact with the W-beam the right-front corner of the vehicle began to crush inward. The vehicle reached post no. 3 at 30 ms after impact and by 94 ms it reached post no. 2. The pickup reached the beginning of the cable anchor box at 104 ms after impact, causing it to become detached at 126 ms. At 136 ms after impact the vehicle impacted the end of the chute, followed at 168 ms by the vehicle impacting post no. 1. The impact head was pushed free of the system and came to rest 55 m (180 ft) downstream of its initial location on a line parallel to the guardrail. The vehicle came to rest 19 m (62 ft - 9 in.) downstream and 19 m (62 ft - 9 in.) behind the system from a line parallel to the W-beam guardrail, as shown in Figures 50 and 52.
