EVALUATION OF A NON-PROPRIETARY, HIGH-TENSION, FOUR-CABLE MEDIAN BARRIER ON LEVEL TERRAIN

MIDWEST ROADSIDE SAFETY FACILITY

MwRSF Research Report No. TRP-03-258-12

November 29, 2012

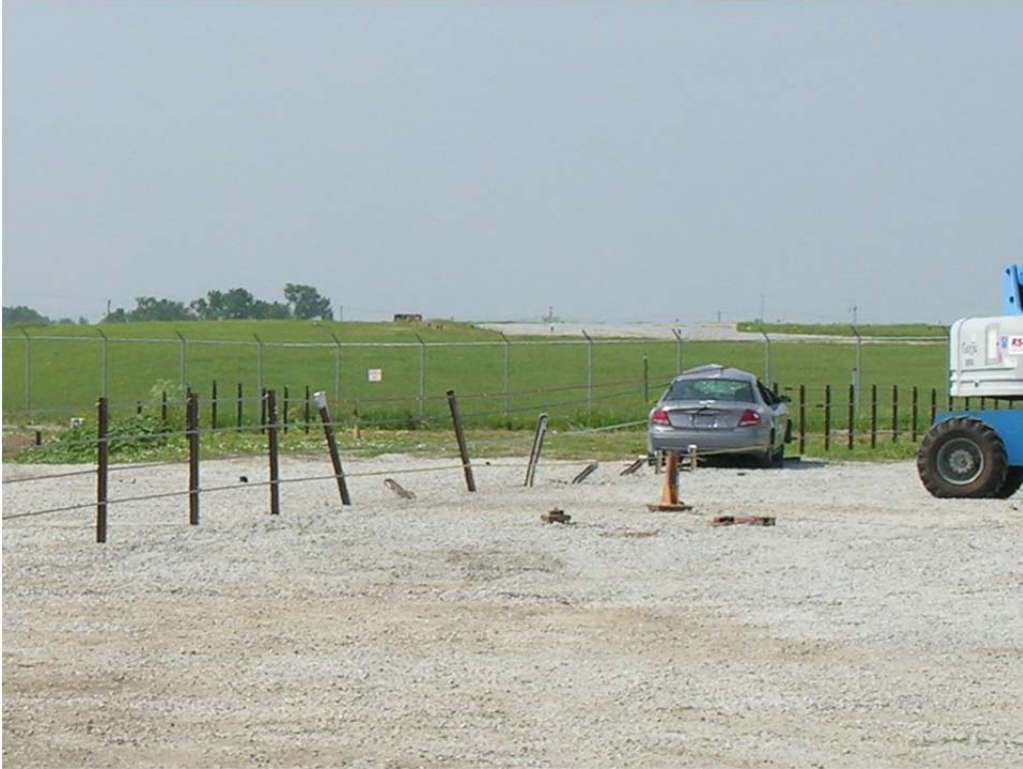
Figure 34. Impact Location, Test No. 4CMBLT-1

Initial vehicle impact was to occur 64 in. (1,626 mm) downstream from post no. 16, as shown in Figure 34, which was selected using an analysis of the vehicle trajectory to maximize the potential for vehicle penetration through the system. A sequential description of the impact events is provided by Table 6. The vehicle came to rest 123 ft (37.5 m) downstream from impact within the system. The vehicle trajectory and final position are shown in Figures 29 and 35.
