**PERFORMANCE EVALUATION OF THE  
MODIFIED G4(1S) GUARDRAIL – UPDATE TO  
NCHRP 350 TEST NO. 3-11 WITH 28" C.G.  
HEIGHT (2214WB-2)**

**MIDWEST ROADSIDE SAFETY FACILITY**

MwRSF Research Report No. TRP-03-169-06

October 9, 2006

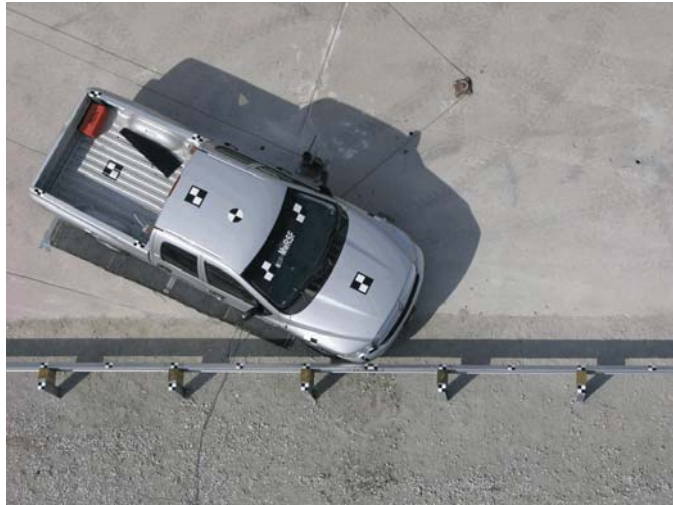
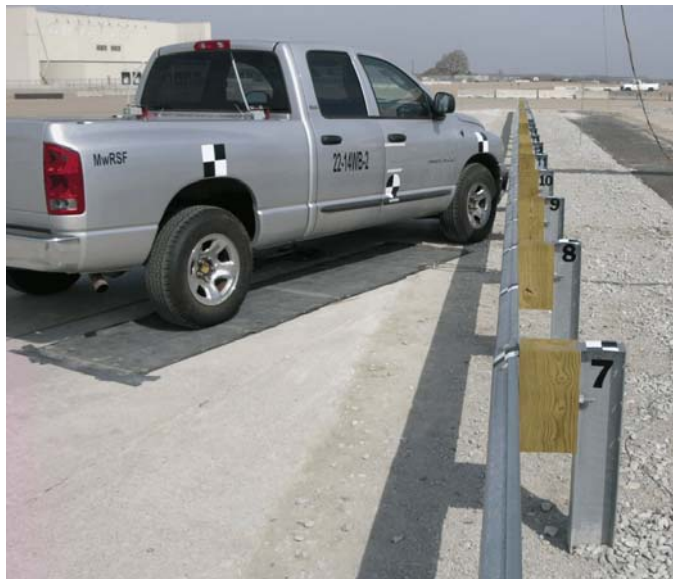
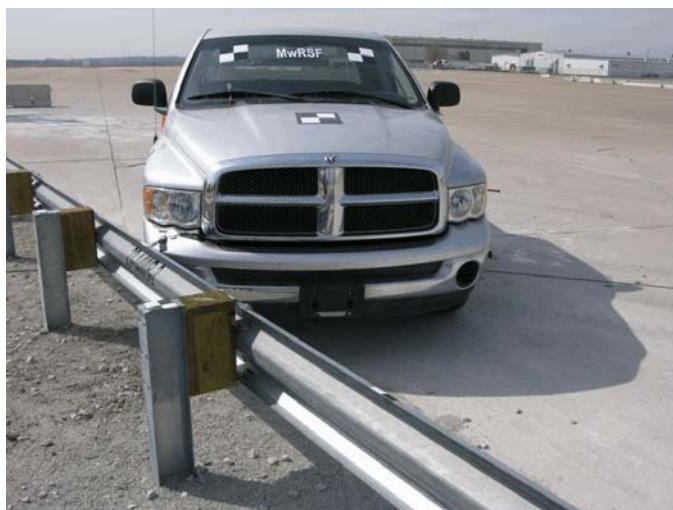
Figure 21. Impact Location, Test 2214WB-2

Initial vehicle impact was to occur between post nos. 10 and 11, or 1,041 mm (41 in.) upstream from the centerline of post no. 11, as shown in Figure 21. Actual vehicle impact occurred 940 mm (37 in.) upstream from the centerline of post no. 11. At 0.004 sec after impact, post no. 11 deflected. At 0.020 sec, post nos. 10 and 12 deflected. At 0.036 sec, the right-front corner of the vehicle was located at post no. 11. At 0.056 sec, the rail released from post no. 11, and the right-front headlight disengaged from the vehicle. At 0.080 sec, the vehicle began to redirect. At 0.092 sec, post nos. 6 through 12 exhibited twisting movement downstream. At 0.136 sec, the right-front corner of the vehicle was located at post no. 12. At 0.144 sec, the lower portion of the rail encountered a tear downstream of post no. 12. At 0.152 sec, the blockout disengaged from post no. 12. At 0.190 sec, the vehicle rolled CW toward the system. At 0.204 sec, post no. 15 deflected as the right-front corner of the vehicle was located at post no. 13. At this same time, the blockout disengaged from post no. 13. At 0.278 sec, the rear of the vehicle protruded over the deformed rail. At 0.292 sec, the right-front corner of the vehicle was located at post no. 14. At 0.300 sec, post no.

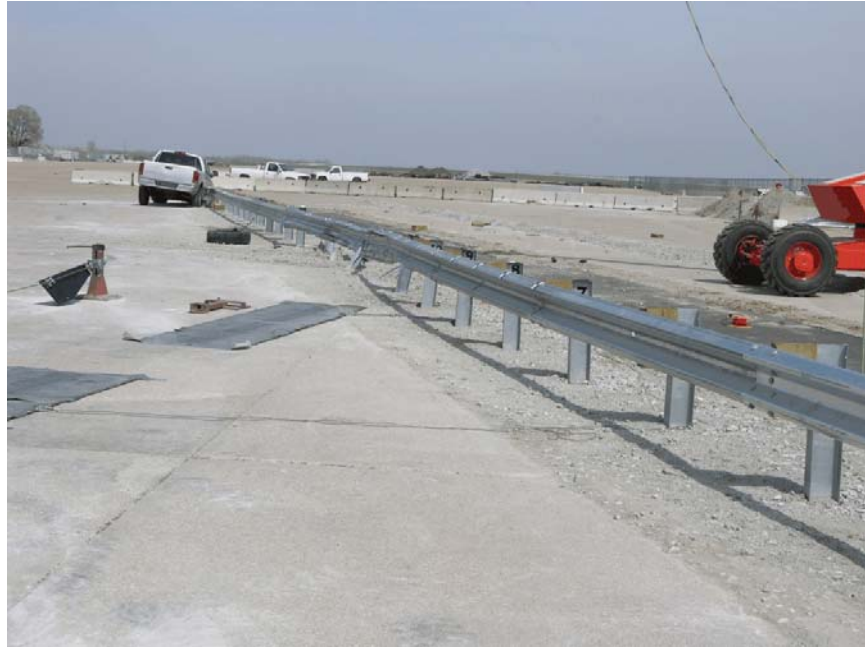
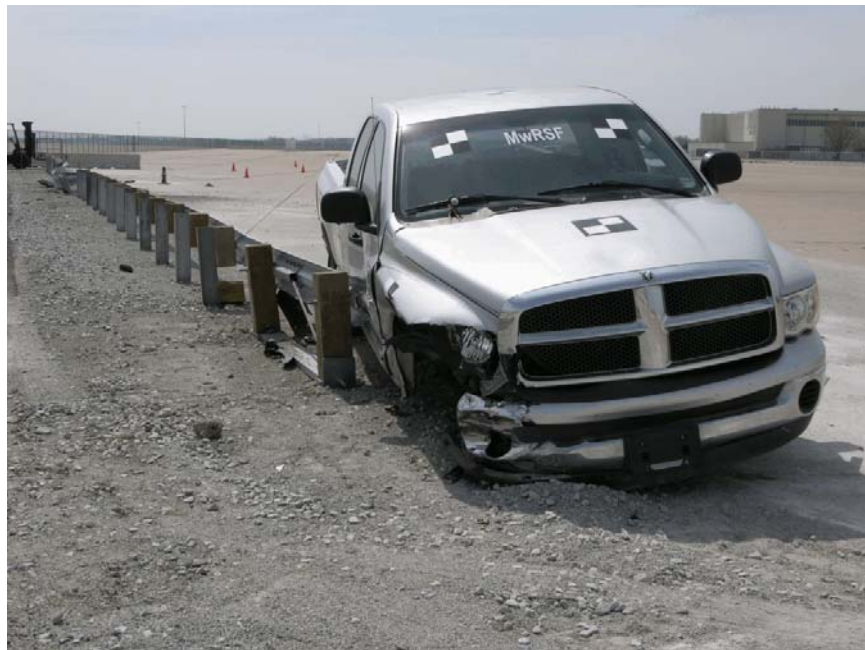
Figure 22. Vehicle Final Position and Trajectory Marks, Test 2214WB-2

16 deflected. At 0.316, the vehicle became parallel to the barrier with a resultant velocity of 63.9 km/h (39.7 mph). At 0.336 sec, the blockout disengaged from post no. 14. At this same time, the CW roll of the vehicle increased. At 0.356 sec, the blockout at post no. 15 fractured and part of it disengaged from the post. At 0.382 sec, the right-front corner of the vehicle was located at post no. 15. At 0.426 sec, the left-rear tire was airborne. At 0.580 sec, the rear of the vehicle pitched downward. At 0.760 sec, the vehicle began to roll CCW away from the system. At 0.790 sec, the rear end of the vehicle yawed away from the system as the front of the vehicle pitched downward. At 0.888 sec, the vehicle exited the system at an angle of 20.7 degrees and a velocity of 50.2 km/h (31.2 mph). At 0.940 sec, the rear of the vehicle descended toward the ground. At 1.350 sec, the vehicle continued to roll CCW away from the system. At 1.490 sec, the vehicle redirected toward the system. At 1.690 sec, the vehicle rolled CW toward the system. At 1.880 sec, the front of the vehicle pitched downward. The vehicle came to rest 36.84 m (120 ft - 10.5 in.) downstream from impact and against the traffic-side face of the guardrail system. The trajectory and final position of the pickup truck are shown in Figures 15 and 22.

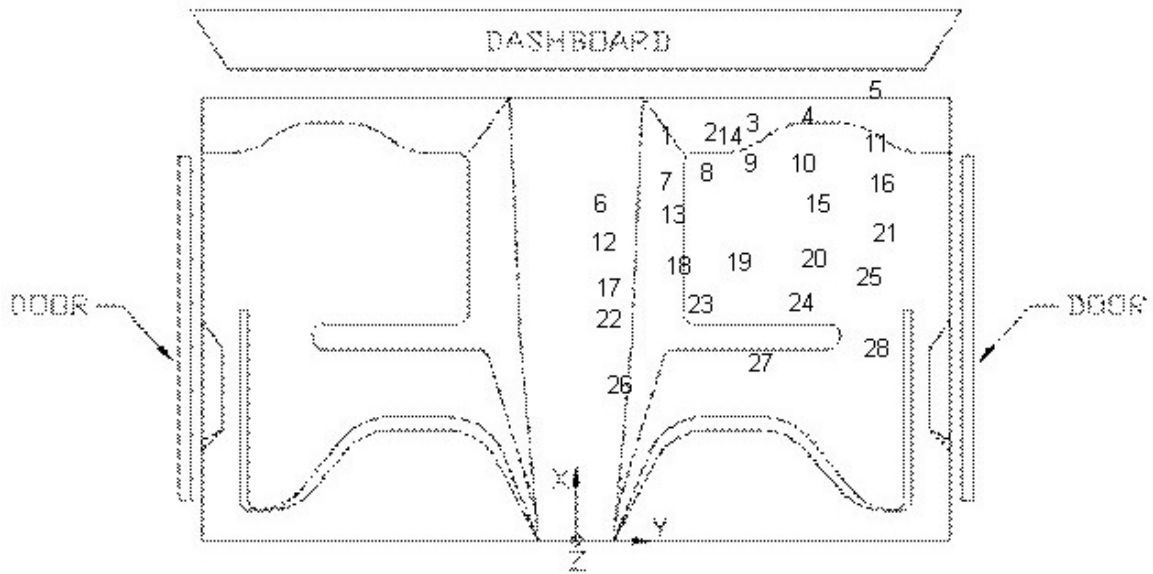
Figure C-1. Occupant Compartment Deformation Data - Set 1, Test 2214WB-2

Exterior vehicle damage was moderate, as shown in Figures 28 and 29. Occupant compartment deformations to the right side and center of the floorboard were judged insufficient to cause serious injury to the vehicle occupants. Maximum longitudinal deflections of 13 mm (0.5 in.) were located near the left side of the right side of the floorboard. Maximum lateral deflections of 13 mm (0.5 in.) were located near the right-front corner of the right-side floor pan and the center of the right side of the floorboard. Maximum vertical deflections of 6 mm (0.25 in.) were located throughout the right side of the floorboard. Complete occupant compartment deformations and the corresponding locations are provided in Appendix C.

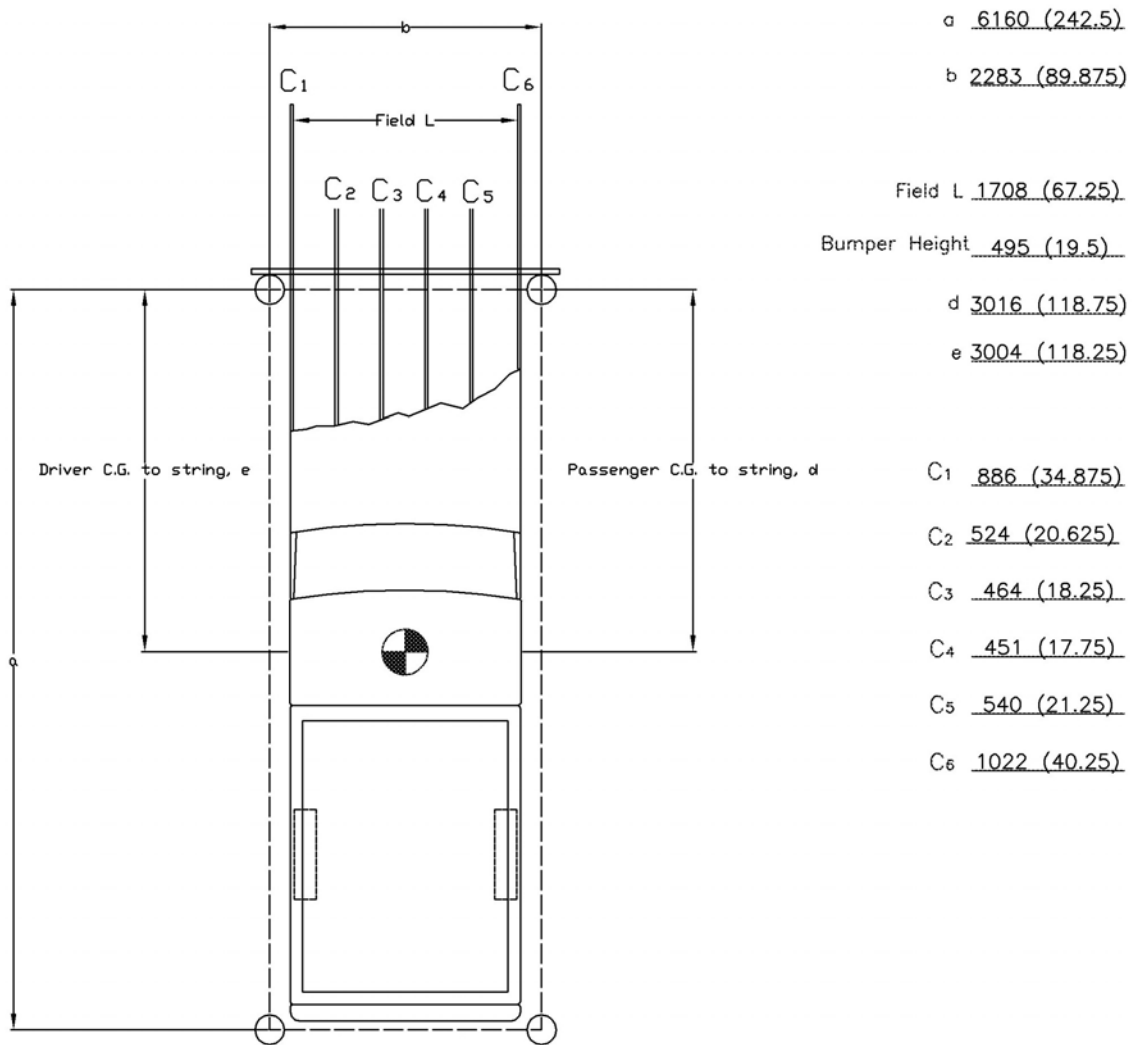
Figure C-4. NASS Crush Data, Test 2214WB-2

Damage was concentrated on the right-front corner of the vehicle. The right-front quarter panel was deformed inward and upward toward the engine compartment. The right side of the front bumper was bent back toward the engine compartment. The both right-side doors encountered deformations and flattening of sheet metal. Contact marks from vehicle-rail interlock were observed along the entire right side of the vehicle. The right-rear quarter panel was deformed inward and away from the bumper. The right side of the rear bumper was dented. The top of the right-front door was ajar. The right side of the grill was fractured. The right-side tail light cover was deformed away from the vehicle. The exhaust pipe was dented and deformed. The right-front wheel assembly deformed and crushed inward toward the engine compartment. The right-side sway bar and lower control arm connection along with the right-front tire disengaged from the rest of the wheel assembly. The right-
