PERFORMANCE EVALUATION OF THE MODIFIED G4(1S) GUARDRAIL – UPDATE TO NCHRP 350 TEST NO. 3-11 (2214WB-1)

MwRSF Research Report No. TRP-03-168-06

October 6, 2006

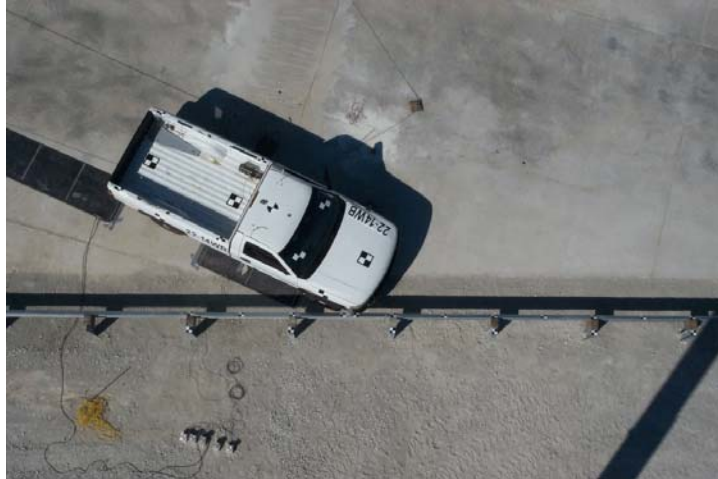
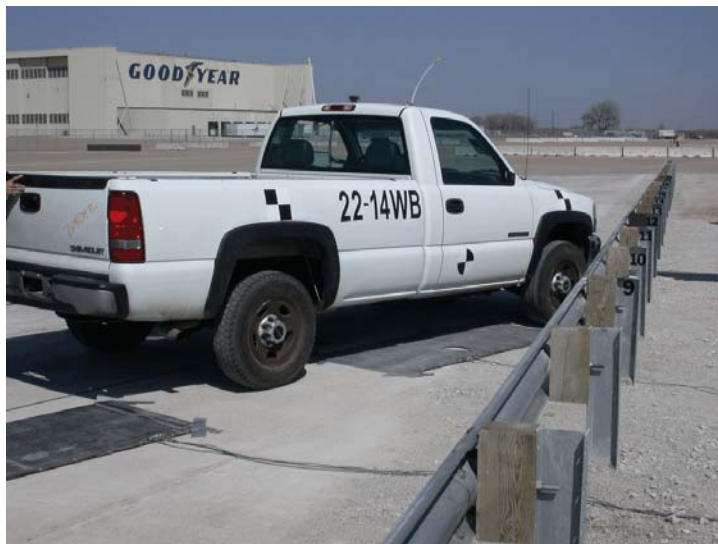
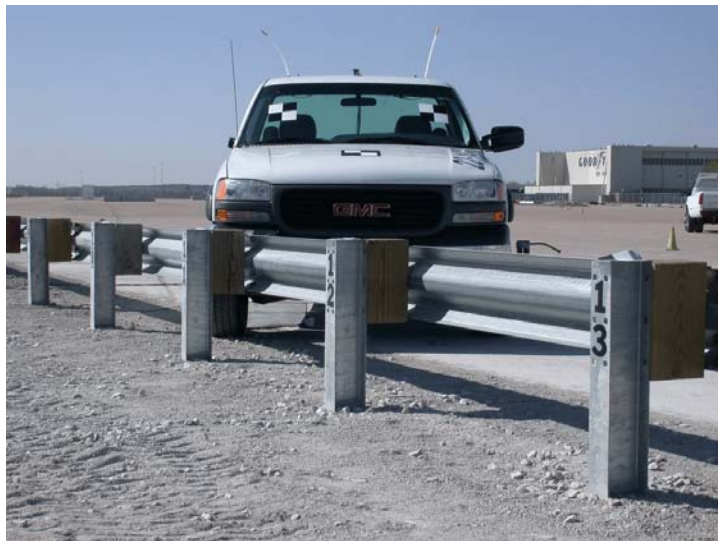
Figure 21. Impact Location, Test 2214WB-1

Initial vehicle impact was to occur between post nos. 10 and 11, or 4.50 m (14 ft - 9 in.) upstream from the center of post no. 13, as shown in Figure 21. Actual vehicle impact occurred 4.57 m (15 ft) upstream from the center of post no. 13. At 0.014 sec after impact, post no. 11 began to deflect backwards. At 0.030 sec, the rail deflected laterally backward with the right-front corner of the vehicle located at post no. 11. At this same time, a separation gap was apparent between the right side of the hood and the right-front quarter panel that was deforming. At 0.060 sec, the right-front corner of the vehicle deformed inward toward the engine compartment and was located at the midspan between post nos. 11 and 12. At this same time, post nos. 9 through 11 twisted clockwise (CW) and the rail flattened between post nos. 11 and 12. At 0.090 sec, the right-front side of the vehicle up to the door was in contact with the system. At this same time, post no. 12 twisted counter-clockwise (CCW) and deflected backward with the right-front tire under the rail. At 0.098 sec, the right-front tire disengaged from the wheel assembly. At 0.102 sec, the rail disengaged from post no. 12. At 0.116 sec, post no. 12 was located under the vehicle and bent downstream to the ground. At

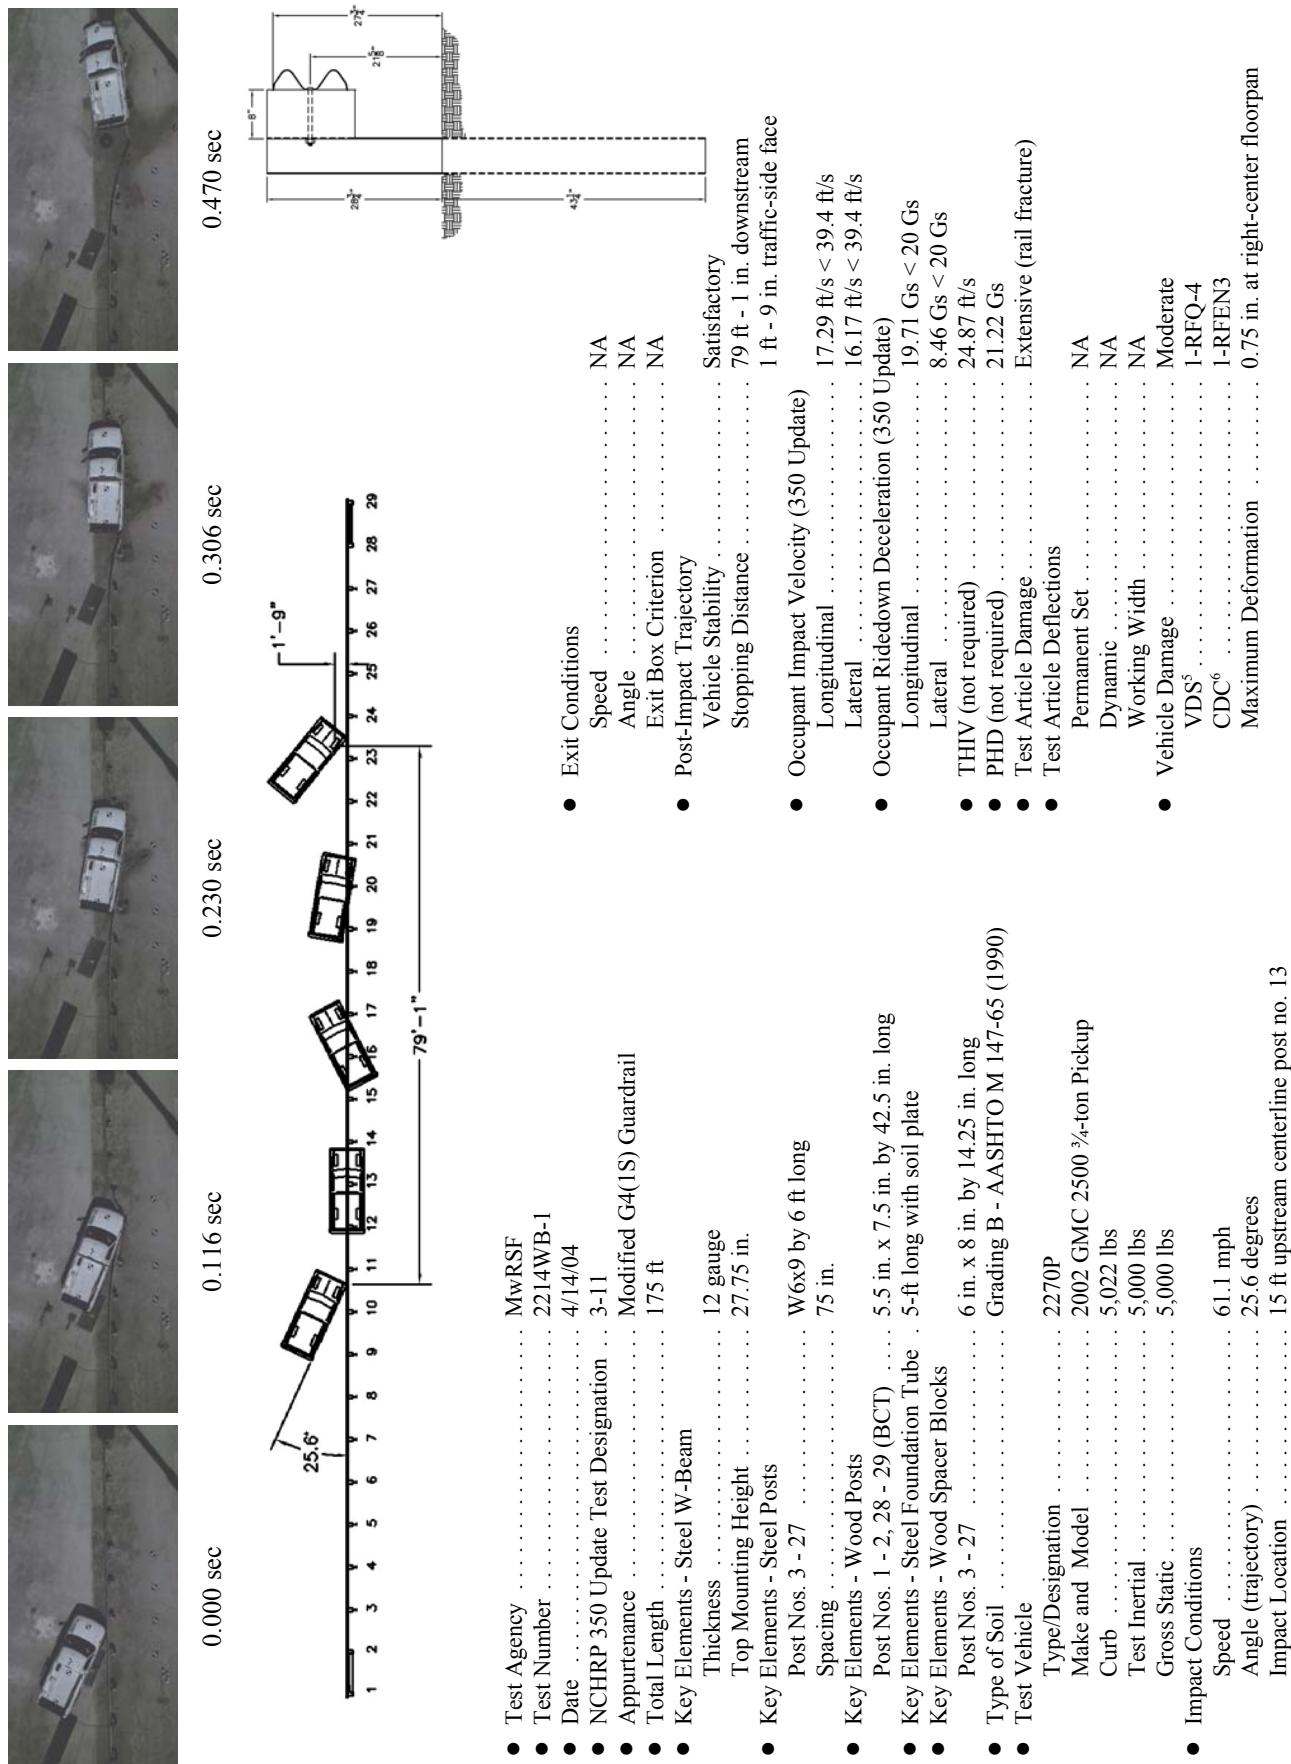
Figure B-1. Summary of Test Results and Sequential Photographs (English), Test 2214WB-1

The analysis of the test results for test no. 2214WB-1 showed that the standard height, strong post, wood blockout W-beam guardrail system impacted with the 2270P vehicle of the Update to NCHRP Report No. 350 did not adequately contain the vehicle on the traffic-side face of the barrier system, but redirected the vehicle. Furthermore, it did not behave as would be expected, since the W-beam guardrail fractured and the vehicle contacted the ground behind the system. There were no detached elements nor fragments which showed potential for penetrating the occupant compartment nor presented undue hazard to other traffic. Deformations of, or intrusion into, the occupant compartment that could have caused serious injury did not occur. The test vehicle did not penetrate nor ride over the barrier system and remained upright during and after the collision. Vehicle roll, pitch, and yaw angular displacements were noted, but they were deemed acceptable because they did not adversely influence occupant risk safety criteria nor cause rollover. After collision, the vehicle's trajectory revealed minimum intrusion into adjacent traffic lanes. In addition, the vehicle exited the barrier within the exit box. Therefore, test no. 2214WB-1 conducted on the standard height, strong post, wood blockout W-beam guardrail system was determined to be unacceptable

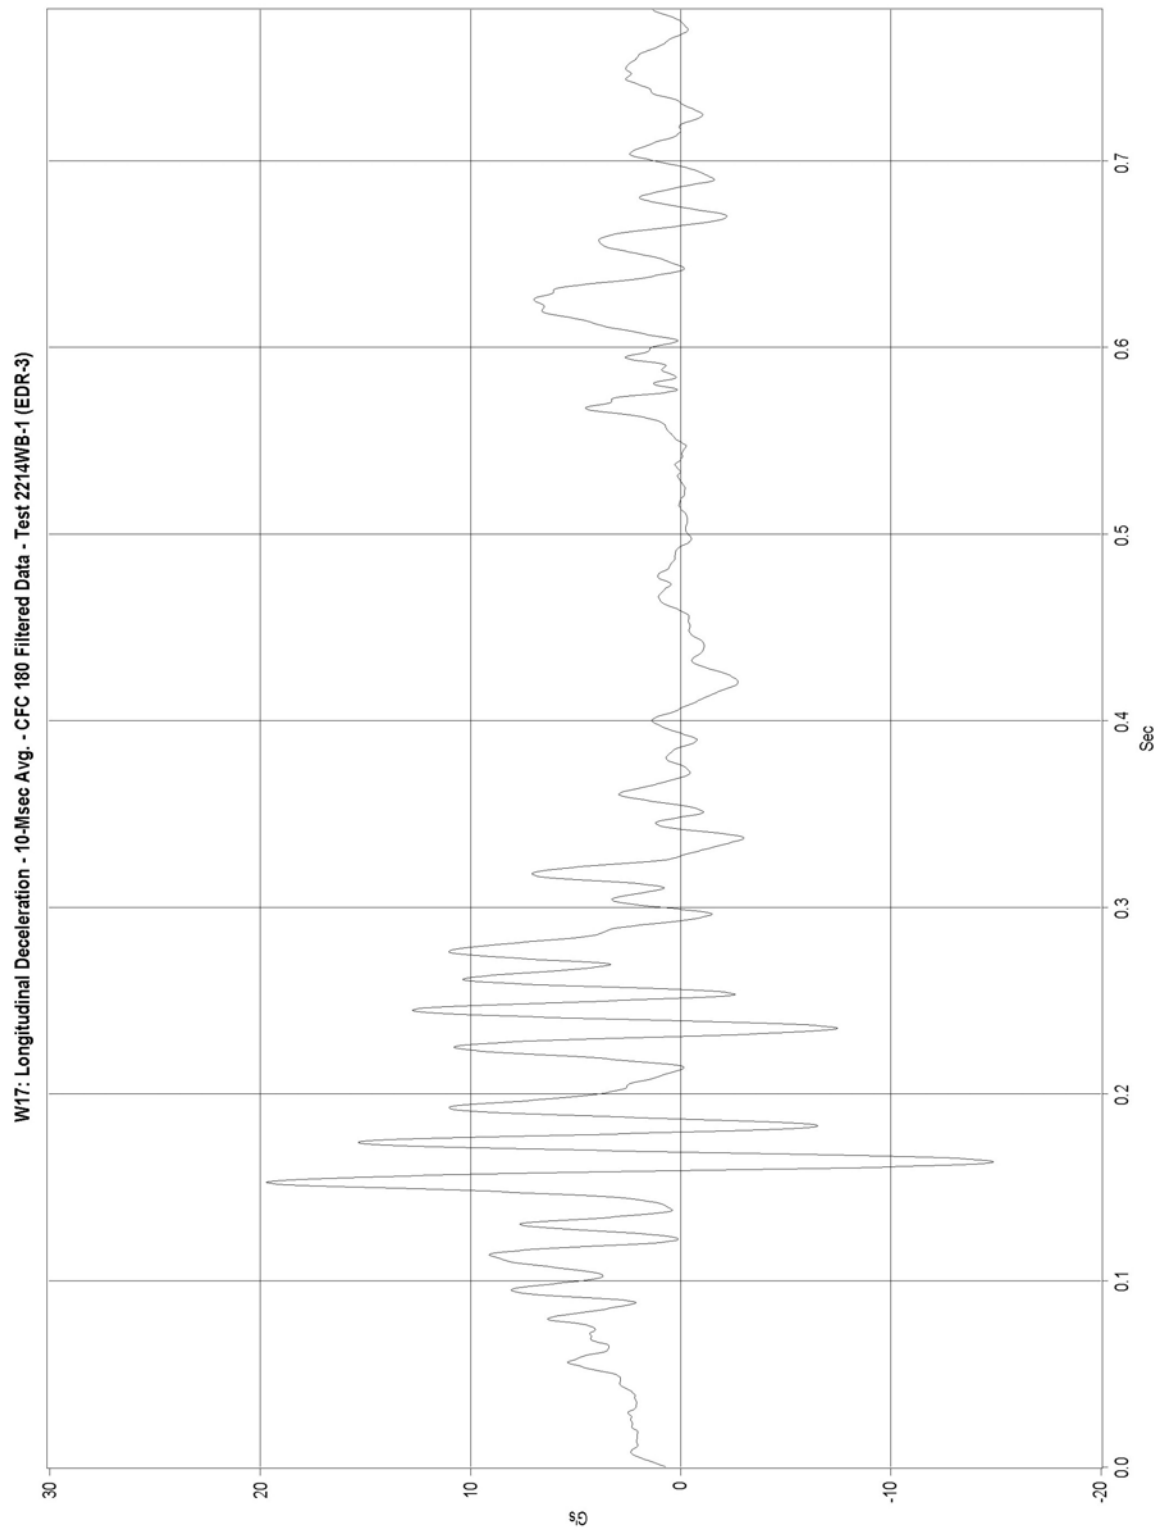
Figure D-1. Graph of Longitudinal Deceleration, Test 2214WB-1

riededown decelerations in the longitudinal and lateral directions were 19.71 Gs and 8.46 Gs, respectively. It is noted that the occupant impact velocities (OIVs) and occupant ridedown decelerations (ORDs) were within the suggested limits provided in the Update to NCHRP Report No. 350. The THIV and PHD values were determined to be 7.58 m/s (24.87 ft/s) and 21.22 Gs, respectively. The results of the occupant risk, as determined from the accelerometer data, are summarized in Figure 15. Results are shown graphically in Appendix D. The results from the rate transducer are shown graphically in Appendix D.
