**PERFORMANCE EVALUATION OF THE  
PERMANENT NEW JERSEY SAFETY SHAPE  
BARRIER – UPDATE TO NCHRP 350  
TEST NO. 4-12 (2214NJ-2)**

MwRSF Research Report No. TRP-03-178-06

October 13, 2006

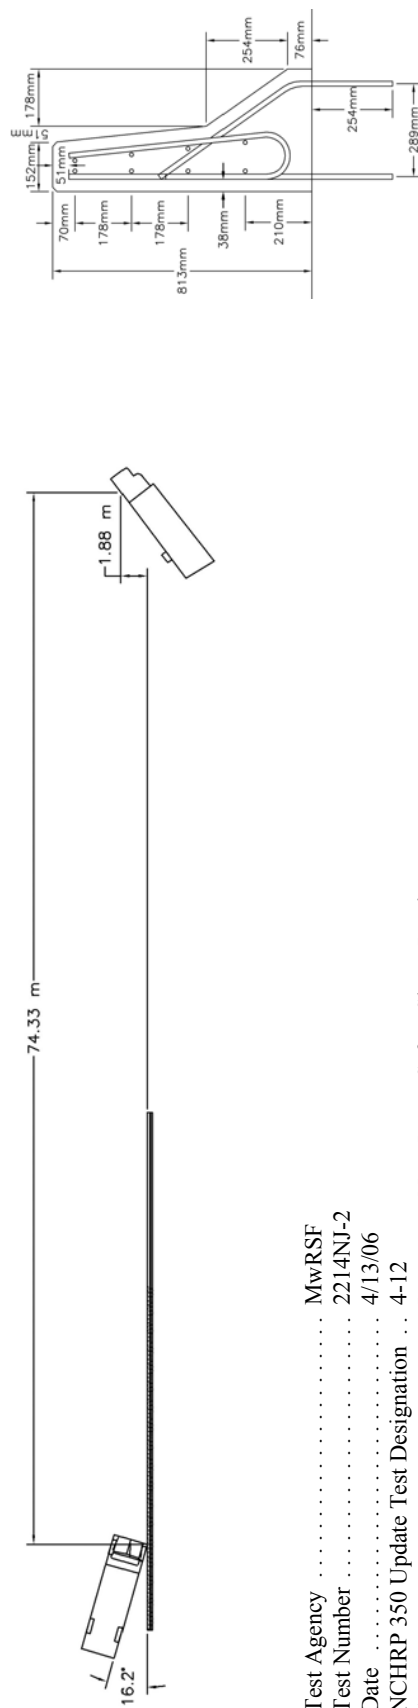
The analysis of the test results for test no. 2214NJ-2 showed that the permanent New Jersey safety shape concrete barrier system impacted with the 10000S vehicle of the Update to NCHRP Report No. 350 did not adequately contain the vehicle on the traffic-side face of the barrier system. It also did not safely redirect the vehicle since the vehicle did not remain upright after collision with the barrier. There were no detached elements nor fragments which showed potential for penetrating the occupant compartment nor presented undue hazard to other traffic. Deformations of, or intrusion into, the occupant compartment that could have caused serious injury did not occur. After collision, the vehicle did not exit the barrier as it rolled over the top of the barrier. Therefore, test no. 2214NJ-2 conducted on the permanent New Jersey safety shape concrete barrier system was determined to be unacceptable according to the TL-4 safety performance criteria found in Update to NCHRP Report No. 350 due to vehicle penetration and rollover the top of the barrier.

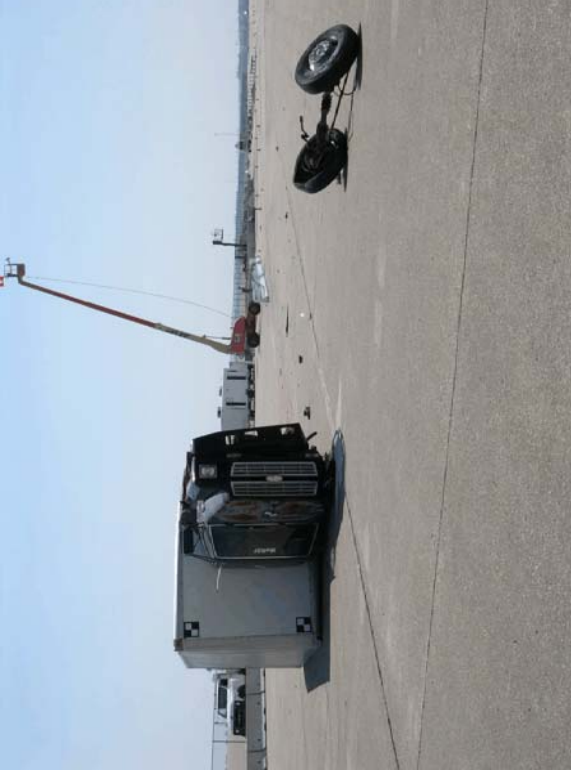
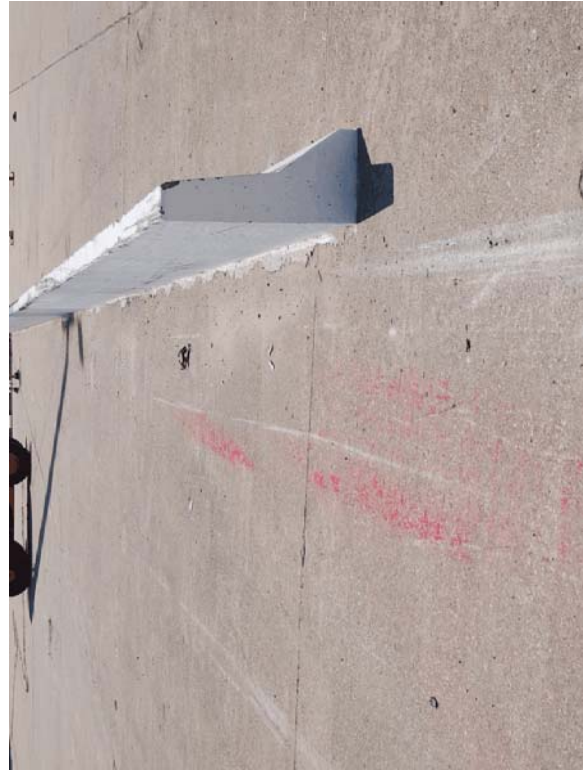
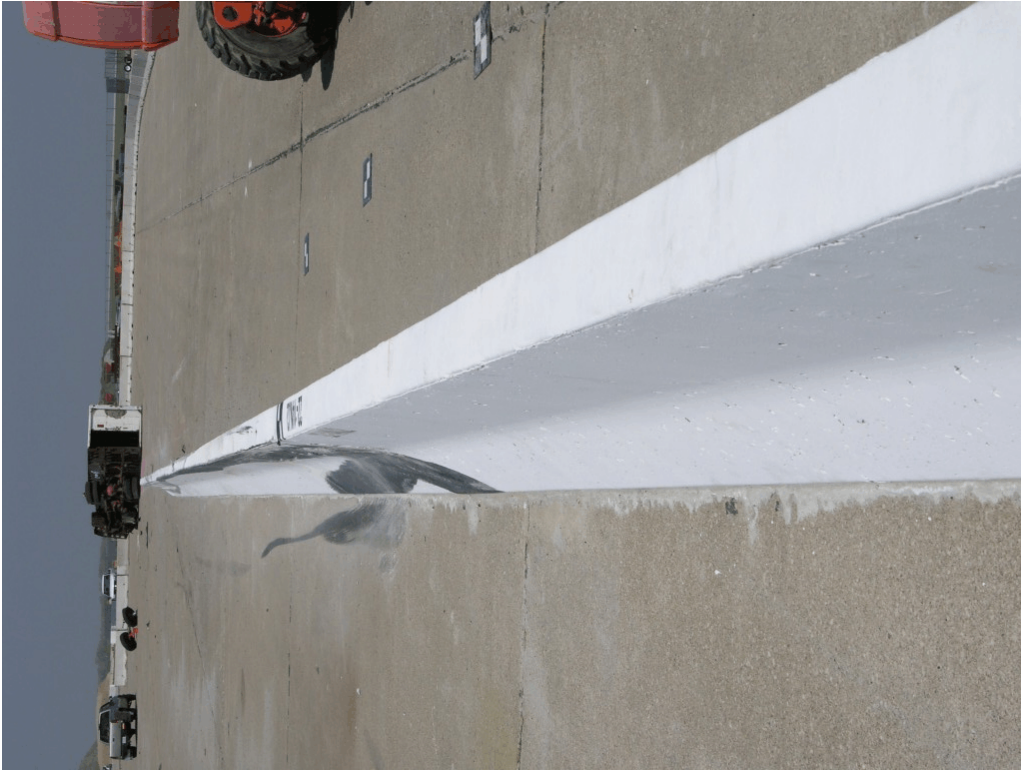
Figure 19. Vehicle Final Position and Trajectory Marks, Test 2214NJ-2

Initial vehicle impact was to occur 6.10 m (20 ft) downstream from the upstream end of the barrier, as shown in Figure 18. Actual vehicle impact occurred at the targeted impact. At 0.064 sec after impact, the vehicle began to redirect. At 0.084 sec, the right-front corner of the vehicle protruded over the top of the barrier. At 0.120 sec, the cab portion of the vehicle encountered counter-clockwise (CCW) roll away from the barrier. At this same time, the right side of the cab rode on top of the barrier and the box contacted the barrier. At 0.140 sec, the cab and box twisted while the box rolled clockwise (CW) toward the barrier. At 0.220 sec, the rear of the box redirected into the barrier as the cab continued to slide along the top of the barrier. At 0.264 sec, the CW roll of the box increased significantly. At 0.310 sec, the roll of the cab ceased. At 0.410 sec, the left-rear tire was airborne. At 0.470 sec, the entire truck rolled CW over the top of the barrier. At 0.526 sec, the left-front tire became airborne. At 0.758 sec, the front axle disengaged from the truck. At 0.850 sec, all tires were airborne. At 1.202 sec, the vehicle had rolled CW to a position of the right side being parallel to the ground. At 1.342 sec, the right side of the vehicle contacted the ground behind
