# **PERFORMANCE EVALUATION OF THE SKT-MGS TANGENT END TERMINAL – UPDATE TO NCHRP 350 TEST NO. 3-34 (2214TT-1)**

MwRSF Research Report No. TRP-03-176-06

October 12, 2006

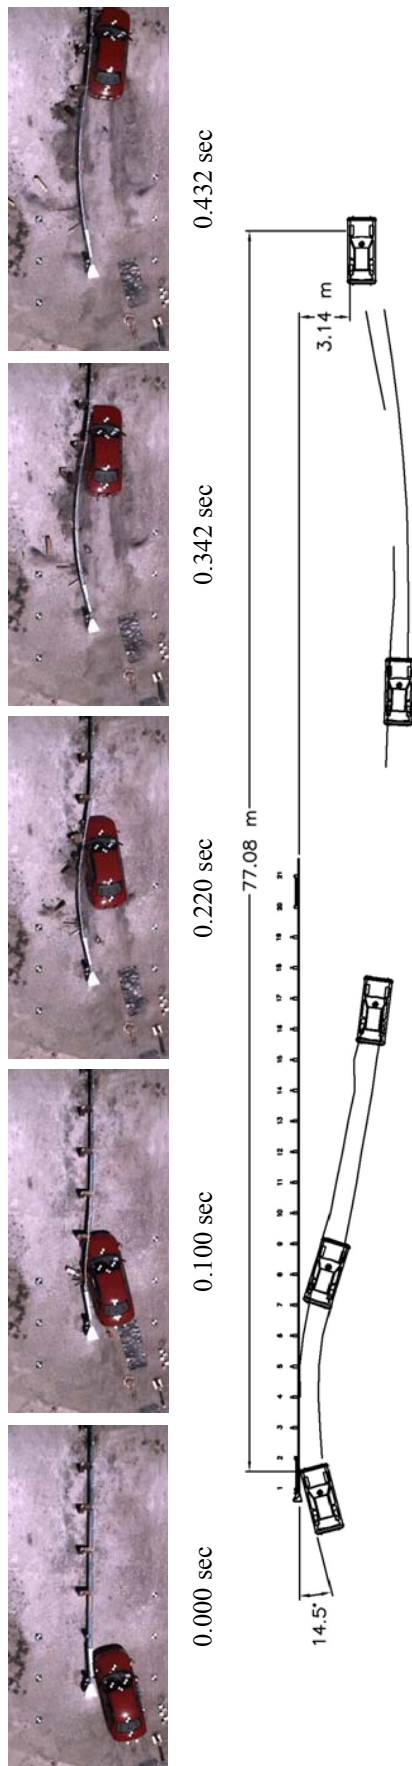
Figure 24. Summary of Test Results and Sequential Photographs, Test 2214TT-1

• Test Agency	MwRSF	• Exit Conditions	
• Test Number	2214TT-1	Speed	69.4 km/h
• Date	7/1/05	Angle	8.8 degrees
• NCHRP 350 Update Test Designation	3-34	Exit Box Criterion	Pass

• Apparatus	SKT-MGS Tangent End Terminal	Post-Impact Trajectory	Satisfactory
• Total Length	39.82 m	Vehicle Stability	77.08 m downstream
• Key Element	SKT impact head	Stopping Distance	3.14 m traffic-side face

• Test Vehicle		• Test Article Damage	Moderate
Type/Designation	1170C	• Test Article Deflections	
Make and Model	2002 Kia Rio	Permanent Set	584 mm
Curb	1,055 kg	Dynamic	703 mm
Test Inertial	1,102 kg	Working Width	1,233 mm
Gross Static	1,178 kg	Vehicle Damage	Moderate

• Impact Conditions		VDS <sup>4</sup>	11-LFQ-6
Speed	103.6 km/h	CDC <sup>5</sup>	11-LYEW4
Angle	14.5 degrees	Maximum Deformation	152 mm at left-front floorpan
Target Impact Location	734 mm downstream centerline post no. 1		
Actual Impact Location	1,013 mm downstream centerline post no. 1

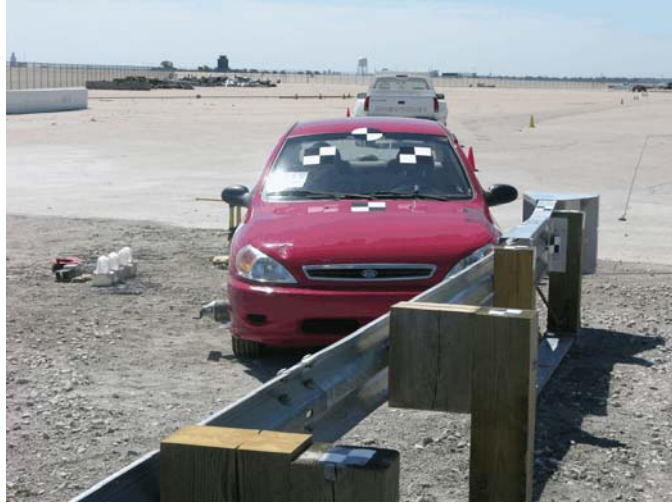
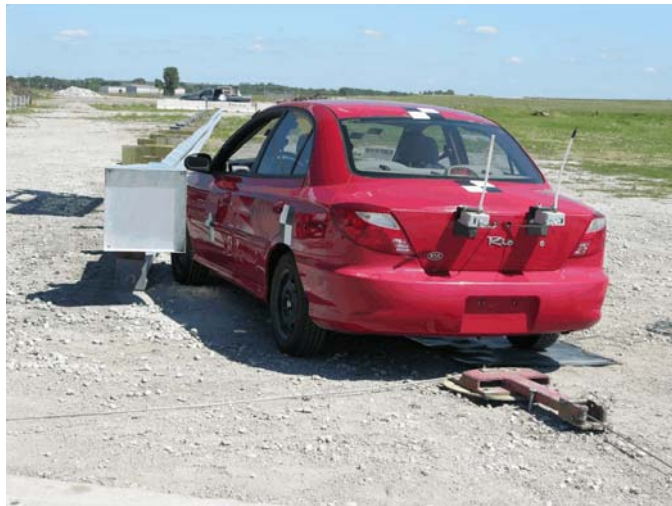
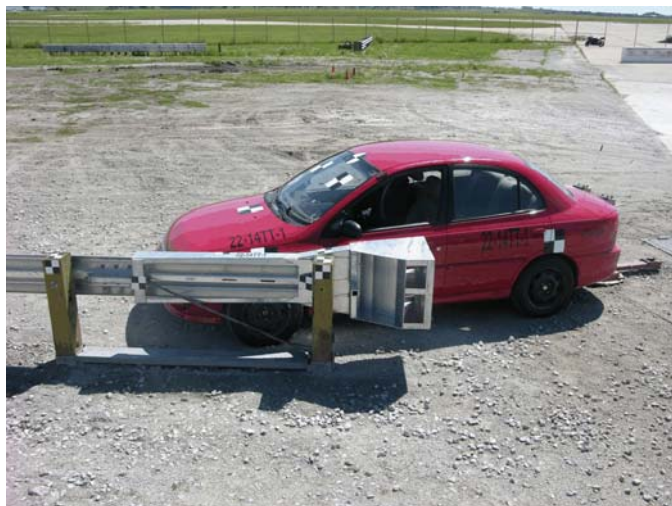
Figure 30. Impact Location, Test 2214TT-1

Initial vehicle impact was to occur between post nos. 1 and 2, or 734 mm (28.9 in.) downstream from the centerline of post no. 1, as shown in Figure 30. Actual vehicle impact occurred 1,013 mm (39.9 in.) downstream from the centerline of post no. 1. At 0.008 sec after impact, the left-front corner of the vehicle crushed inward toward the engine compartment. At 0.032 sec, the left-front corner of the vehicle was located at post no. 2 as the rail began to deflect. At 0.052 sec, the left-front tire contacted post no. 2. At 0.070 sec, post no. 2 fractured, and the left-front corner of the vehicle was located at the midspan between post nos. 2 and 3. At this same time, post no. 3 deflected backward, and the rail appeared to be on top of the hood. At 0.100 sec, the left-front corner of the vehicle was located at post no. 3 which continued to deflect backwards. At 0.120 sec, post no. 3 fractured. At 0.138 sec, the left-front tire contacted post no. 4. At the same time, the bottom of the left-side mirror was riding along the top of the rail while the left-front corner of the hood protruded under the rail. At 0.174 sec, the vehicle's left-front tire protruded under the rail. At 0.190 sec, post no. 4 fractured while the vehicle redirected. At 0.202 sec, the left-front tire disengaged from the vehicle. At 0.224 sec, the top of the left-side door was ajar. At 0.258 sec, the left-front corner of the

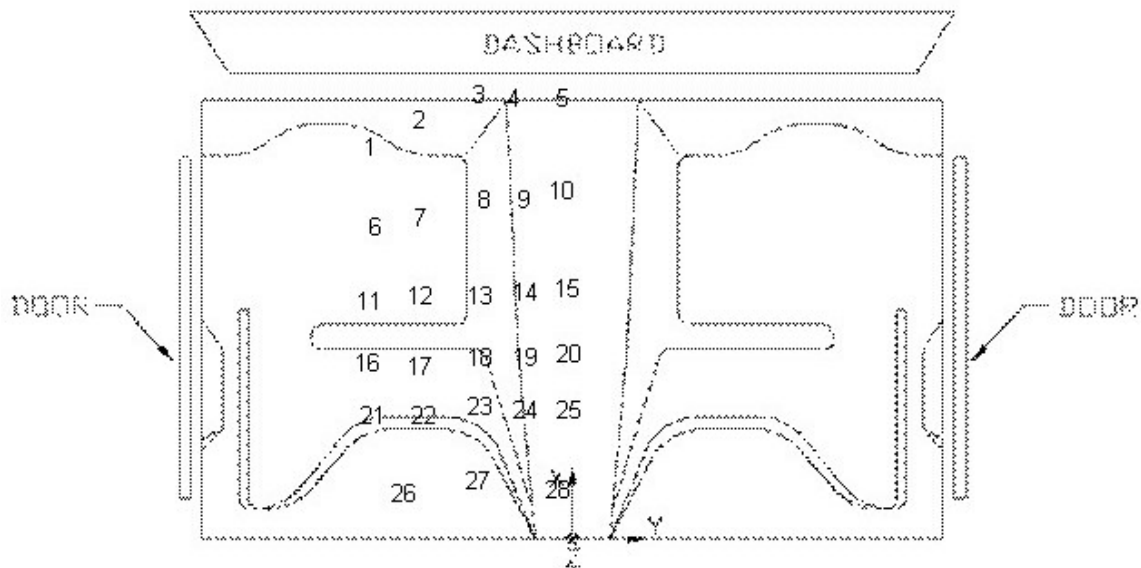
Figure C-1. Occupant Compartment Deformation Data - Set 1, Test 2214TT-1

Exterior vehicle damage was moderate, as shown in Figures 36 through 39. Occupant compartment deformations to the left side of the floorboard were judged insufficient to cause serious injury to the vehicle occupants, as shown in Figure 39. Maximum longitudinal deflections of 89 mm (3.5 in.) were located near the left-front corner of the left-side floorboard. Maximum lateral deflections of 152 mm (6 in.) were located near the left-front corner of the left-side floorboard. Maximum vertical deflections of 57 mm (2.25 in.) were located near the left center of the left-side floorboard. Complete occupant compartment deformations and the corresponding locations are provided in Appendix C.
