**PERFORMANCE EVALUATION OF THE  
GUARDRAIL TO CONCRETE BARRIER  
TRANSITION – UPDATE TO NCHRP 350 TEST  
NO. 3-21 WITH 28" C.G. HEIGHT (2214T-1)**

MwRSF Research Report No. TRP-03-175-06

October 12, 2006

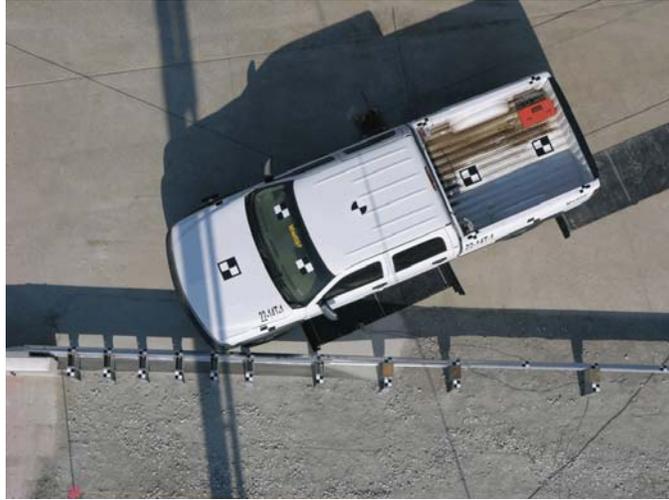
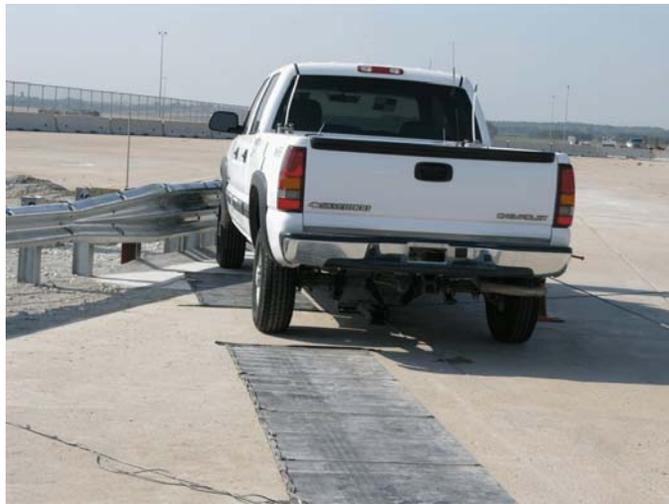
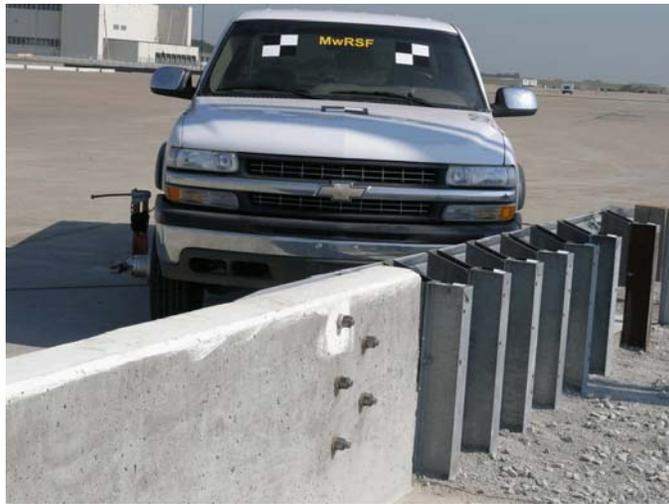
Figure 31. Impact Location, Test 2214T-1

Initial vehicle impact was to occur between post nos. 12 and 13, or 2.44 m (7 ft - 11.875 in.) upstream from the upstream end of the concrete barrier, as shown in Figure 31. Actual vehicle impact occurred at the targeted impact. At 0.008 sec after initial impact, the left-front bumper contacted the thrie beam and began to deform. At 0.016 sec, the top of the impacted thrie beam deformed while the rail between post nos. 13 and 14 developed a slight buckle point. At this same time the left-front quarter panel deformed inward toward the engine compartment. At 0.024 sec, the hood protruded over the rail near the midspan between post nos. 13 and 14. At this same time, the left-front tire mounted the curb. At 0.032 sec, post nos. 11 through 16 rotated backward as the left-front quarter panel continued to deform. At 0.046 sec, the vehicle began to redirect while the rail near post no. 12 twisted slightly. At 0.056 sec, the protruding hood was positioned over post no. 16 as the rail continued to deform from the vehicle contact. At 0.076 sec, the front of the vehicle was positioned near the upstream end of the concrete barrier. At this same time, the left-front tire was in contact with the rail. At 0.088 sec, the hood extended over the top of the concrete barrier. At this

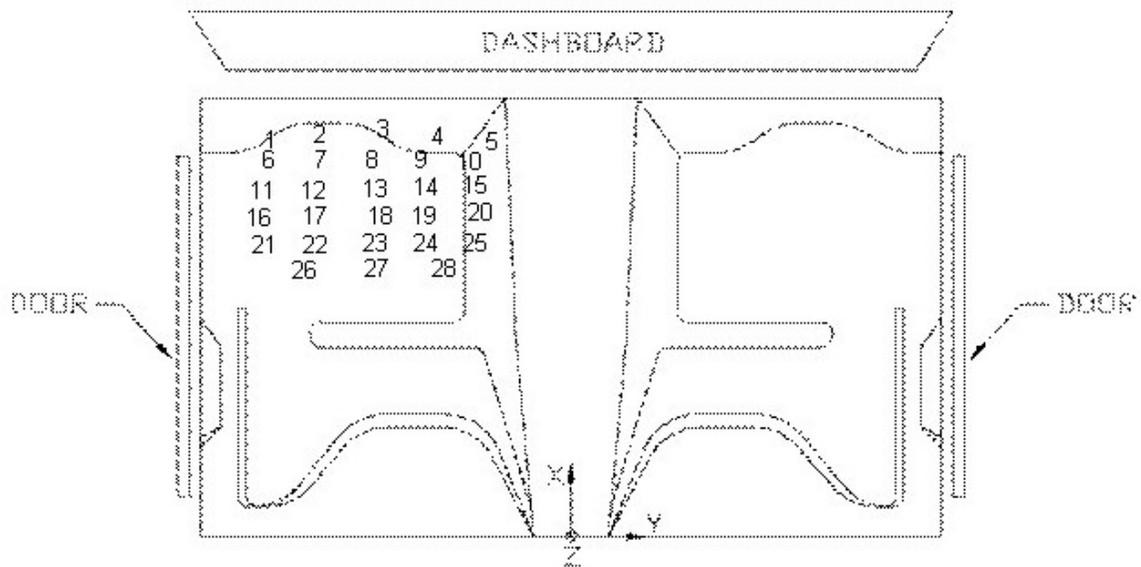
Figure C-1. Occupant Compartment Deformation Data - Set 1, Test 2214T-1

Exterior vehicle damage was moderate, as shown in Figures 36 through 40. Occupant compartment deformations to the left side and front of the floorboard were judged insufficient to cause serious injury to the vehicle occupants. Maximum longitudinal deflections of 102 mm (4 in.) were located near the left-front corner of the left side of the floorboard. Maximum lateral deflections of 44 mm (1.75 in.) were located near the right-front corner of the left-side floorboard. Maximum

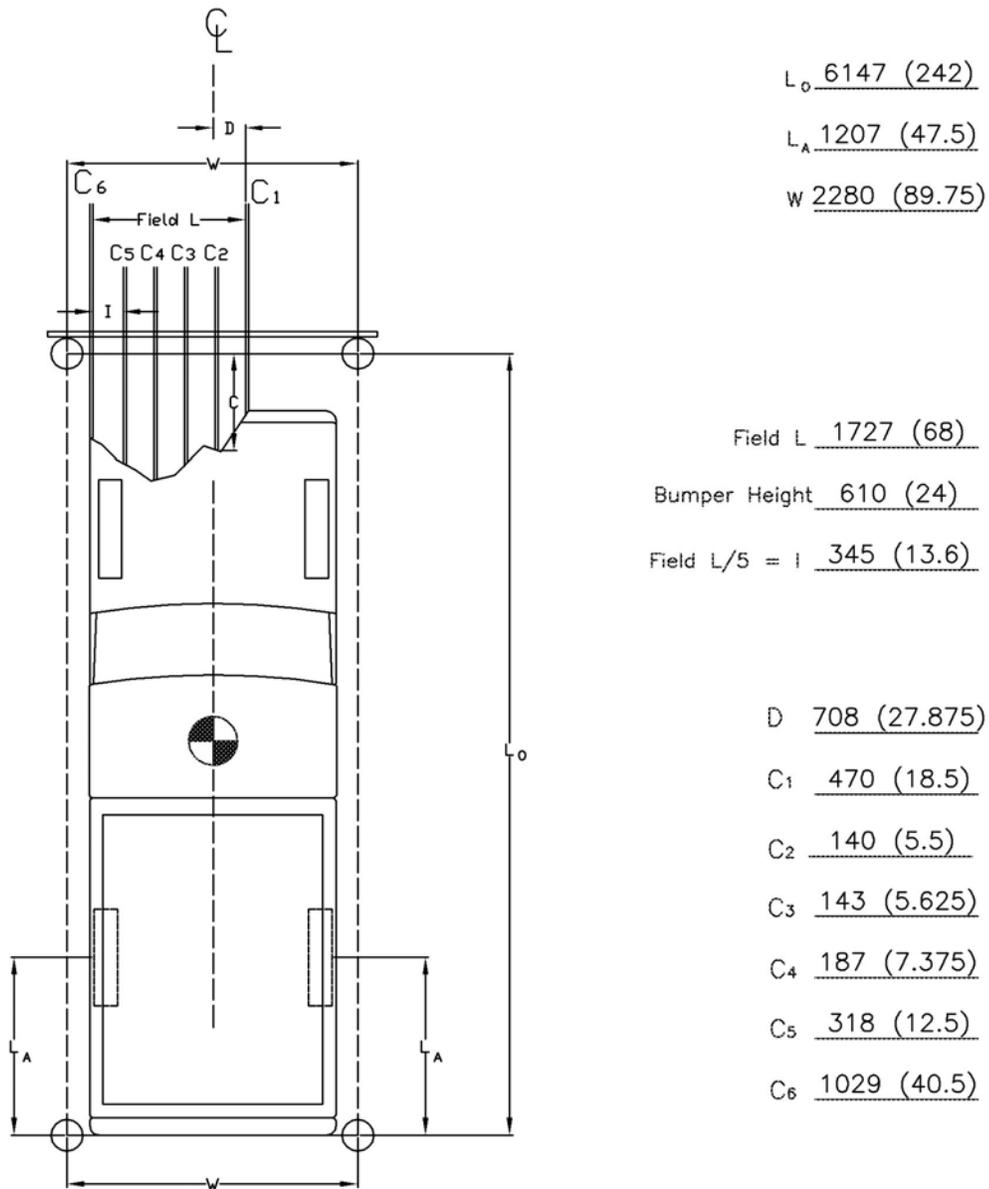
Figure C-4. NASS Crush Data, Test 2214T-1

Damage was concentrated on the left-front corner of the vehicle. The left-front quarter panel was deformed inward and downward toward the engine compartment. The left side of the front bumper was flattened and bent back toward the engine compartment. Buckle points at the third points were found on the front bumper. The left-front door encountered deformations and sheet metal tears. The left-rear door encountered scratches and contact marks. The front of the vehicle shifted toward the right while the hood remained in place. The box was dented and deformed along the entire left side. The grill and plastic around the left-side headlight was fractured and removed. The left-front plastic wheel well protection disengaged. The right side of the rear bumper was dented. The tail gate was misaligned. The left side of the frame was bent inward. The drive shaft encountered a dent in the housing. The left-front wheel assembly deformed and crushed inward toward the engine compartment. The left-side tire bearing and ball joint were fractured. The left-side sway bar and control arm connection was bent. The left-front tire disengaged from the rest of the wheel assembly. All hydraulic lines for the left-front wheel were sheared off. The left-rear rim, hub, and tire encountered scratch and scuff marks, and the rim was dented. The exhaust pipe and mount were dented and deformed. The front engine mount was fractured. The windshield encountered cracking in a radial pattern beginning at the lower center of the windshield. All other window glass remained undamaged.
