**PERFORMANCE EVALUATION OF THE
FREE-STANDING TEMPORARY BARRIER –
UPDATE TO NCHRP 350 TEST NO. 3-11 WITH 28"
C.G. HEIGHT (2214TB-2)**

MIDWEST ROADSIDE SAFETY FACILITY

MwRSF Research Report No. TRP-03-174-06

October 12, 2006

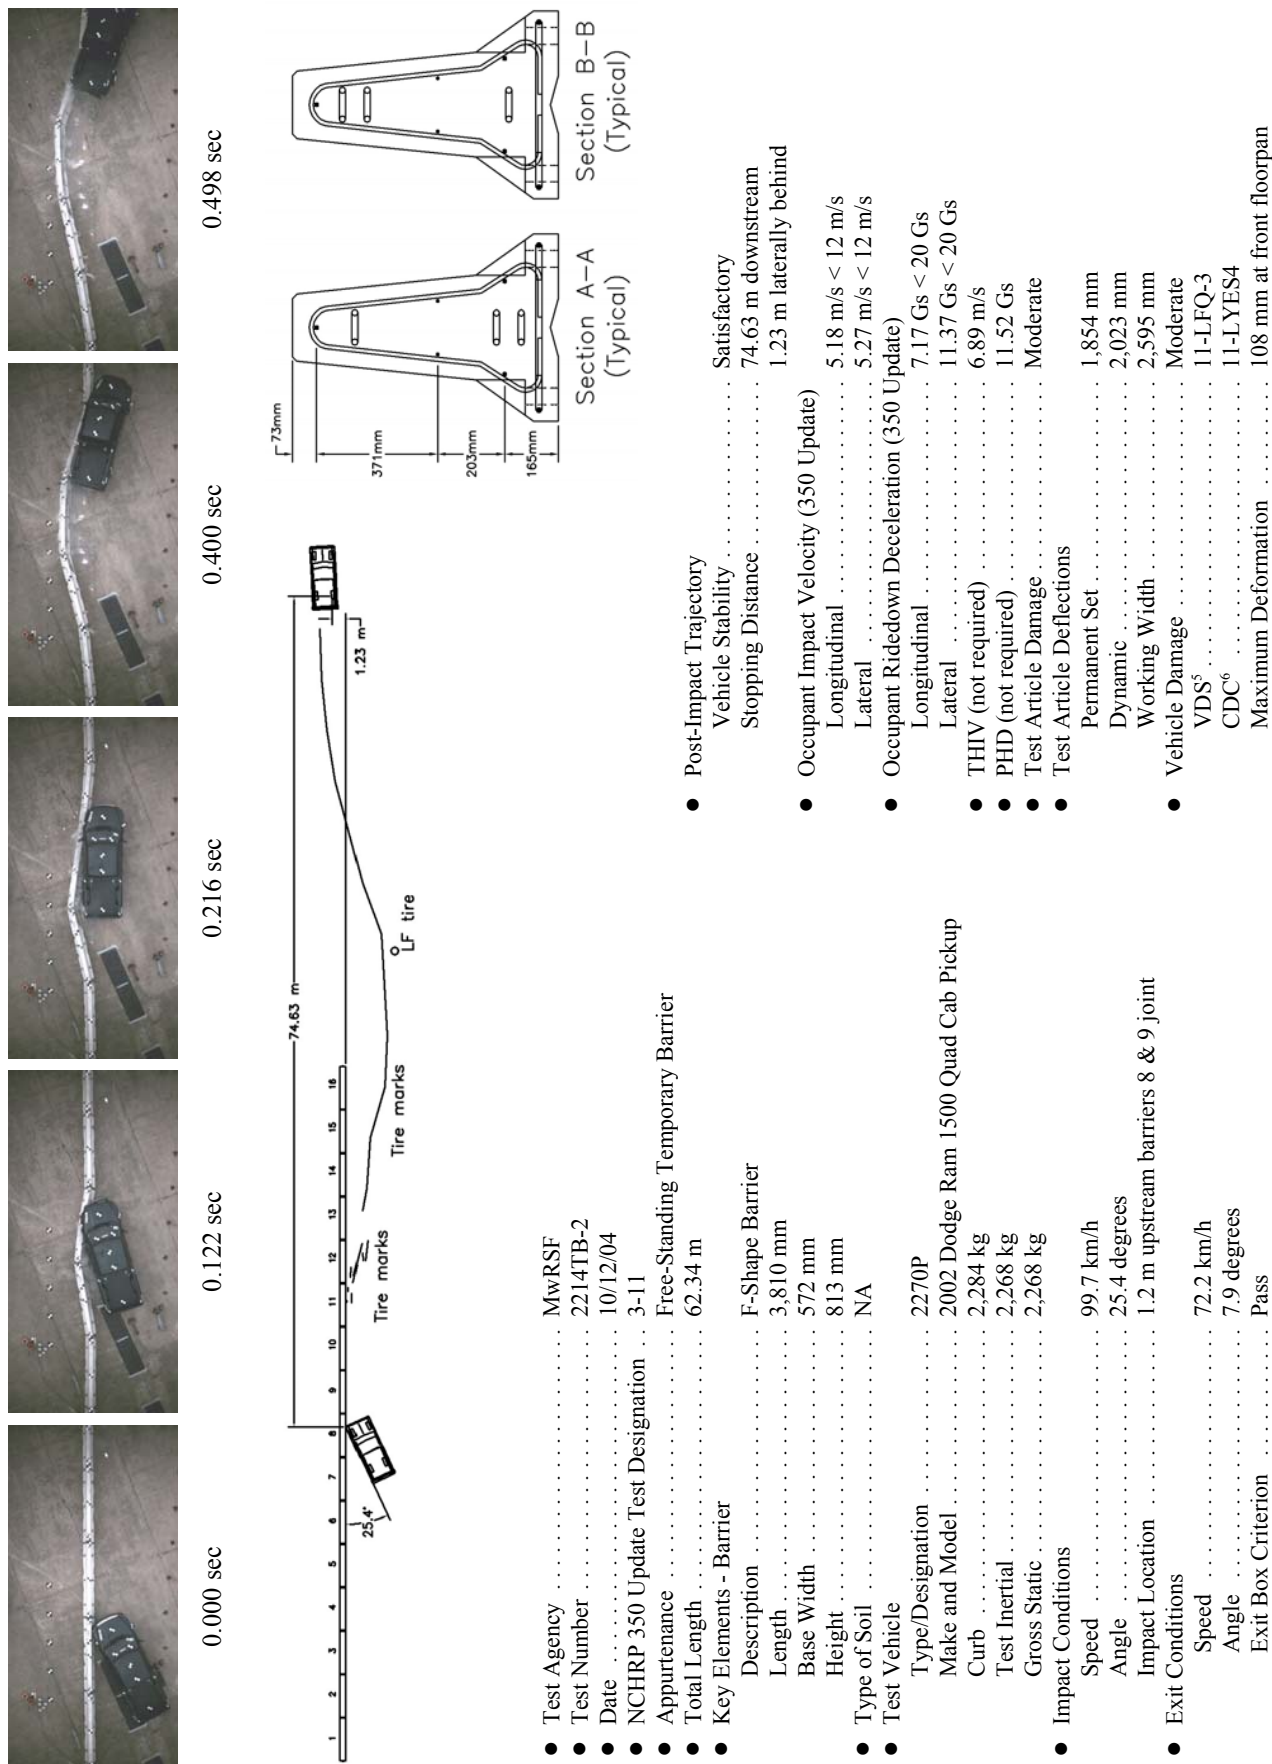
Figure 13. Summary of Test Results and Sequential Photographs, Test 2214TB-2

The 2,268-kg (5,000-lb) pickup truck impacted the free-standing temporary barrier system at a speed of 99.7 km/h (61.9 mph) and at an angle of 25.4 degrees. A summary of the test results and sequential photographs are shown in Figure 13. The summary of the test results and sequential photographs in English units are shown in Appendix B. Additional sequential photographs are shown in Figures 14 through 17. Documentary photographs of the crash test are shown in Figures 18 and 19.

The analysis of the test results for test no. 2214TB-2 showed that the free-standing temporary concrete barrier system impacted with the 2270P vehicle of the Update to NCHRP Report No. 350 adequately contained and redirected the vehicle with controlled lateral displacements of the barrier system. There were no detached elements nor fragments which showed potential for penetrating the occupant compartment nor presented undue hazard to other traffic. Deformations of, or intrusion into, the occupant compartment that could have caused serious injury did not occur. The test vehicle did not penetrate nor ride over the temporary concrete barrier system and remained upright during

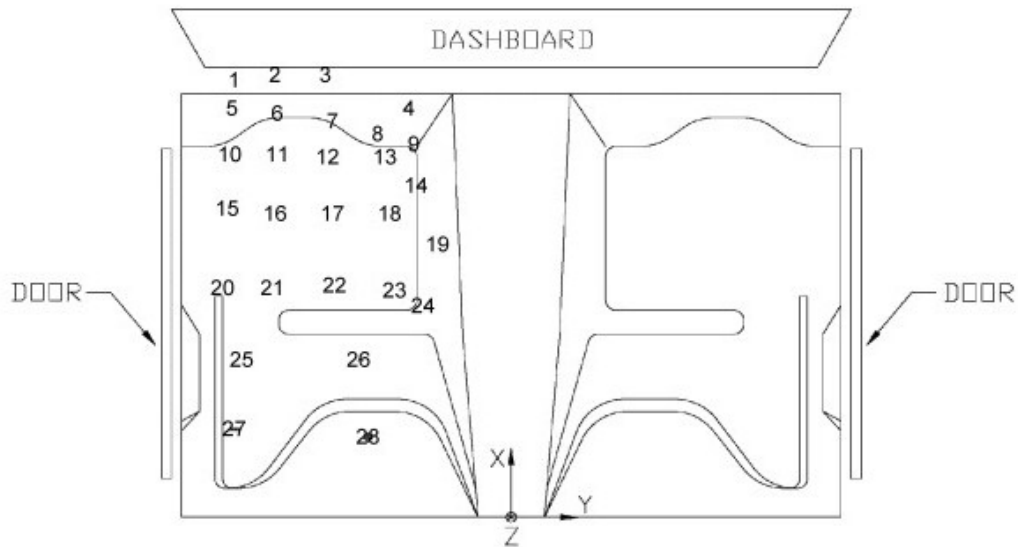
Figure C-1. Occupant Compartment Deformation Data - Set 1, Test 2214TB-2

compartment deformations to the left side and center of the floorboard, as shown in Figure 29, were judged insufficient to cause serious injury to the vehicle occupants. Maximum longitudinal deflections of 108 mm (4.25 in.) were located near the left-front corner of the left-side floor pan. Maximum lateral deflections of 32 mm (1.25 in.) were located near the left-front corner of the left-side floor pan. Maximum vertical deflections of 102 mm (4 in.) were located near the left-front corner of the left-side floor pan. Complete occupant compartment deformations and the corresponding locations are provided in Appendix C.
