# **Performance Evaluation of Missouri's 6-in. Barrier Curb Under W-Beam Guardrail**

**Midwest Roadside Safety Facility (MwRSF)  
Center for Infrastructure Research**

April 1994

MwRSF Research Report No. TRP-03-40-94

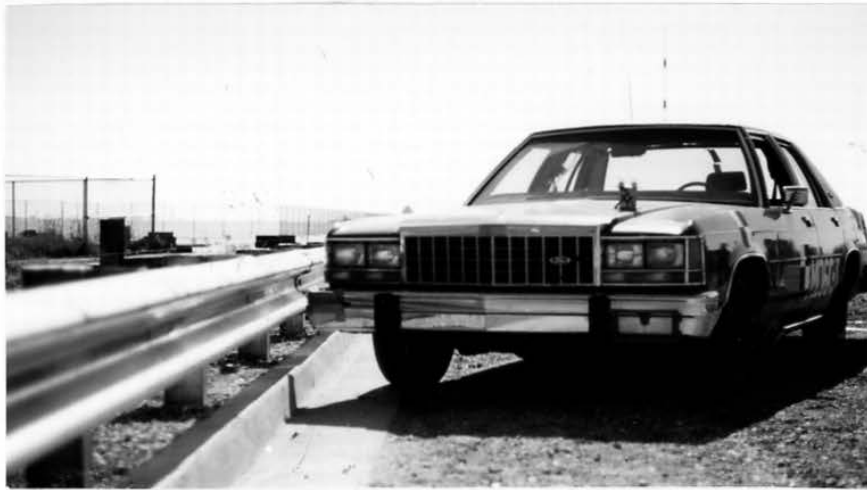
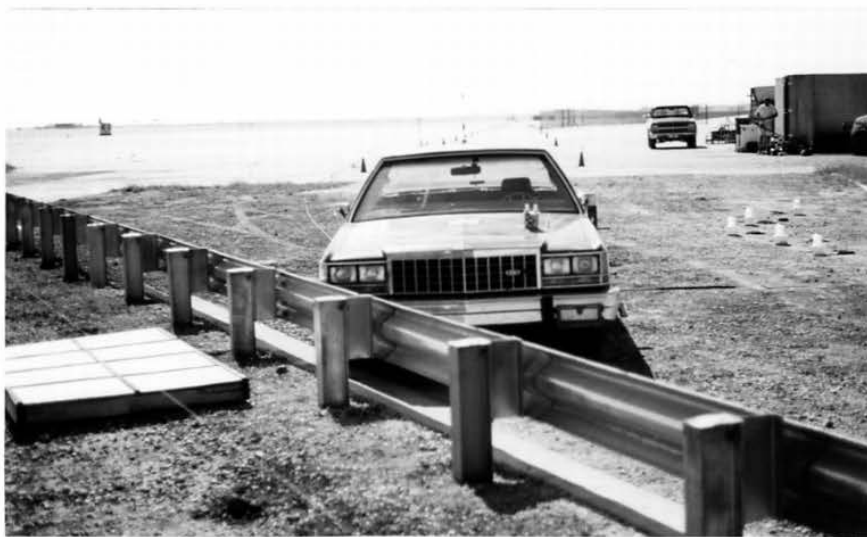
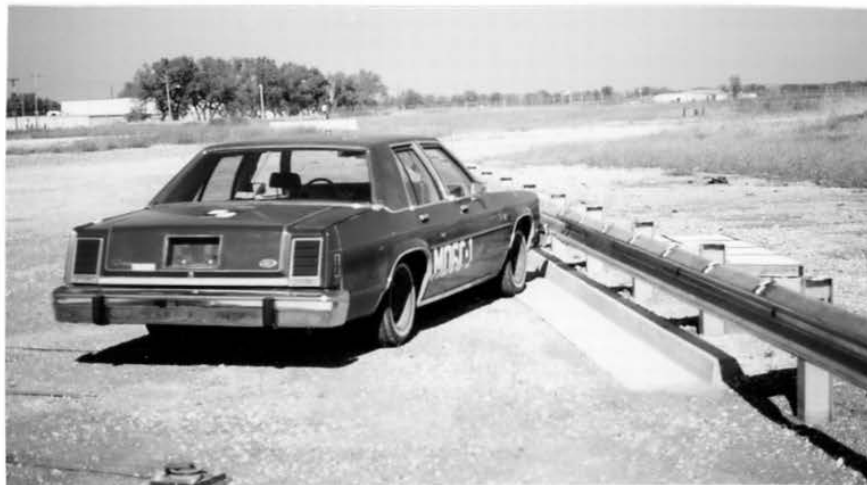
Figure 9. Impact Location

Test MO6C-1 was conducted with a 1985 Ford LTD weighing 4,500-lbs at an impact speed of 59.7 mph and impact angle of 25.1 degrees at a location approximately 11.7 ft upstream of the system's center (Post No. 15). The location of impact is shown in Figure 9. The test installation was G4(1S) system consisting of single 12-gauge W-beam at 6 ft - 3 in. post spacing with a 6-in. barrier curb (Type A Integral) (4), placed flush with the guardrail front face. A summary of the test results and sequential photographs are presented in Figure 10. Additional sequential photographs are shown in Figure 11. Documentary photographs of the crash test are shown in Figures 12 through 14.

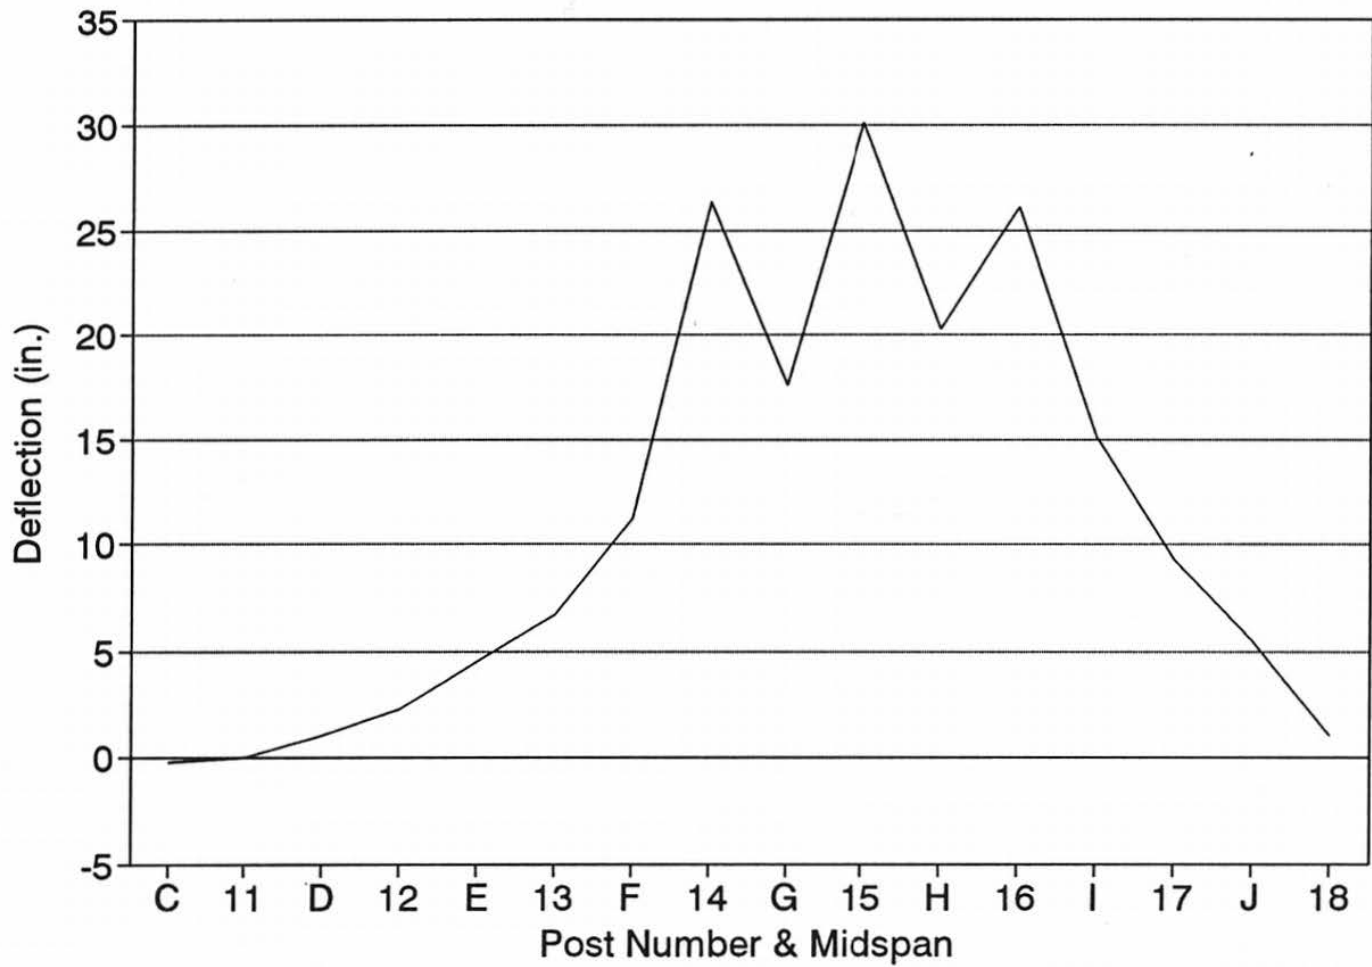
Figure 19. Permanent Set Post and Rail Deflections

The W-beam guardrail damage is shown in Figures 17 and 18. Four 25-ft sections of guardrail were damaged during the test; the target impact section (section 4), the ends of the sections upstream and downstream of the target section (sections 3 and 5), and the section that was impacted during the secondary impact (section 7). The measured contact length between the vehicle and the rail (impact to Post No. 18) was approximately 30 ft. The permanent set and maximum dynamic deflections were 30.1 and 31.7 in., respectively. Maximum guardrail and post permanent set and dynamic deflections are shown in Figures 19 and 20, respectively.
