# Analysis of Existing Work-Zone Devices with MASH Safety Performance Criteria

**Final Report**  
**February 2009**

MwRSF Research Report No. TRP-03-225-10

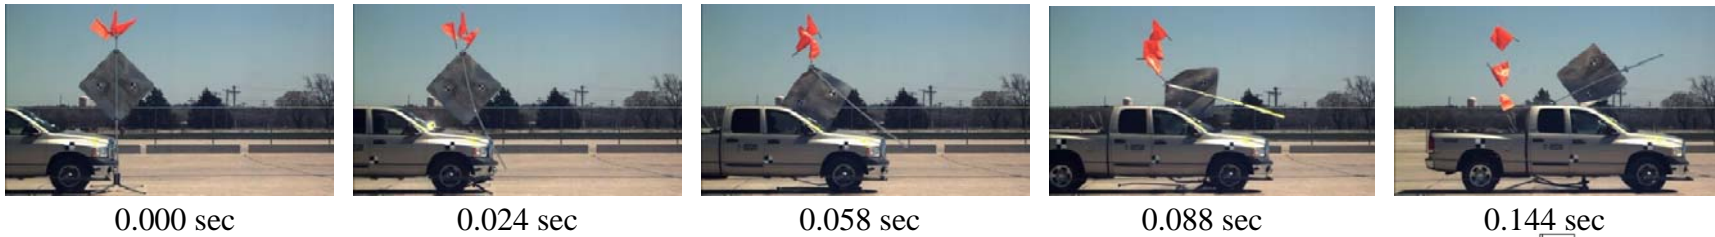
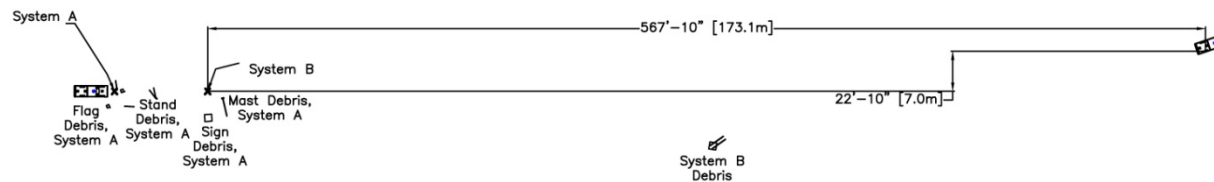
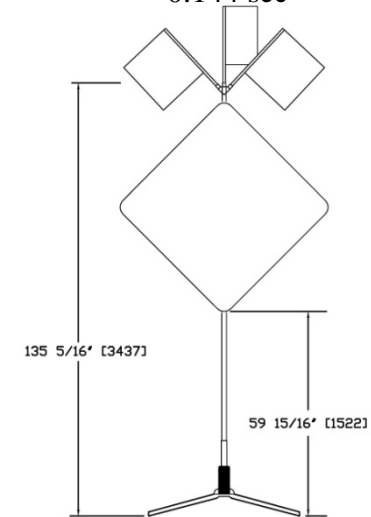
Figure 45. Summary of Test Results and Sequential Photographs, Test No. WZ09-1A

The 5,159-lb (2,340-kg) pickup truck with a simulated occupant seated in the right-front seat impacted System No. 1A, a work-zone sign support oriented end-on to the vehicle, at a speed of 63.4 mph (102.1 km/h) and at an angle of 90 degrees. The pickup truck then impacted System No. 1B, a work-zone sign support oriented end-on to the vehicle at a speed of 62.0 mph (99.8 km/h) and at an angle of 90 degrees. A summary of the test results and sequential photographs are shown in Figures 45 and 46. Additional sequential photographs are shown in Figures 47 and 48. Documentary photographs of the crash test are shown in Figure 49.

Following test no. WZ09-1, a safety performance evaluation was conducted, and the performance of System No. 1A was determined to be unacceptable according to the MASH criteria. It was deemed unacceptable due to the flag holder penetrating the roof, the sign panel penetrating the windshield, windshield indentation greater than 3 in. (76 mm), and significant windshield cracking. Deformations of, and intrusion into, the occupant compartment did occur as System No. 1A penetrated into the occupant compartment on the right side of the windshield when the corner of the sign panel sliced through the windshield and also when the metal flag holder penetrated the roof into the occupant compartment.

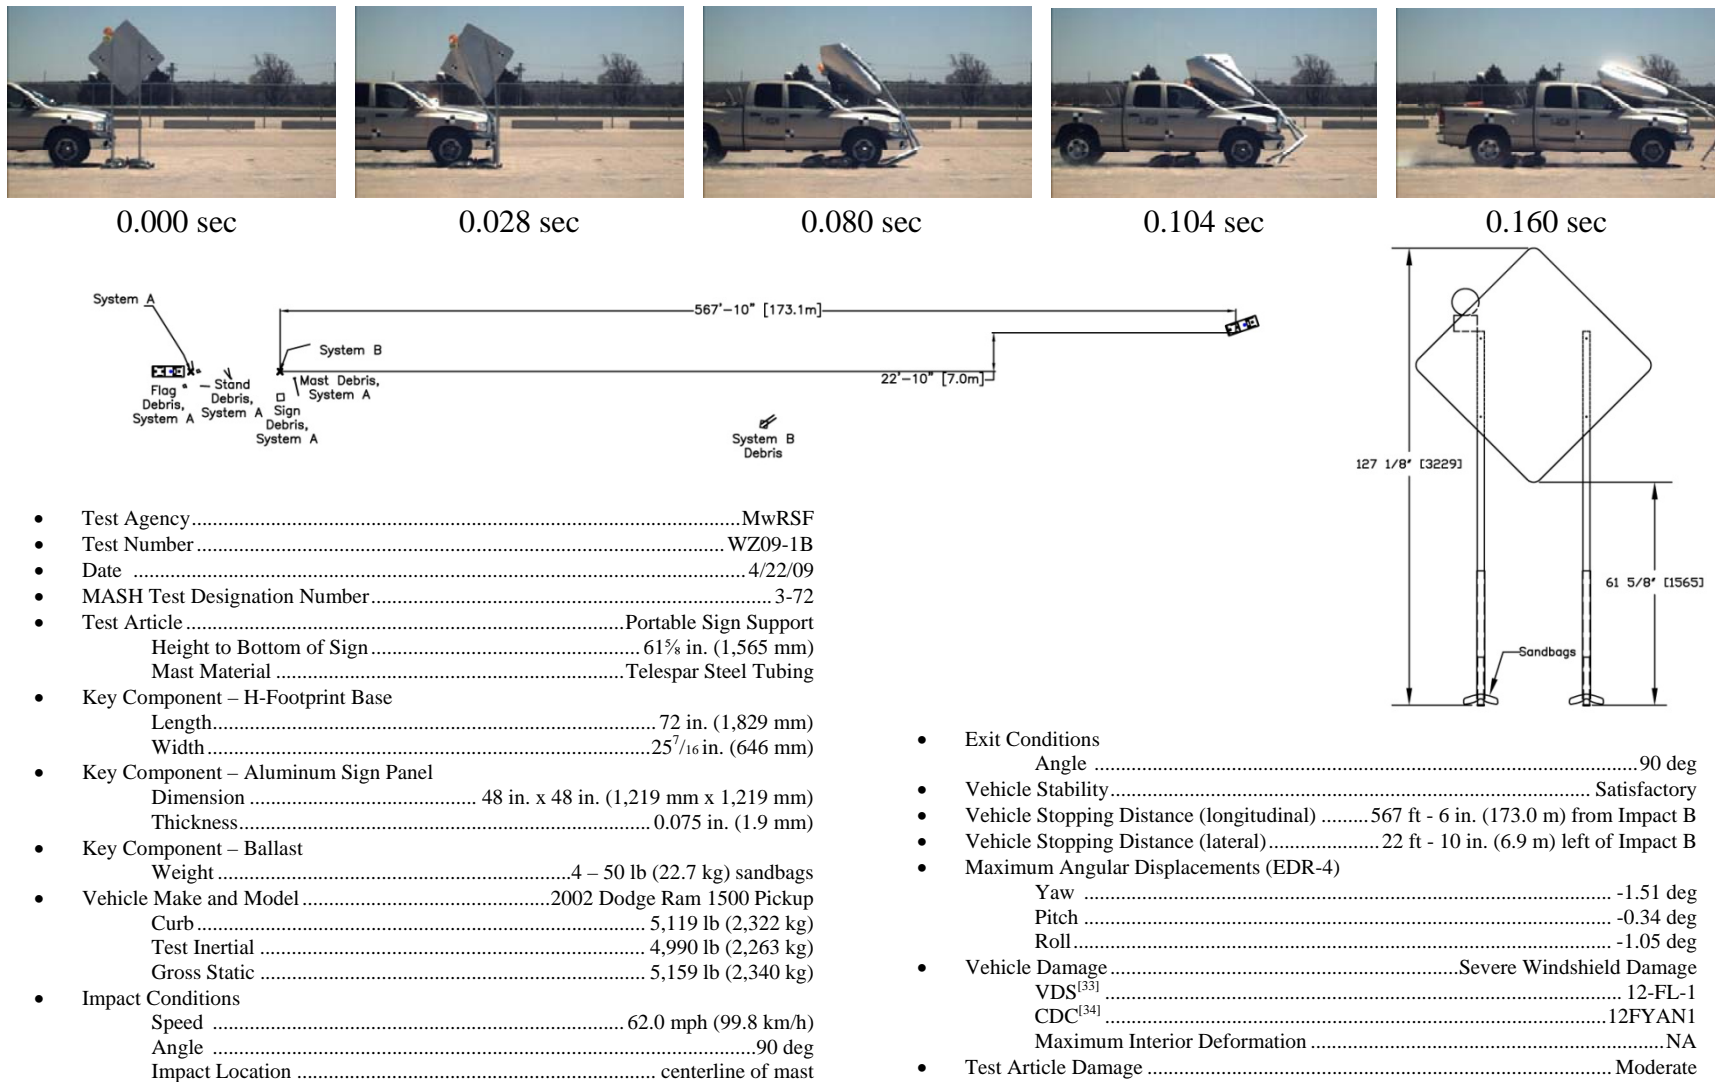
Figure 46. Summary of Test Results and Sequential Photographs, Test No. WZ09-1B

System No. 1B was also determined to be unacceptable according to the MASH criteria due to the light and mast penetrating the windshield, windshield indentation greater than 3 in. (76 mm), and significant windshield cracking, which caused the obstruction of driver visibility and the loss of structure in both glass layers in the windshield. Deformations of, and intrusion into, the occupant compartment did occur as System No. 1B penetrated into the occupant compartment near the upper-center region and upper-left corner of the windshield when the light, mast, and sign panel contacted the windshield. The vehicle's trajectory did not intrude into adjacent traffic lanes.

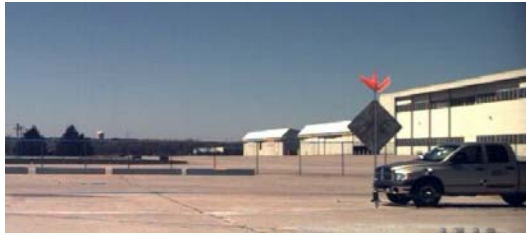
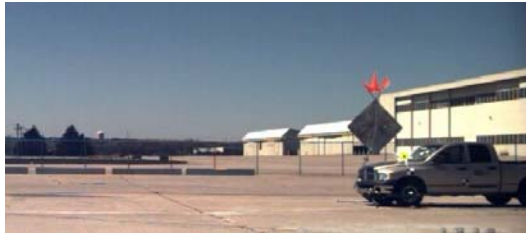
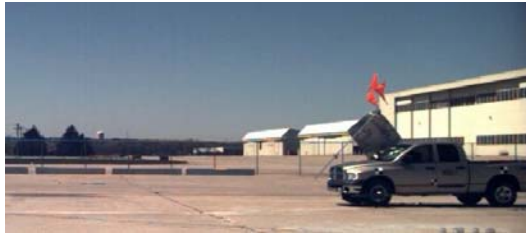
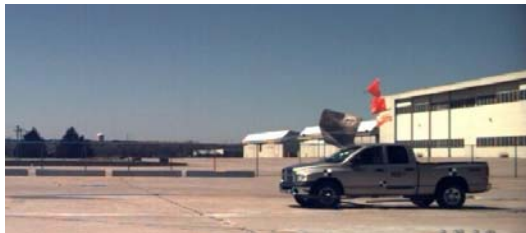
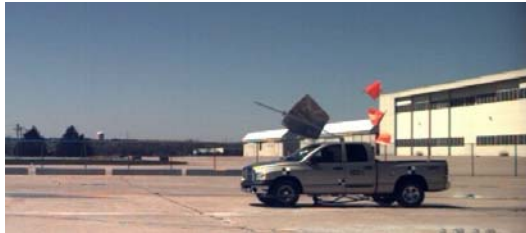
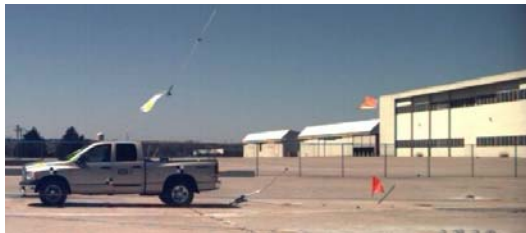
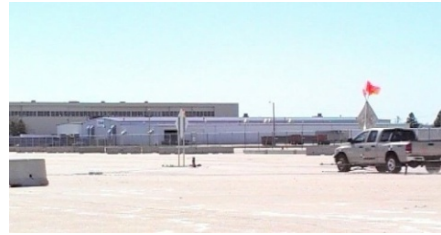
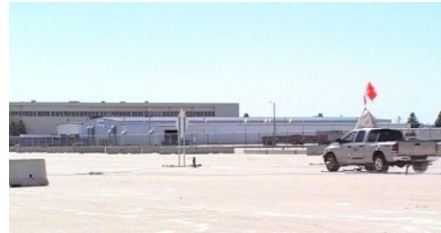
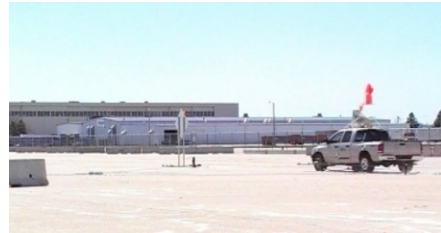
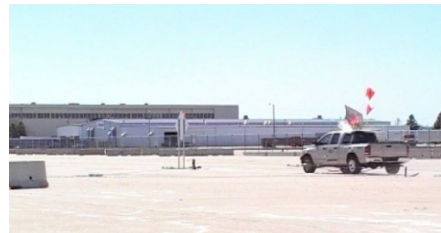
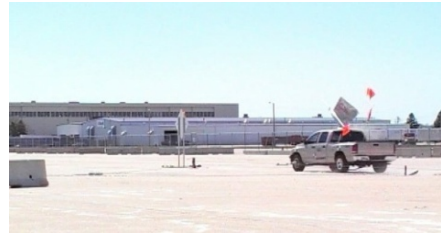
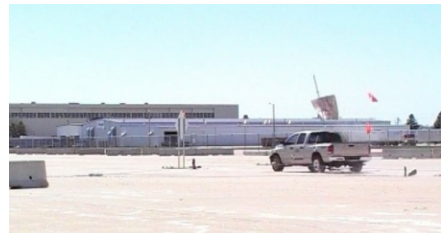
Figure 47. Additional Sequential Photographs, Test No. WZ09-1A

TIME (sec)	EVENT
0	Front bumper impacted the mast of System No. 1A
0.004	The mast fractured away from the base
0.008	The bottom of sign released from the bracket, and the upper mast started bending
0.010	Sign panel began to fall and two flags detached from the flag holder
0.012	Truck traversed over the legs
0.046	Sign panel impacted windshield, and mast rotated toward the truck
0.050	Top of sign panel impacted roof
0.088	Sign disengaged from the mast at the upper bracket
0.096	Third flag disengaged as the mast continued to rotate toward the vehicle
0.128	The flag holder penetrated the roof
0.144	Sign panel disengaged from the roof of the vehicle
0.176	The flag holder disengaged from the roof, and the mast rotated over the truck

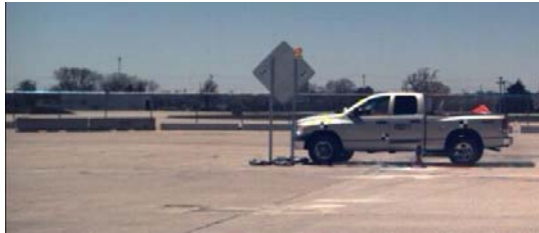
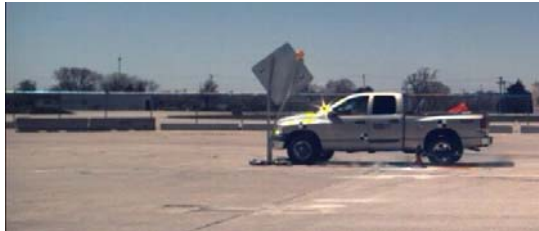
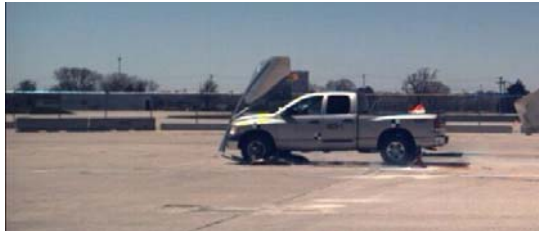
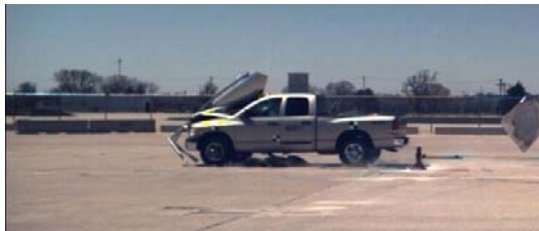
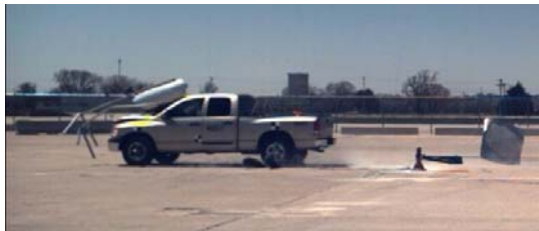
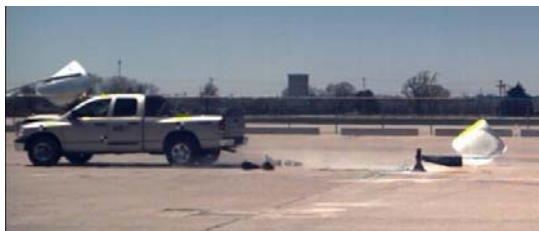
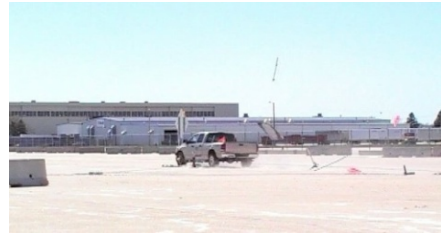
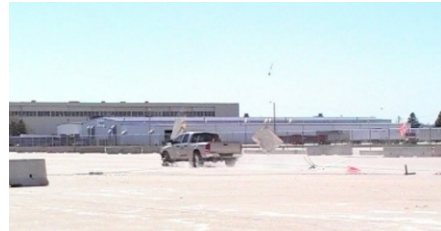
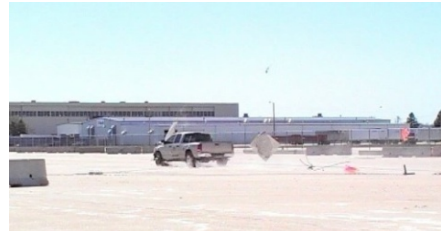
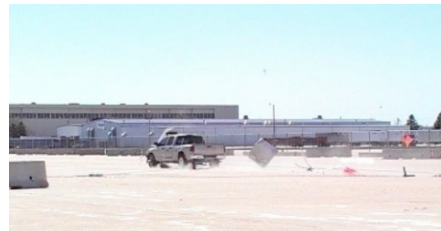
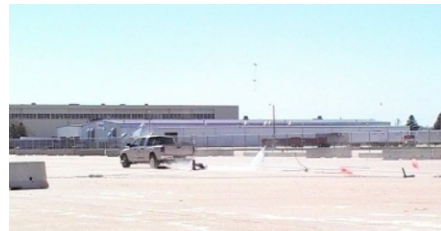
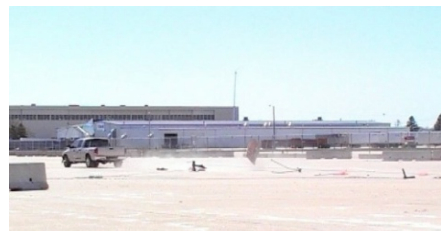
Figure 48. Additional Sequential Photographs, Test No. WZ09-1B

TIME (sec)	EVENT
0	Front bumper impacted the mast of System No. 1B
0.004	Impact-side leg fractured
0.006	Sign panel began rotating as impact-side mast bent around front of hood
0.014	Sign panel bent at its vertical center
0.020	Impacted mast contacted non-impacted mast
0.028	Non-impact side leg fractured
0.080	Sign panel corner contacted windshield
0.084	Sign stand became completely airborne
0.104	Light contacted upper-left corner of windshield and roof
0.122	Impact-side mast lost contact with the hood and pushed the light through windshield
0.160	Sign panel reached maximum bending
0.320	Sign panel lost contact with the windshield and rotated off the right side of the truck

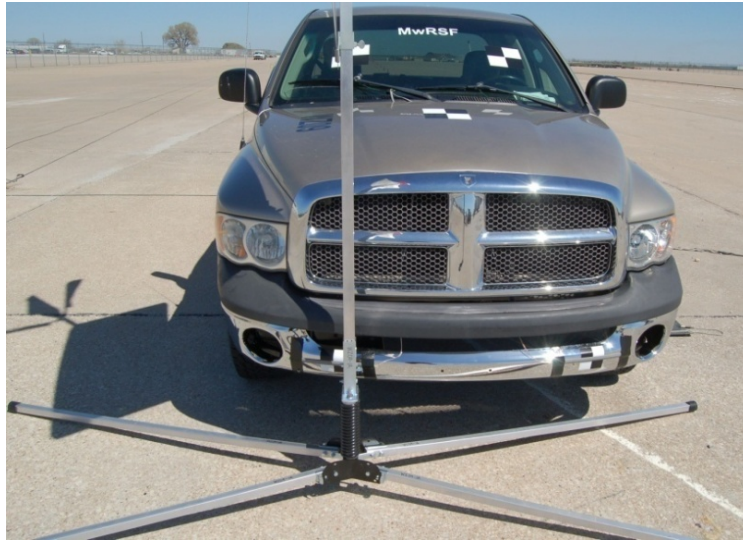
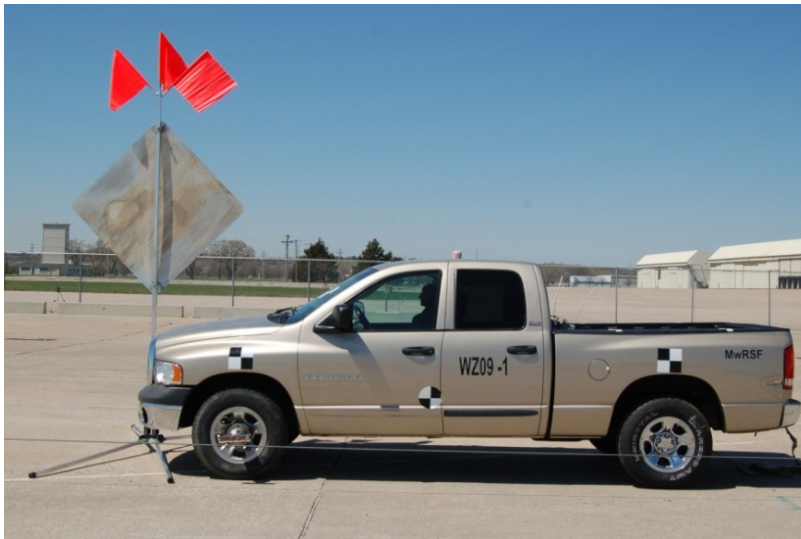
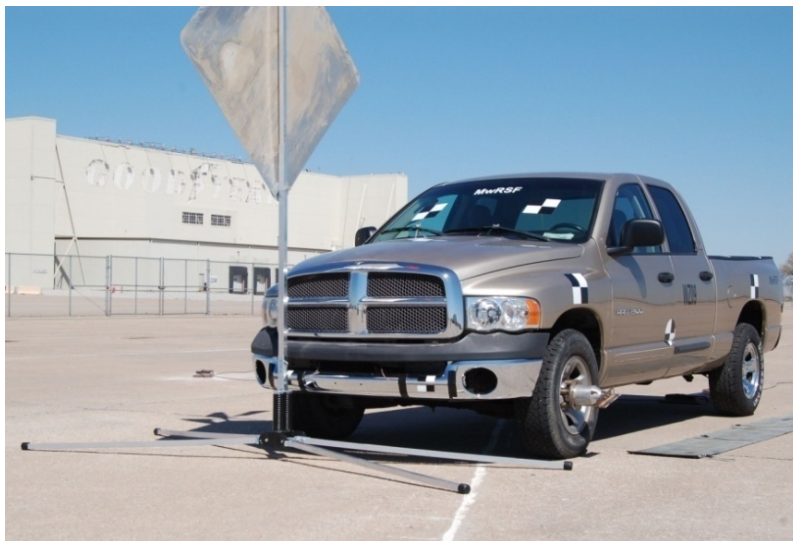
Figure 50. Impact Location, Test No. WZ09-1A

For System No. 1A, initial vehicle impact was to occur with the centerline of the mast 2 in. (51 mm) to the left of the right-side quarter point on the pickup truck's bumper, as shown in Figure 50. The actual point of impact was with the centerline of the mast 5½ in. (140 mm) to the

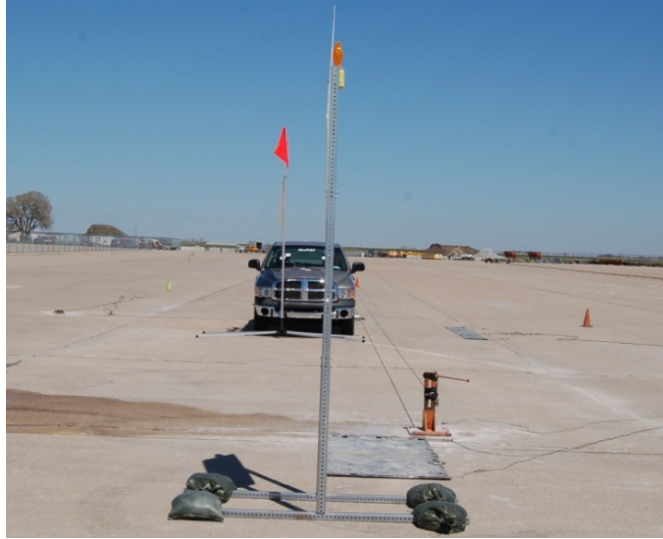
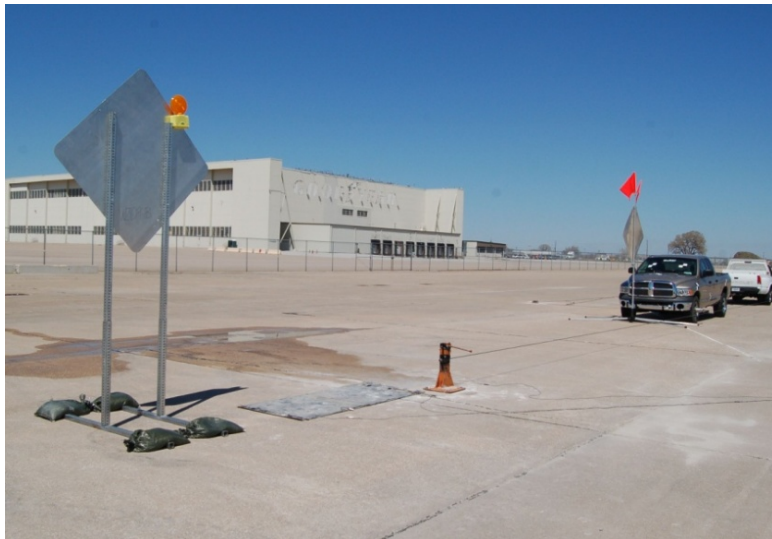
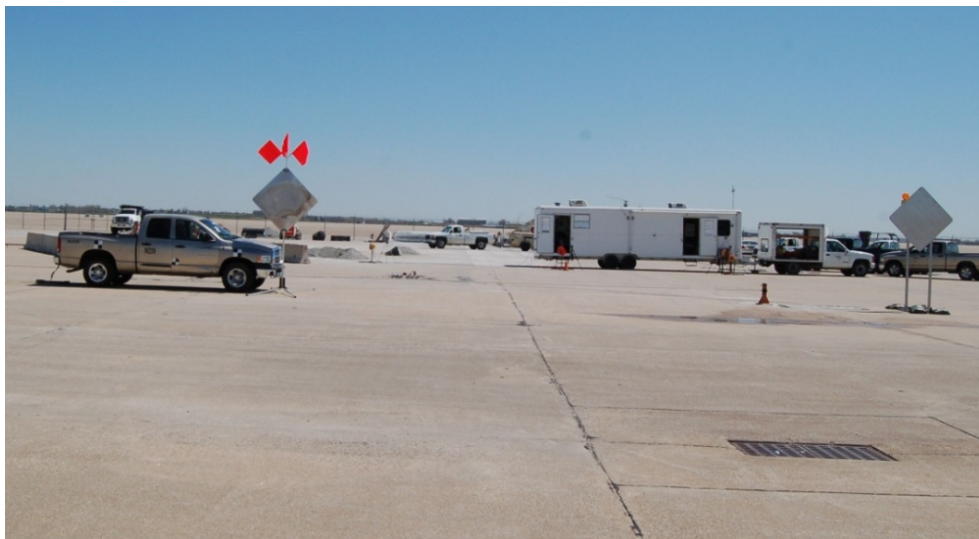
Figure 51. Impact Location, Test No. WZ09-1B

left of the right-side quarter point. For System No. 1B, initial vehicle impact was to occur with the centerline of the impact-side mast 2 in. (51 mm) to the right of the left-side quarter point on the pickup truck's bumper, as shown in Figure 51. The actual point of impact was with the centerline of the mast 2 in. (51 mm) to the right of the left-side quarter point.

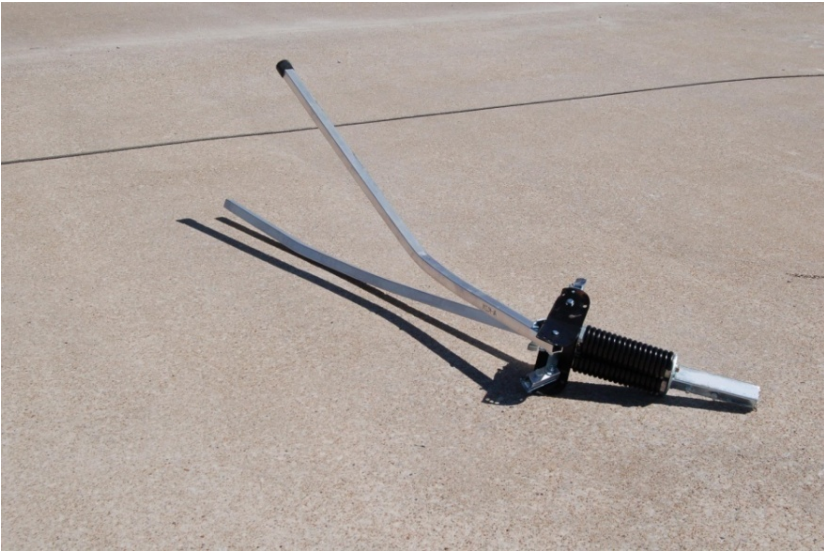
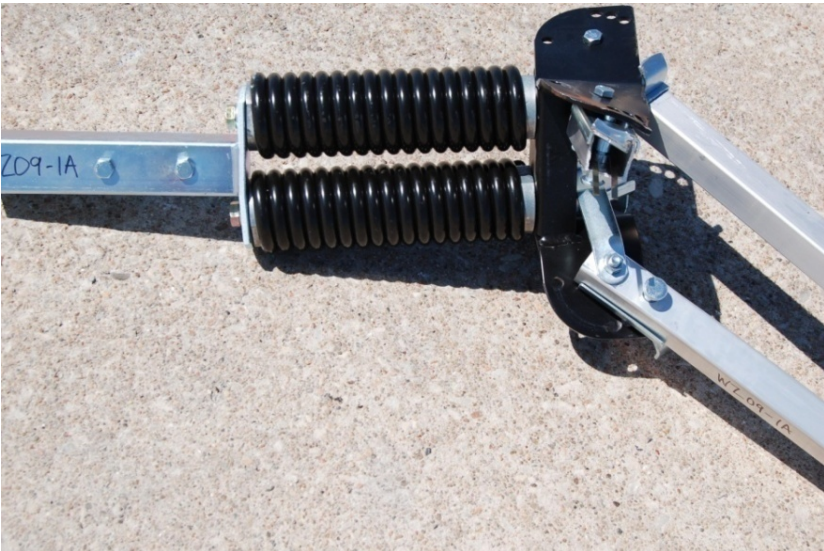
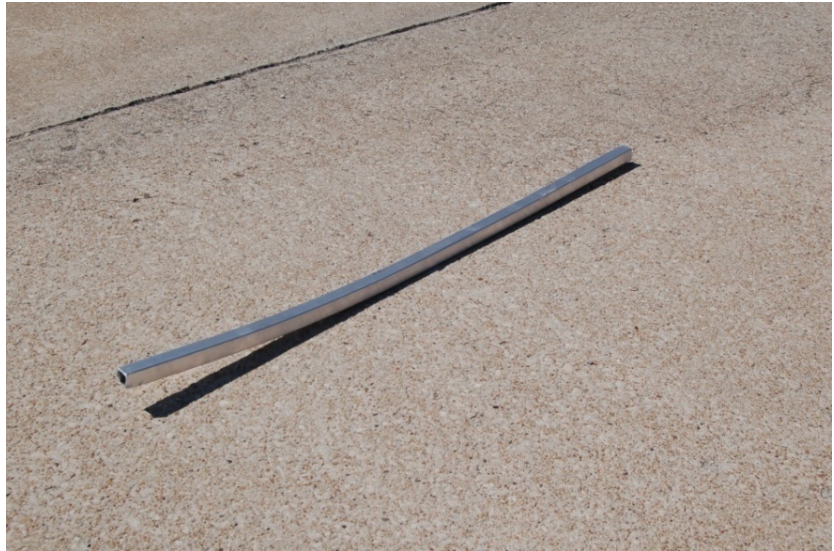
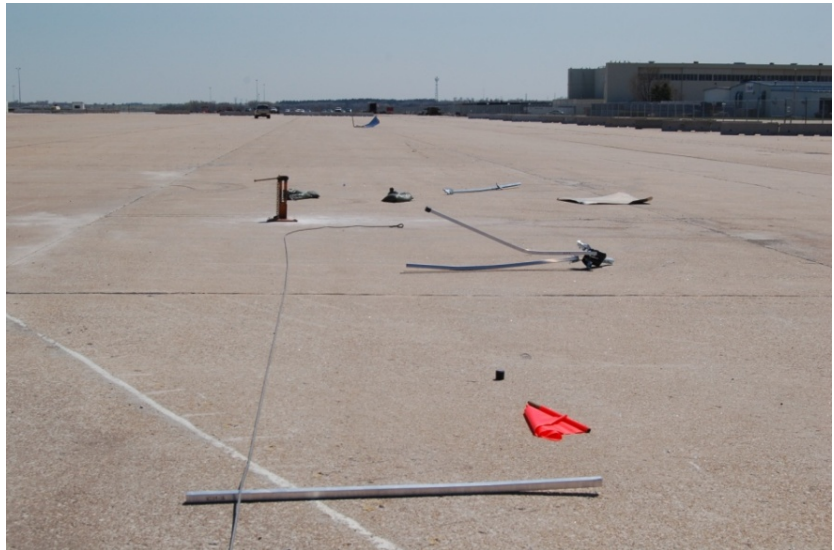
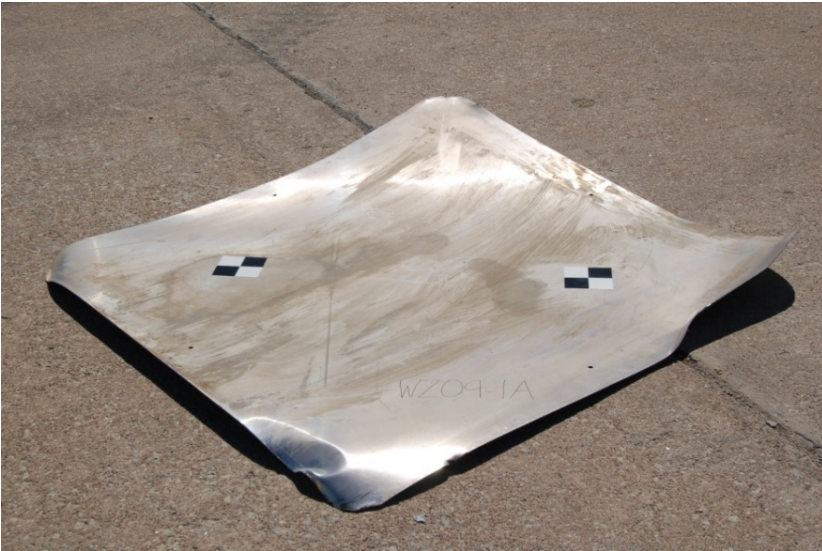
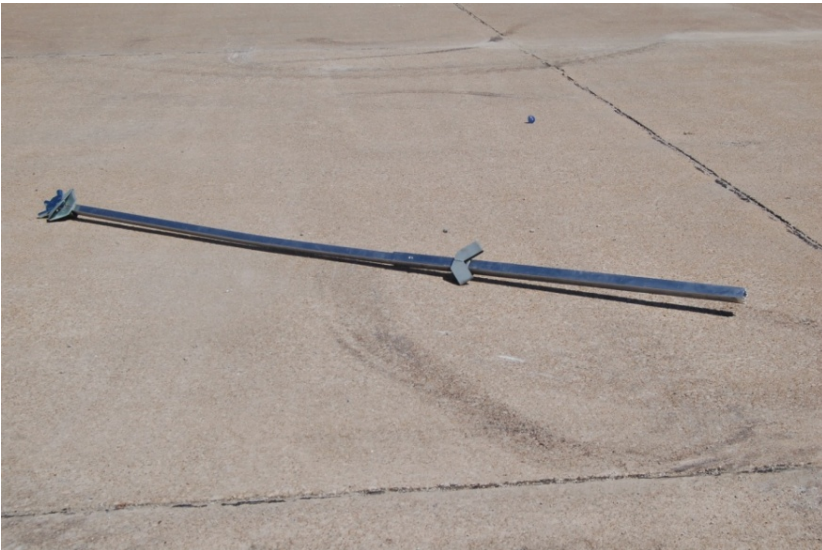
Figure 53. System Damage, Test No. WZ09-1A

Damage to System Nos. 1A and 1B is shown in Figures 53 through 56. System No. 1A encountered severe damage to the sign support stand. Two of the four legs were still attached to the base but were not in their original positions. One of the attached legs was bent moderately, and the other was bent slightly. The other two legs were fractured completely at the leg release/lock mechanism and were slightly bent. The angled base plates attaching the legs were bent, and the plate above the springs was slightly bent. The lower mast was fractured at the breakaway holes. The upper mast was slightly bent. The upper rigid bracket was significantly deformed out. All corners of the sign panel were dented and scratched. All three flags were undamaged, and one was located in the bed of the pickup truck.

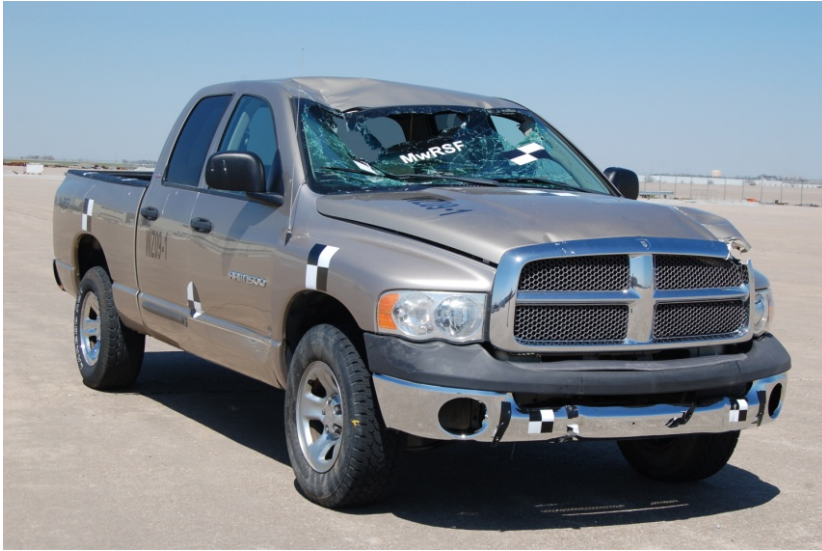
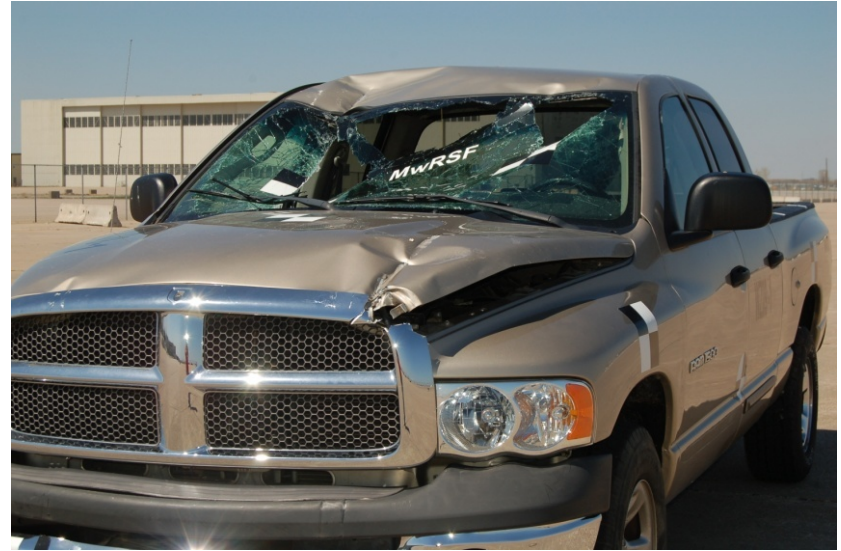
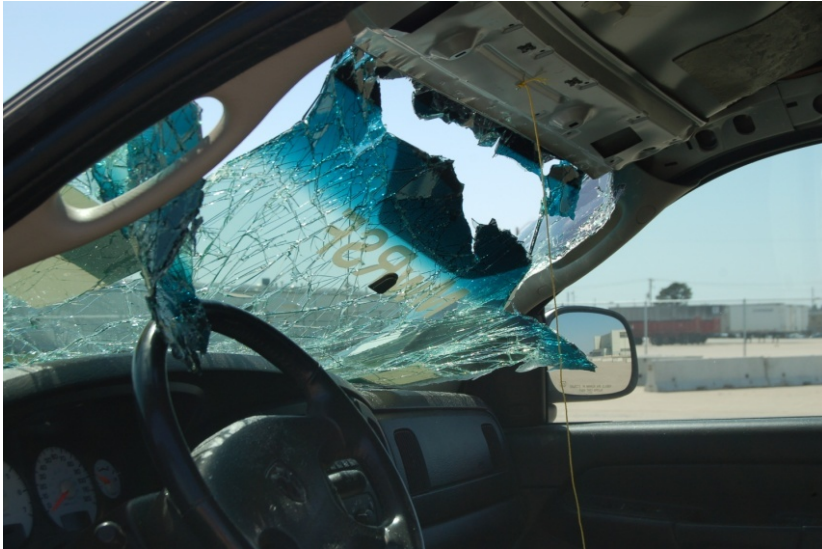
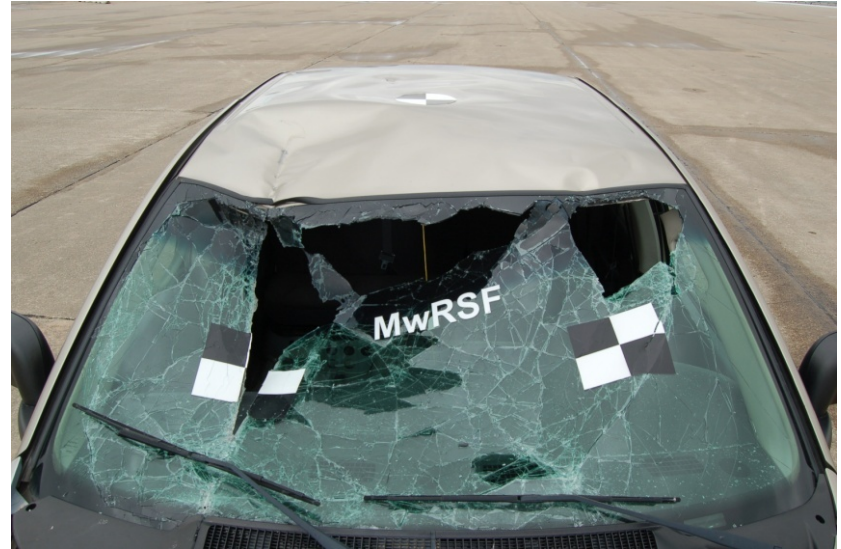
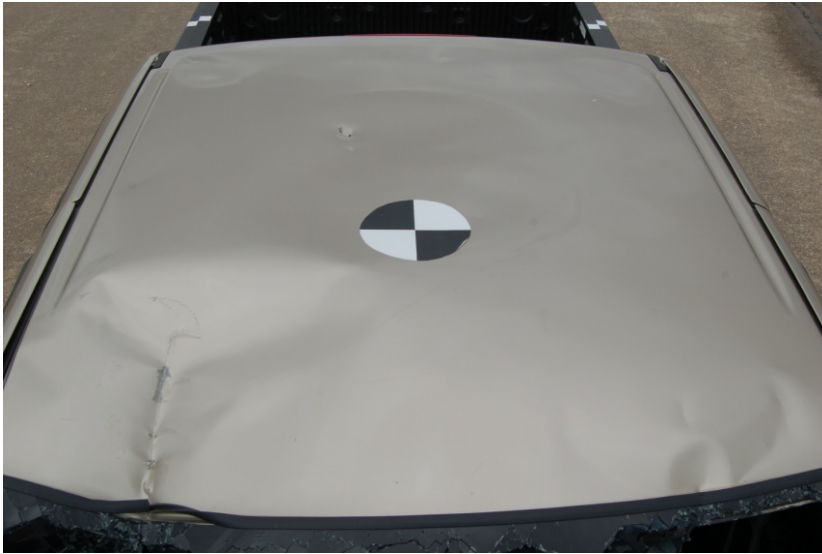
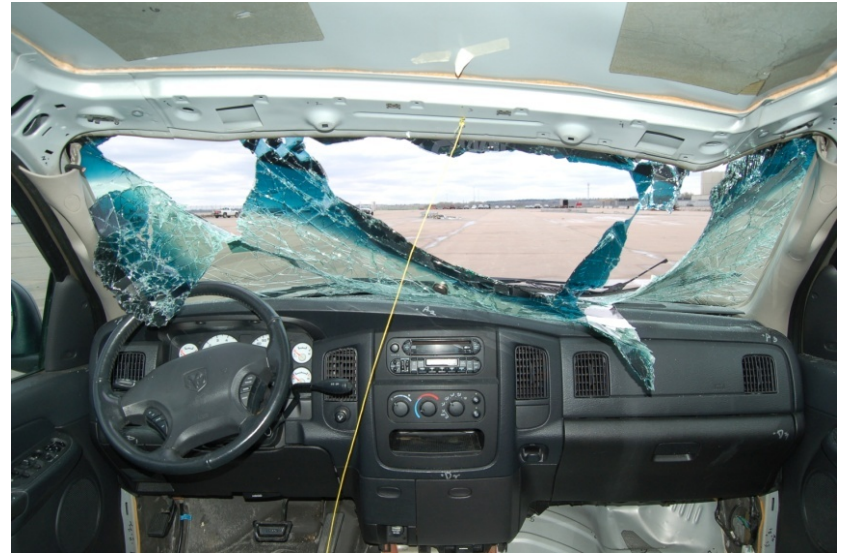
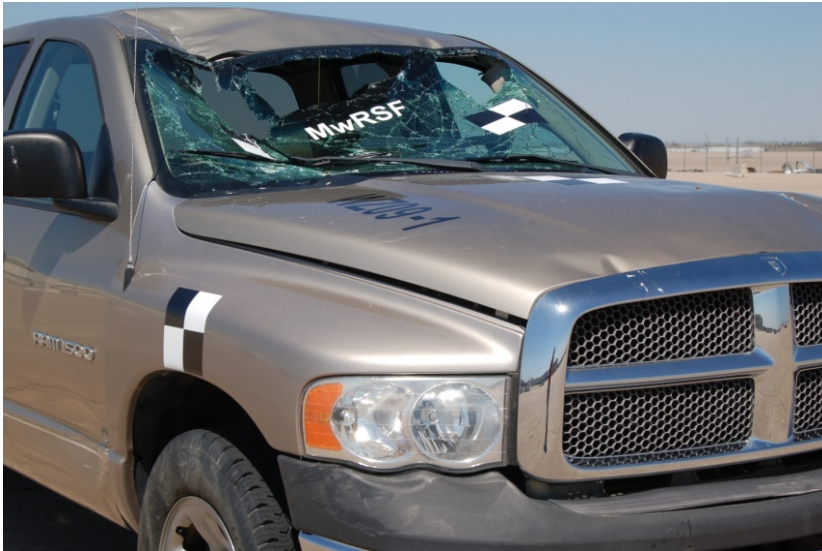
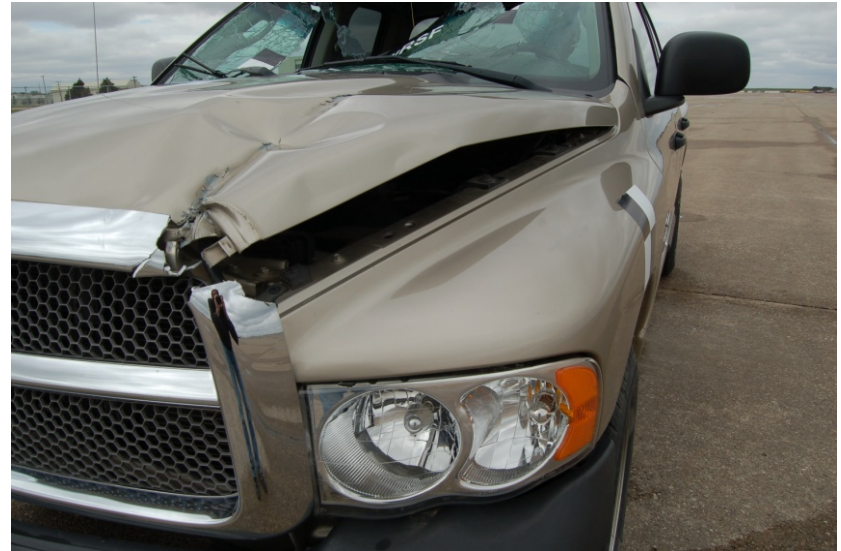
Figure 57. Vehicle Damage, Test No. WZ09-1

Vehicle damage is shown in Figures 57 and 58. The bumper was dented inward where it contacted System Nos. 1A and No. 1B. Small scuffs were found on the plastic bumper on the right side and at both impact locations. The upper-right side of the grill was scratched. The left corner of the grill was broken, and the engine hood sustained a cut at the left-side impact location. The hood was pushed backward and upward at the left-front corner, and the left-front half of the hood was scratched. The windshield was sliced through at the center of the right target where it was contacted by the sign panel from System No. 1A. The upper-center windshield contained a large hole along the roofline where the sign panel of System No. 1B impacted. The upper-left corner of the windshield encountered another large hole where the light and mast of System No. 1B impacted. Significant windshield indentation and cracking occurred. The roof was dented and encountered scratches at the right-side impact location. Small dents were found in the front of the roof at the left-side impact location. A small hole was observed in the middle of the roof and slightly off center to the right side where the flag holder of System No. 1B impacted.

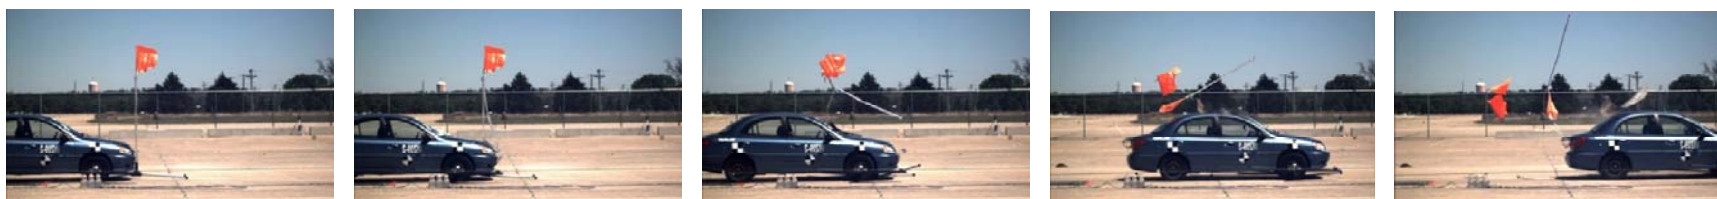
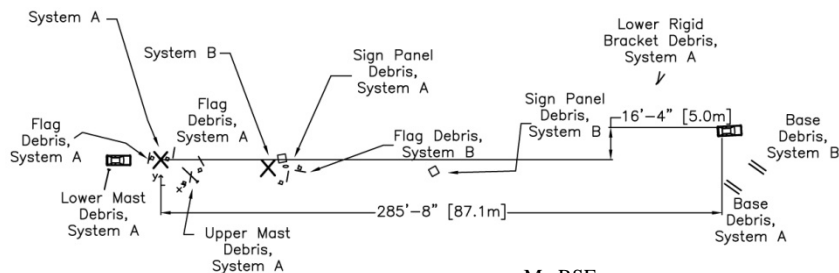
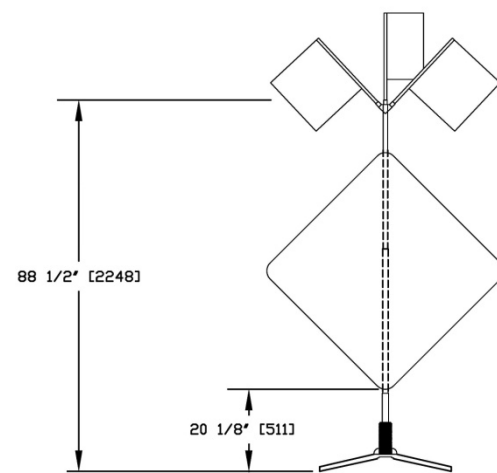
Figure 59. Summary of Test Results and Sequential Photographs, Test No. WZ09-2A

Following test no. WZ09-2, a safety performance evaluation was conducted, and the performance of System No. 2A was determined to be successful according to the MASH criteria. The windshield damage from System Nos. 2A and 2B overlapped at the middle third of the windshield, but the damage to the right third of the windshield was specifically from System No. 2A. A concentrated point of impact from the flash bulb on the lower windshield, and not the test article, occurred in the lower-right corner of the windshield. All other cracking and indentation on the right side of the windshield was from the test article. Detached elements and debris from System No. 2A contacted the windshield, and moderate cracking occurred. A maximum deformation of 2¼ in. (57 mm) occurred on the right side of the windshield, which is below the 3 in. (76 mm) maximum value defined in MASH. There was no penetration of the windshield and no tear in the plastic liner. Moderate windshield cracking also occurred along the upper-right two-thirds of the windshield when the sign panel from System No. 2A released and impacted the windshield, as determined from high-speed video analysis. The cracking appeared to be the same at the upper-middle region of the windshield as well as to the right side. The maximum deformations at the top of the windshield are unknown due to overlapping damage with System No. 2B, but the deformations were less than 3 in. (76 mm). Therefore, the system performance was determined to be acceptable.

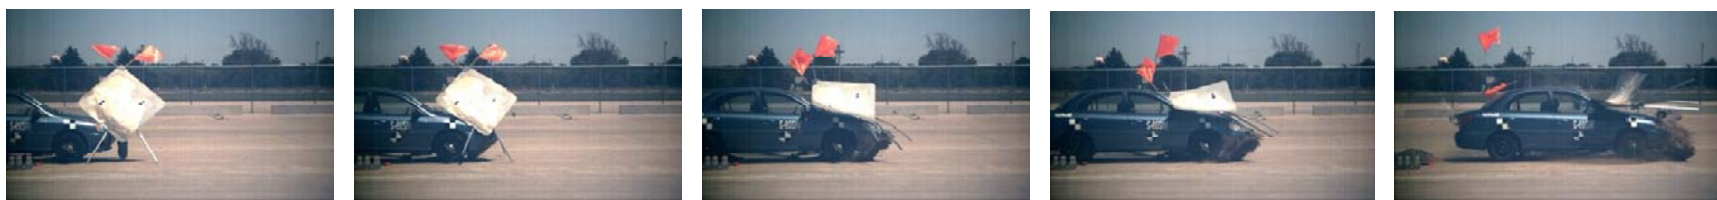
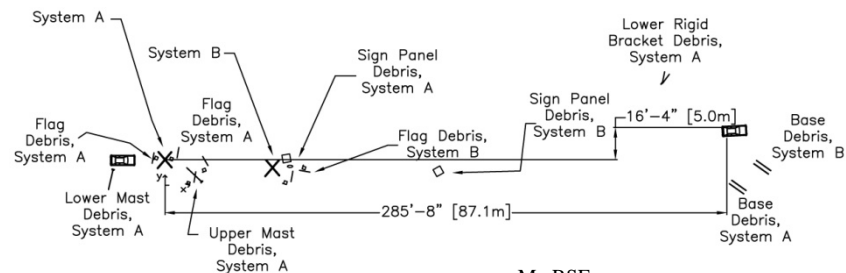
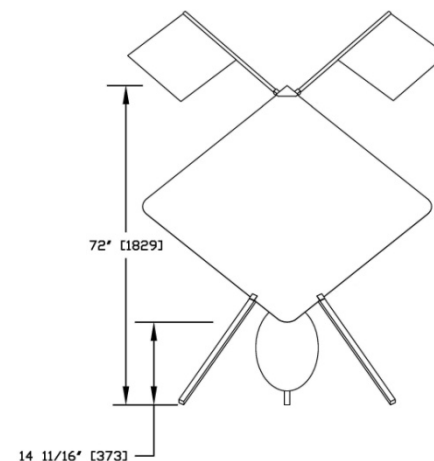
Figure 60. Summary of Test Results and Sequential Photographs, Test No. WZ09-2B

System No. 2B was determined to be unacceptable according to the MASH criteria due to significant windshield cracking, windshield indentation greater than 3 in. (76 mm), and windshield penetration. Deformations of, and intrusion into, the occupant compartment did occur as System No. 2B penetrated into the occupant compartment near the upper-center region of the windshield when the mast contacted the windshield. Even though the mast impacted the top of the windshield, which was already weakened from the impact with System No. 2A, the penetration was significant and was believed to have occurred without the prior damage. The vehicle's trajectory did not intrude into adjacent traffic lanes.

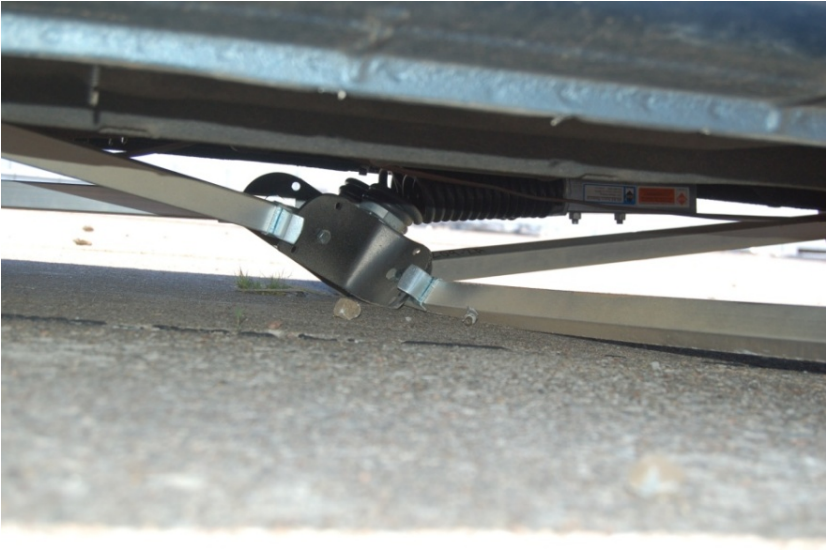
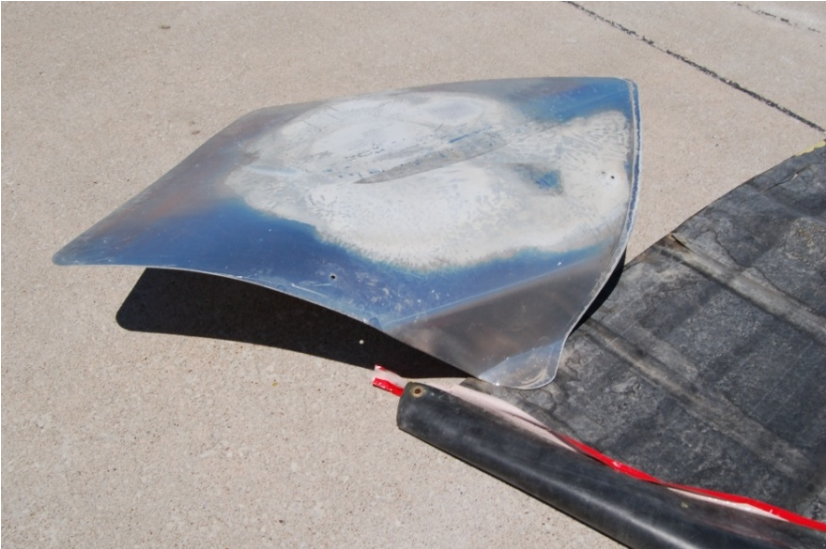
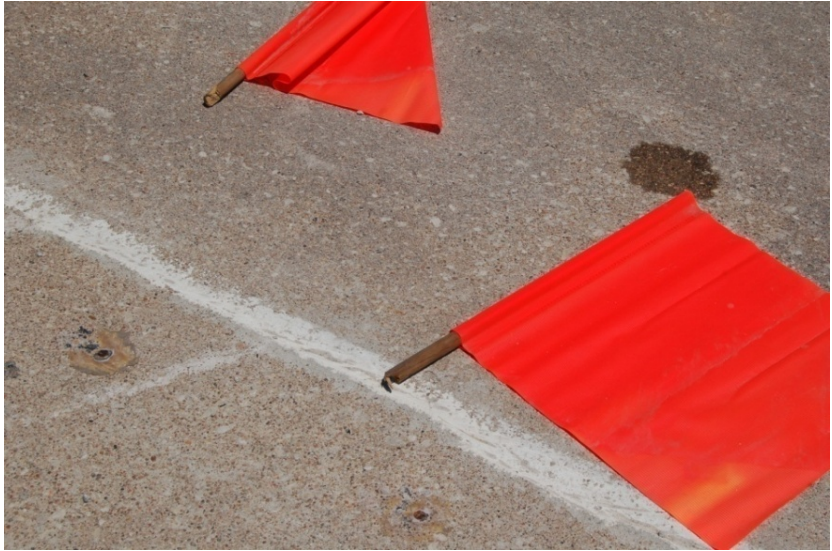
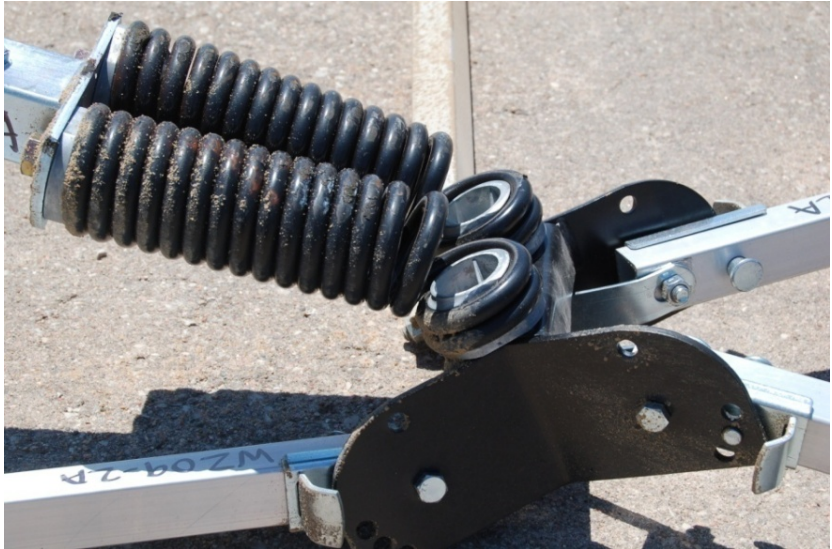
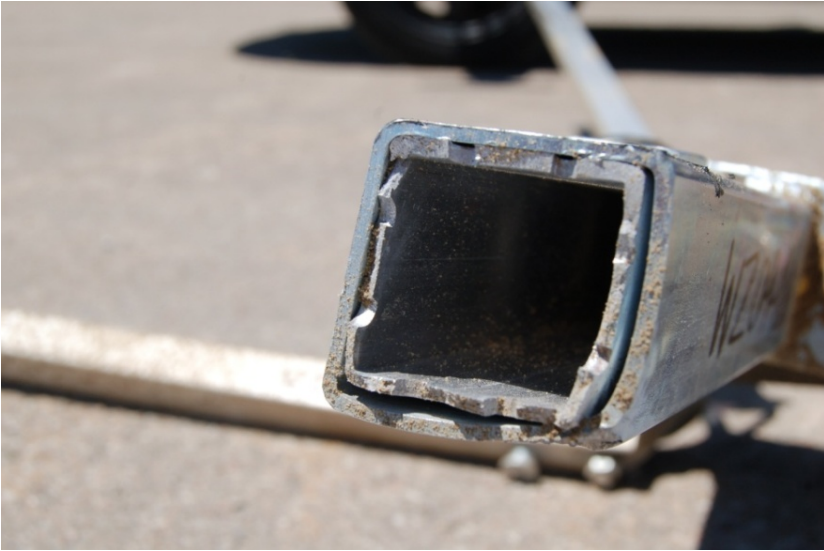
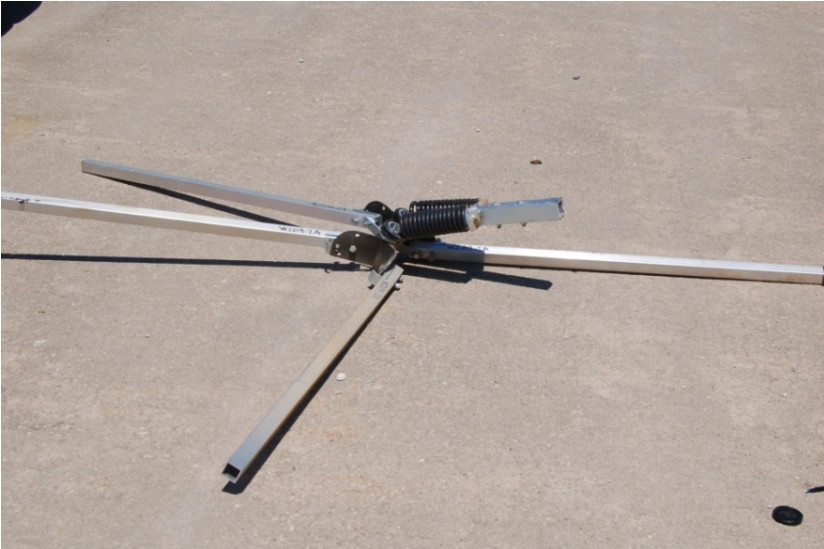
Figure 67. System Damage, Test No. WZ09-2A

Damage to System Nos. 2A and 2B is shown in Figures 67 through 70. System No. 2A encountered severe damage to the sign support stand. The lower mast fractured at the breakaway holes and landed upstream of the impact. The base, with all four legs attached, remained intact under the car. The angled plate attaching two of the legs was bent and torn at one of the bolt holes. The other angled plate's corner was deformed and crushed from dragging. Both coil springs were significantly deformed and bent over. The upper rigid bracket deformed out. The flag holders were slightly bent, and the bottoms of two flag staffs were fractured. The upper mast was bent slightly. The lower rigid bracket was slightly deformed out. The sign panel was deformed out with a crease at the top corner from the rigid panel bracket.
