# Analysis of Existing Work-Zone Devices with MASH Safety Performance Criteria

**Final Report**  
**February 2009**

MwRSF Research Report No. TRP-03-225-10

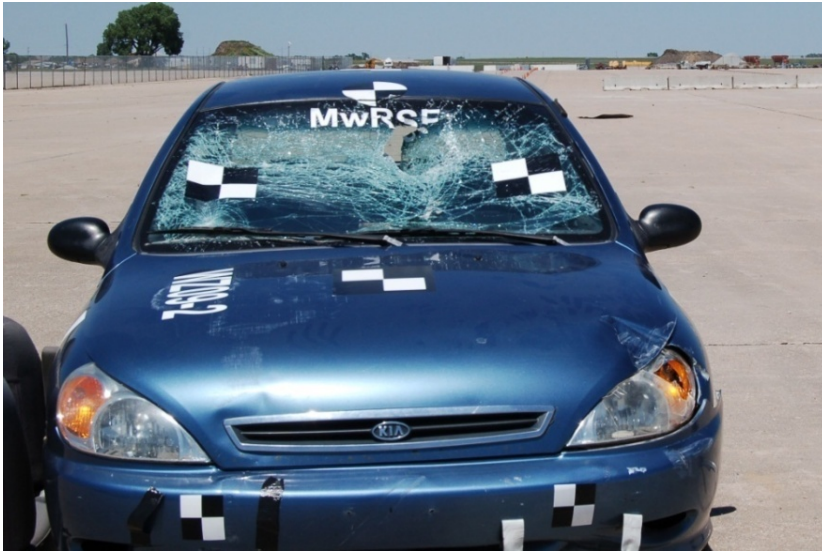
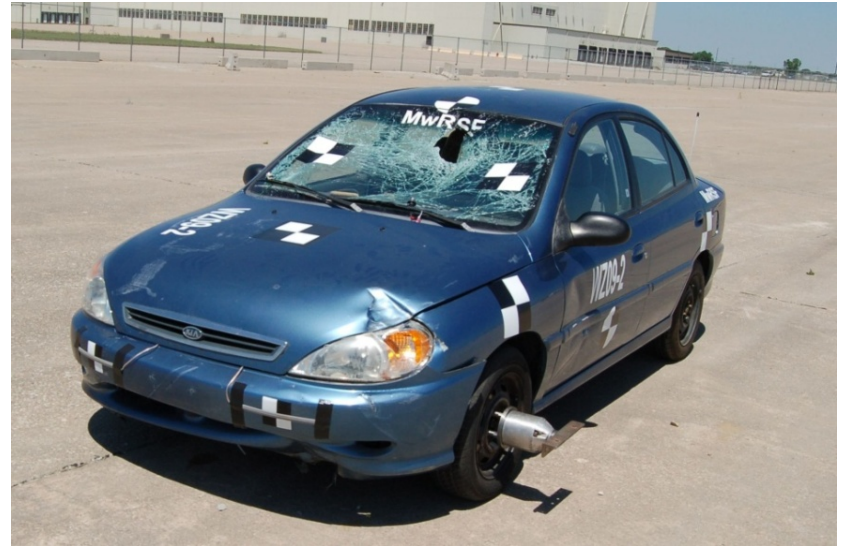
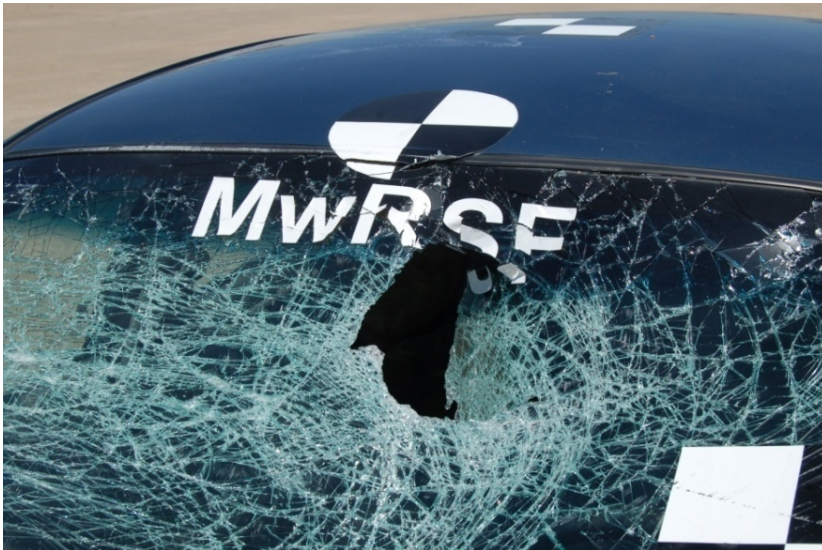
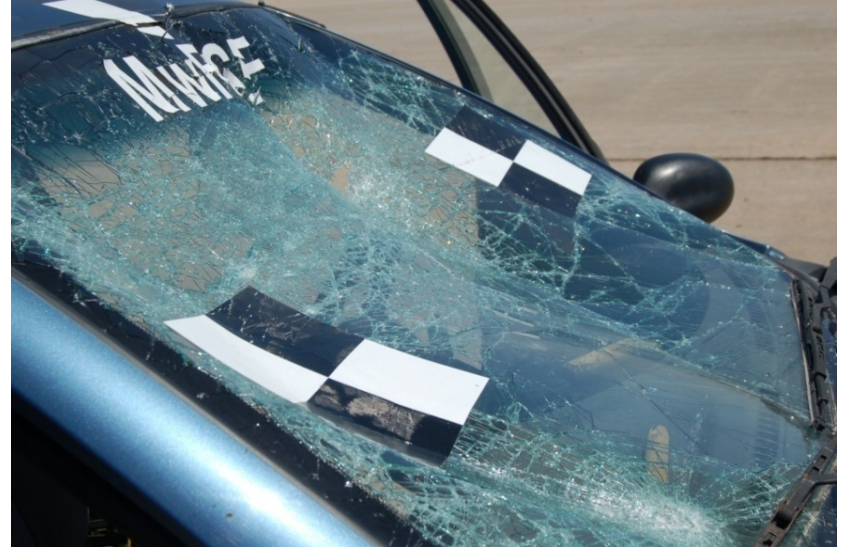
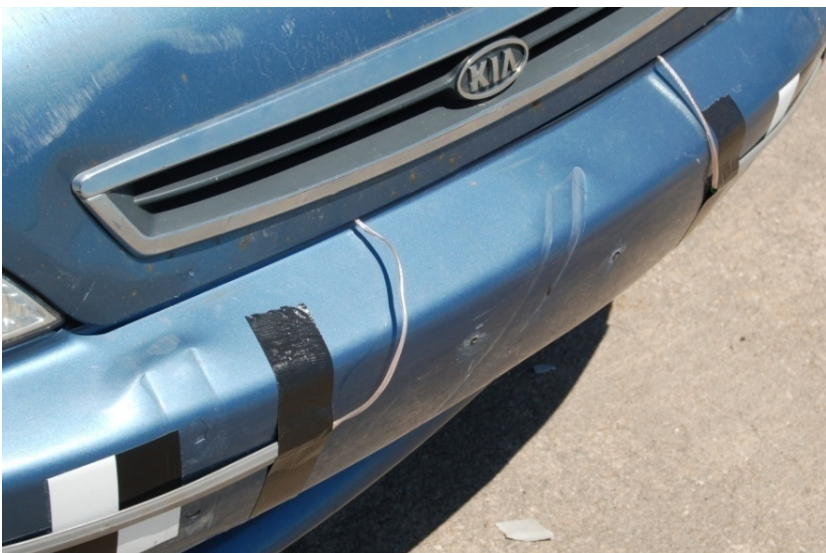
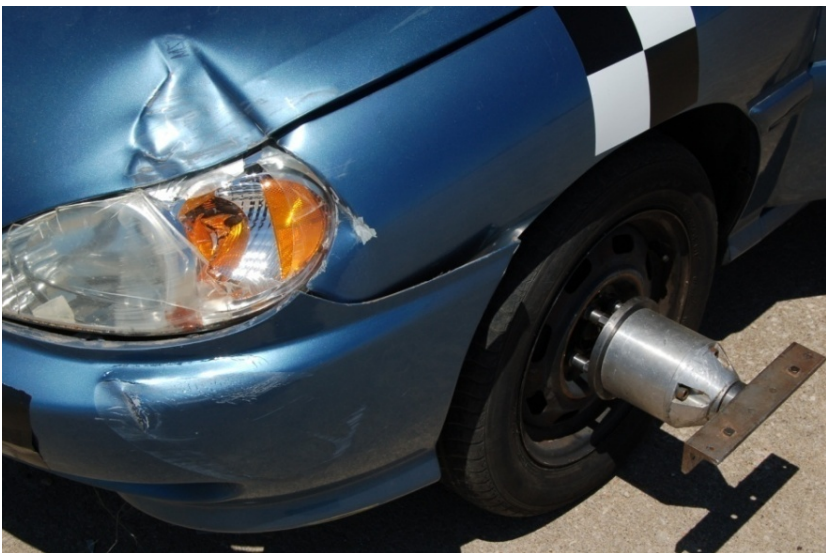
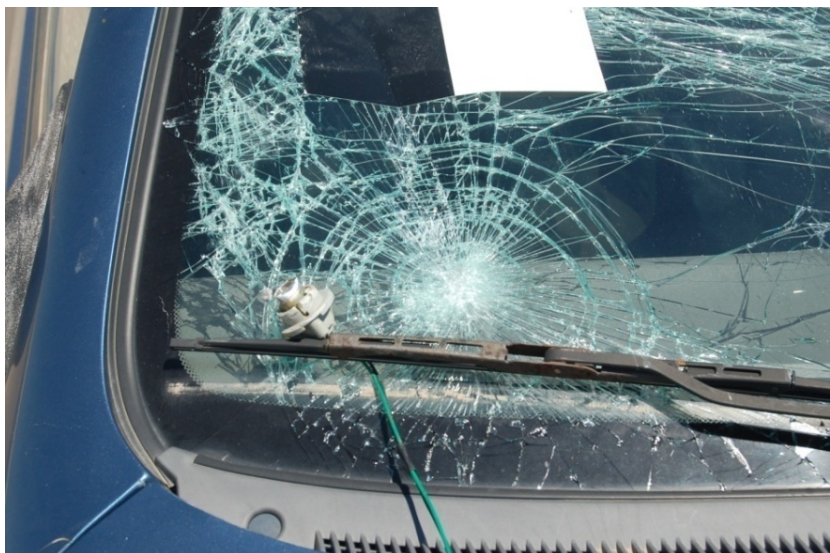
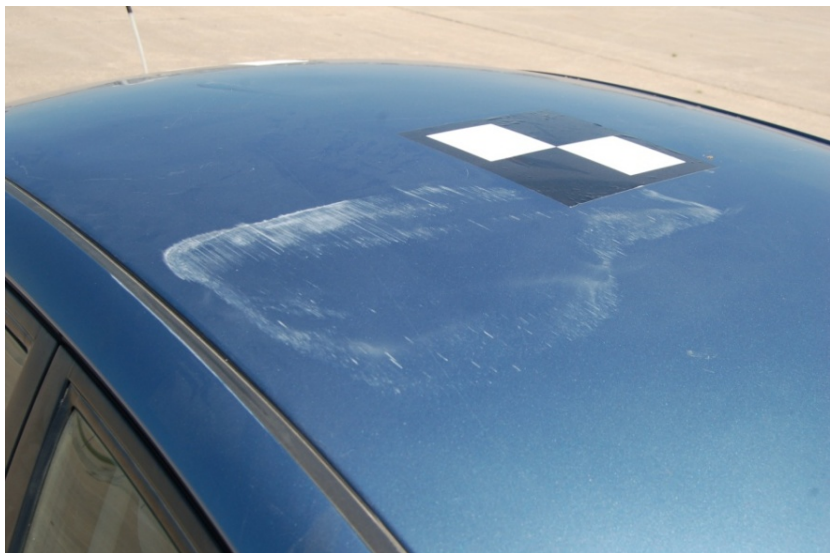
Figure 71. Vehicle Damage, Test No. WZ09-2

Vehicle damage is shown in Figures 71 and 72. The left side of the front plastic bumper was scuffed and cut where it contacted System No. 2B, and it was deformed outward from the left-front quarter panel. The lower-left side of the plastic bumper was deformed backward and torn. The left headlight was fractured. The left-front quarter panel was dented at the front. The left-front corner of the hood was deformed down. The right side of the engine hood and roof were scuffed from the sign panel of System No. 2A. A concentrated point of impact was found at the bottom-right corner of the windshield from the flash bulb deforming into the windshield. A large hole was found at the top of the windshield slightly to the left of center where the upper rigid bracket and mast of System No. 2B impacted. The entire windshield encountered cracking with severe cracking at the upper half of the windshield. The rearview mirror disengaged from the windshield, and glass was found on both the front and back seats.

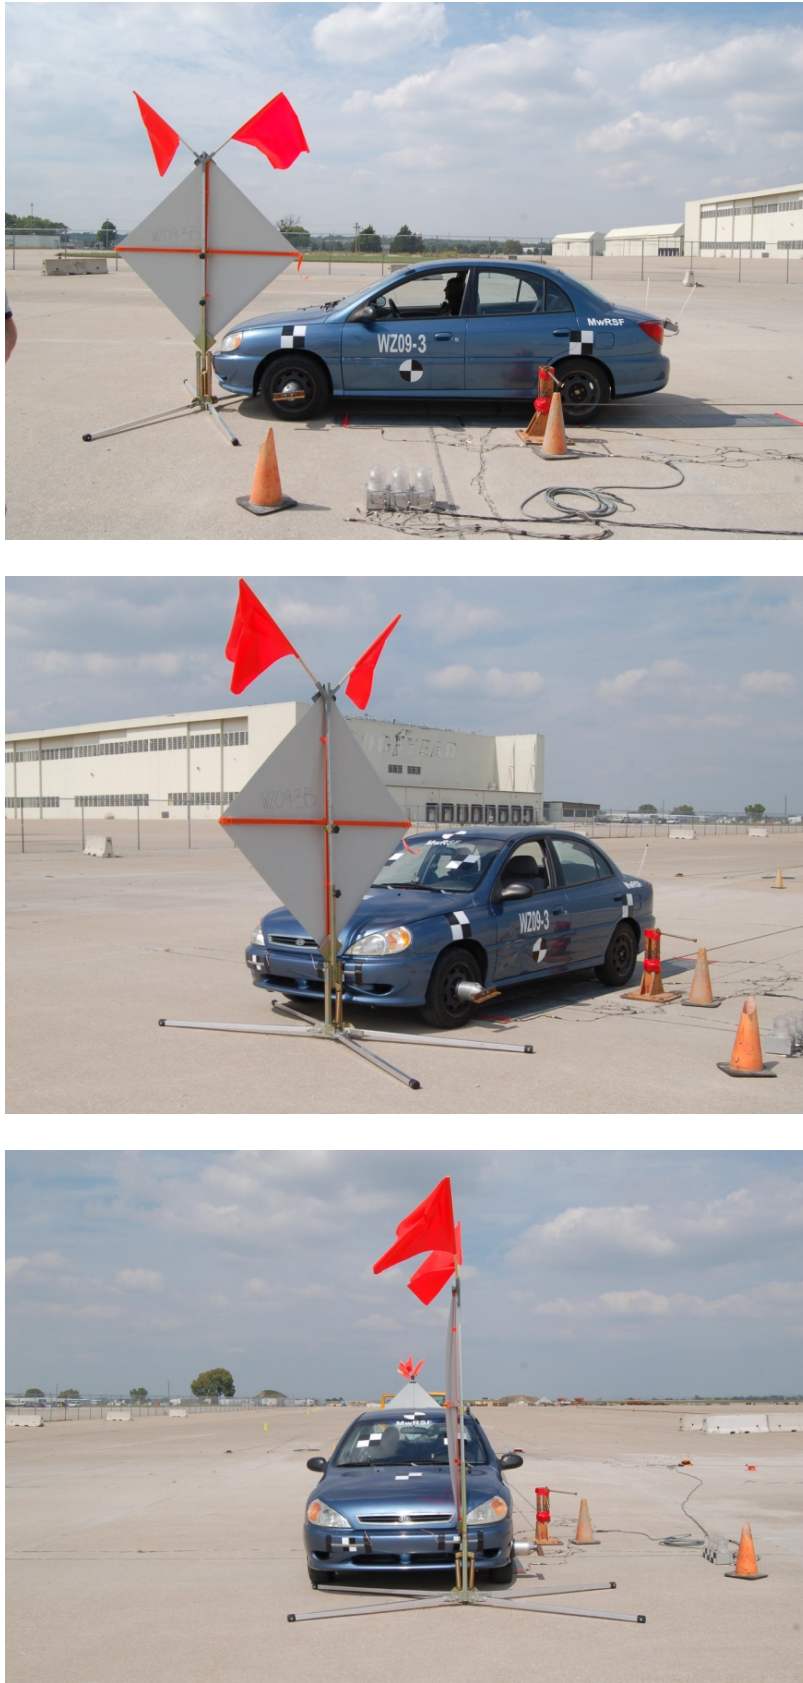
Figure 80. Impact Location, Test No. WZ09-3B

vehicle impact was to occur with the centerline of the mast at the left-side quarter point on the car's bumper, as shown in Figure 80. The actual point of impact was at the left-side quarter point.

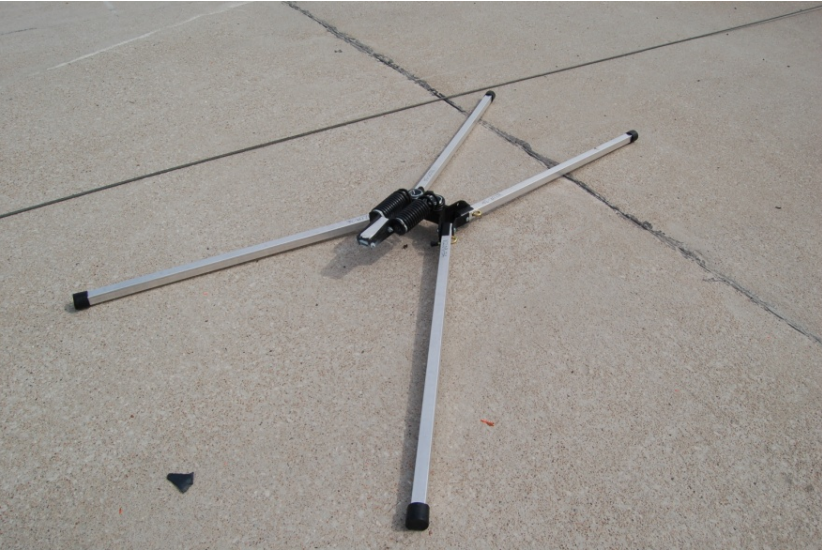
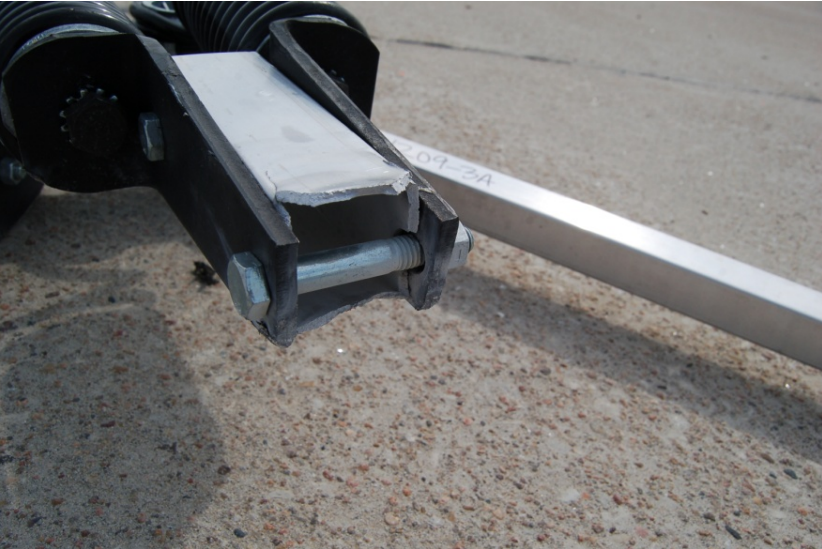
Figure 82. System Damage, Test No. WZ09-3A

Damage to System Nos. 3A and 3B is shown in Figures 82 through 85. System No. 3A encountered moderate damage. The three flags released from the flag holder. Both springs were deformed to a horizontal position. The front of base plate deformed inward, and the front legs were pushed closer together. The lower mast completely fractured at the top of bolt side plates and was crushed at the fracture point. The lower mast aluminum was torn below the fracture point at one corner. The sign panel remained intact with the car, and reflective material was scraped on the front face. The sign panel was also deformed outward with a small hole near the top. Damage to the concrete surface around the original location of System No. 3A included gouges 2½ ft (0.8 m) downstream of the impact, where the bottom part of the lower mast contacted the concrete.

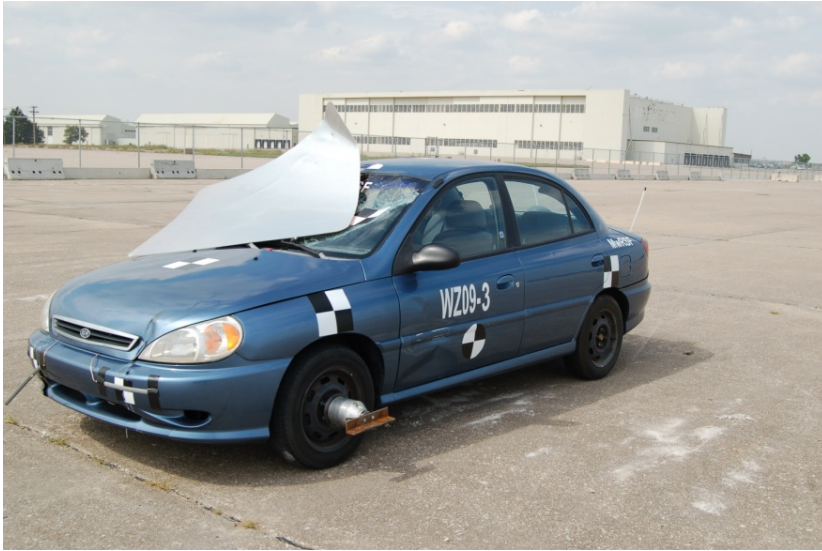
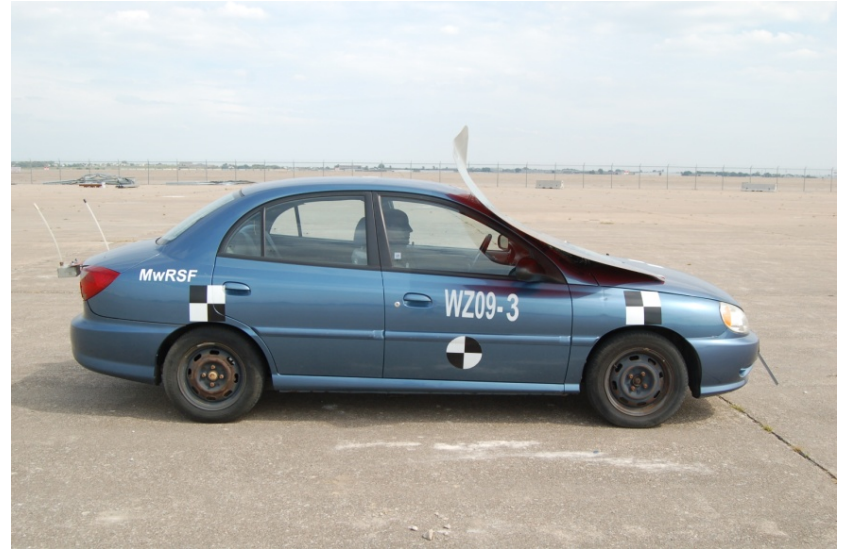
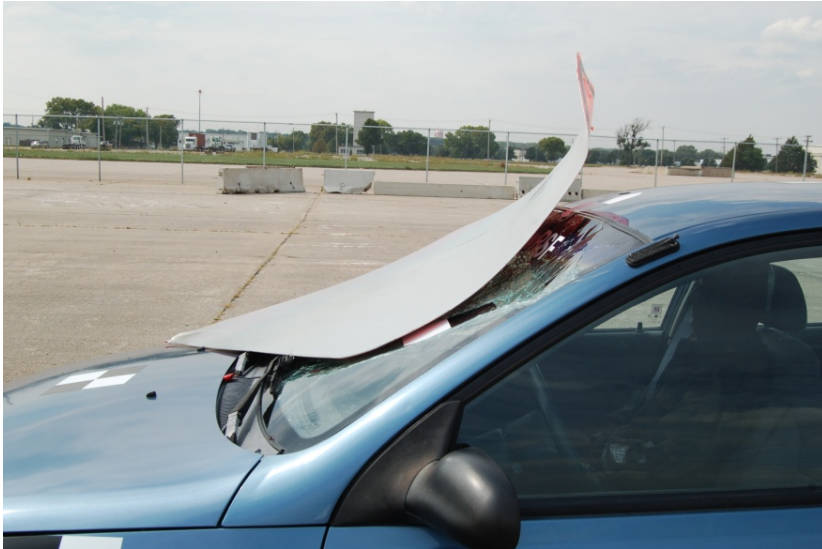
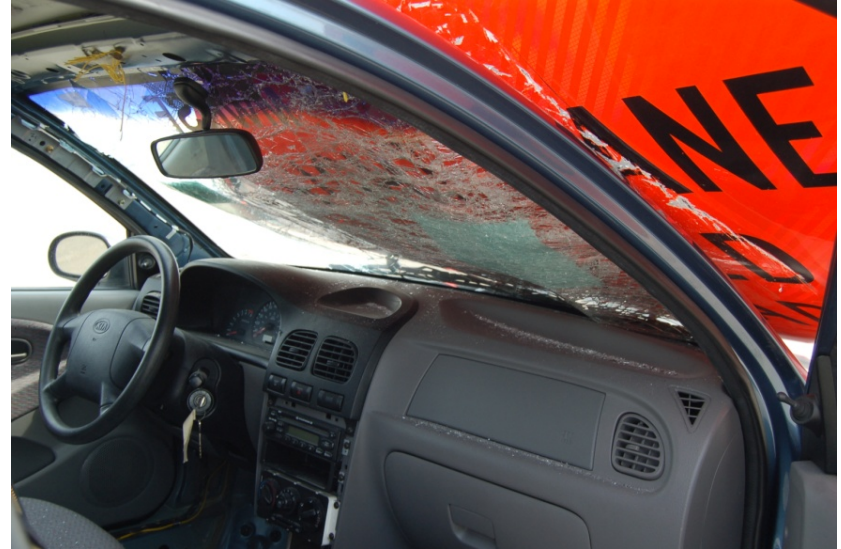
Figure 86. Vehicle Damage, Test No. WZ09-3

Vehicle damage is shown in Figures 86 and 87. The lower and upper plastic front bumpers were fractured at both the left- and right-side impact locations. The bolts underneath the car were scuffed on the left and right sides. The left front of the engine hood was dented and scraped, and black scuff marks were found on the left side of the hood. Minor scraping occurred along the right side of the hood. Significant windshield cracking occurred with a concentrated point of impact from the right-side flash bulb deforming into the windshield. Orange reflective material was embedded in the windshield cracks on the right side. A hole was found in the upper-middle region of the windshield where the rearview mirror was attached. A small scrape was found on the right-front roof, and minor scuffing occurred along the right side of the roof.

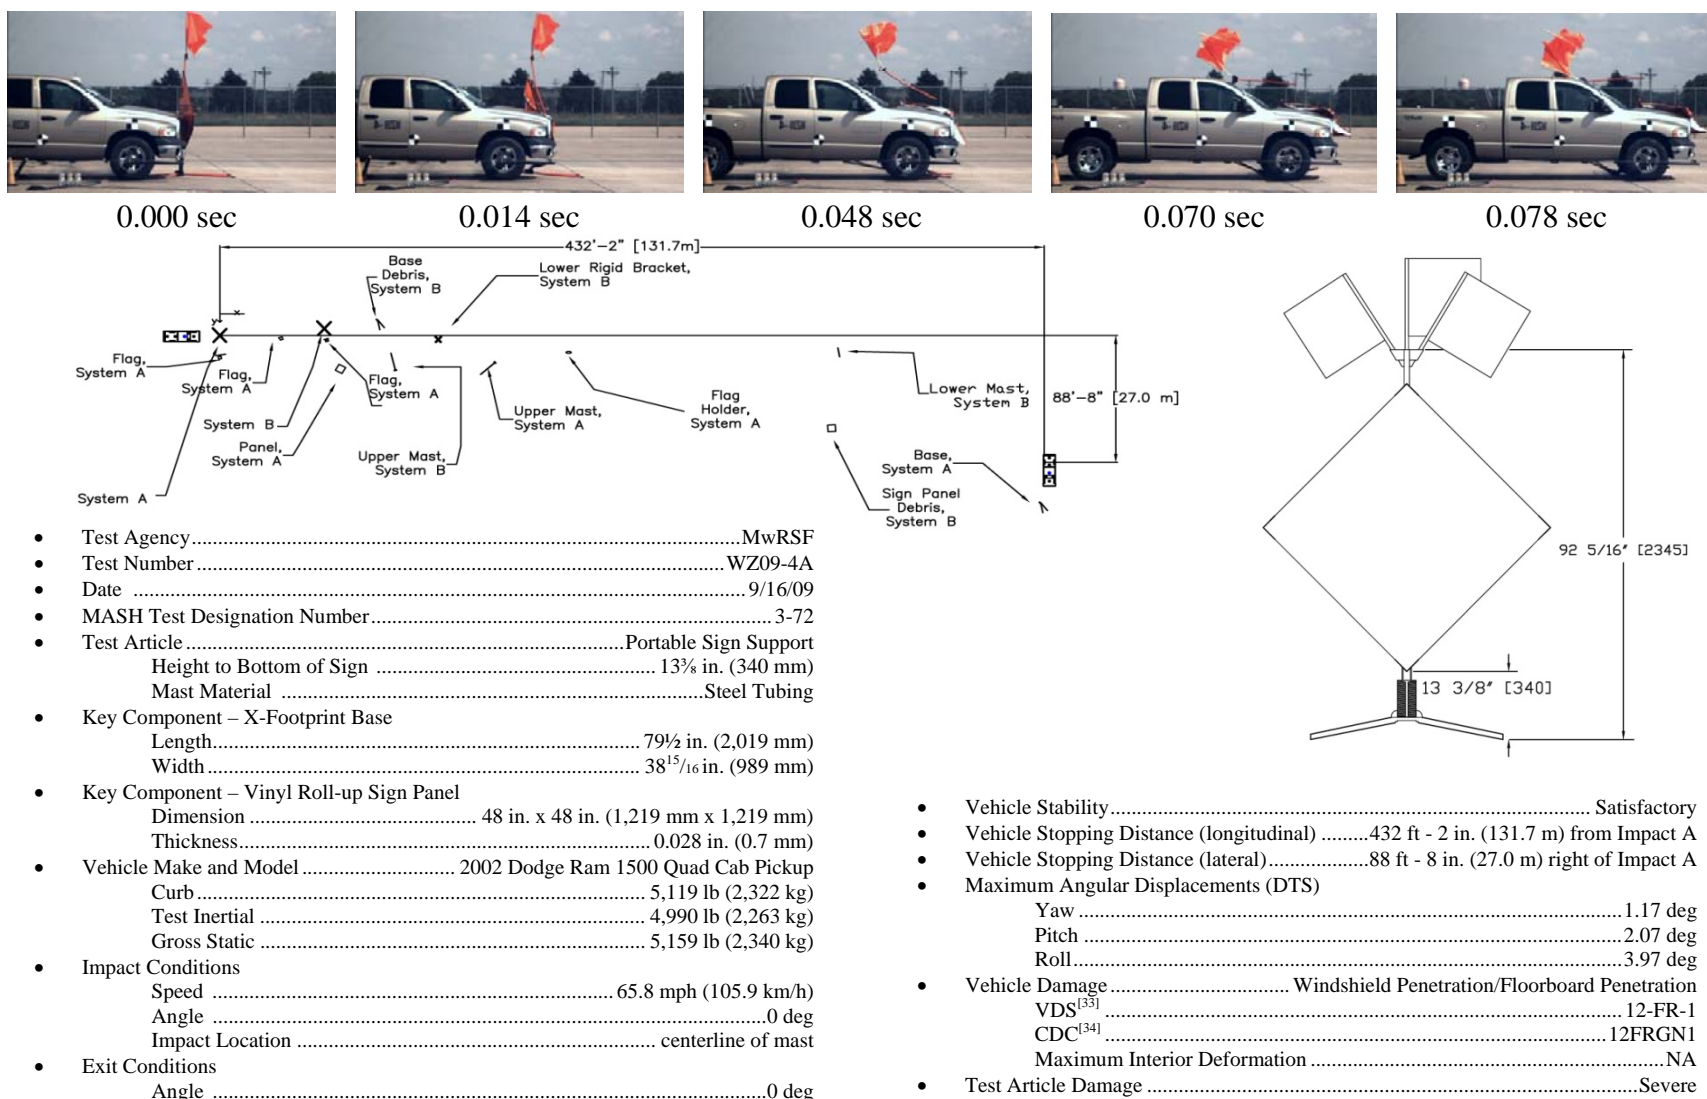
Figure 88. Summary of Test Results and Sequential Photographs, Test No. WZ09-4A

Following test no. WZ09-4, a safety performance evaluation was conducted, and the performance of System No. 4A was determined to be unacceptable according to the MASH criteria. It was deemed unacceptable due to the mast penetrating the windshield and a leg penetrating into the occupant compartment. Deformations of, and intrusion into, the occupant compartment did occur as System No. 4A penetrated into the upper-right corner of the windshield and the occupant compartment on the floorboard behind the left-front seat. Also, one of the legs on System No. 4A was wedged behind the right-front tire which inhibited the braking system on the pickup truck. This caused the pickup truck to veer to the right and impact a concrete barrier prior to stopping. This result could be considered a danger to workers in the work-zone area as well as to the occupants of vehicle depending on what objects would have been located to the right side of the roadway.

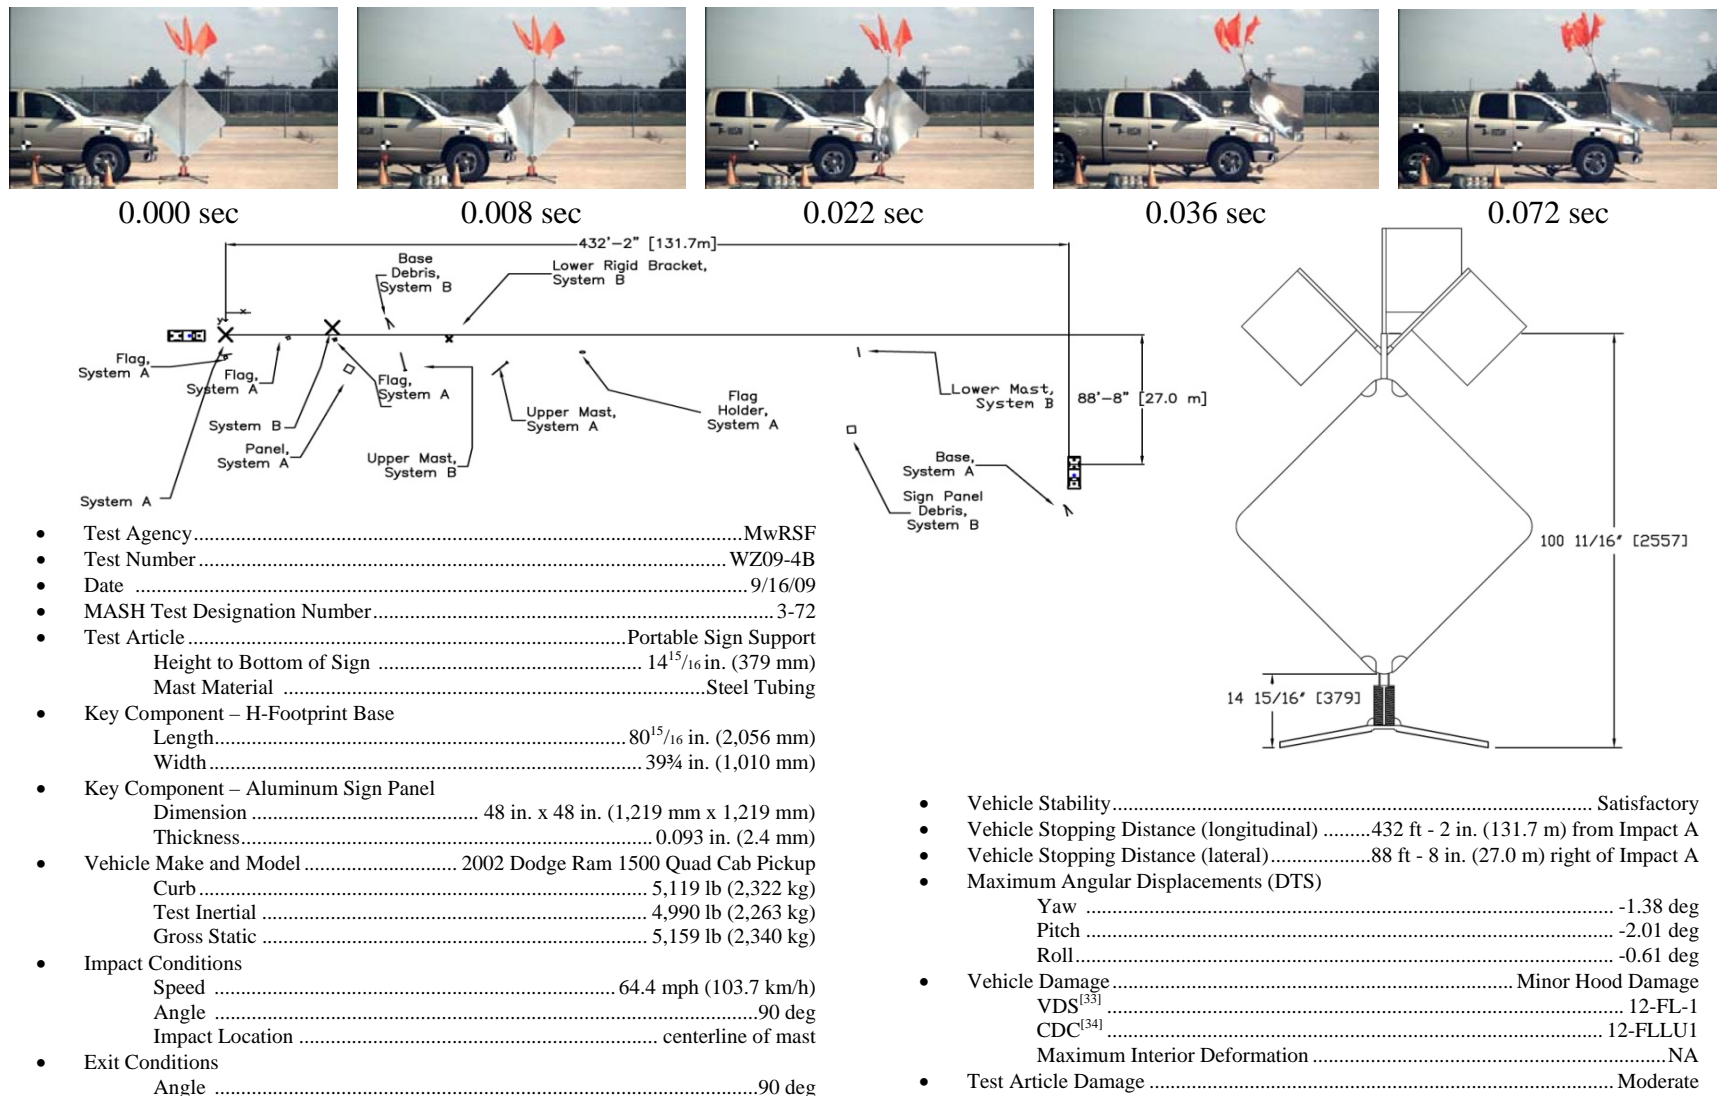
Figure 89. Summary of Test Results and Sequential Photographs, Test No. WZ09-4B

System No. 4B was determined to be acceptable according to the MASH criteria since the components of System No. 4B did not contact the pickup truck's windshield or roof. Deformations of, and intrusion into, the occupant compartment did not occur, and System No. 4B did not show any potential for occupant compartment penetration. The impact with System No. 4B did not affect the vehicle's trajectory.

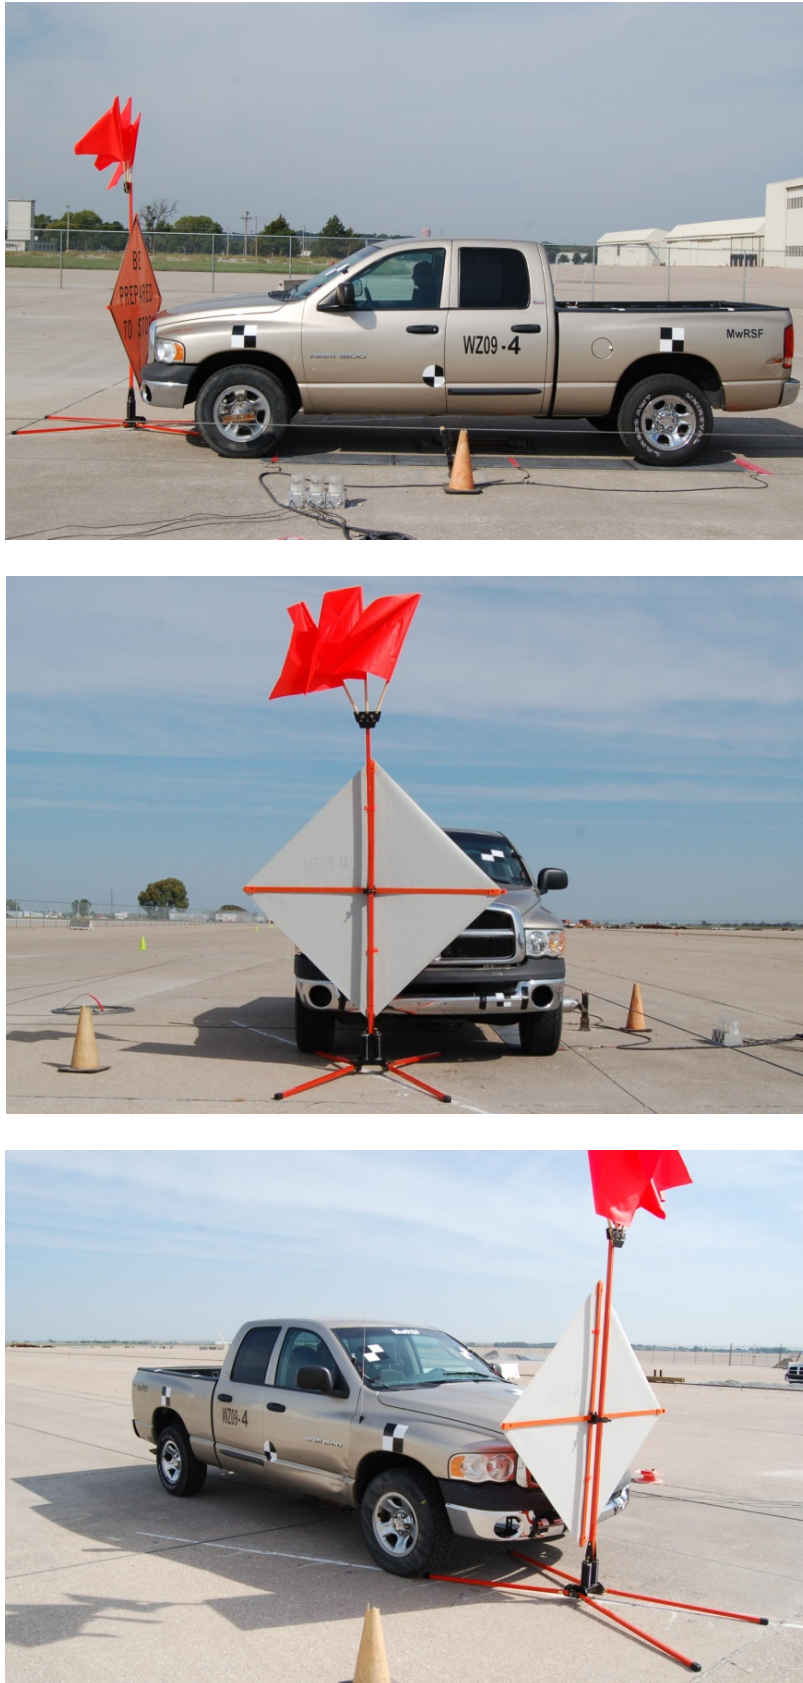
Figure 93. Impact Location, Test No. WZ09-4A

For System No. 4A, initial vehicle impact was to occur with the centerline of the mast at the right-side quarter point on the pickup truck's bumper, as shown in Figure 93. The actual point of impact was 1½ in. (38 mm) to the left of the right-side quarter point. For System No. 4B,

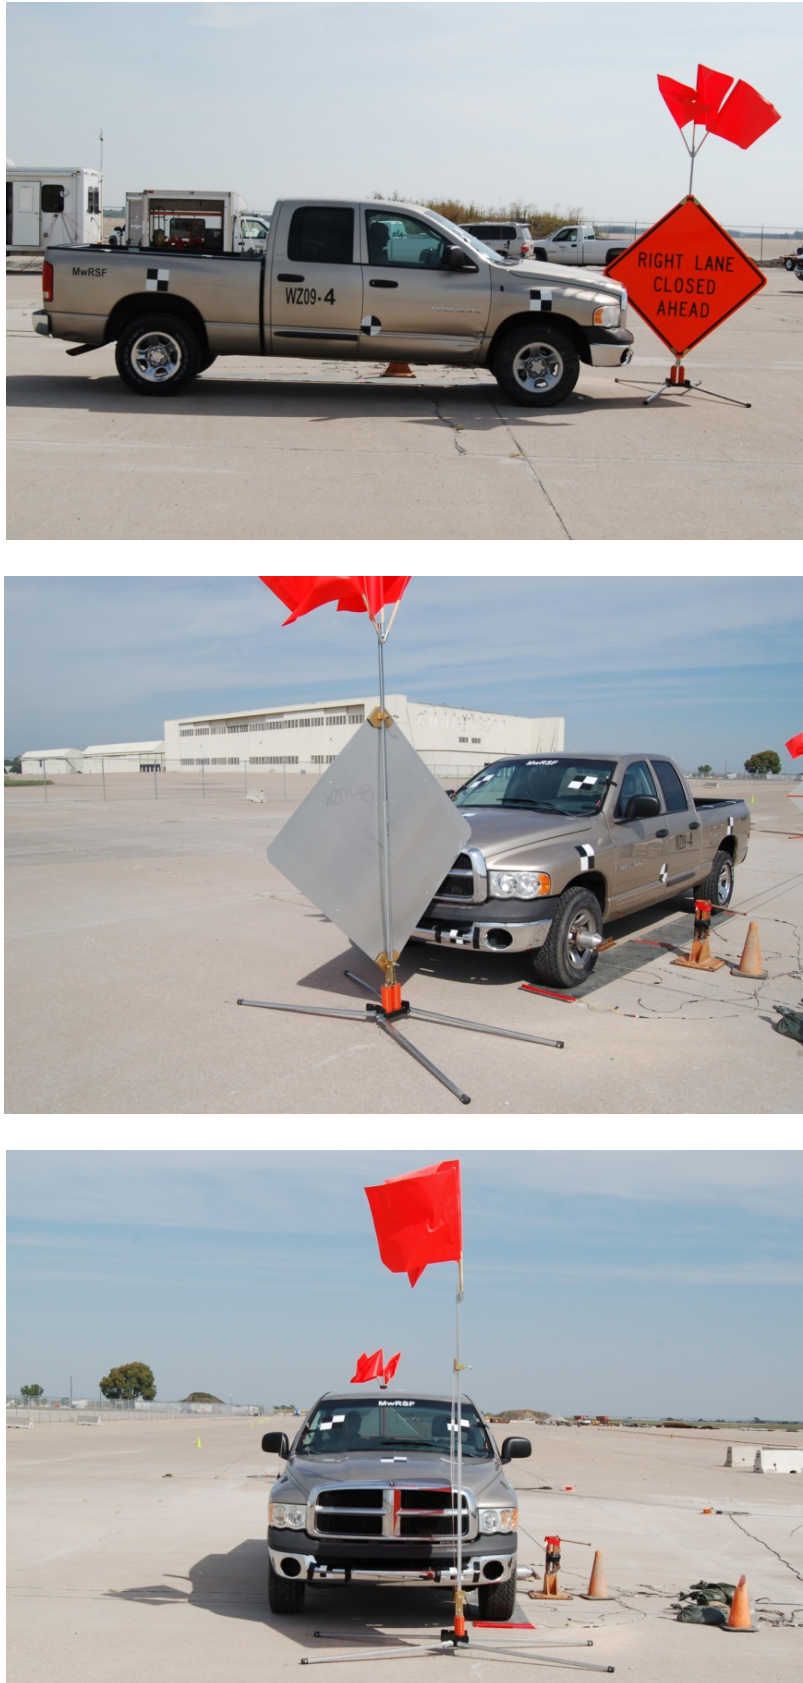
Figure 94. Impact Location, Test No. WZ09-4B

initial vehicle impact was to occur with the centerline of the mast to the right of the left-side quarter point on the pickup truck's bumper, as shown in Figure 94. The actual point of impact was 2 in. (51 mm) to the right of the left-side quarter point.

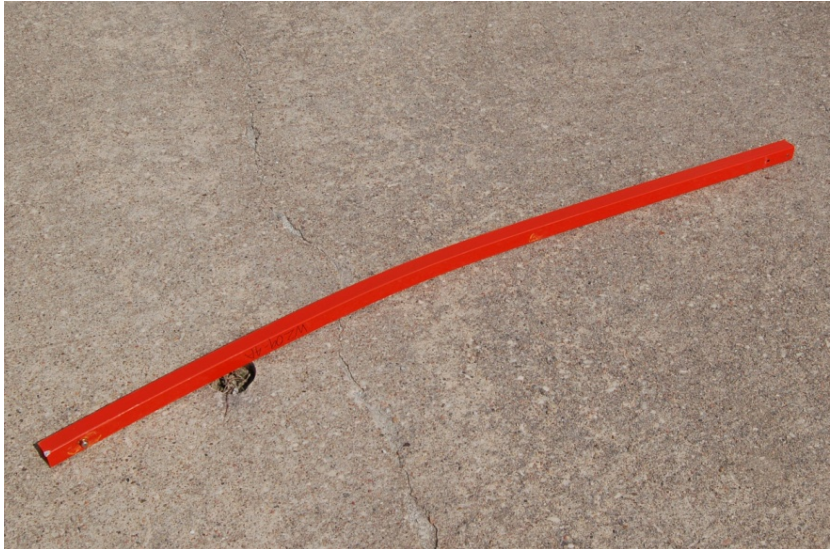
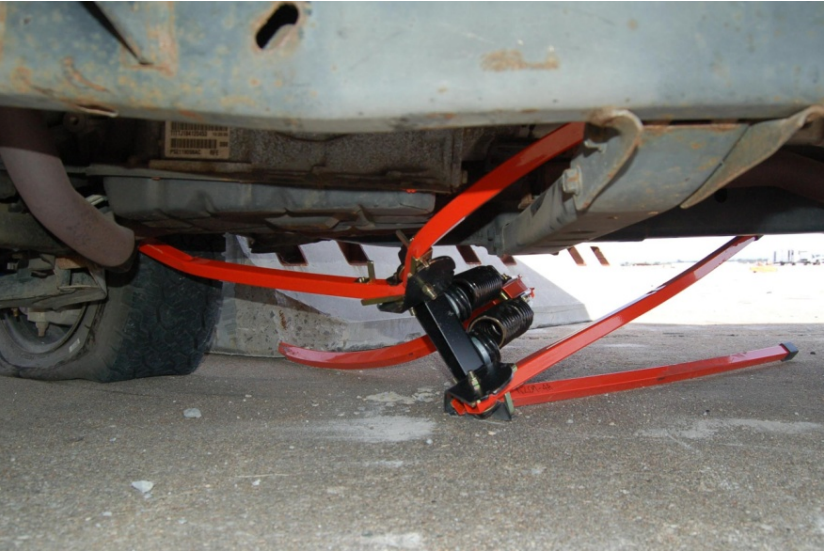
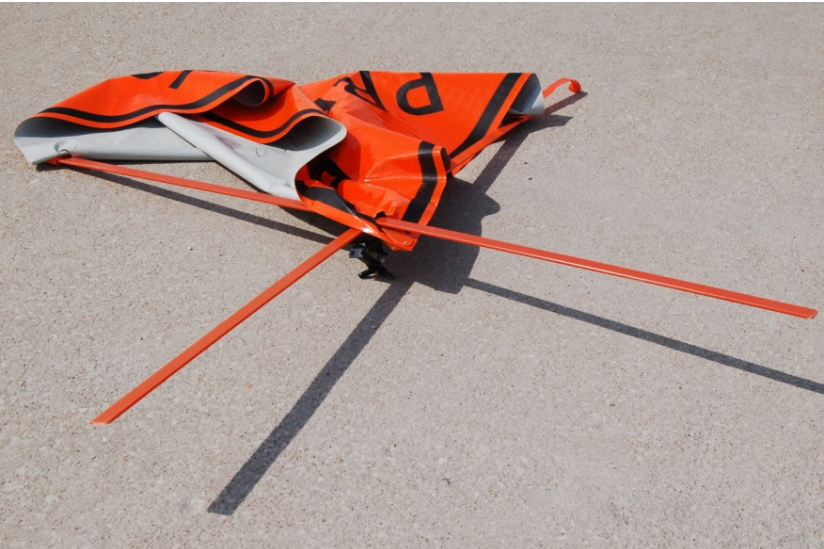
Figure 96. System Damage, Test No. WZ09-4A

Damage to System Nos. 4A and 4B is shown in Figures 96 through 99. System No. 4A encountered severe damage. All three flag staffs fractured at the top of the flag holder, and the ends remained intact with the flag holder. The vertical crossbracing tore through the top of sign panel. The upper mast was bent slightly and separated from the lower mast. The flag holder separated from the upper mast and had scratches and denting on one corner. The base was carried underneath the truck the entire time. One leg penetrated the floorboard and was bent significantly. One leg was wedged behind the right-front wheel and was bent slightly. The lower mast almost completely fractured 1½ in. (38 mm) above the top bent plates. The springs deformed to a horizontal position and were scraped on their sides. All legs released from their original lock positions.

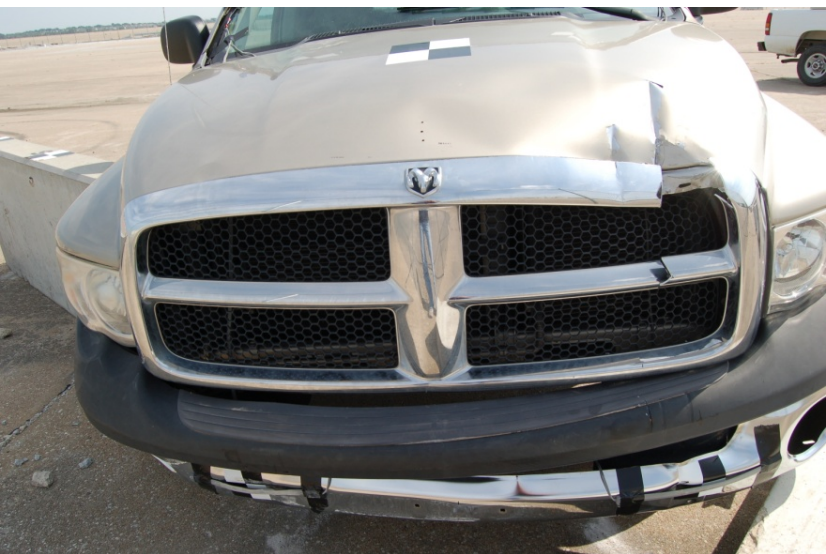
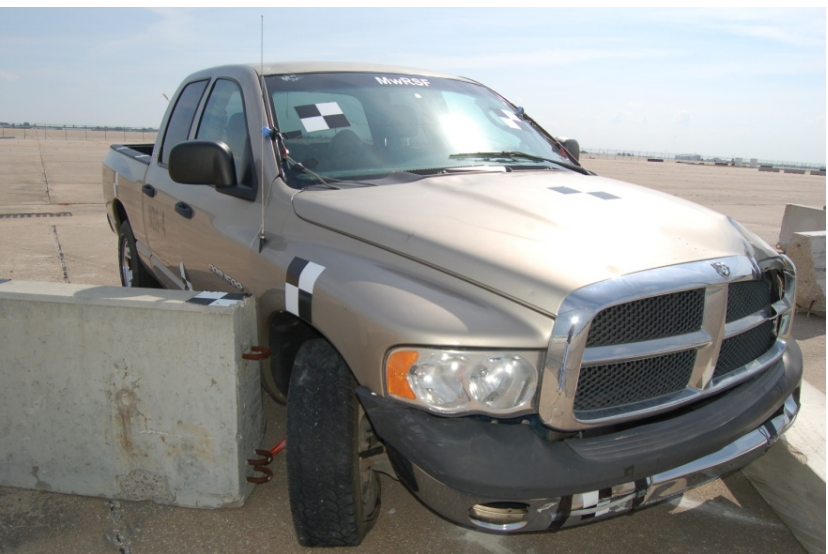
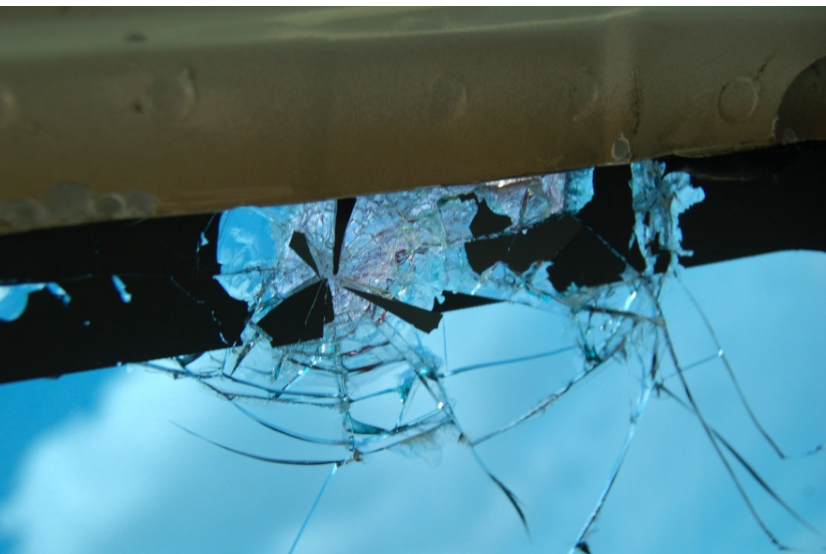
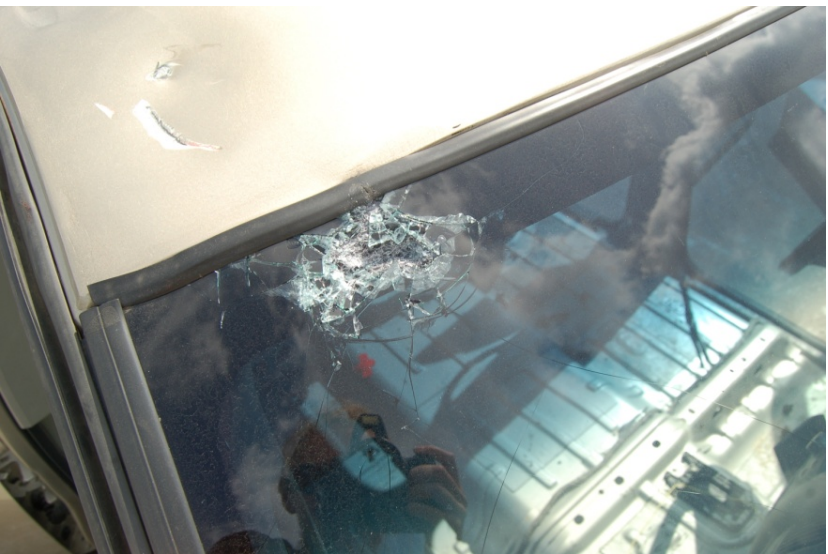
Figure 100. Vehicle Damage, Test No. WZ09-4

Vehicle damage is shown in Figures 100 and 101. The bumper was dented inward where it contacted System No. 4A and where it contacted System No. 4B. The grill was sliced at the upper-left region. The left front of the engine hood was dented inward and sliced. Scraping occurred on the right-front corner of the hood. A small dent was found in the right-front corner of the hood, and a scratch was found down the right side of the hood. A concentrated tear occurred in the upper-right corner of the windshield where it was contacted by the flag holder from System No. 4A. Two hairline cracks were found beginning at the lower-left corner of the windshield and spanning to the upper-right corner of the windshield. A dent and a scratch were found at the right-front region of the roof. A small hole was found in the floorboard on the left side with one of the legs of System No. 4A protruding through it. The right-front tire was deflated, and one leg of System No. 4A was wedged behind the right-front tire. The front bumper was pushed down and scuffed from a secondary impact with a concrete barrier prior to stopping.

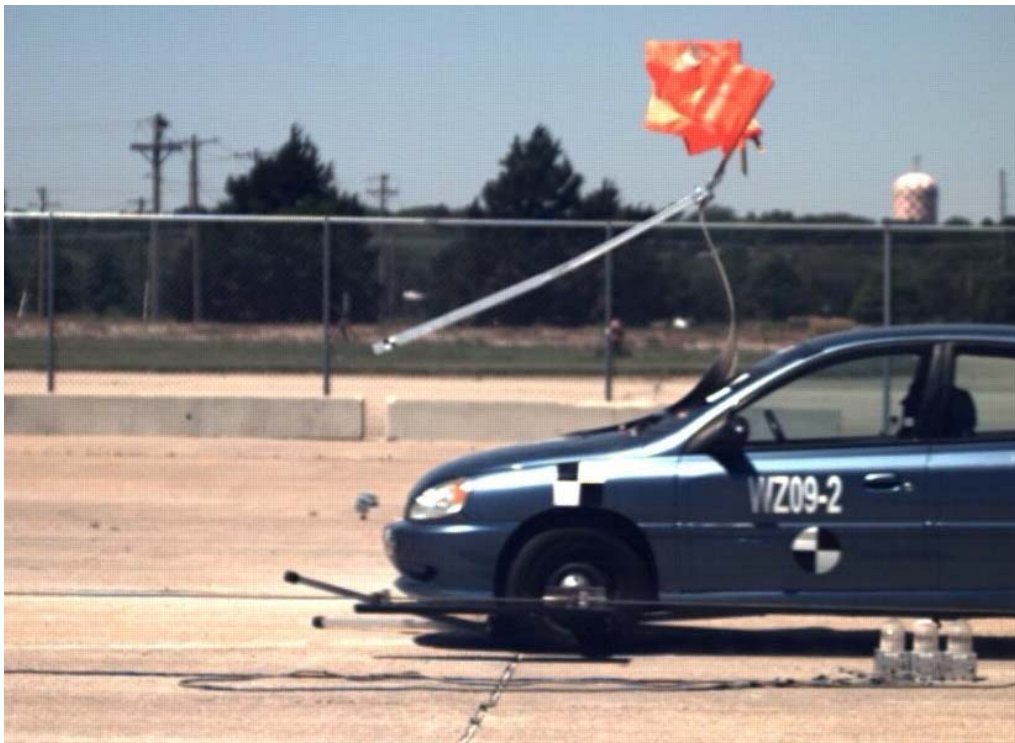
Figure 103. System No. 3A, Frangible Mast

A mast with a frangible base reduces the amount of flex that develops in the sign panel and mast (System Nos. 1A, 2A, 3A, and 4A). This relatively quick release of the mast from the stand allows the sign panel and mast to fall upon the vehicle with little additional force than what normally occurs through the impact event, as shown in Figure 103. However, this force can still be sufficient to cause indentation or penetration of the windshield. On the other hand, when base bending occurs, as shown in Figure 104, the sign panel and the top of mast are accelerated downward into the windshield (System No. 1B). When the mast was unloaded, the sign panel and mast have the tendency to "whip" downward onto the vehicle. In addition, a base-bending

mast typically releases from the stand late in the event, if at all, which adds to the amount of flex in the sign panel and mast. When the mast bends or has a delayed fracture, it is more likely that the sign panel or flag assembly will impact the windshield at a high rate of speed. When the connection between the upper and lower masts fails upon impact, the mast and sign panel cause insignificant damage (System Nos. 3B and 4B).

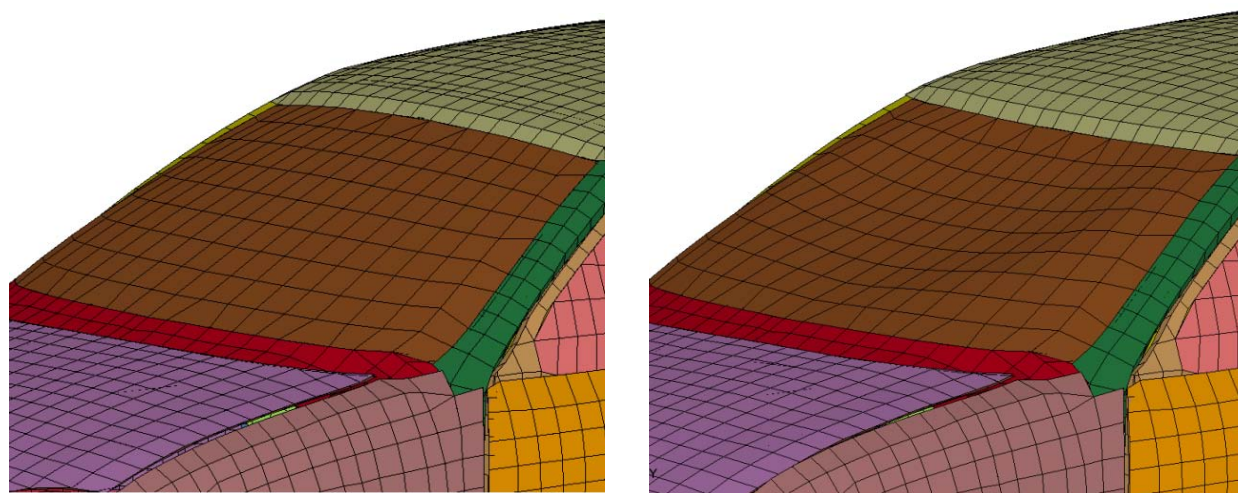
Figure 117. Windshield Deformation

Although the windshield material model was believed to be inaccurate in predicting deformations, the windshield deformed similar to what was found in test no. WZ09-2A. A comparison of the deformation in the simulation is shown in Figure 117. The vertical displacement of the windshield was compared over time, as shown in Figure 118. The maximum vertical deformation in the simulation was 2.24 in. (56.8 mm). The maximum windshield deformation in the full scale crash test was 2¼ in. (57 mm).
