# **CRASH TESTING OF MISSOURI'S W-BEAM TO THRIE-BEAM TRANSITION ELEMENT**

## **MIDWEST ROADSIDE SAFETY FACILITY**

MwRSF Research Report No. TRP-03-94-00

September 12, 2000

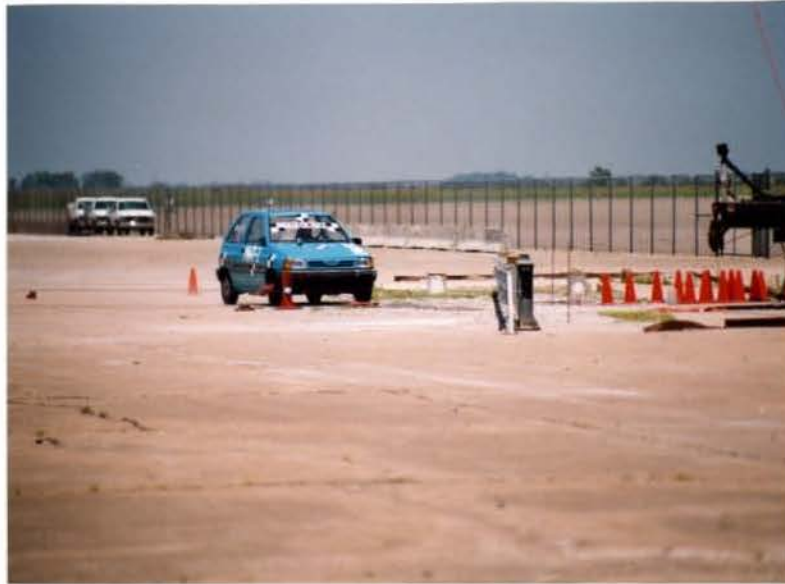
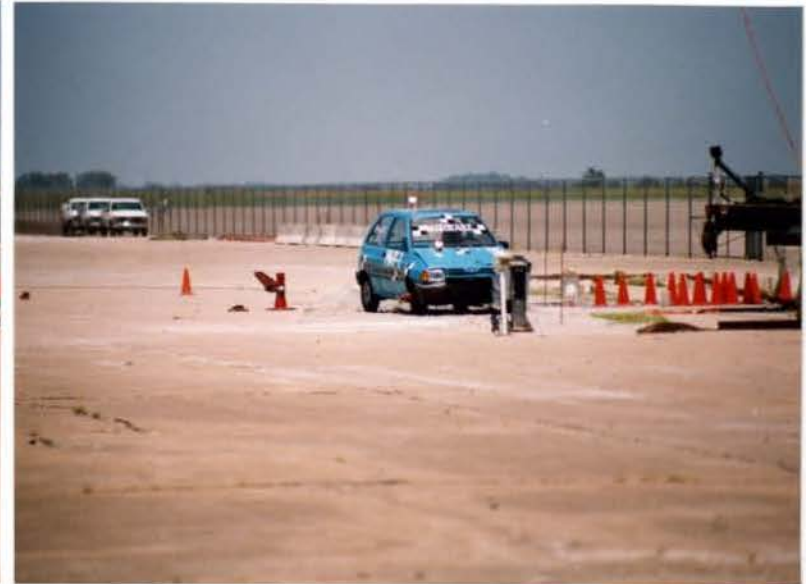
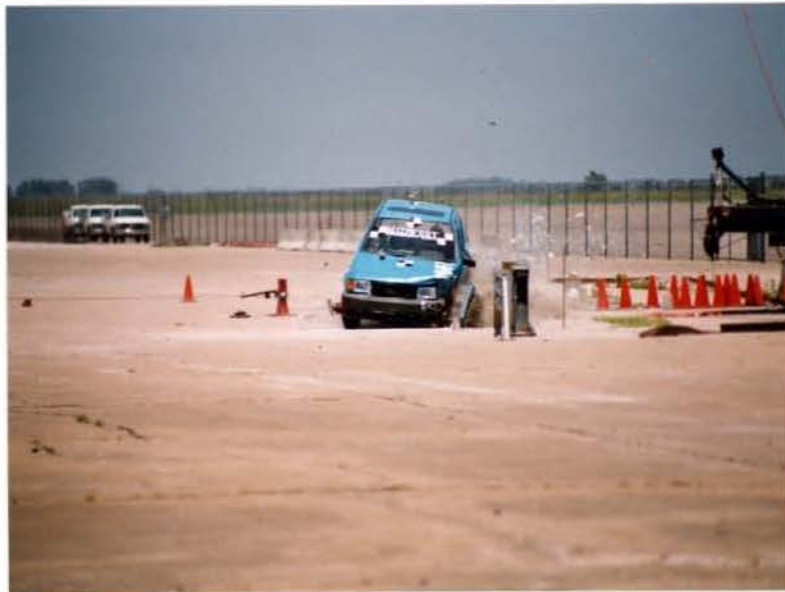
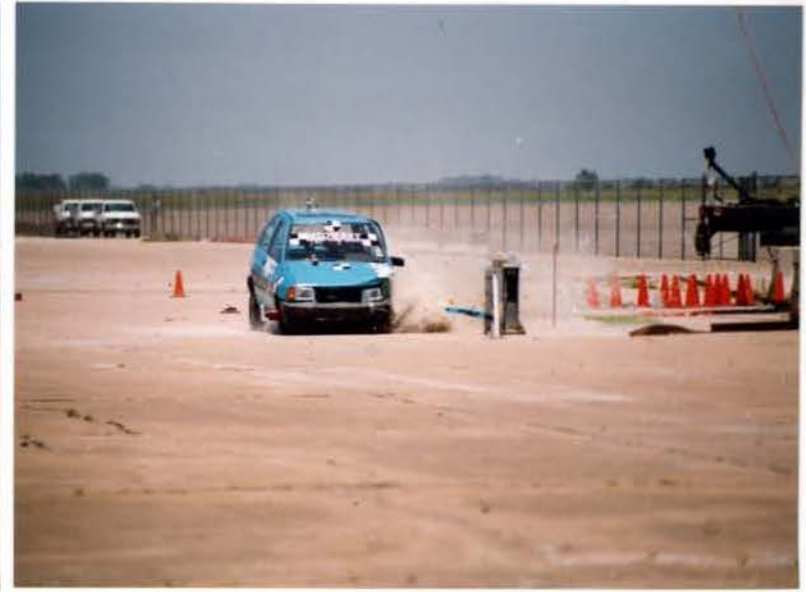
Figure 23. Documentary Photographs, Test MWT-1

The 896-kg small car impacted the guardrail system upstream from the W-beam to thrie beam transition element at a speed of 99.5 km/hr and an angle of 25.7 degrees. A summary of the test results and the sequential photographs are shown in Figure 21. Additional sequential photographs are shown in Figure 22. Documentary photographs of the crash test are shown in Figures 23 through 25.

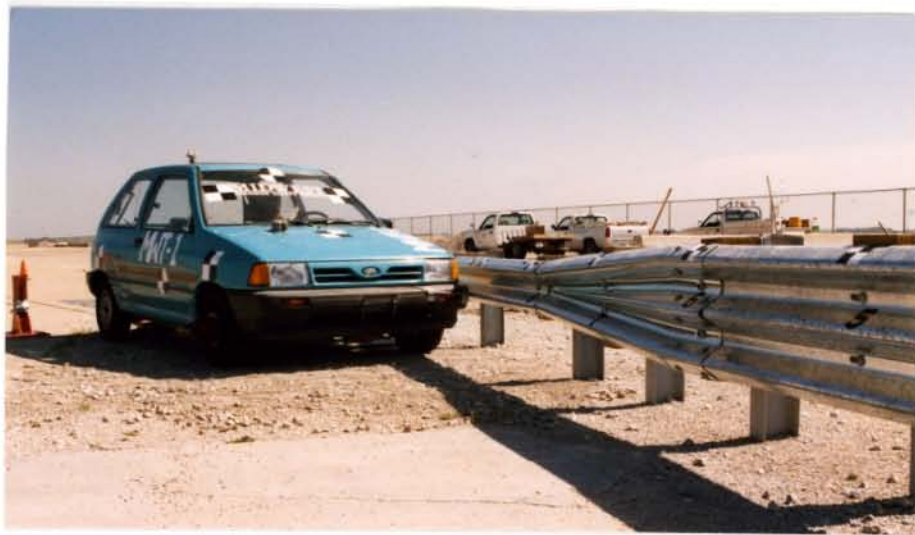
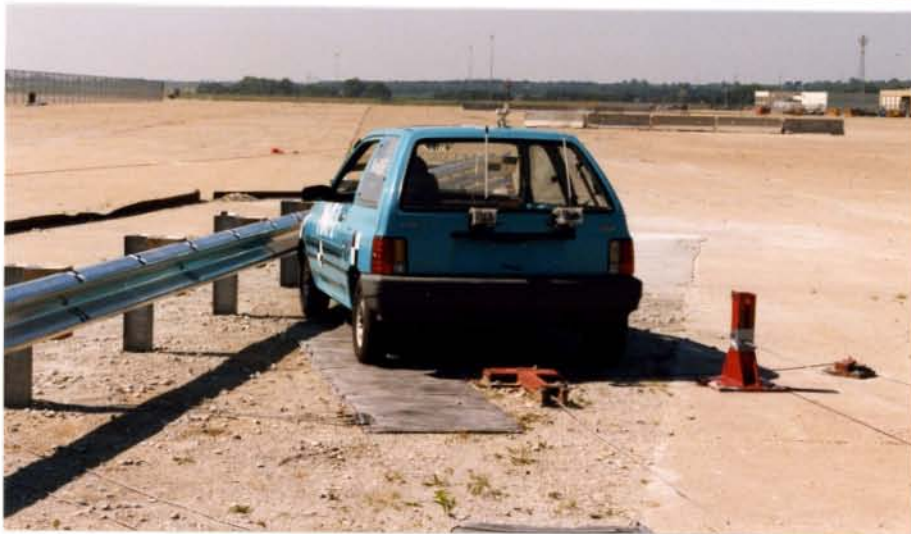
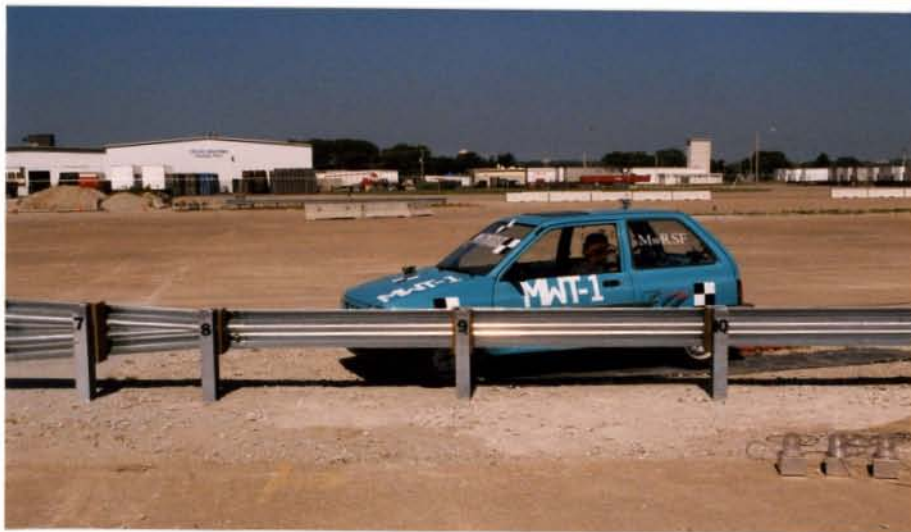
Figure 26. Impact Location, Test MWT-1

Initial impact occurred between post nos. 8 and 9 or 1,219-mm upstream from the center of post no. 8, as shown in Figure 26. At 0.040 sec after impact, the left-front corner of the vehicle was at post no. 8, and the hood began to bulge upward and separate from the fenders. At 0.052 sec, the left-front tire only rubbed across the face of post no. 8. At this same time, the left-front fender crushed inward toward the engine compartment, and the top of the left-side door separated from the top of the vehicle. At 0.081 sec, the left-front corner of the vehicle was at post no. 7. At 0.098 sec, the left-front tire wedged under the W-beam to thrie beam transition section, and the tire impacted the bottom of the wooden blockout at post no. 7 and snagged on post no. 7. At this same time, the left-side window shattered. At 0.113 sec, the left-front corner of the vehicle was at post no. 6. At 0.126 sec, the deformed left-front tire, still wedged under the rail, was at the midpoint between post nos. 6 and 7. At this same time, the front of the vehicle was downstream from post no. 6 and with the dummy's head protruding out of the left-door's shattered window. At 0.149 sec, the left rear of the vehicle contacted the guardrail with the rear bumper slightly upstream of post no. 8. At this same time, the shattered glass from the left-side door was flying away from the vehicle. At 0.150 sec, the

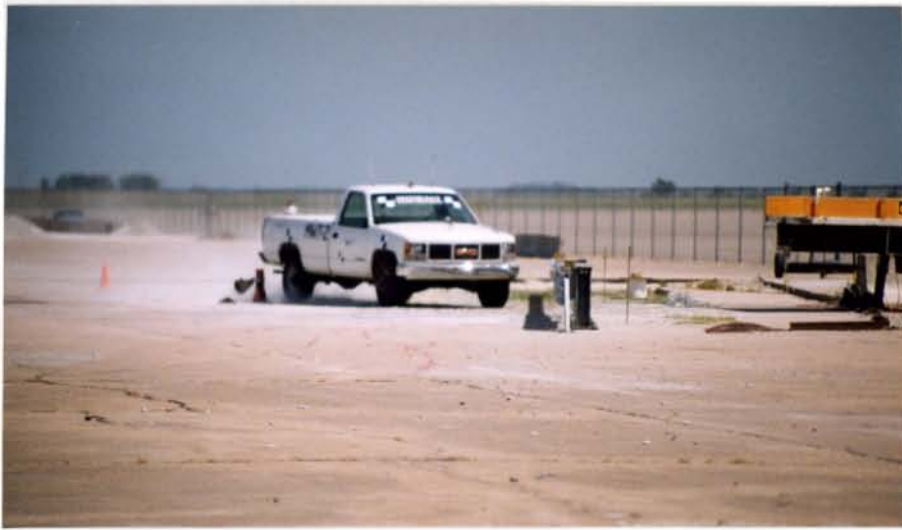
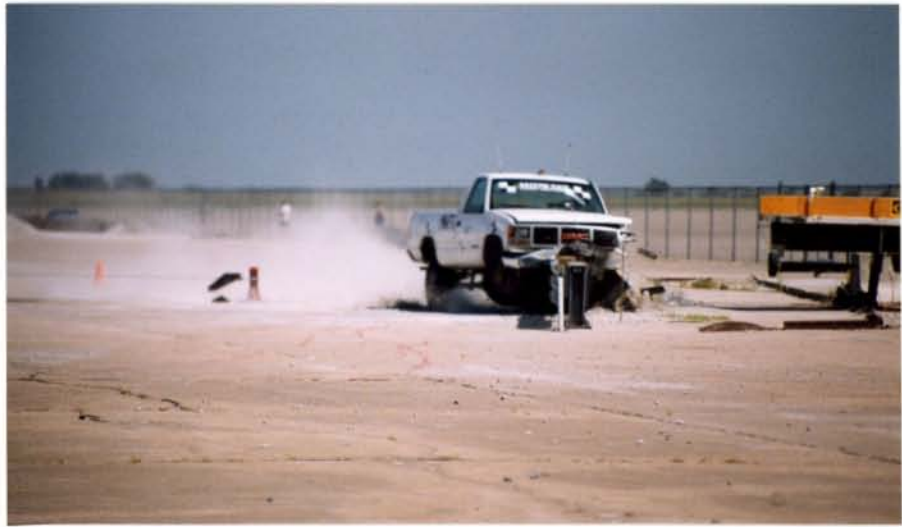
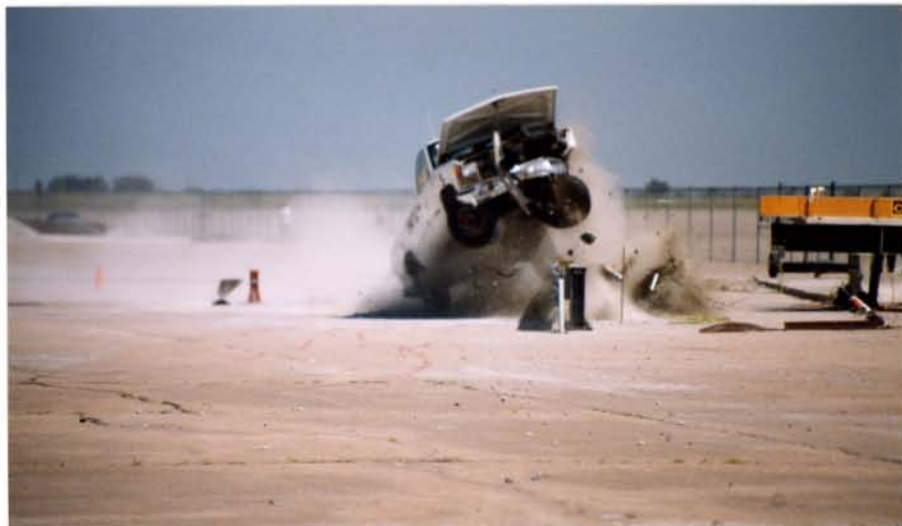
Figure 39. Documentary Photographs, Test MWT-2

The 2,022-kg pickup truck impacted the guardrail system upstream from the W-beam to thrie beam transition element at a speed of 98.3 km/hr and an angle of 25.3 degrees. A summary of the test results and the sequential photographs are shown in Figure 36. Additional sequential photographs are shown in Figures 37 and 38. Documentary photographs of the crash test are shown in Figures 39 through 41.

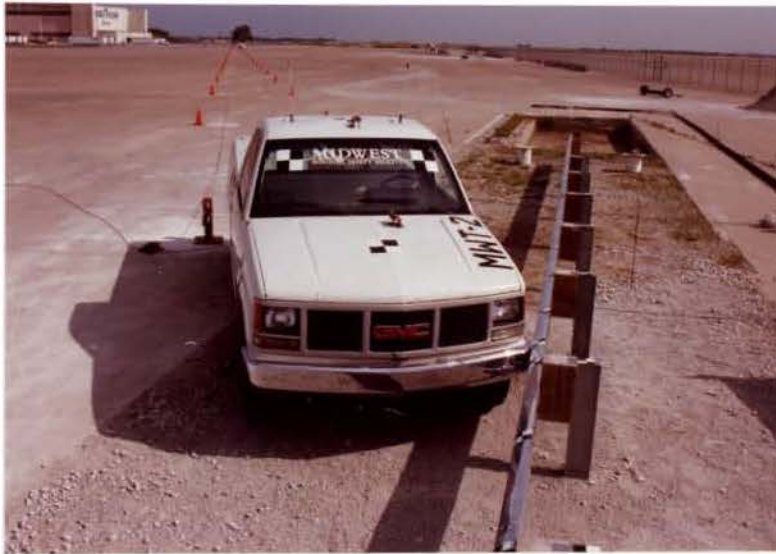
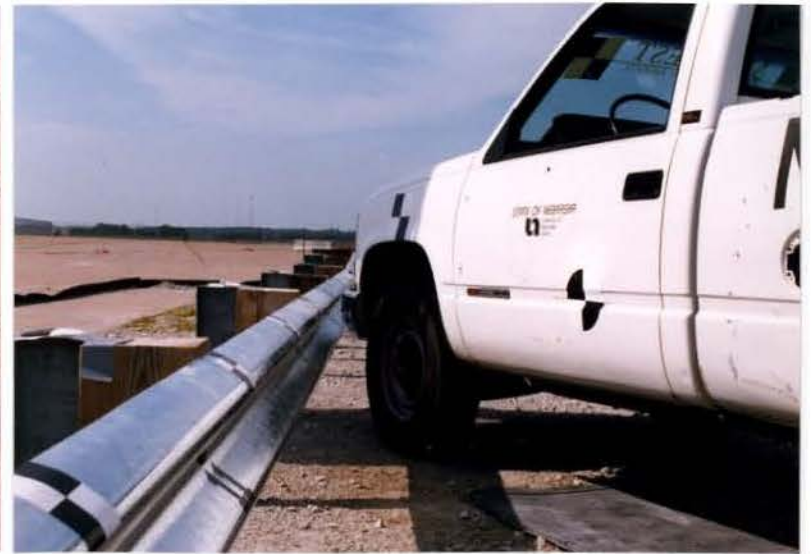
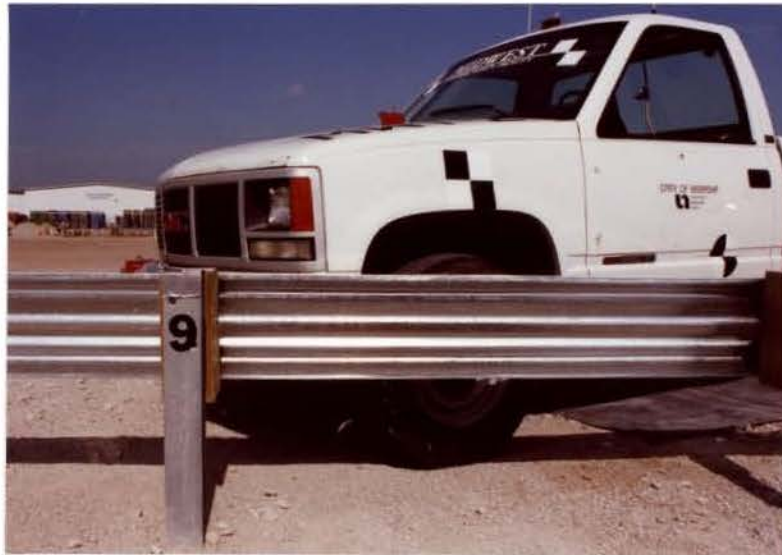
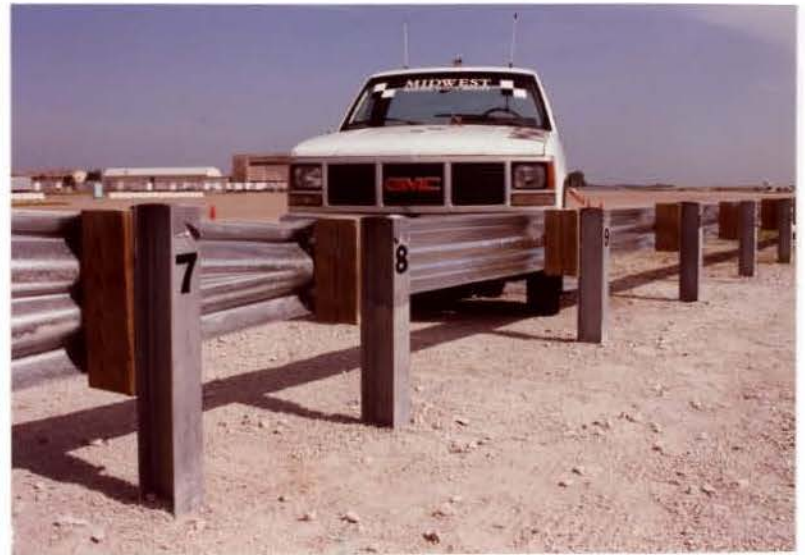
Figure 42. Impact Location, Test MWT-2

Initial impact occurred between post nos. 9 and 10 or 330-mm upstream from the center of post no. 9, as shown in Figure 42. At 0.040 sec after impact, the left-front corner of the vehicle was at the midspan between post nos. 8 and 9. At this same time, post no. 9 was observed to be pushed backward and away from its original position. At 0.056 sec, post no. 8 began to twist CCW, and the left-front side of the bumper and lower fender crushed inward. At this same time, the left-front corner of the engine hood and upper edge of the fender became separated. At 0.080 sec, the left-front corner of the vehicle was at post no. 8, and the left-front tire had turned sideways. At this same time, post no. 7 had not moved, although significant twist about its longitudinal axis was observed in the rail between post nos. 7 and 8. At 0.094 sec, post no. 7 began to deflect backward and twist about its vertical axis. At 0.102 sec, the deformed left-front tire snagged on the bottom of post no. 8 which had deflected, causing the tire to turn sharply to the left. However, the tire was not captured under the rail. At 0.113 sec, post no. 6 began to deflect away from its original position. At 0.117 sec, the rail upstream of post no. 6 kinked across the full depth. At 0.124 sec, significant vehicle pocketing in the rail upstream of post no. 7 was observed. At this same time, post no. 7 was
