## **Phase II Development of a Short-Radius Guardrail for Intersecting Roadways**

### **MIDWEST ROADSIDE SAFETY FACILITY**

MwRSF Research Report No. TRP-03-137-03

September 9, 2003

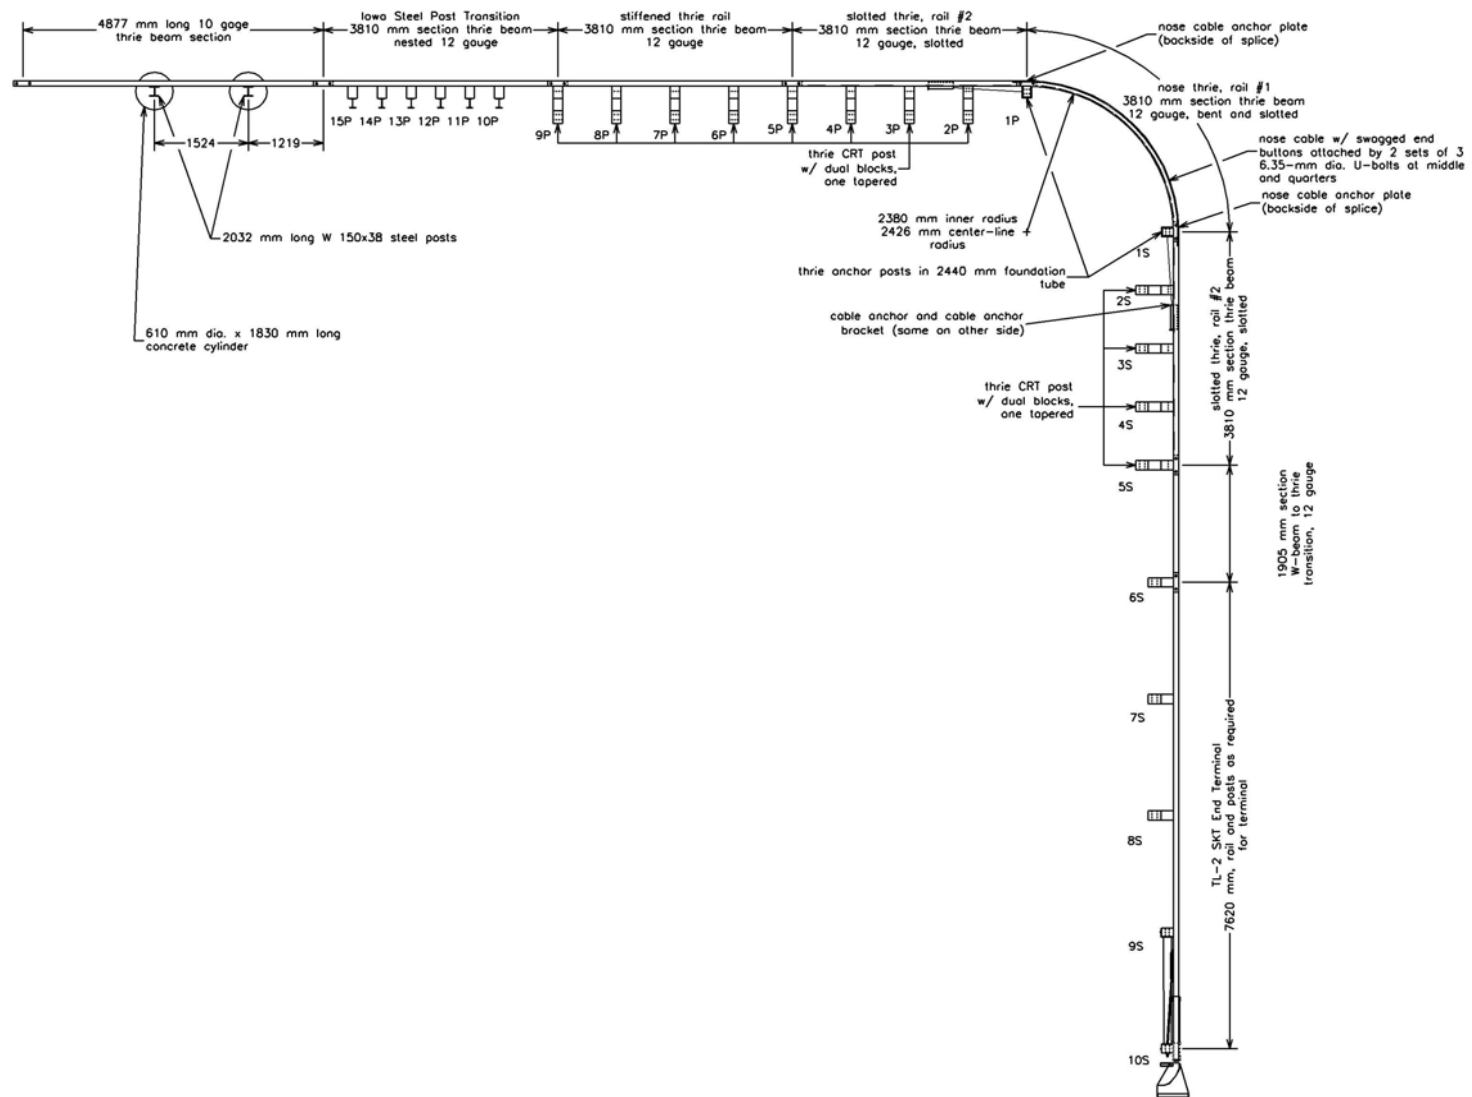
Figure 42. System Details, Test SR-2

The final design modification implemented in the system prior to test SR-2 was removal of the moat that was placed behind the system. The moat was removed since it added unnecessary complexity to the design problem and significantly increased the instability of the pickup truck during the impact. The modified short-radius guardrail system for test SR-2 is shown in Figure 42.

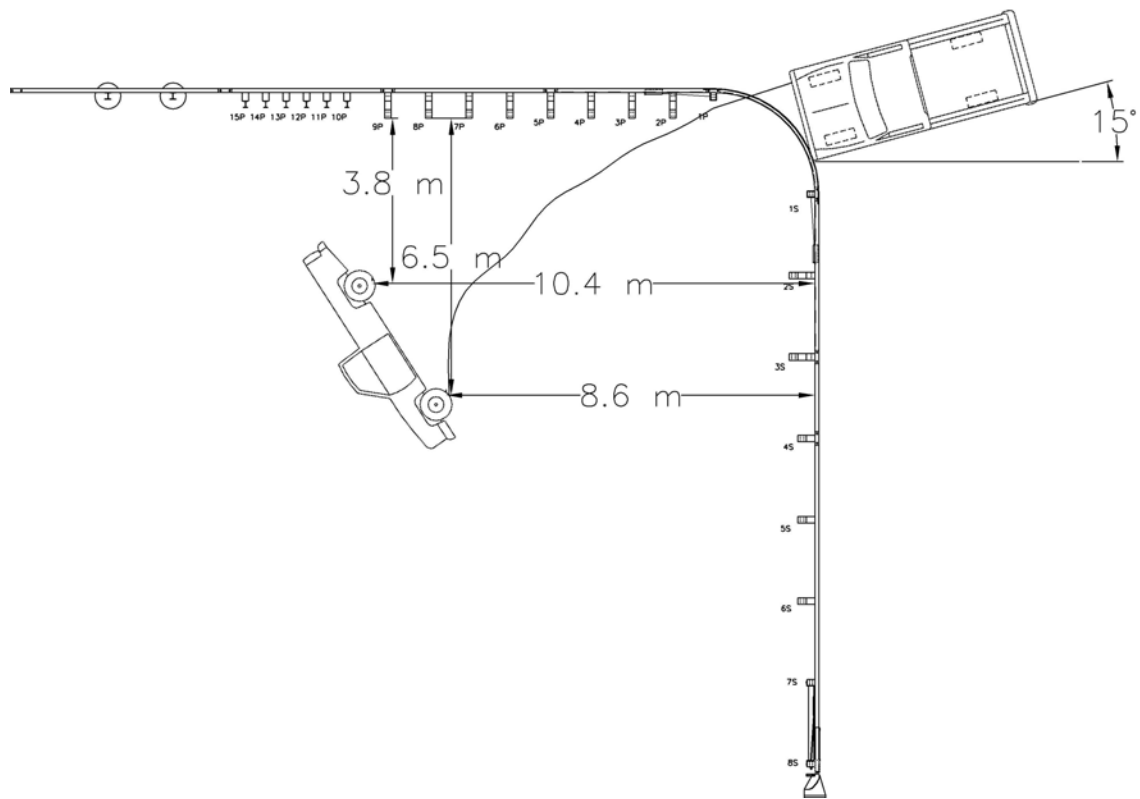
Figure 44. Vehicle Trajectory, Test SR-2

angle. The resulting loading, combined with the impact orientation of the pickup truck, caused the vehicle to begin to yaw to the right at approximately 0.150 sec. By 0.192 sec, post nos. 2P and 3S were fractured due to tension in guardrail as it was pulled downstream. The vehicle continued to yaw as it moved downstream becoming perpendicular to the primary side of the system at approximately 0.640 sec. At this point, the deflecting guardrail promoted the fracture of post nos. 3P through 8P and post no. 4S. After becoming perpendicular to the primary side of the system, the left side of the pickup truck lifted off the ground, and the right side of the pickup truck rolled over the thrie beam. Because the velocity of the vehicle at the time was minimal, the vehicle came to rest on its right side after rolling over the rail. The final position of the pickup truck was 6.8 m to the left of the primary side of the system and 8.6 m to the right of the secondary side of the system. The trajectory and final position of the pickup truck are shown in Figure 44.

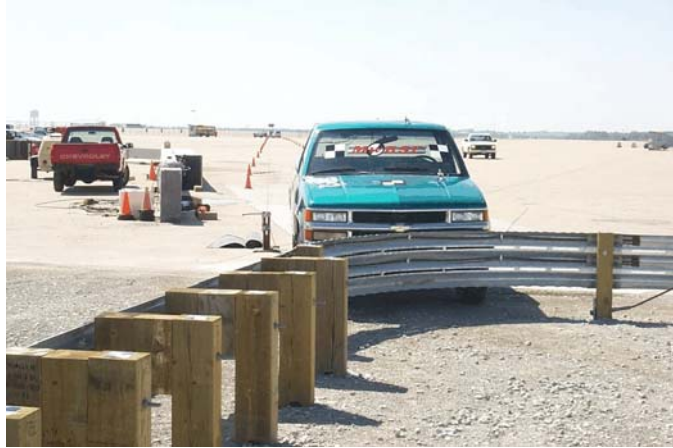
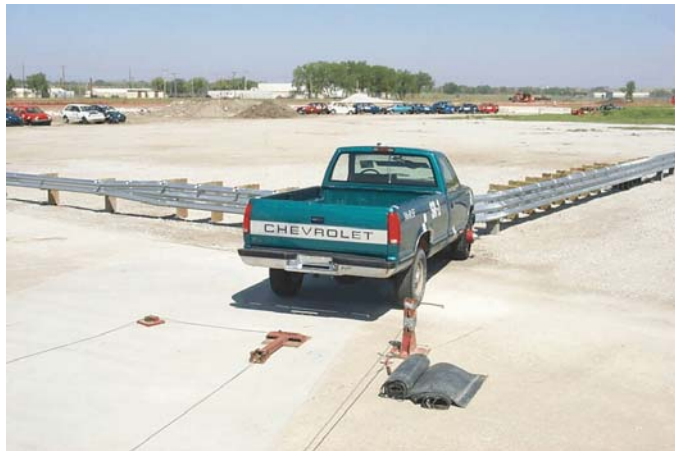
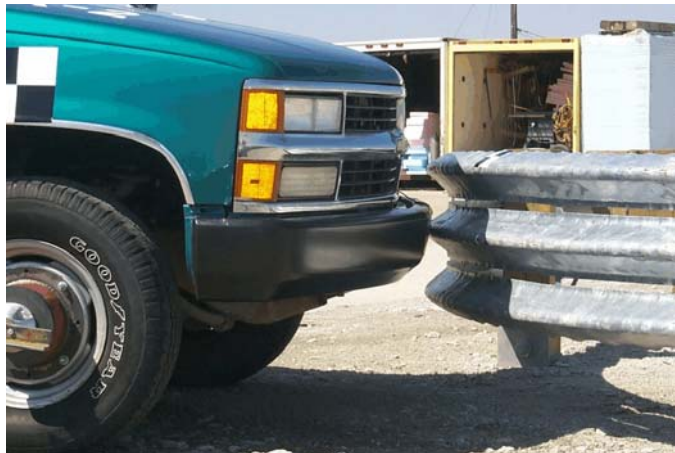
Figure 50. Impact Location, Test SR-2

The test vehicle impacted the curved section of the short-radius guardrail system, as shown in Figure 50. Upon impact, the front of the pickup truck began to deform the curved section of guardrail inward with the vehicle's front bumper impacting the middle hump of the three beam guardrail. As the vehicle deformed the nose of the system inward, the top and middle humps of guardrail were pushed above the bumper, and the bottom hump was pushed beneath the bumper and was rolled over by the left-front tire. At 0.080 sec after impact, post no. 1S was fractured as it was loaded by the deformed guardrail. As the vehicle moved forward, the three beam rail wrapped around the right-front corner of the pickup truck, causing the rail to bend around post no. 1P and fracture it at 0.080 sec. In addition, complete fracture of the middle hump of the three beam nose section was observed near the left-front corner of the pickup truck, but the nose cables remained positioned above the front bumper. At approximately 0.130 sec, post no. 2S fractured. As the pickup truck continued into the system, the guardrail on the primary side of the system bent around and was pulled downstream, and the guardrail on the secondary side of the system was pulled back at an

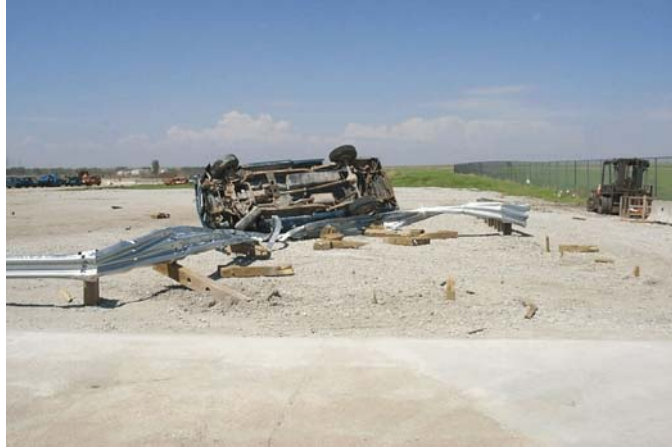
Figure 51. System Damage, Test SR-2

Damage to the short-radius system was extensive, as shown in Figures 51 through 55. Post nos. 1S and 4S on the secondary side were fractured due to the guardrail on the secondary side being pulled towards the middle of the system. Post no. 5S pulled out of the ground but was not fractured. Rail section no. 2 on the secondary side of the system was bent around the post and blockout at post no. 6S. The nose section of guardrail, rail section no. 1, displayed completely torn slot tabs along the bottom set of slots in the rail. In addition, the top and middle humps of the thrie beam were completely torn near the start of the secondary side of the system. The nose cables of the system remained attached to the guardrail by the anchor plates. On the primary side of the system, post nos. 1P through 8P were fractured, while post no. 9P was deflected in the soil. Rail section no. 2 on the primary side was bent around post no. 9P and twisted due to the vehicle rolling over it.

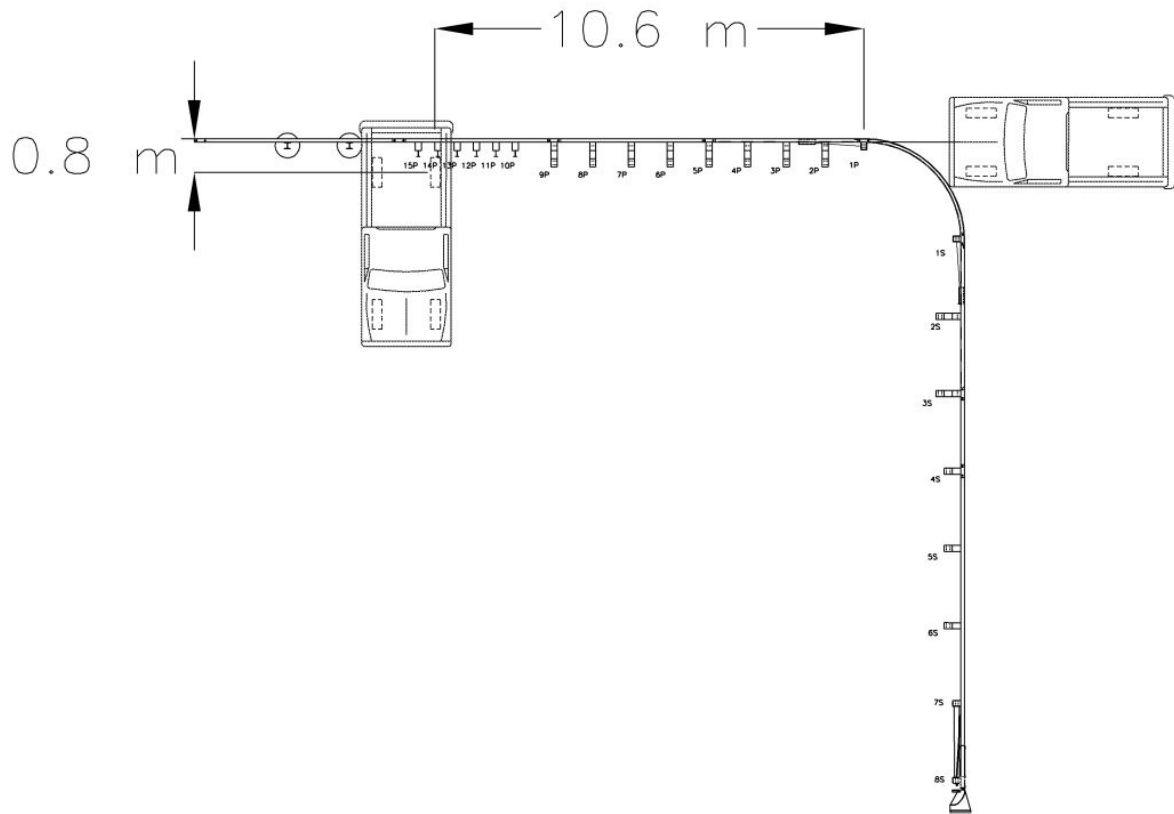
Figure 58. Vehicle Trajectory, Test SR-3

back on its wheels with the rear of the truck still propped up on the primary side guardrail. The final position of the pickup truck was 10.6-m downstream and 0.8 m to the left of post no. 1P. The trajectory and final position of the pickup truck are shown in Figure 58.

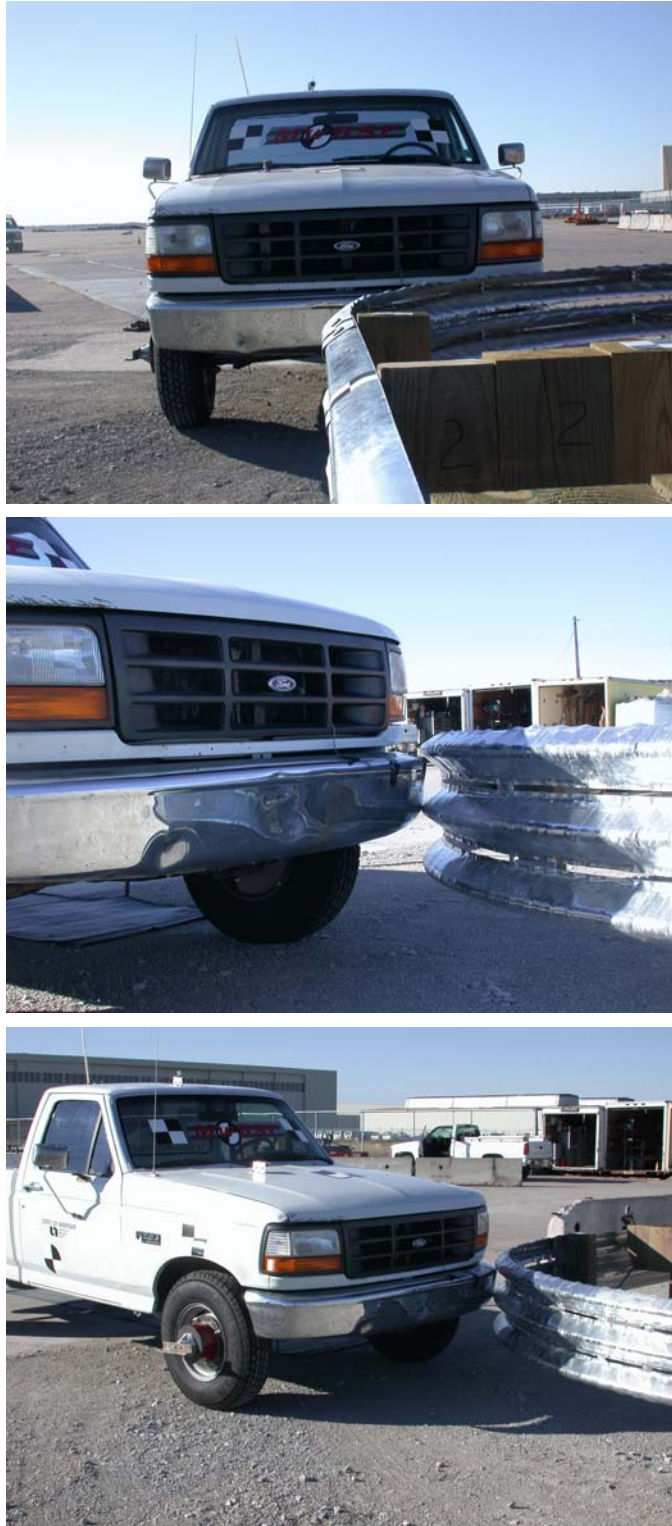
Figure 63. Impact Location, Test SR-3

The test vehicle impacted the curved section of the short-radius guardrail, as shown in Figure 63. Upon impact, the front of the pickup truck began to deform the curved section of guardrail inward with the vehicle's front bumper pushing in between the top two humps of the thrie beam guardrail. As the bumper slid through the slots in the guardrail, several of the slot tabs between the top and middle humps were torn. The top hump of guardrail then moved above the bumper, while the middle and bottom humps were pushed beneath the bumper and were rolled over by the left-front tire. At 0.078 sec after impact, the pickup truck impacted and fractured post no. 1P. As the vehicle moved forward past post no. 1P, the thrie beam guardrail was buckled inward towards the middle

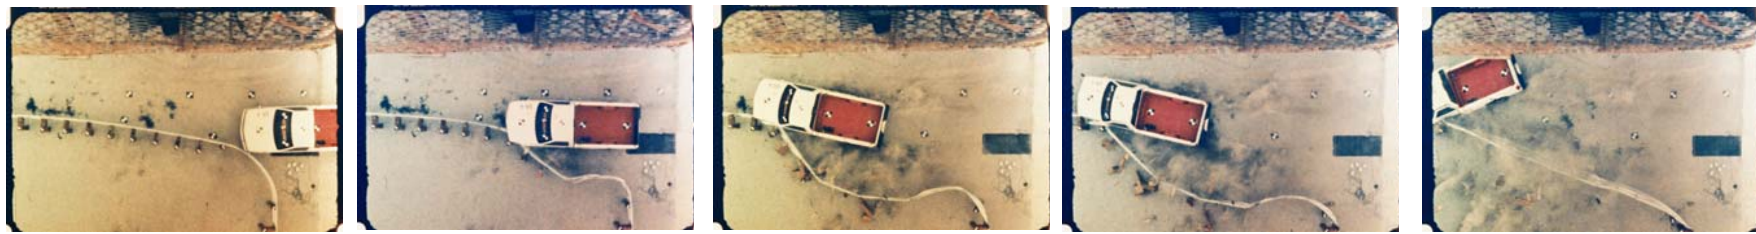
Figure 85. Summary of Test Results and Sequential Photographs, Test SR-4

The longitudinal occupant impact velocity (OIV) was determined to be 4.32 m/s. The maximum 0.010-sec average occupant ridedown deceleration (ORD) in the longitudinal direction was 23.61 g's. The lateral occupant impact velocity (OIV) was determined to be 3.02 m/s. The maximum 0.010-sec average occupant ridedown deceleration (ORD) in the lateral direction was 11.68 g's. It is noted that the occupant ridedown deceleration in the longitudinal direction exceeded the NCHRP Report No. 350 suggested limit of 20 g's. The remaining occupant risk values were within the suggested limits provided in NCHRP Report No. 350. The results of the occupant risk data are summarized in Figure 85. Results are shown graphically in Appendix F.

The failure of test SR-4 to meet the safety performance criteria was directly attributed to the intrusion and snagging of the thrie beam guardrail into the wheel well region of the pickup truck. Through the initial portion of the impact, the thrie beam guardrail was impacted by the left-front corner of the vehicle and deflected towards the inside of the short-radius guardrail system. After approximately 0.300 sec, the leading edge of impacting guardrail slid past the left-front corner and into the wheel well. The intruding guardrail punched a large hole in the floor pan of the occupant compartment and causing a rapid deceleration and yaw of the vehicle. The intrusion of the thrie beam was caused by the combination of the orientation of the impact vehicle, the geometry of the system, and the lack of upstream tension in the guardrail. Because the cable anchorage at post no. 1P was disengaged almost immediately, there was little or no upstream tension in the flared guardrail section. Therefore, the vehicle moved downstream along the system with very little redirection. This in turn led to the intrusion of the thrie beam into the wheel well region.

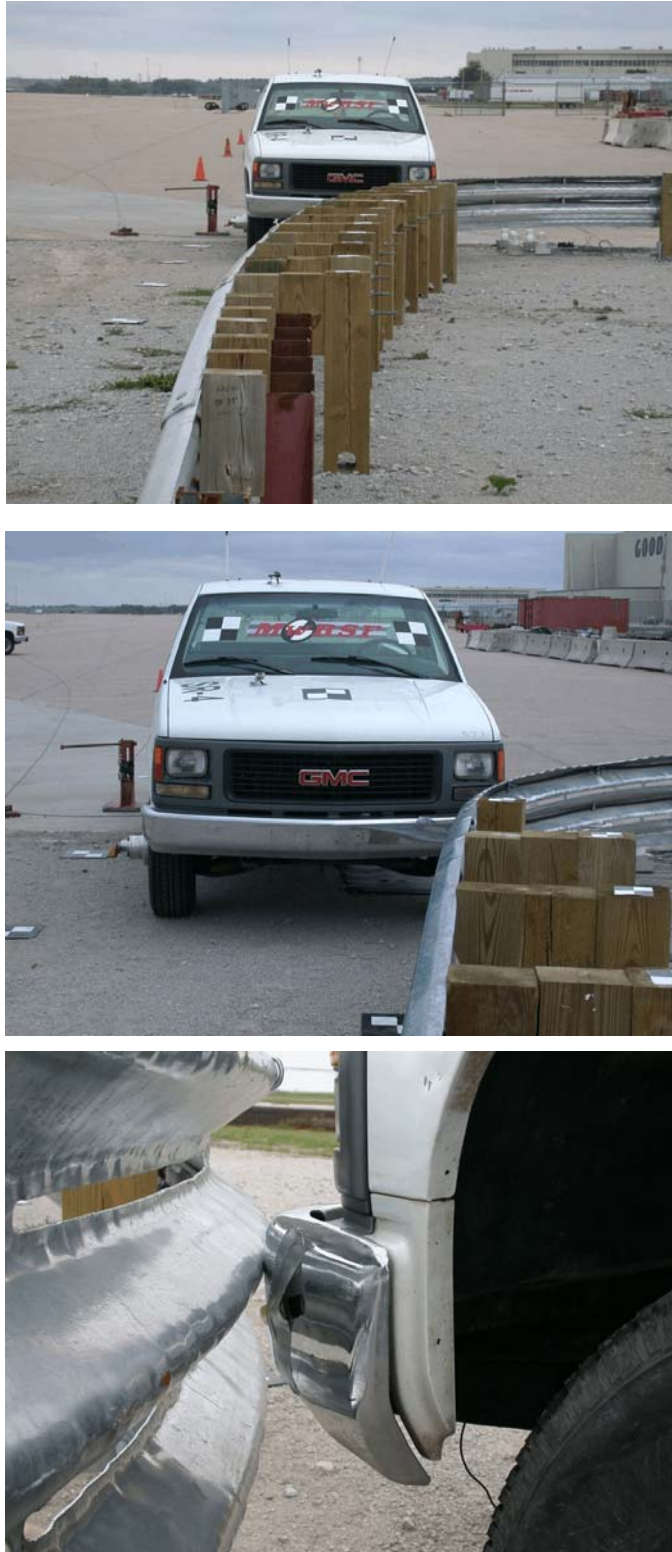
Figure 90. Impact Location, Test SR-4

The left-front corner of the test vehicle impacted the curved nose section of the short-radius guardrail just upstream of post no. 1P, as shown in Figure 90. At 0.036 sec, the left-front corner of the pickup truck impacted and fractured post no. 1P. The pickup truck continued downstream fracturing post no. 2P at 0.69 sec and pushing the thrie beam to the left of the vehicle. By 0.100 sec, the pickup truck had reached post no. 3P and began to redirect. The pickup truck proceeded downstream while pushing the deflected thrie beam off of the left-front corner of the vehicle and towards the inside of the system, fracturing post nos. 3P through 8P by 0.284 sec. At 0.306 sec, the leading edge of the thrie beam guardrail formed a bent knee and slid off of the left-front corner of the pickup truck and into the wheel well. The bent knee of guardrail impacted and snagged the rear of the wheel well and the firewall. This caused the pickup truck to decelerate rapidly and yaw counterclockwise before coming to rest 1.85 m to the right of post no. 10P. The trajectory and final position of the pickup truck are shown in Figure 86.

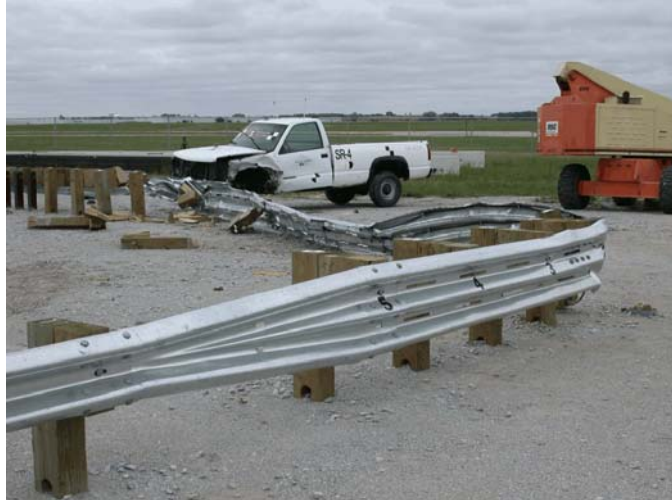
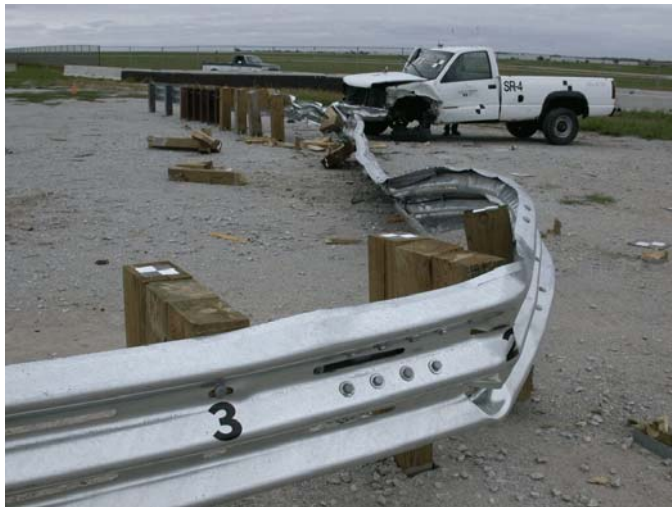
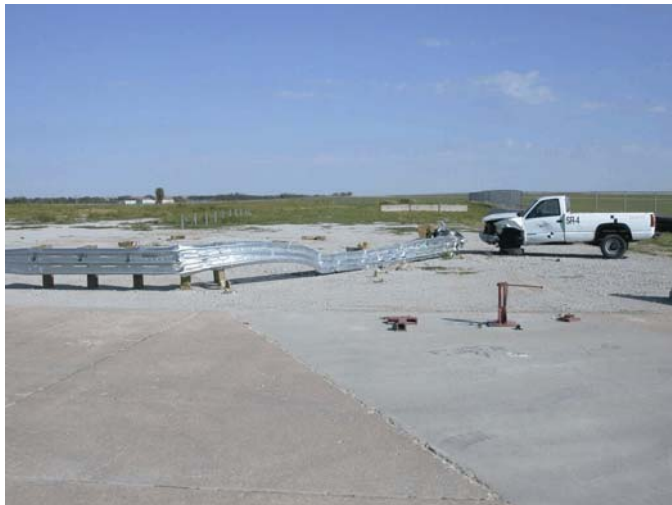
Figure 91. System Damage, Test SR-4

Damage to the short-radius system was extensive, as shown in Figures 91 through 93. Post no. 1S on the secondary side was fractured due to the guardrail on the secondary side being pulled towards the middle of the system. Post nos. 2S and 3S displayed minor deflections but were not fractured. Rail section no. 2S on the secondary side of the system was bent around the post and blockout at post no. 2S. Damage was more severe on the primary side of the system. On the primary side of the system, post nos. 1P through 9P were completely fractured, while post nos. 10P through 13P were deflected in the soil. Rail section no. 2 on the primary side was severely buckled and crushed. Rail section nos. 2P and 3P were deformed from the impact and redirection of the vehicle. Rail section no. 3P was severely crushed and buckled due to snagging in the wheel well, beginning approximately 254-mm upstream of post no. 9P.

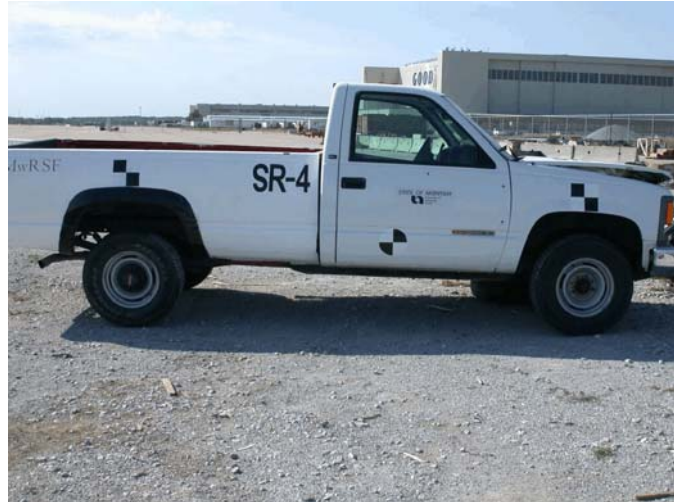
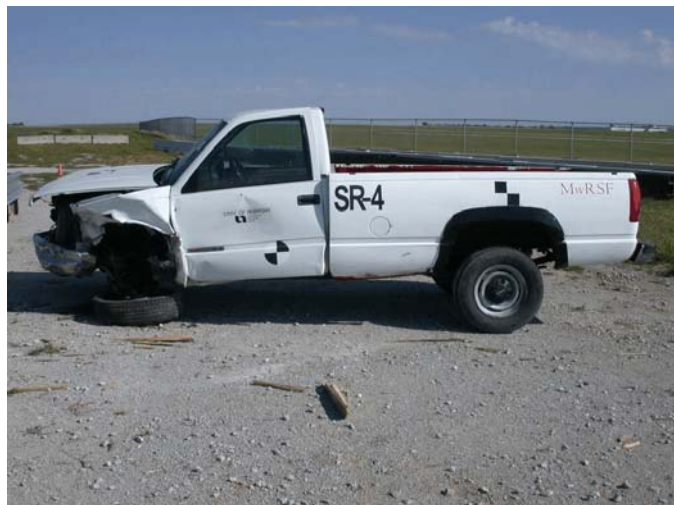
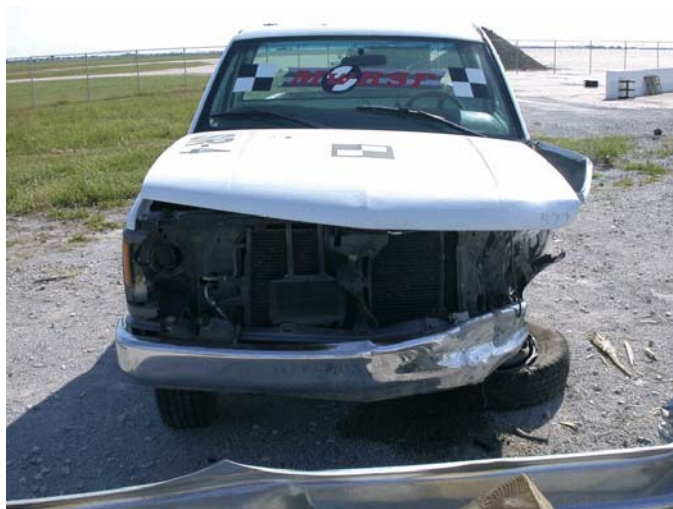
Figure 94. Vehicle Damage, Test SR-4

Vehicle damage was extensive, as shown in Figures 94 through 96. The left-front area of the vehicle, including the bumper, radiator, and headlights, was crushed inward due to the impact with the system. The front grill was detached, and the left-front corner of the hood was bent slightly. The left-front fender of the pickup truck was deformed and crushed. The front suspension on the left side of the vehicle was damaged as well. This damage consisted of bent upper and lower control arms, a bent stabilizer bar, and failed connections on the tie rod and upper control arm. The left-front wheel was still attached at the lower control arm connection. Some deformation of the left-front rim was observed. The driver-side door was jarred shut and displayed some deformation.

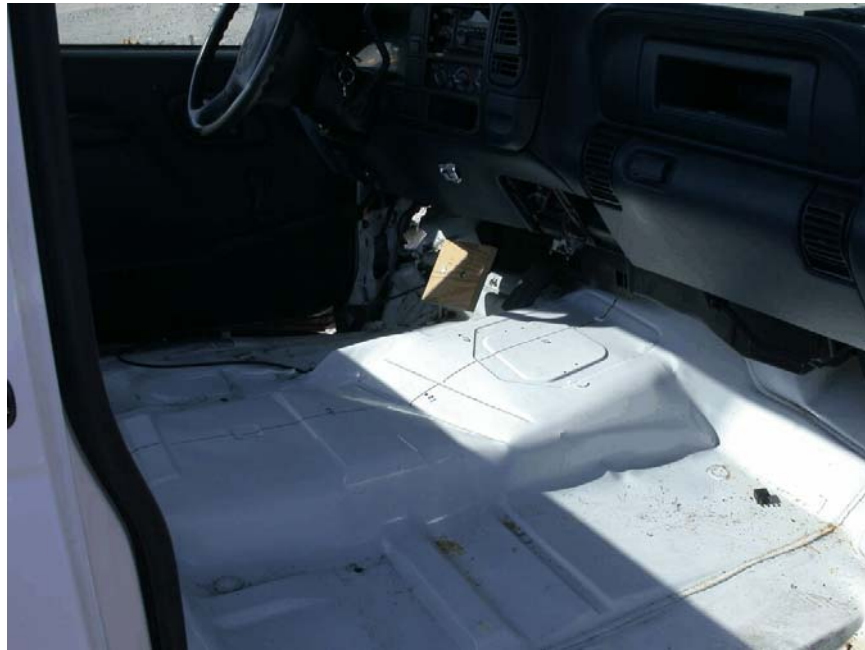
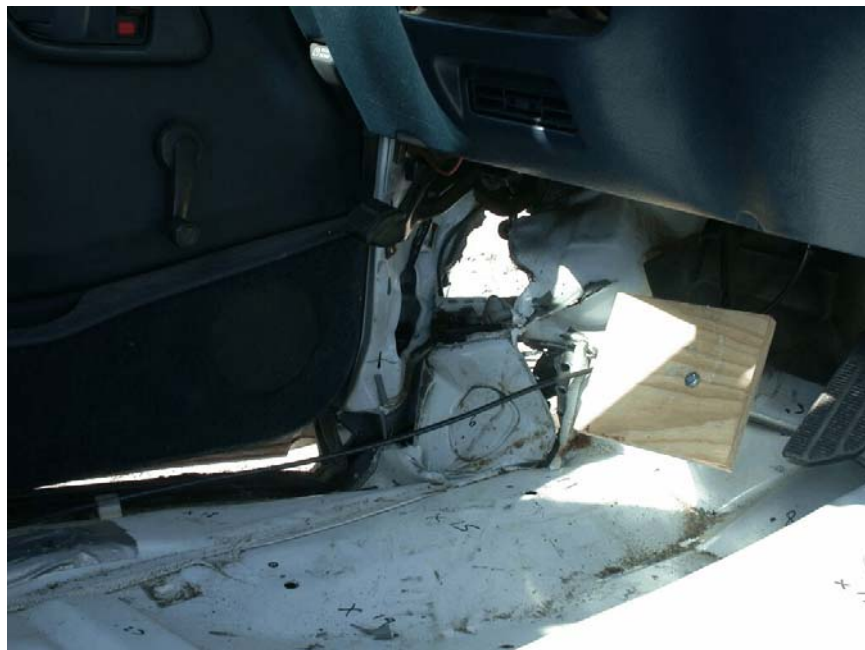
Figure 96. Vehicle Damage, Test SR-4

Damage to the interior occupant compartment of the vehicle is shown in Figure 96. The damage included a 254-mm long rupture on the front of the floor pan near the left side.

Deformations of both the floor pan and the dash were also observed. Maximum vertical deflections of 146 mm and 159 mm were measured near the right-front corner of the driver's-side floor pan. A maximum lateral deflection of 57 mm was measured near the left-front corner of the driver's-side floor plan. A maximum longitudinal deflection of 260 mm was measured near the rear of the driver's-side floor plan. Maximum deflection of the dashboard was measured to be 38 mm in the vertical direction. The large rupture in the floor pan and the significant longitudinal floor pan deformation were unacceptable according to the criteria in NCHRP Report No. 350. Complete occupant compartment deformation details are given in Appendix E.

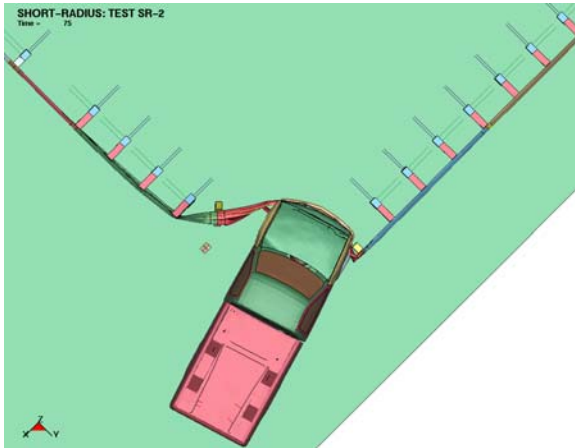
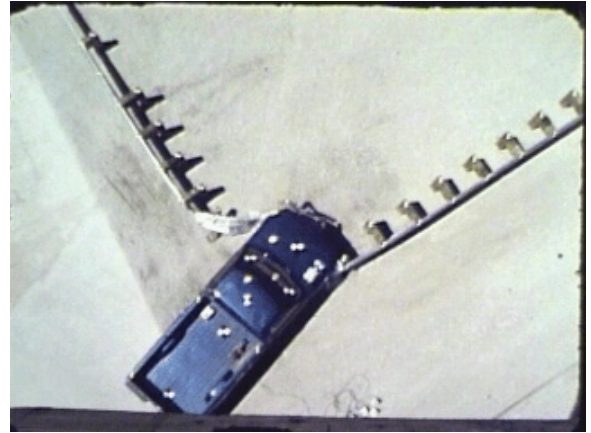
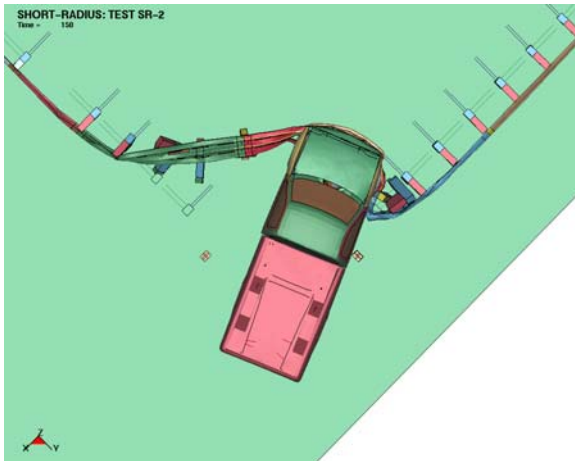
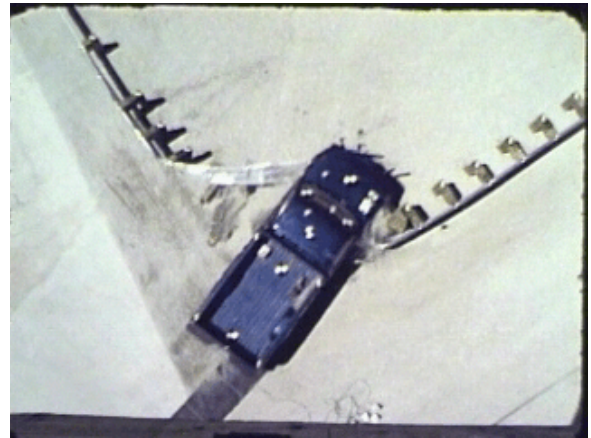
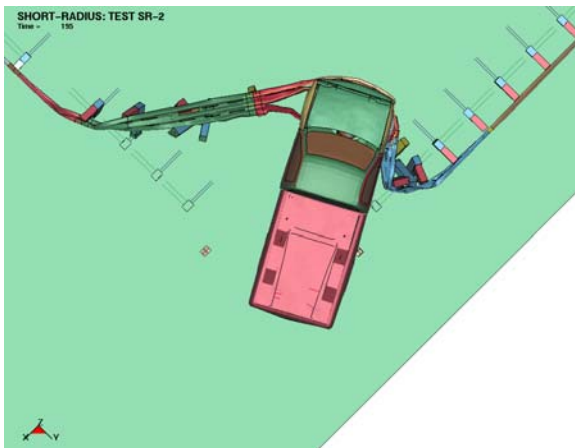
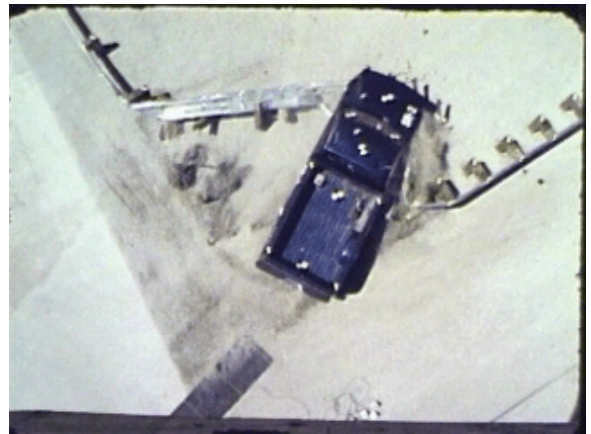
Figure 98. Comparison of Full-Scale Test and LS-DYNA Simulation Model, Test No. SR-2

The modeling of the short-radius system displayed good correlation with full-scale test results for approximately the first 150 msec to 200 msec of the impact. The models were capable of accurately replicating the initial portion of the impact event, including the deformation of the system and the capture and/or redirection of the impacting vehicle. Basic comparisons of LS-DYNA simulations and full-scale test nos. SR-2, SR-3, and SR-4 are shown in Figures 98, 99, and 100, respectively.
