Performance Level 2 Tests on a 29-in. Open Concrete Bridge Rail

Midwest Roadside Safety Facility (MwRSF) Center for Infrastructure Research

Transportation Research Report TRP-03-51-95

June 1996

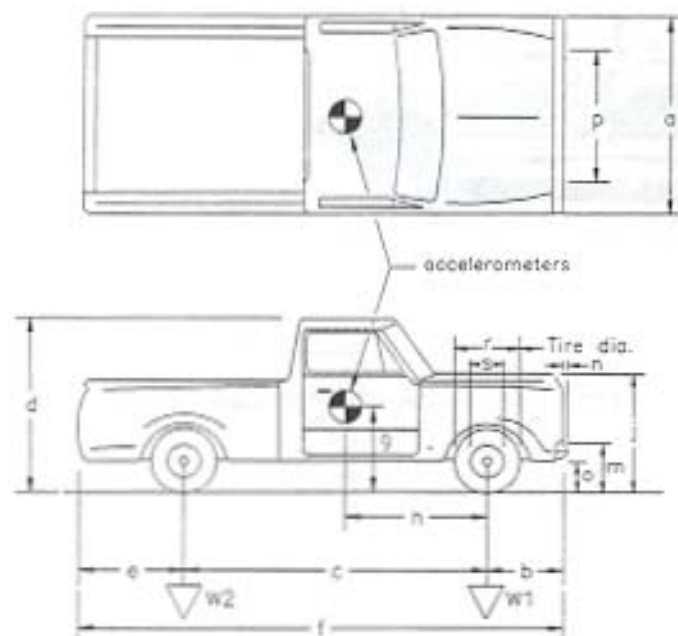
FIGURE 13. Test Vehicle Dimensions and Weights, Test NEOCR-5

Note any damage prior to test: Driver-side door creased at front joint.

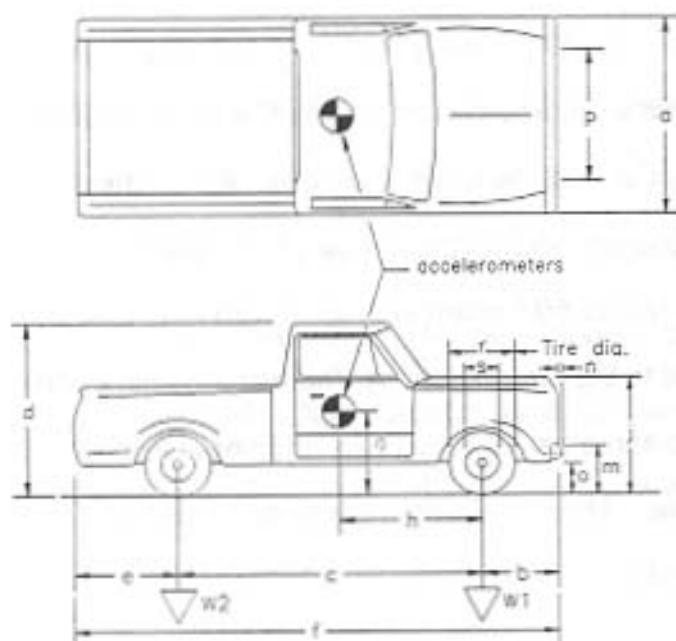
FIGURE 15. Test Vehicle Dimensions and Weights, Test NEOCR-6

Note any damage prior to test: Extensive rust to box floor and cab floor.

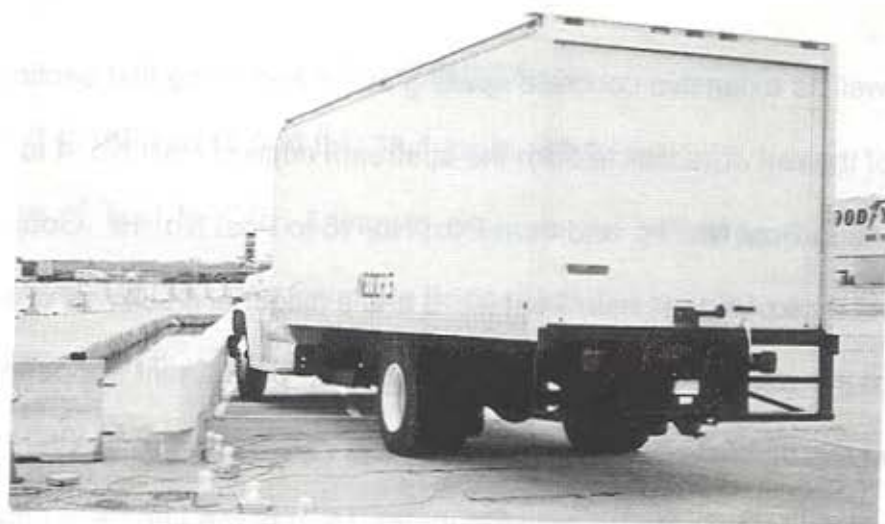
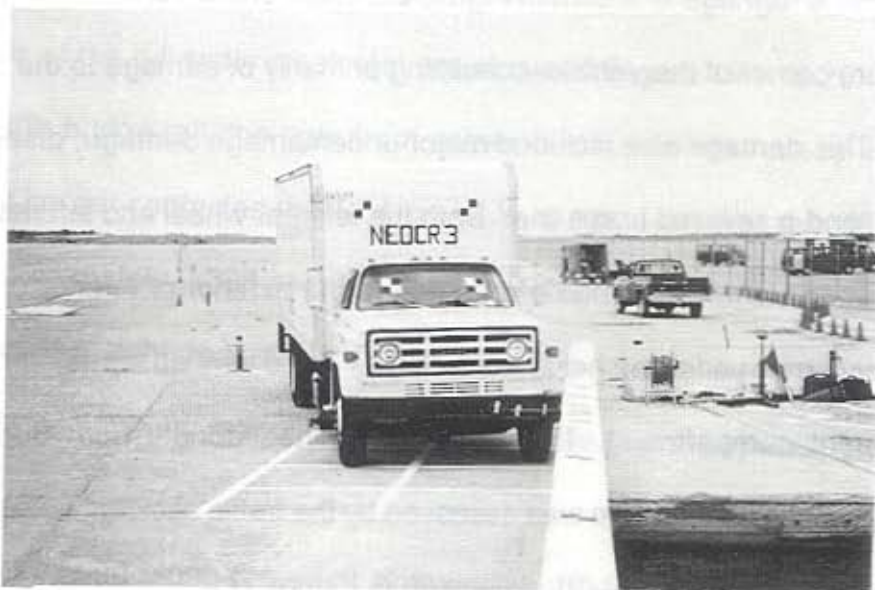
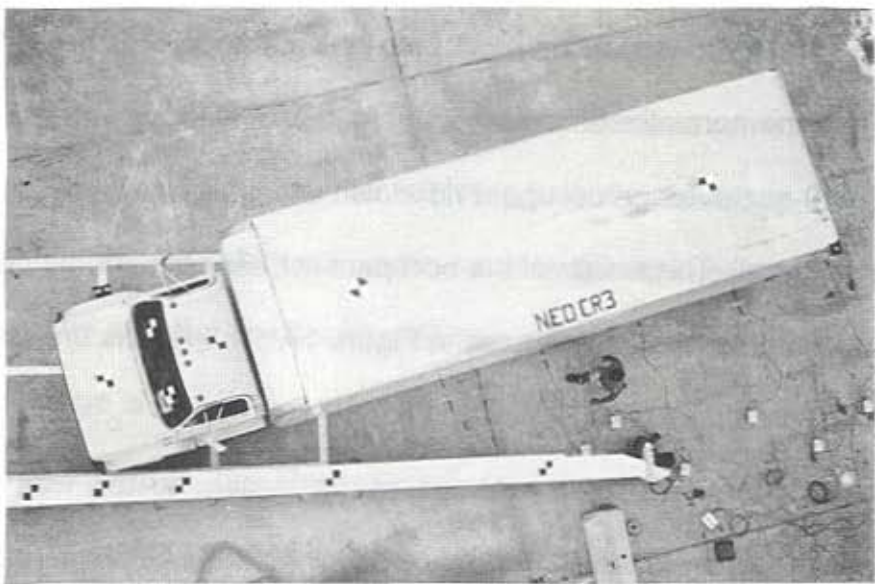
FIGURE 16. Impact Location, Test NEOCR-3

The purpose of Test NEOCR-3 was to evaluate the safety performance of the discontinuous rail section of the Open Concrete Bridge Rail. The location of the impact was 1.5-m (5-ft) upstream from the upstream end of the 11.4-cm (4 ½-in.) gap, as shown in Figure 16. A summary of the test results and the overhead sequential photographs are shown in Figure 17. Additional sequential photographs are shown in Figure 18.

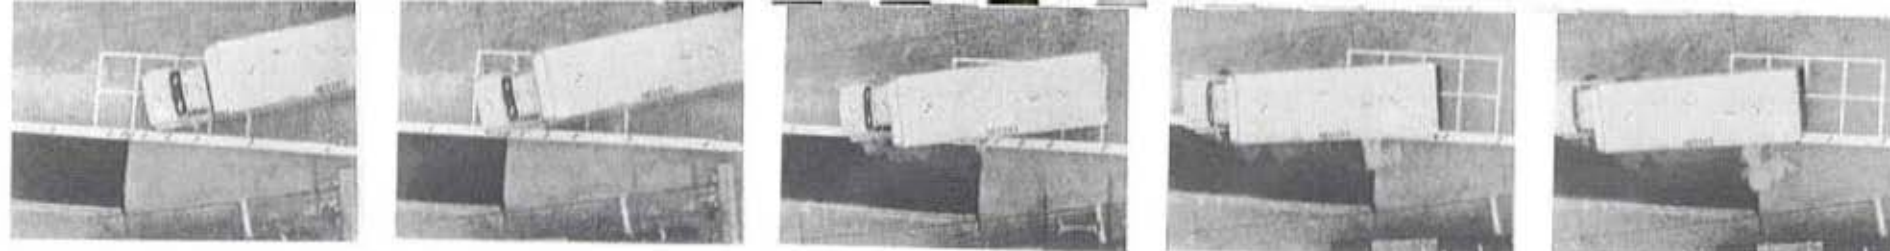
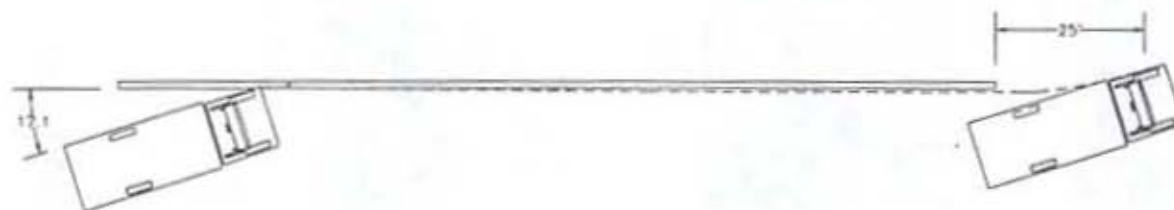
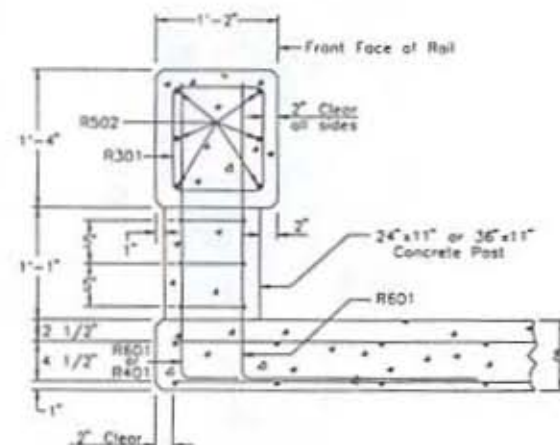
FIGURE 17. Summary and Sequential Photographs, Test NEOCR-3

Test Number	NEOCR-3
Date	6/21/94
Installation	Nebraska Open Concrete Rail
Total Length	47.1 m (154 ft - 4 5/8 in.)
Concrete Material	Nebraska 47-BD Mix
Reinforcing Steel Material	Grade 60 Rebar - Epoxy Coated
Concrete Rail	
Length	47.1 m (154 ft - 4 5/8 in.)
Width	35.6 cm (14 in.)
Height	73.7 cm (29 in.)
Depth	40.6 cm (16 in.)
Concrete Posts	
Length	61.0 cm (24 in.)
Width	27.9 cm (11 in.)
Height	33.0 cm (13 in.)
Concrete Posts Adjacent to Gap	
Length	91.4 cm (36 in.)
Width	27.9 cm (11 in.)
Height	33.0 cm (13 in.)
Concrete Bridge Deck	
Length	37.0 m (121 ft - 6 in.)
Width	1.75 m (5 ft - 9 in.)
Depth	20.3 cm (8 in.)

Vehicle	
Model	1986 GMC 7000 Series
Box Length	6.7 m (22 ft)
Test Inertial Weight	8165 kg (18,000 lb)
Vehicle Speed	
Impact	78.1 km/h (48.5 mph)
Exit	NA
Vehicle Angle	
Impact	17.1 deg
Exit	NA
Snagging	None
Vehicle Stability	Satisfactory
Occupant Impact Velocities (Normalized)	
Longitudinal	3.0 m/s (9.7 fps) < 9.1 m/s (30 fps)
Lateral	2.0 m/s (6.6 fps) < 7.6 m/s (25 fps)
Occupant Ridedown Decelerations	
Longitudinal	2.1 G's < 15 G's
Lateral	3.0 G's < 15 G's
Vehicle Damage	
TAD	11-LFQ-3
VDI	11LFW52
Vehicle Rebound Distance	none
Coefficient of Friction (μ)	0.35 (fair)
Bridge Rail Damage	Concrete Cracking and Spalling at Gap

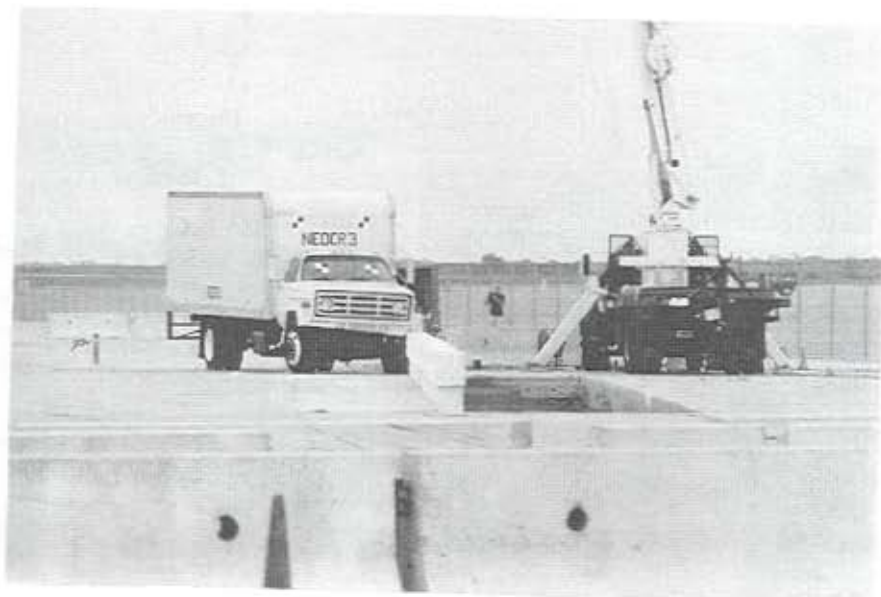
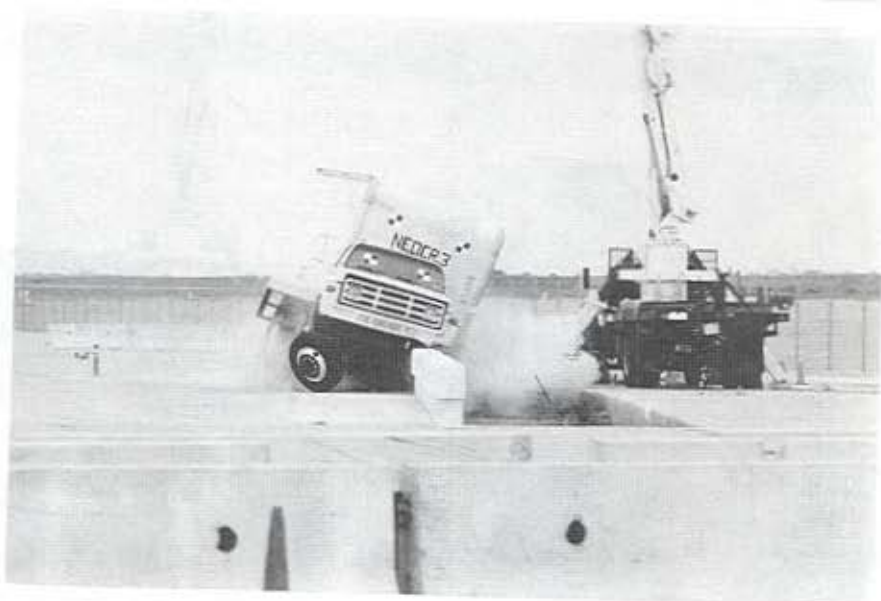
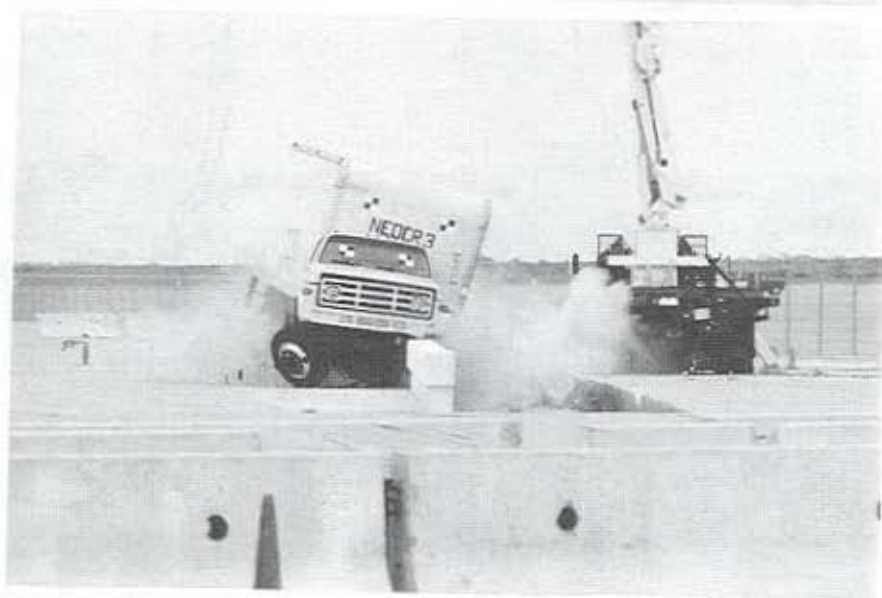
FIGURE 19. Full Scale Test, NEOCR-3

Photographs of the full scale crash test are shown in Figure 19 and 20. After the initial impact with the bridge rail, the right front corner of the vehicle crushed inward. At 0.050 sec, the front corner contacted the 11.4-cm (4 ½-in.) gap, causing the left front tire to blow out. At approximately 0.388 sec, the right rear side of the vehicle contacted the bridge rail causing the right rear tire to blow out. The vehicle became parallel at approximately 0.447 sec and the rear of the truck cleared the gap at approximately 0.539 sec.

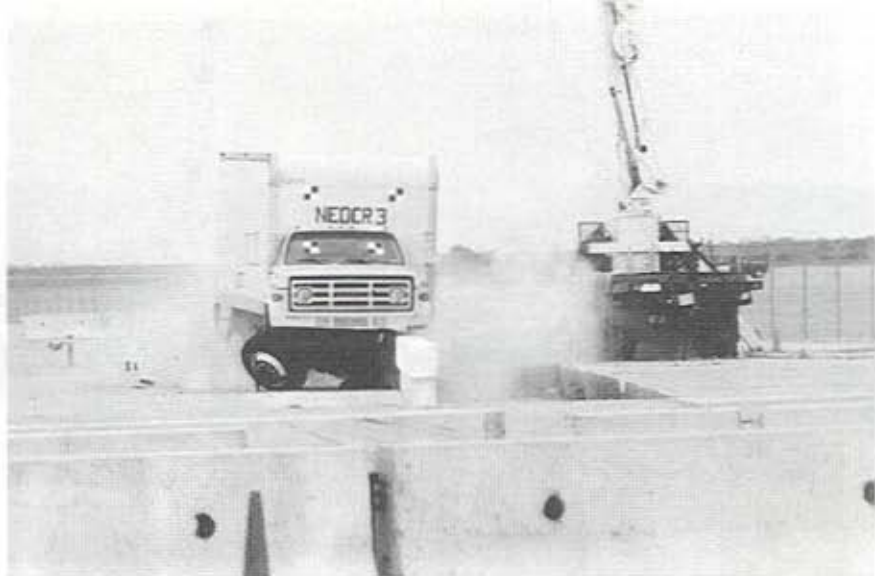
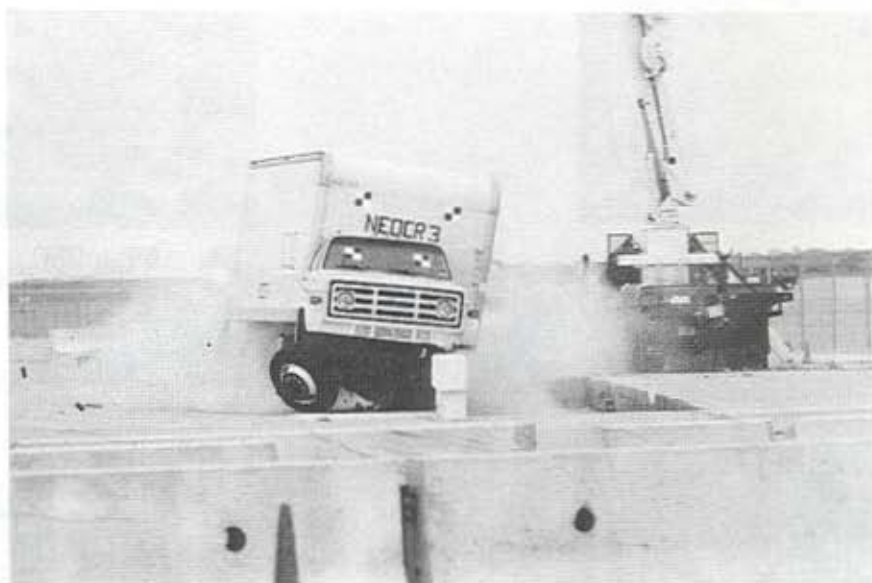
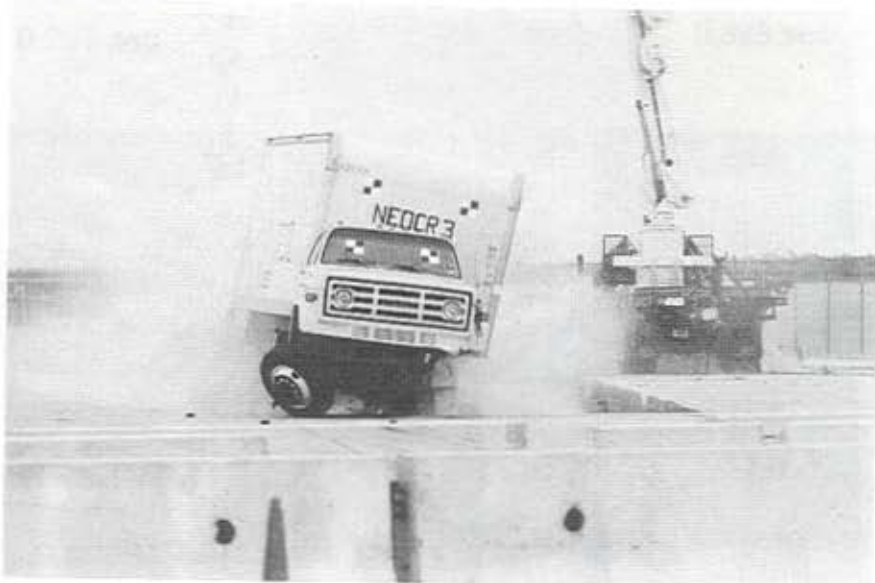
FIGURE 20. Full Scale Test, NEOCR-3

The vehicle traveled along the edge of the rail for the total length of bridge rail. Therefore, no exit angle was measured. The blowouts of the front and rear tires on the left side combined with the damage to the front axle caused the vehicle to come to rest 7.62-m (25-ft) downstream of the end of the rail. The vehicle's trajectory is shown in Figure 17. There was no measurable rebound distance as the truck remained in contact with the rail throughout the event. The effective coefficient of friction was determined to be fair (0.35).

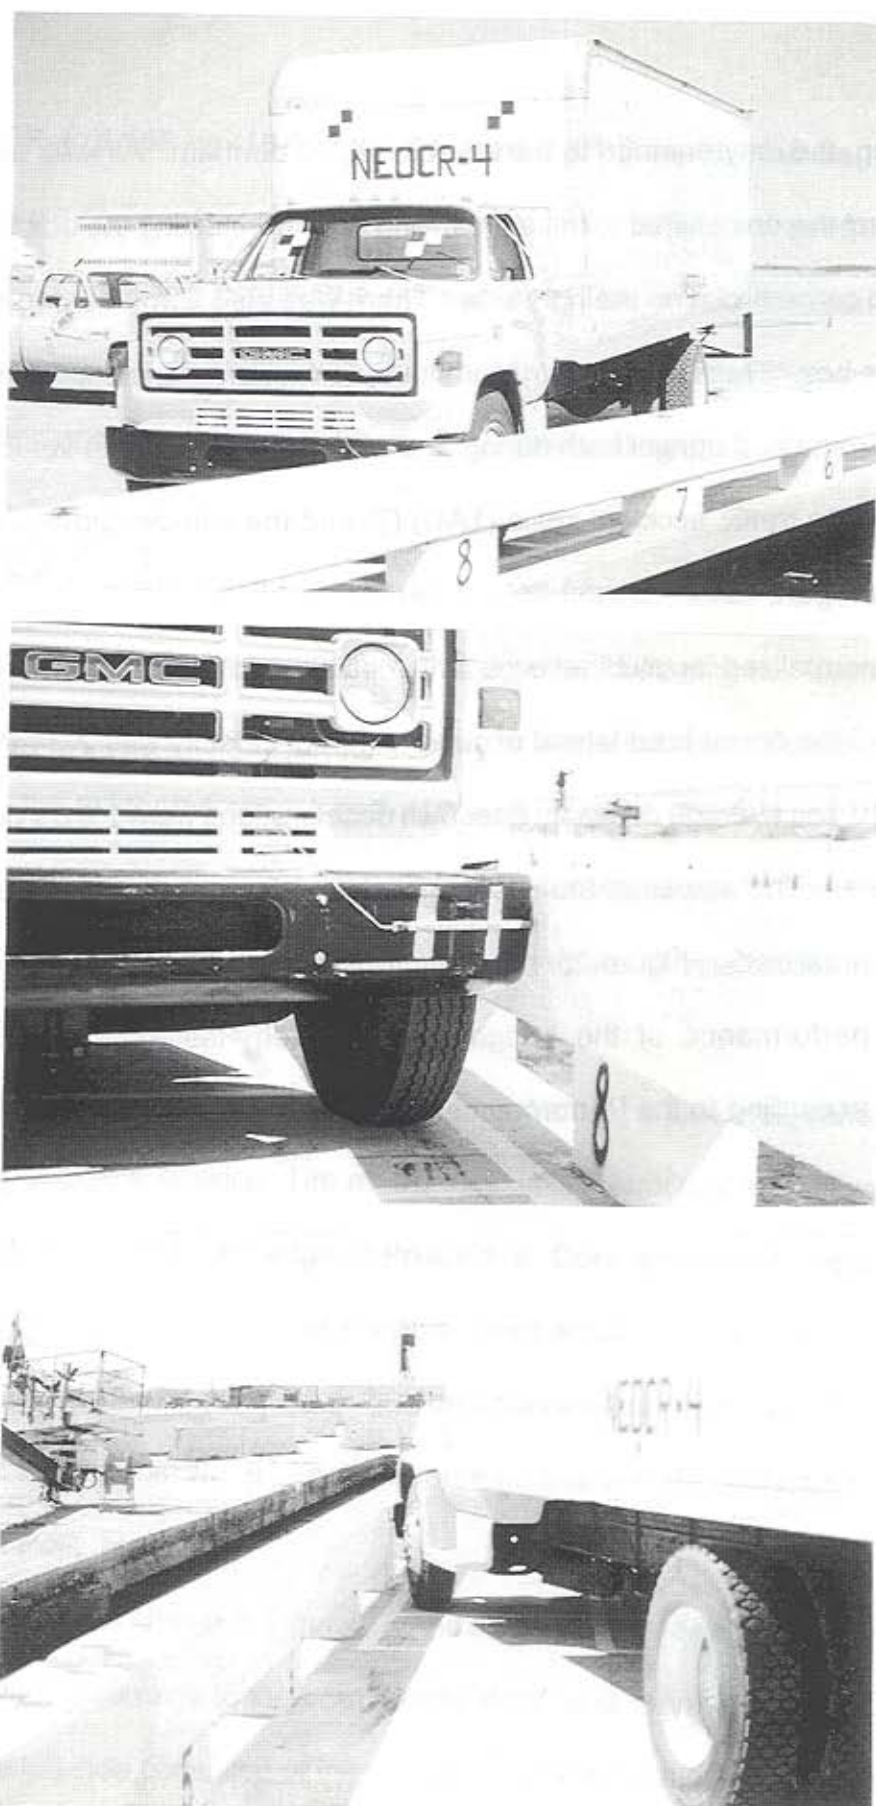
FIGURE 24. Impact Location, Test NEOCR-4

The purpose of Test NEOCR-4 was to evaluate the structural adequacy and the redirection capacity of the continuous rail section. The impact location was at the upstream end of Post No. 8, as shown in Figure 24. A summary of the test results and sequential photographs are shown in Figure 25. Additional sequential photographs are shown in Figure 26.

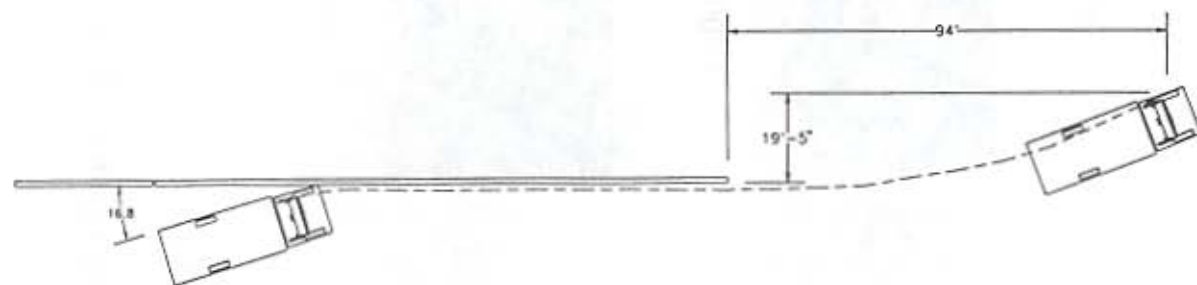
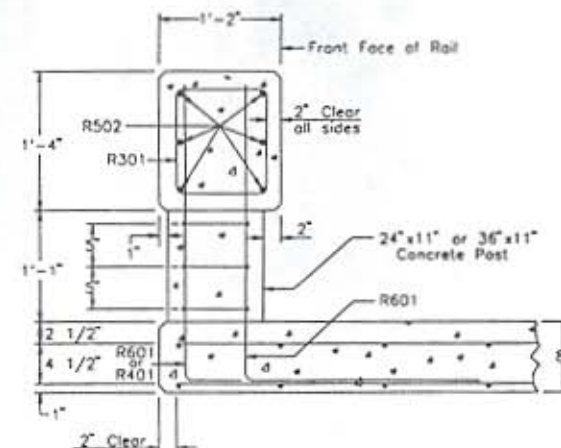
The normalized longitudinal occupant impact velocity was determined to be 2.4 m/s (8.0 fps) and the normalized lateral occupant impact velocity was 2.3 m/s (7.7 fps). The highest 0.010-sec average occupant ridedown decelerations were 2.9 g's (longitudinal) and 5.4 g's (lateral). The results of the occupant risk, as determined from the accelerometer data are summarized in Figure 25. The results are shown graphically in Appendix A.

Test Number	NEOCR-4
Date	8/24/94
Installation	Nebraska Open Concrete Rail
Total Length	47.1 m (154 ft - 4 5/8 in.)
Concrete Material	Nebraska 47-BD Mix
Reinforcing Steel Material	Grade 60 Rebar - Epoxy Coated
Concrete Rail	
Length	47.1 m (154 ft - 4 5/8 in.)
Width	35.6 cm (14 in.)
Height	73.7 cm (29 in.)
Depth	40.6 cm (16 in.)
Concrete Posts	
Length	61.0 cm (24 in.)
Width	27.9 cm (11 in.)
Height	33.0 cm (13 in.)
Concrete Posts Adjacent to Gap	
Length	91.4 cm (36 in.)
Width	27.9 cm (11 in.)
Height	33.0 cm (13 in.)
Concrete Bridge Deck	
Length	37.0 m (121 ft - 6 in.)
Width	1.75 m (5 ft - 9 in.)
Depth	20.3 cm (8 in.)

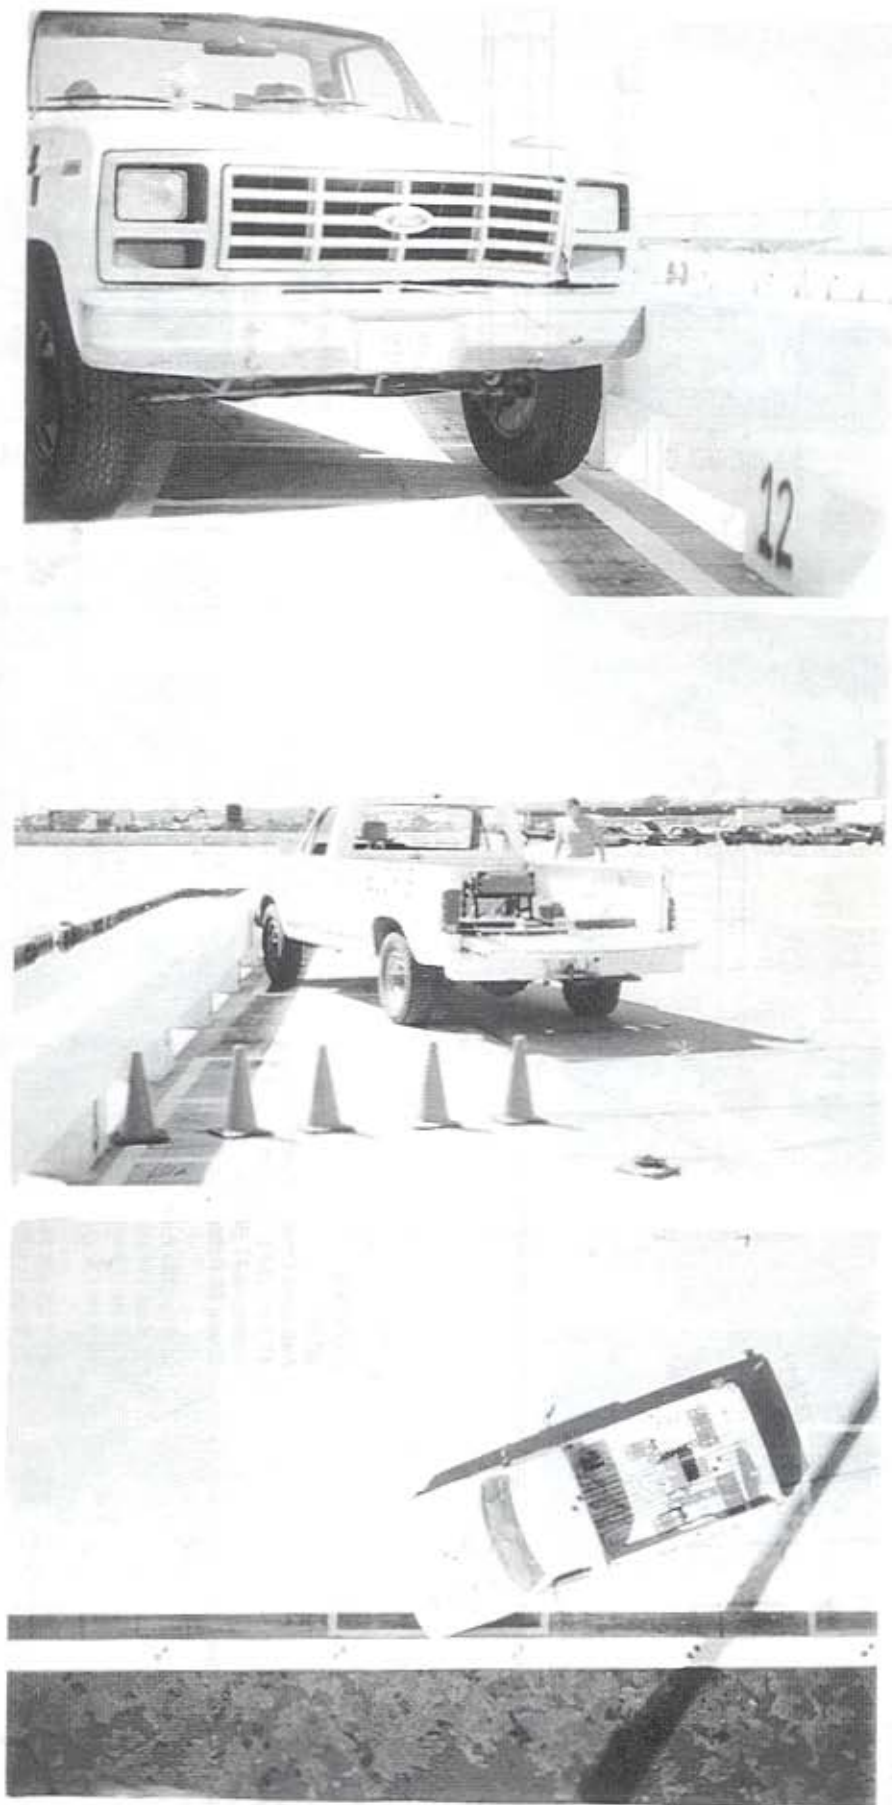
FIGURE 29. Impact Location, Test NEOCR-5

The purpose of Test NEOCR-5 was to evaluate the structural adequacy and the redirection capacity of the continuous rail section. The impact location was at the midspan of the section between Post Nos. 11 and 12, as shown in Figure 29. A summary of the test results and sequential photographs are shown in Figure 30. Additional sequential photographs are shown in Figure 31.

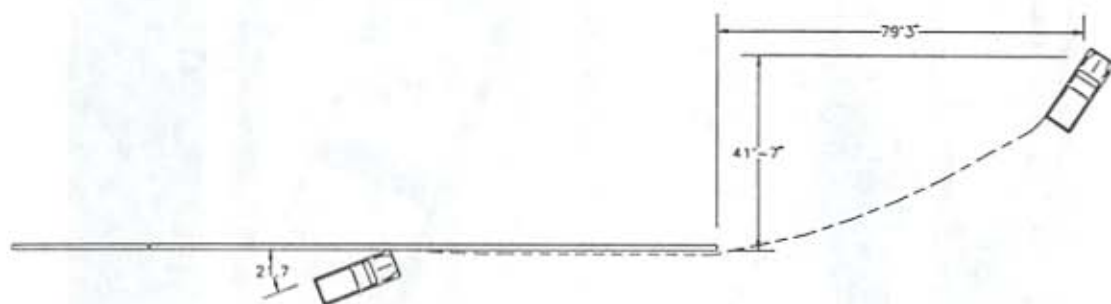
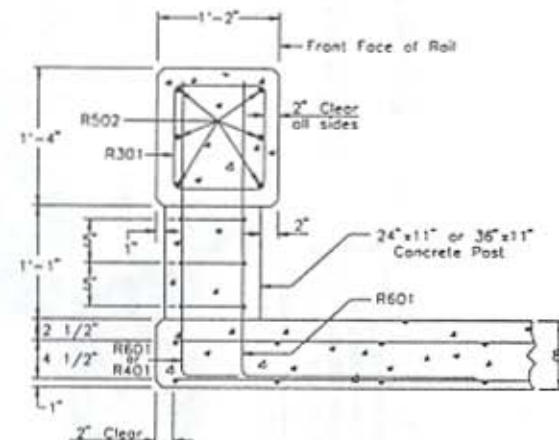
Test Number	NEOCR-5
Date	9/7/94
Installation	Nebraska Open Concrete Rail
Total Length	47.1 m (154 ft - 4 5/8 in.)
Concrete Material	Nebraska 47-BD Mix
Reinforcing Steel Material	Grade 60 Rebar - Epoxy Coated
Concrete Rail	
Length	47.1 m (154 ft - 4 5/8 in.)
Width	35.6 cm (14 in.)
Height	73.7 cm (29 in.)
Depth	40.6 cm (16 in.)
Concrete Posts	
Length	61.0 cm (24 in.)
Width	27.9 cm (11 in.)
Height	33.0 cm (13 in.)
Concrete Posts Adjacent to Gap	
Length	91.4 cm (36 in.)
Width	27.9 cm (11 in.)
Height	33.0 cm (13 in.)
Concrete Bridge Deck	
Length	37.0 m (121 ft - 6 in.)
Width	1.75 m (5 ft - 9 in.)
Depth	20.3 cm (8 in.)

Vehicle	
Model	1986 Ford F-250
Test Inertial Weight	2447 kg (5,394 lb)
Vehicle Speed	
Impact	96.2 km/h (59.8 mph)
Exit	68.2 km/h (42.4 mph)
Vehicle Angle	
Impact	21.7 deg
Exit	NA
Snagging	None
Vehicle Stability	Satisfactory
Occupant Impact Velocities (Normalized)	
Longitudinal	5.4 m/s (17.7 fps) < 9.1 m/s (30 fps)
Lateral	6.4 m/s (21.0 fps) < 7.6 m/s (25 fps)
Occupant Ridedown Decelerations	
Longitudinal	9.8 G's < 15 G's
Lateral	9.8 G's < 15 G's
Vehicle Damage	
TAD	11-LFQ-4, 11-LP-2
VDI	11LFES2, 11LPES2
Vehicle Rebound Distance	30.5 cm (12 in.)
Coefficient of Friction (μ)	0.31 (fair)
Bridge Rail Damage	Minor

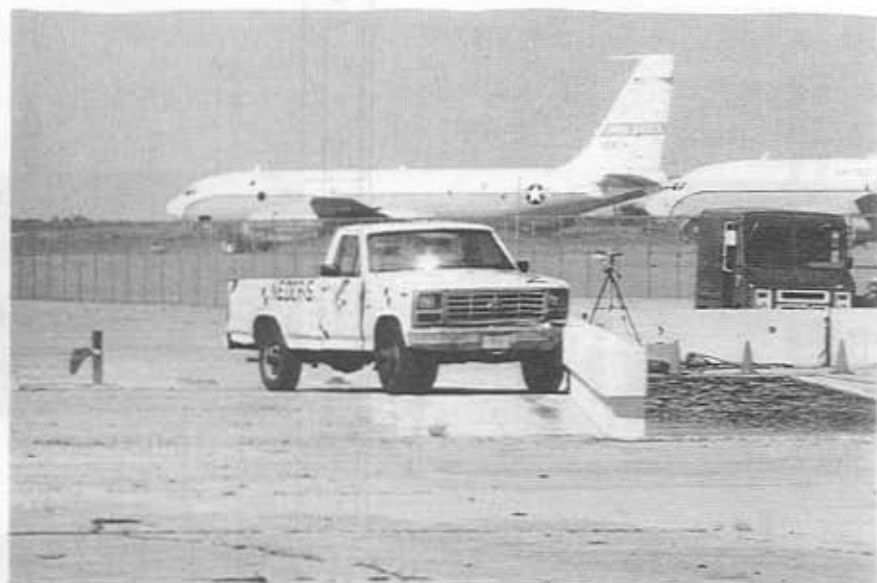
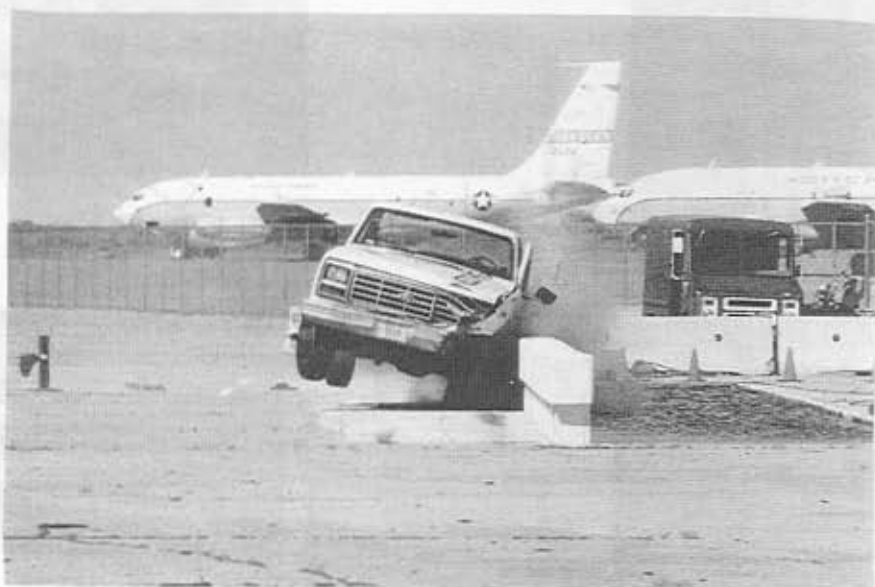
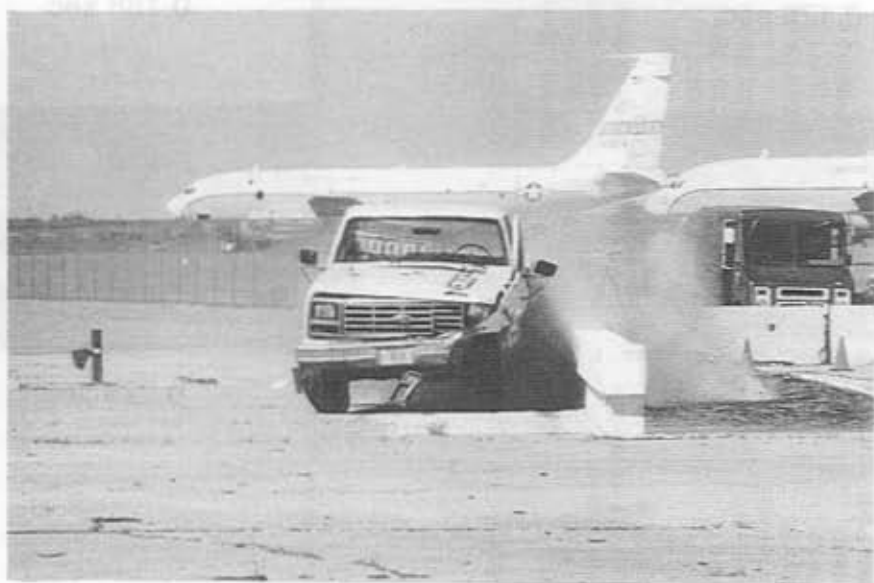
FIGURE 32. Full Scale Test, Test NEOCR-5

Photographs of the full scale crash test are shown in Figures 32 and 33. After the initial impact with the bridge rail (midspan of the section between Post Nos. 11 and 12), the left-front corner of the vehicle crushed inward, reaching a maximum at 0.075 sec. The vehicle became parallel to the rail at approximately 0.179 sec. The vehicle began to exit at a very shallow angle at approximately 0.359 sec. The maximum roll of approximately 8 deg. occurred at 0.375 sec. The vehicle's trajectory is shown in Figure 30. The maximum rebound distance of the vehicle was approximately 30.5-cm (12-in.) at a location 21.3-m (70-ft) downstream of impact. The effective coefficient of friction was determined to be fair ($\mu=0.31$).

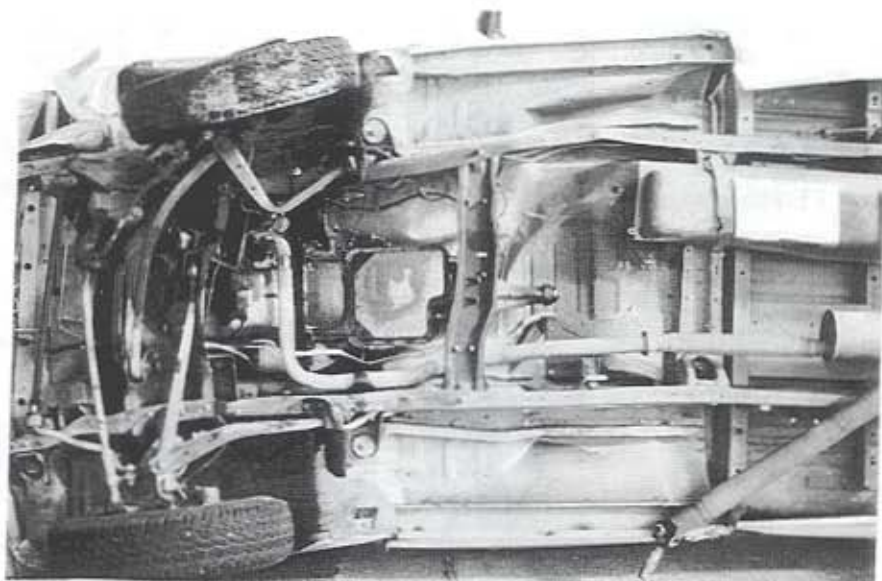
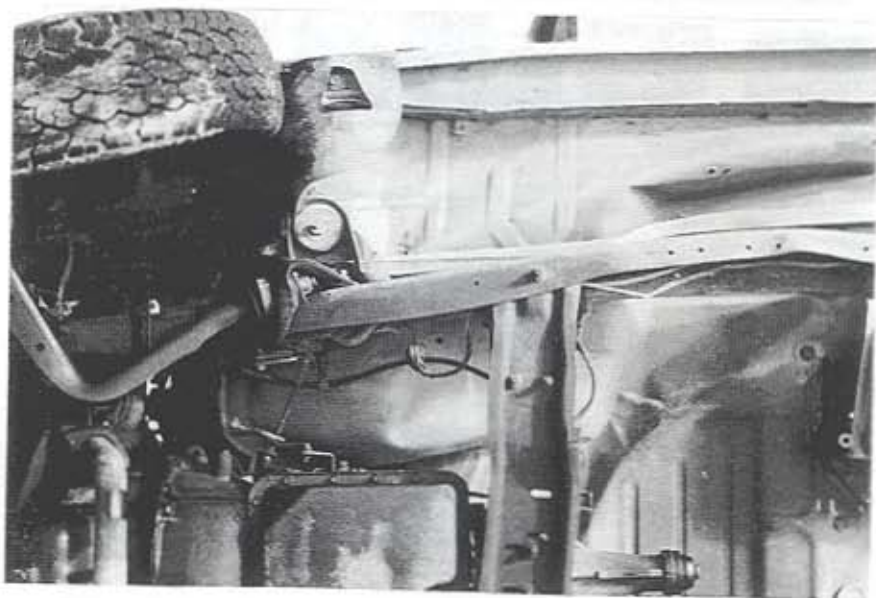
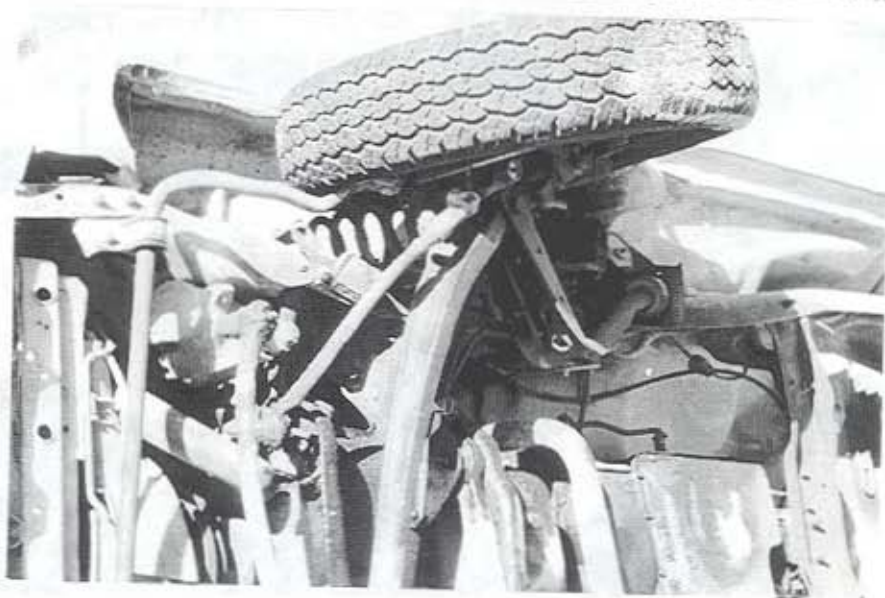
FIGURE 36. Undercarriage Damage, Test NEOCR-5

undercarriage damage consisted of the left front wheel assembly being shoved inward, which caused damage to many key suspension members, including the buckling of the left control arm and the bending of the right control arm, which caused the frame to be twisted. Undercarriage damage is shown in Figure 36. Other damage included deformation inward of the door panel that caused the door to jar out at the top, a cracked windshield on the driver's side, and buckling of the rear bumper. Occupant compartment damage is shown in Figure 37. Damage included an inward crush of the rear of the cab, buckling of the dash, outward buckling of the floor at the driver's side seat location, and downward buckling at driver's side floorboard area. The maximum occupant compartment crush, near the center of the cab compartment floor pan, was approximately 13.3 cm (5 1/4-in.). The center of the dash buckled upward approximately 64 mm (2.5 in.) higher than its original orientation. These occupant compartment deformations were judged to be acceptable, based on the extent and location of the deformations, as discussed in Section 5. The vehicle remained upright both during and after the impact. The vehicle damage was assessed by the traffic accident scale (TAD) (7) and the vehicle damage index (VDI) (8), as shown in Figure 30.

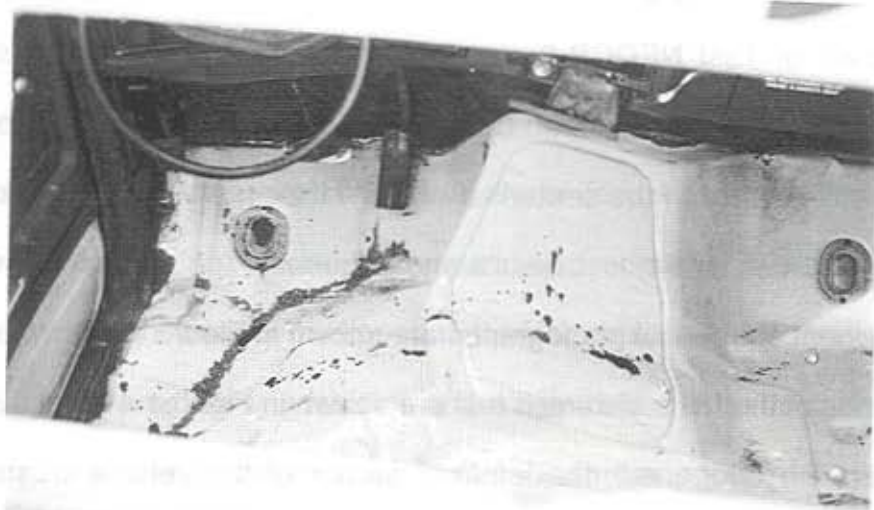
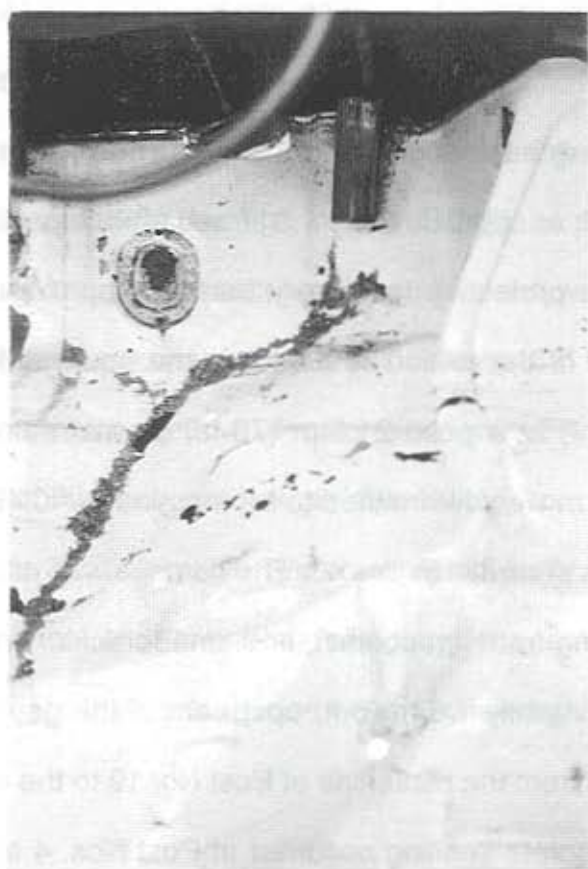
FIGURE 37. Occupant Compartment Damage, Test NEOCR-5

Although both of the pickup tests (NEOCR-5 and 6) sustained moderate damage and exhibited occupant compartment deformations, the tests were judged acceptable based on the extent and locations of the deformations. This type of deformation could reasonably be expected to cause injuries to an occupant's feet and ankles, but would most

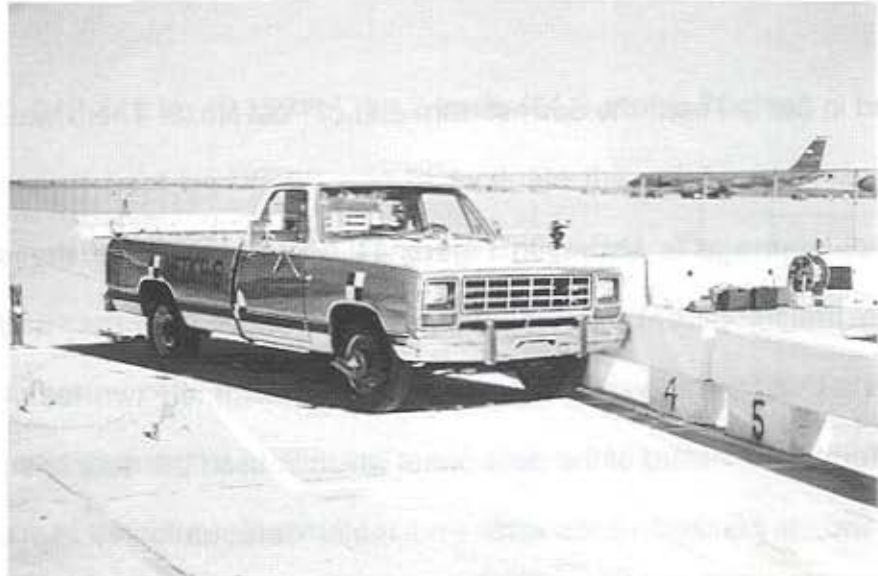
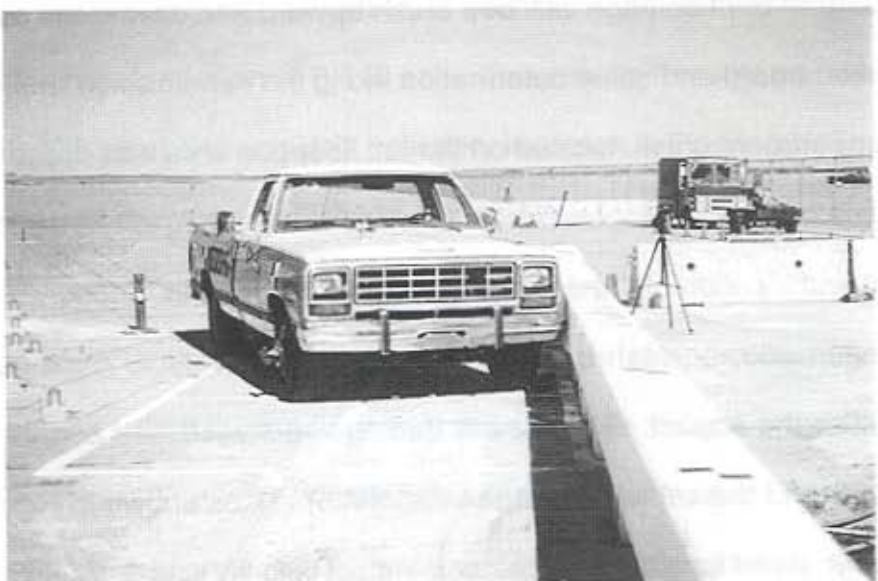
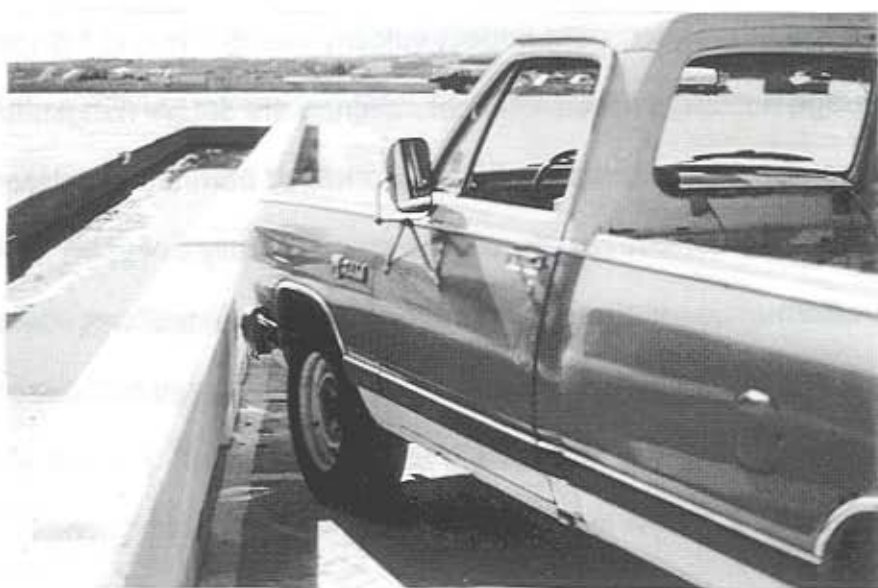
FIGURE 38. Impact Location, Test NEOCR-6

The purpose of Test NEOCR-6 was to evaluate the safety performance of the discontinuous rail section of the Open Concrete Bridge Rail. The impact location was 1.4-m (4.45-ft) upstream from the centerline of the 11.4-cm (4 ½-in.) gap, as shown in Figure 38. A summary of the test results and sequential photographs are shown in Figure 39. Additional sequential photographs are shown in Figure 40.

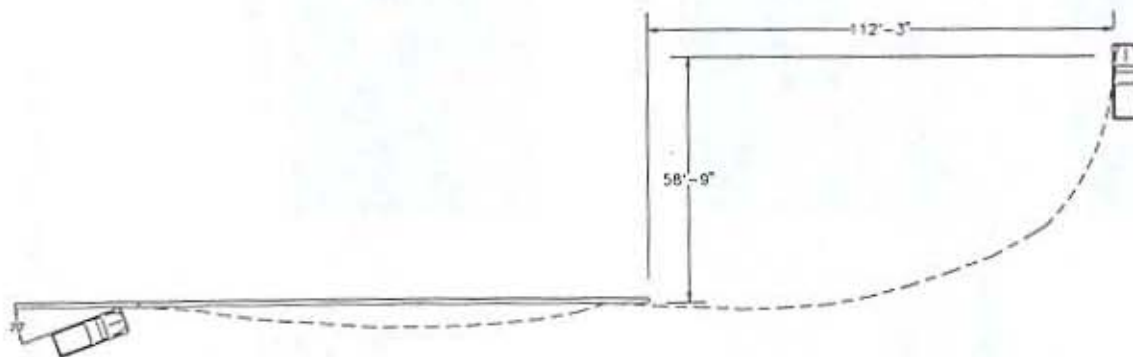
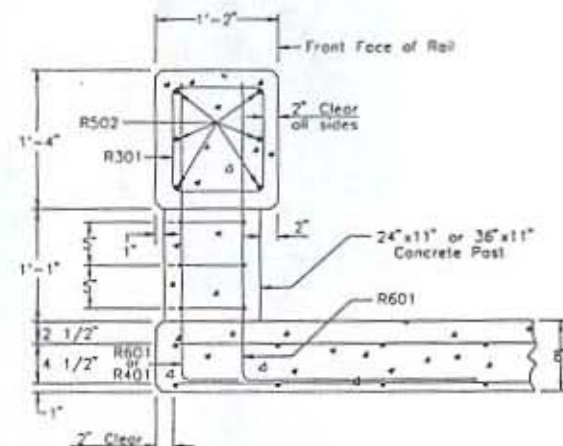
Test Number	NEOCR-6
Date	10/25/94
Installation	Nebraska Open Concrete Rail
Total Length	47.1 m (154 ft - 4 5/8 in.)
Concrete Material	Nebraska 47-BD Mix
Reinforcing Steel Material	Grade 60 Rebar - Epoxy Coated
Concrete Rail	
Length	47.1 m (154 ft - 4 5/8 in.)
Width	35.6 cm (14 in.)
Height	73.7 cm (29 in.)
Depth	40.6 cm (16 in.)
Concrete Posts	
Length	61.0 cm (24 in.)
Width	27.9 cm (11 in.)
Height	33.0 cm (13 in.)
Concrete Posts Adjacent to Gap	
Length	91.4 cm (36 in.)
Width	27.9 cm (11 in.)
Height	33.0 cm (13 in.)
Concrete Bridge Deck	
Length	37.0 m (121 ft - 6 in.)
Width	1.75 m (5 ft - 9 in.)
Depth	20.3 cm (8 in.)

Vehicle	
Model	1985 Dodge Ram 250
Test Inertial Weight	2449 kg (5,399 lb)
Vehicle Speed	
Impact	98.2 km/h (61.0 mph)
Exit	75.2 km/h (46.7 mph)
Vehicle Angle	
Impact	20.0 deg
Exit	NA
Snagging	None
Vehicle Stability	Satisfactory
Occupant Impact Velocities (Normalized)	
Longitudinal	5.6 m/s (18.5 fps) < 9.1 m/s (30 fps)
Lateral	6.6 m/s (21.6 fps) < 7.6 m/s (25 fps)
Occupant Ridedown Decelerations	
Longitudinal	5.4 G's < 15 G's
Lateral	9.1 G's < 15 G's
Vehicle Damage	
TAD	11-LFQ-4, 11-LP-3
VDI	11LFES2, 11LFES2
Vehicle Rebound Distance	1.7 m (67 in.)
Coefficient of Friction (μ)	0.40 (marginal)
Bridge Rail Damage	Minor

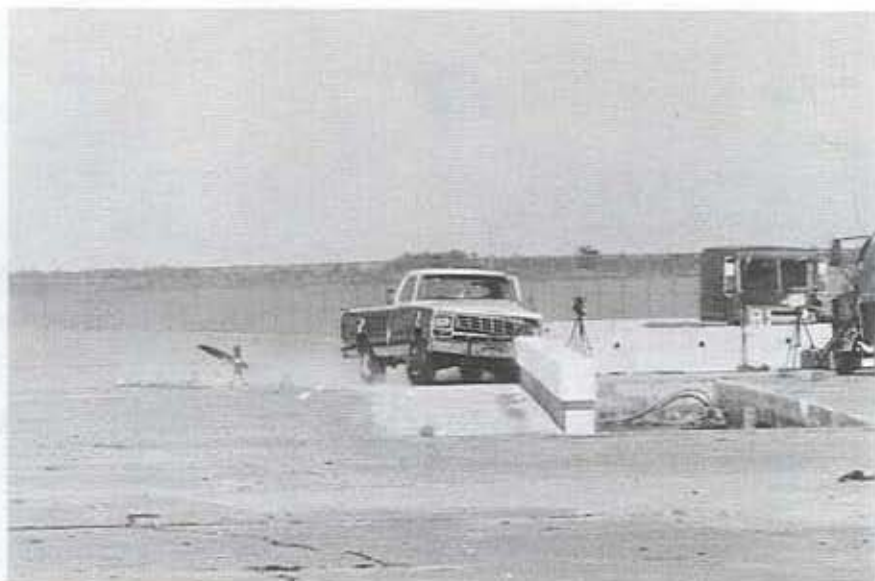
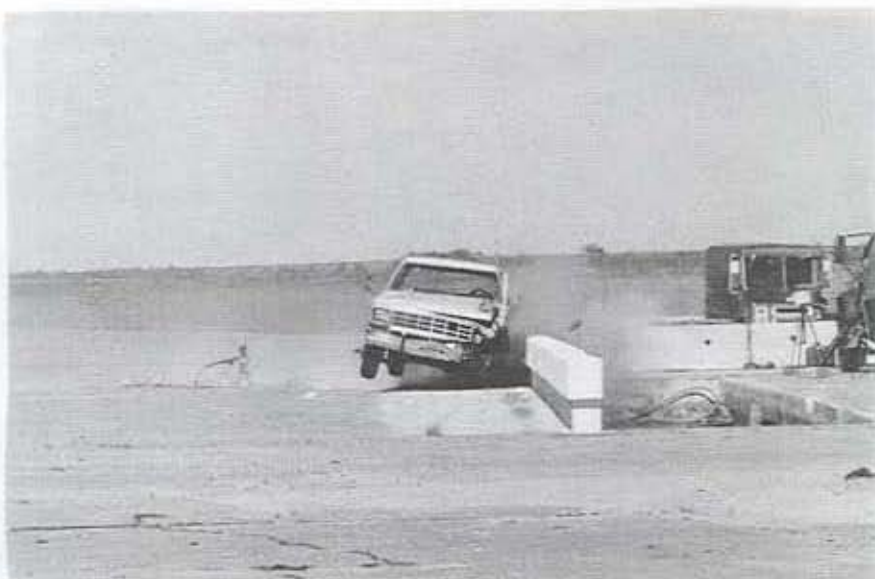
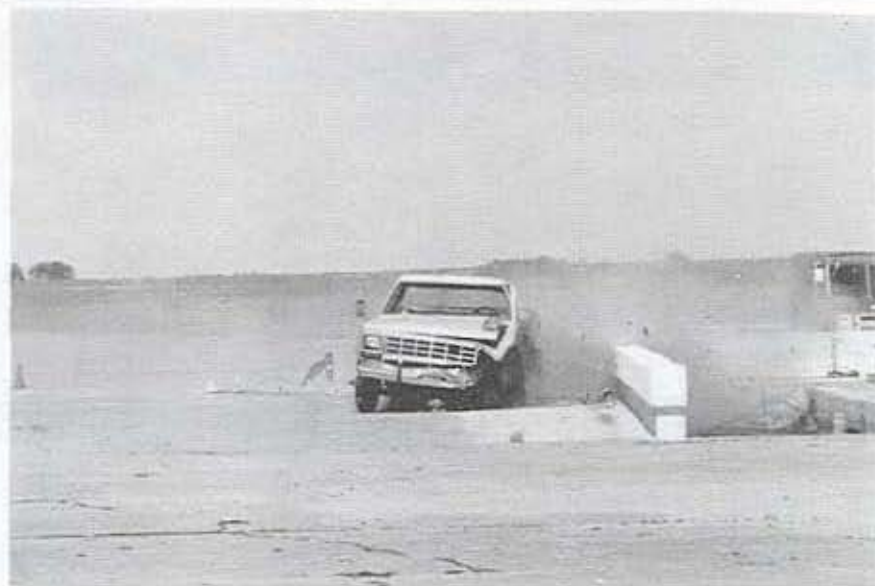
FIGURE 41. Full Scale Test, Test NEOCR-6

Photographs of the full scale crash test are shown in Figures 41 and 42. After the initial impact with the bridge rail, the left-front corner of the vehicle crushed inward, reaching its maximum deformation at 0.119 sec. The vehicle became parallel to the rail at approximately 0.178 sec. The vehicle's trajectory is shown in Figure 39. The right front tire became airborne at approximately 0.138 sec and the right rear tire left the ground at approximately 0.237 sec. These tires returned to the ground at 0.474 sec and 0.553 sec, respectively. The vehicle obtained a maximum roll angle of approximately 8 degrees towards the rail before rolling back and exiting the rail. The vehicle impacted the rail a second time at Post No. 19, at approximately 1.817 sec after impact. The vehicle came to rest after contacting the protective temporary barriers approximately 34-m (112-ft.) downstream from the end of the rail. The vehicle's maximum rebound distance was approximately 1.7-m (67-in.) at a point 21.3-m (70-ft.) downstream from impact. The effective coefficient of friction was determined to be marginal ($\mu=0.40$).
