Performance Level 2 Tests on a 29-in. Open Concrete Bridge Rail

Midwest Roadside Safety Facility (MwRSF) Center for Infrastructure Research

Transportation Research Report TRP-03-51-95

June 1996

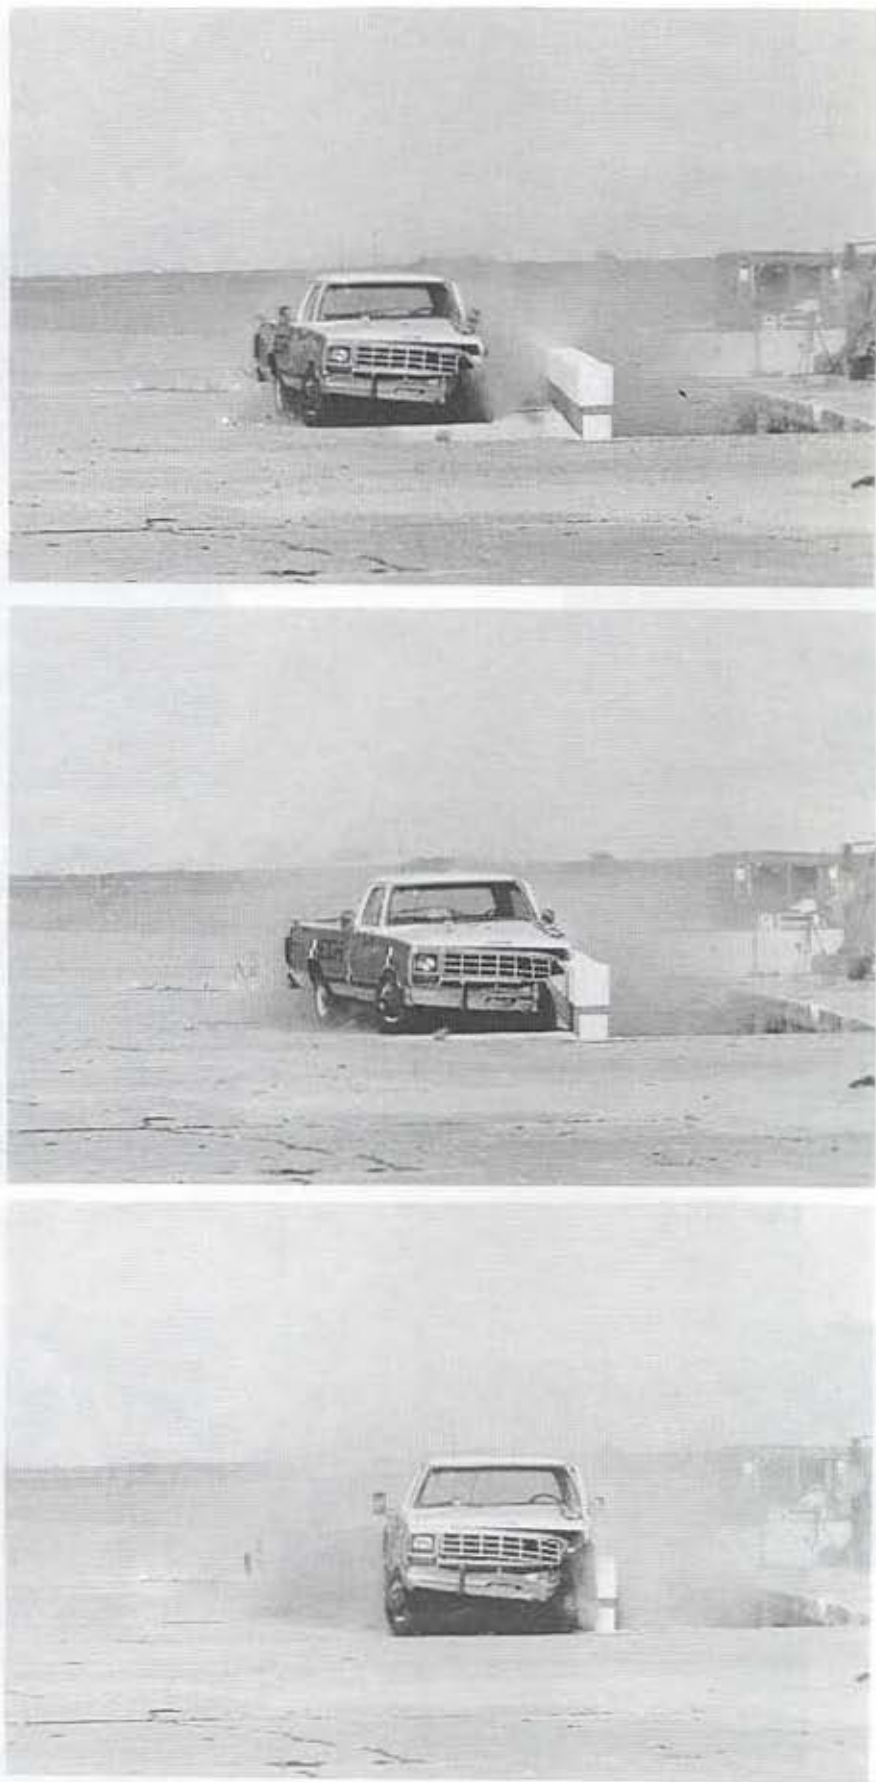
FIGURE 42. Full Scale Test, Test NEOCR-6

Photographs of the full scale crash test are shown in Figures 41 and 42. After the initial impact with the bridge rail, the left-front corner of the vehicle crushed inward, reaching its maximum deformation at 0.119 sec. The vehicle became parallel to the rail at approximately 0.178 sec. The vehicle's trajectory is shown in Figure 39. The right front tire became airborne at approximately 0.138 sec and the right rear tire left the ground at approximately 0.237 sec. These tires returned to the ground at 0.474 sec and 0.553 sec, respectively. The vehicle obtained a maximum roll angle of approximately 8 degrees towards the rail before rolling back and exiting the rail. The vehicle impacted the rail a second time at Post No. 19, at approximately 1.817 sec after impact. The vehicle came to rest after contacting the protective temporary barriers approximately 34-m (112-ft.) downstream from the end of the rail. The vehicle's maximum rebound distance was approximately 1.7-m (67-in.) at a point 21.3-m (70-ft.) downstream from impact. The effective coefficient of friction was determined to be marginal ($\mu=0.40$).
