# **PERFORMANCE LIMITS FOR 6-IN. (152-MM) HIGH CURBS PLACED IN ADVANCE OF THE MGS USING MASH VEHICLES PART III: FULL-SCALE CRASH TESTING (TL-2)**

MwRSF Research Report No. TRP-03-237-10

November 24, 2010

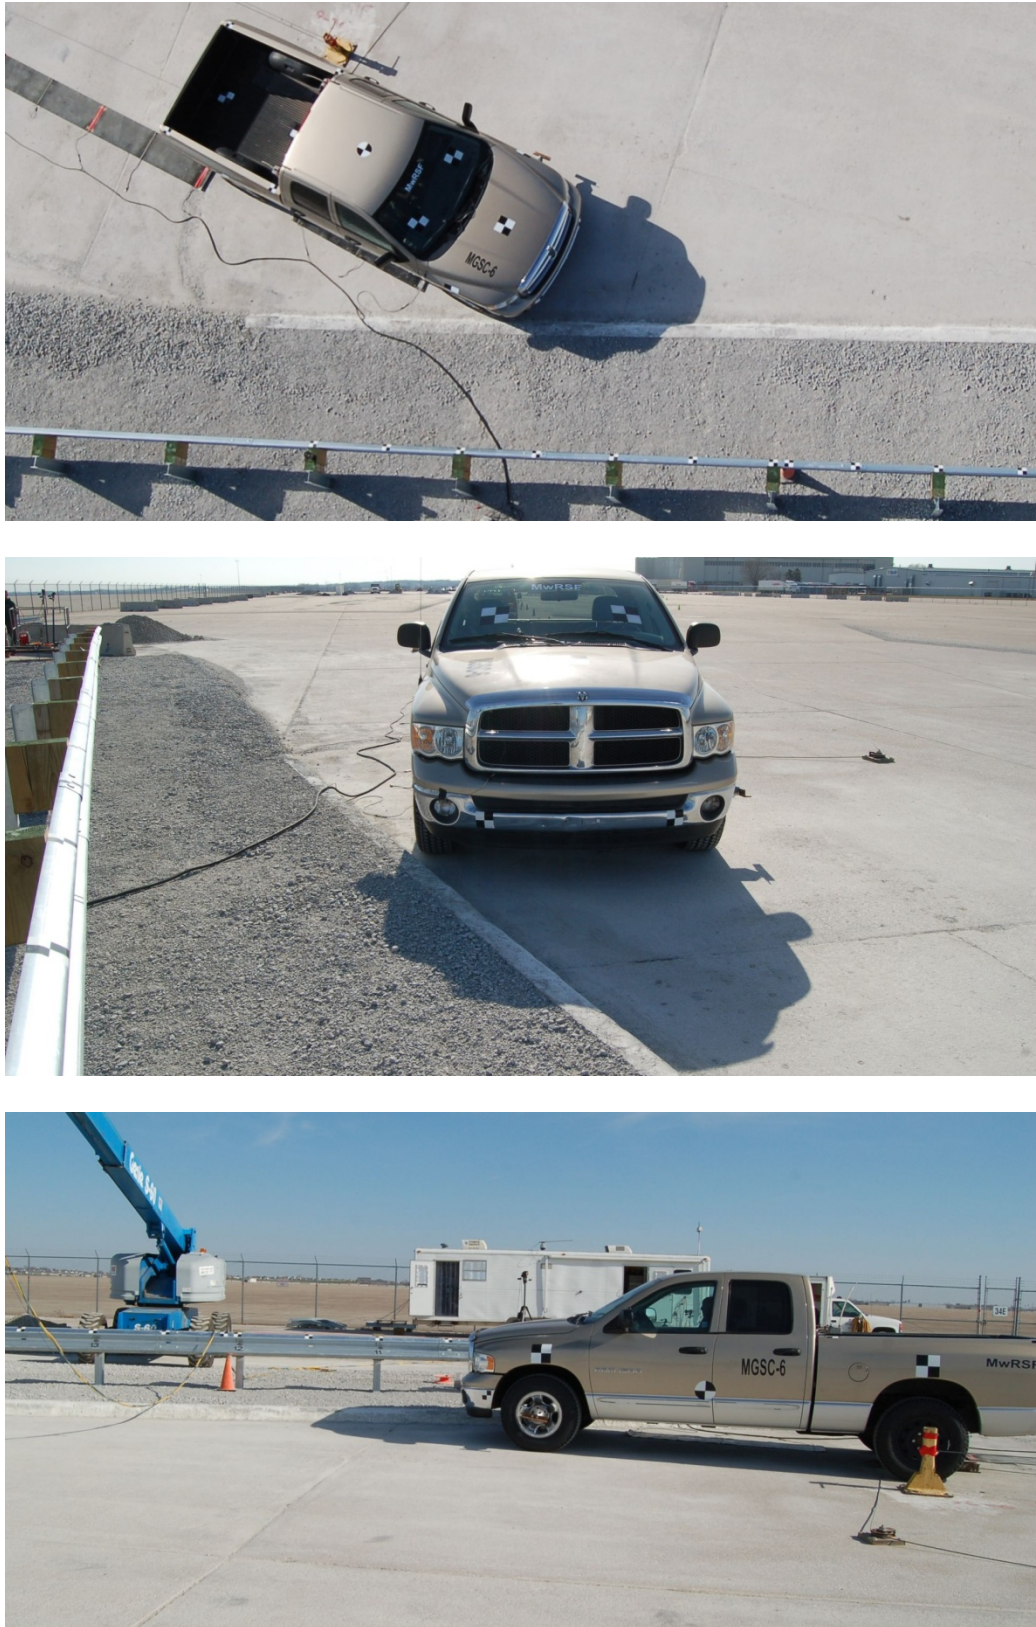
Figure 26. Impact Location, Test No. MGSC-6

Initial vehicle impact with the guardrail was to occur 14 ft - 11 in. (4.6 m) upstream of the centerline of the splice between post nos. 14 and 15, as shown in Figure 26. The actual point of impact was 15 ft - 2½ in. (4.6 m) upstream of the centerline of the splice between post nos. 14 and 15. A sequential description of the impact events is contained in Table 4. The vehicle came to rest 211 ft - 8 in. (64.5 m) downstream from impact and 87 ft (26.5 m) laterally behind the front face of the guardrail. The vehicle trajectory and final position are shown in Figures 19 and 27, respectively.
