*Research Project Number TPF-5(193) Supplement #130*

# **EVALUATION OF THE NEW YORK LOW-TENSION THREE-CABLE BARRIER ON CURVED ALIGNMENT**

MwRSF Research Report No. TRP-03-263-12

February 19, 2013

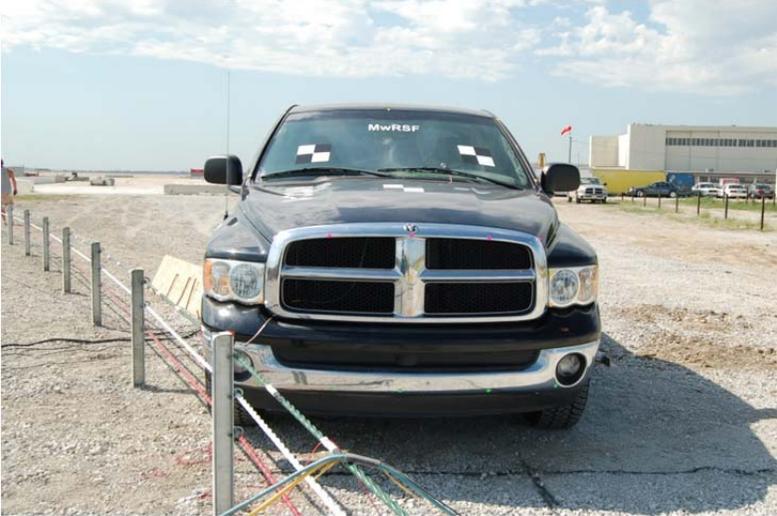
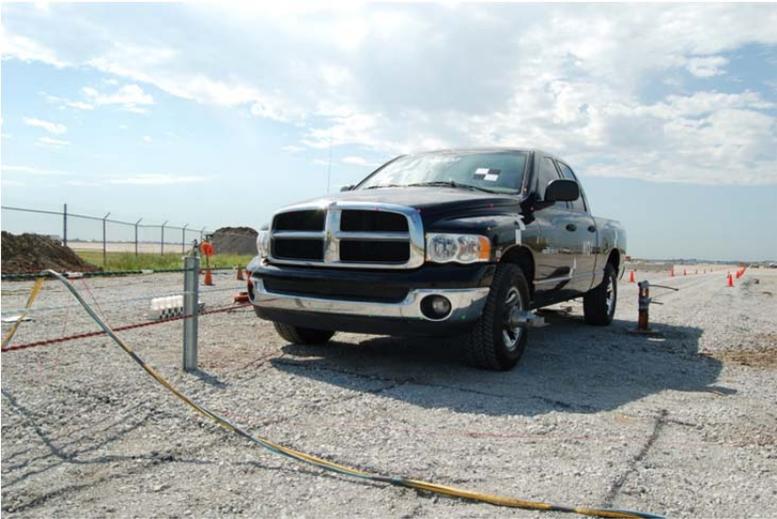
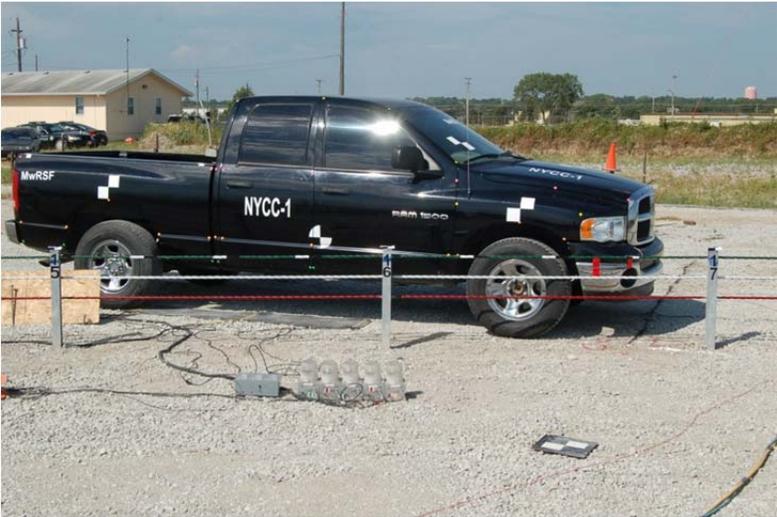
Figure 39. Impact Location, Test No. NYCC-1

Initial vehicle impact occurred at the targeted impact point 70 ft (21.3 m) downstream of post no. 8, or 2 ft (0.6 m) upstream of post no. 17, as shown in Figure 39, which was selected by NYSDOT personnel. A sequential description of the impact events is contained in Table 4. The vehicle came to rest 220 ft - 10 in. (67.3 m) downstream of impact and adjacent to the downstream anchorage. The vehicle trajectory and final position are shown in Figures 32 and 40.

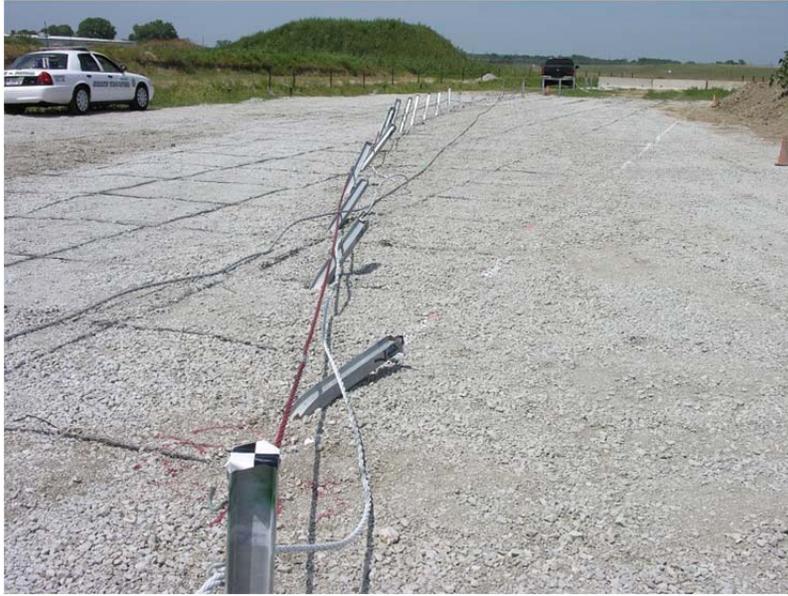
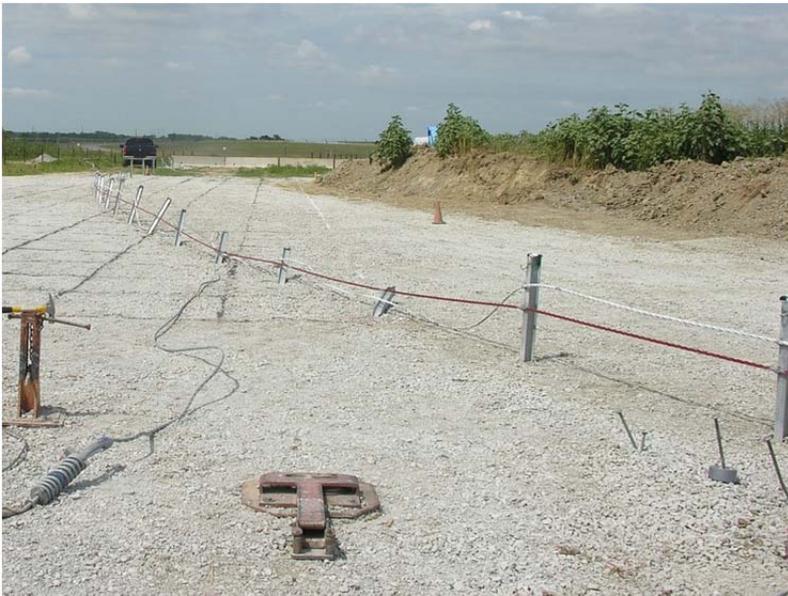
Figure 41. System Damage, Test No. NYCC-1

Damage to the barrier was extensive, as shown in Figures 41 through 55. Barrier damage consisted of bent posts, disengaged cables, weld failures, and anchor rod fractures. The length of vehicle contact along the barrier was approximately 130 ft (39.6 m), which spanned from 2 ft (0.6 m) upstream from post no. 17 through post no. 33.

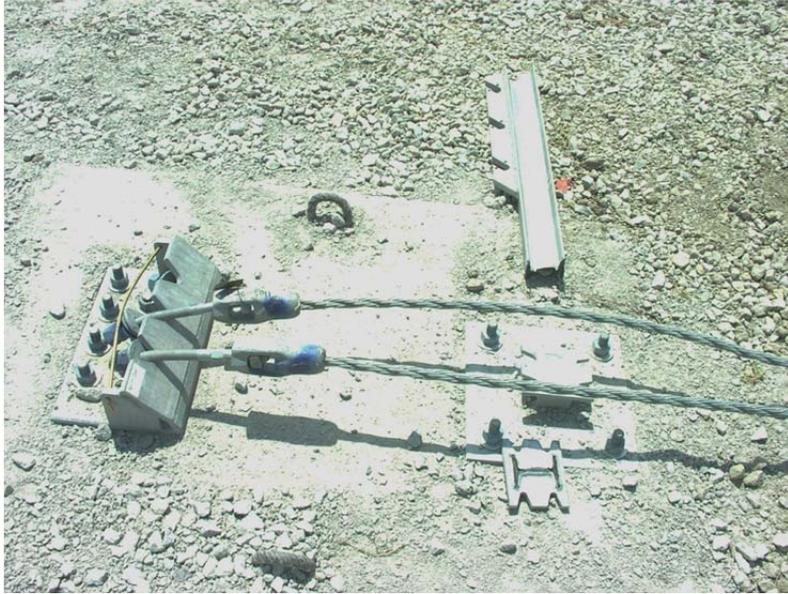
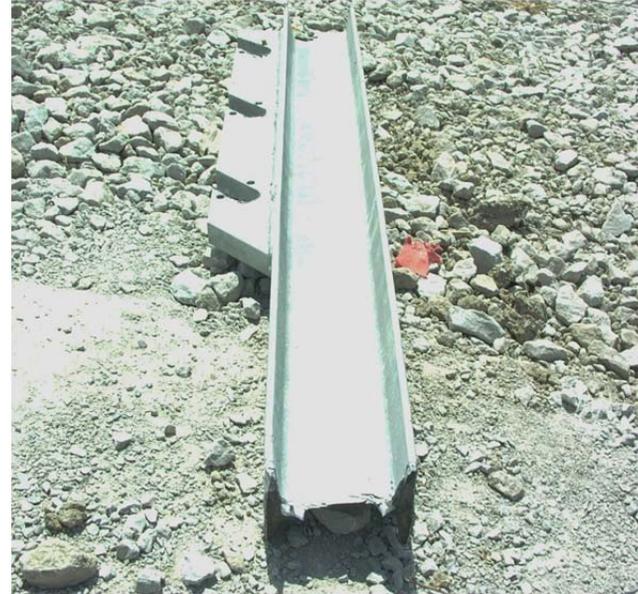
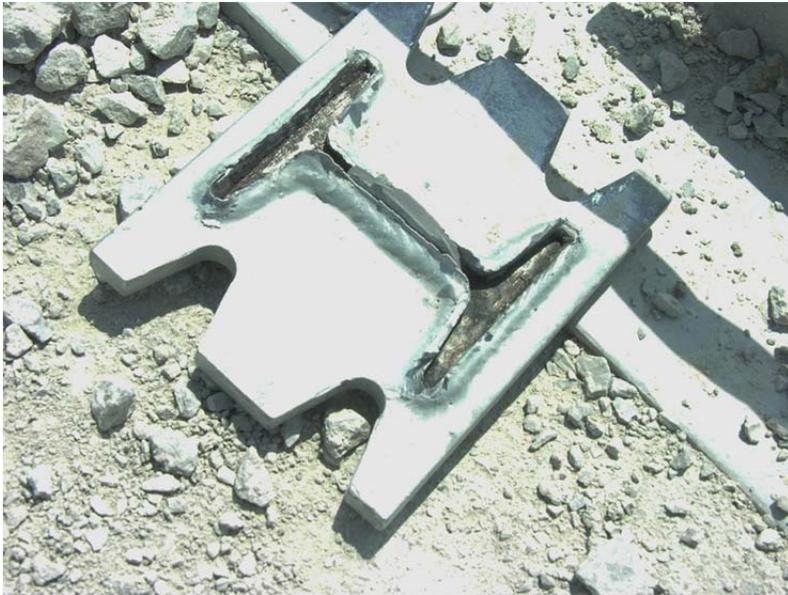
Figure 42. System Damage: Upstream Anchor and Post No. 1, Test No. NYCC-1

The upstream anchorage was moderately and unexpectedly damaged. The weld between post no. 1 and the slip base plate failed, as shown in Figure 42. Both the post and the plate were found adjacent to the slip base stub. All of the cables were disengaged from post no. 1. The top cable anchor rod fractured and the middle cable anchor rod bent, as shown in Figure 43. The upstream end of the top cable came to rest about 10 ft (3 m) in front of post no. 15. The brass keeper rod on the angled anchor plate was also bent.

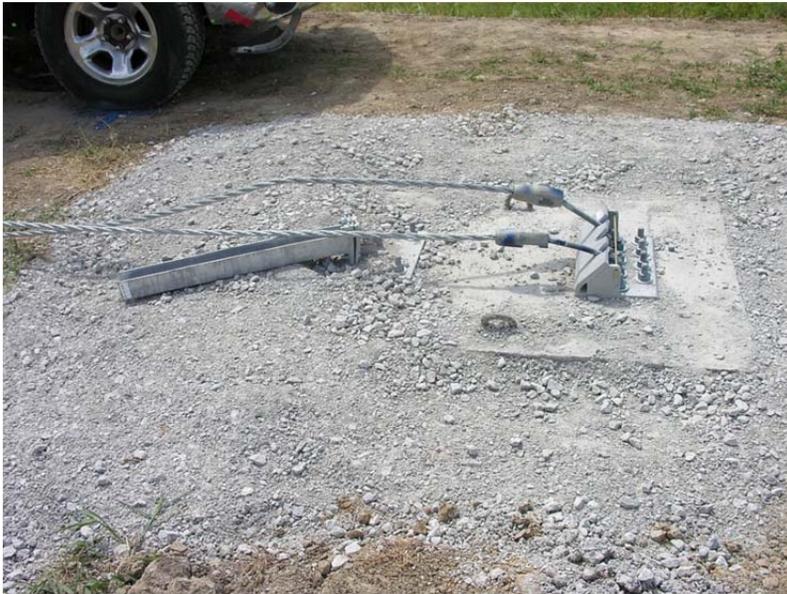
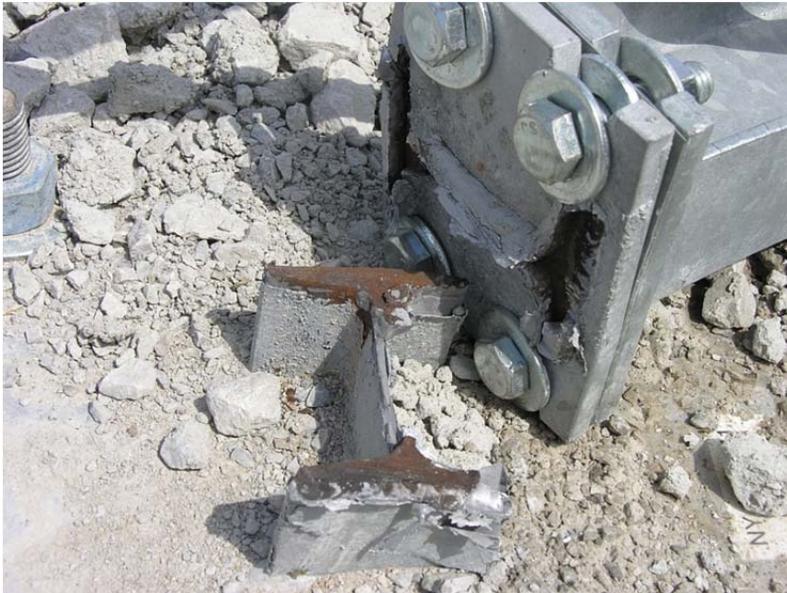
Figure 44. System Damage: Downstream Anchor and Post No. 40, Test No. NYCC-1

The downstream anchorage experienced similar damage. The weld between the bottom slip base plate and the post stub failed, as shown in Figure 44. The post came to rest adjacent to the stub with the slip base completely intact. All three cables were disengaged from the post. The middle cable anchor rod fractured, as shown in Figure 45, due to the cable being snagged on the vehicle. The downstream end of the middle cable came to rest behind the vehicle, about 6 ft (2 m) in front of post no. 38.

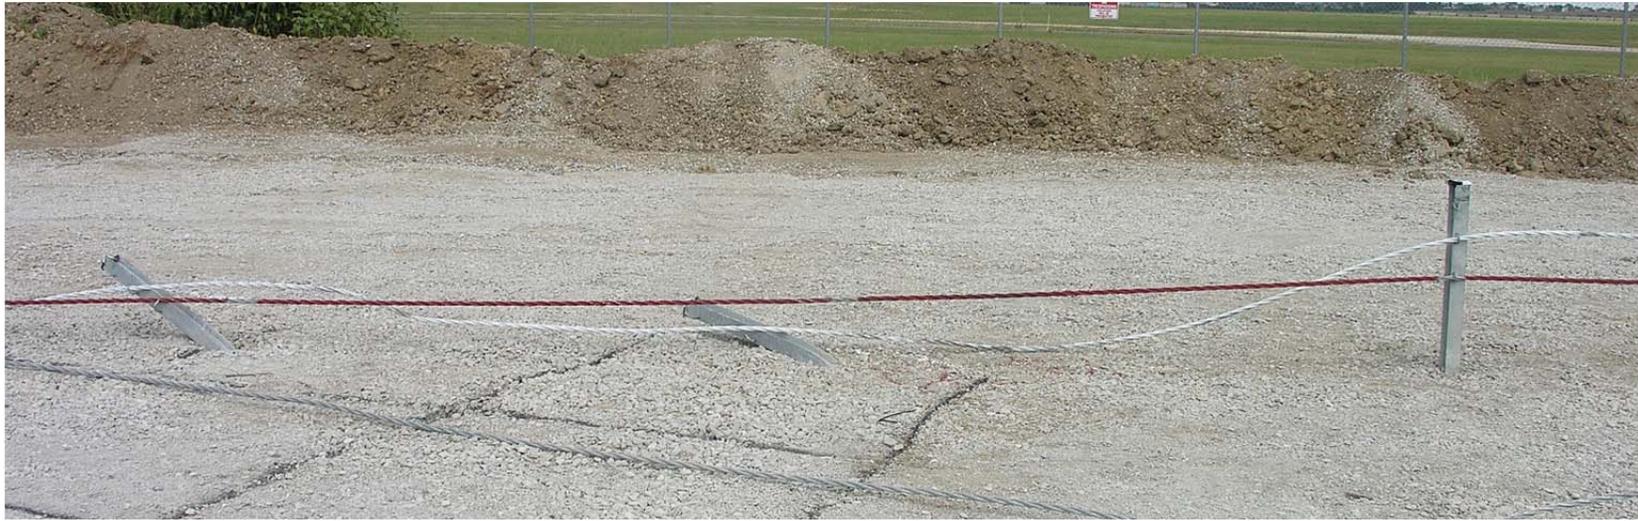
Figure 46. System Damage: Middle Cable between Post Nos. 17 and 18, Test No. NYCC-1

through 19, 30, and 33. The middle cable between post nos. 17 and 18 frayed. The fray consisted of two broken wire strands, as shown in Figure 46.

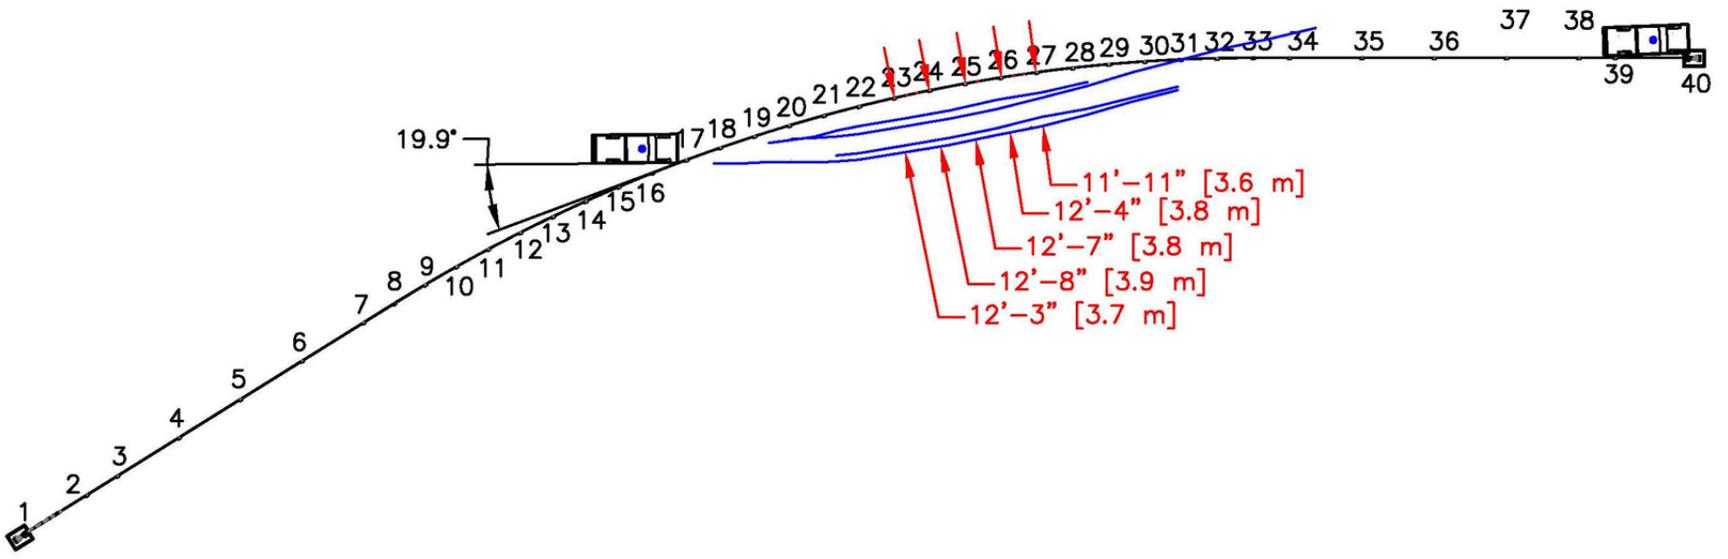
79 Figure 56. Working Width, Test No. NYCC-1

The maximum lateral dynamic barrier deflection before the cable release at the end anchorage was 8.5 ft (2.6 m) located 2 ft (0.6 m) upstream from post no. 21, as determined from high-speed digital video analysis. The working width of the system was determined to be 12 ft – 8 in. (3.9 m), as shown in Figure 56. The maximum lateral dynamic barrier deflection after the cable released from the end anchorage was 12 ft – 7 in. (3.8 m), which was calculated at the same location and time as the working width. The working width of the system was determined to be larger than expected due to the fracture of the top cable's upstream end anchor rod.

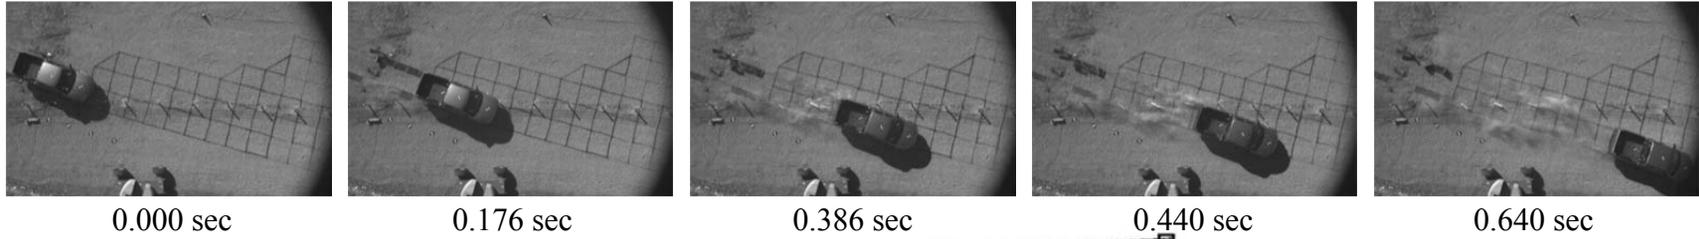
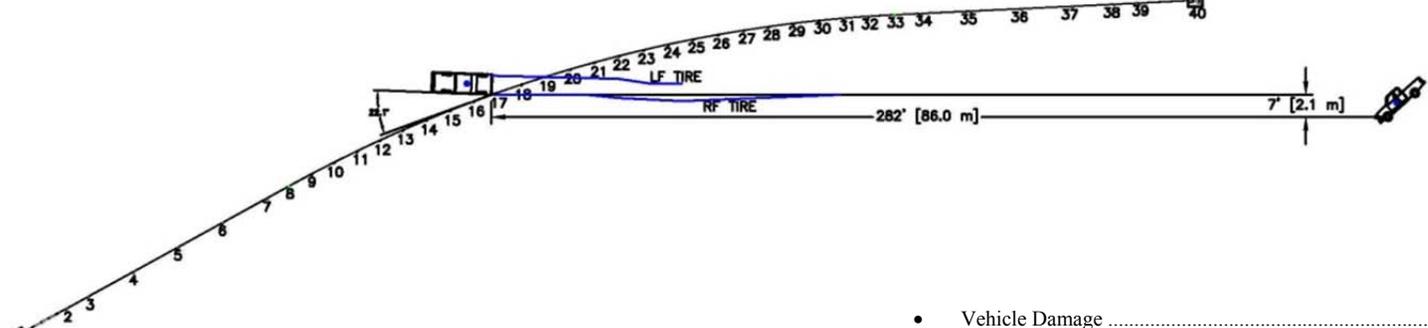
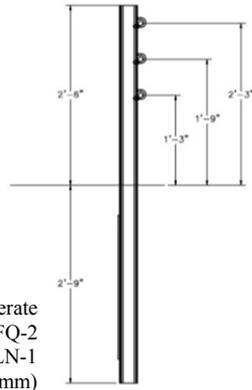
Figure 66. Summary of Test Results and Sequential Photographs, Test No. NYCC-2

The analysis of the test results for test no. NYCC-2 showed that the generic, three-cable barrier with a 440 ft (134.1 m) curved radius and a 27 in. (686 mm) top mounting height did not adequately contain or redirect the 2270P vehicle since the vehicle overrode the barrier. The vehicle did not remain upright after the collision; however, it is believed that the rollover was caused by contact with an embankment behind the system. Thus, the rollover was not directly caused by the system containment failure. Vehicle roll, pitch, and yaw angular displacements, as shown in Appendix F, were deemed acceptable prior to the vehicle rolling over the embankment. There were no detached elements or fragments which showed potential for penetrating the occupant compartment, nor did any detached elements present undue hazard to other traffic. However, excessive occupant compartment deformations were imparted to the roof of the vehicle due to the eventual vehicle rollover. Therefore, test no. NYCC-2 was determined to be unacceptable according to the MASH safety performance criteria for modified test designation no. 3-11.

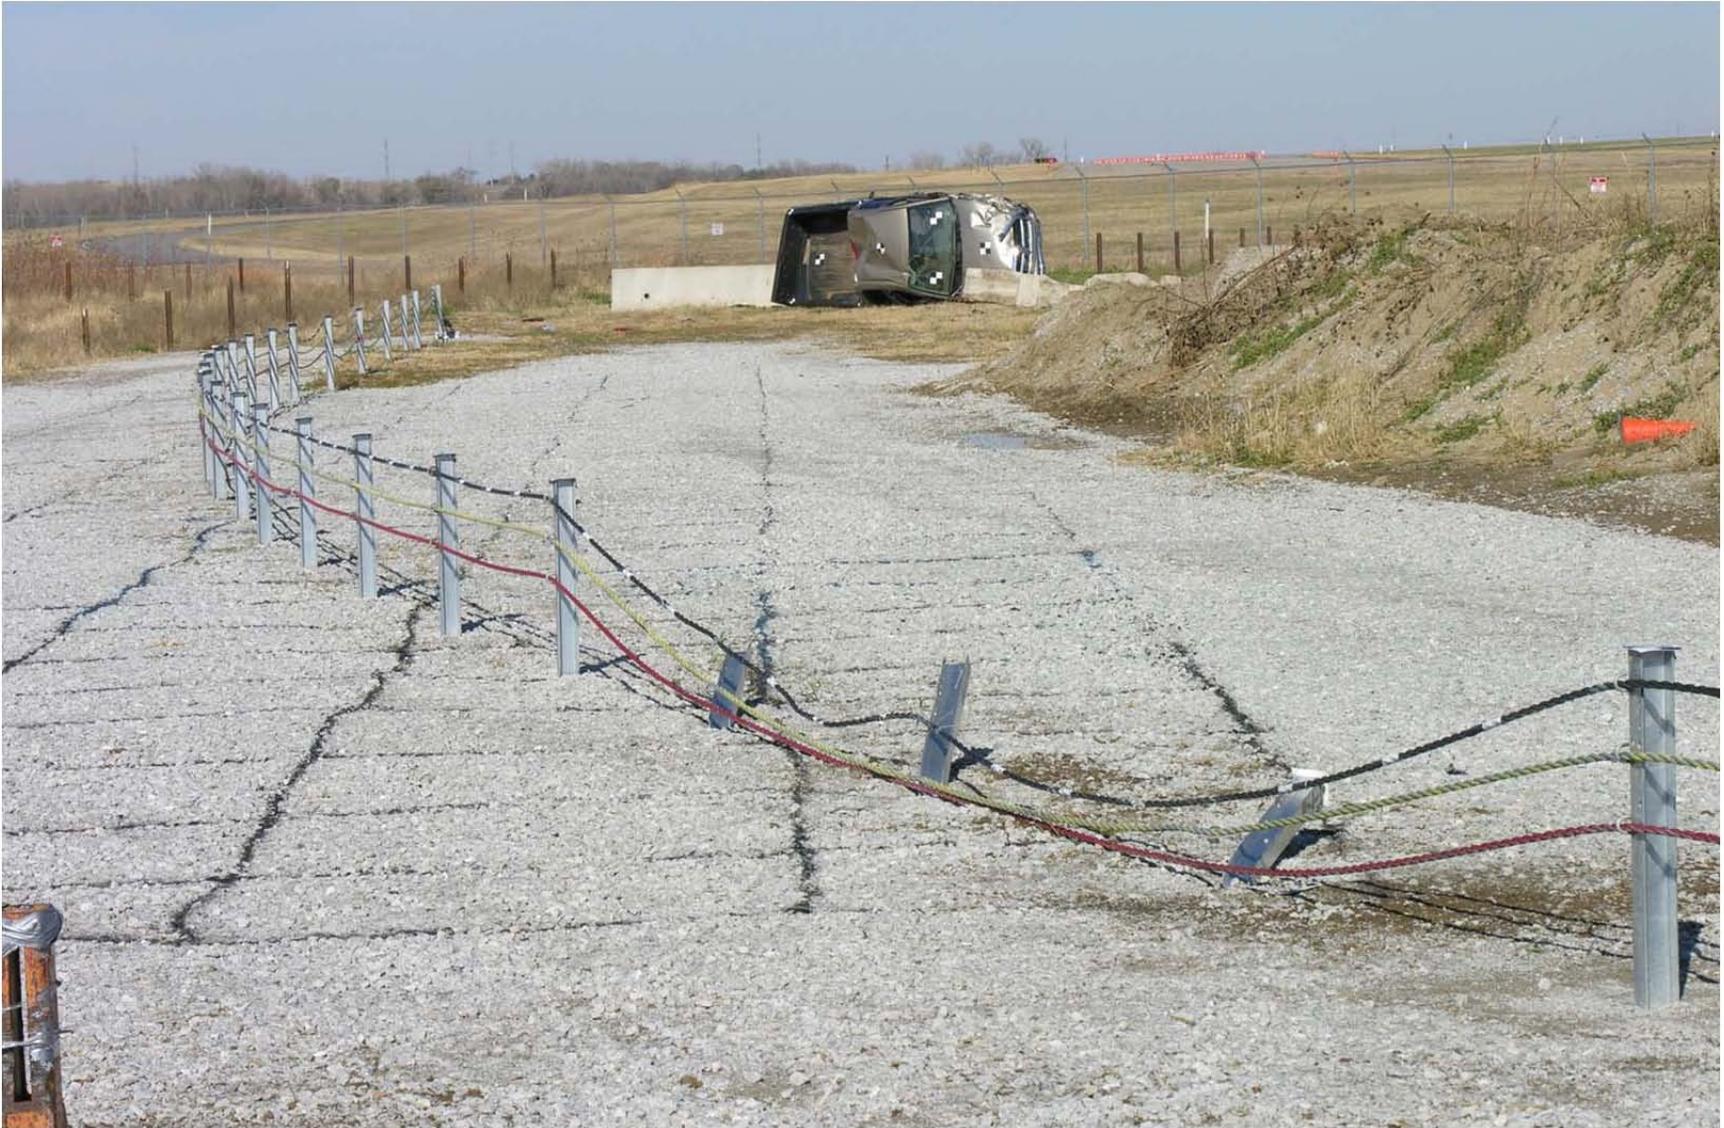
Figure 71. Vehicle Final Position and Trajectory Marks, Test No. NYCC-2

Initial vehicle impact occurred at the targeted impact point 2 ft (0.6 m) upstream of post no. 17, or 70 ft (21.3 m) downstream of post no. 8, as shown in Figure 70, which was selected by NYSDOT personnel. A sequential description of the impact events is contained in Table 9. The vehicle came to rest on its side behind the barrier at a location of 282 ft (86.0 m) downstream of impact and 7 ft (2.1 m) laterally behind a line parallel to the impact point, as shown in Figures 66 and 71.

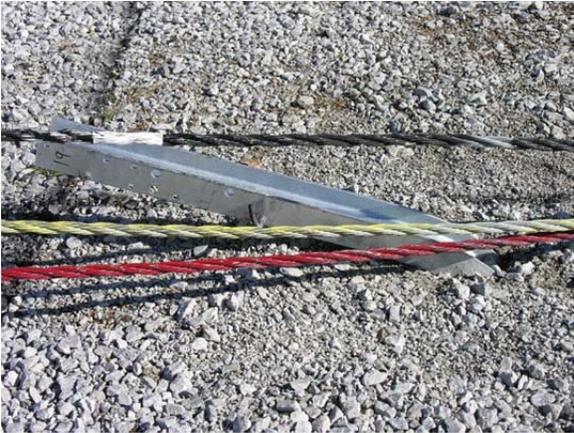
Post No. 19

The top, middle, and bottom cables disengaged from post nos. 17 through 19. All cable-to-post J-bolt attachments on post nos. 17 and 18 were bent. Additionally, the top and middle J-bolts on post nos. 17 and 18 were rotated upstream. The top and middle J-bolts on post no. 19 were fractured and the bottom J-bolt was bent and rotated upstream.

Figure 74. System Damage: Post Nos. 17 through 19, Test No. NYCC-2

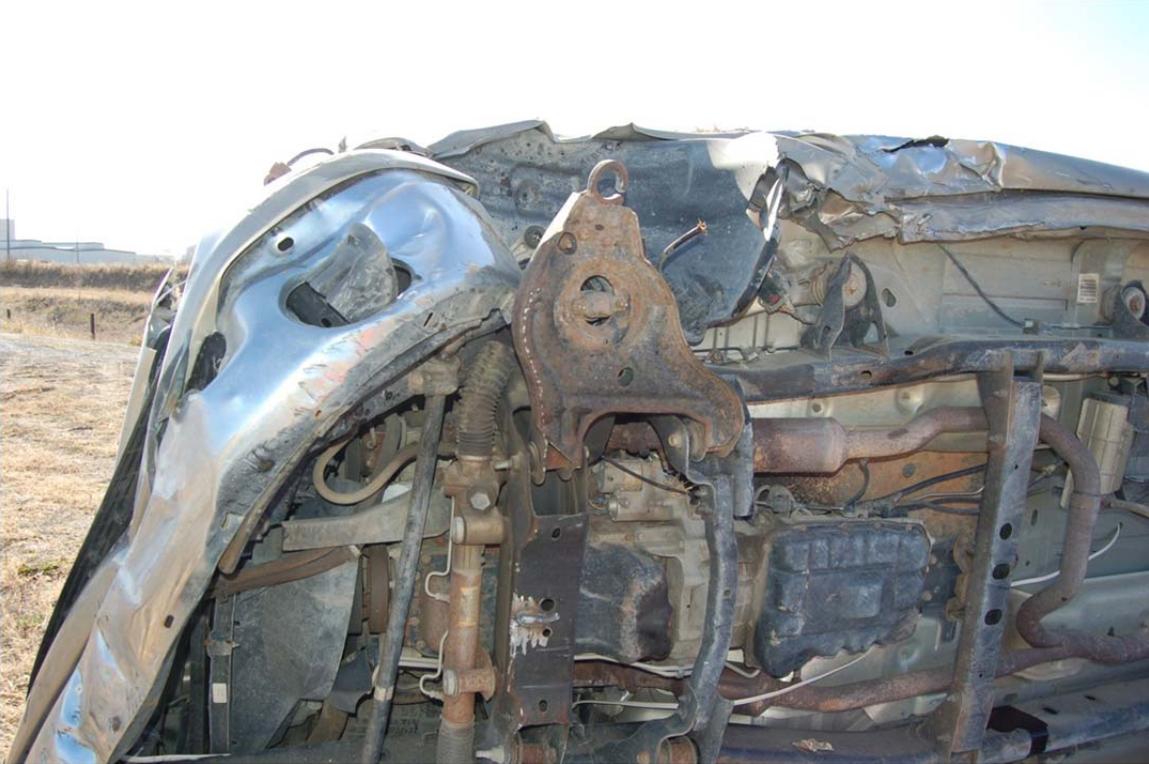
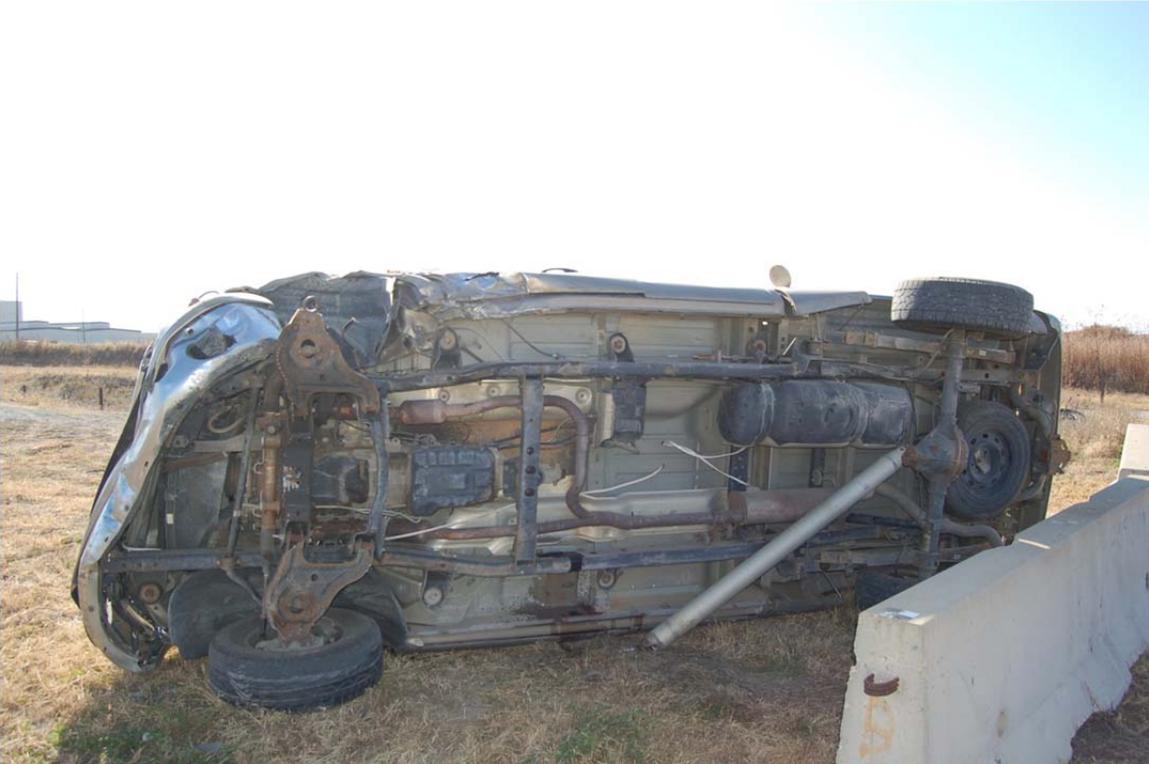
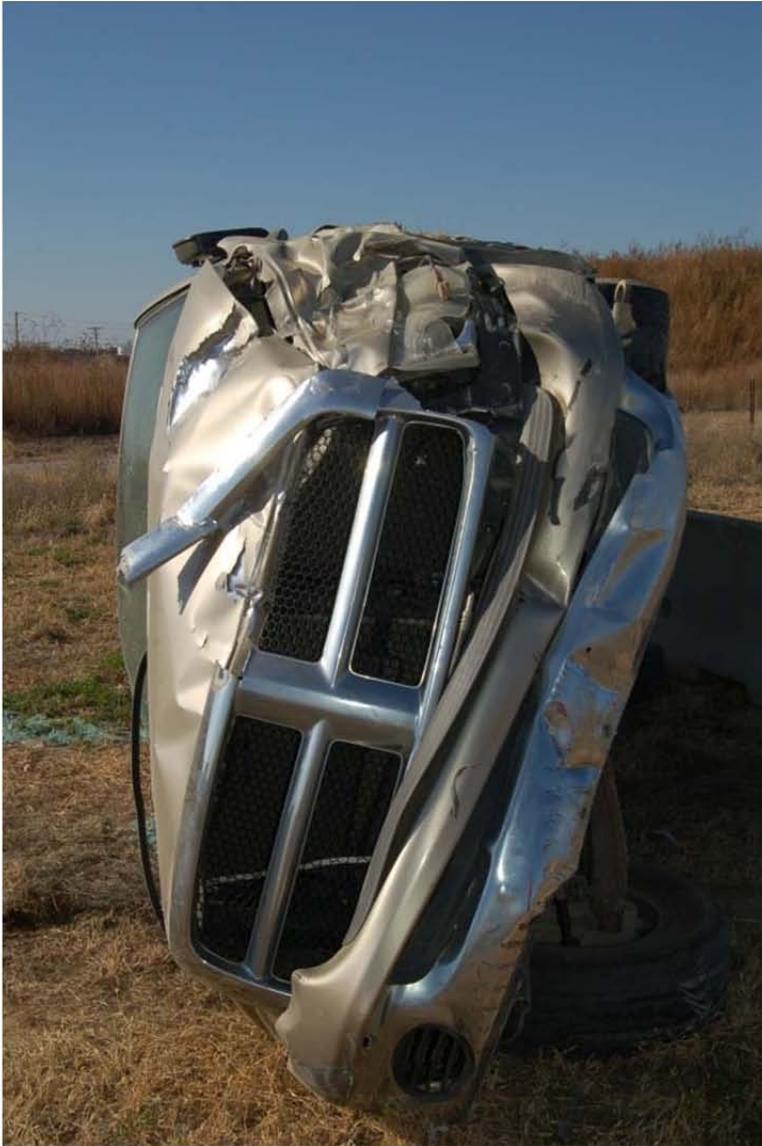
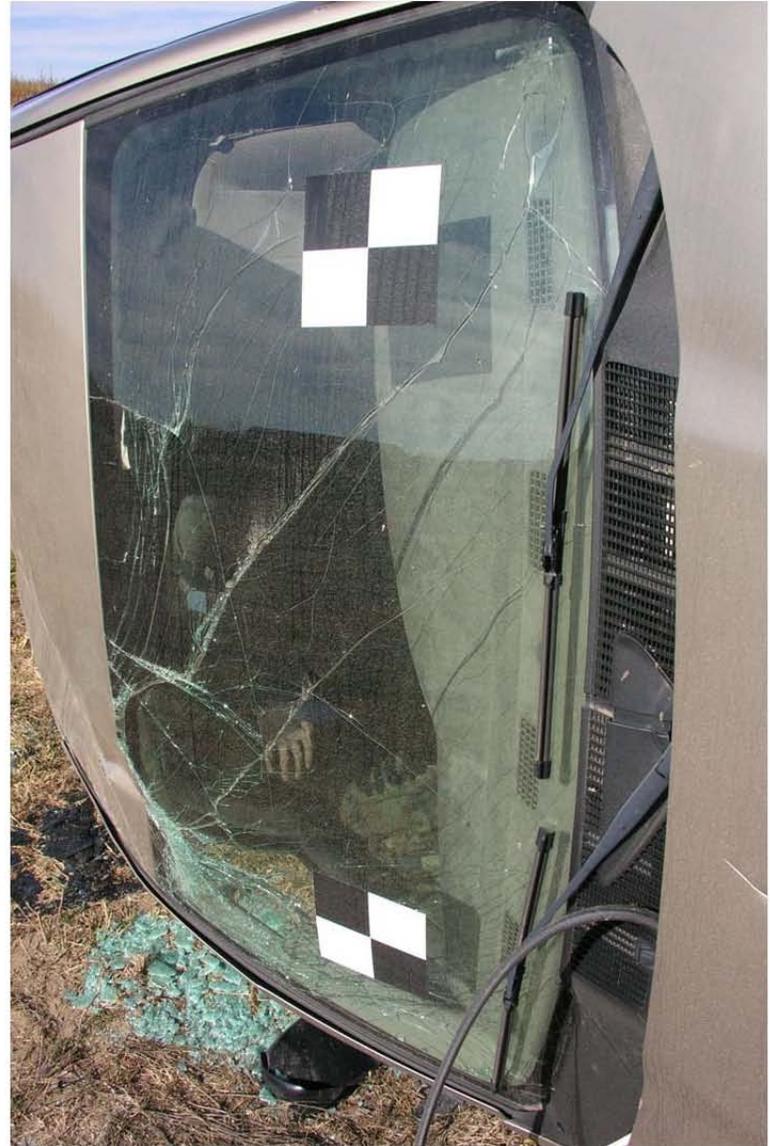
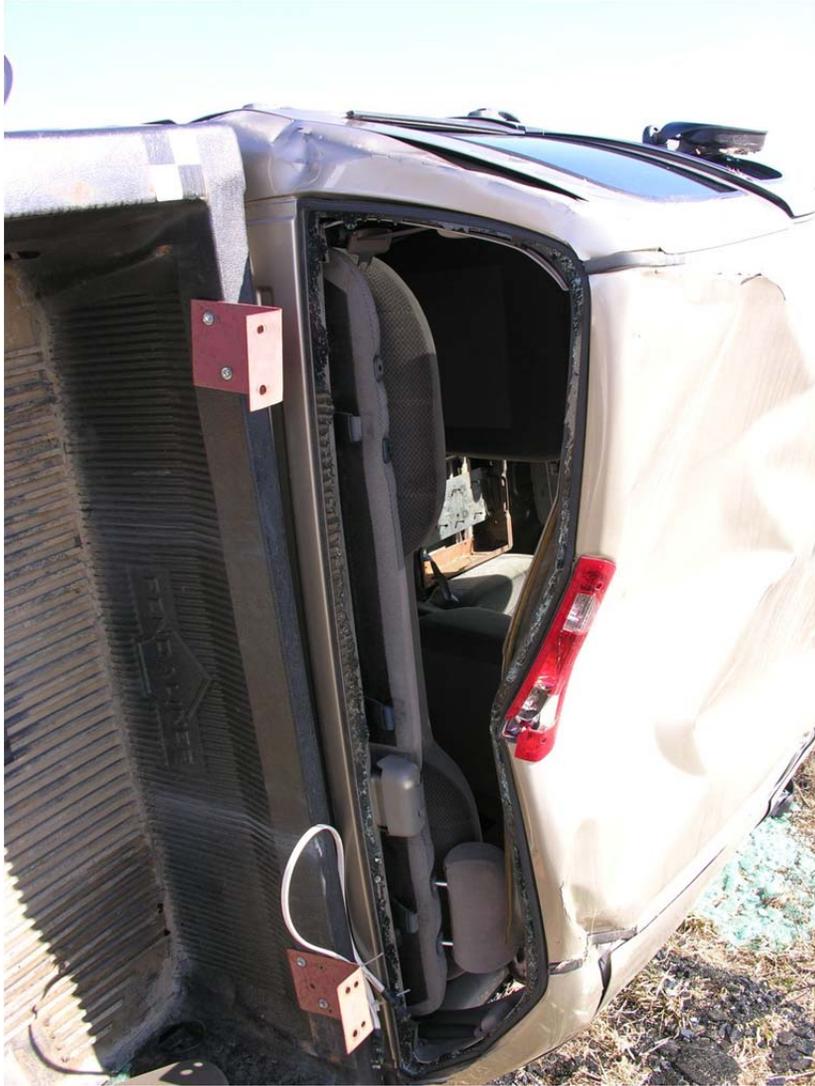
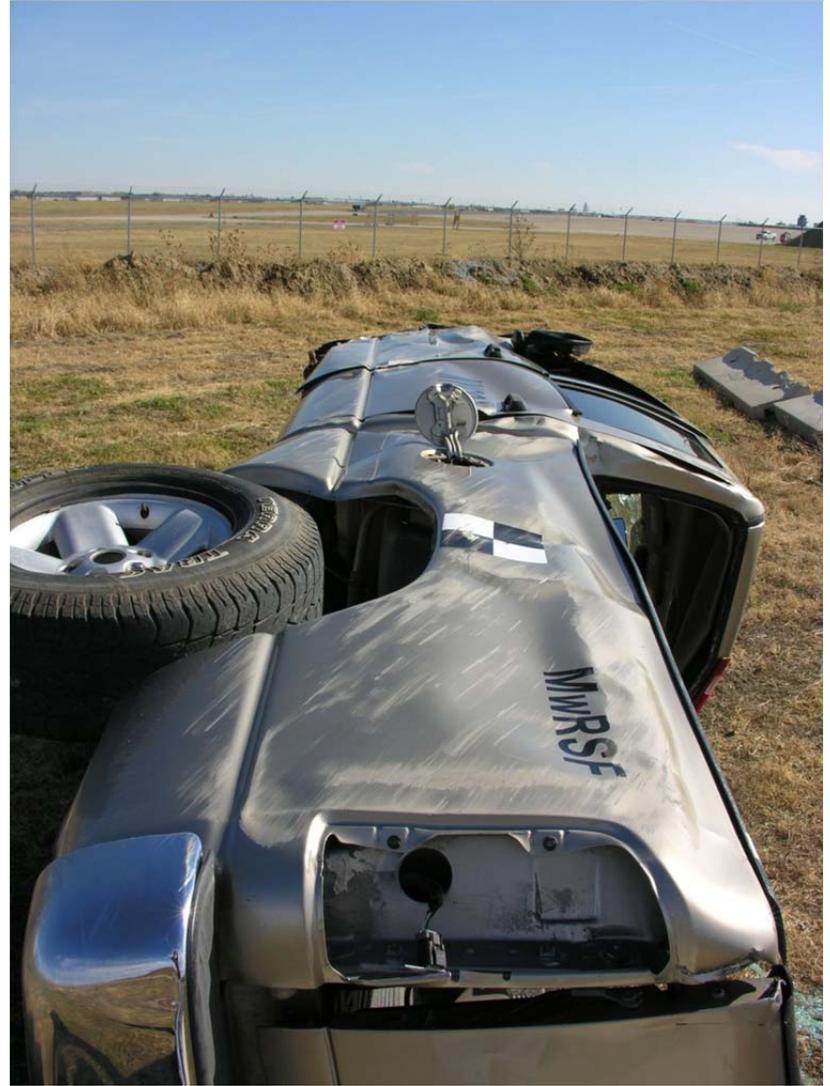
The damage to the vehicle was moderate, as shown in Figures 75 through 78. However, only minor vehicle damage resulted from the interaction with the barrier. The damage due to rollover was not attributable to the curved-cable system as the vehicle was stable and tracking before climbing the embankment. The maximum occupant compartment deformations are listed in Table 10 along with the deformation limits established in MASH for various areas of the occupant compartment. Note that the maximum permissible roof crush limits described in

Figure 76. Vehicle Damage, Test No. NYCC-2

Figure 77. Vehicle Damage, Test No. NYCC-2

Figure 78. Vehicle Damage, Test No. NYCC-2

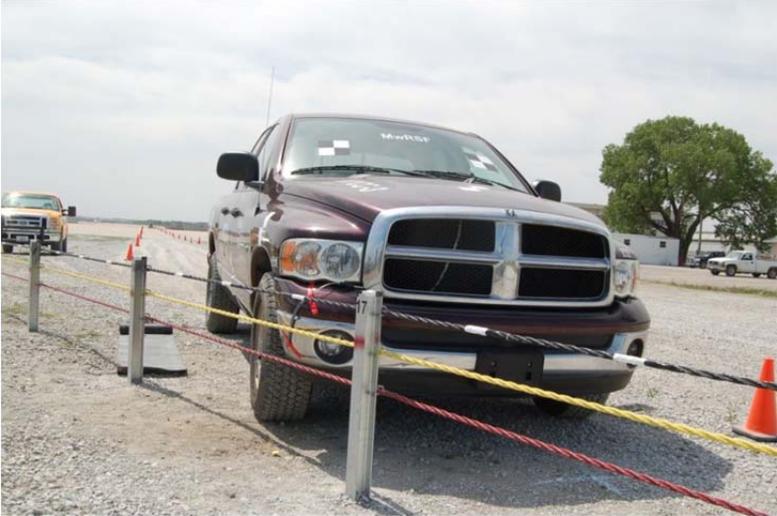
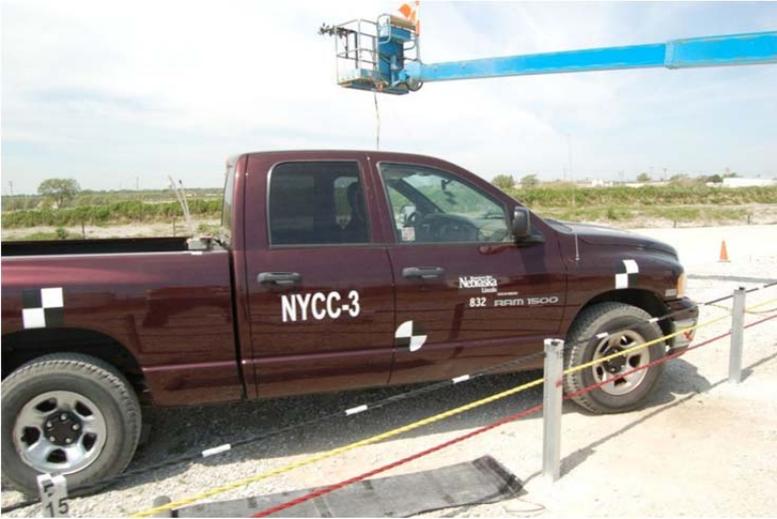
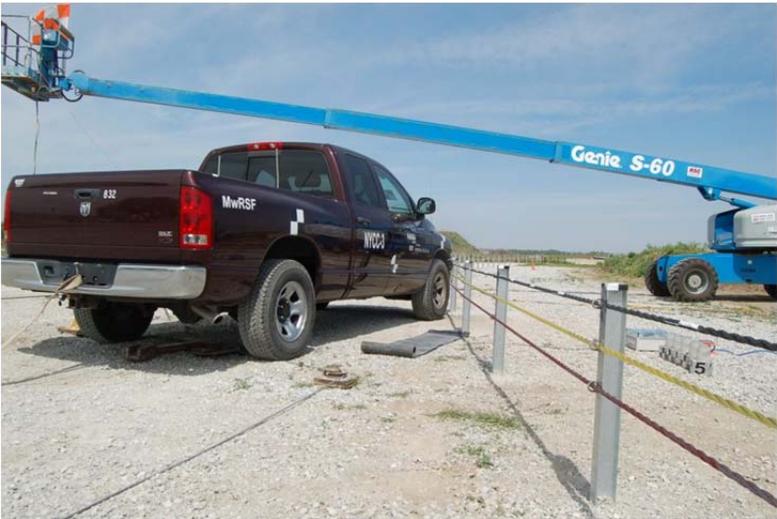
Figure 105. Impact Location, Test No. NYCC-3

Initial vehicle impact occurred at the targeted impact point 2 ft (0.6 m) upstream of post no. 17, as shown in Figure 105, which was selected by NYSDOT personnel. A sequential description of the impact events is contained in Table 14. The vehicle came to rest 310 ft – 7 in. (94.7 m) downstream of impact and 78 ft – 11 in. (24.0 m) laterally from the original impact point. The vehicle trajectory and final position are shown in Figures 99 and 106.

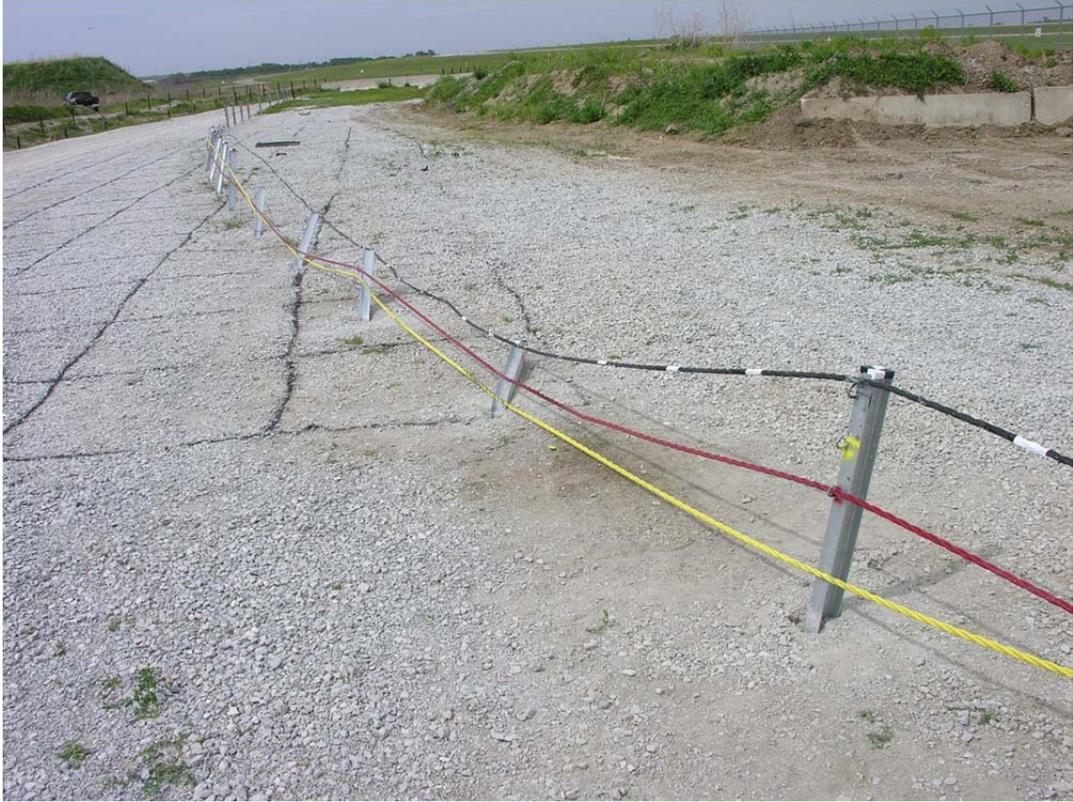
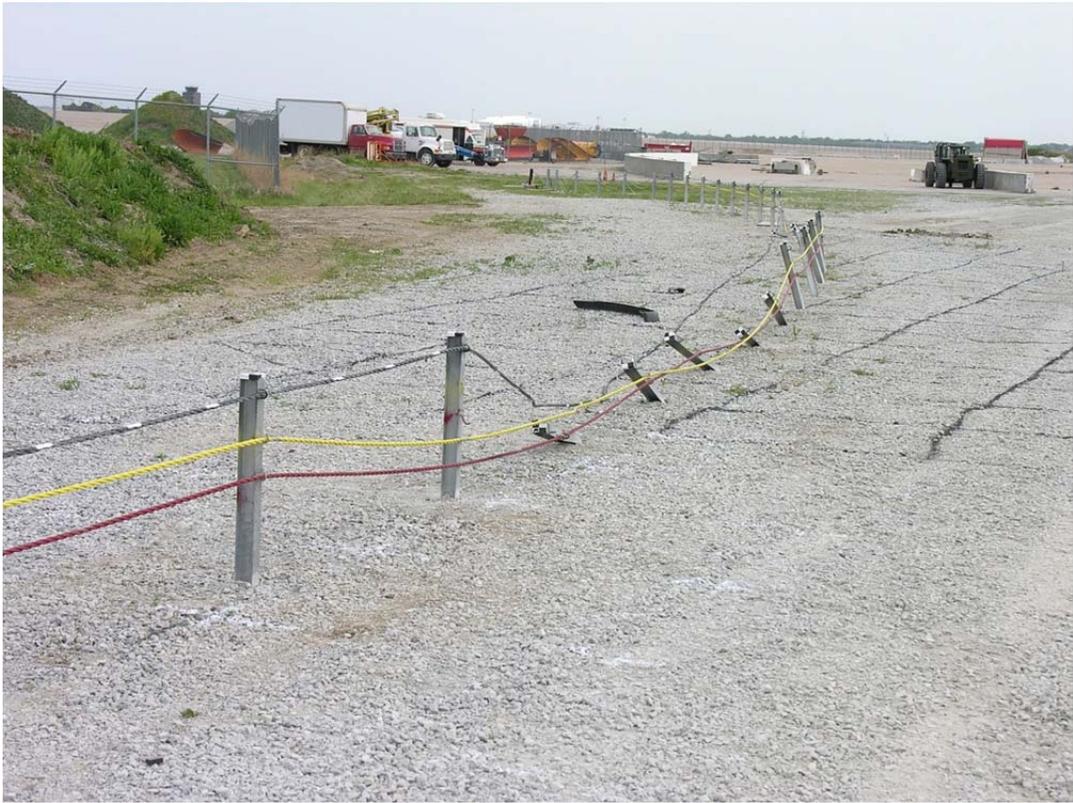
Figure 107. System Damage, Test No. NYCC-3

Damage to the barrier was moderate, as shown in Figures 107 through 116. Barrier damage consisted of bent posts and disengaged cables. The length of vehicle contact along the barrier was approximately 130 ft (39.6 m), which spanned from 2 ft (0.6 m) upstream from post no. 17 through post no. 31.

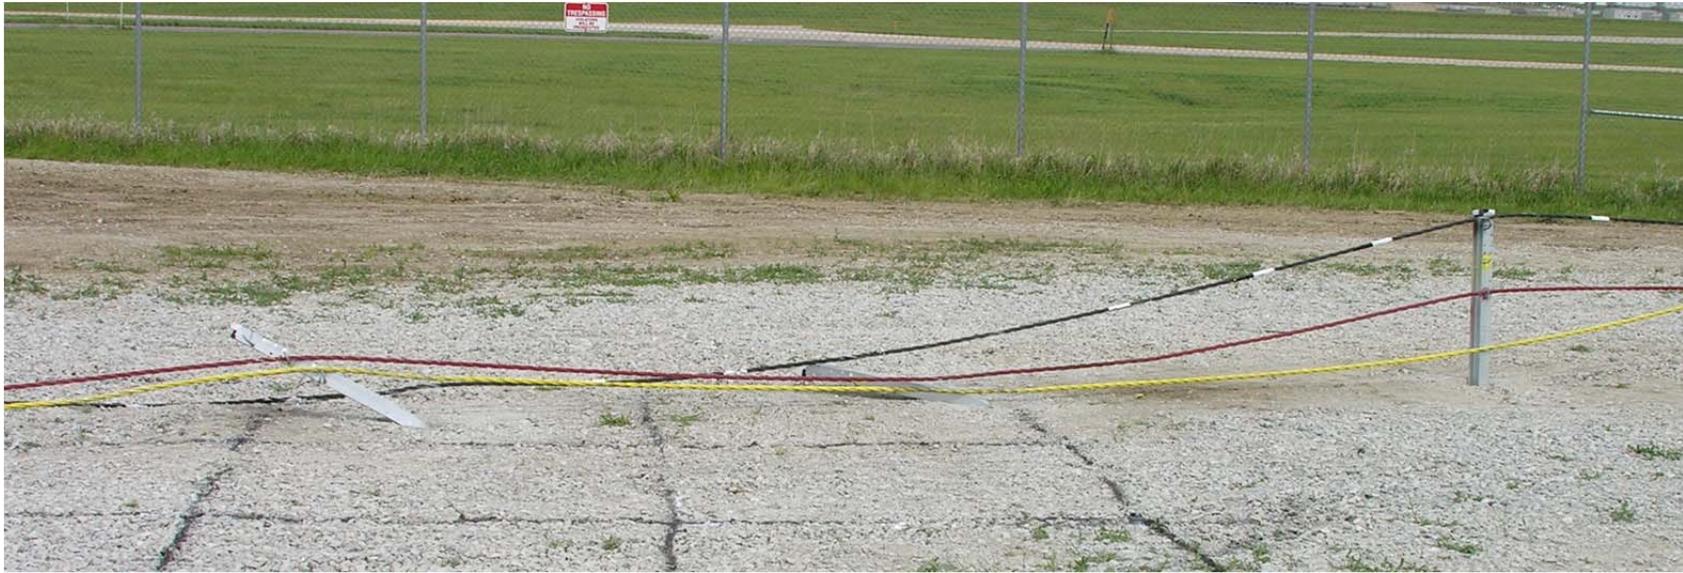
Figure 108. System Damage: Post No. 1, Test No. NYCC-3

Post no. 1 was bent downstream at the slip base. All cables remained engaged with the upstream end anchorage as shown in Figure 108. No damage occurred to the system between post nos. 2 and 15.

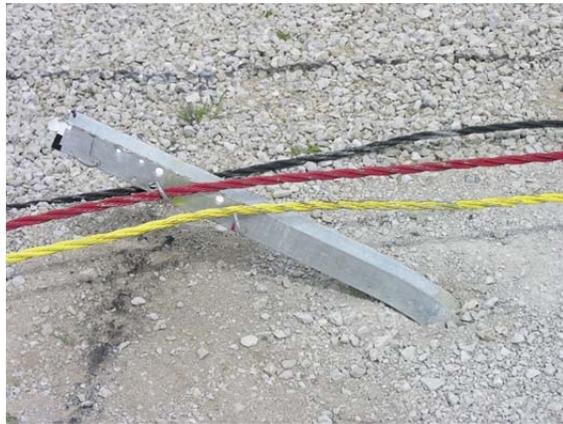
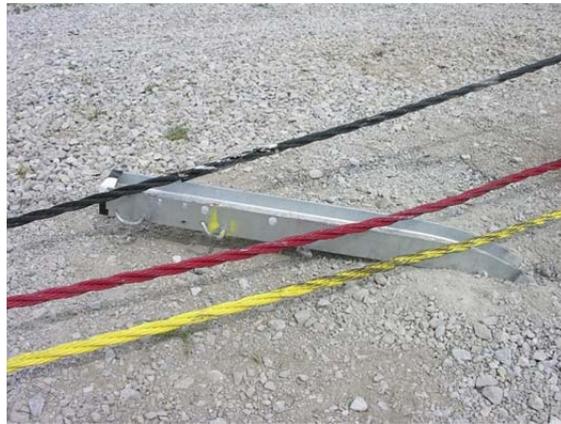
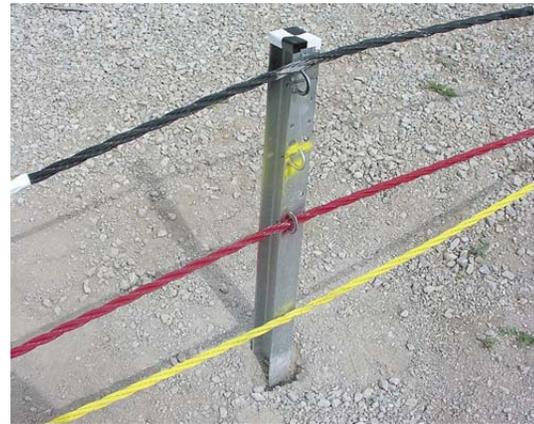
Figure 109. System Damage: Post Nos. 16 through 18, Test No. NYCC-3

Post no. 16 was bent and rotated downstream. Post nos. 17 through 20 were severely bent backward and twisted downstream with contact marks observed on the front flanges. Post nos. 21 through 25 were bent and rotated backward and downstream. Post nos. 26 through 30 were bent and twisted downstream with contact marks on the upstream edges of the flanges. Additionally, post no. 30 had gouges in the front and back flanges. The brass keeper rod for the bottom cable on post no. 40 was disengaged and the post was bent upstream with weld failure under the slip base as shown in Figure 116.
