*Research Project Number TPF-5(193) Supplement #130*

# **EVALUATION OF THE NEW YORK LOW-TENSION THREE-CABLE BARRIER ON CURVED ALIGNMENT**

MwRSF Research Report No. TRP-03-263-12

February 19, 2013

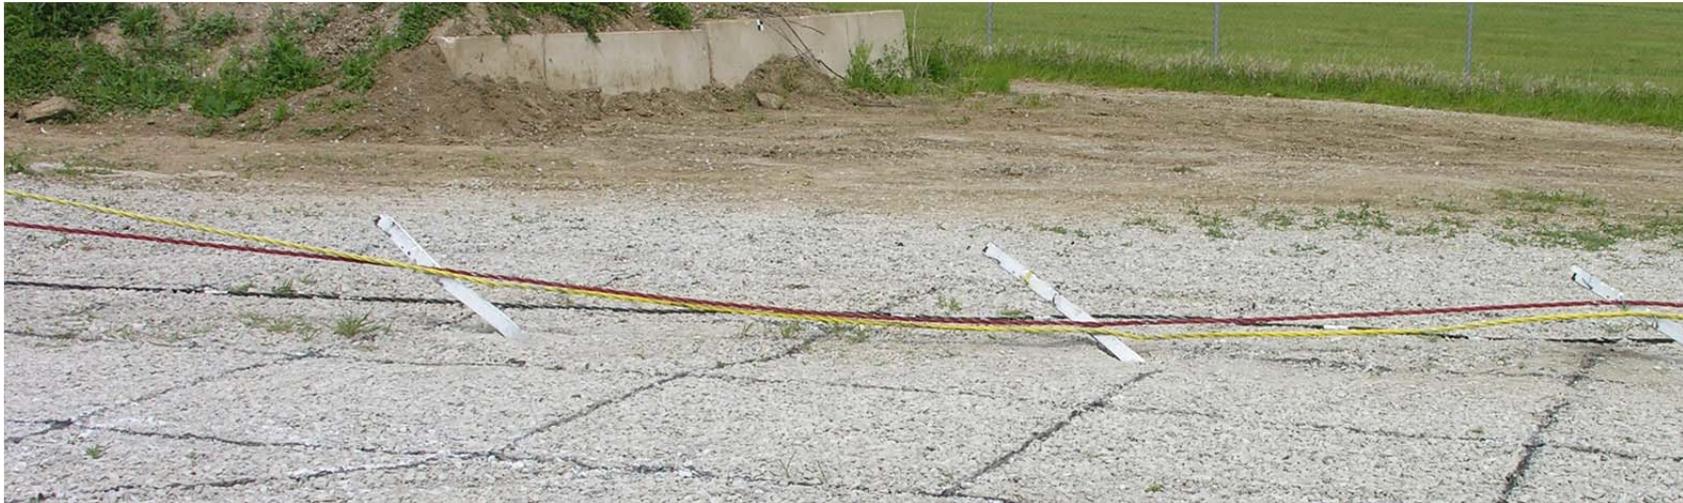
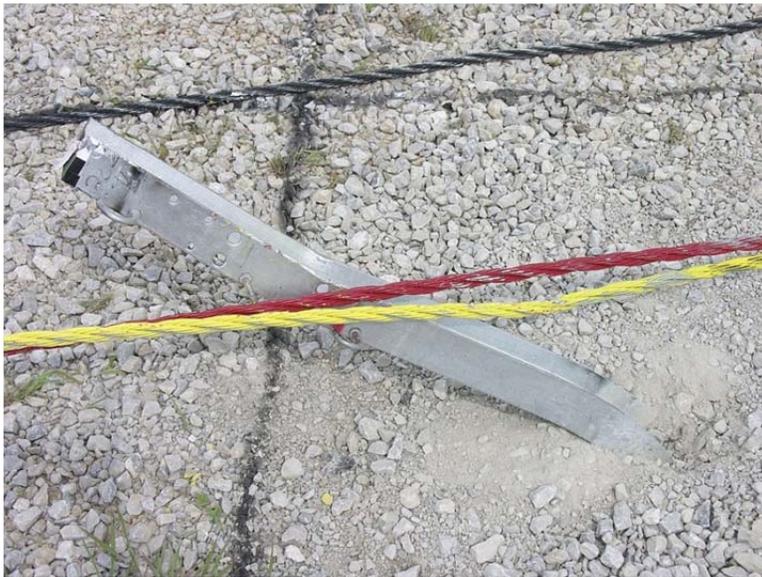
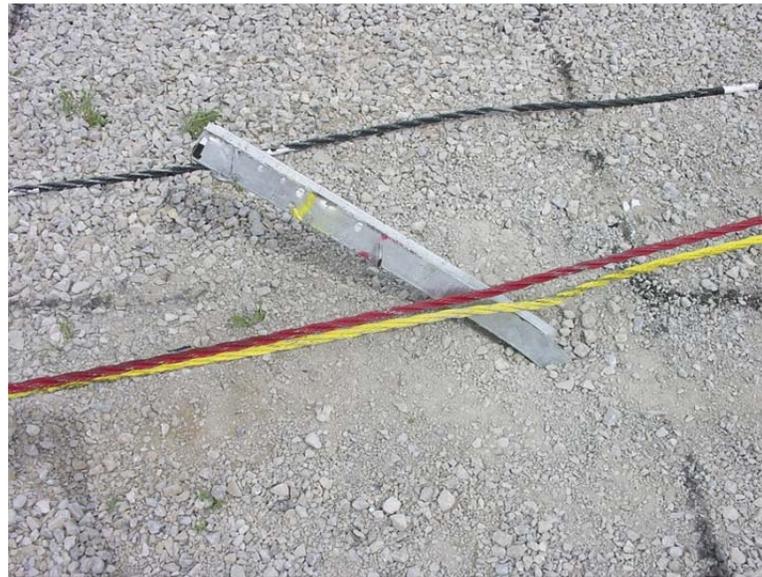
Figure 110. System Damage: Post Nos. 19 and 20, Test No. NYCC-3

Post no. 16 was bent and rotated downstream. Post nos. 17 through 20 were severely bent backward and twisted downstream with contact marks observed on the front flanges. Post nos. 21 through 25 were bent and rotated backward and downstream. Post nos. 26 through 30 were bent and twisted downstream with contact marks on the upstream edges of the flanges. Additionally, post no. 30 had gouges in the front and back flanges. The brass keeper rod for the bottom cable on post no. 40 was disengaged and the post was bent upstream with weld failure under the slip base as shown in Figure 116.

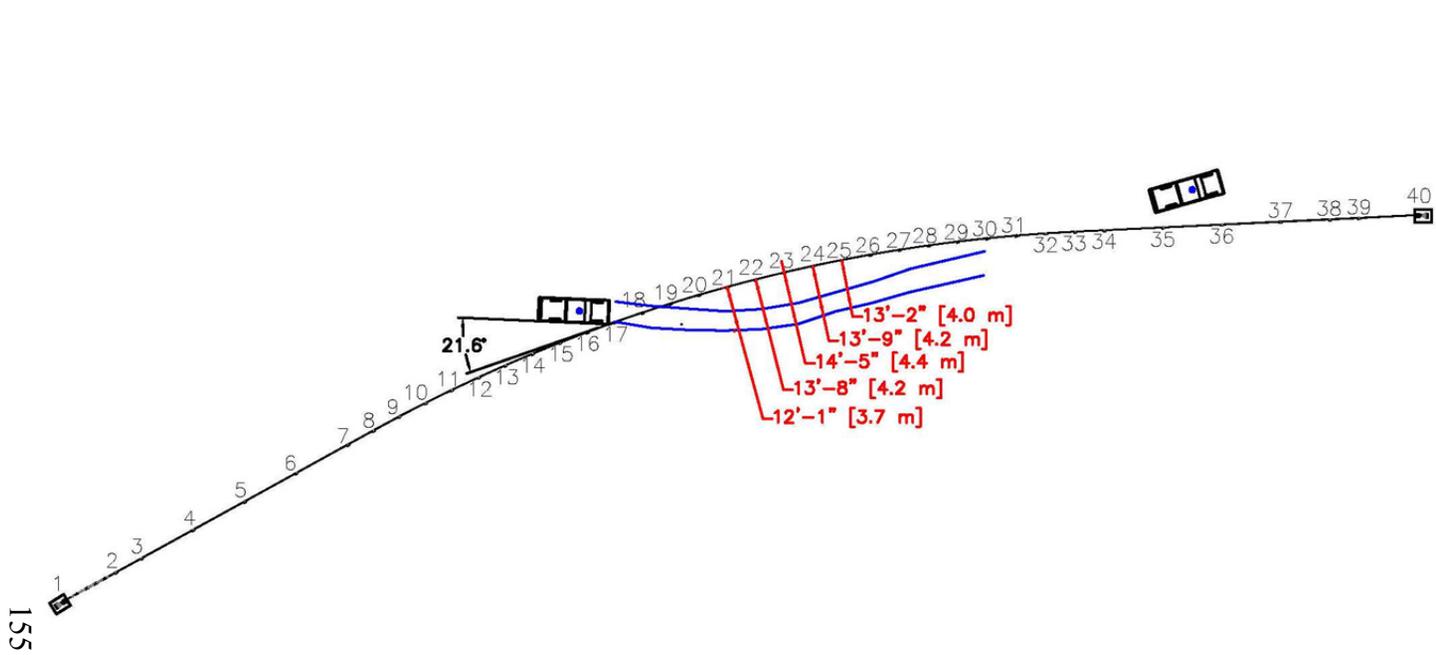
Figure 117. Working Width, Test No. NYCC-3

The permanent set of the system was 24 in. (610 mm) which occurred at post no. 17, as measured in the field. The maximum lateral dynamic barrier deflection was 14 ft - 4 in. (3,564 mm) which occurred near post no. 22, as determined from high-speed digital video analysis. The working width of the system was found to be 14 ft – 5 in. (4.4 m) and is shown in Figure 117.

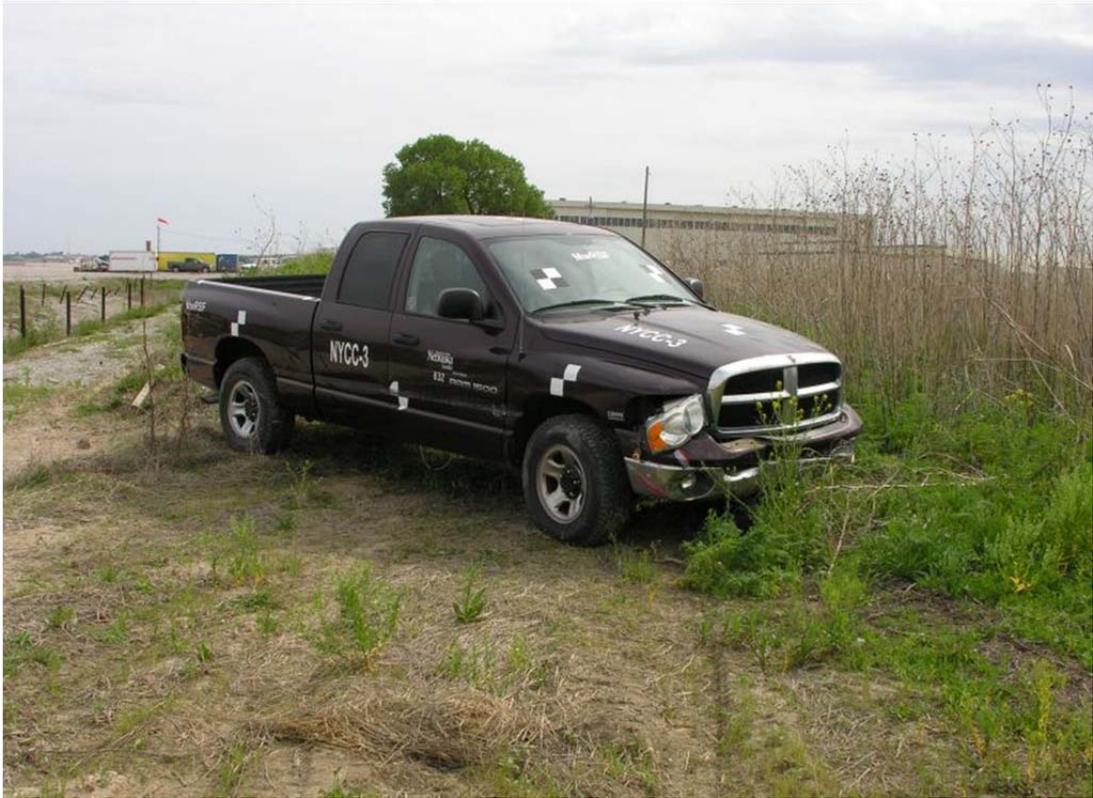
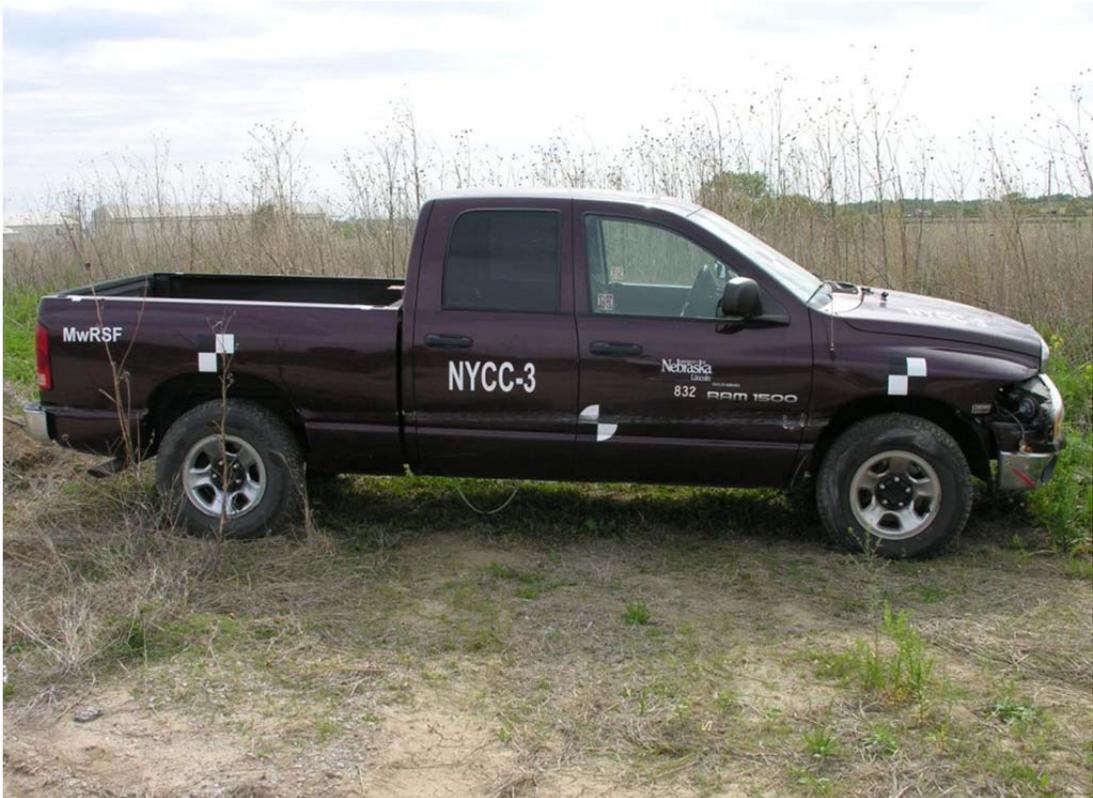
Figure 118. Vehicle Damage, Test No. NYCC-3

The damage to the vehicle was minimal, as shown in Figures 118 and 119. The maximum occupant compartment deformations are listed in Table 15 along with the deformation limits established in MASH for various areas of the occupant compartment. Note that none of the MASH established deformation limits were exceeded. Complete occupant compartment and vehicle deformations and the corresponding locations are provided in Appendix D.
