TWO APPROACH GUARDRAIL TRANSITIONS FOR CONCRETE SAFETY SHAPE BARRIERS

MIDWEST ROADSIDE SAFETY FACILITY

MwRSF Research Report No. TRP-03-69-98

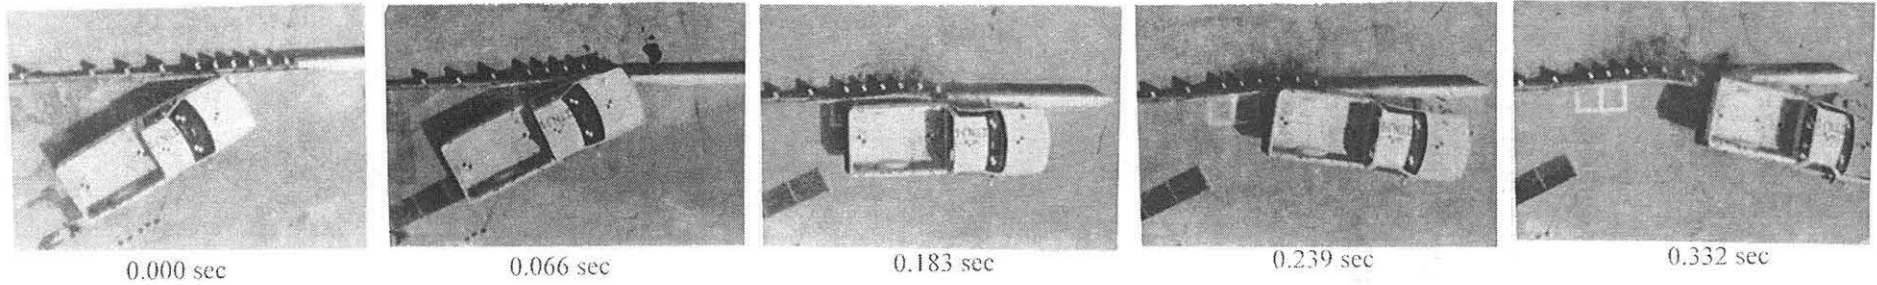
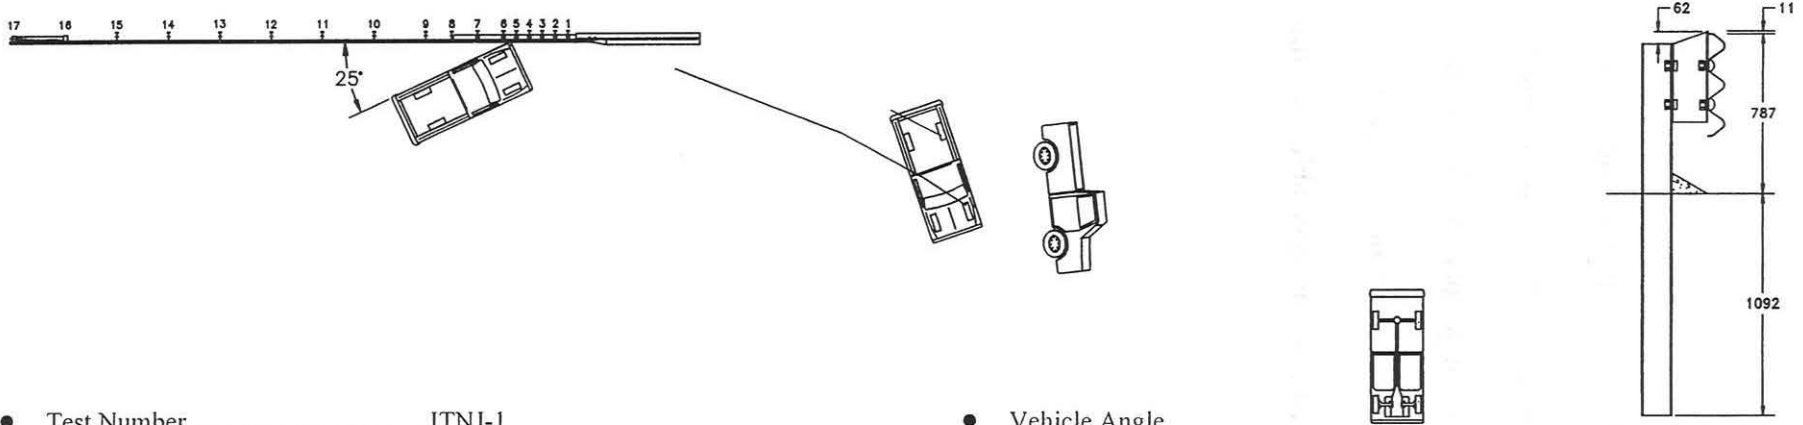
Figure 27. Summary of Test Results and Sequential Photographs, Test ITNJ-1 (Design No. 1)

Initial impact occurred at the midspan between post nos. 5 and 6 or 2,435-mm upstream from the end of the concrete barrier, as shown in Figure 29. Large lateral dynamic and permanent set barrier deflections occurred, as shown in Figures 27 and 30. This was evidenced by the sharp crease formed in the thrie beam rail at the end of the concrete barrier. During vehicle redirection, the pickup truck's left-front quarter panel extended over the thrie beam, contacting the top corner of the spacer blocks as well as the top edge of the concrete end section. This contact caused moderate tearing of the sheet metal and downward forces applied to the left-front corner of the vehicle. At 0.183 sec after impact, the vehicle became parallel to the barrier with a velocity of 65.2 km/hr. During vehicle tail-slap with the barrier, the rear-end of the vehicle pitched upward moderately, allowing the left-rear corner of the bumper to mount the top of the thrie beam and contact the spacer blocks. At 0.422 sec after impact, the vehicle exited the barrier at an angle of 16.2 degrees and a speed of 64.7 km/hr. Subsequently, the left-front wheel assembly contacted the ground with significant vehicular motions, including counter-clockwise vehicle roll, downward pitching, and clockwise yawing. These angular motions caused the pickup truck to roll over 2½ times. The vehicle's post-impact trajectory is shown in Figure 27. The vehicle came to rest 38.71 m downstream from impact and 15.85 m away from the traffic-side face of the barrier.

The analysis of the test results for test ITNJ-1 showed that the barrier satisfactorily contained the vehicle but inadequately redirected the vehicle, since the vehicle did not remain upright after collision with the barrier. After collision, the vehicle's trajectory intruded into adjacent traffic lanes. In addition, the vehicle's exit angle was greater than 60 percent of the impact angle. Therefore, test ITNJ-1 conducted on Design No. 1 was determined to be unacceptable according to the NCHRP Report 350 criteria.

- Vehicle Angle
 - Impact 25.0 deg
 - Exit 16.2 deg
- Vehicle Snagging Minor contact on top of spacer blocks and concrete end section
- Vehicle Pocketing Minor
- Vehicle Stability Vehicle rollover
- Occupant Ridedown Deceleration (10 msec avg.)
 - Longitudinal 11.90 < 20 G's
 - Lateral (not required) 15.46
- Occupant Impact Velocity (Normalized)
 - Longitudinal 10.03 < 12 m/s
 - Lateral (not required) 7.75
- Vehicle Damage Extensive
 - TAD¹⁸ NA
 - SAE¹⁹ NA
- Vehicle Stopping Distance 38.71 m downstream
15.85 m on traffic- side face
- Barrier Damage Moderate
- Maximum Deflections
 - Permanent Set 241 mm
 - Dynamic 349 mm

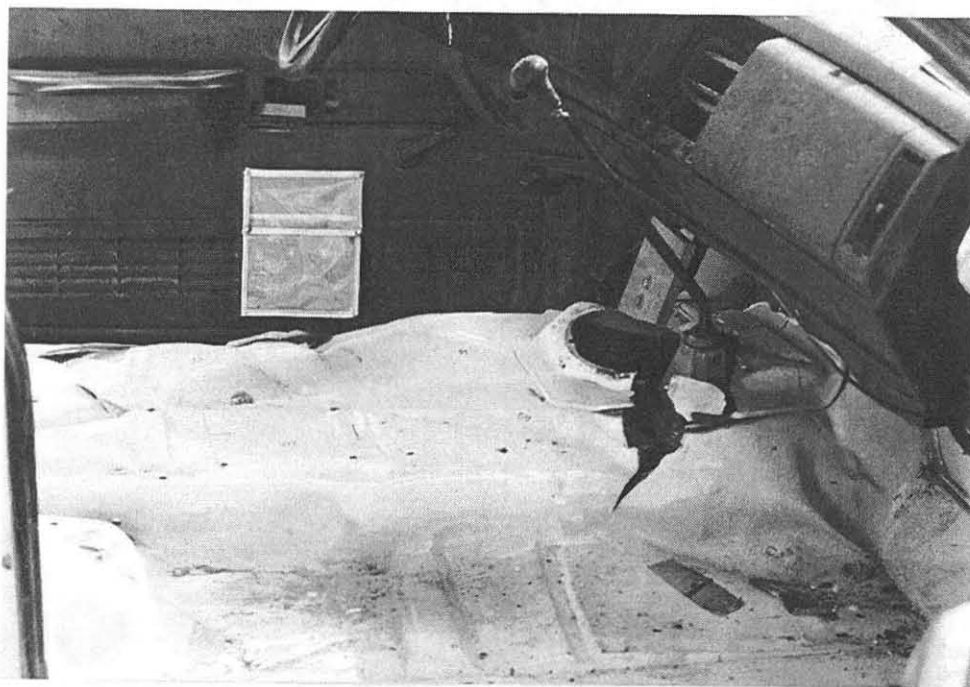
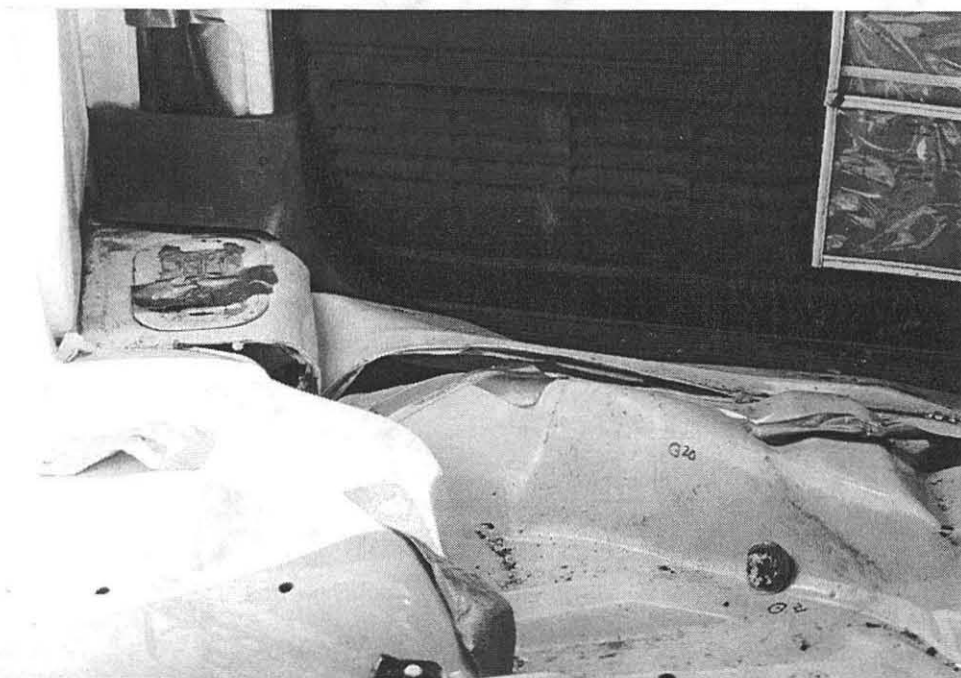
Figure 35. Occupant Compartment Deformation, Test ITNJ-1 (Design No. 1)

Exterior and interior vehicle damage was extensive and occurred at several body locations, as shown in Figures 34 and 35. The left-front quarter panel was crushed inward, and the left-side of the front bumper was bent back toward the engine compartment. The engine hood, roof, truck cab, and window glass were severely crushed during the vehicle rollovers. The floorboard of the occupant compartment also sustained significant plastic deformations due to the severe impact with the barrier as well as from vehicle rollover.

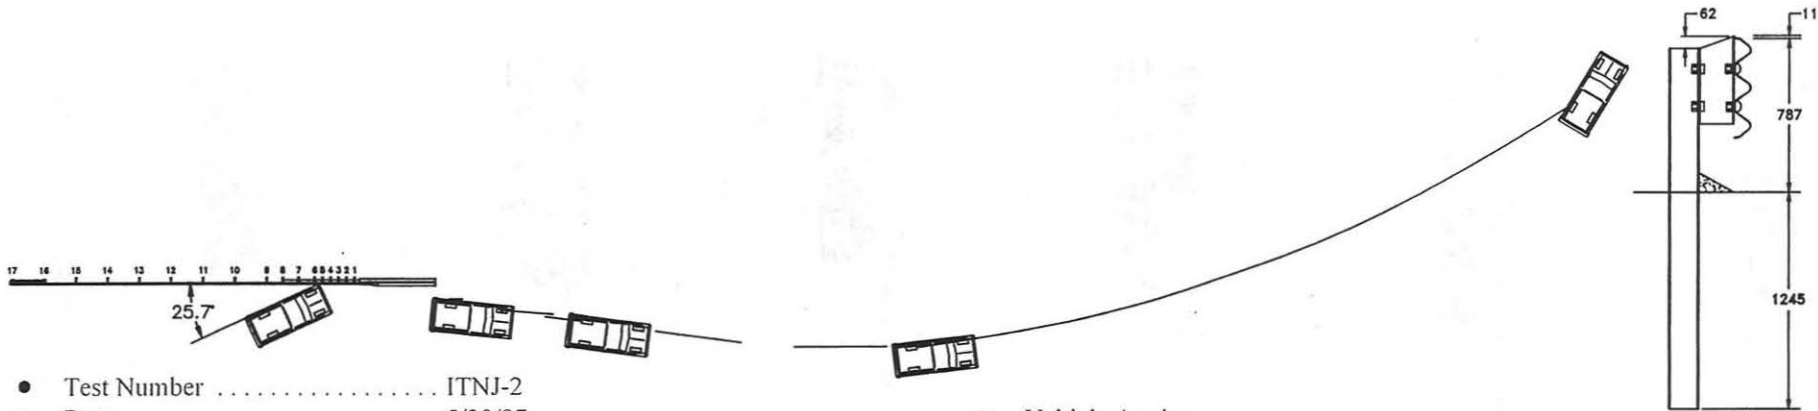
Figure 37. Summary of Test Results and Sequential Photographs, Test ITNJ-2 (Design No. 2)

Initial impact occurred at the midspan between post nos. 5 and 6 or 2,435-mm upstream from the end of the concrete barrier, as shown in Figure 41. Moderate lateral dynamic and permanent set barrier deflections were encountered, as shown in Figures 37 and 42. During vehicle redirection, the pickup truck's left-front quarter panel extended over the thrie beam, contacting the top corner of the spacer blocks as well as the top edge of the concrete end section. This contact caused moderate tearing of the sheet metal and downward forces applied to the left-front corner of the vehicle. At 0.183 sec after impact, the vehicle became parallel to the barrier with a velocity of 71.1 km/hr. During vehicle tail-slap with the barrier, the rear-end of the vehicle pitched upward slightly; however, the left-rear corner of the bumper did not mount the top of the thrie beam nor contact the spacer blocks. Subsequently, the vehicle began to roll counter-clockwise toward the barrier with the right-side wheels becoming airborne. At 0.329 sec after impact, the vehicle exited the barrier at an angle of 6.9 degrees and a speed of 70.8 km/hr. As the vehicle exited the barrier, the left-front wheel assembly contacted the ground but with minor counter-clockwise vehicle roll, resulting in a smooth and stable vehicle redirection. The vehicle's post-impact trajectory is shown in Figure 37. The vehicle came to rest 76.8 m downstream and 11.2 m behind the barrier.

The analysis of the test results for test ITNJ-2 showed that the barrier adequately contained and redirected the vehicle with controlled lateral displacement of the barrier. Minor deformations to the occupant compartment were evident but not considered excessive enough to cause serious injuries to the occupants. The vehicle remained upright both during and after the collision. Vehicle roll, pitch, and yaw angular displacements were noted, but they were deemed acceptable because they did not adversely influence occupant safety criteria or cause rollover. After collision, the vehicle's trajectory intruded slightly into adjacent traffic lanes but was determined to be acceptable. In addition, the vehicle's exit angle was less than 60 percent of the impact angle. Therefore, test ITNJ-2 conducted on Design No. 2 was determined to be acceptable according to the NCHRP Report 350 criteria.

- Vehicle Angle
 - Impact 25.7 deg
 - Exit 6.9 deg
- Vehicle Snagging Minor contact on top of spacer blocks and concrete end section
- Vehicle Pocketing None
- Vehicle Stability Satisfactory
- Occupant Ridedown Deceleration (10 msec avg.)
 - Longitudinal 11.24/-17.72 < 20 G's
 - Lateral (not required) 18.43
- Occupant Impact Velocity (Normalized)
 - Longitudinal 6.94 < 12 m/s
 - Lateral (not required) 7.07
- Vehicle Damage Moderate
 - TAD¹⁸ 11-LFQ-5
 - SAE¹⁹ 11LDEW3
- Vehicle Stopping Distance 76.8 m downstream
11.2 m behind
- Barrier Damage Moderate
- Maximum Deflections
 - Permanent Set 92 mm
 - Dynamic 133 mm (visible)

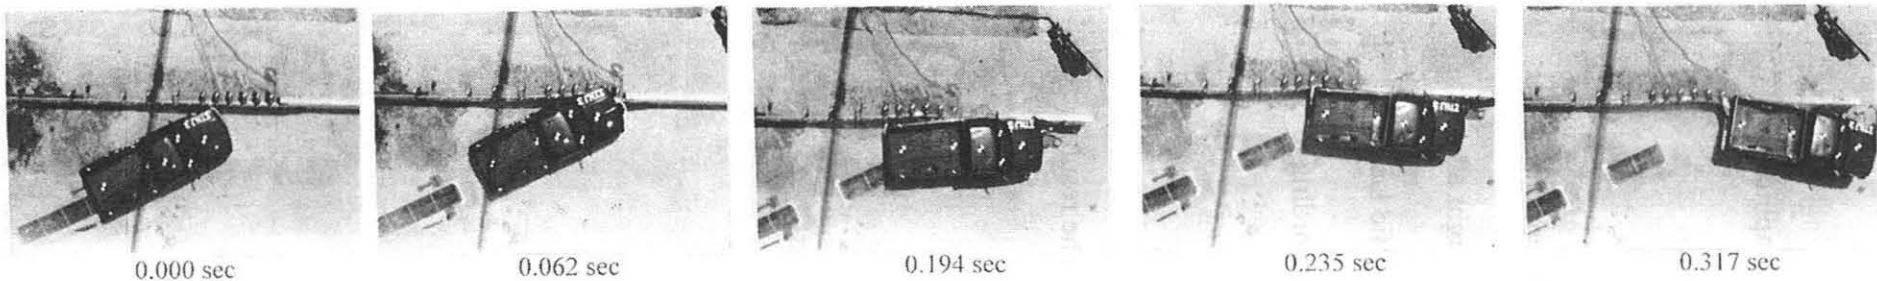
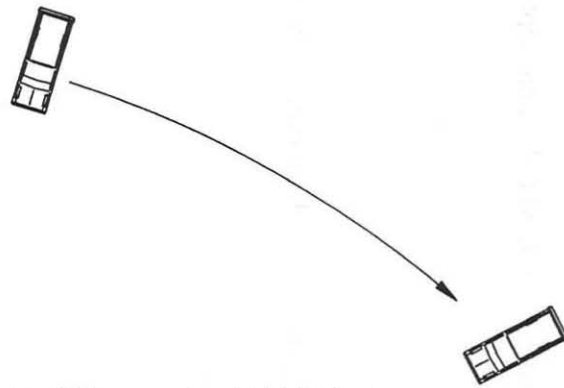
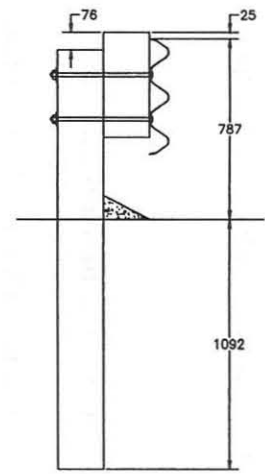
Figure 51. Summary of Test Results and Sequential Photographs, Test ITNJ-3 (Design No. 3)

Initial impact occurred at the midspan between post nos. 5 and 6 or 2,435-mm upstream from the end of the concrete barrier, as shown in Figure 55. Large lateral dynamic and permanent set barrier deflections occurred, as shown in Figures 51 and 56. This was evidenced by the crease formed in the thrie beam rail near post no. 3. During vehicle redirection, the pickup truck's left-front quarter panel extended over the thrie beam, contacting the top corner of the spacer blocks as well as the top edge of the concrete end section. This contact caused moderate tearing of the sheet metal and downward forces applied to the left-front corner of the vehicle. At 0.208 sec after impact, the vehicle became parallel to the barrier with a velocity of 63.1 km/hr. During vehicle tail-slap with the barrier, the rear-end of the vehicle pitched upward moderately, allowing the left-rear corner of the bumper to mount the top of the thrie beam and contact the several spacer blocks and concrete end section. At 0.401 sec after impact, the vehicle exited the barrier at an angle of 13.1 degrees and a speed of 61.7 km/hr. Subsequently, the left-front wheel assembly contacted the ground with significant vehicular motions, including counter-clockwise vehicle roll, downward pitching, and clockwise yawing. These angular motions caused the pickup truck to roll over 3 times. The vehicle's post-impact trajectory is shown in Figure 51. The vehicle came to rest 44.2 m downstream from

- Test Number ITNJ-3
- Date 7/8/97
- Appurtenance Approach Guardrail Transition to a NJ Safety Shape End Section w/ Curb
- Total Length 25.34 m
- Steel Thrie Beam (Nested)
 - Thickness 2.66 mm
 - Top Mounting Height 787 mm
- Wood Posts
 - Post Nos. 1 - 8 152 mm x 203 mm by 1829-mm long
- Wood Spacer Blocks
 - Post Nos. 1 - 8 152 mm x 203 mm by 457-mm long
- Steel Posts
 - Post Nos. 9 - 15 W150x13.5 by 1829-mm long
- Steel Spacer Blocks
 - Post Nos. 9 - 15 W150x13.5 by 337-mm long
- Soil Type Grading B - AASHTO M 147-65 (1990)
- Vehicle Model 1990 Chevrolet 2500 2WD
 - Curb 1,813 kg
 - Test Inertial 1,987 kg
 - Gross Static 1,987 kg
- Vehicle Speed
 - Impact 102.0 km/hr
 - Exit 61.7 km/hr

- Vehicle Angle
 - Impact 26.9 deg
 - Exit 13.1 deg
- Vehicle Snagging Contact on top of spacer blocks and concrete end section
- Vehicle Pocketing None
- Vehicle Stability Vehicle rollover
- Occupant Ridedown Deceleration (10 msec avg.)
 - Longitudinal 6.27/-7.82 < 20 G's
 - Lateral (not required) 15.27
- Occupant Impact Velocity (Normalized)
 - Longitudinal 8.71 < 12 m/s
 - Lateral (not required) 6.71
- Vehicle Damage Extensive
 - TAD¹⁸ NA
 - SAE¹⁹ NA
- Vehicle Stopping Distance 44.2 m downstream
17.1 m behind
- Barrier Damage Moderate
- Maximum Deflections
 - Permanent Set 171 mm
 - Dynamic 264 mm (visible)

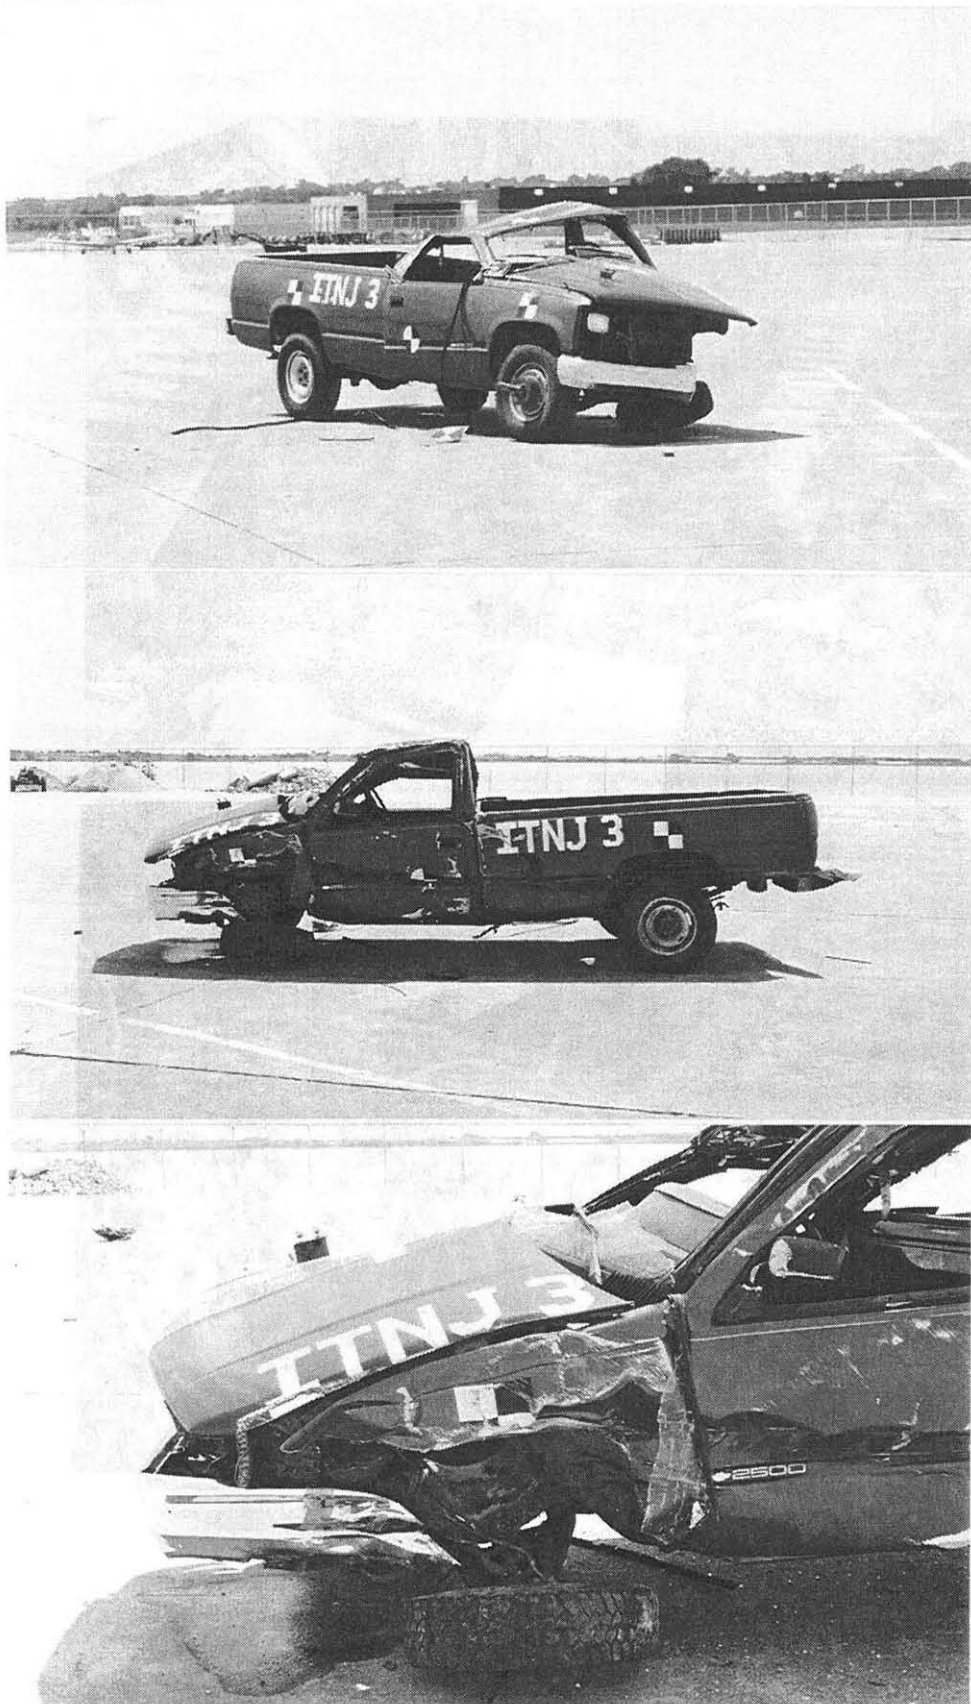
Figure 60. Vehicle Damage, Test ITNJ-3 (Design No. 3)

Exterior and interior vehicle damage was extensive and occurred to several body locations, as shown in Figures 60 and 61. The left-front quarter panel was crushed inward, and the left-side of the front bumper was also bent back toward the engine compartment. The engine hood, roof, truck cab, and window glass were severely crushed during the vehicle rollovers. The floorboard of the occupant compartment also contained significant plastic deformations due to the severe impact with the barrier as well as from vehicle rollover.

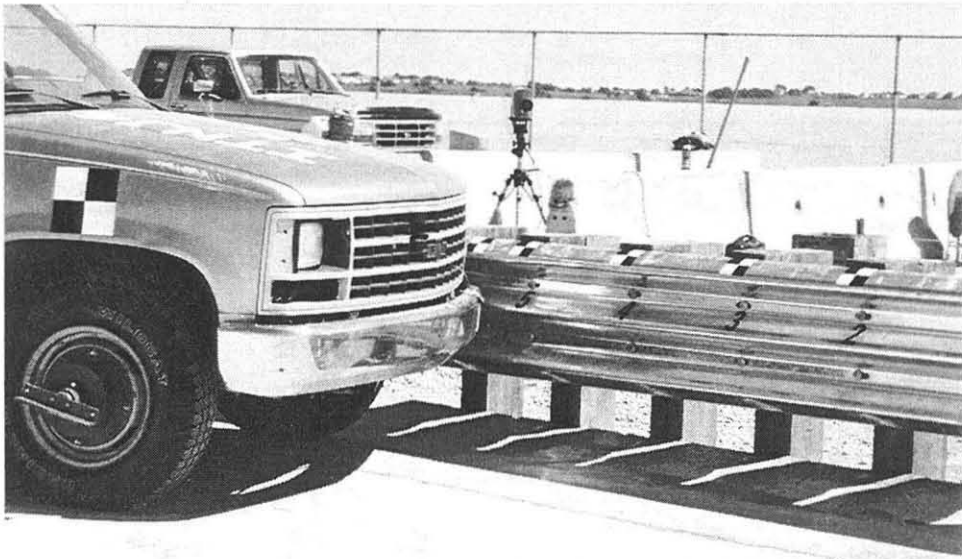
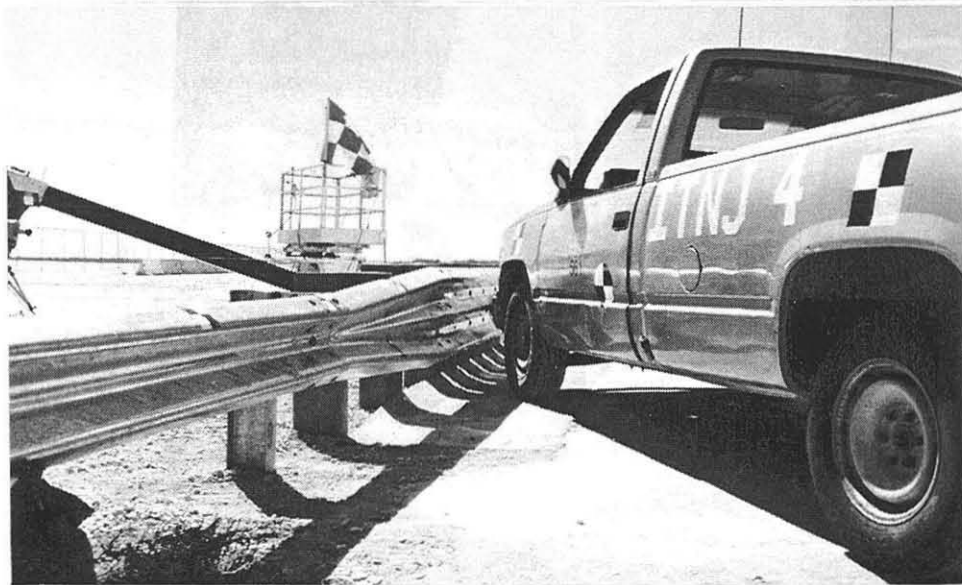
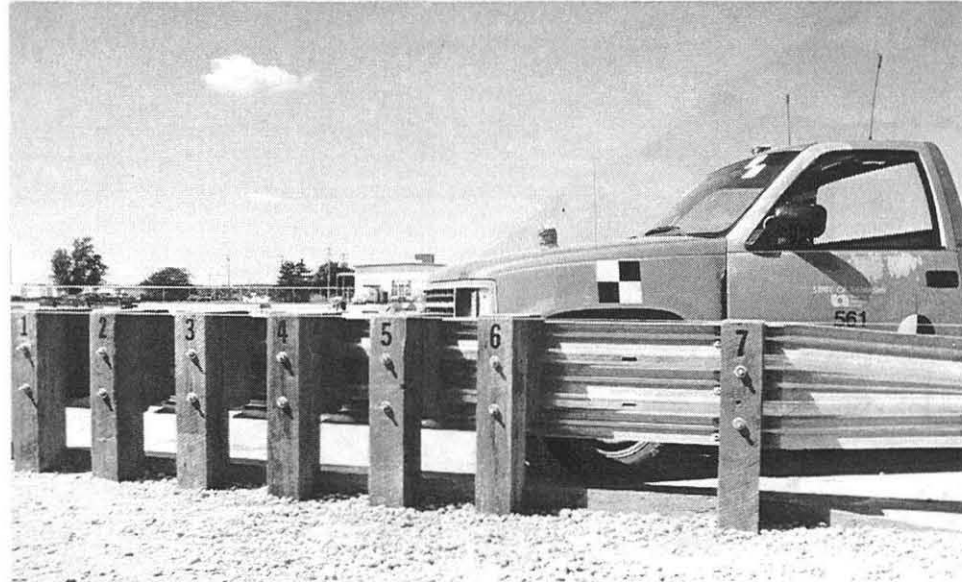
Figure 68. Impact Location, Test ITNJ-4 (Design No. 4)

Initial impact occurred at the midspan between post nos. 5 and 6 or 2,435-mm upstream from the end of the concrete barrier, as shown in Figure 68. Minor lateral dynamic and permanent set barrier deflections were encountered, as shown in Figures 64 and 69. During vehicle redirection, the pickup truck's left-front quarter panel extended over the thrie beam, contacting the top corner of the spacer blocks as well as the top edge of the concrete end section. This contact caused moderate tearing of the sheet metal and downward forces applied to the left-front corner of the vehicle. At 0.190 sec after impact, the vehicle became parallel to the barrier with a velocity of 72.8 km/hr. During vehicle tail-slap with the barrier, the left-rear corner of the bumper did not mount the top of the thrie beam nor contact the spacer blocks. Subsequently, the vehicle began to roll counter-clockwise toward the barrier with the right-side wheels becoming airborne. At 0.371 sec after impact, the vehicle exited the barrier at an angle of 7.2 degrees and a speed of 72.3 km/hr. As the vehicle exited the barrier, the left-front wheel assembly contacted the ground but with minor counter-clockwise vehicle roll, resulting in a smooth and stable vehicle redirection. The vehicle's post-impact trajectory is shown in Figure 64. The vehicle came to rest 68.4 m downstream and 12.9 m behind the barrier.

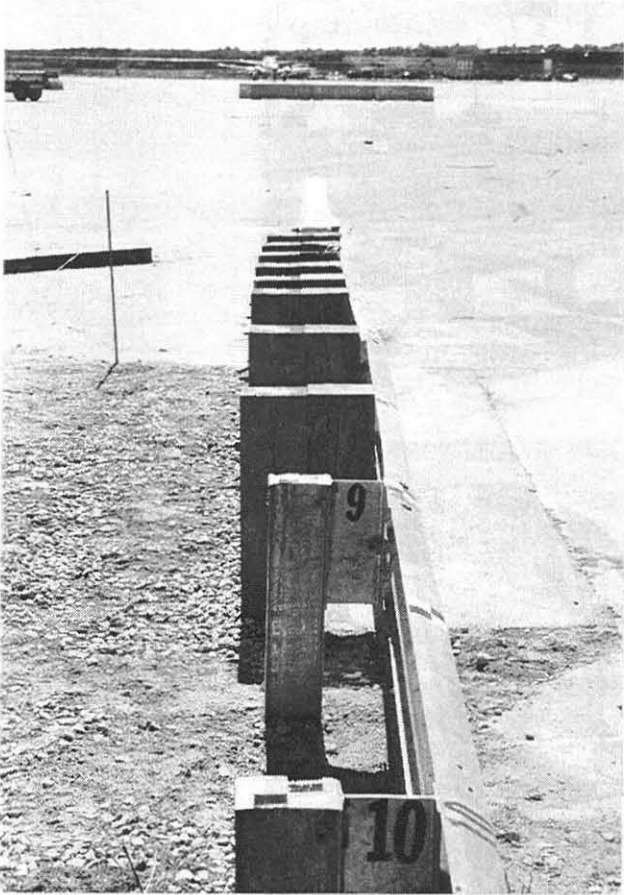
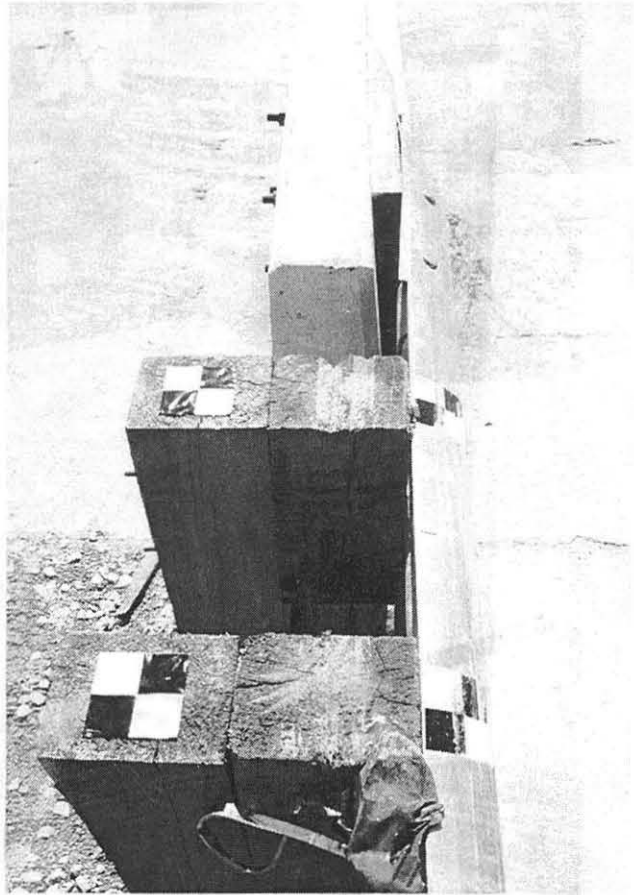
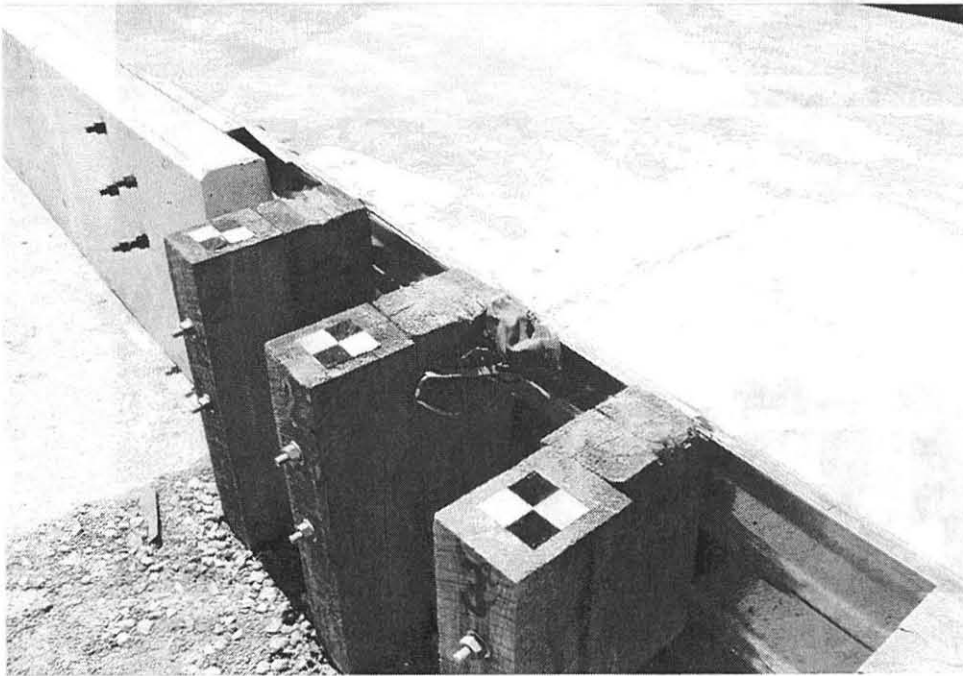
Figure 69. Barrier Damage, Test ITNJ-4 (Design No. 4)

Damage to the barrier was moderate, as shown in Figures 69 and 70. Barrier damage consisted mostly of deformed thrie beam and tire marks on the lower upstream face of the concrete end section. No cracking was observed in the concrete end section. The permanent set of the guardrail and posts is shown in Figures 69 and 70. The maximum lateral permanent set deflection was approximately 32 mm at post no. 4 through the midspan between post nos. 2 and 3, as measured in the field. The maximum lateral dynamic deflection was 99 mm at post no. 3, as determined from the high-speed film analysis. It is noted that some dynamic deflection measurements were not available for viewing from the overhead camera due to the vehicle extending over the barrier.

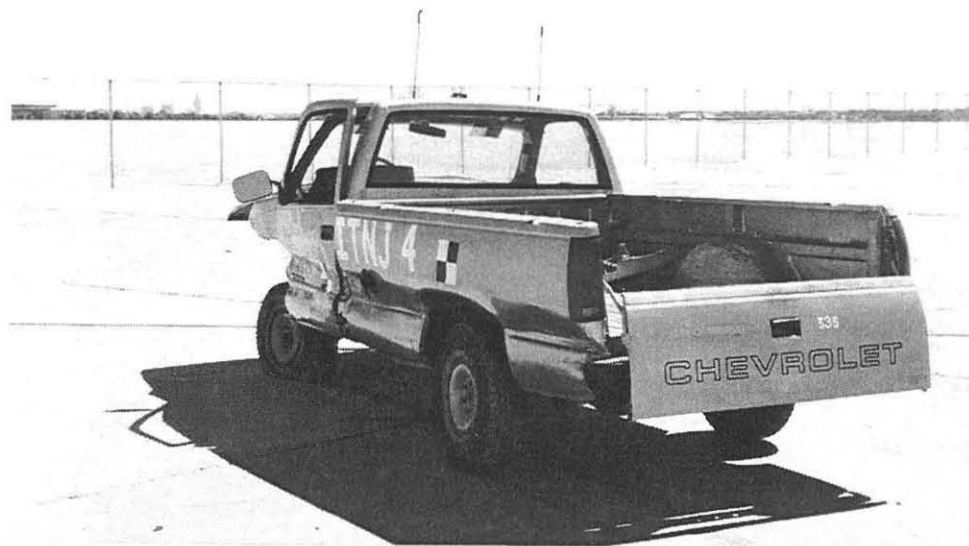
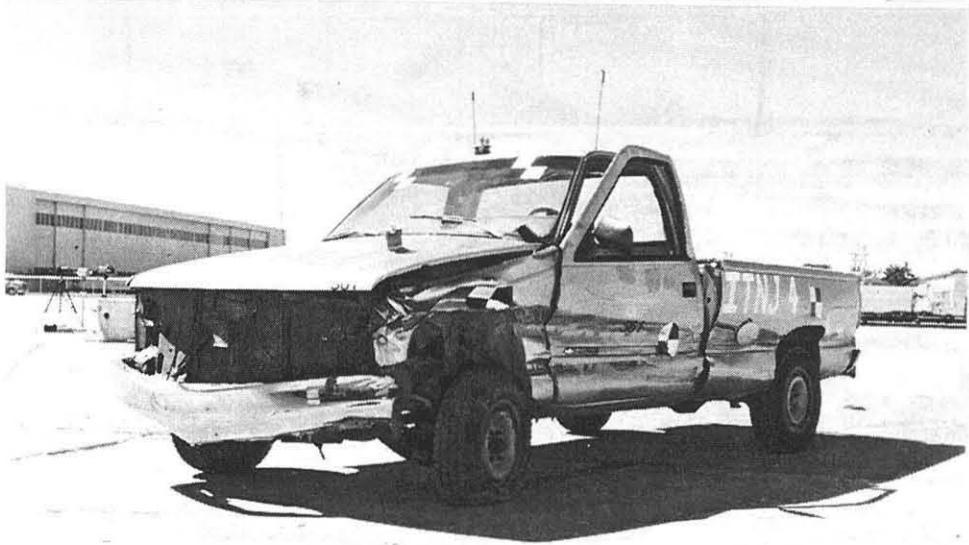
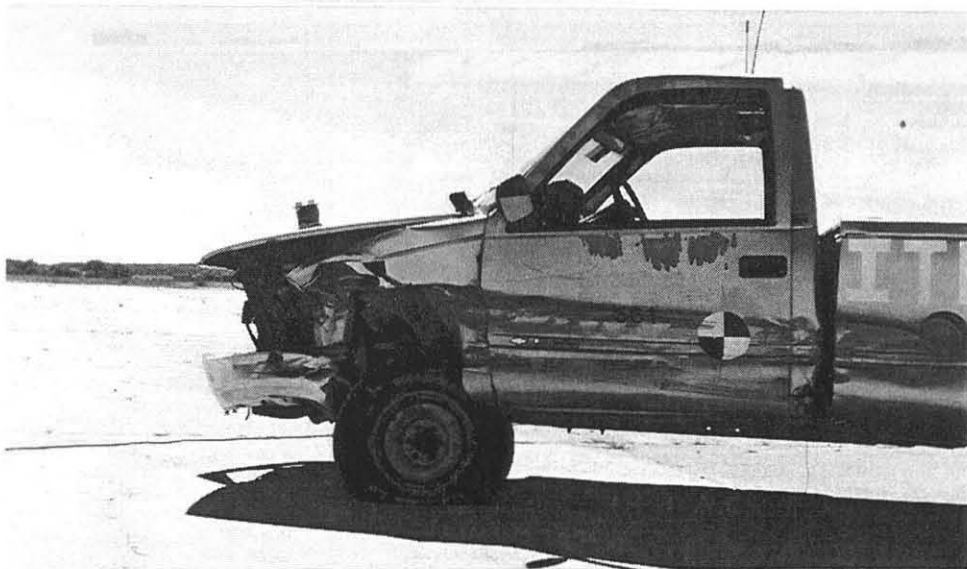
Figure 71. Vehicle Damage, Test ITNJ-4 (Design No. 4)

Vehicle damage was moderate, as shown in Figure 71. The left-front quarter panel was crushed inward, and the left-side of the front bumper was also bent back toward the engine compartment. The left-front wheel assembly was deformed and pushed backward into the firewall. Longitudinal deformations, due to vehicle-rail interlock, were observed along the entire left-side of the vehicle. Maximum occupant compartment deformations to the floorboard and/or firewall in the lateral, longitudinal, and vertical directions were 114 mm, 89 mm, and 133 mm, respectively, as shown in Figure 72.
