DEVELOPMENT OF A TL-2 STEEL BRIDGE RAILING AND TRANSITION FOR USE ON TRANSVERSE, NAIL-LAMINATED, TIMBER BRIDGES

WEST VIRGINIA DEPARTMENT OF TRANSPORTATION

MwRSF Research Report No. TRP-03-212-09

August 13, 2009

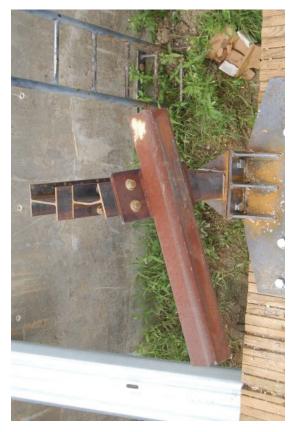
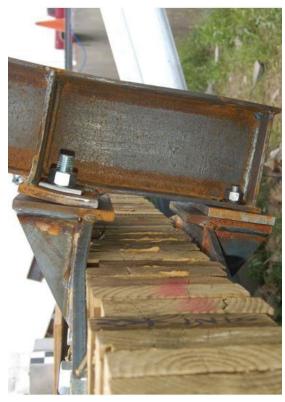
Figure 18. Post Assembly Damage, Test No. WVTL2-1

Damage to the post assembly included plastic bending and minor buckling, as shown in Figure 18. The top deck plate was bent downward near its attachment to the post. The post had minor buckling along its compression flange, and a gap had opened between the post plate and the top end plate. Also, the web of the post blockout was bent, resulting in the impact tube rotating approximately 20 degrees. Damage to the timber bridge deck consisted of only minor bearing deformations to the bolt holes, as shown in Figure 19.

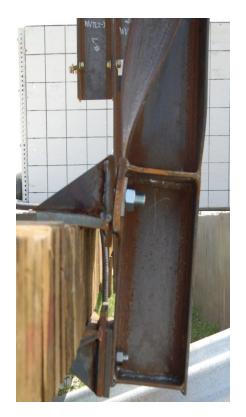
Figure 22. Post Assembly Damage, Test No. WVTL2-2

The post experienced severe plastic deformations, resulting from twisting and bending of the post, as shown in Figure 22. The post was bent backward and twisted nearly 90 degrees about its vertical axis. Localized buckling was found on the rear post flange, just above the connection to the deck plates. Also, the top deck plate was bent downward off of the edge of the timber bridge deck. The upper post region (portion above the bottom end of the blockout) and the blockout sustained limited deformation due to the additional gussets placed in these regions to prevent premature collapse or failure under eccentric loading. The timber bridge deck sustained only minor bearing deformations to the bolt holes, as shown in Figure 23.

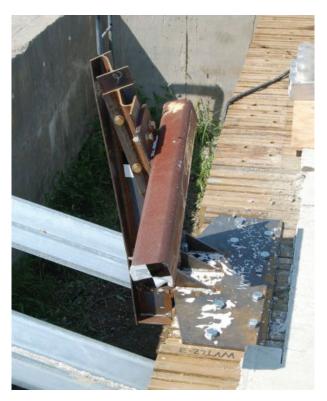
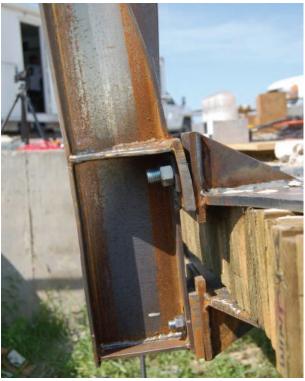
Figure 26. Post Assembly Damage, Test No. WVTL2-3

Damage to the bridge post assembly consisted of plastic bending, twisting, and localized buckling, as shown in Figure 26. The post was bent backward, and a gap had opened between the post plate and the top end plate. The post was also twisted clockwise resulting in localized flange buckling and bending of the web. The web of the post blockout was bent in the opposite direction as the web of the post, which resulted in the horizontal impact tube remaining normal to the path of the bogie. The deck plates and the timber bridge deck sustained no visual damage, as shown in Figures 26 and 27.

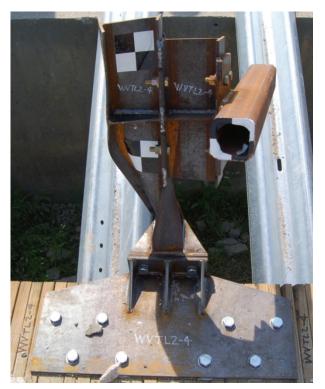
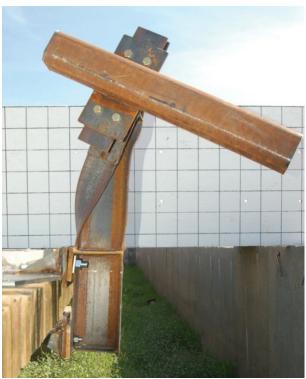
Figure 30. Post Assembly Damage, Test No. WVTL2-4

Damage to the post assembly included plastic bending and twisting, as shown in Figure 30. The post was twisted nearly 90 degrees between the deck connection and the impact height. Flange and web buckling were evident throughout this region of the post. A small gap had opened between the post plate and the top end plate, but there did not appear to be any damage to the deck plates. The post blockout did not appear to be damaged or deformed. Also, the timber deck did not sustain any visual damage, as shown in Figure 31.
