1. Report No. TX-96/5388-1F		2. Government Accession No.		3. Recipient's Catalog No.	
4. Title and Subtitle EVALUATION OF WORK ZONE BARRICADES AND TEMPORARY SIGN SUPPORTS				5. Report Date February 1996

EVALUATION OF WORK ZONE BARRICADES AND TEMPORARY SIGN SUPPORTS

Report No. 5388-1F
Research Study No. 585xxA3014
Research Study Title: Development of New Designs for Barricades
and Sign Supports in Work Zones

February 1996

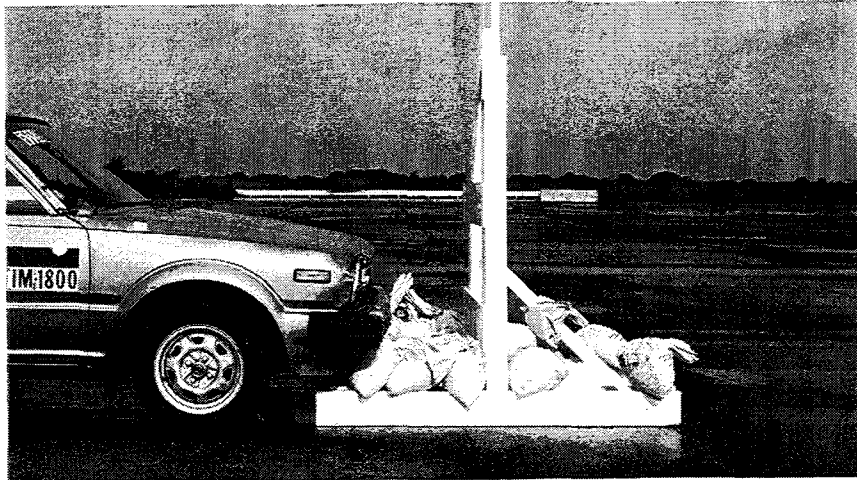
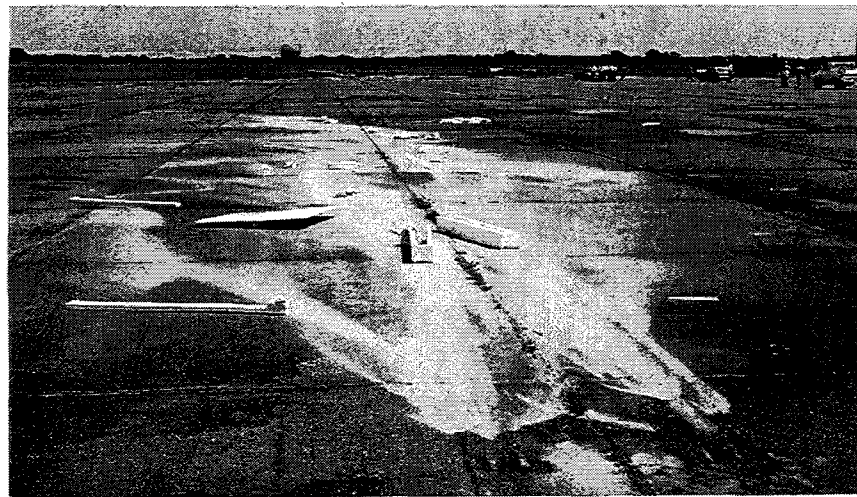
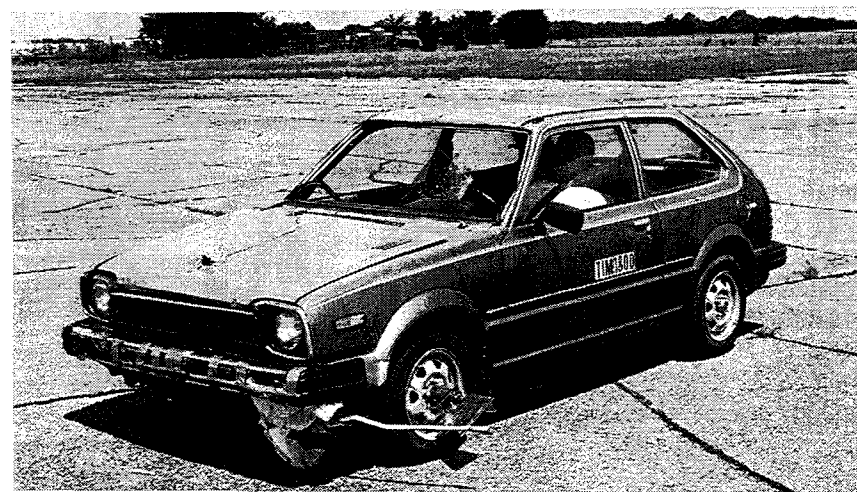
Figure 2. Vehicle and Barricade for Test No. 453360-1

As can be seen in Figure 2, the Type III Wood Barricade separated upon impact. Debris and sand were strewn along the path of the vehicle in an area 11 m wide by 37 m long. Figure 2 shows damage to the vehicle. There were two dents in the bumper, 38 mm and 19 mm from

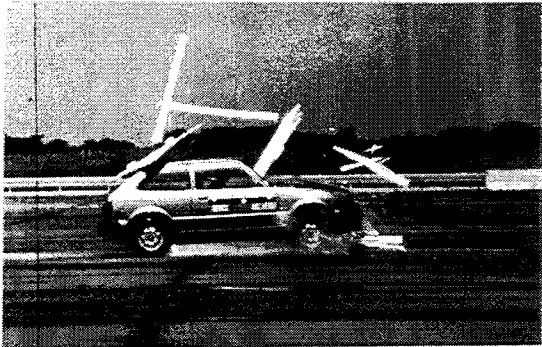
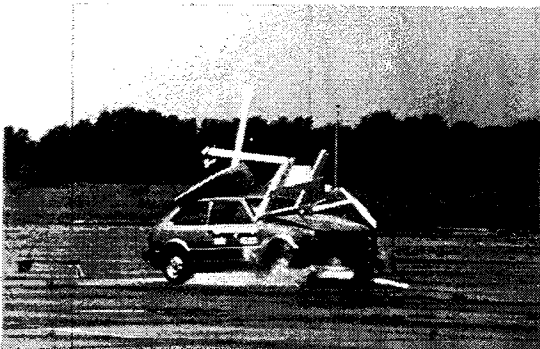
Figure 3. Sequential Photographs for Test No. 453360-1

At 10 msec after initial impact, the sign panel broke loose from the barricade, and the vertical supports began to break loose from the bases. The sign panel struck the roof just above the windshield at 62 msec. The top of the vertical supports, which had broken off at the base, impacted and penetrated the windshield at 74 msec. As the vehicle continued forward, the sign panel rotated up and over the vehicle, striking the telemetry antenna resulting in loss of data transmission at about 93 msec. The time at loss of contact with the barricade, i.e., when the support ended contact with the vehicle, was 209 msec and the vehicle had slowed to 84.5 km/h. The support rotated as it went over the vehicle, and one leg momentarily contacted the rear portion of the roof just above the rear hatch at about 307 msec. Brakes on the vehicle were applied at 1.05 seconds after impact, which was after the vehicle cleared the immediate test site. Prior to brake application, the test vehicle was traveling on a relatively straight-forward path. However, one brake did not actuate upon application, causing the vehicle to yaw in a clockwise rotation. The vehicle subsequently came to rest 137 m down and 37 m to the right of the point of impact. Figure 3 shows sequential photographs of the test period.

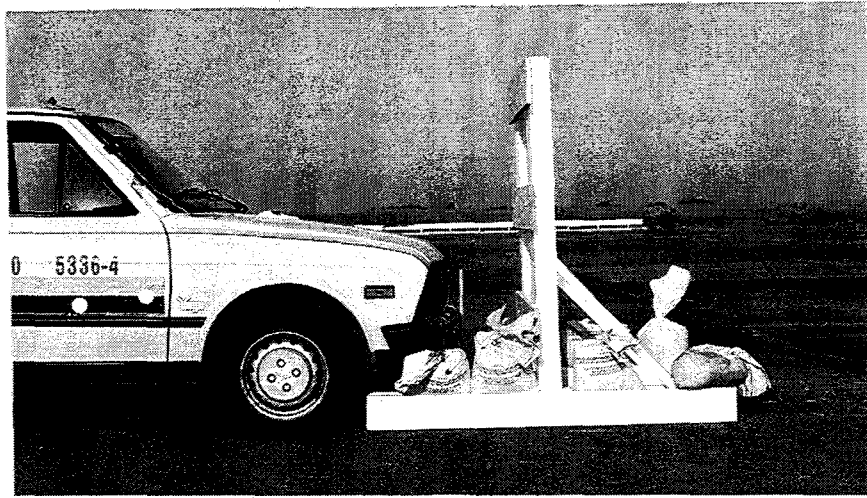
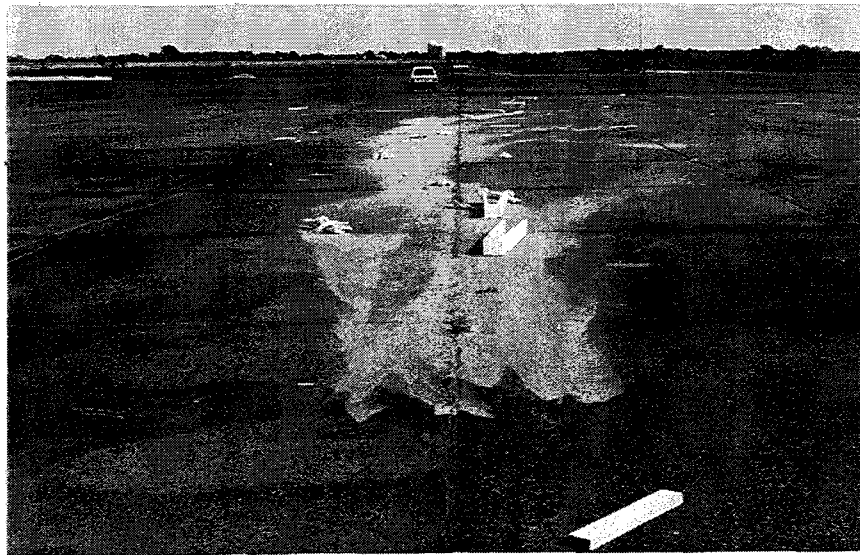
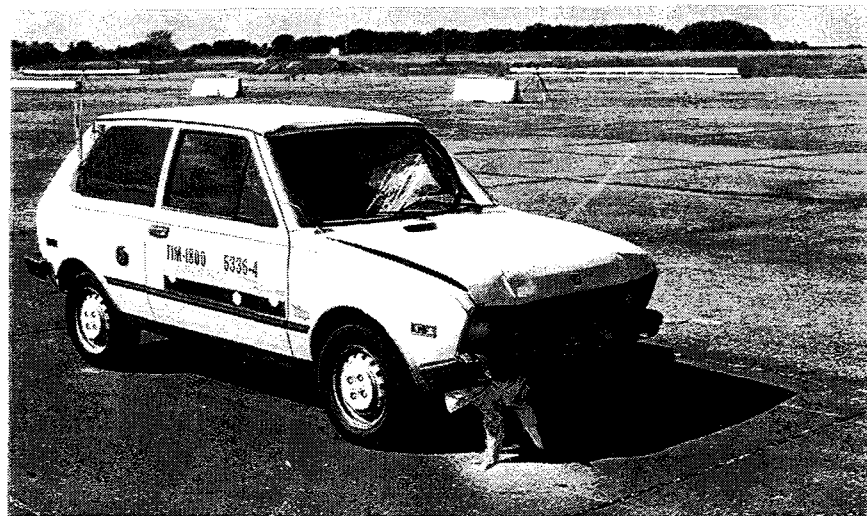
Figure 6. Vehicle and Barricade for Test No. 453360-4

The barricade shattered upon impact, as can be seen in Figure 6. Debris and sand were strewn along the path of the vehicle in an area 18 m wide by 56 m long. Figure 6 shows damage to the vehicle. There were two dents in the bumper, 89 mm and 64 mm from impact with the vertical supports. The windshield was broken and had fallen into the occupant compartment,

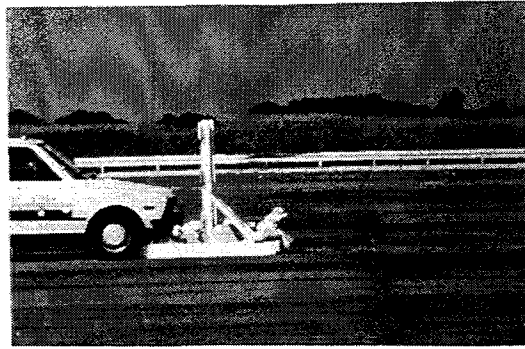
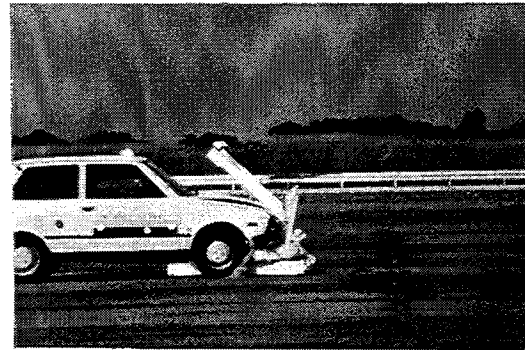
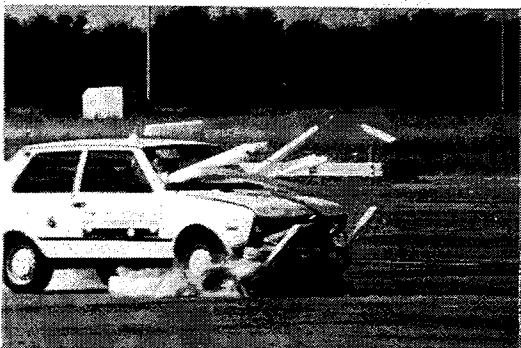
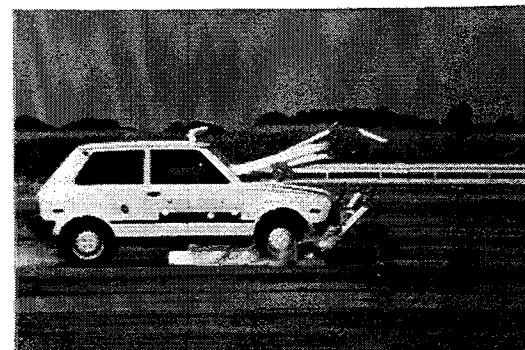
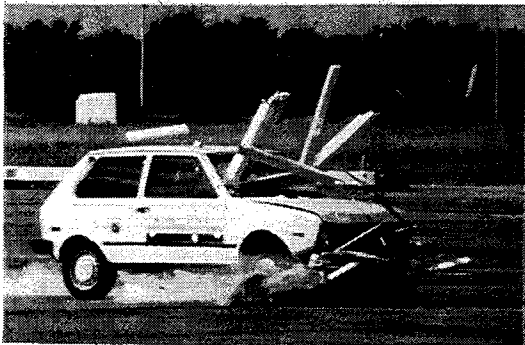
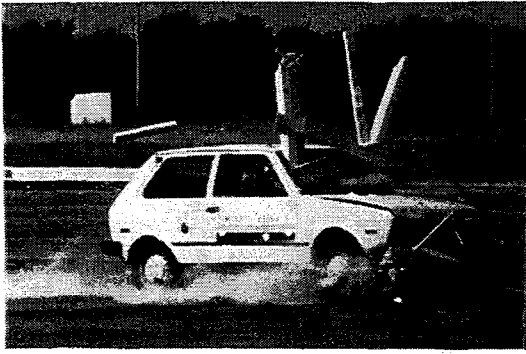
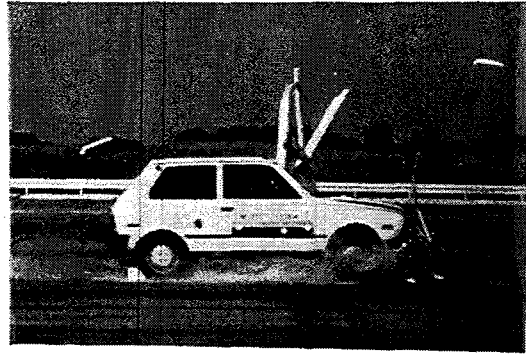
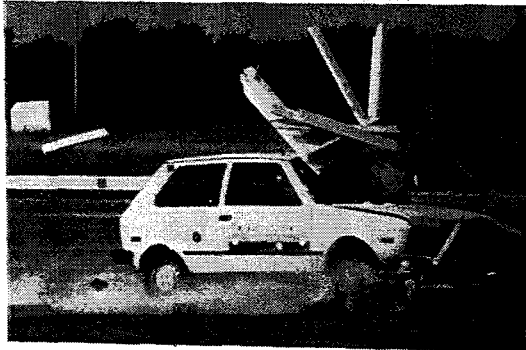
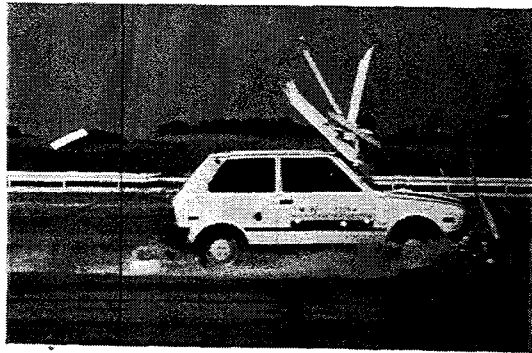
Figure 7. Sequential Photographs for Test No. 453360-4

Upon impact, the vertical supports fractured and contacted the hood of the vehicle while the vehicle traveled over the bases. The top rear section of the barricade separated at 17 msec and made contact with the windshield at 40 msec. The windshield broke at 45 msec, and a fragment of the barricade entered the occupant compartment at 72 msec. As the vehicle continued forward, the other fragments contacted the roof of the vehicle just above the windshield at 117 msec and then lost contact at 164 msec. At this time, the vehicle had slowed to 84.5 km/h. The fragments rotated as they went over the vehicle and momentarily contacted the left rear portion of the roof at about 226 msec. After the vehicle cleared the immediate test site, brakes on the vehicle were applied at 860 msec. Prior to brake application, the test vehicle was traveling on a relatively straight-forward path. The vehicle subsequently came to rest 71 m down from the point of impact. Figure 7 shows sequential photographs of the test period.

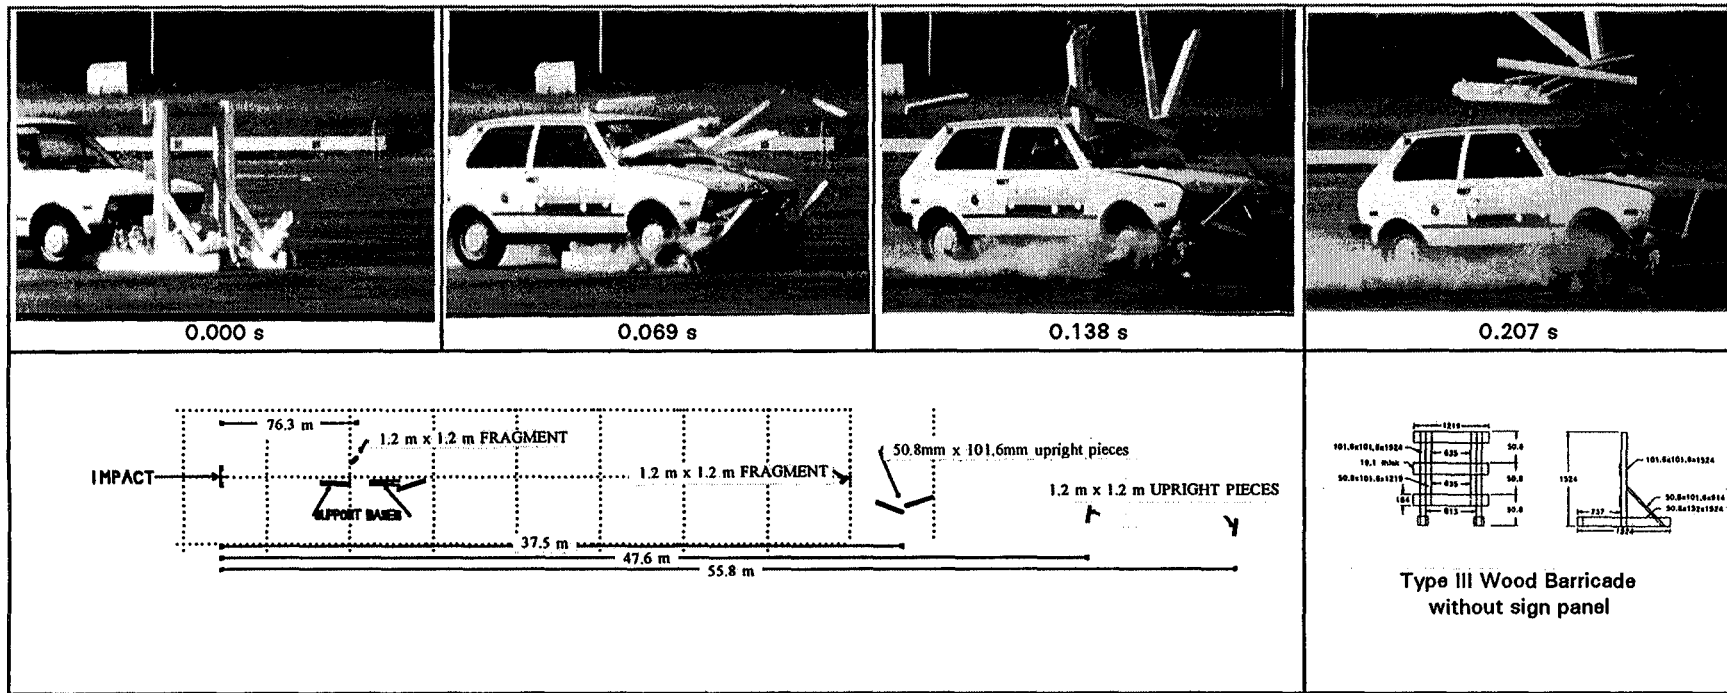
Figure 8. Summary of Results for Test No. 453360-4

Figure 8 presents a brief summary of the results of this test. The barricade shattered upon impact, and a segment of the barricade impacted the windshield, penetrated and intruded into the occupant compartment. The 533 mm long fragment was found in the rear section of the occupant compartment, showing potential risk to occupants in the vehicle. Sand and many fragments of the barricade were scattered along an area 18 m wide by 56 m long. Some fragments were fairly large, which could pose potential hazard to oncoming traffic in adjacent lanes and to workers in the area. Sand was also scattered on the pavement, which could lead to loss of control of other vehicles. The vehicle sustained damage to the front bumper, hood, windshield and roof. The longitudinal occupant impact velocity was 2.8 m/s and the highest 10-msec average ridedown acceleration was -0.9 g. There was no lateral occupant contact during the test period. The 50-msec average accelerations were -4.8 g in the longitudinal direction and 0.7 g in the lateral direction. The vehicle exited the immediate test site in a relatively smooth, stable manner and showed no potential for intrusion into adjacent traffic lanes.

In summary, the performance of the barricade was judged to be unsatisfactory due to penetration of the windshield and the occupant compartment by the fractured vertical supports of the barricade.

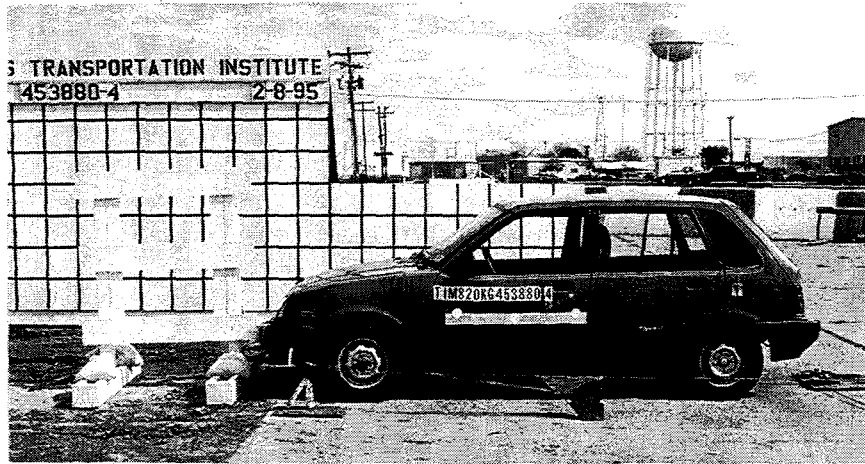
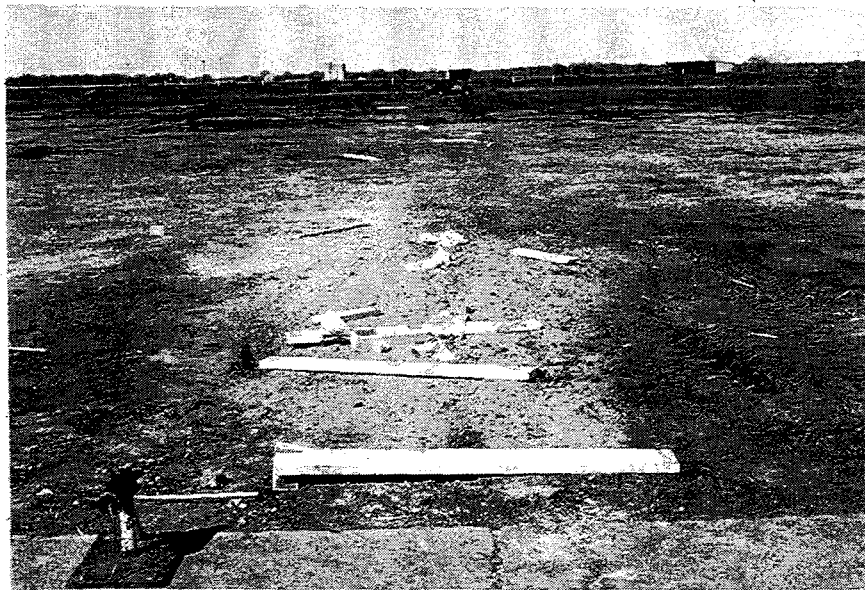
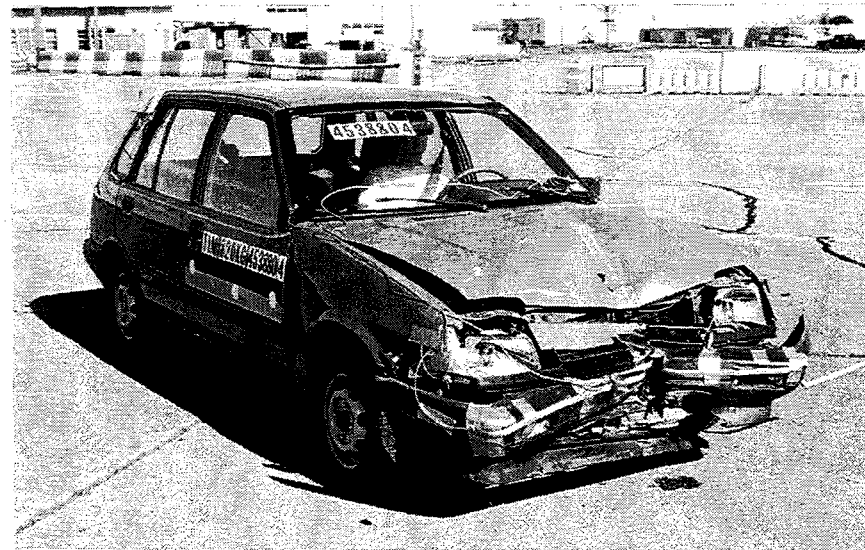
Figure 10. Vehicle and Barricade for Test No. 453880-4

The barricade separated from the base upon impact, as can be seen in Figure 10. Debris and sand were strewn along the path of the vehicle in an area 4.3 m wide by 58.8 m long. Figure 10 shows damage to the vehicle. Maximum crush to the exterior of the vehicle was 190 mm to the center front bumper. The right front door was jammed, and there was damage to the bumper, grill, and hood. The right front tire was flat.

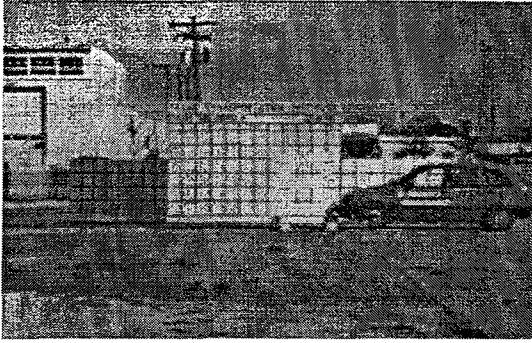
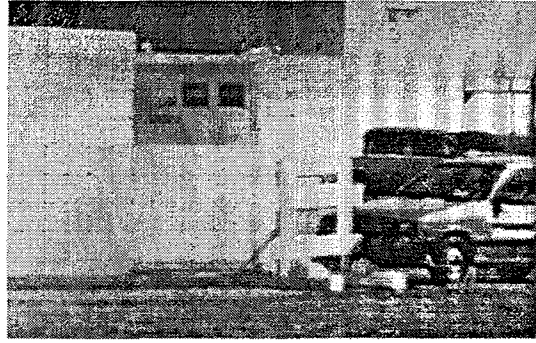
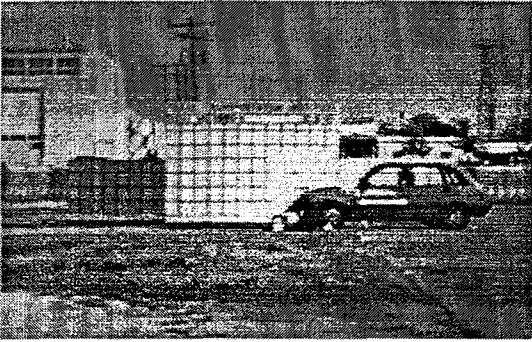
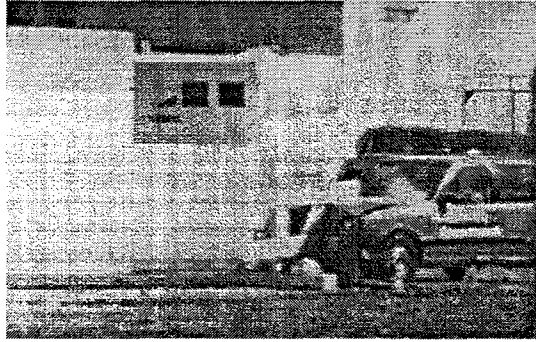
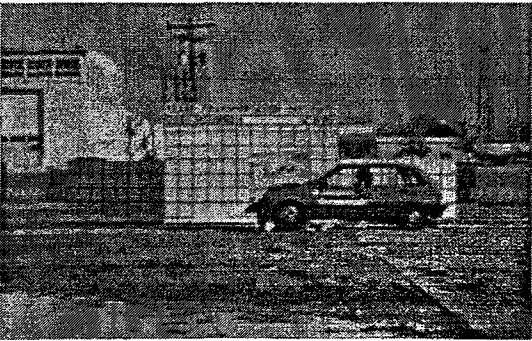
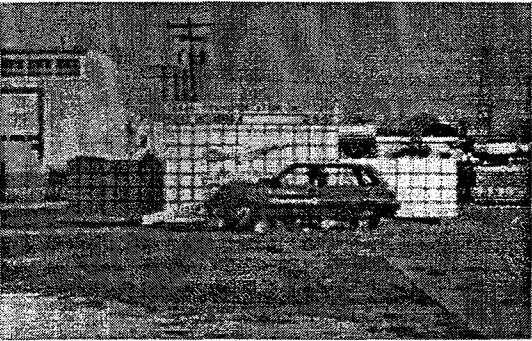
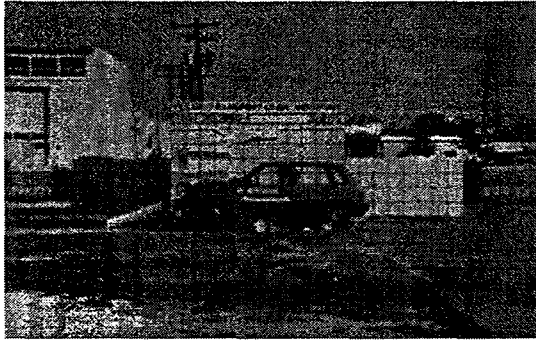
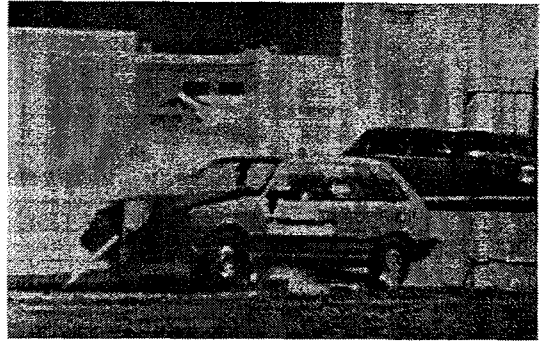
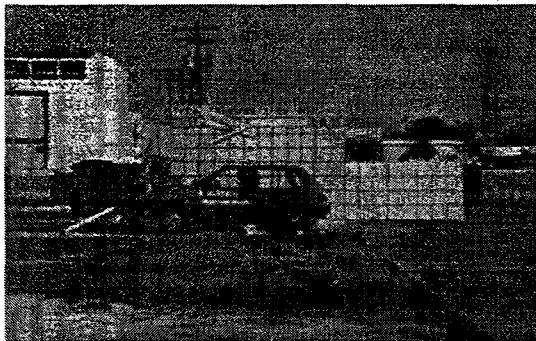
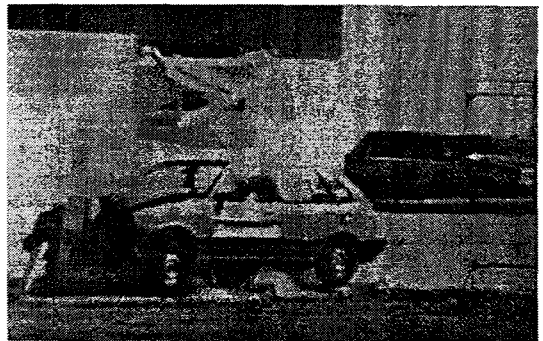
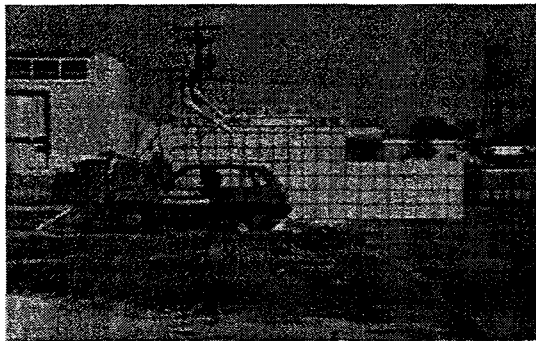
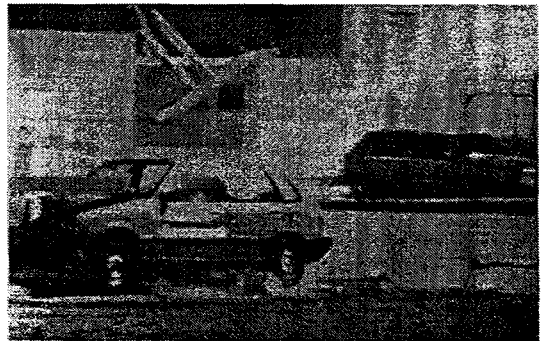
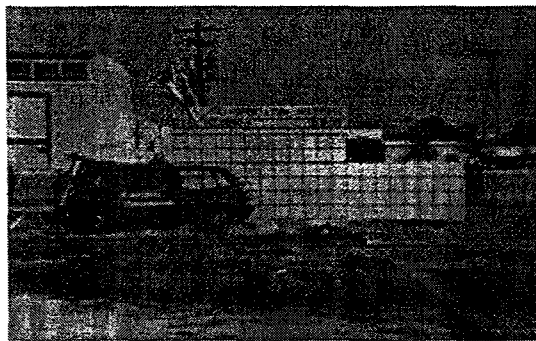
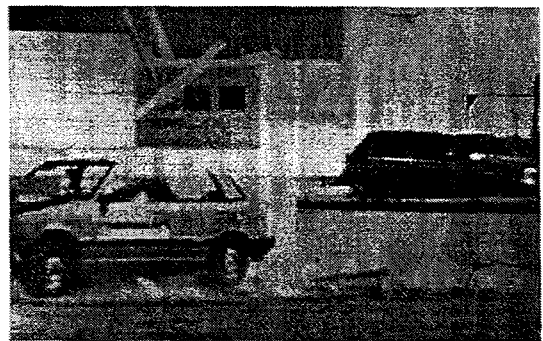
Figure 11. Sequential Photographs for Test No. 453880-4

As the vehicle impacted the end of the rail elements, the right vertical support separated from the base. The vehicle contacted the right vertical support at 7 msec. At 12 msec, the lower rail element separated from the vertical supports. At 17 msec, the middle rail element separated from the vertical support and contacted the hood of the vehicle at 20 msec. The front tires of the vehicle rode over the right base, which separated from the vertical support. The left vertical support separated at 48 msec, and the vehicle rode over the left base, carrying the remaining debris of the barricade with it. At 221 msec, the vehicle cleared the installation site traveling at a speed of 93.1 km/h. Prior to brake application, the vehicle was tracking straight forward. The vehicle subsequently came to rest 102.4 m down and 1.7 m to the right of the point of impact. Figure 11 shows sequential photographs of the test period.

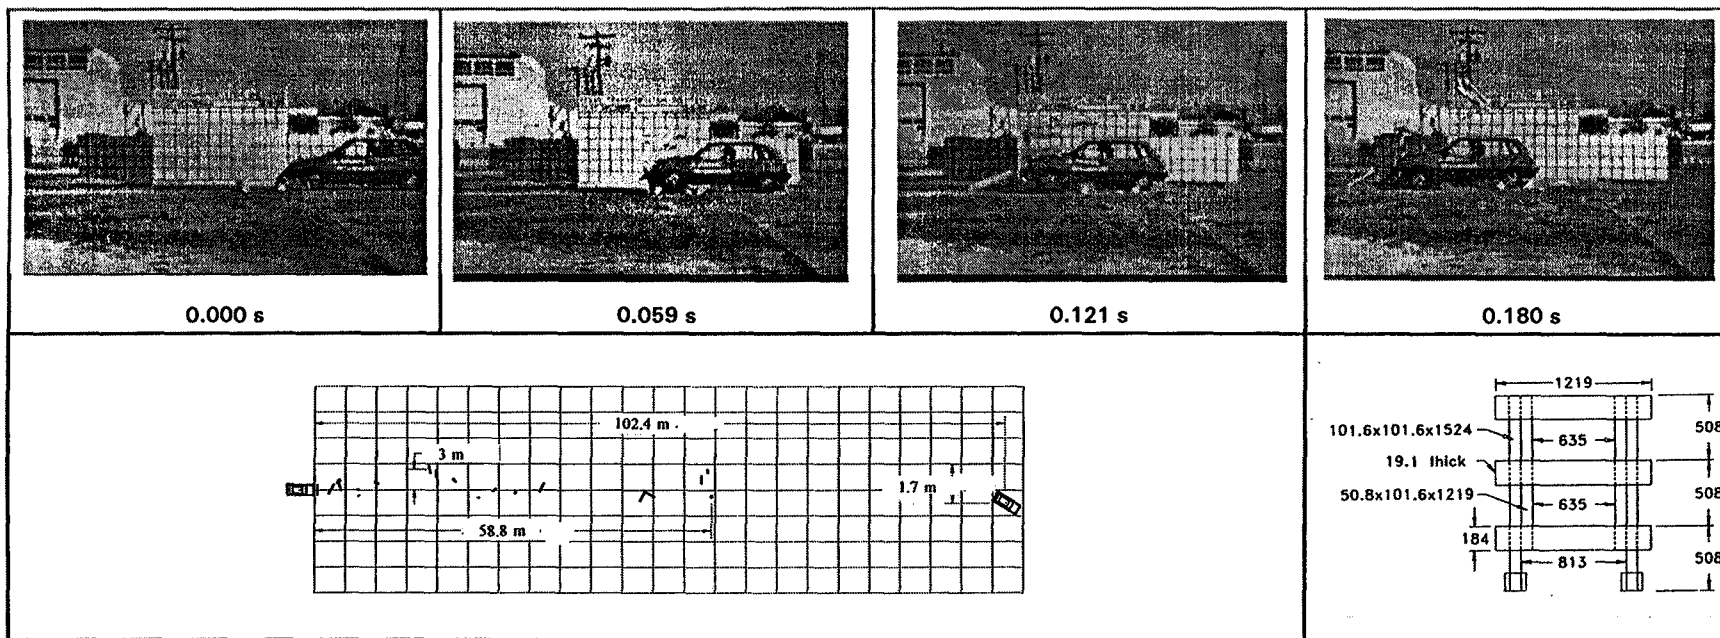
Figure 12. Summary of Results for Test No. 453880-4

Figure 12 presents a brief summary of the results of this test. The barricade came apart upon impact; however, there was no penetration or intrusion into the occupant compartment. Sand and fragments of the barricade were scattered along an area 4.3 m wide by 58.8 m long.

However, most fragments were not large enough to pose potential hazard to oncoming traffic in adjacent lanes or to construction workers in the area. The vehicle sustained minor damage to the bumper, grill and hood. Maximum crush to the center front bumper was 190 mm. The longitudinal occupant impact velocity was 2.1 m/s, and the highest 10-msec average ridedown acceleration was -2.4 g. Lateral occupant impact velocity was 0.9 m/s, and the highest 10-msec average ridedown acceleration was -5.4 g. The 50-msec average accelerations were -3.2 g in the longitudinal direction and 1.1 g in the lateral direction. The vehicle exited the immediate test site in a relatively smooth, stable manner and showed no potential for intrusion into adjacent traffic lanes.

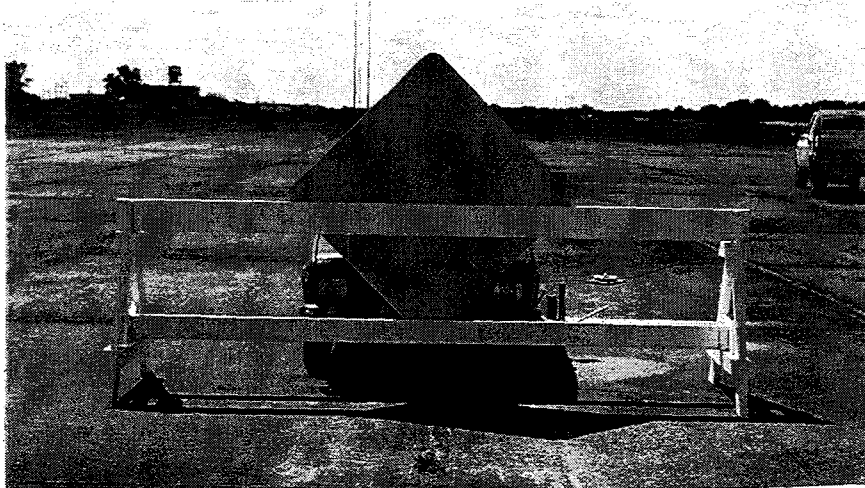
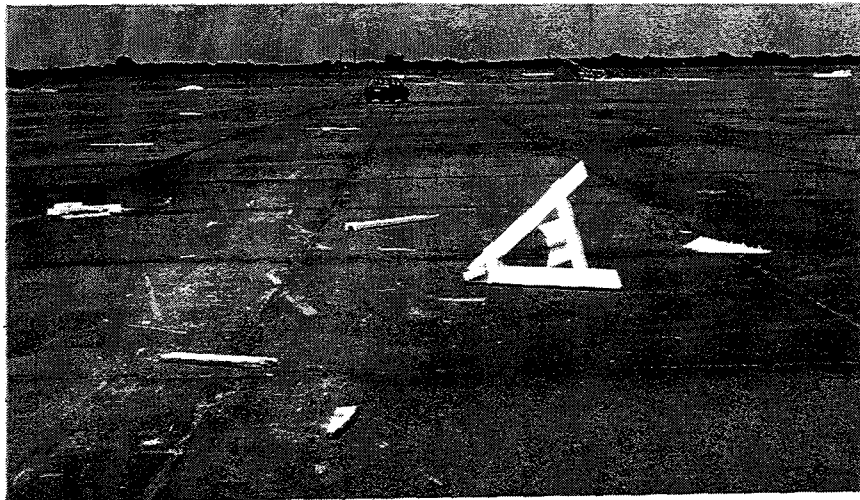
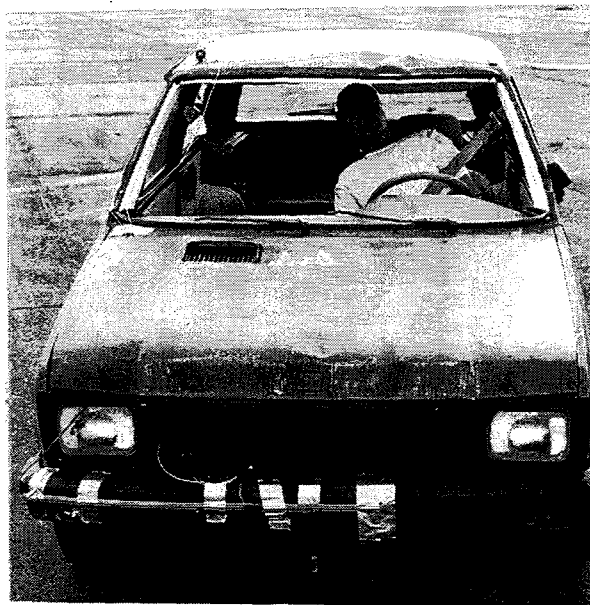
Figure 14. Vehicle and Barricade for Test No. 453360-5

The barricade shattered upon impact, as can be seen in Figure 14. Debris and sand were strewn along the path of the vehicle in an area 15 m wide by 53 m long. Figure 14 shows damage to the vehicle. There were two dents in the bumper, 38 mm and 19 mm from impact with the rail elements. There were scrapes in the hood leading up to the windshield, the windshield was broken and fallen into the occupant compartment, and there were dents on the A-pillars starting 152 mm above the bottom of the windshield frame and ending at the top edge of the roof.

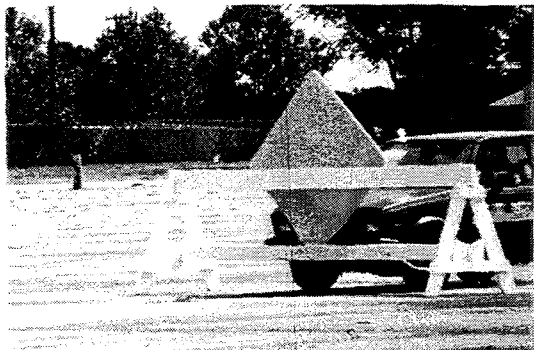
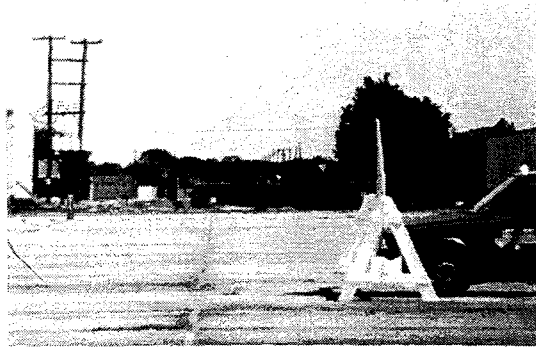
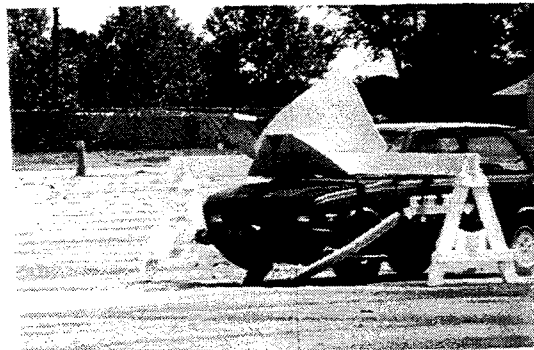
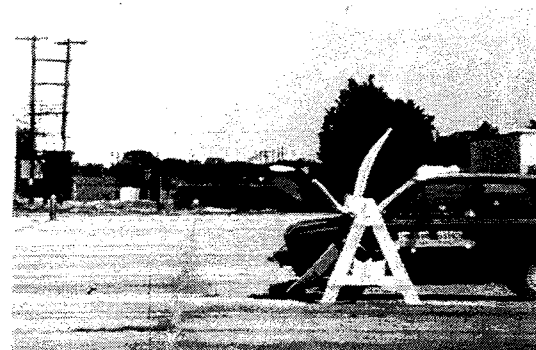
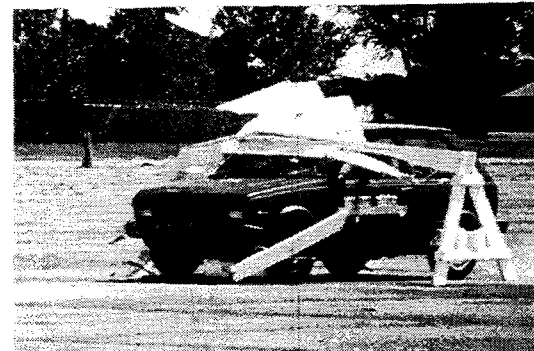
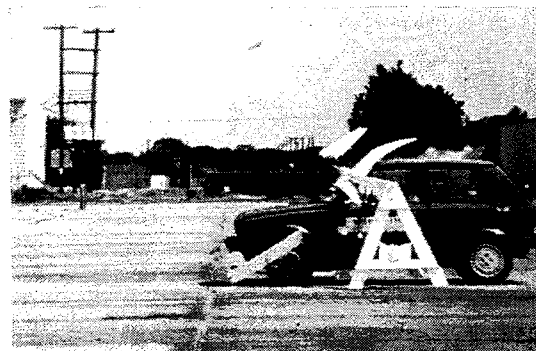
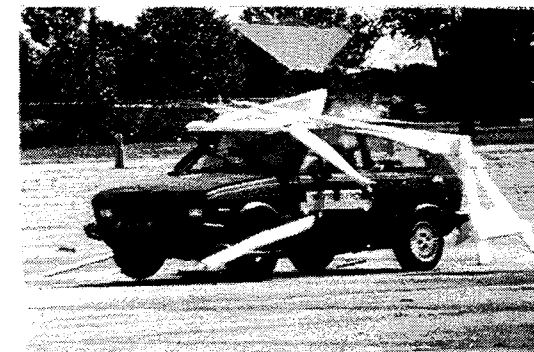
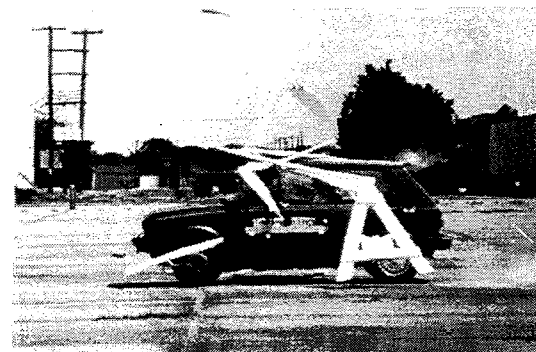
Figure 15. Sequential Photographs for Test No. 453360-5

Upon impact, the bottom rail element broke. At 15 msec after impact, the sign panel cracked. As the vehicle continued forward, the fragments rose and struck the windshield, which broke at 57 msec. At the same time, the top rail element of the barricade contacted the A-pillars of the vehicle. The sign panel continued to go up and lost contact with the vehicle at 122 msec, while the remaining fragments of the rail elements lost contact at 156 msec. The vehicle had slowed to 91.2 km/h by this time. After the vehicle cleared the immediate test site, brakes on the vehicle were applied at 960 msec after impact. Prior to brake application, the test vehicle was traveling on a relatively straightforward path. The vehicle subsequently came to rest 68 m down from the point of impact. Figure 15 shows sequential photographs of the test period.

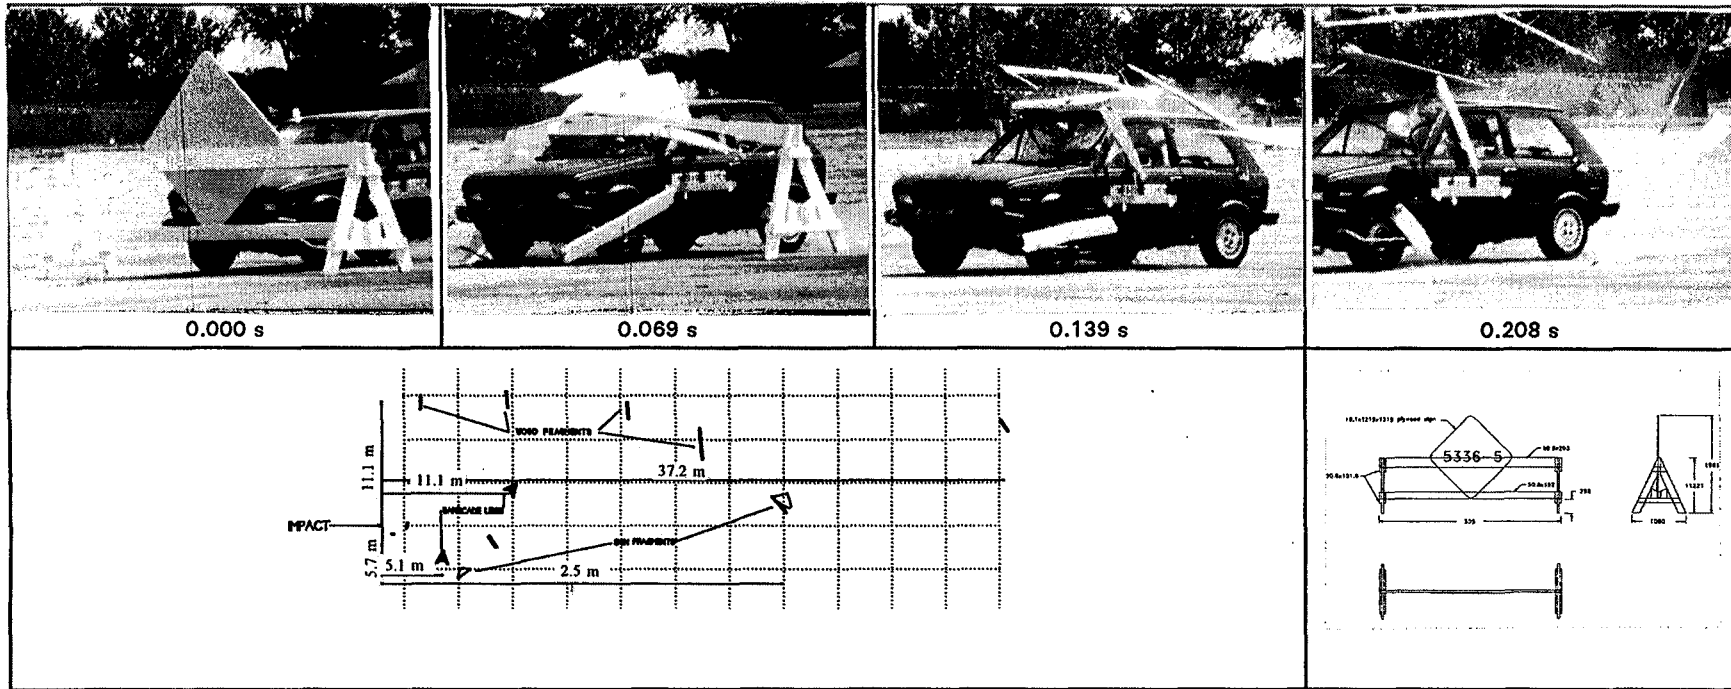
Dyanmic	Broke apart
Permanent	Broke apart
Vehicle Damage	
Exterior	
VDS	12FD1
CDC	12FDEK1 & 12FDGW6
Interior	
OCDI	FS0000000
Maximum Exterior Vehicle Crush (in)	
	1.5 (3.8 cm)
Max. Occ. Compartment Deformation (in)	
	Broken windshield
Post-Impact Behavior	
Max. Roll Angle (deg)	-2.2
Max. Pitch Angle (deg)	-1.9
Max. Yaw Angle (deg)	2.1

fragments of the barricade were scattered along an area 15 m wide by 53 m long. Some fragments were fairly large, which could pose potential hazard to oncoming traffic in adjacent lanes and to workers in the area. Sand was also scattered on the pavement, which could lead to loss of control of other vehicles. The longitudinal occupant impact velocity was 0.8 m/s and the highest 10-msec average ridedown acceleration was -0.1 g. There was no lateral occupant contact during the test period. The 50-msec average accelerations were -1.1 g in the longitudinal direction and 0.5 g in the lateral direction. The vehicle exited the immediate test site in a relatively smooth, stable manner and showed no potential for intrusion into adjacent traffic lanes.

In summary, the performance of the barricade was judged to be unsatisfactory due to penetration of the windshield and the occupant compartment by the fractured vertical supports of the barricade.

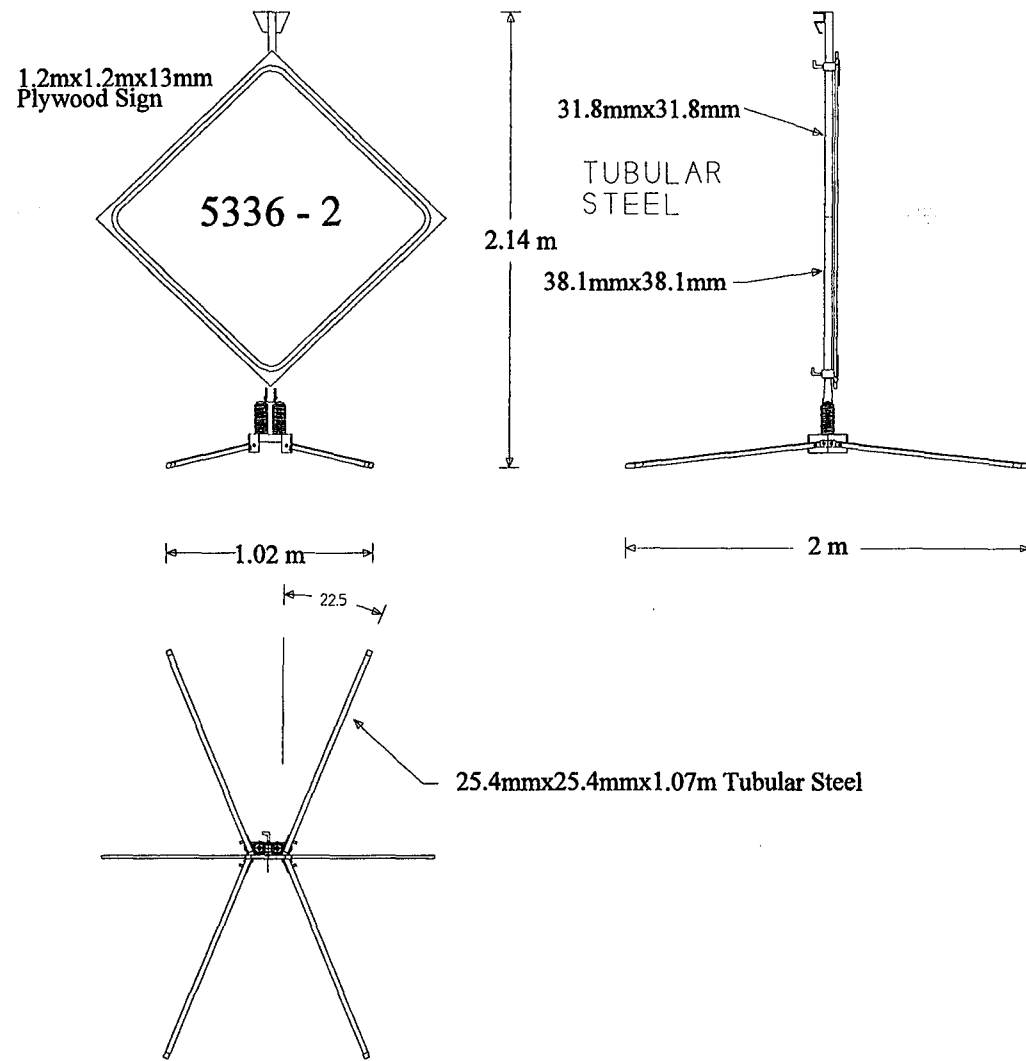
Figure 17. Schematic of Spring Mounted Sign Support with Wooden Sign Panel (Test No. 453360-2)

Figure 17 shows a schematic of the spring-mounted portable sign support with a 1219 mm x 1219 mm wooden sign panel mounted at a height of 305 mm. The test vehicle was a 1988 Yugo GV, as shown in Figure 18. Appendix Figure 92 gives dimensions and information on the vehicle. The test vehicle impacted the sign support head-on with the centerline of the vehicle aligned with the centerline of the sign support, traveling at a speed of 97.0 km/h.

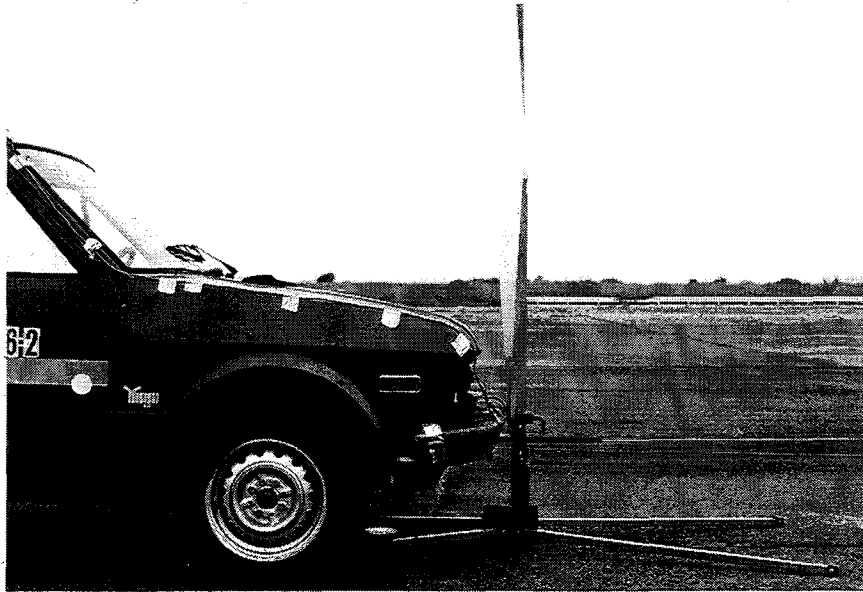
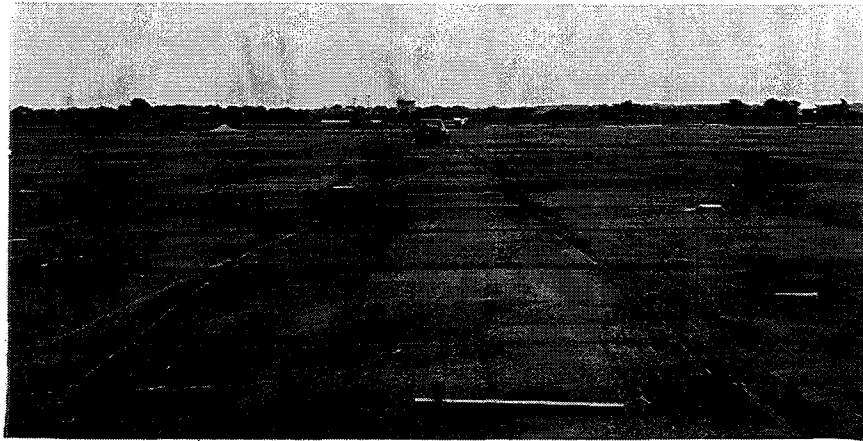
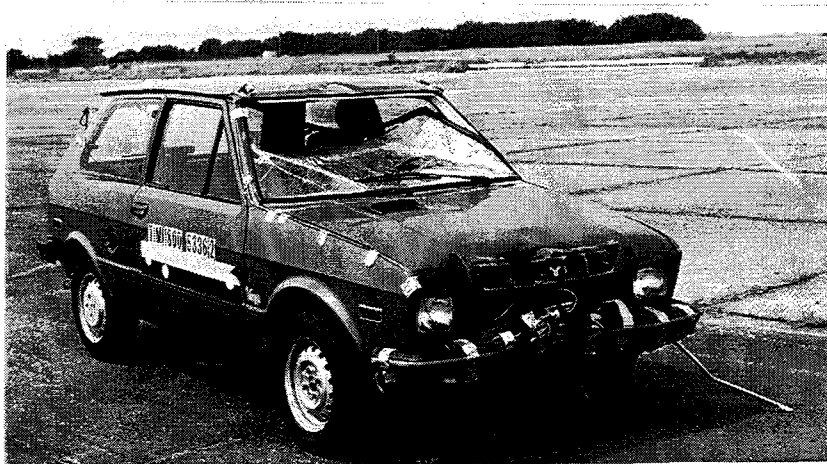
Figure 18. Vehicle and Sign Support for Test No. 453360-2

The spring-mounted portable sign support shattered upon impact, as can be seen in Figure 18. Debris were strewn along the path of the vehicle in an area 17 m wide by 21 m long. Figure 18 shows damage to the vehicle. There was a maximum crush of 89 mm in the bumper from impact with the sign support. There was a 25-mm deep dent in the roof just above the windshield, and the windshield was broken and had partially fallen into the occupant compartment.

In summary, the performance of the spring-mounted portable sign support with a wooden sign panel was judged to be unsatisfactory due to penetration of the windshield and the occupant compartment by the sign panel and a portion of the sign support.
