1. Report No. TX-96/5388-1F		2. Government Accession No.		3. Recipient's Catalog No.	
4. Title and Subtitle EVALUATION OF WORK ZONE BARRICADES AND TEMPORARY SIGN SUPPORTS				5. Report Date February 1996

EVALUATION OF WORK ZONE BARRICADES AND TEMPORARY SIGN SUPPORTS

Report No. 5388-1F
Research Study No. 585xxA3014
Research Study Title: Development of New Designs for Barricades
and Sign Supports in Work Zones

February 1996

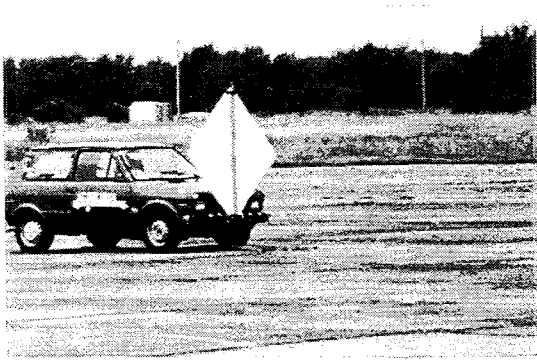
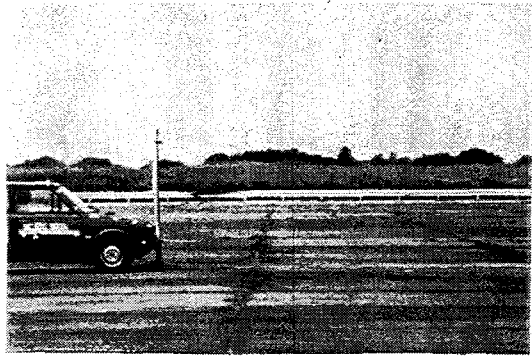
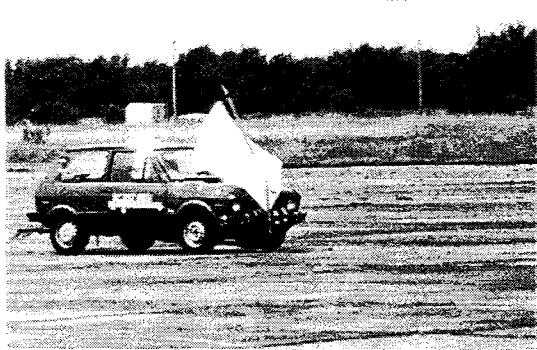
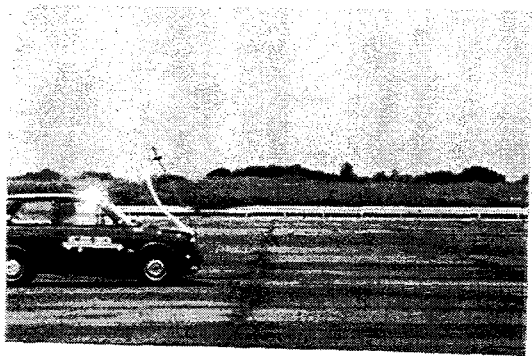
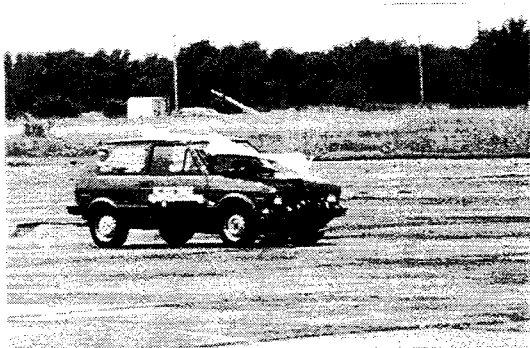
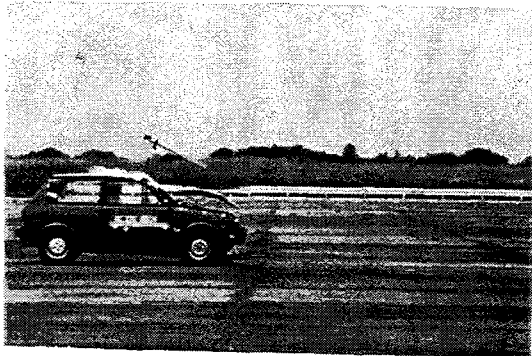
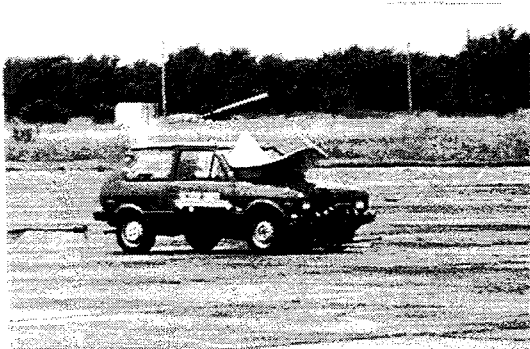
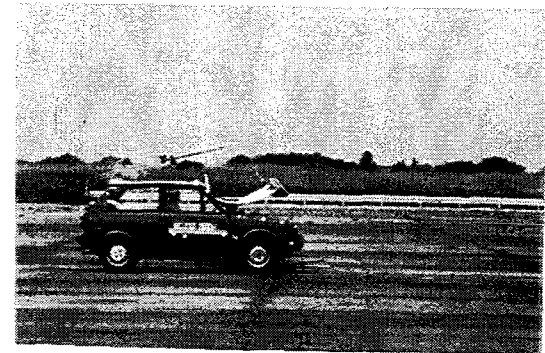
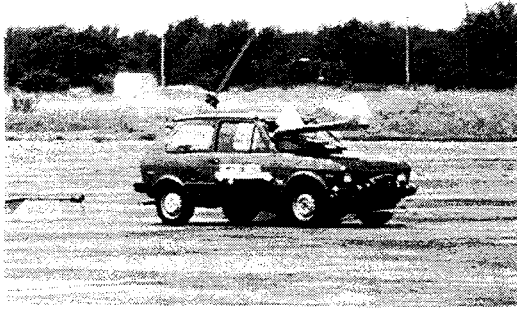
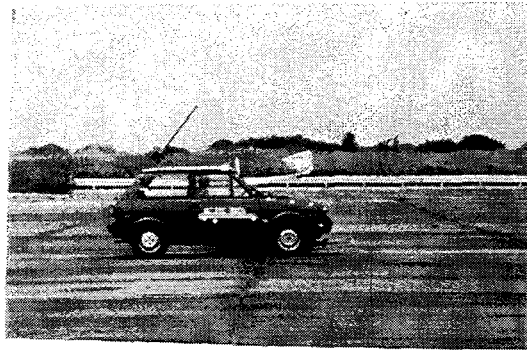
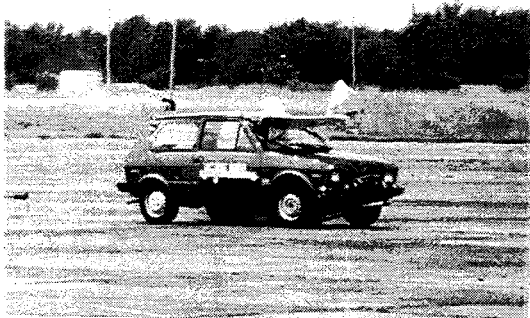
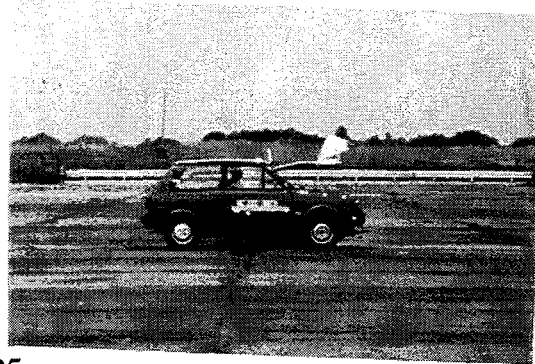
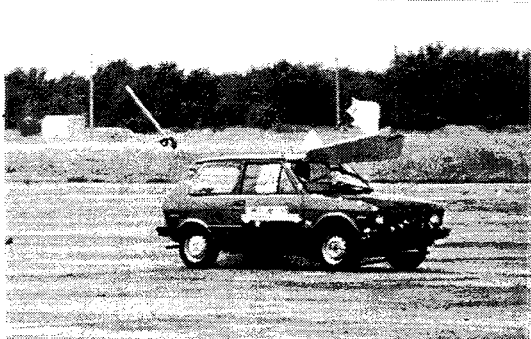
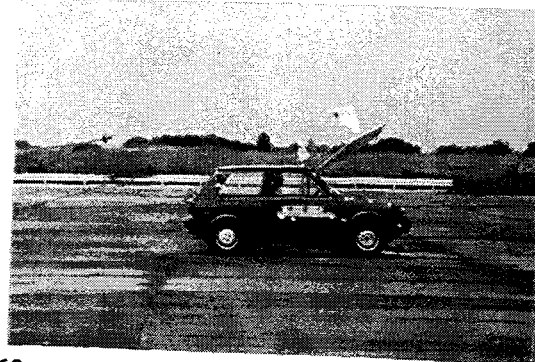
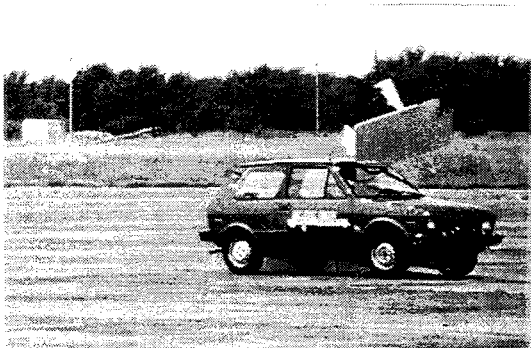
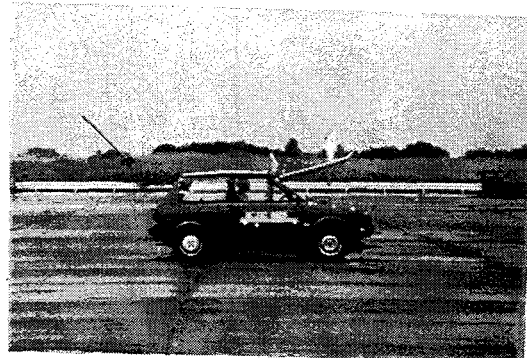
Figure 19. Sequential Photographs for Test No. 453360-2

At approximately 10 msec after impact, the sign panel began to crack. The bracket supporting the sign panel broke at 17 msec, and at 22 msec the sign panel slipped out of the bracket. The sign panel continued moving upward and contacted the edge of the roof of the vehicle just above the windshield. As the vehicle continued forward, the sign panel deformed, impacted and penetrated the windshield, the bracket went over the roof, and the base hung up on the undercarriage of the vehicle. The panel rotated up and over the vehicle and lost contact at 200 msec, at which time the vehicle had slowed to 91.4 km/h. After the vehicle cleared the immediate test site, brakes on the vehicle were applied at 937 msec after impact. Prior to brake application, the test vehicle was traveling on a relatively straight-forward path. The vehicle subsequently came to rest 59 m down and 6 m to the east of the point of impact. Figure 19 shows sequential photographs of the test period.

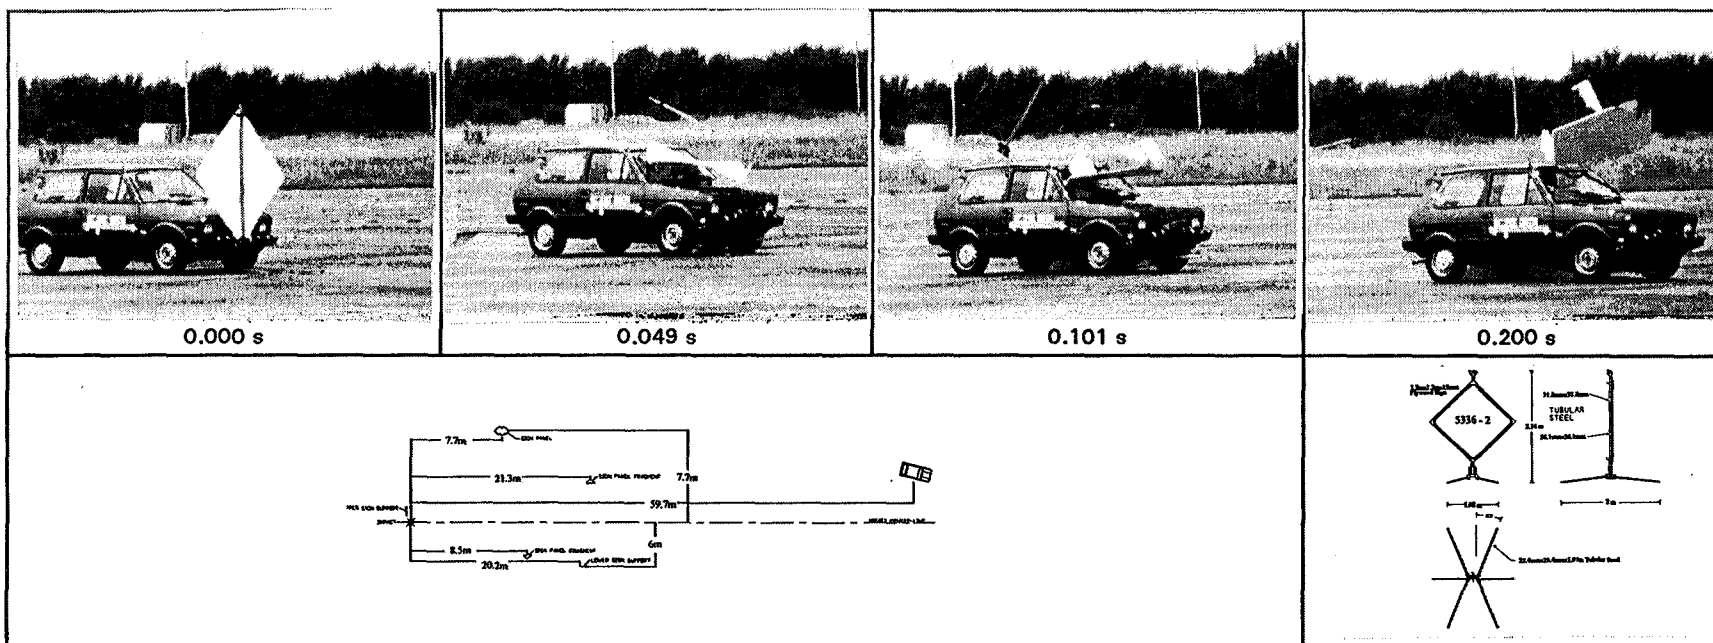
Figure 20. Summary of Results for Test No. 453360-2

A brief summary of the results of this test is presented in Figure 20. The sign support shattered upon impact. The wooden sign panel and a segment of the sign support impacted and penetrated the windshield, showing potential risk to occupants in the vehicle. Debris of the sign support were scattered along an area 17 m wide by 21 m long. Some of the fragments were fairly large, which could pose potential hazard to oncoming traffic in adjacent lanes and to workers in the area. The vehicle sustained damage to the front bumper, hood, windshield and roof. The longitudinal occupant impact velocity was 1.7 m/s, and the highest 10-msec average ridedown acceleration was -1.5 g. There was no occupant contact in the lateral direction during the test period. The maximum 50-msec average accelerations were -1.3 g in the longitudinal direction and 0.6 g in the lateral direction. The vehicle exited the immediate test site in a relatively smooth, stable manner and showed no potential for intrusion into adjacent traffic lanes.

In summary, the performance of the spring-mounted portable sign support with a wooden sign panel was judged to be unsatisfactory due to penetration of the windshield and the occupant compartment by the sign panel and a portion of the sign support.

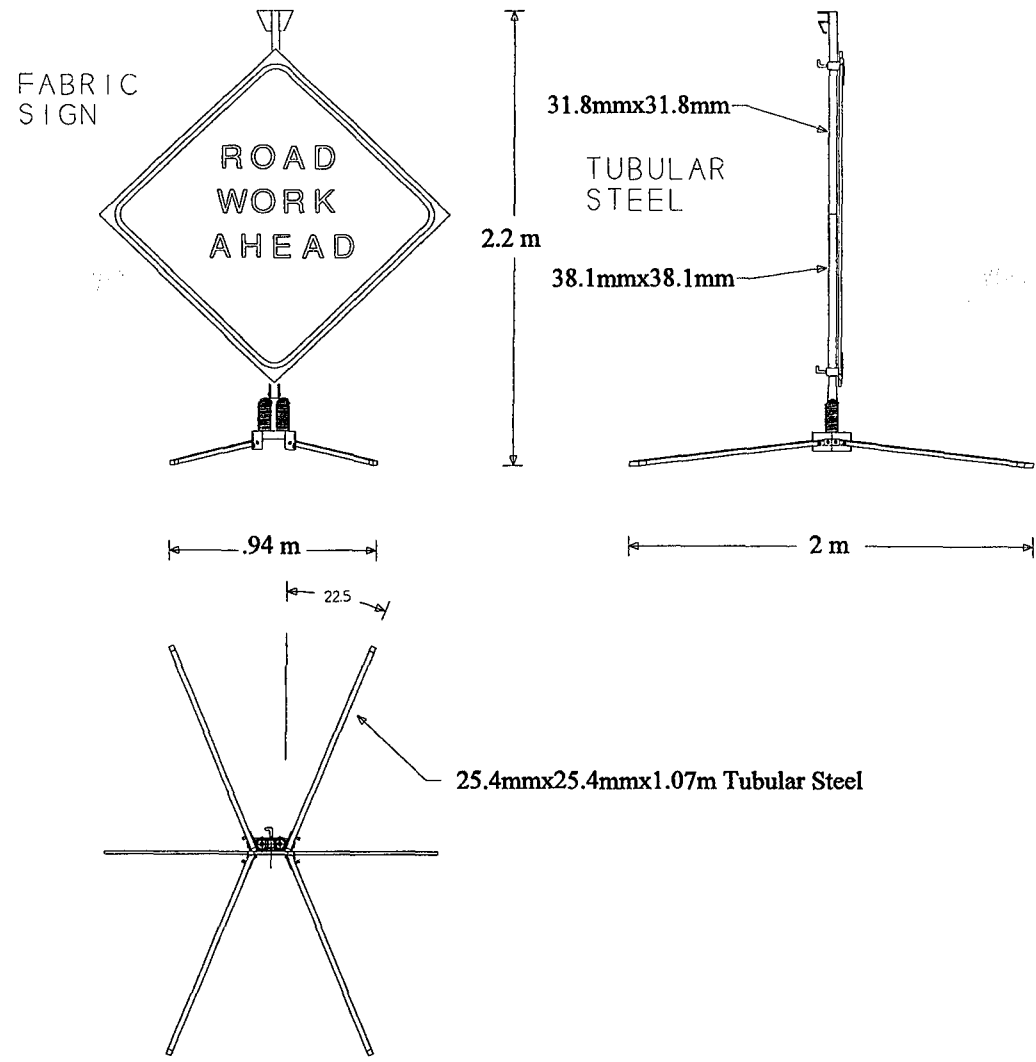
Figure 21. Schematic of Spring Mounted Sign Support with Plastic/Fabric Sign (Test No. 453580-1)

Figure 21 shows a schematic of the spring-mounted portable sign support with a 1219 mm x 1219 mm plastic/fabric sign mounted at a height of 305 mm. The test vehicle was a 1987 Yugo GV, as shown in Figure 22. Dimensions and information on the vehicle are given in Appendix Figure 93. The test vehicle impacted the sign support head-on with the centerline of the vehicle aligned with the centerline of the sign support, traveling at a speed of 99.0 km/h.

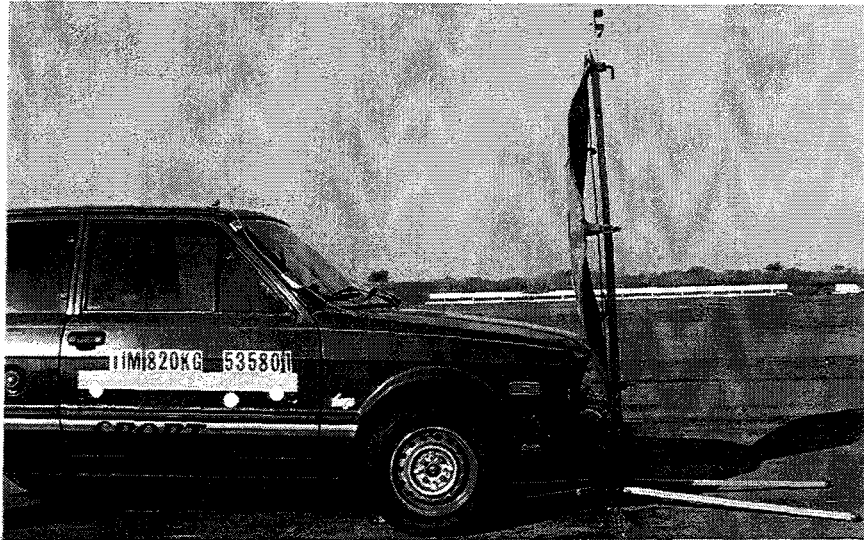
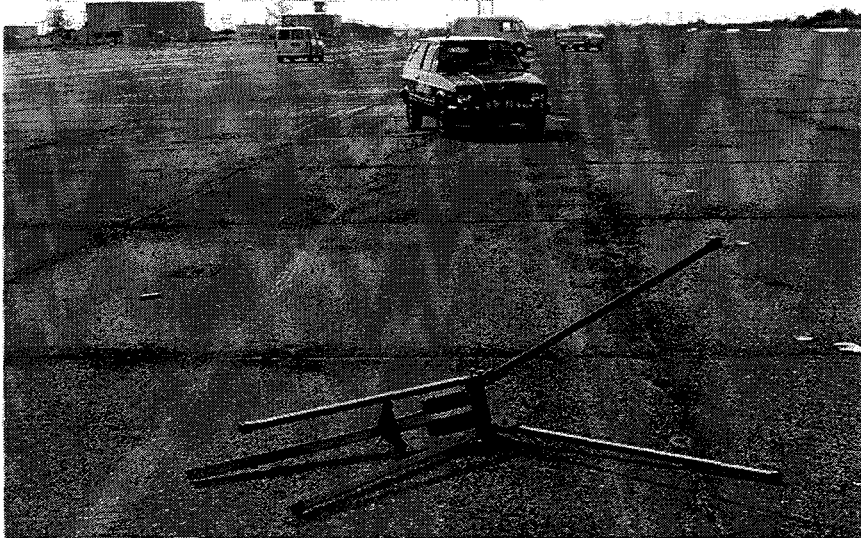
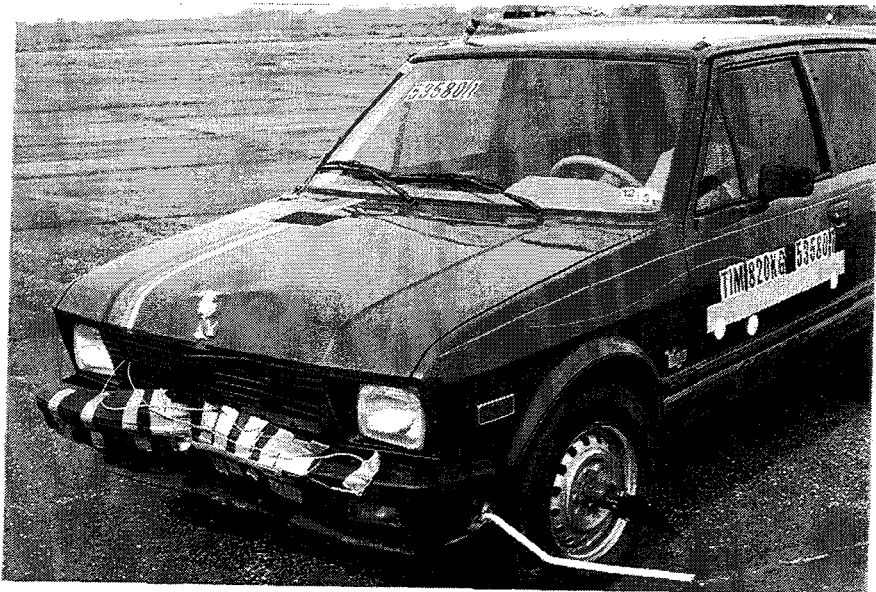
Figure 22. Vehicle and Sign Support for Test No. 453580-1

The spring-mounted portable sign support separated upon impact, as can be seen in Figure 22. Debris were strewn along the path of the vehicle in an area 3 m wide by 73 m long. Figure 22 shows damage to the vehicle. There was a maximum crush in the bumper of 70 mm from impact with the support. There was a 32 mm deep dent in the roof toward the rear, the windshield received a small chip, and the hood, bumper, and grill were dented and scratched.

In summary, the spring-mounted portable sign support with plastic/fabric sign panel was judged to have met all evaluation criteria set forth in NCHRP Report 350.

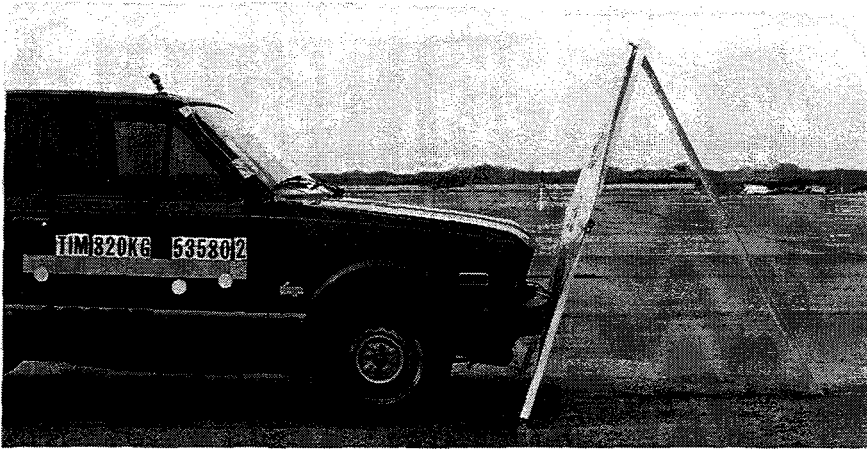
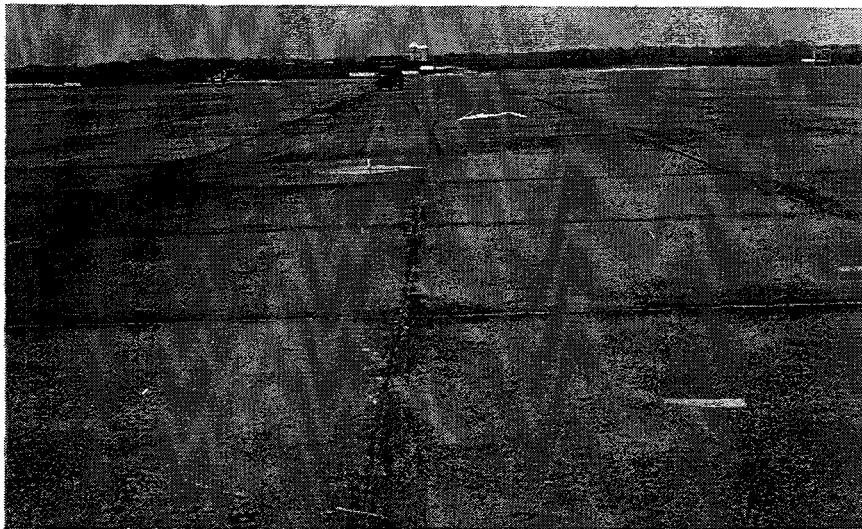
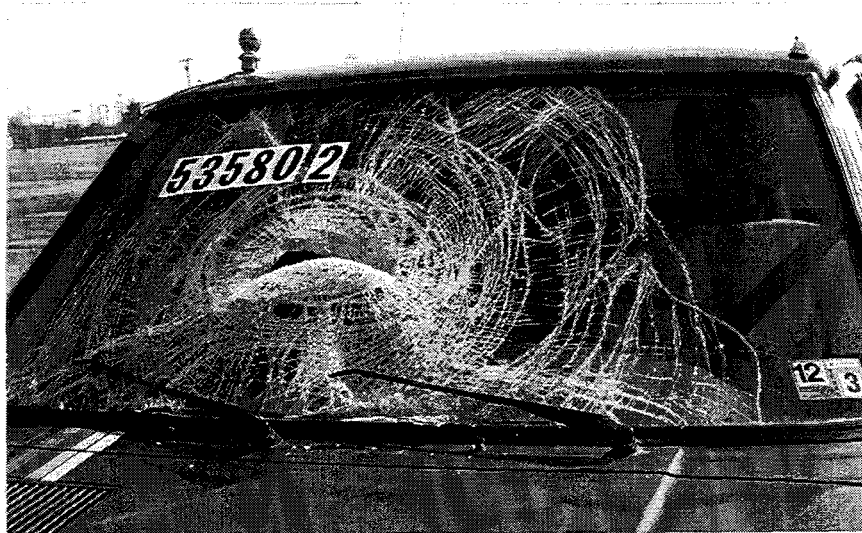
Figure 26. Vehicle and Sign Support for Test No. 453580-2

As Figure 26 shows, the sign panel of the easel sign support released, and the support came apart upon impact. Debris were strewn along the path of the vehicle in an area 4 m wide by 32 m long. Figure 26 shows damage to the vehicle. There was no measurable crush to the exterior of the vehicle. There was a small hole in the windshield caused by penetration of the top of the easel support and a small dent in the hood.

In summary, the easel portable sign support failed to meet the evaluation criteria set forth in NCHRP Report 350 and is not recommended for further field use.

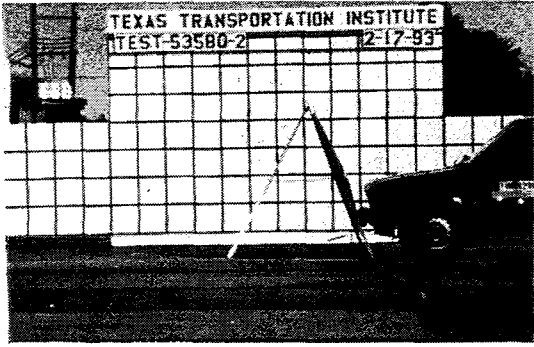
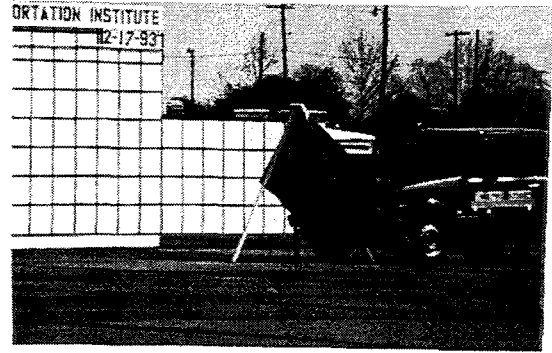
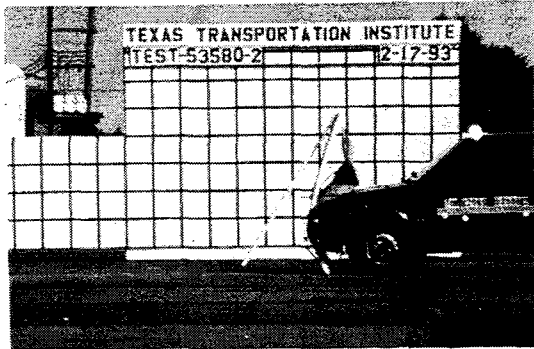
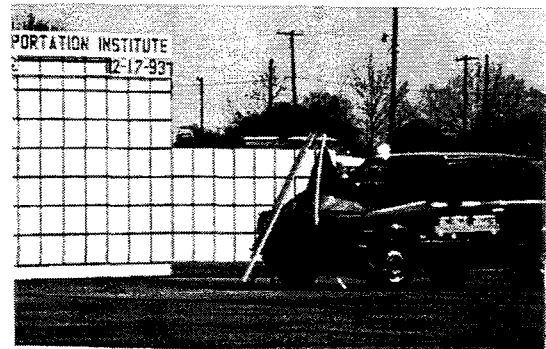
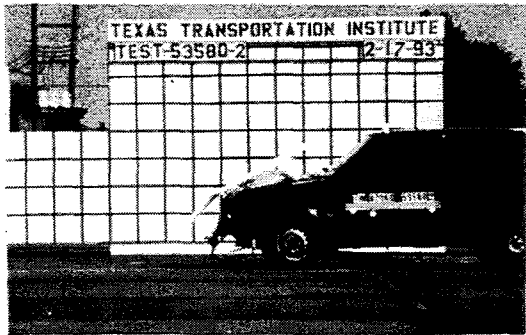
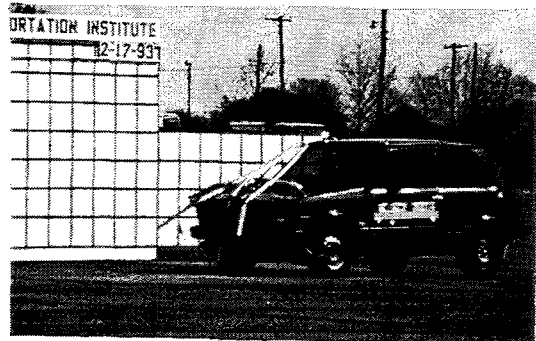
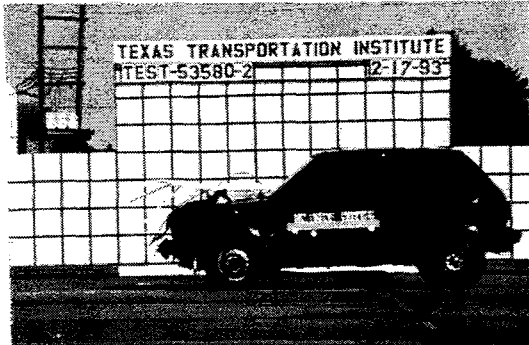
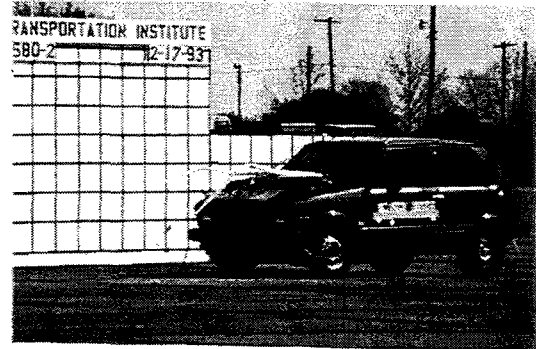
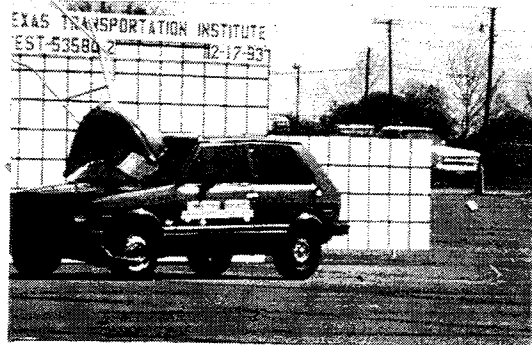
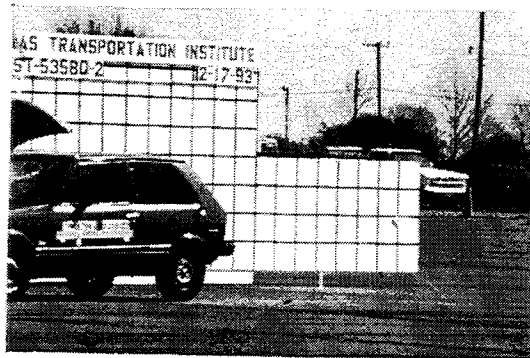
Figure 27. Sequential Photographs for Test No. 453580-2

Upon impact, the front legs of the support bent at bumper height. At 17 msec, the top of the sign panel released from the top of the support. The easel support flipped up and the top of the support contacted and penetrated the windshield at 60 msec. At 251 msec, the easel support lost contact with the vehicle and windshield. Speed of the vehicle at loss of contact was 95.1 km/h. After the vehicle cleared the immediate test site, brakes on the vehicle were applied at 1.3 seconds after impact. Prior to brake application, the test vehicle was traveling on a relatively straightforward path. The vehicle subsequently came to rest 71 m down and 3 m to the left of the point of impact. Sequential photographs of the test period are shown in Figure 27.

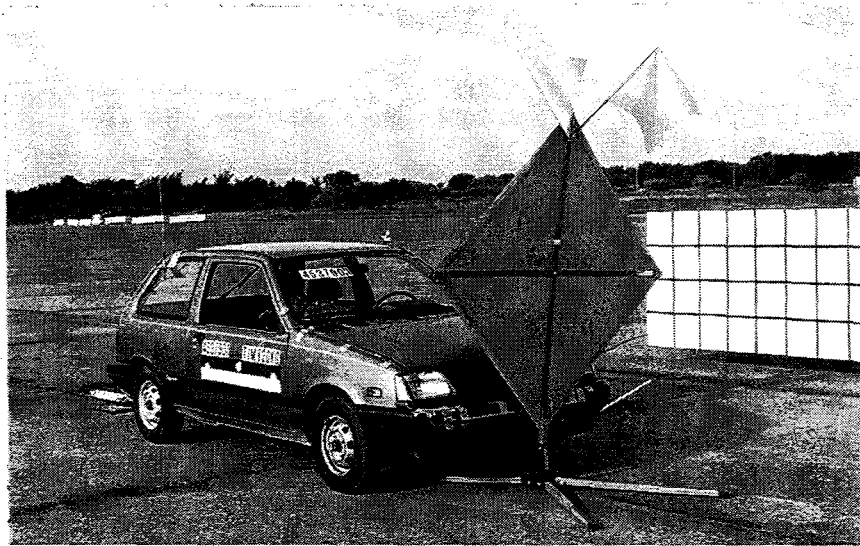
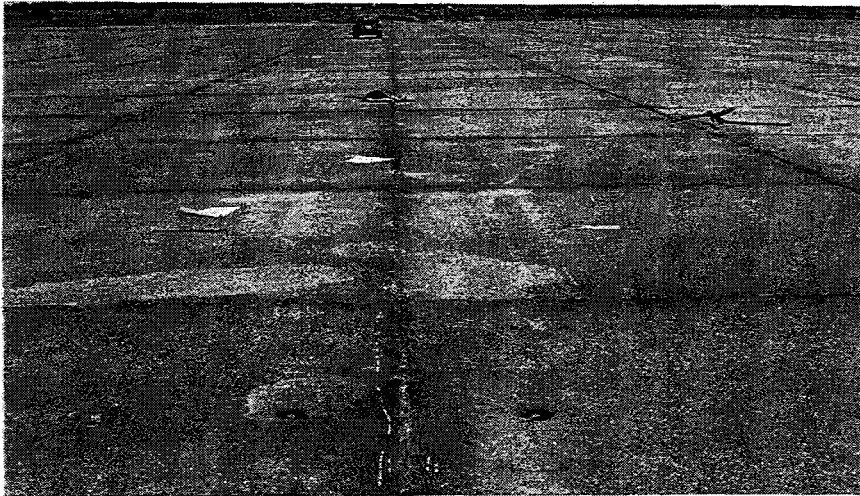
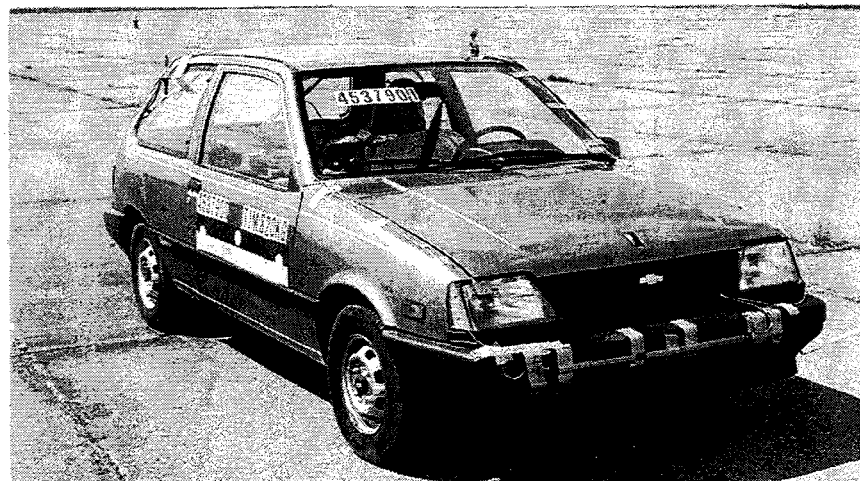
Figure 30. Vehicle and Sign Support for Test No. 453790-1

The portable sign support separated upon impact, as can be seen in Figure 30. Fragments of the sign were strewn along the path of the vehicle in an area 5.5 m wide by 19.3 m long. Figure 30 shows damage to the vehicle. There was no measurable crush to the exterior of the vehicle, only scratches on the hood and on the roof where the flags made contact.

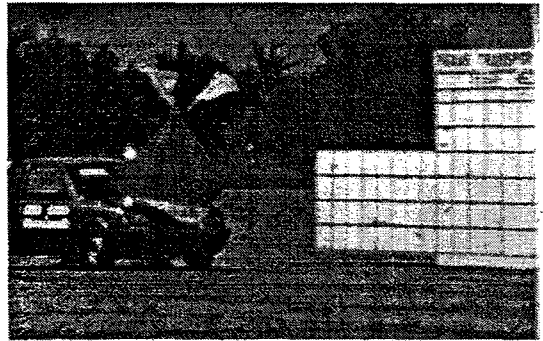
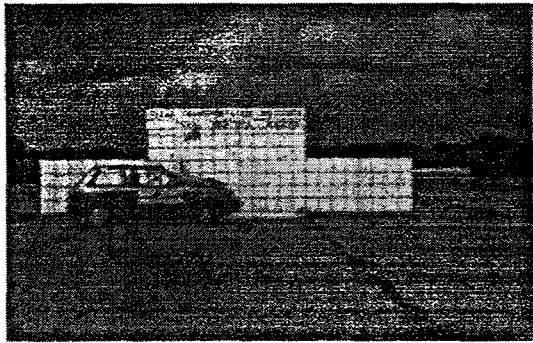
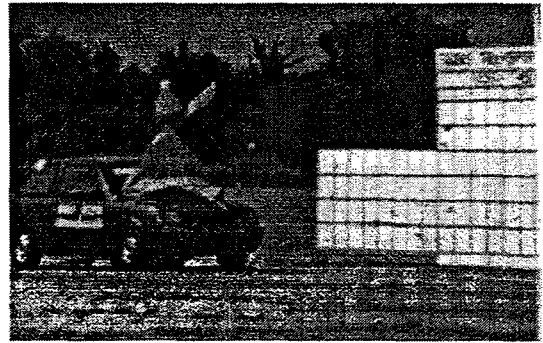
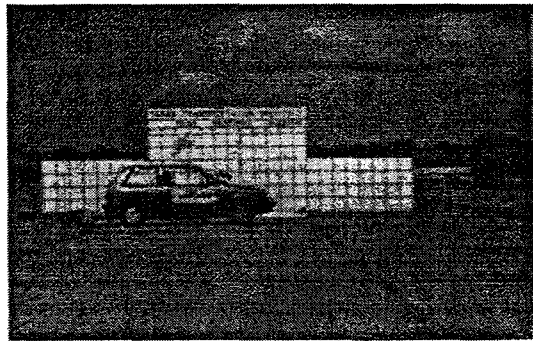
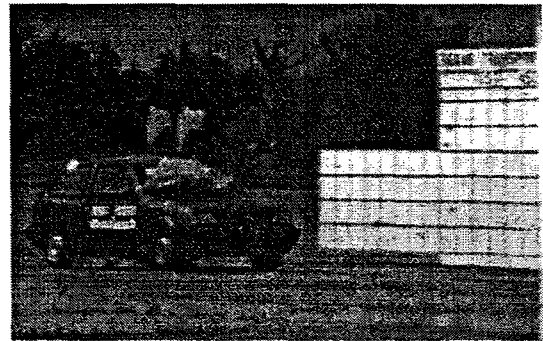
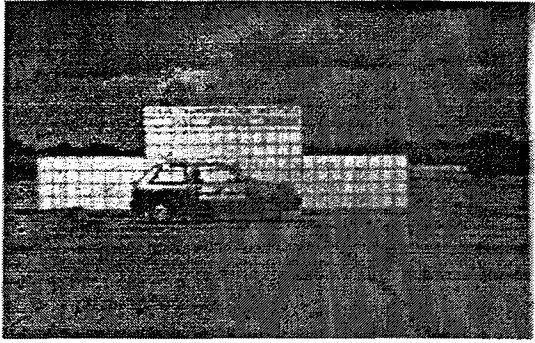
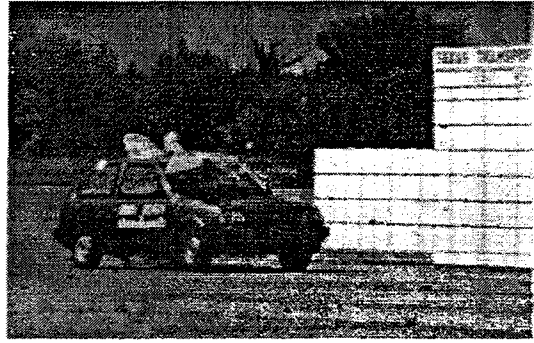
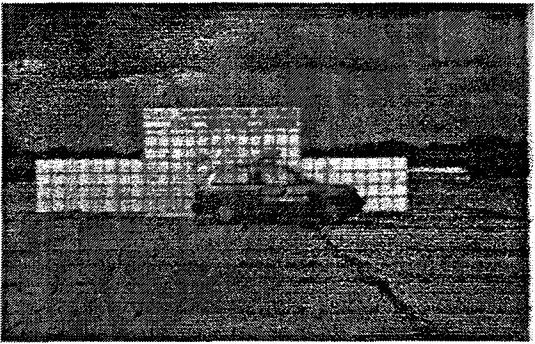
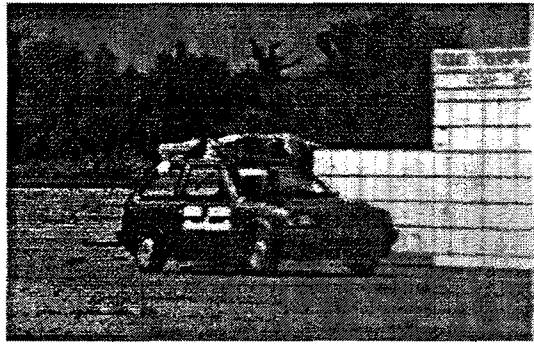
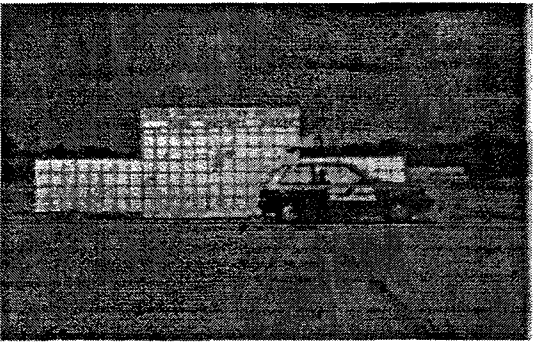
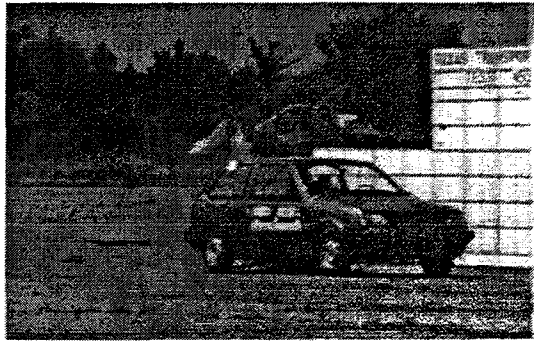
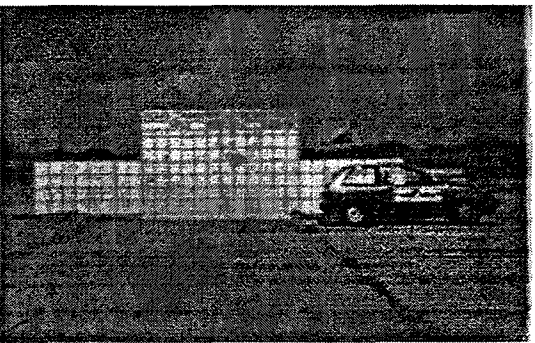
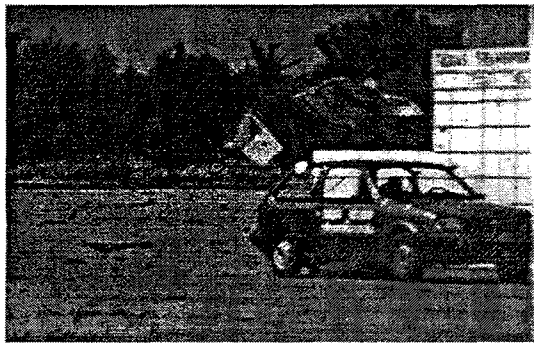
Figure 31. Sequential Photographs for Test No. 453790-1

As the vehicle impacted the portable sign support, the upper portion of the sign separated from the base, and the plastic/fabric sign panel formed to the front of the vehicle. The plastic/fabric sign panel and reinforcement strips contacted the windshield at 50 msec and 69 msec, respectively. At 100 msec, the flags contacted the roof of the vehicle and separated from the sign panel. At 221 msec, the vehicle cleared the installation site traveling at a speed of 95.8 km/h. Prior to brake application, the vehicle was tracking straightforward. The vehicle subsequently came to rest 102 m down and 1.7 m to the right of the point of impact. Figure 31 shows sequential photographs of the test period.

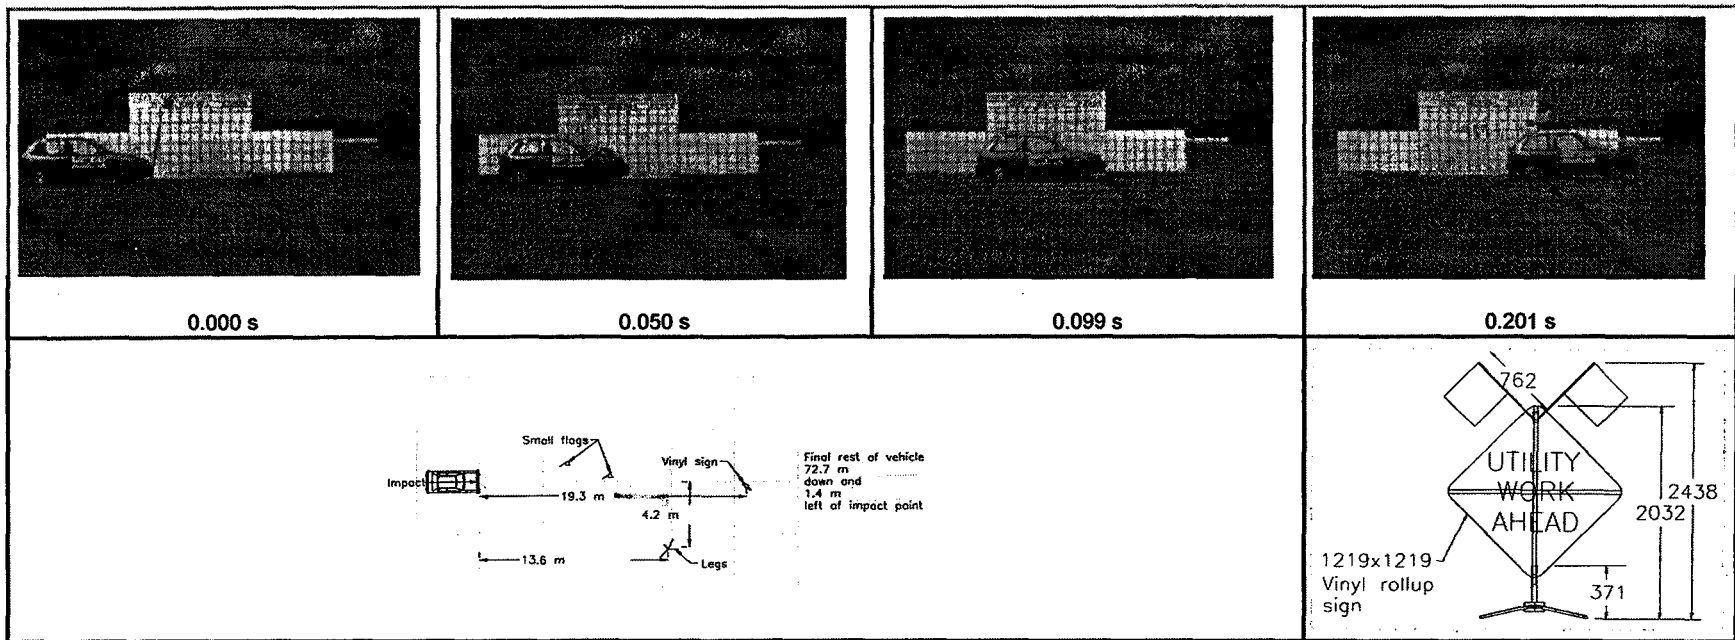
Figure 32. Summary of Results for Test No. 453790-1

Figure 32 presents a brief summary of the results of this test. The portable sign support shattered upon impact. Fragments of the plastic/fabric sign panel and the sign support made contact with the roof, but there was no penetration or intrusion into the occupant compartment. Debris from the sign was thrown along an area 5.5 m wide by 19.3 m long. The fragments were not large enough to pose potential hazard to oncoming traffic in adjacent lanes or to workers in the area. The vehicle sustained minor scratches to the hood and roof. There was no measurable crush to the exterior of the vehicle. There was no longitudinal or lateral occupant impact. The 50-msec average accelerations were -0.6 g in the longitudinal direction and -0.4 g in the lateral direction. The vehicle exited the immediate test site in a relatively smooth, stable manner and showed no potential for intrusion into adjacent traffic lanes.

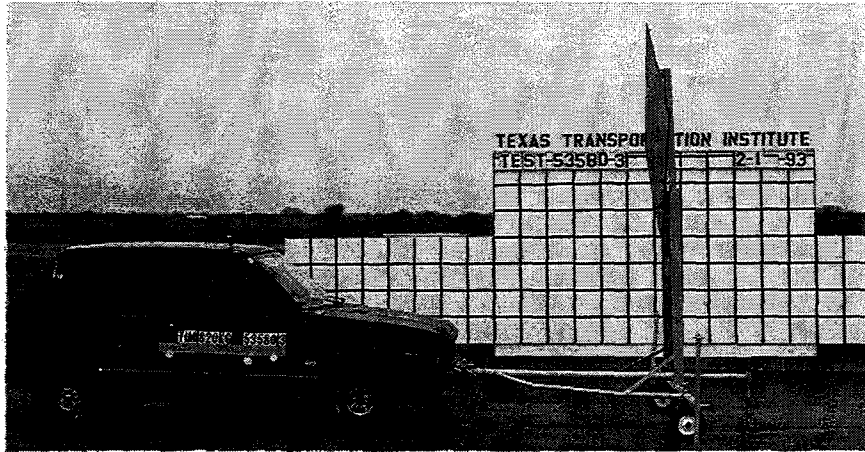
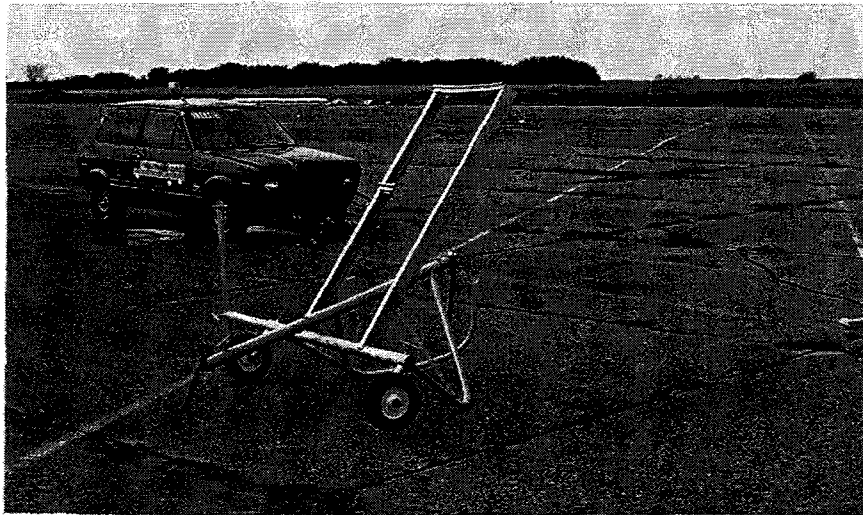
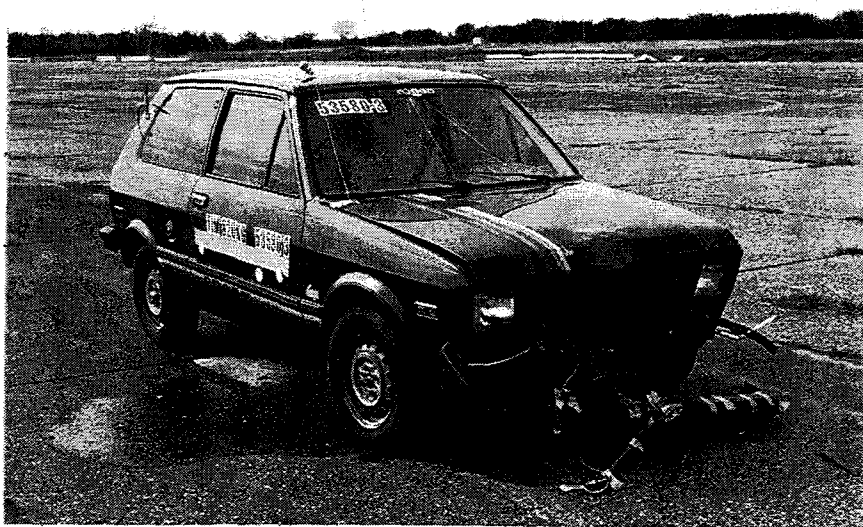
Figure 34. Vehicle and Sign Trailer for Test No. 453580-3

As Figure 34 shows, the sign panel and support separated from the trailer upon impact. The sign panel and upper support structure came to rest 2 m down and 4 m to the left side of the vehicle path. The sign support trailer came to rest 106 m down and 3 m to the right of the point of impact with a fragment 3.4 m west of the trailer. The trailer was deformed and some of the welds broken. As Figure 34 also shows, the vehicle sustained moderate damage to the front. The maximum crush at bumper height was 330 mm. The windshield was cracked starting at the edge of the roof near the center. There were also two dents in the roof, the deepest approximately 8 mm. There were dents and scratches on the hood and the bumper, and the grill and radiator were damaged.

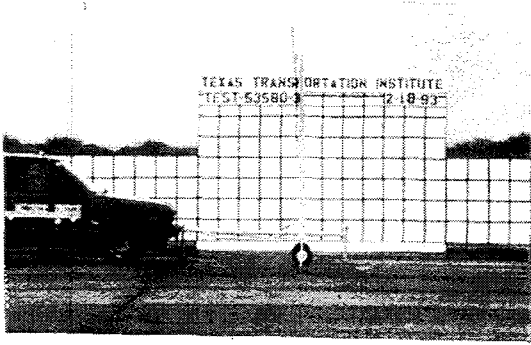
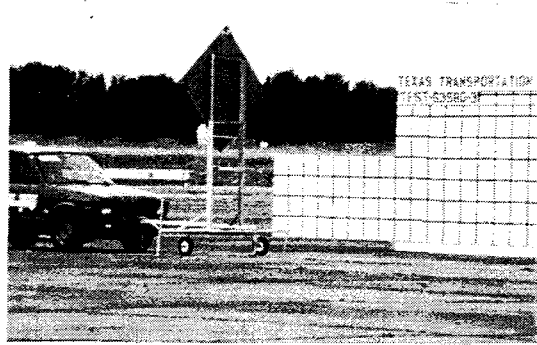
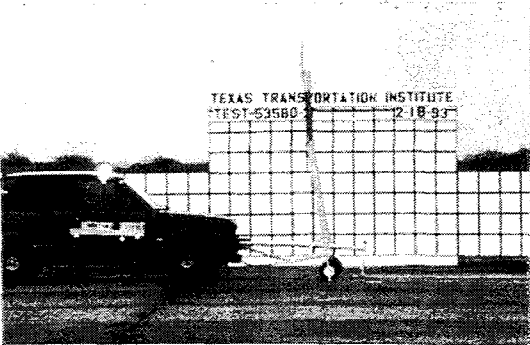
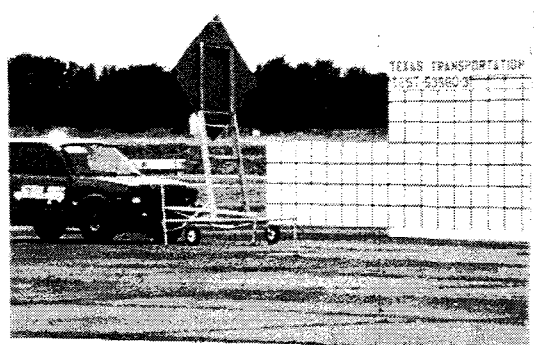
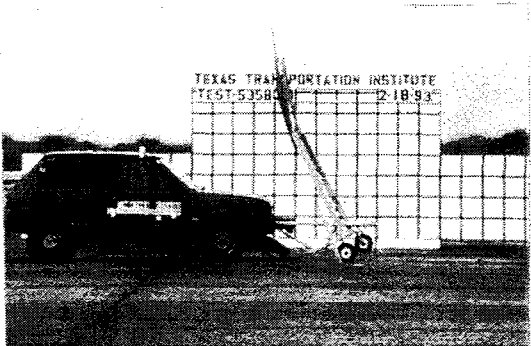
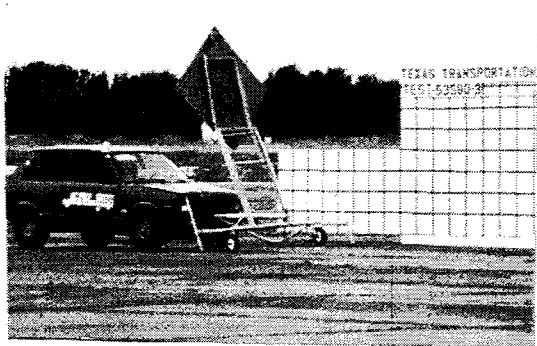
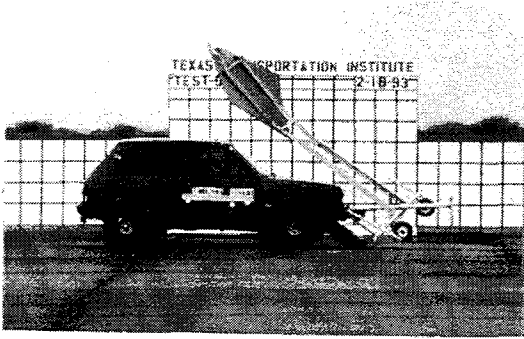
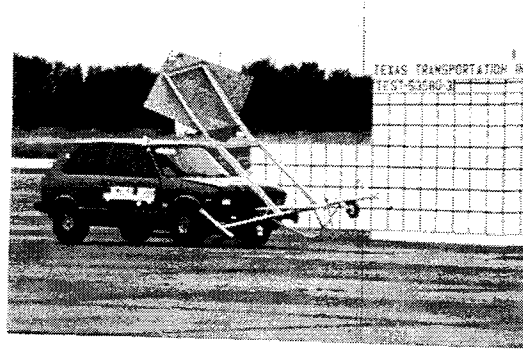
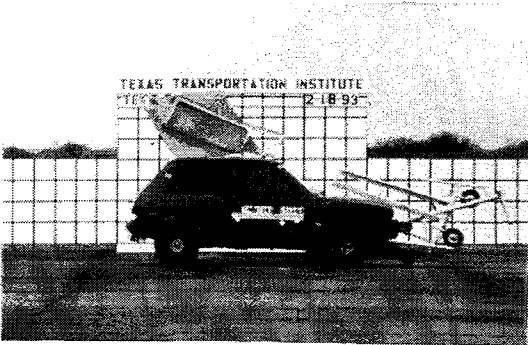
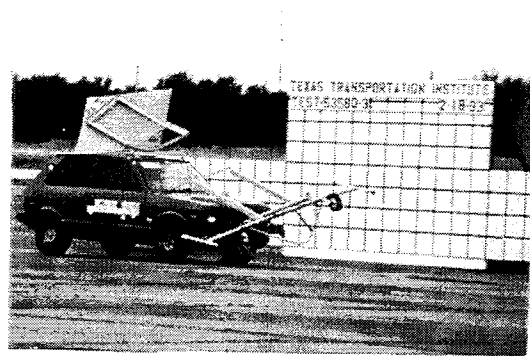
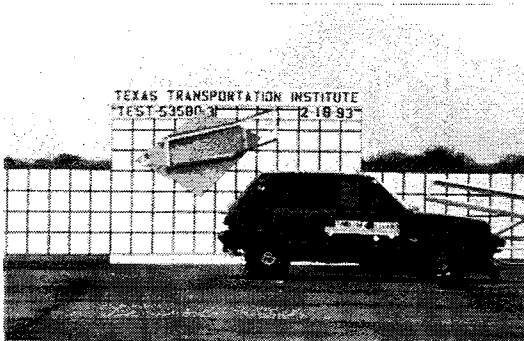
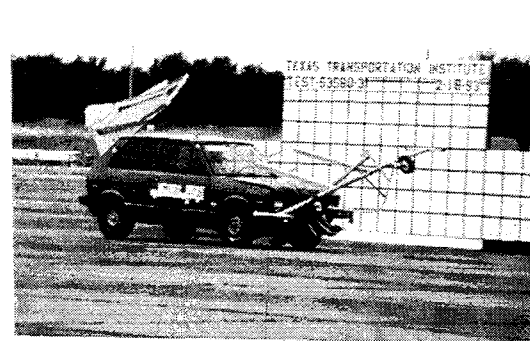
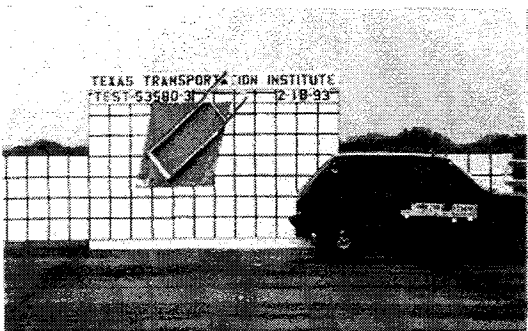
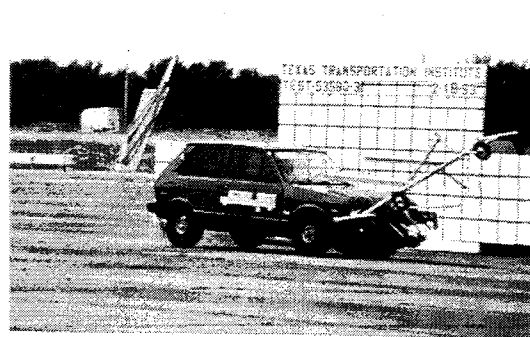
Figure 35. Sequential Photographs for Test No. 453580-3

m down and 2 m to the west of the point of impact. The trailer continued another 7 m forward before coming to rest. Figure 35 shows sequential photographs of the test period.

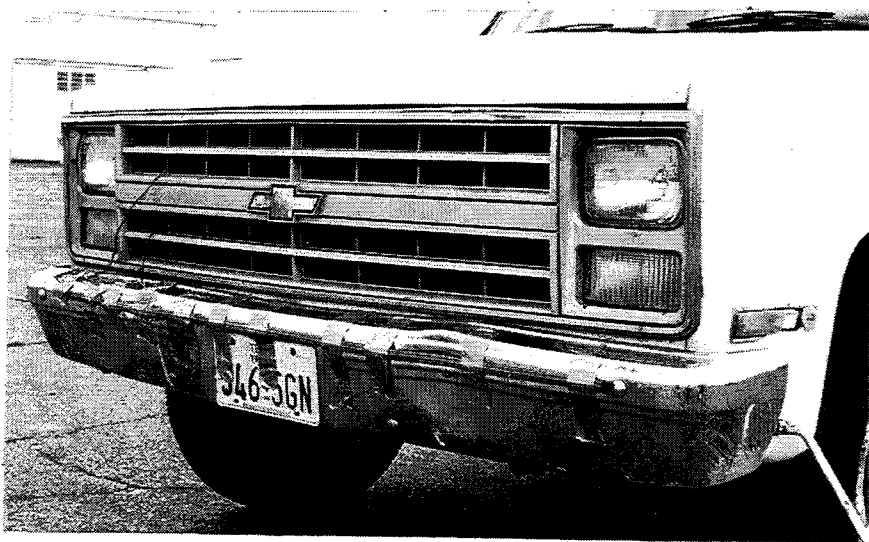
Figure 38. Vehicle and Sign Support for Test No. 453360-3

As Figure 38 shows, the skid-mounted sign support fractured upon impact. Debris and sand were strewn along the path of the vehicle in an area 9 m wide by 59 m long. Figure 38 also shows damage to the vehicle. There were two dents in the bumper, 13 mm and 19 mm, from impact with the supports. There was a small dent in the rear of the roof of the cab.
