1. Report No. TX-96/5388-1F		2. Government Accession No.		3. Recipient's Catalog No.	
4. Title and Subtitle EVALUATION OF WORK ZONE BARRICADES AND TEMPORARY SIGN SUPPORTS				5. Report Date February 1996

EVALUATION OF WORK ZONE BARRICADES AND TEMPORARY SIGN SUPPORTS

Report No. 5388-1F
Research Study No. 585xxA3014
Research Study Title: Development of New Designs for Barricades
and Sign Supports in Work Zones

February 1996

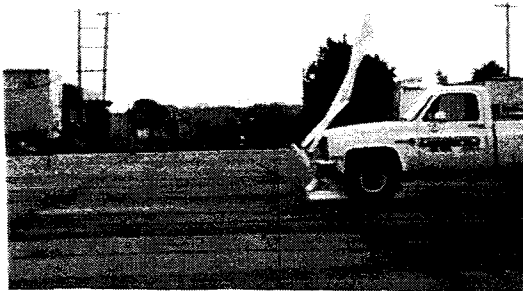
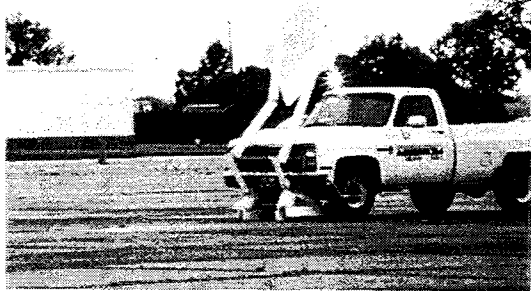
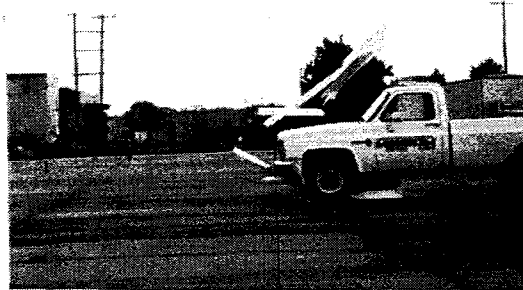
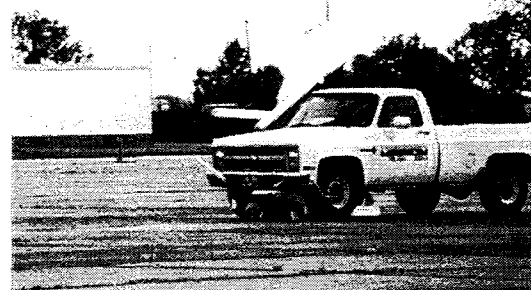
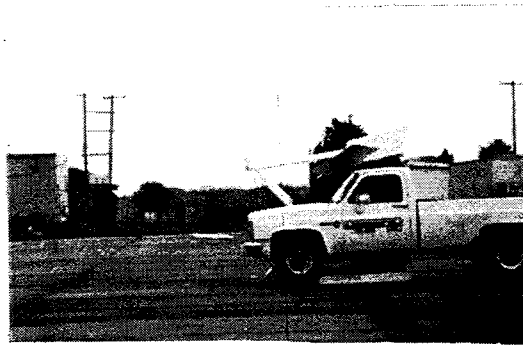
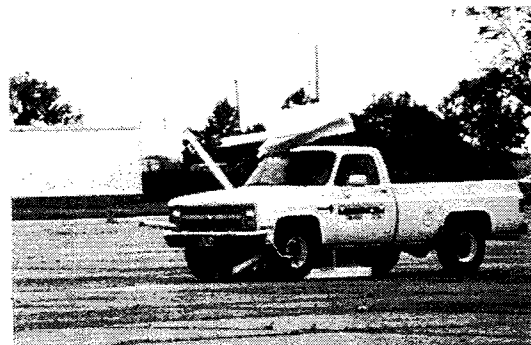
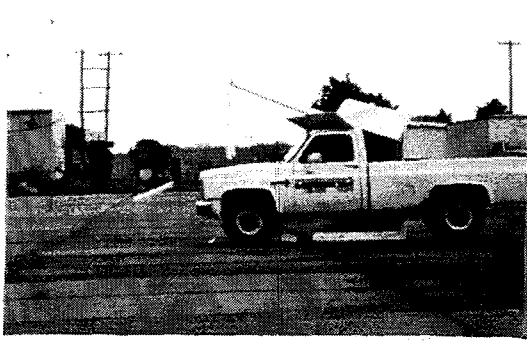
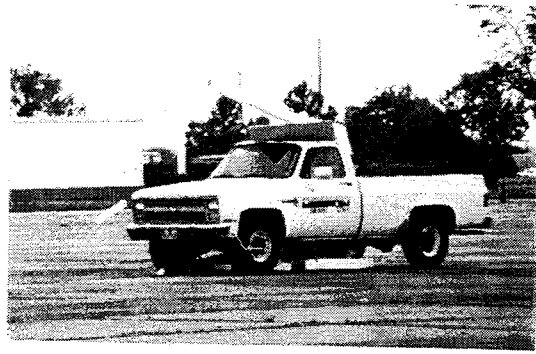
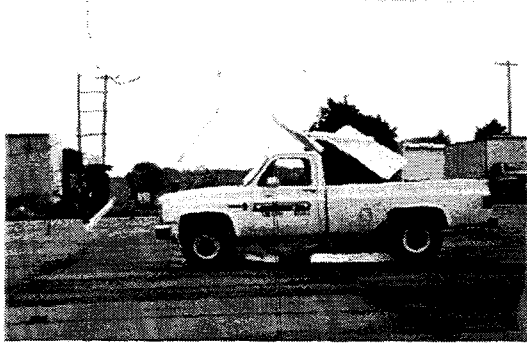
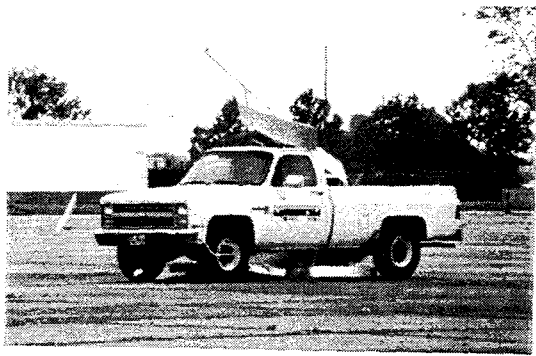
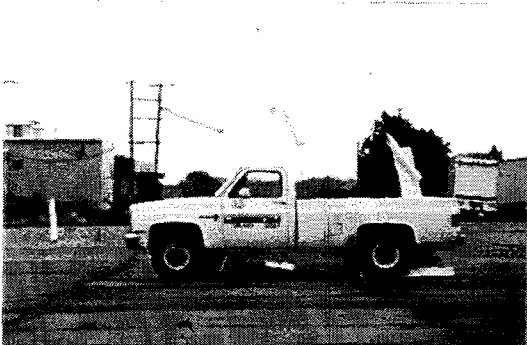
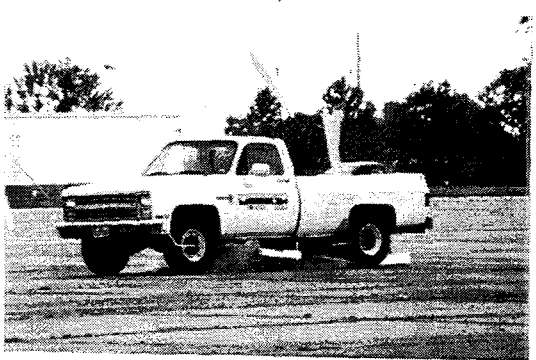
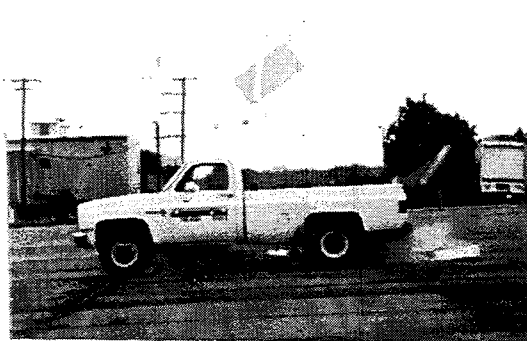
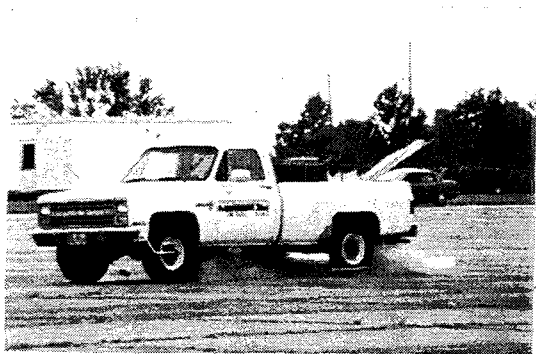
Figure 39. Sequential Photographs for Test No. 453360-3

Immediately upon impact, the vertical supports began to fracture at bumper height and approximately 1.8 m above ground level. The panel and pieces of the support rose up and over the hood of the pickup, while the pickup traveled over the bases. A broken segment of the support then struck the roof near the rear of the cab at 79 msec and bounced off at 126 msec. Pieces of the support continued over the pickup with several pieces landing in the bed of the pickup. The time at loss of contact with the sign support, i.e., when the fractured support ended contact with the vehicle, was 126 msec, and the vehicle had slowed to 91.4 km/h. After the vehicle cleared the immediate test site, brakes on the vehicle were applied at 950 msec after impact. Prior to brake application, the test vehicle was traveling on a relatively straightforward path. The vehicle subsequently came to rest 133 m down and 4 m to the left of the point of impact. Figure 39 shows sequential photographs of the test period.

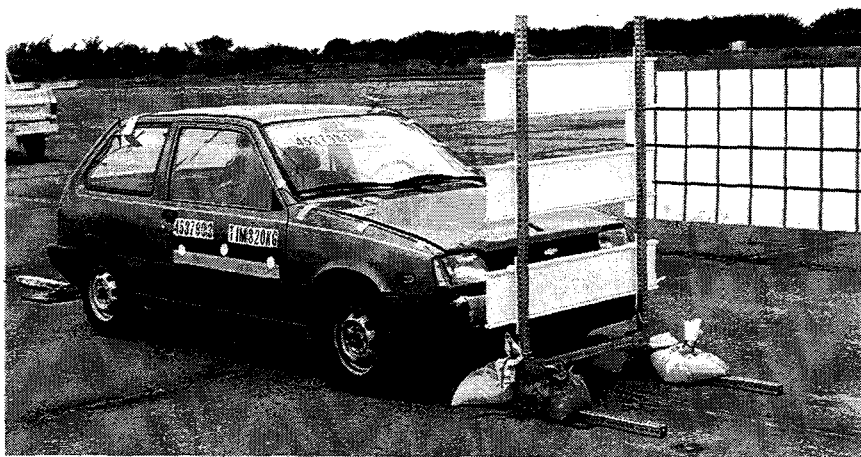
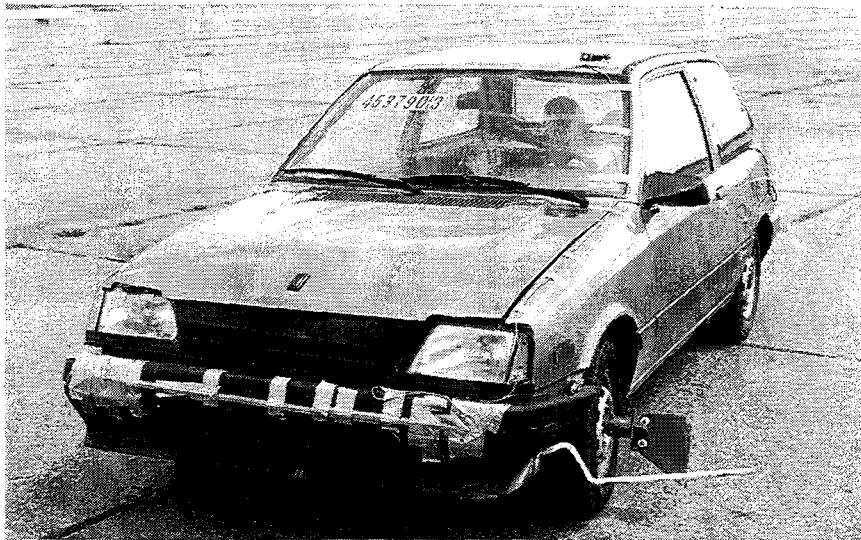
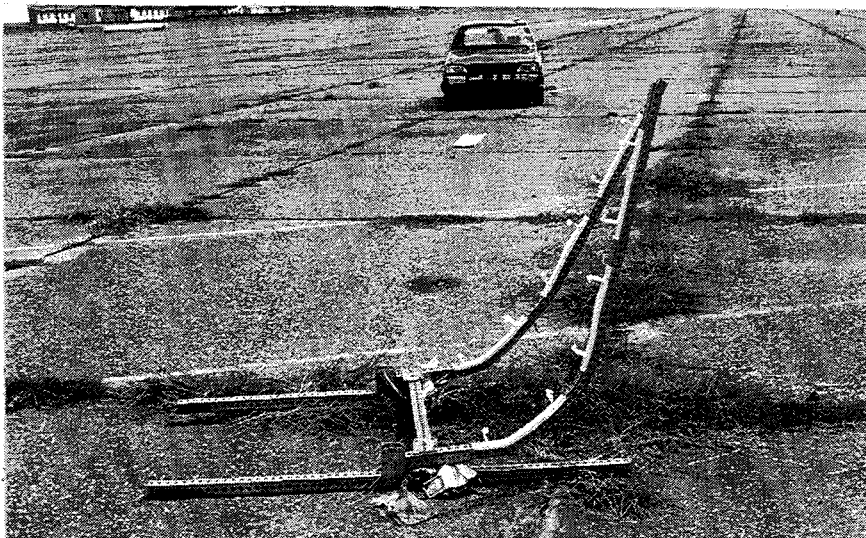
Figure 46. Vehicle and Barricade for Test No. 453790-3

As Figure 46 shows, the plastic rail elements separated from the vertical supports upon impact. The shear pins for the vertical supports sheared as designed, but the impact speed was too high for the vertical supports to fold down. Instead, the vertical supports wrapped around the front the vehicle and stayed with the vehicle until final rest. Debris and sand were strewn along the path of the vehicle in an area 11 m wide by 109 m long. Figure 46 shows damage to the vehicle. The bumper, grill, and hood were dented and scratched. The windshield was cracked; however, no penetration or intrusion of the occupant compartment occurred. Maximum crush to the exterior of the vehicle at the left front corner of the bumper was 70 mm.

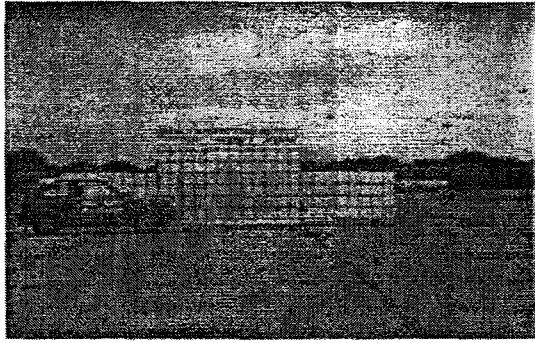
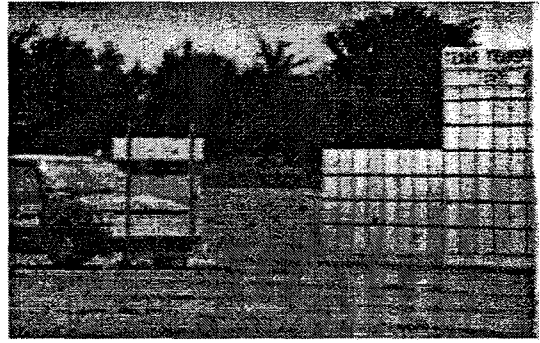
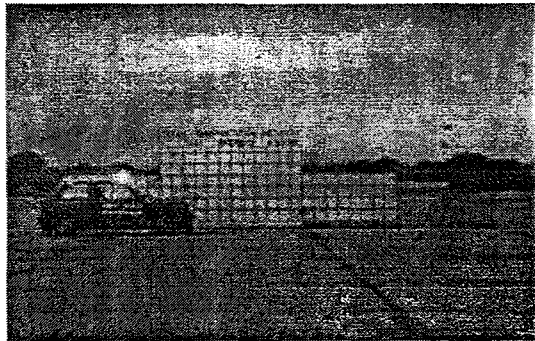
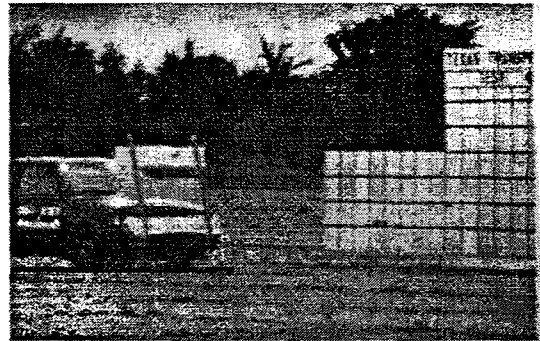
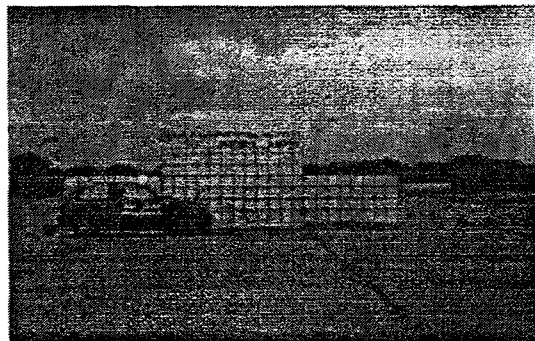
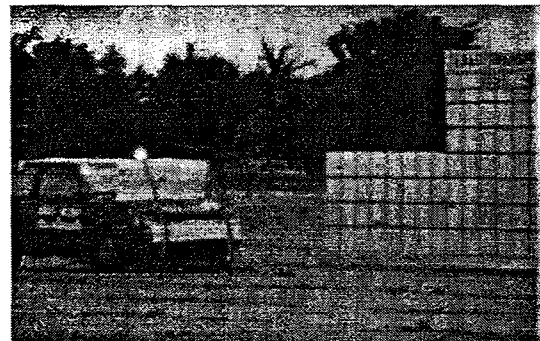
As the vehicle impacted the vertical supports, the middle and upper plastic rail elements separated from the vertical supports. The lower plastic rail element and vertical supports deformed and wrapped around the front of the vehicle. Windshield contact by the middle plastic rail element occurred at 42 msec and with the upper rail element at 54 msec. The vehicle lost contact with the barricade at 69 msec, traveling at a speed of 95.2 km/h. Prior to brake application, the vehicle was tracking straightforward. The vehicle subsequently came to rest 91.7 m down and 7.9 m to the left of the point of impact. Figure 47 shows sequential photographs of the test period.

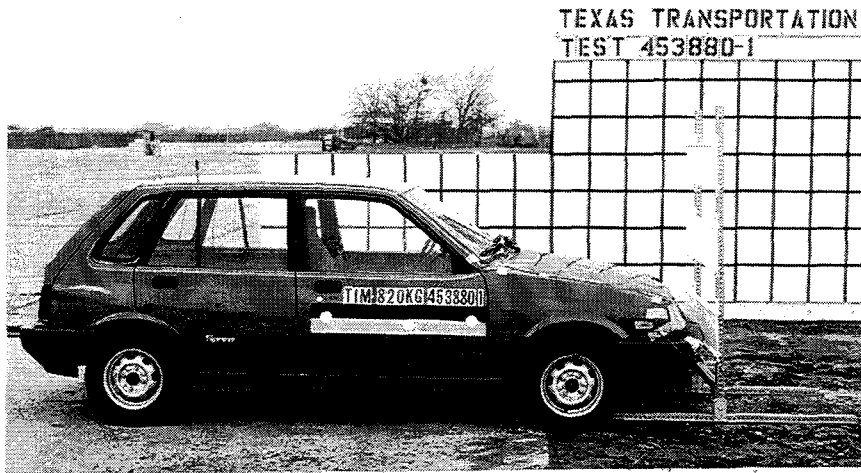
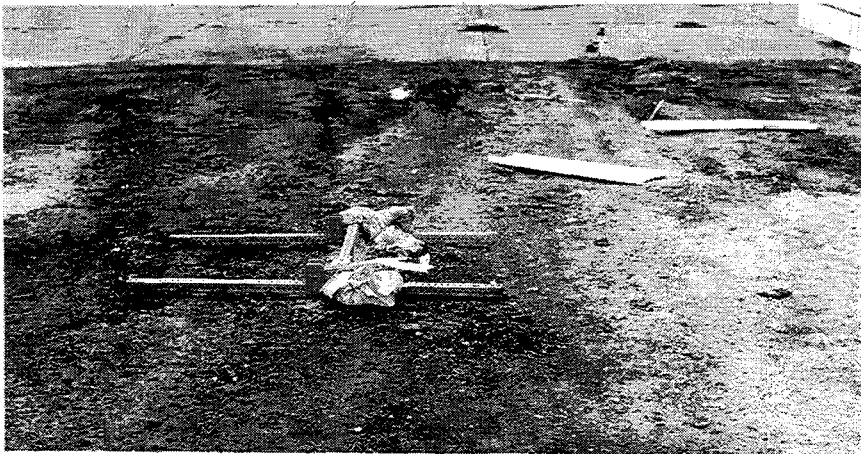
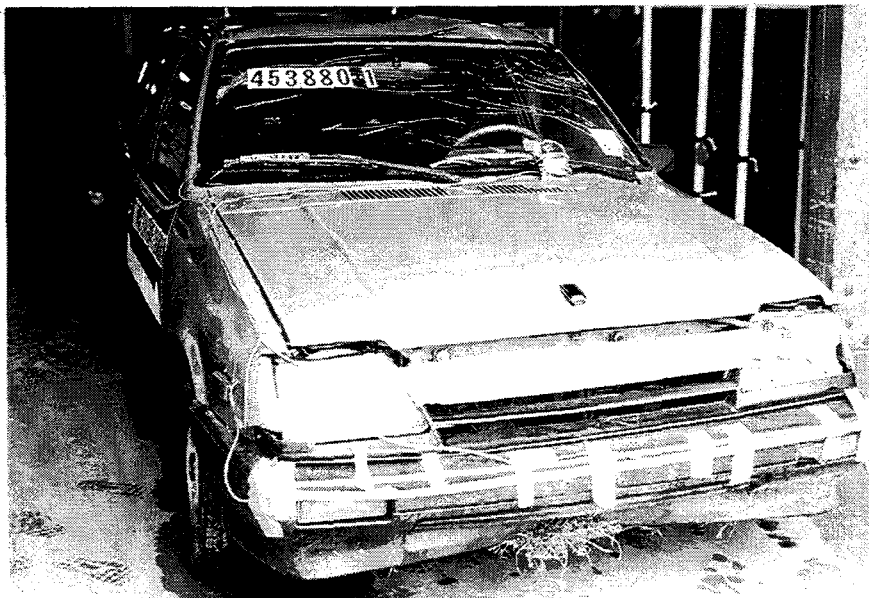
Figure 50. Vehicle and Barricade for Test No. 453880-1

As Figure 50 shows, the plastic rail elements separated from the barricade upon impact, and the barricade came apart subsequently. Debris and sand were strewn along the path of the vehicle in an area 12.6 m wide by 121 m long. Damage to the vehicle is also shown in Figure 50. There were three dents in the roof from impact with the plastic rail elements, and the windshield was cracked. A vertical support made a cut on the roof 15 mm deep and 55 mm long just above the windshield on the driver's side. There were scratches along the hood.

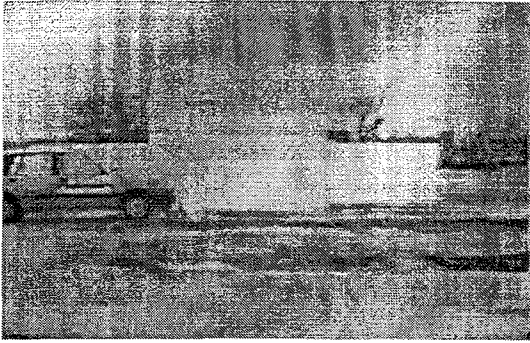
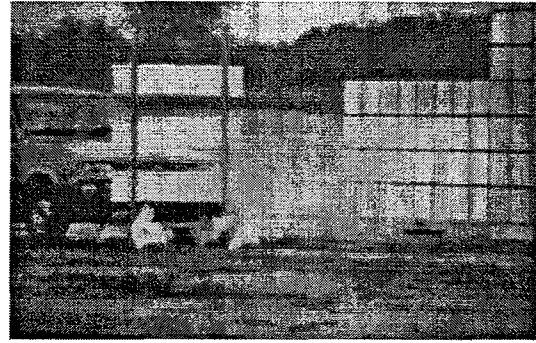
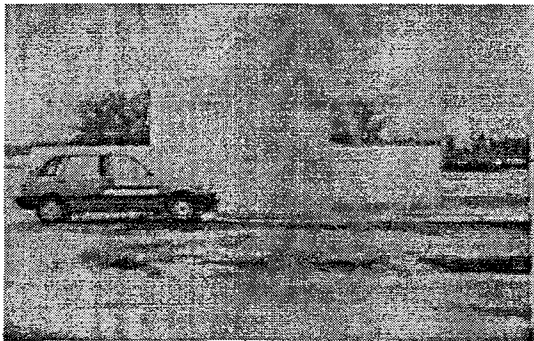
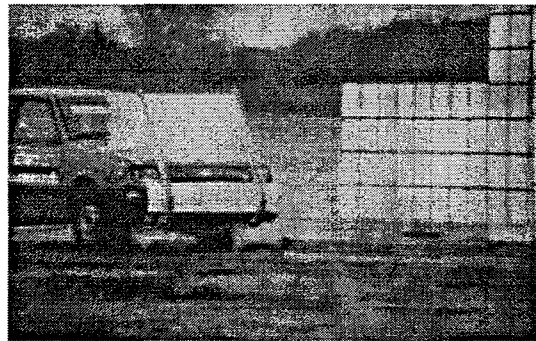
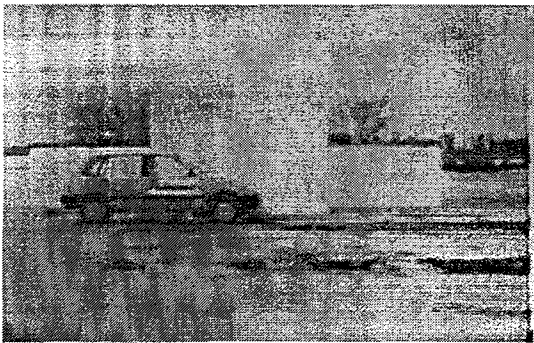
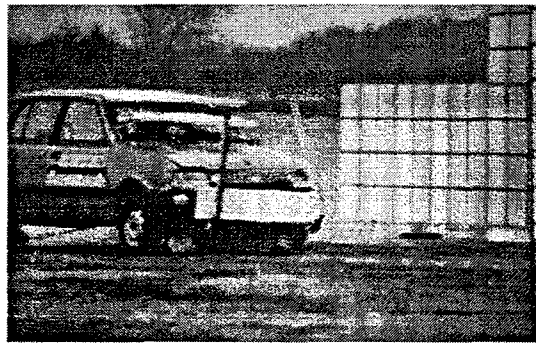
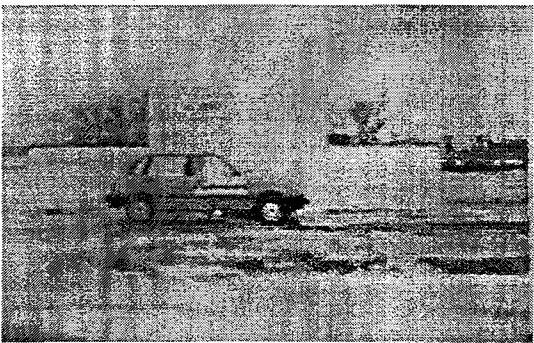
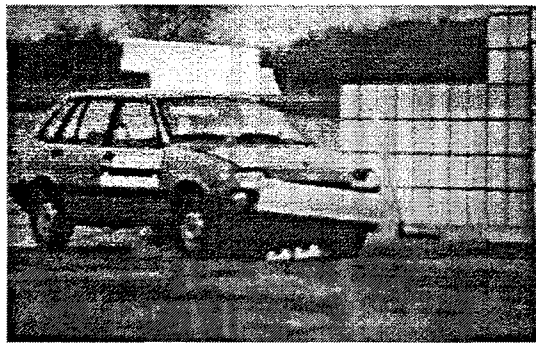
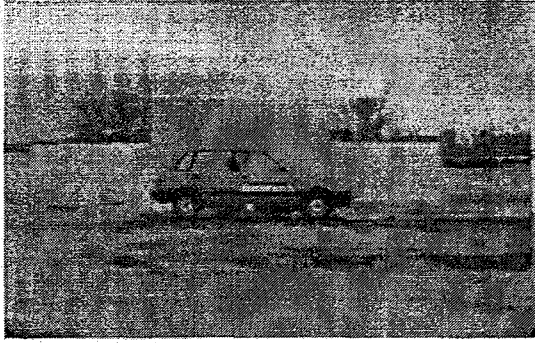
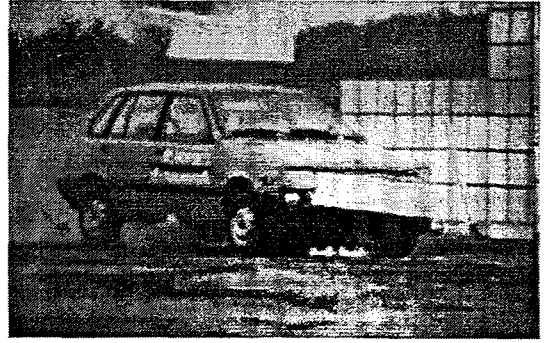
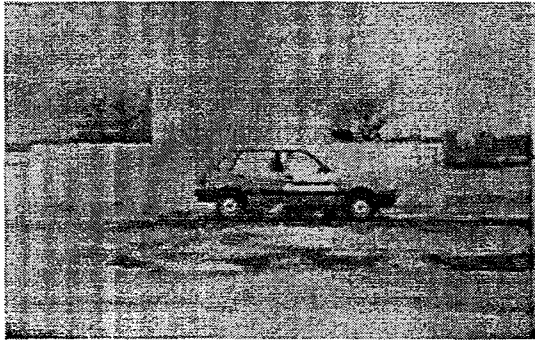
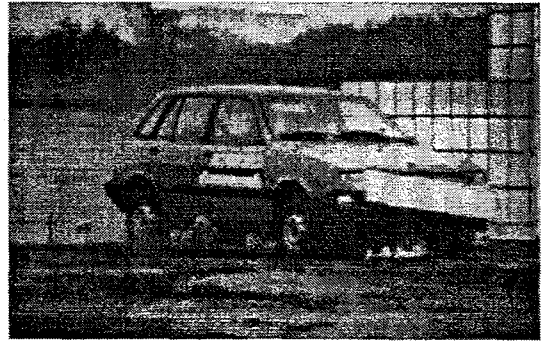
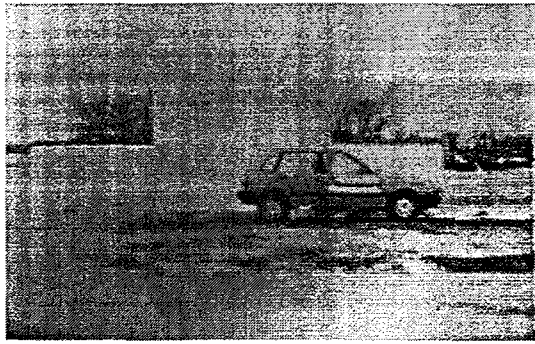
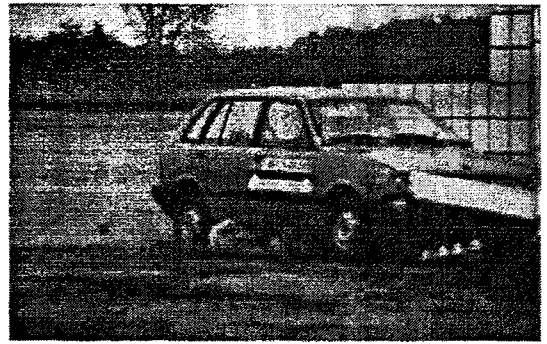
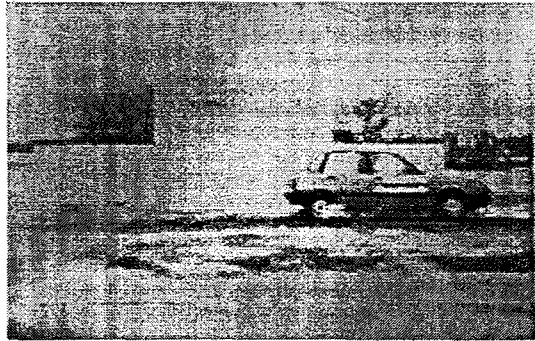
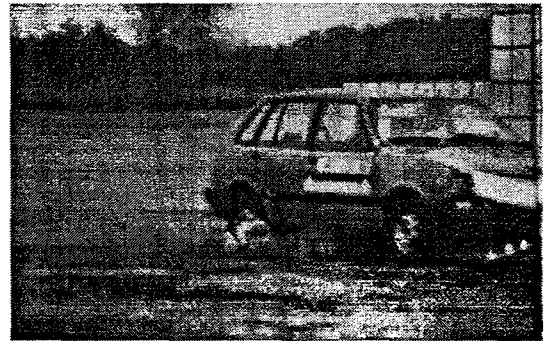
Figure 51. Sequential Photographs for Test No. 453880-1

the installation site traveling at a speed of 92.2 km/h. Prior to brake application, the vehicle was tracking straightforward. The vehicle subsequently came to rest 123 m down and 7.6 m to the left of the point of impact. Figure 51 shows sequential photographs of the test period.

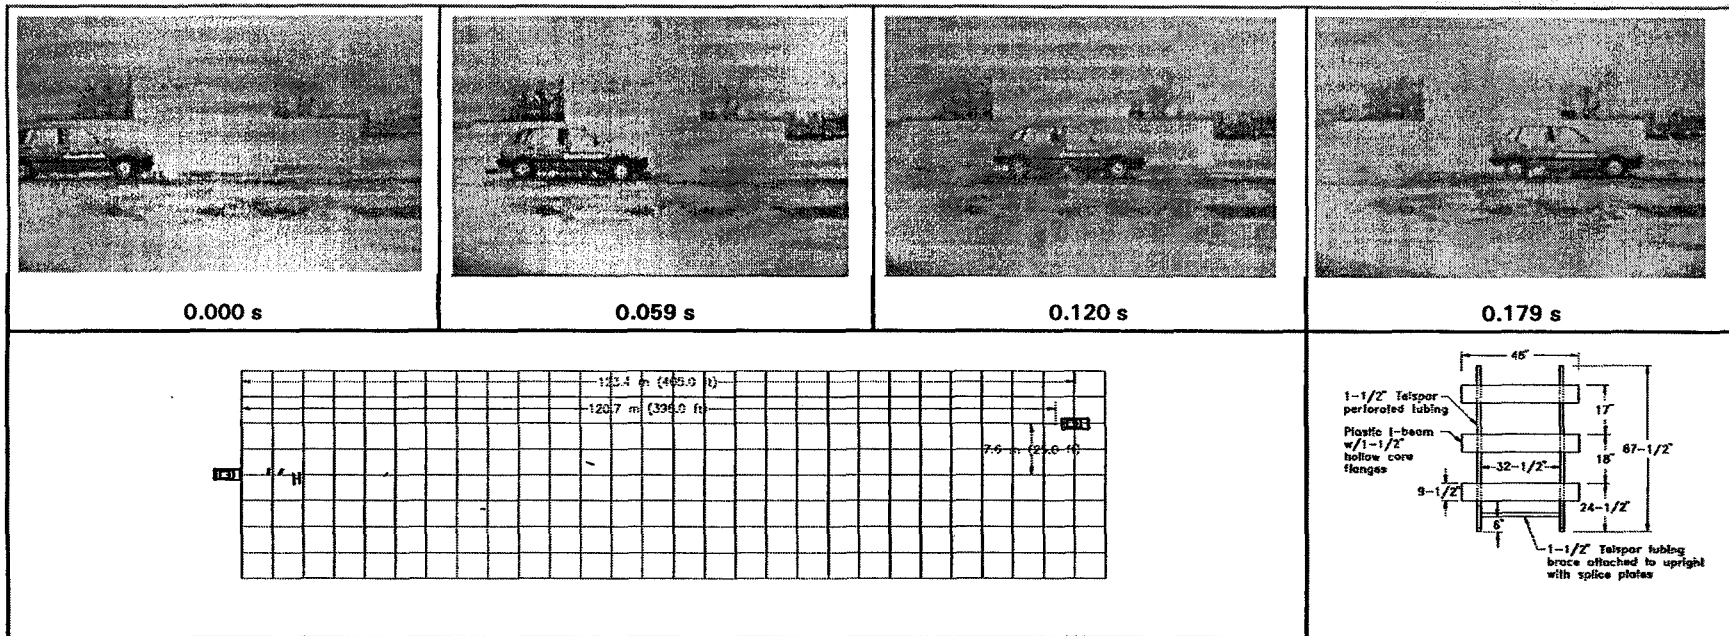
Figure 52. Summary of Results for Test No. 453880-1

Figure 52 presents a brief summary of the results of this test. The barricade came apart upon impact, and the broken segments contacted the hood, windshield, and roof of the vehicle. However, there was no penetration or intrusion into the occupant compartment. Sand and fragments of the barricade were scattered along an area 12.6 m wide by 121 m long. Most fragments were not large enough to pose potential hazard to oncoming traffic in adjacent lanes; however, the metal tubing from the vertical support could pose a hazard to workers in the area. The vehicle sustained minor damage to the hood and windshield, with a small cut in the roof. The longitudinal occupant impact velocity was 1.9 m/s and the highest 10-msec average ridedown acceleration was -2.7 g. The lateral occupant impact velocity was 1.0 m/s and the highest 10-msec average ridedown acceleration was -3.6 g. The 50-msec average accelerations were -3.3 g in the longitudinal direction and -0.8 g in the lateral direction. The vehicle exited the immediate test site in a relatively smooth, stable manner and showed no potential for intrusion into adjacent traffic lanes.

General Information		Impact Conditions		Test Article Deflections (m)	
Test Agency	Texas Transportation Institute	Speed (km/h)	100.5 (62.5 mi/h)	Thrown Forward	120.7 (396.0 ft)
Test No.	453880-1	Angle (deg)	0	Thrown Laterally	7.6 (25.0 ft)
Date	02/07/95	Exit Conditions		Vehicle Damage	
Test Article		Speed (km/h)	92.2 (57.3 mi/h)	Exterior	
Type	Type III Barricade	Angle (deg)	0	VDS	12FD1
Name or Manufacturer	Traffix-RAIL	Occupant Risk Values		CDC	12FDEW1
Installation Length (m)	1.2 m (4.0 ft)	Impact Velocity (m/s)		Interior	
Size and/or dimension and material of key elements	Plastic panels on 38 mm (1.5 in) Telspar perforated tubing	x-direction	1.9 (6.2 ft/s)	OCDI	FS0000000
Soil Type and Condition	Strong soil, wet	THIV (optional)		Maximum Exterior	
Test Vehicle		Ridedown Accelerations (g's)		Vehicle Crush (mm)	15 (0.6 in)
Type	Production	x-direction	-2.7	Max. Occ. Compart. Deformation (mm)	0
Designation	820C	y-direction	-3.6	Post-Impact Behavior

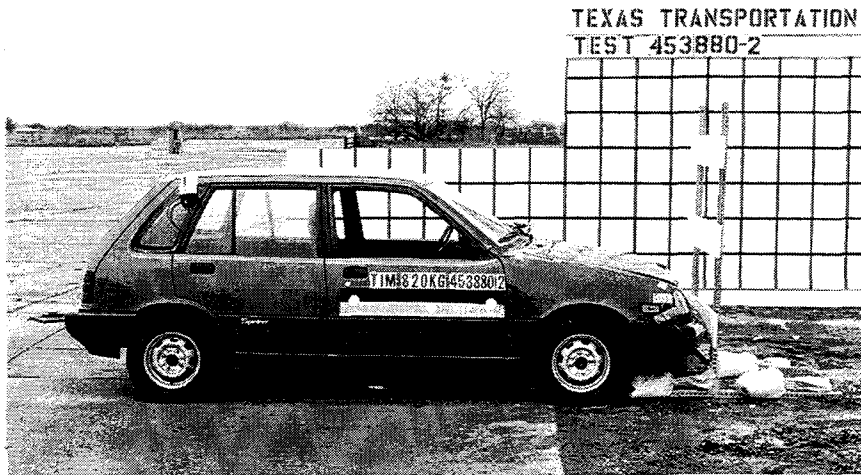
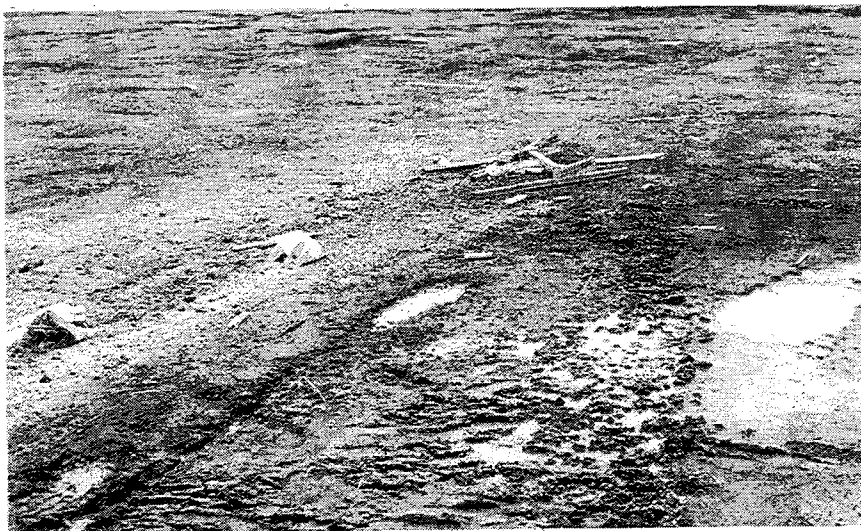
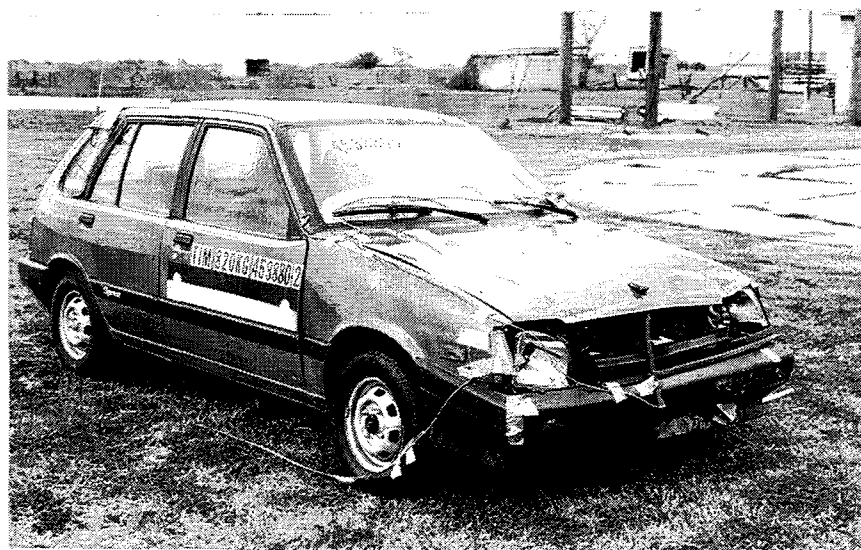
Figure 54. Vehicle and Barricade for Test No. 453880-2

As Figure 54 shows, the barricade shattered upon impact. Debris and sand were strewn along the path of the vehicle in an area 11 m wide by 46 m long. Figure 54 shows damage to the vehicle. There were dents and scratches along the bumper, grill, and hood, and the left rear tire was flat.

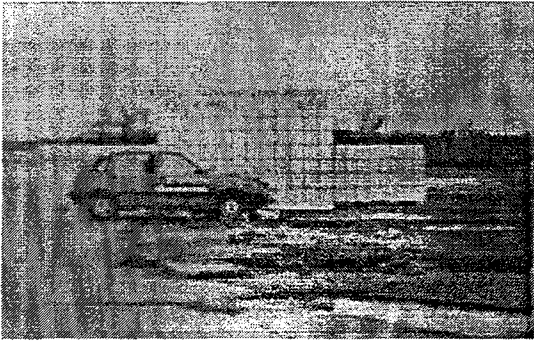
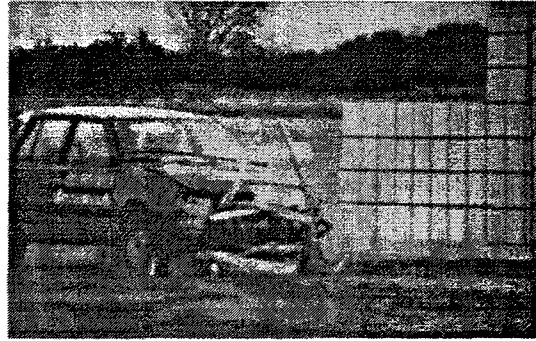
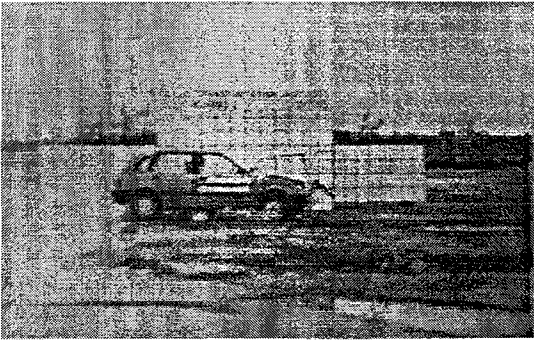
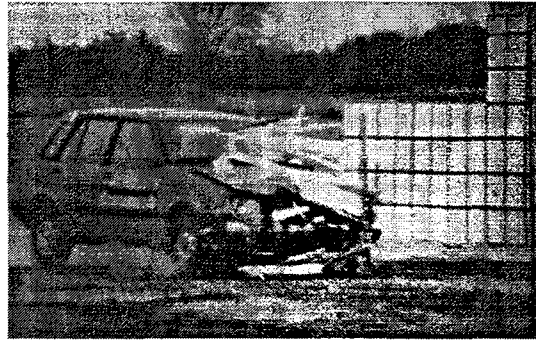
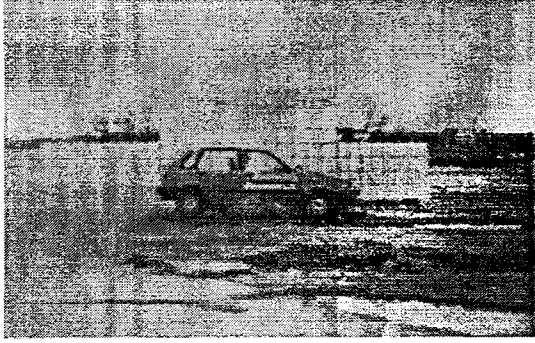
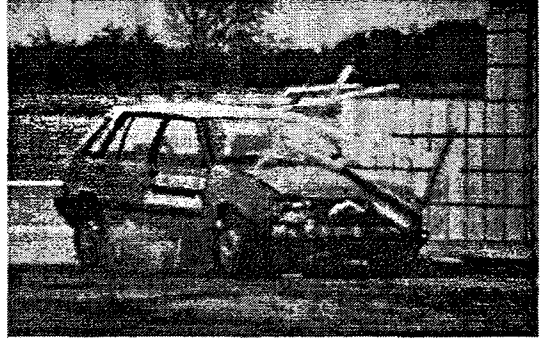
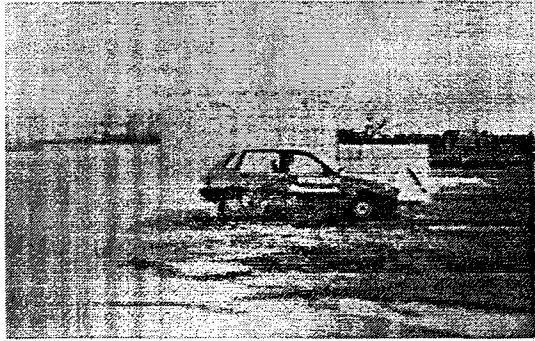
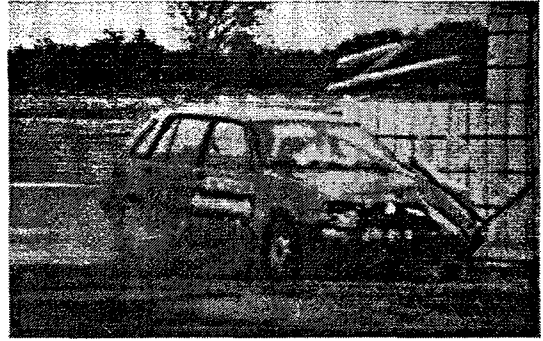
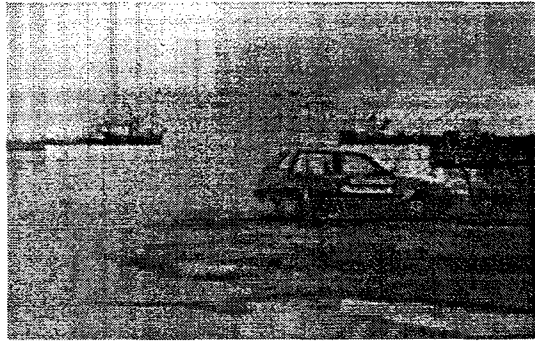
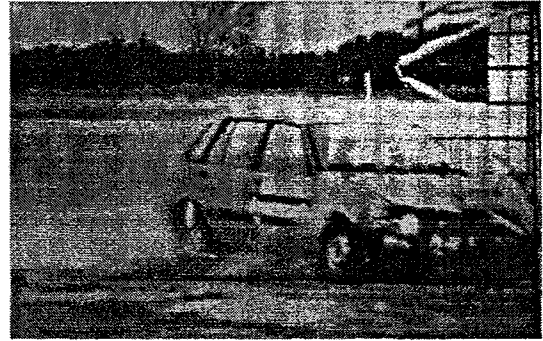
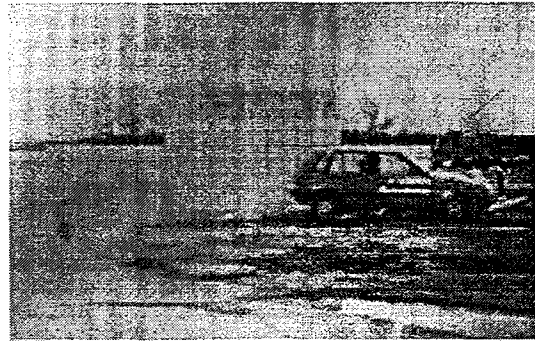
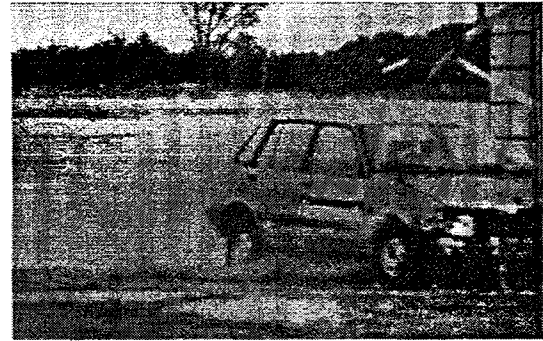
Figure 55. Sequential Photographs for Test No. 453880-2

at bumper height. The top wooden rail element contacted the hood of the vehicle at 38 msec. At 46 msec, the right vertical support separated from the rail element and became airborne while the vehicle was traveling at a speed of 93.4 km/h. The left vertical support rode along the front of the vehicle and lost contact with the vehicle at 176 msec as the vehicle had slowed to 92.5 km/h. Prior to brake application, the vehicle was tracking straight-forward. The vehicle subsequently came to rest 116 m down and 6.7 m left of the point of impact. Figure 55 shows sequential photographs of the test period.

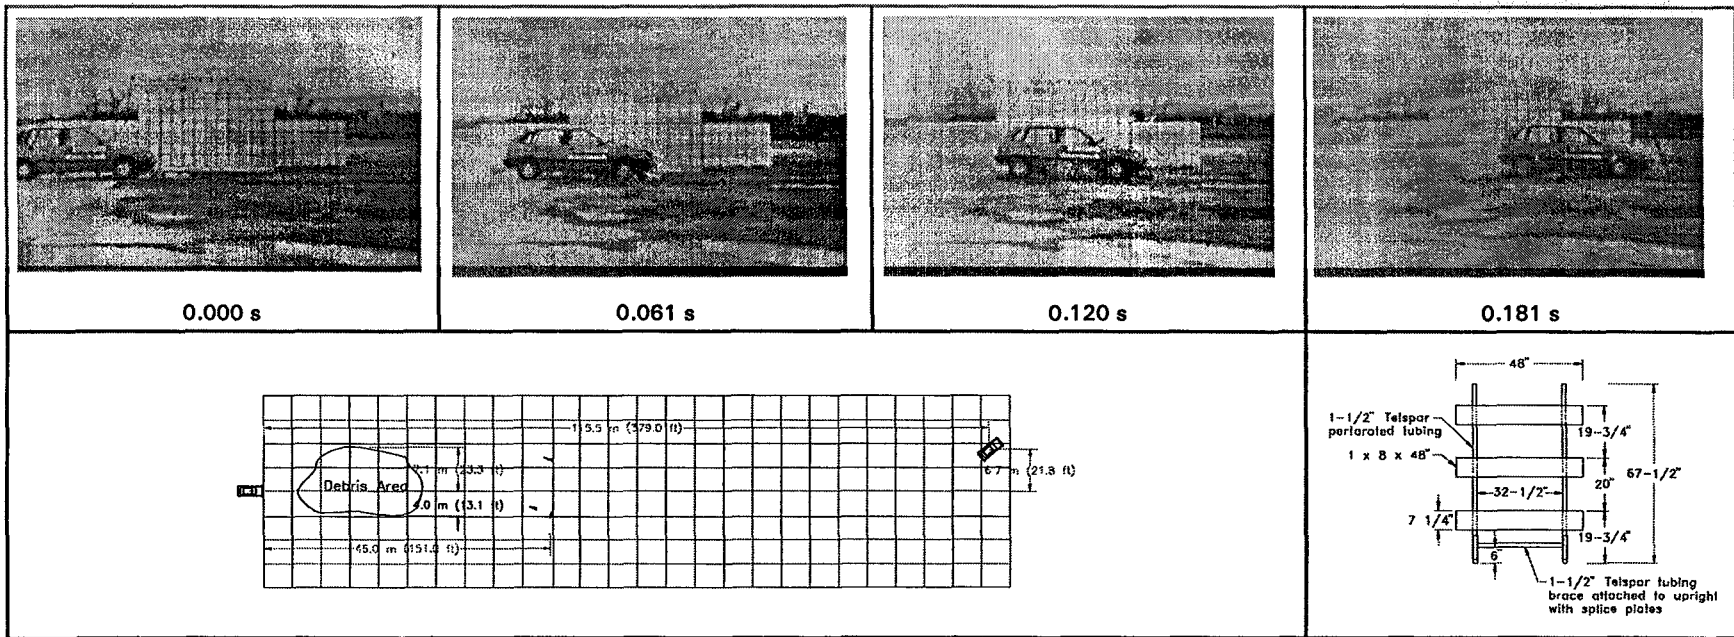
Figure 56. Summary of Results for Test No. 453880-2

A brief summary of the results of this test is presented in Figure 56. The barricade shattered upon impact and broken segments of the barricade made contact with the hood but did not penetrate the occupant compartment. Debris from the barricade was thrown along an area 11 m wide by 46 m long. Most fragments were not large enough to pose potential hazard to oncoming traffic in adjacent lanes. The fractured metal vertical supports could cause minor hazard to workers in the area. The vehicle sustained minor damage to the bumper, grill, and hood. There was no penetration or intrusion into the occupant compartment. The longitudinal occupant impact velocity was 2.3 m/s, and the highest 10-msec average ridedown acceleration was -1.8 g. There was no lateral occupant contact. The 50-msec average accelerations were -3.5 g in the longitudinal direction and 0.7 g in the lateral direction. The vehicle exited the immediate test site in a relatively smooth, stable manner and showed no potential for intrusion into adjacent traffic lanes.

In summary, the Type III barricade fabricated from perforated tubing with wooden rail elements tested with wet soil condition was also judged to have met all evaluation criteria set forth in NCHRP Report 350.

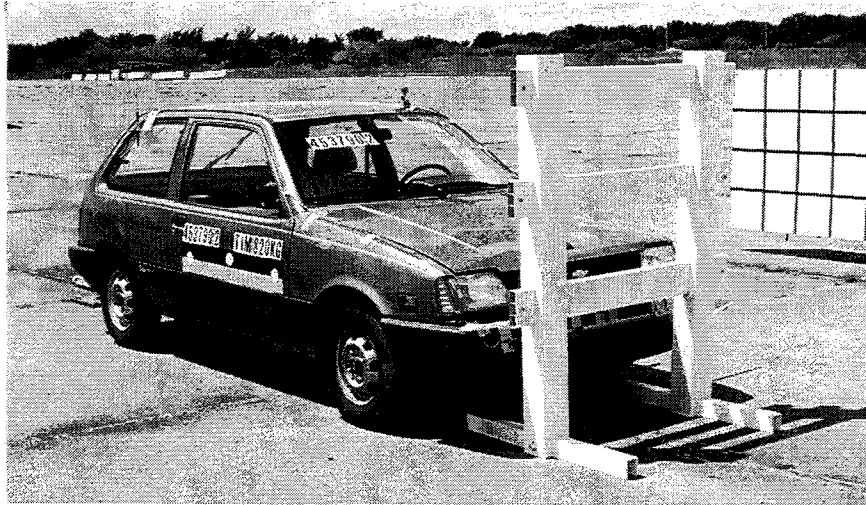
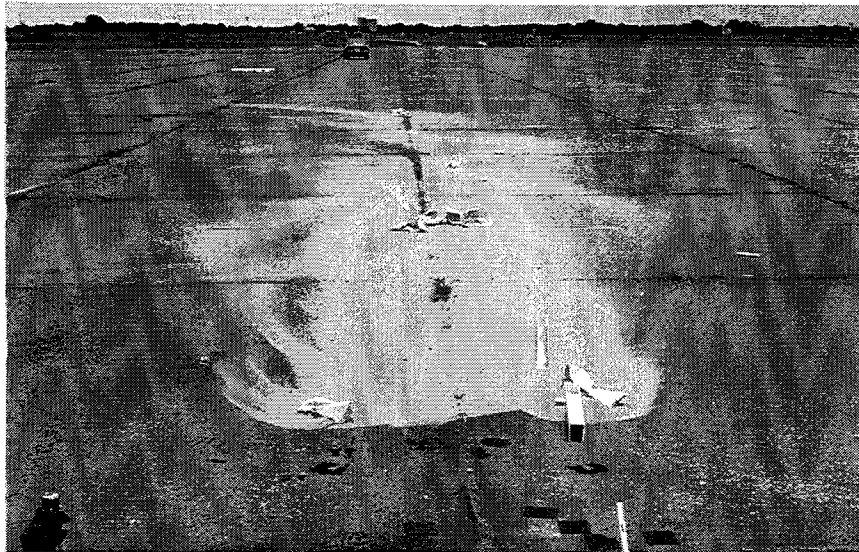
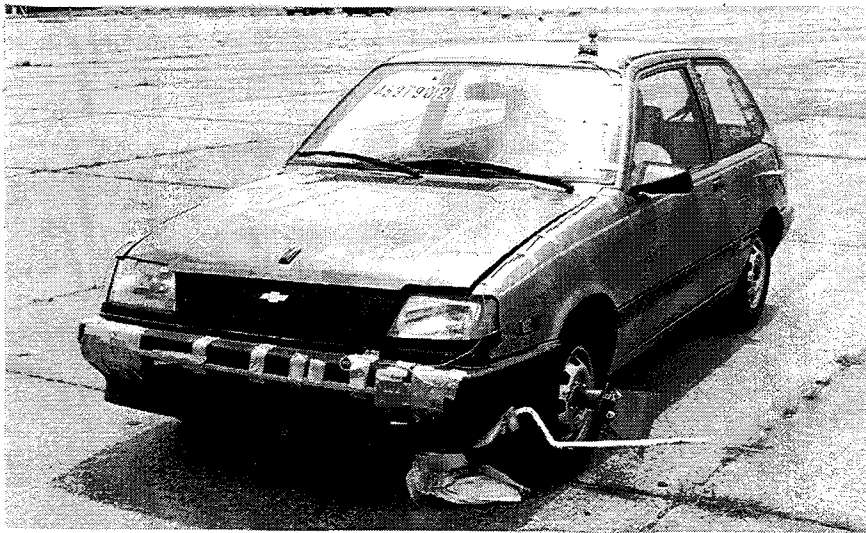
Figure 58. Vehicle and barricade for Test No. 453790-2

As Figure 58 shows, the barricade separated from the base upon impact. Debris and sand were strewn along the path of the vehicle in an area 6 m wide by 54 m long. Figure 58 also shows damage to the vehicle. The bumper was pushed up slightly, and the headlight on the driver's side was loose. The hood was dented on each corner, and there were three scratches along the hood.

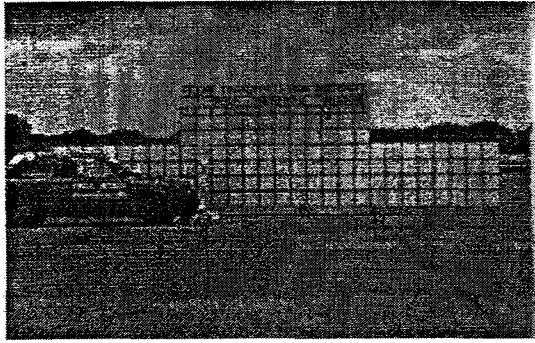
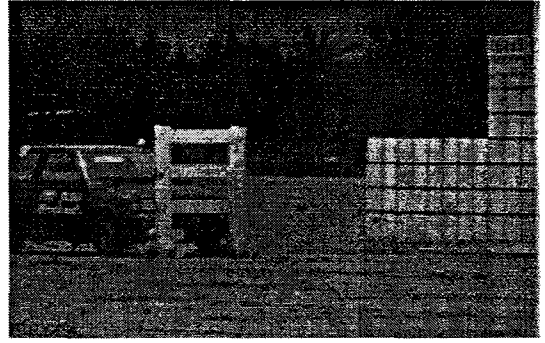
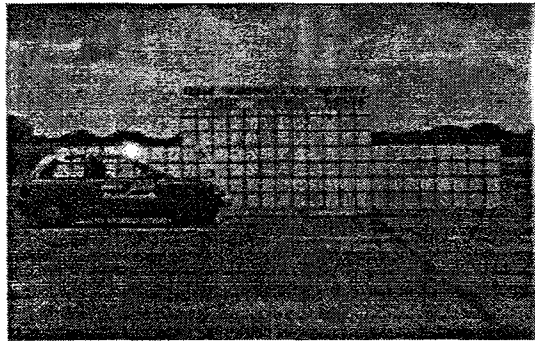
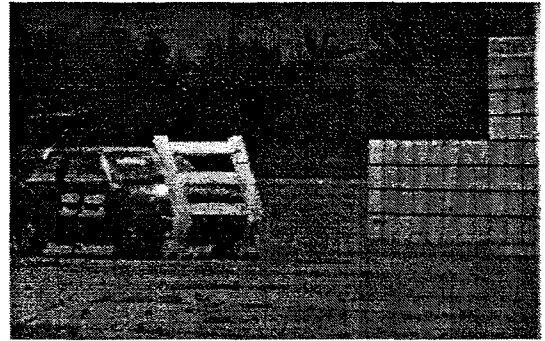
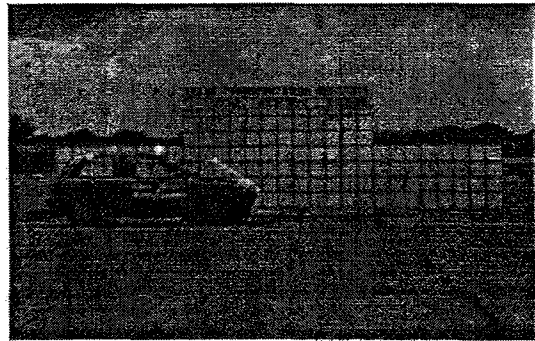
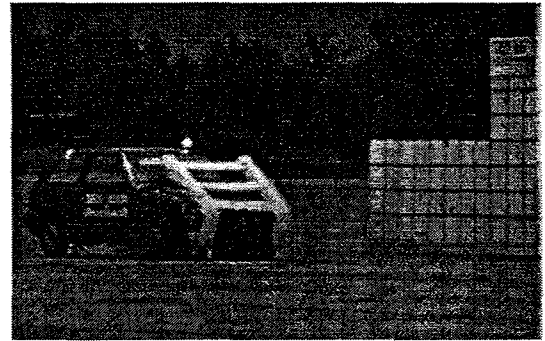
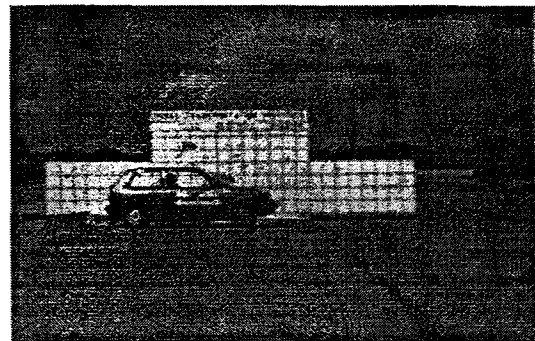
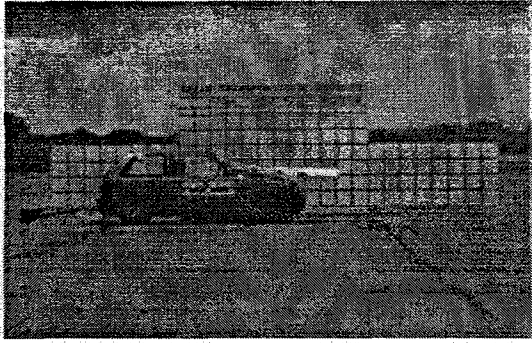
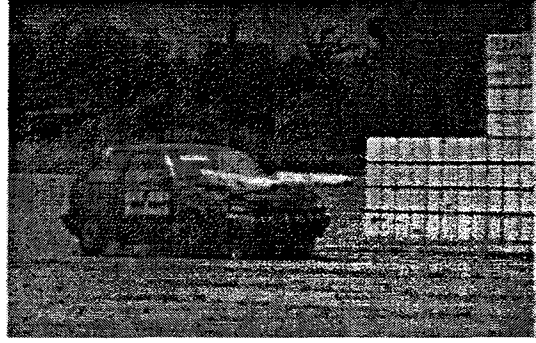
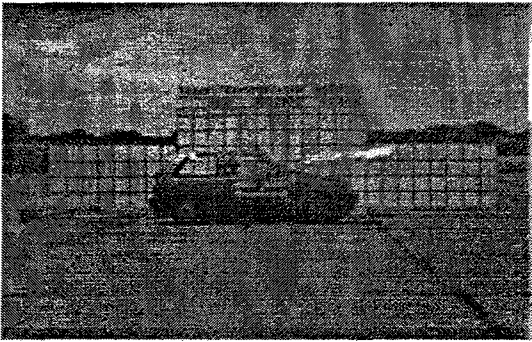
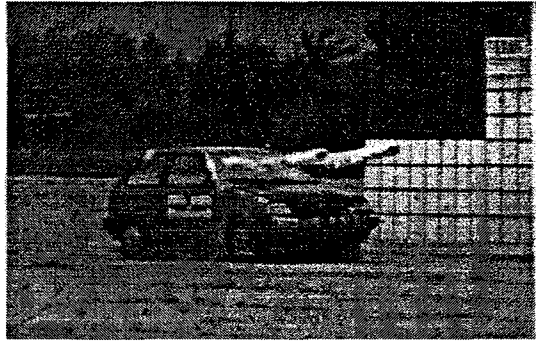
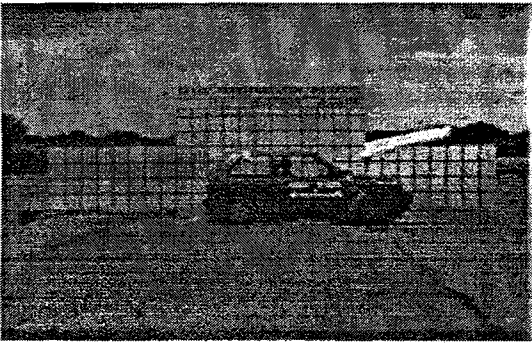
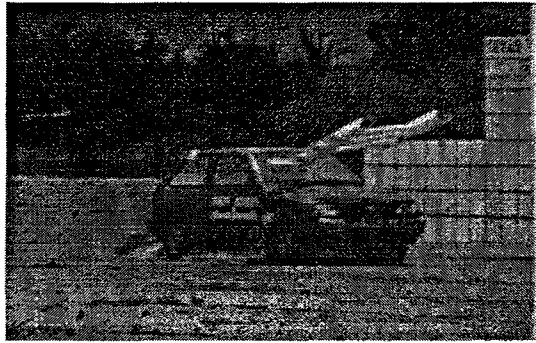
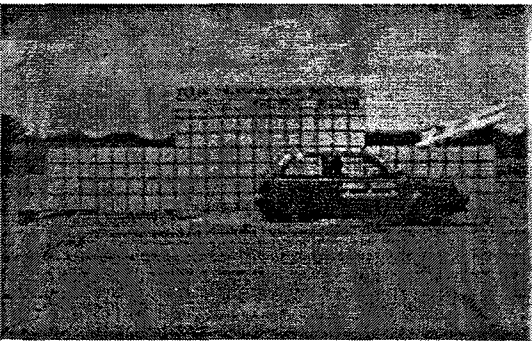
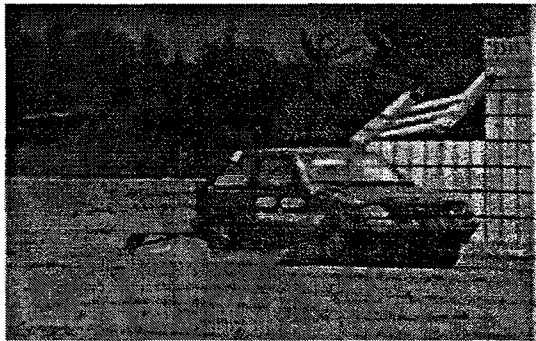
Figure 59. Sequential Photographs for Test No. 453790-2.

As the vehicle impacted the barricade, the vertical supports separated from the base as one unit and deformed to the front of the vehicle. At 57 msec, the barricade was in full contact with the hood of the vehicle and continued up and over the vehicle. The vehicle lost contact with the barricade at 69 msec, traveling at a speed of 96.3 km/h. Prior to brake application, the vehicle was tracking straightforward. The vehicle subsequently came to rest 85 m down and 2.6 m left of the point of impact. Figure 59 shows sequential photographs of the test period.

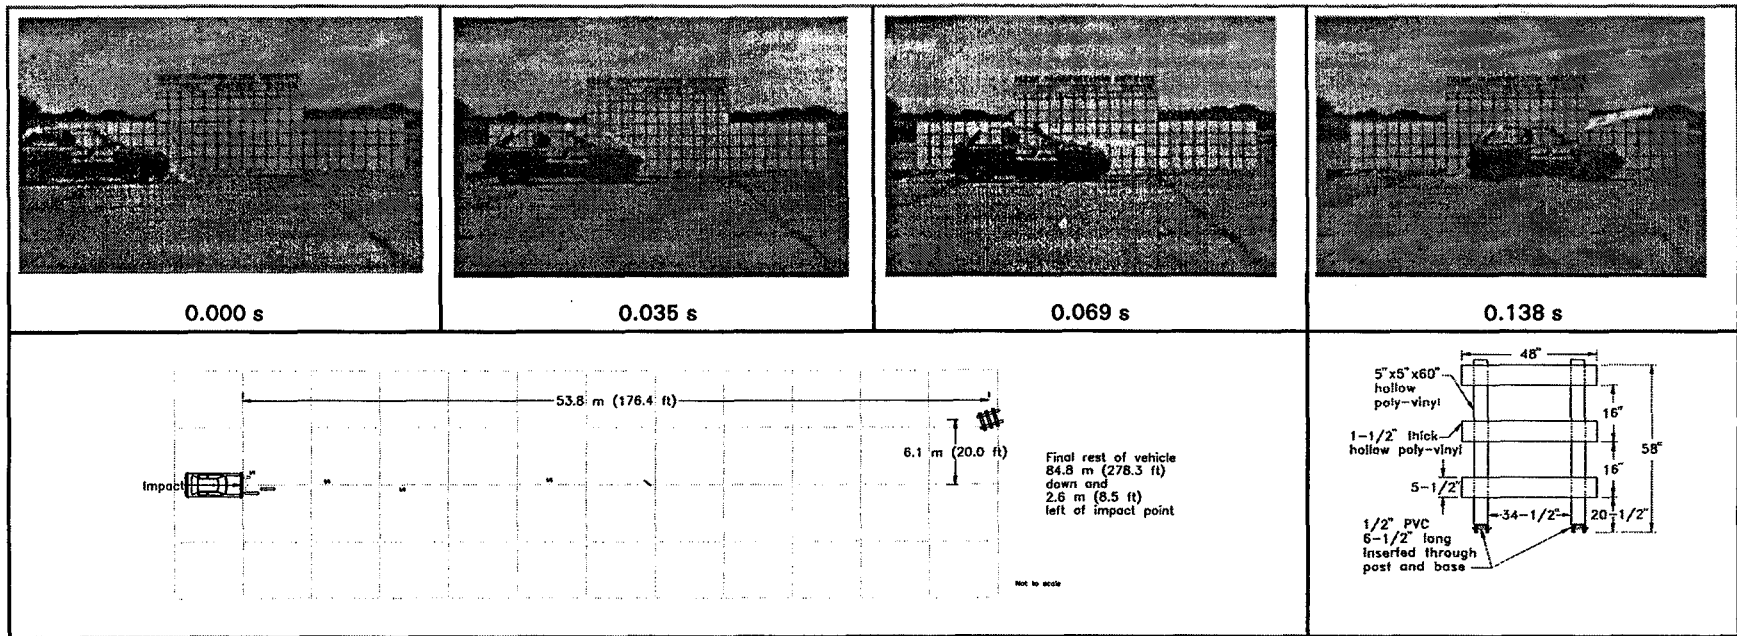
Figure 60. Summary of Results for Test No. 453790-2

A brief summary of the results of this test is presented in Figure 60. The vertical supports of the barricade separated from the base upon impact and made contact with the hood, but did not penetrate the occupant compartment. Debris from the barricade was thrown along an area 6 m wide by 54 m long. Most fragments were not large enough or heavy enough to pose potential hazard to oncoming traffic in adjacent lanes; however, the vertical supports may pose a slight hazard to workers in the area. The vehicle sustained minor damage to the bumper and hood. The longitudinal occupant impact velocity was 0.8 m/s, and the highest 10-msec average ridedown acceleration was -0.2 g. There was no lateral occupant contact. The 50-msec average accelerations were -1.9 g in the longitudinal direction and -0.3 g in the lateral direction. The vehicle exited the immediate test site in a relatively smooth, stable manner and showed no potential for intrusion into adjacent traffic lanes.
