1. Report No. TX-96/5388-1F		2. Government Accession No.		3. Recipient's Catalog No.	
4. Title and Subtitle EVALUATION OF WORK ZONE BARRICADES AND TEMPORARY SIGN SUPPORTS				5. Report Date February 1996

EVALUATION OF WORK ZONE BARRICADES AND TEMPORARY SIGN SUPPORTS

Report No. 5388-1F
Research Study No. 585xxA3014
Research Study Title: Development of New Designs for Barricades
and Sign Supports in Work Zones

February 1996

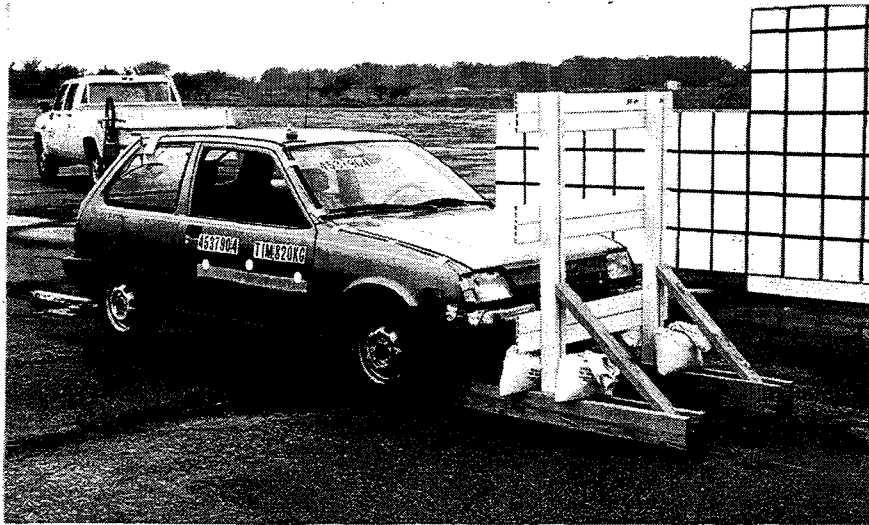
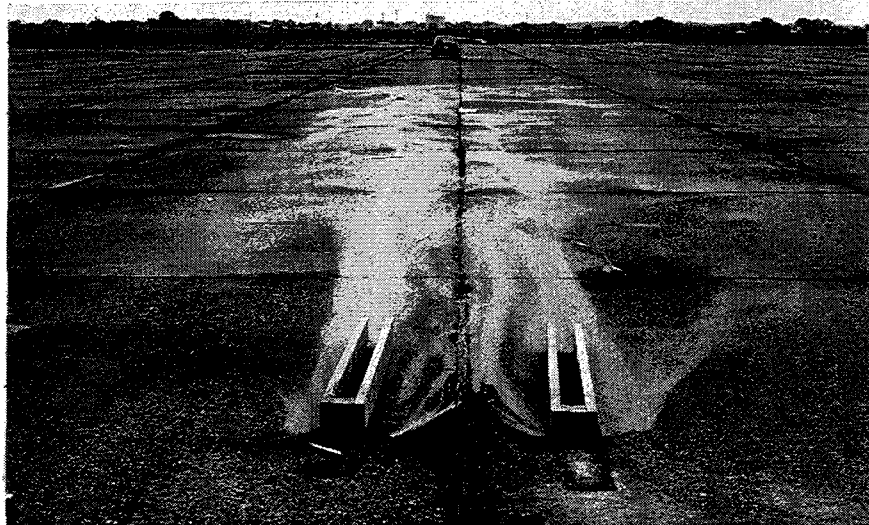
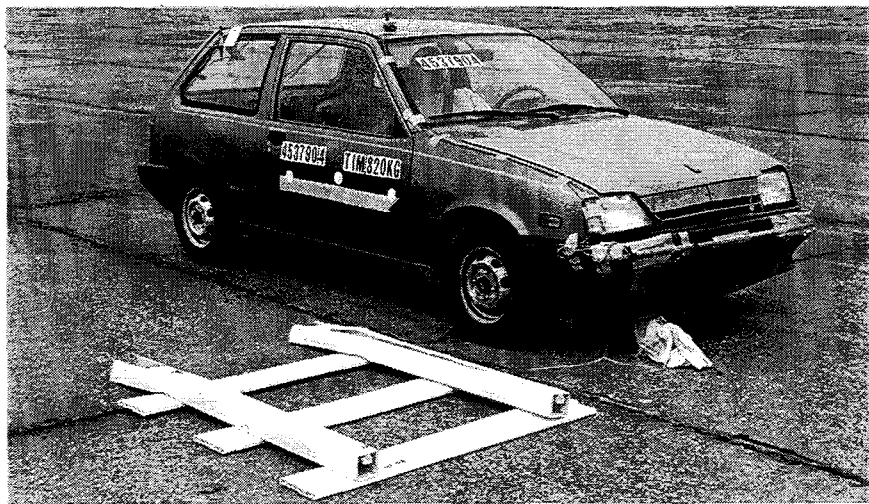
Figure 62. Vehicle and Barricade for Test No. 453790-4

As Figure 62 shows, the hollow core recycled plastic vertical supports and rail elements separated from the wooden base upon impact. Debris and sand were strewn along the path of the vehicle in an area 17 m wide by 77 m long. Figure 62 also shows damage to the vehicle. The bumper and hood of the vehicle were scratched. No penetration or intrusion of the occupant compartment occurred. There was no measurable crush to the exterior of the vehicle.

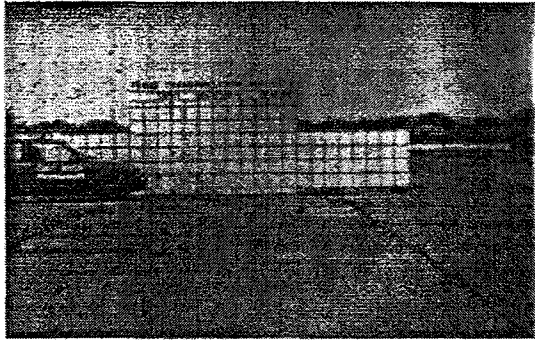
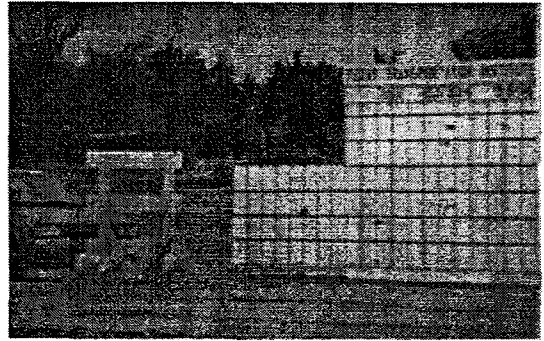
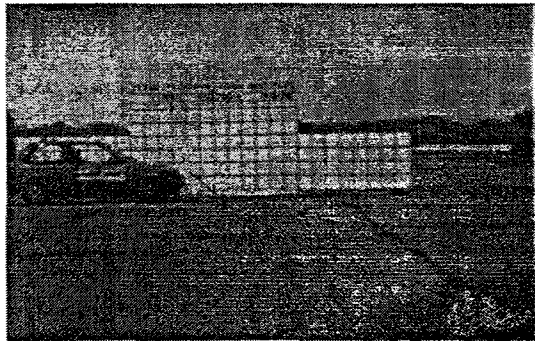
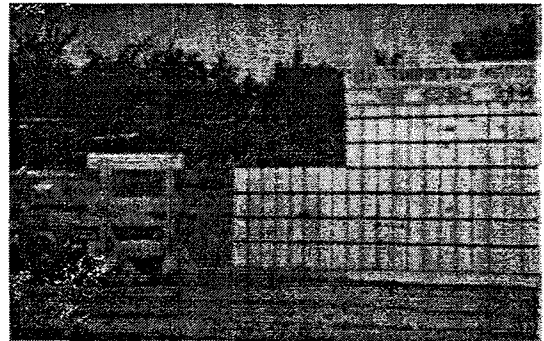
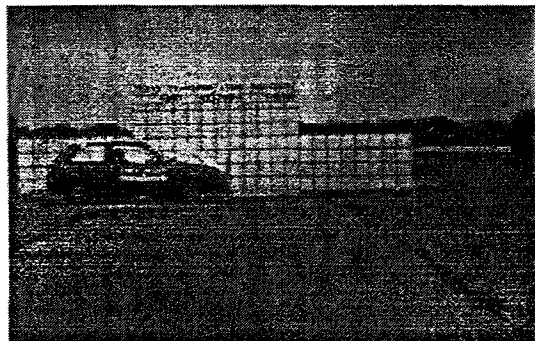
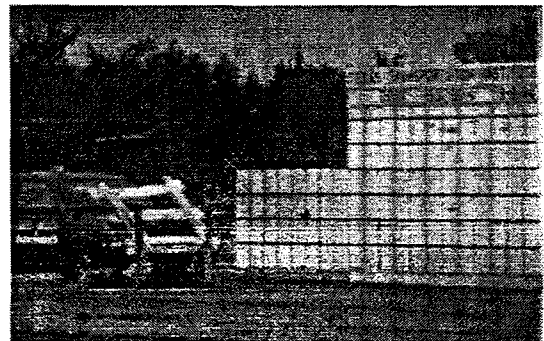
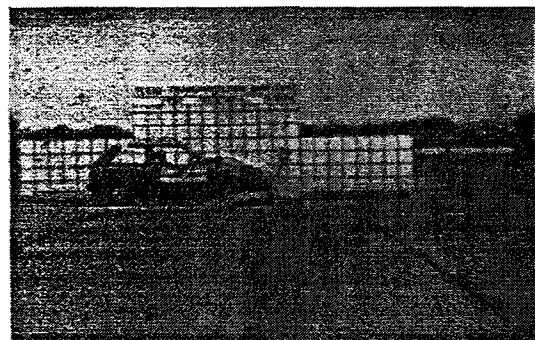
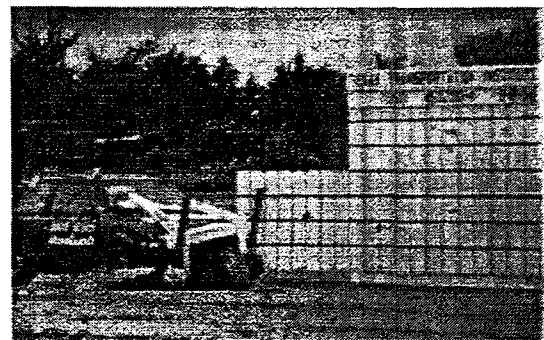
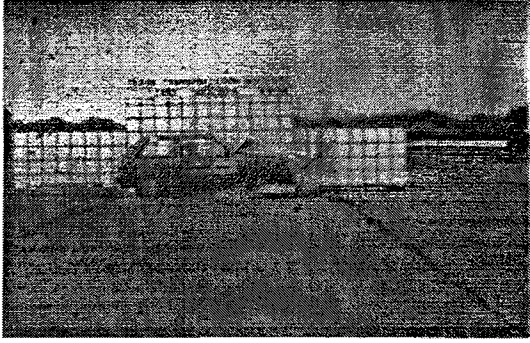
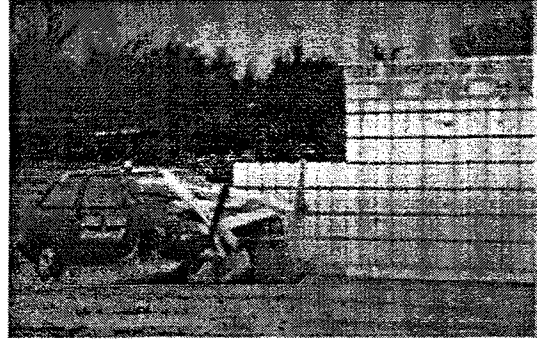
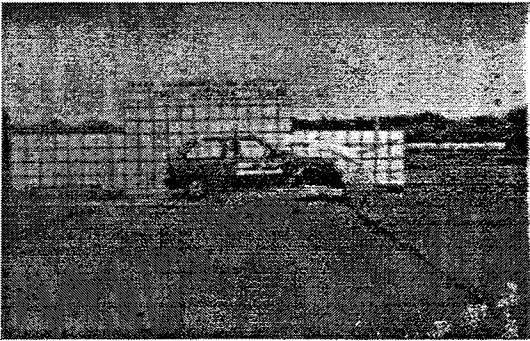
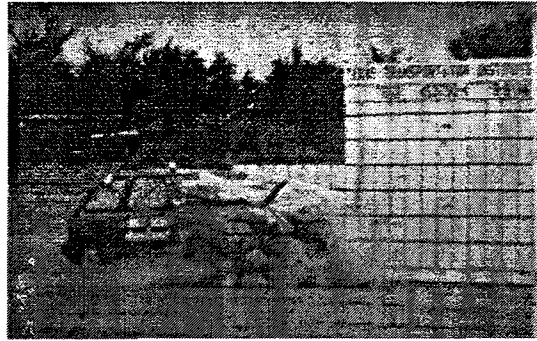
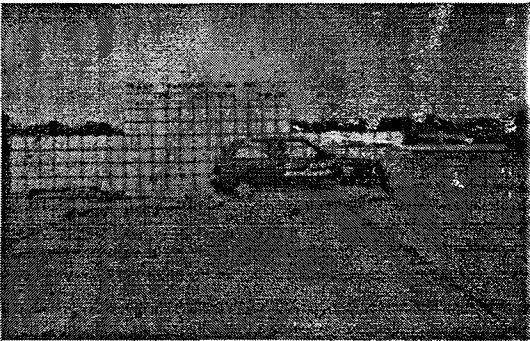
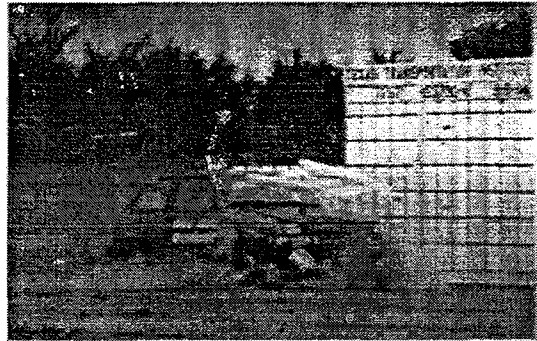
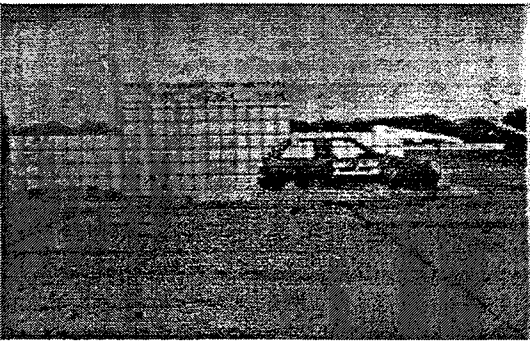
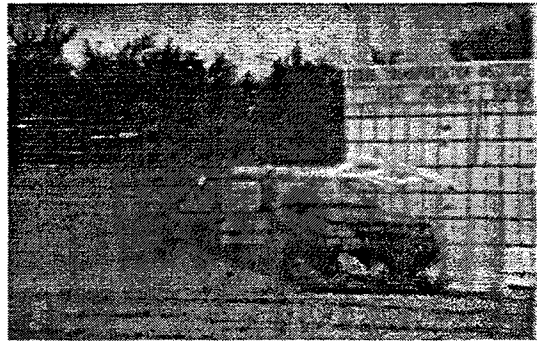
Figure 63. Sequential Photographs for Test No. 453790-4

At 10 msec after impact, the braces for the vertical supports broke away, and at 15 msec, the vertical supports and rail elements separated from the base as a single unit. The top of the vertical supports contacted the wipers in the windshield area at 47 msec. The vehicle lost contact with the barricade at 87 msec, traveling at a speed of 93.5 km/h. Prior to brake application, the vehicle was tracking straight-forward. The vehicle subsequently came to rest 76 m down and 1.5 m to the left of the point of impact. Figure 63 shows sequential photographs of the test period.

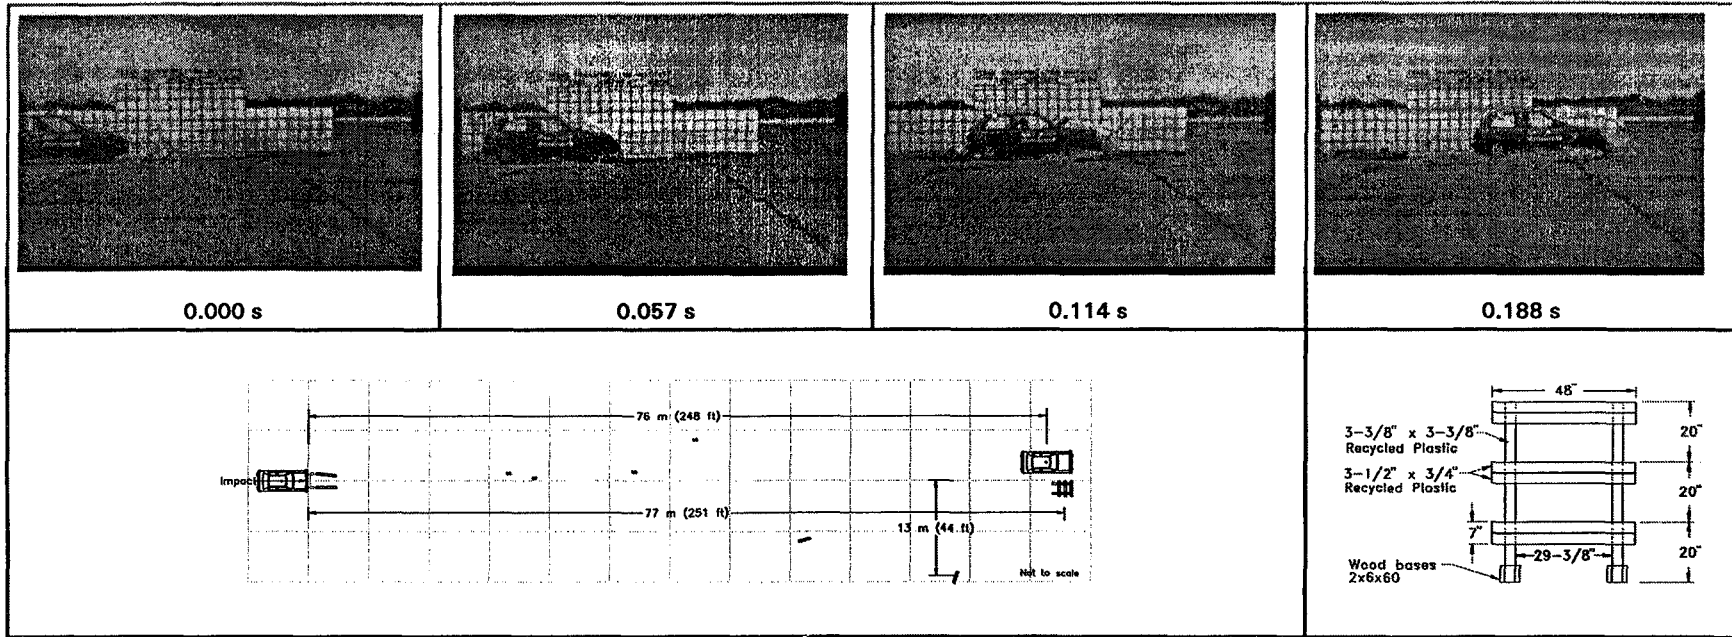
hood and windshield of the vehicle, but did not penetrate the occupant compartment. Debris from the barricade was thrown along an area 17 m wide by 77 m long. The plastic vertical supports and wooden braces rode along with the vehicle. The wooden base remained near the point of impact and most of the remaining fragments were not large enough to pose potential hazard to oncoming traffic in adjacent lanes or to workers in the area. Damage to the vehicle included scratches to the bumper and hood. The plastic vertical supports, which separated from the wooden base, contacted the windshield area, but there was no penetration or intrusion into the occupant compartment. The longitudinal occupant impact velocity was 1.6 m/s, and the highest 10-msec average ridedown acceleration was 0.4 g. There was no lateral occupant contact. The 50-msec average accelerations were -3.3 g in the longitudinal direction and -0.3 g in the lateral direction. The vehicle exited the immediate test site in a relatively smooth, stable manner and showed no potential for intrusion into adjacent traffic lanes.

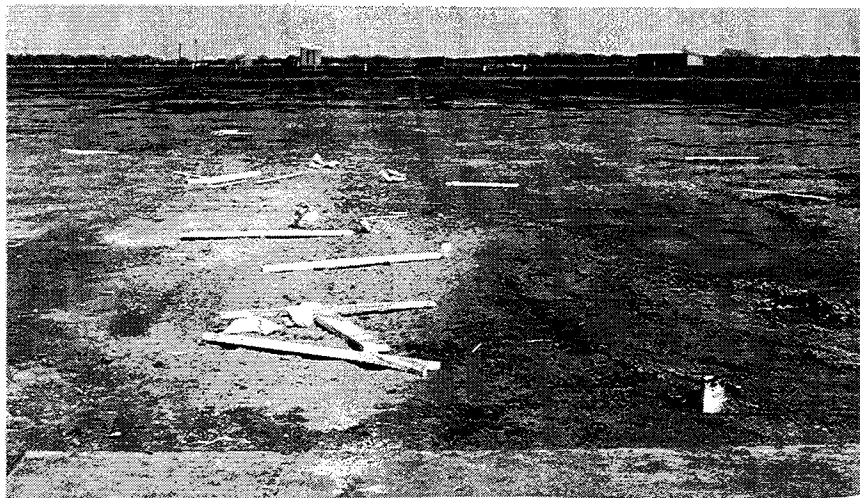
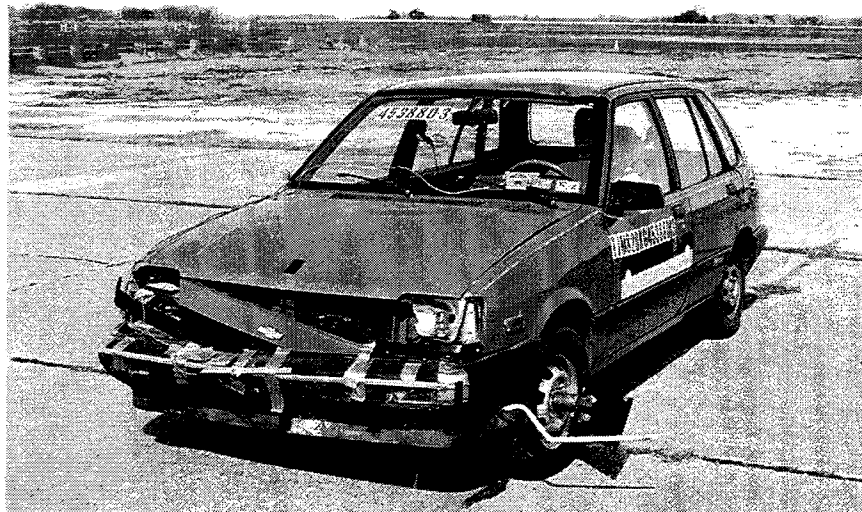
Figure 66. Vehicle and Barricade for Test No. 453880-3

As Figure 66 shows, the hollow core recycled plastic vertical supports and rail elements separated from the base fabricated from solid recycled plastic upon impact and subsequently shattered. Debris and sand were strewn along the path of the vehicle in an area 9.9 m wide by

48 m long. Figure 66 shows damage to the vehicle. The damage to the vehicle included the bumper, grill, and scratches on the hood. The right rear tire was flat.

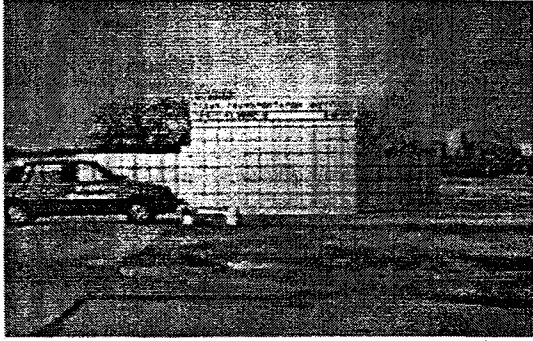
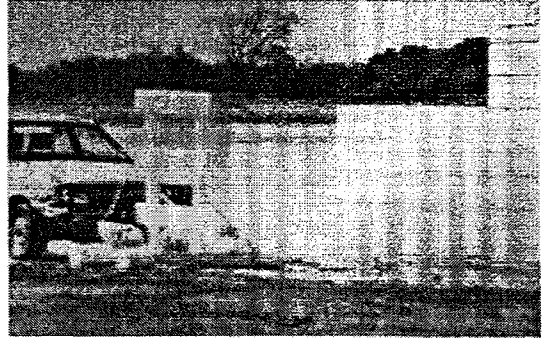
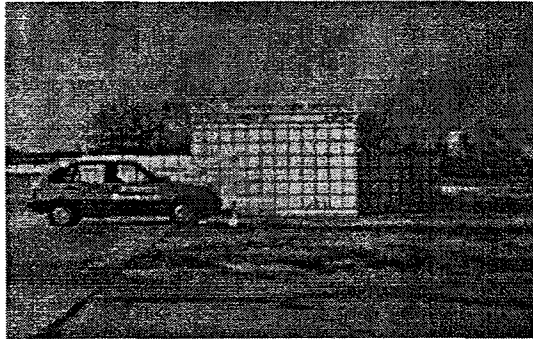
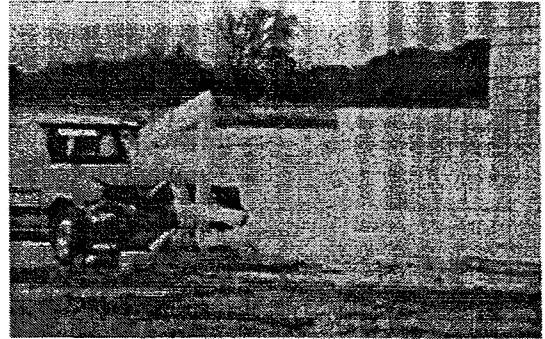
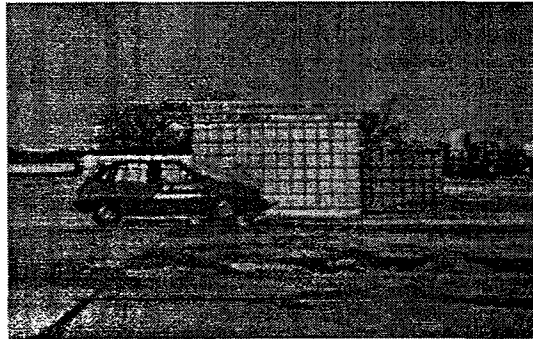
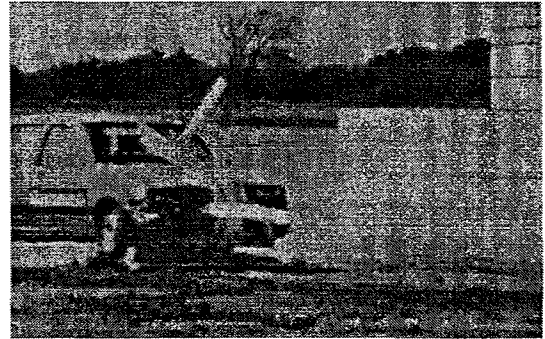
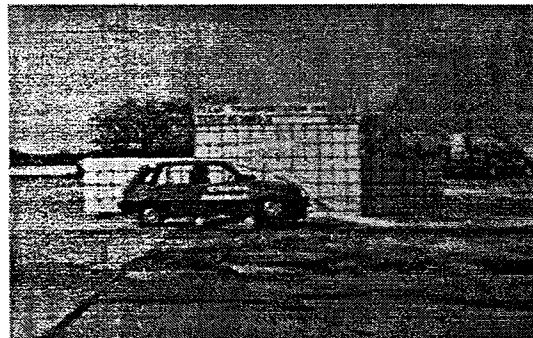
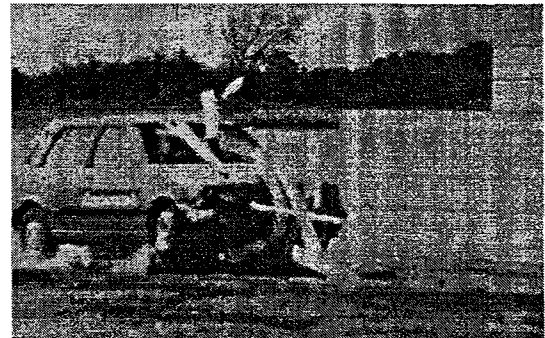
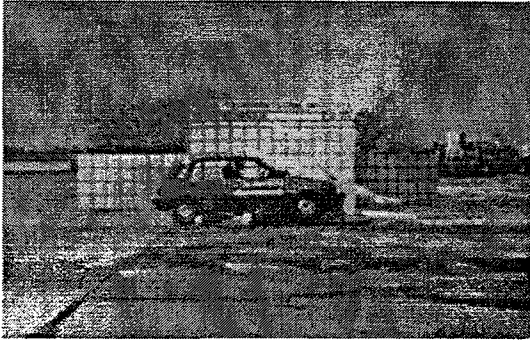
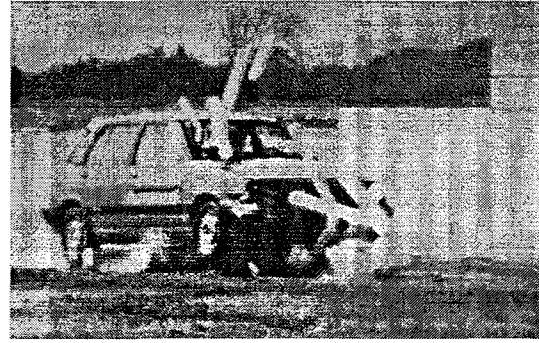
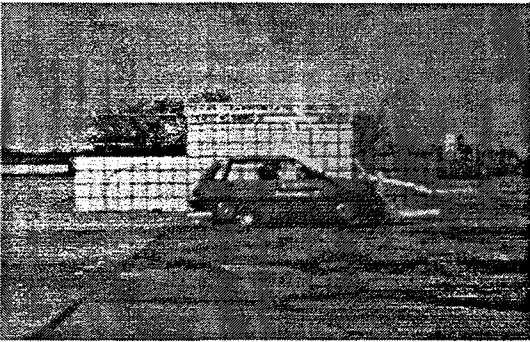
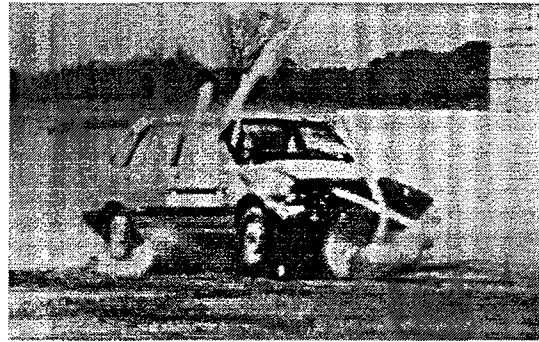
Figure 67. Sequential Photographs for Test No. 453880-3

At 6 msec after impact, the lower rail element separated from the right vertical support. The vehicle contacted the left vertical support at 10 msec. At 15 msec, the middle rail element separated from the left vertical support, and the top rail element twisted. The lower edge of the middle rail element contacted the hood of the vehicle at 19 msec. The vehicle contacted the right vertical support at 39 msec, and the top rail element contacted the hood. At 41 msec, the middle rail element contacted the windshield with no resulting damage. Shortly thereafter, the rail elements separated from the right vertical support, and the debris rode along with the vehicle. At 221 msec, the vehicle cleared the test site traveling at a speed of 95.4 km/h. Prior to brake application, the vehicle was tracking straightforward. The vehicle subsequently came to rest 114 m down and 1.8 m to the right of the point of impact. Figure 67 shows sequential photographs of the test period.

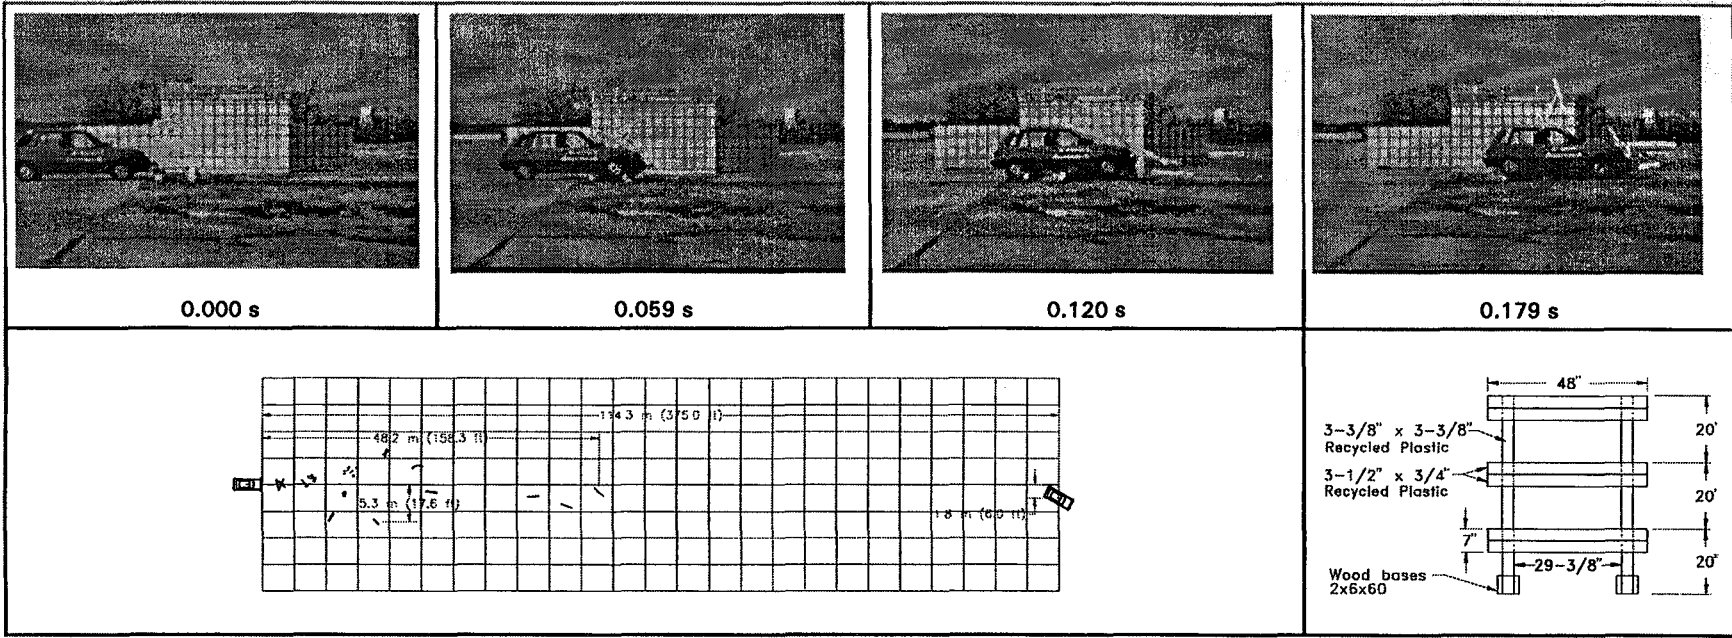
Figure 68. Summary of Results for Test No. 453880-3

A brief summary of the results of this test is presented in Figure 68. The hollow core recycled plastic vertical supports and rail elements separated from the solid recycled plastic base upon impact. The broken segments made contact with the hood and the windshield, but did not penetrate the occupant compartment. Sand and fragments of the barricade were scattered along an area 9.9 m wide by 48 m long. Most fragments were not large enough to pose potential hazard to oncoming traffic in adjacent lanes or to workers in the area. The vehicle sustained minor damage to the bumper, grill and hood. The longitudinal occupant impact velocity was 1.7 m/s and the highest 10-msec average ridedown acceleration was 3.4 g. There was no lateral occupant contact. The 50-msec average accelerations were -2.6 g in the longitudinal direction and -0.6 g in the lateral direction. The vehicle exited the immediate test site in a relatively smooth, stable manner and showed no potential for intrusion into adjacent traffic lanes.

In summary, the Type III barricade fabricated from hollow core recycled plastic material with a base constructed of solid recycled plastic material tested with wet soil condition was also judged to have met all evaluation criteria set forth in NCHRP Report 350.

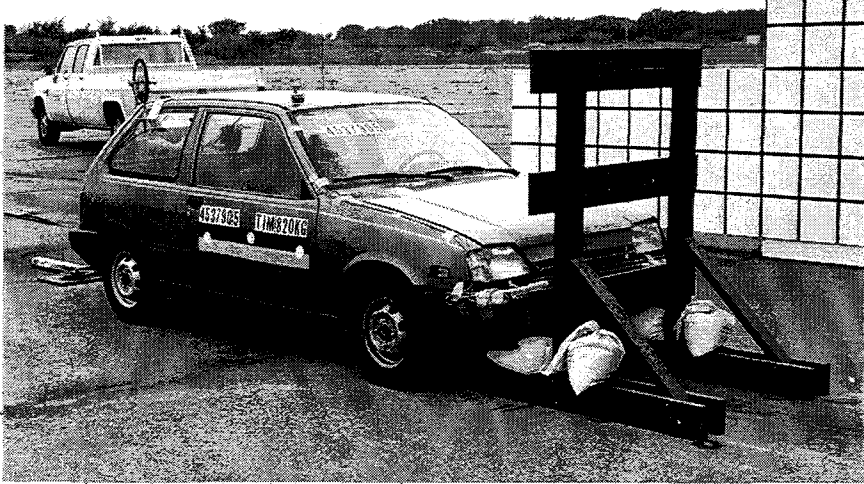
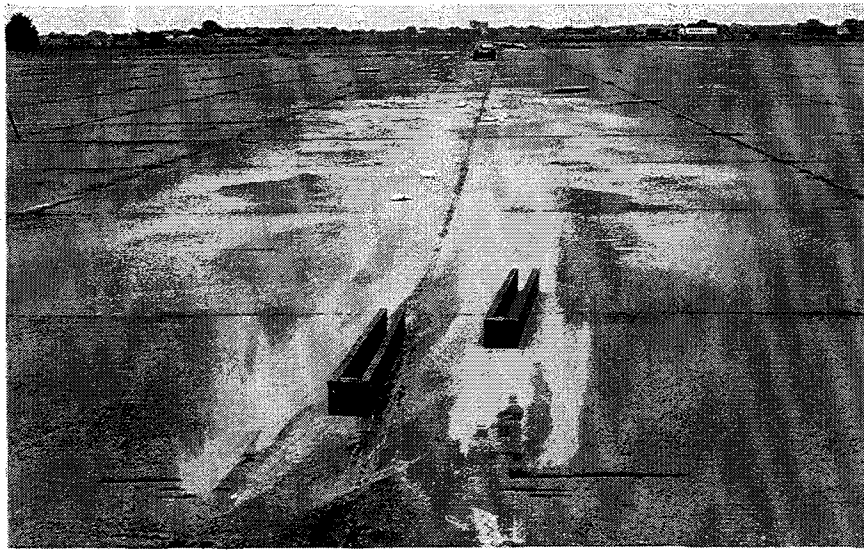
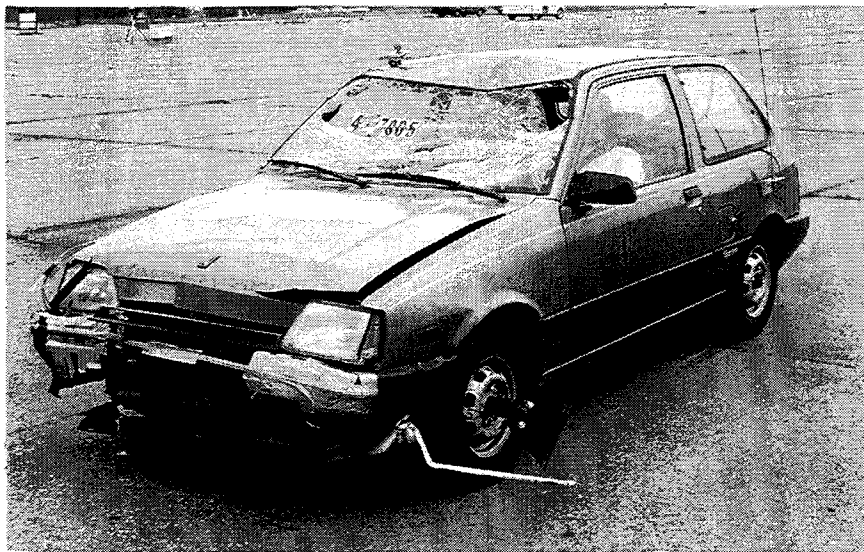
Figure 70. Vehicle and Barricade for Test No. 453790-5

As Figure 70 shows, the solid recycled plastic barricade shattered upon impact. Debris and sand were strewn along the path of the vehicle in an area 14.5 m wide by 63 m long. Figure 70 also shows damage to the vehicle. The bumper, grill, and hood of the vehicle were dented and scratched. The left side A-post was dented, the windshield was broken, and the roof was dented. Maximum exterior crush to the front of the vehicle at bumper height was 80 mm. Maximum intrusion into the occupant compartment (measured from high-speed film) was 259 mm near the head area of the driver. The maximum residual deformation into the occupant compartment was 61 mm.

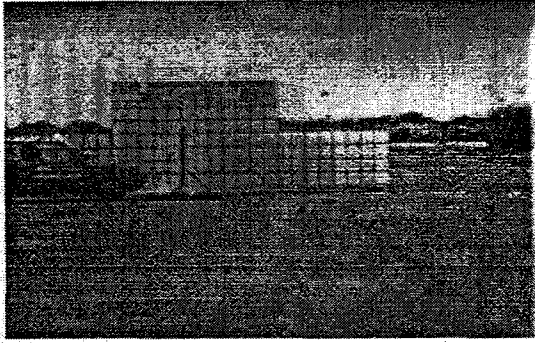
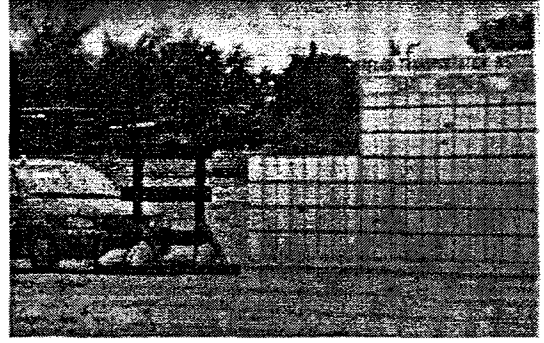
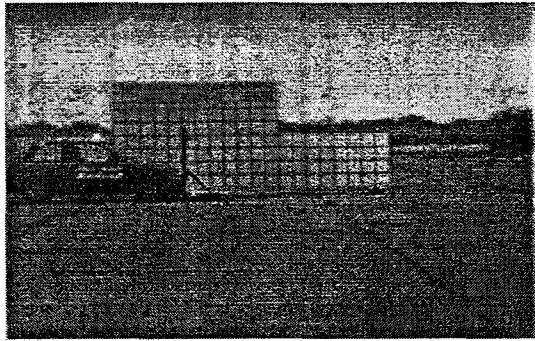
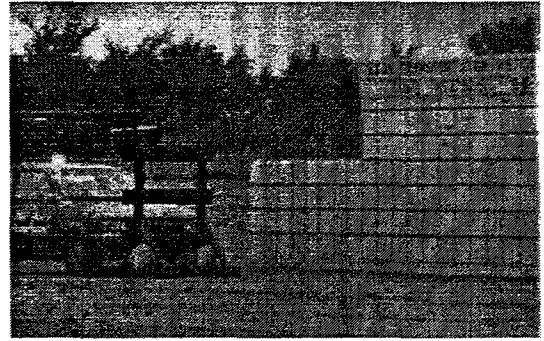
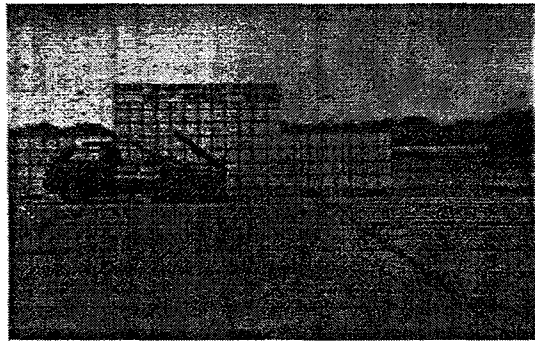
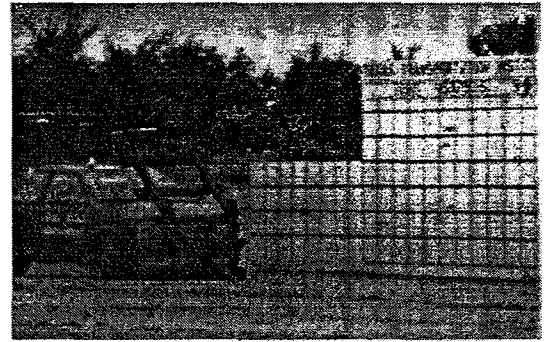
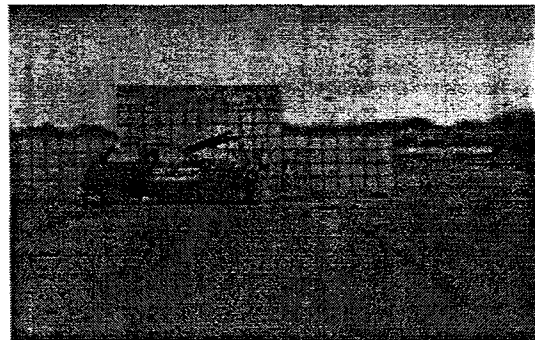
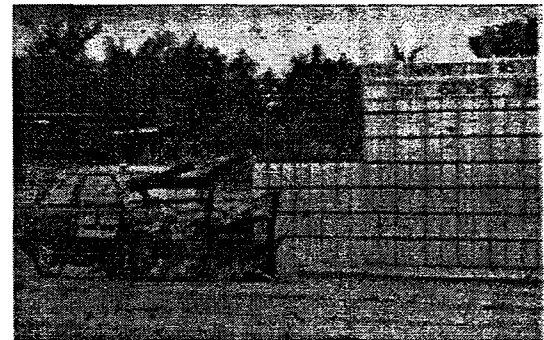
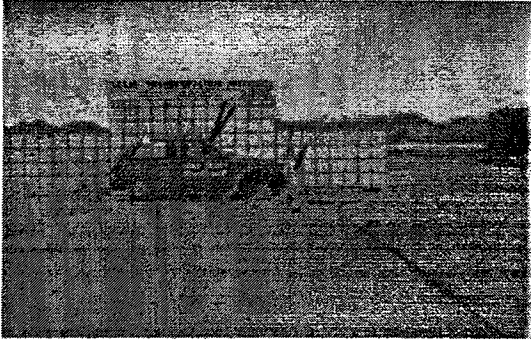
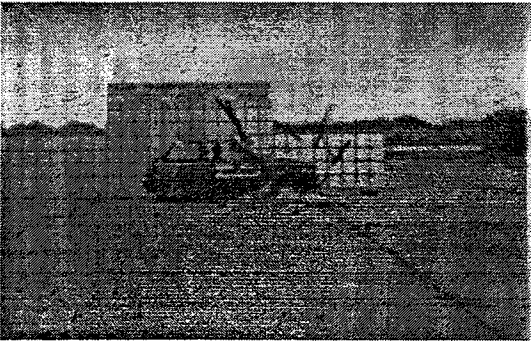
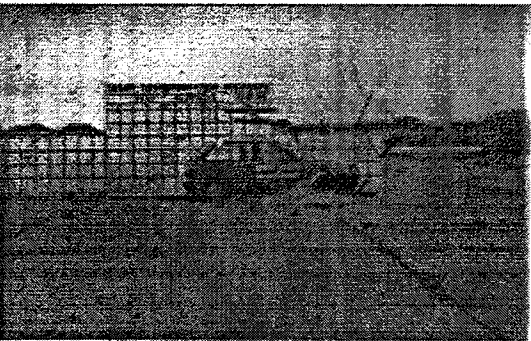
Figure 71. Sequential Photographs for Test No. 453790-5

At 5 msec after impact, the barricade shattered. At 47 msec, the fractured vertical support impacted and penetrated the windshield. The segment then went up over the vehicle and touched the roof. The vehicle lost contact with the barricade at 176 msec, traveling at a speed of 93.6 km/h. Prior to brake application, the vehicle was tracking straightforward. The vehicle subsequently came to rest 93 m down and 1.2 m to the left of the point of impact. Figure 71 shows sequential photographs of the test period.

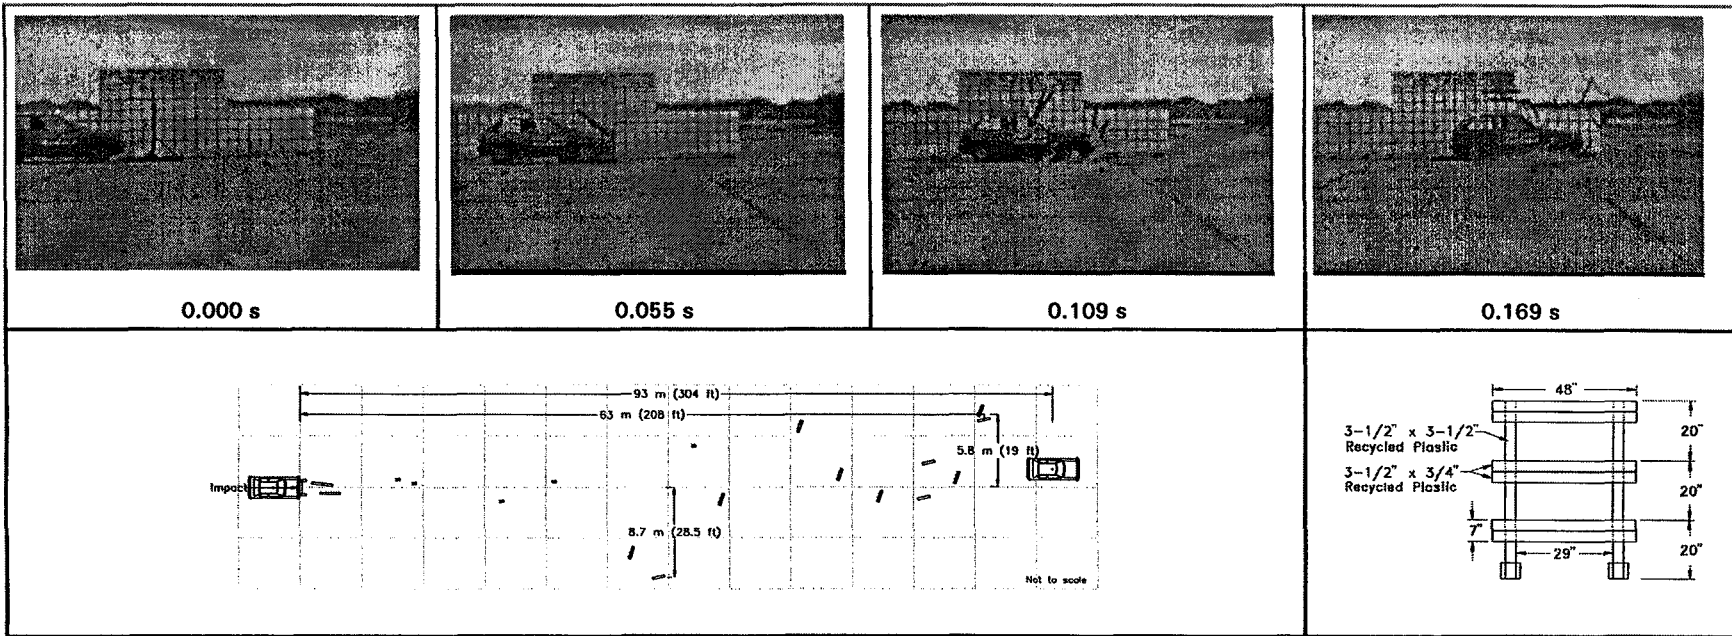
Figure 72. Summary of Results for Test No. 453790-5

Figure 72 presents a brief summary of the results of this test. The barricade shattered upon impact. A segment of the vertical support made contact with the windshield and penetrated into the occupant compartment. Maximum intrusion into the occupant compartment was 259 mm near the driver's head area. Debris from the barricade was thrown along an area 14.5 m wide by 63 m long. Most of the fragments were not large enough to pose potential hazard to oncoming traffic in adjacent lanes or to workers in the area. Damage to the vehicle included dents and scratches to the bumper and hood and penetration to the windshield area. The longitudinal occupant impact velocity was 2.0 m/s and the highest 10-msec average ridedown acceleration was 0.4 g. Lateral occupant impact velocity was 0.6 m/s, and the highest 10-msec average ridedown acceleration was 0.5 g. The 50-msec average accelerations were -3.9 g in the longitudinal direction and -0.4 g in the lateral direction. The vehicle exited the immediate test site in a relatively smooth, stable manner and showed no potential for intrusion into adjacent traffic lanes.

In summary, the performance of the Type III barricade fabricated from solid recycled plastic material was judged to be unsatisfactory due to penetration of the windshield and the occupant compartment by a segment of the fractured vertical support.

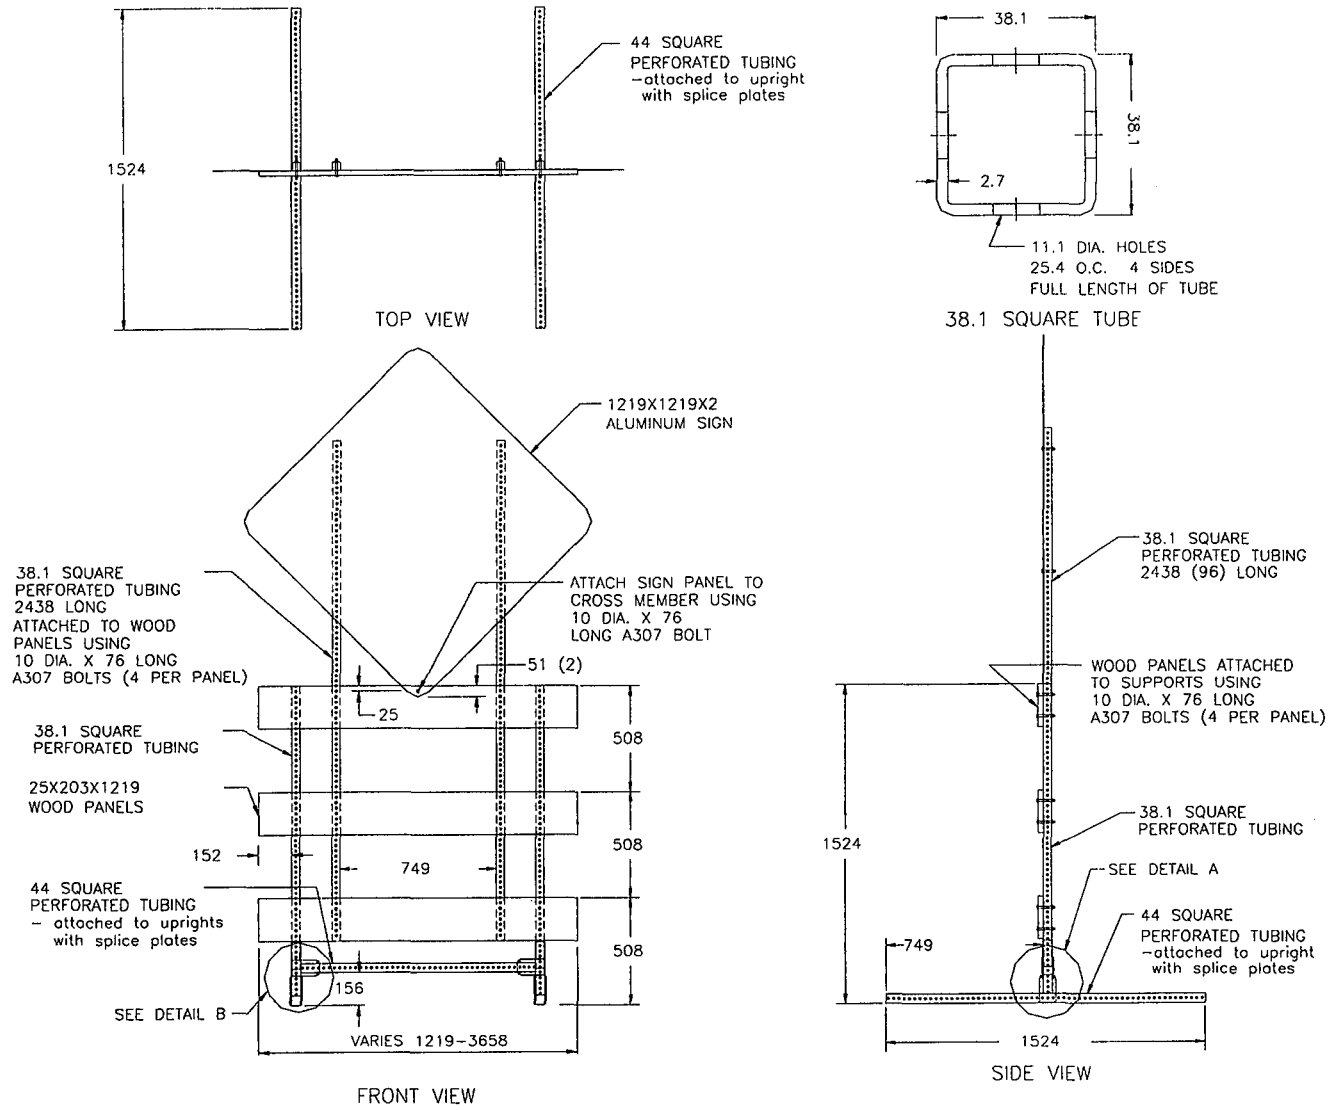
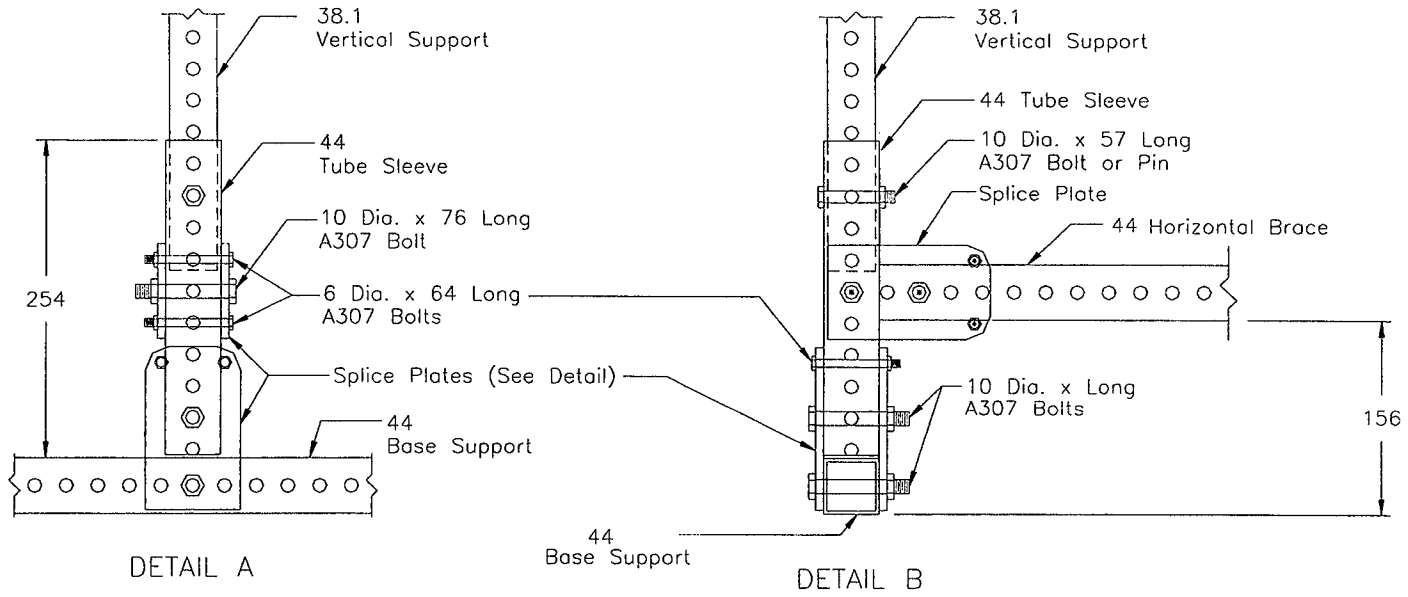
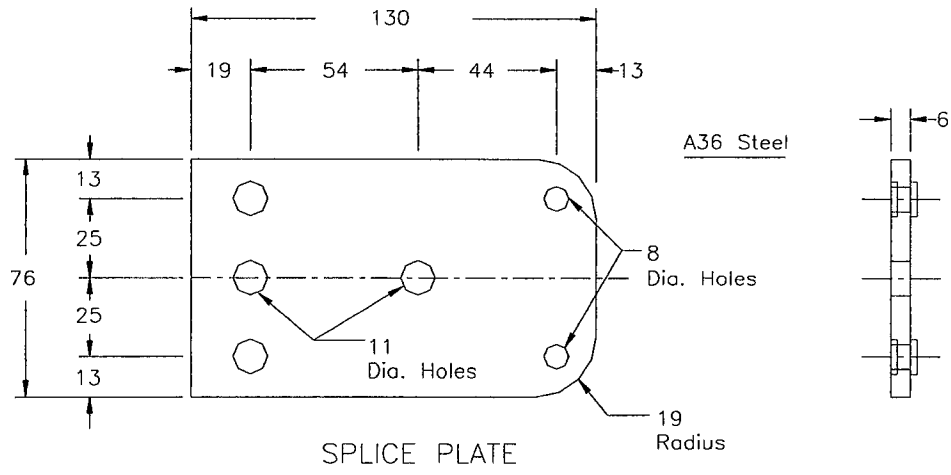
Figure 73. Perforated Steel Tube Type III Barricade with Sign Panel Attached to Wood Panels

The crash test with the first sign attachment alternative (test no. 453880-5) was judged to be unsatisfactory. The bottom of the sign panel bent backward and shattered the windshield, though there was no penetration into the occupant compartment. Otherwise, the test would have been acceptable. The problem with the bending of the sign panel could be remedied by adding bracing to the sign panel or by attaching the bottom of the sign panel to the top rail element. With this adjustment to the sign panel, this sign attachment mechanism would have performed satisfactorily and would be considered acceptable.

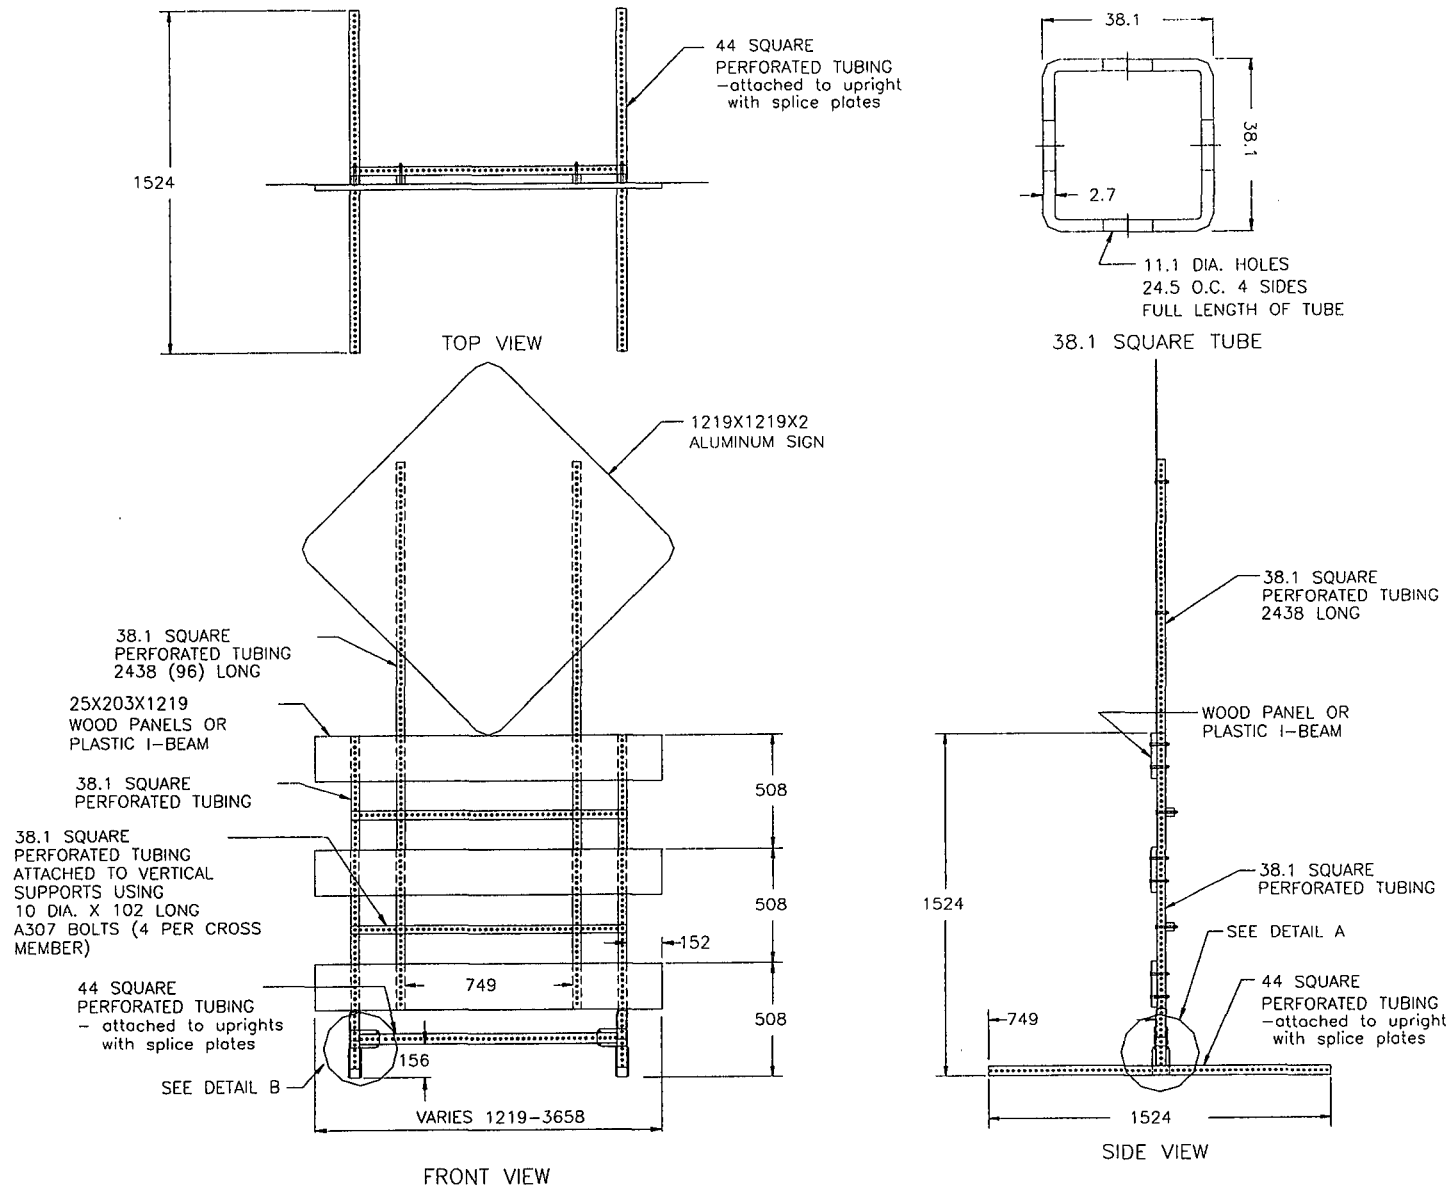
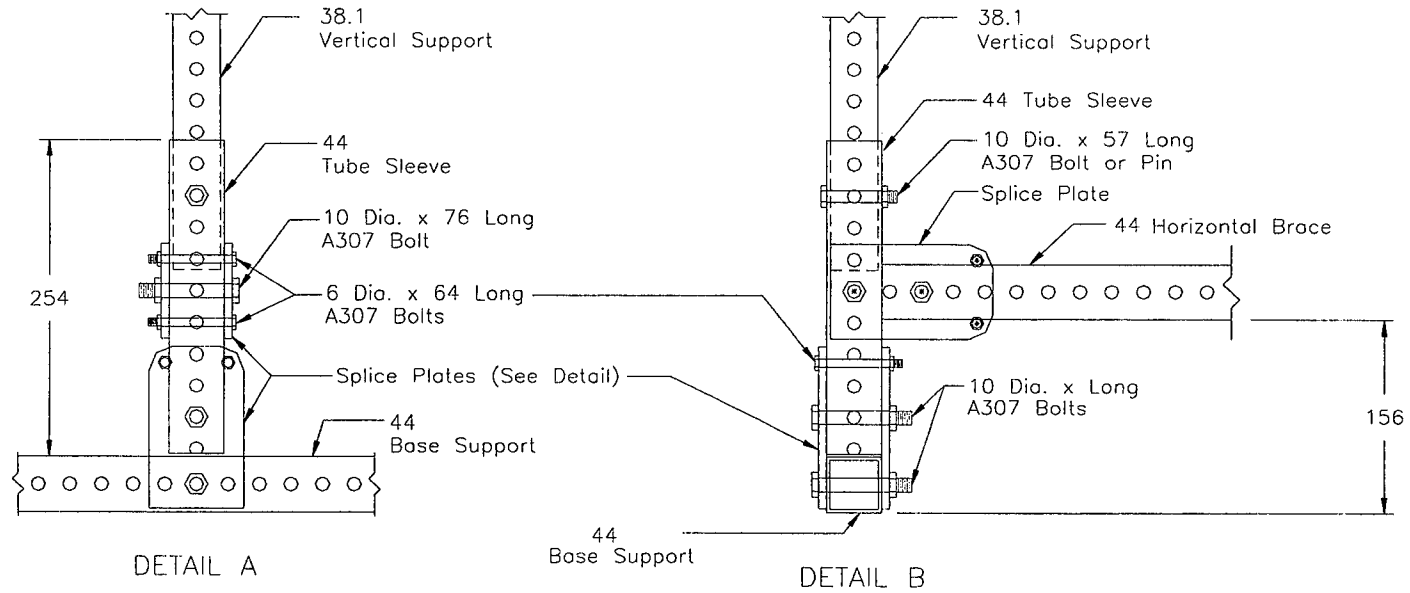
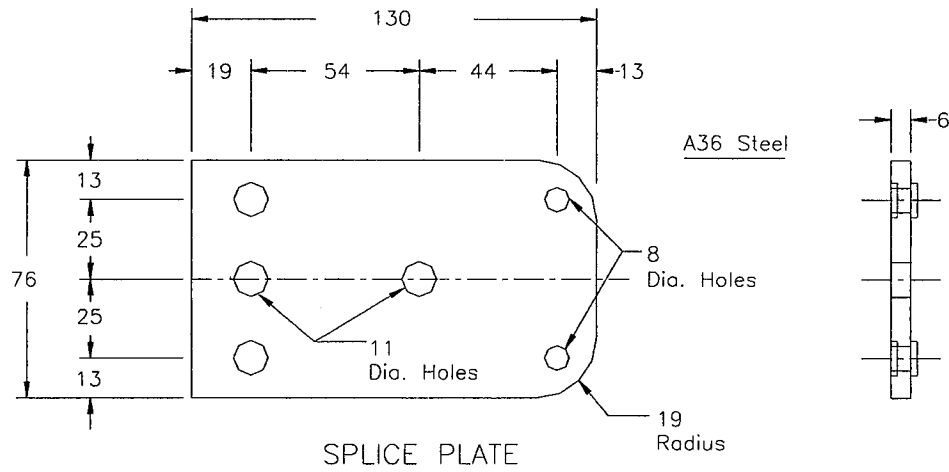
Figure 74. Perforated Steel Tube Type III Barricade with Sign Panel Attached to Perforated Tube Cross Members

The crash test with the second sign attachment alternative (test no. 453880-7) was successful. However, the fractured vertical supports, the rail elements and the sign panel stayed as a single unit and was thrown forward by the impacting vehicle, raising concern that this may pose a hazard to adjacent traffic and workers in the area. After consultation with TxDOT, it was decided that this sign attachment mechanism is not desirable and should not be considered for implementation.
