1. Report No. TX-96/5388-1F		2. Government Accession No.		3. Recipient's Catalog No.	
4. Title and Subtitle EVALUATION OF WORK ZONE BARRICADES AND TEMPORARY SIGN SUPPORTS				5. Report Date February 1996

EVALUATION OF WORK ZONE BARRICADES AND TEMPORARY SIGN SUPPORTS

Report No. 5388-1F
Research Study No. 585xxA3014
Research Study Title: Development of New Designs for Barricades
and Sign Supports in Work Zones

February 1996

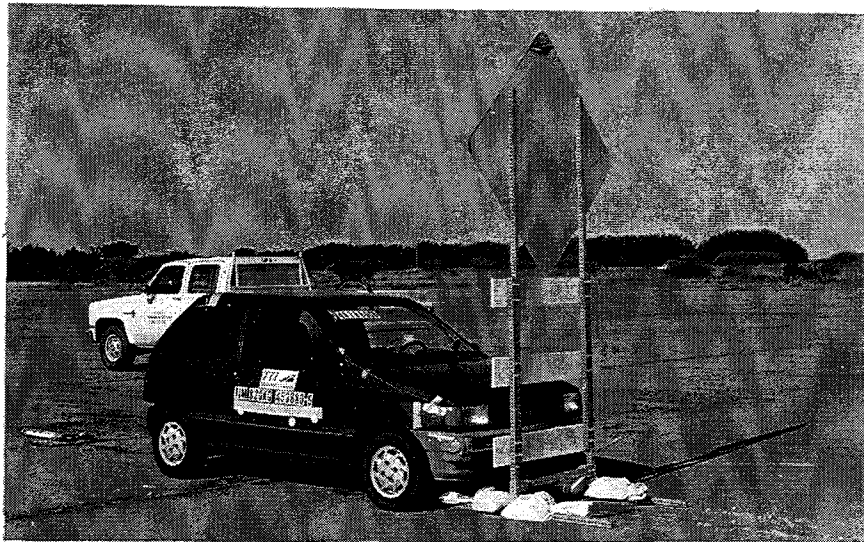
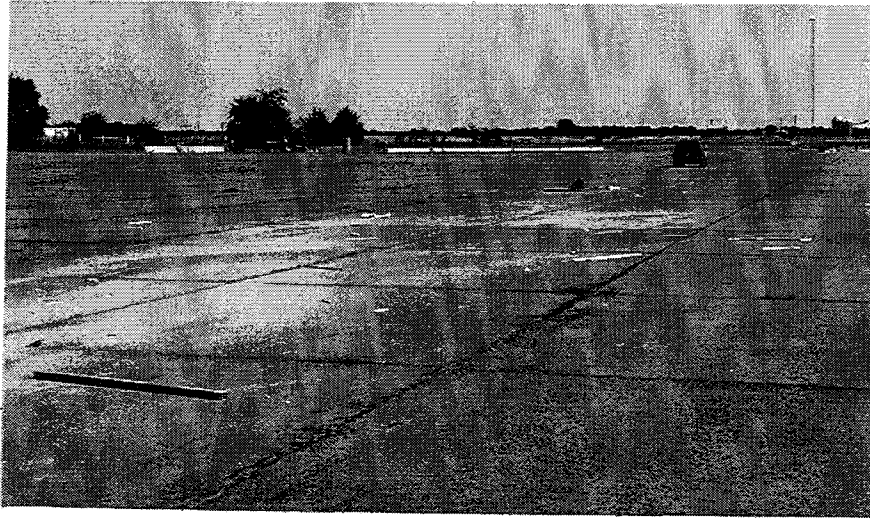
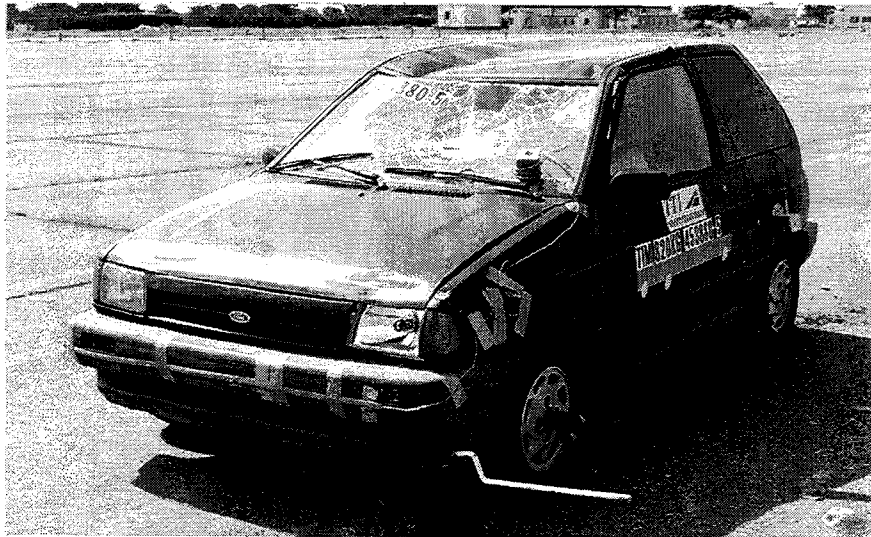
Figure 77. Vehicle and Barricade for Test No. 453880-5

As Figure 77 shows, the barricade and the sign attachment shattered upon impact. Debris and sand were strewn along the path of the vehicle in an area 14.6 m wide and 90.5 m long. Figure 77 also shows damage to the vehicle. There was damage to the hood, roof, and left headlight, but the damage was limited to minor scrapes. The windshield was shattered and deformed into the occupant compartment 51 mm.

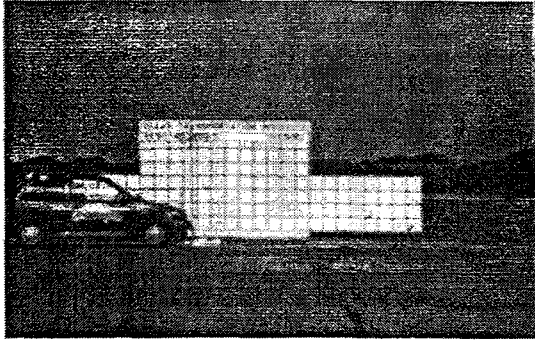
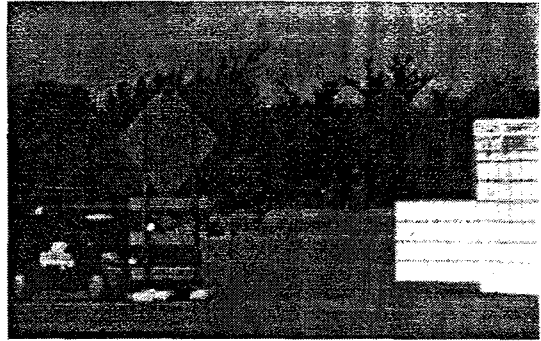
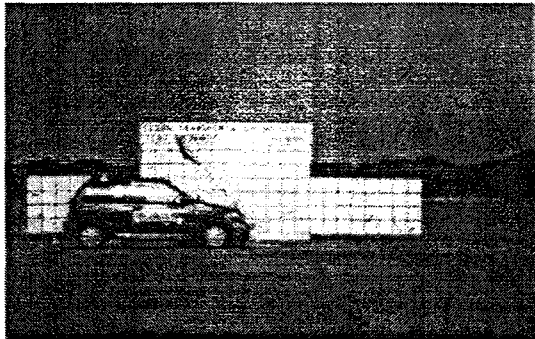
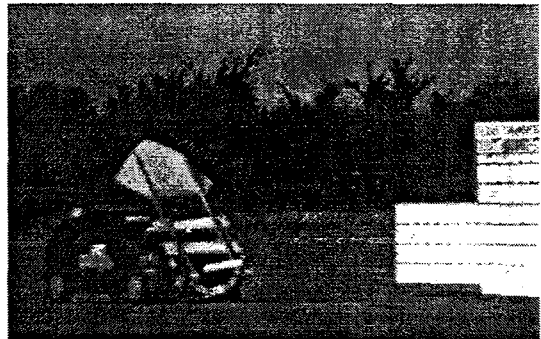
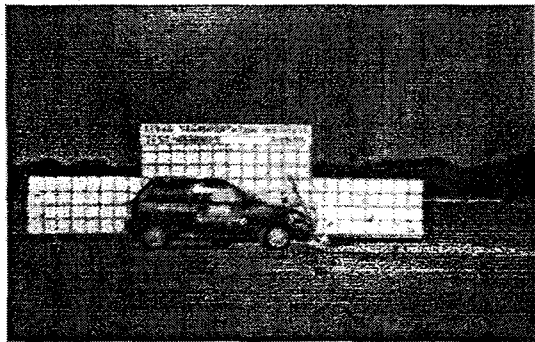
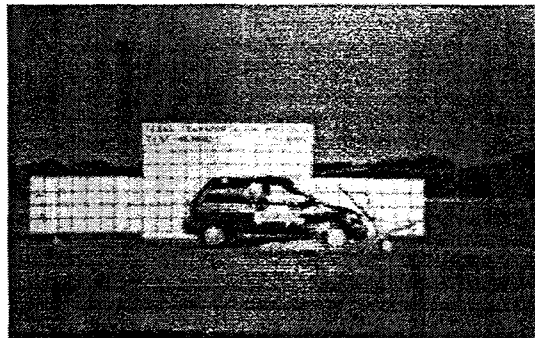
Figure 78. Sequential Photographs for Test No. 453880-5

As the vehicle impacted the barricade, the bottom rail element began to break and the vertical supports for the barricade began to bend. At 11 msec, the top and center rail elements began to break. At 24 msec, the right vertical support for the sign panel started to separate from the barricade. The right vertical support for the sign panel cleared the bumper and hood at 39 msec, and the left vertical supports for the sign panel and the barricade began to rise at 48 msec. The top of the sign panel contacted the roof at 71 msec. The bottom of the sign panel folded forward and subsequently contacted and penetrated the windshield at 97 msec. At 103 msec, the supports lost contact with the vehicle as it traveled at 86.9 km/h; however, the sign panel remained in contact with the roof. The left vertical support for the sign panel began to separate from the left vertical support of the barricade at 116 msec. At 258 msec, the right vertical support for the barricade began to separate from the base. Prior to brake application, the vehicle was tracking straightforward. The vehicle subsequently came to rest 78 m down and 3.2 m to the right of the point of impact. Figure 78 shows sequential photographs of the test period.

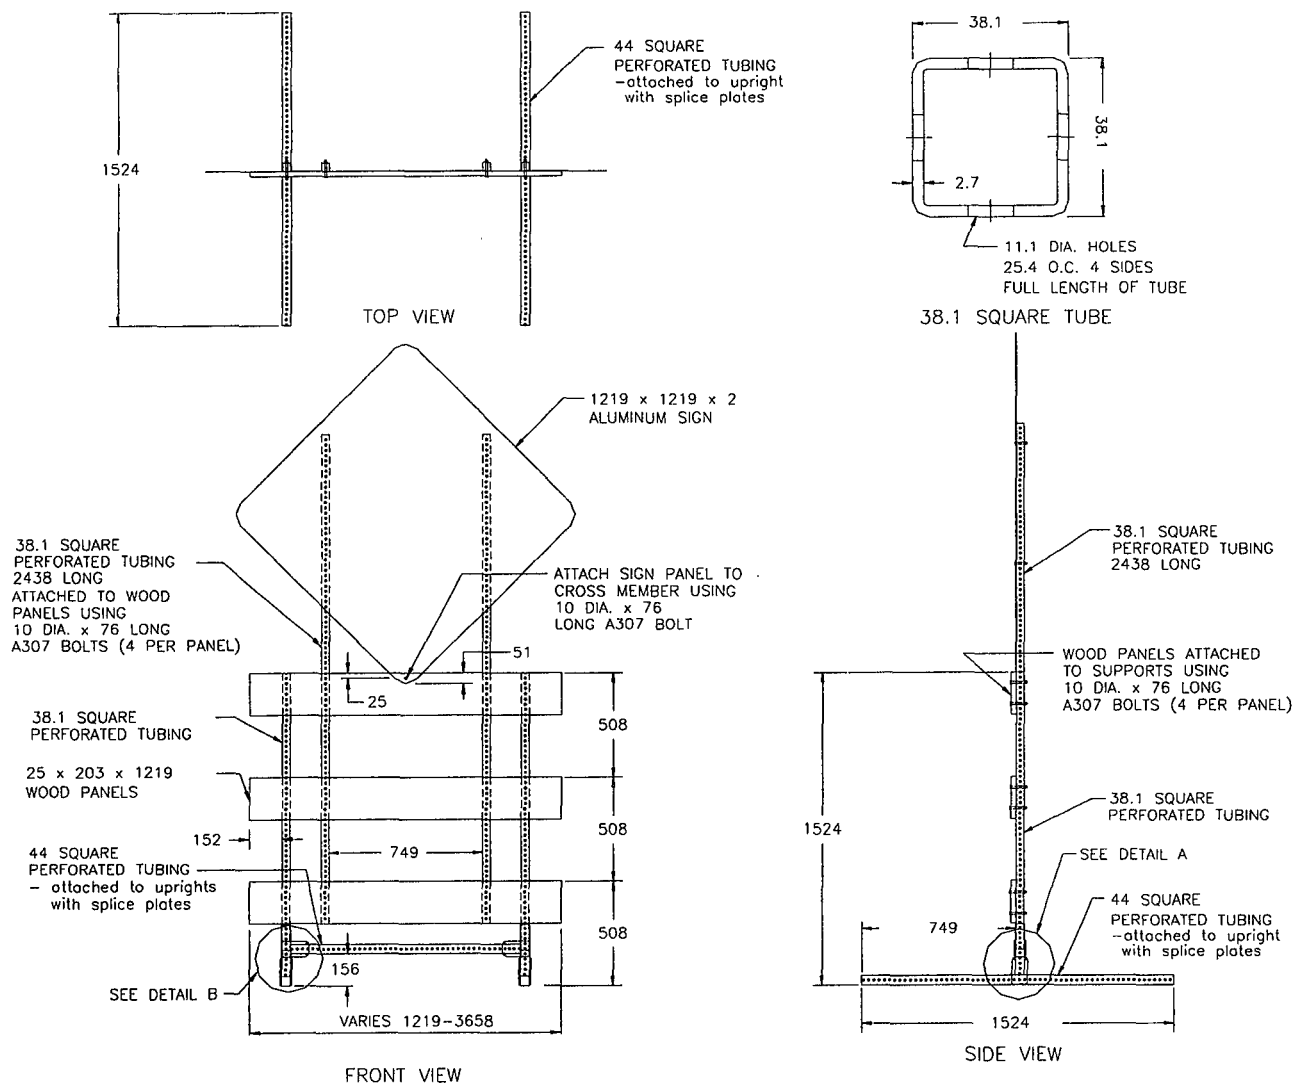
Figure 80. Schematic of Perforated Tubing Type III Barricade with Sign Panel Attached to Cross Members (Test No. 453880-7)

A different sign attachment mechanism was used with a Type III barricade with perforated steel tubing and wooden rail elements in this test. Two cross members fabricated from perforated tubing were bolted to the barricade vertical supports. Two vertical sign supports, also fabricated from perforated tubing, were bolted to the cross members, and an aluminum sign panel was attached to two vertical sign supports. The sign panel was 1219 mm x 1219 mm in size and mounted at a height of 914 mm from the ground to the bottom of the sign panel. Figure 80 shows a schematic of the barricade with the sign attachment. The test vehicle was a 1989 Ford Festiva, as shown in Figure 81. Dimensions and information on the vehicle are given in Appendix Figure 98. The test vehicle impacted the barricade head-on with the centerline of the vehicle aligned with the centerline of the barricade, traveling at a speed of 99.5 km/h.

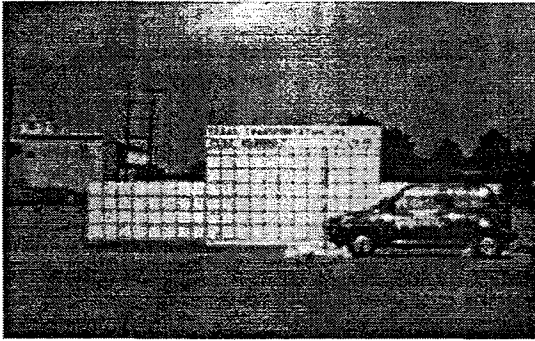
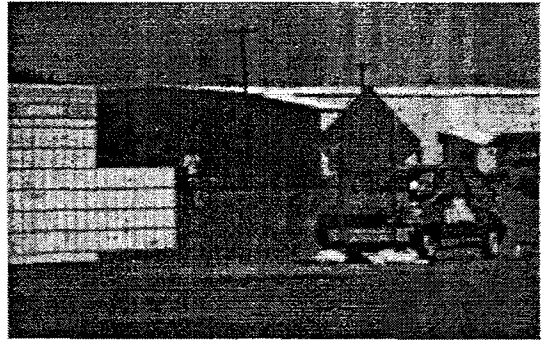
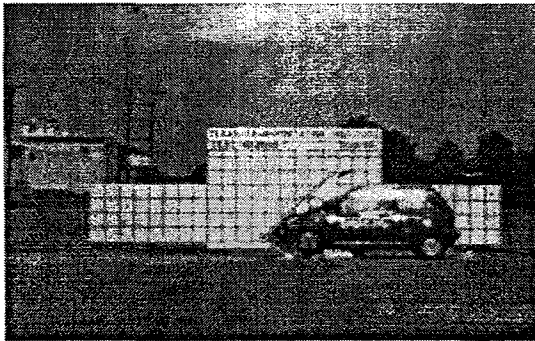
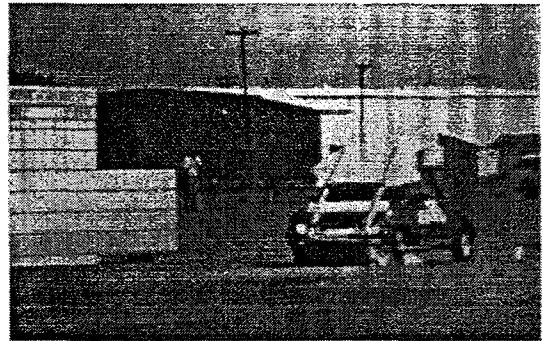
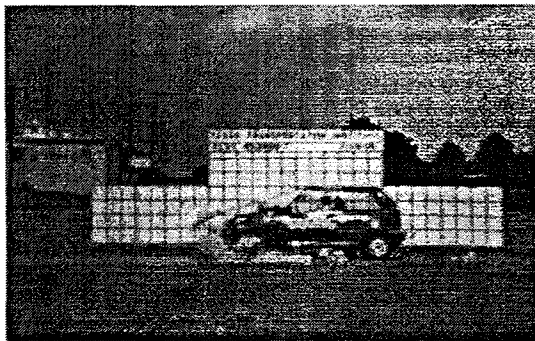
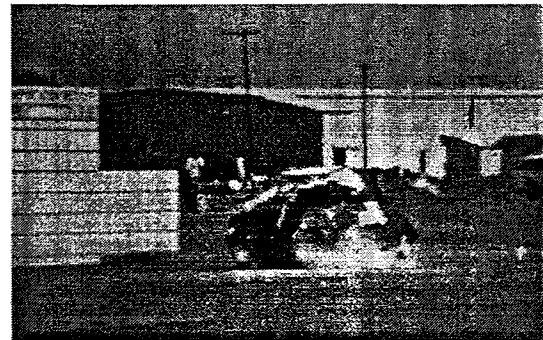
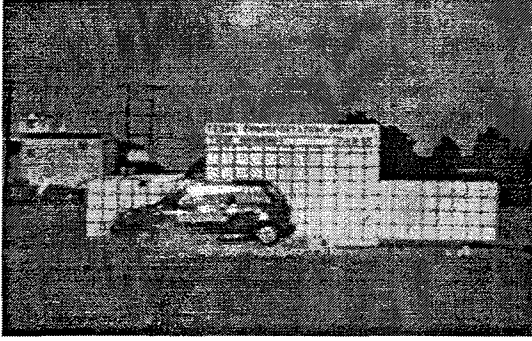
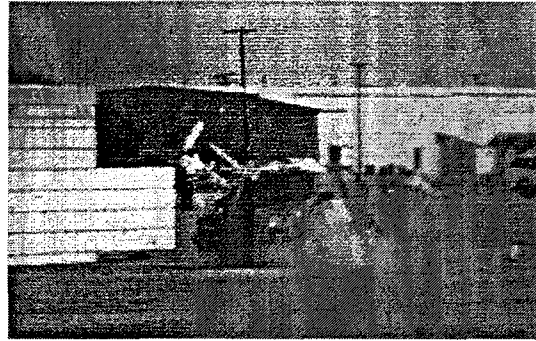
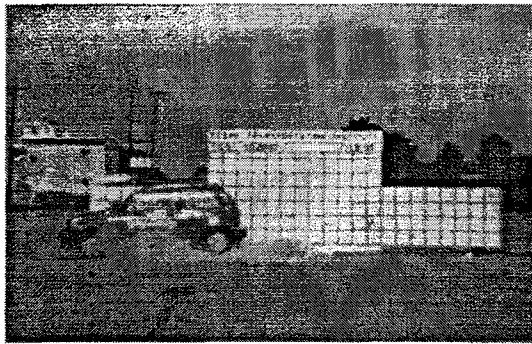
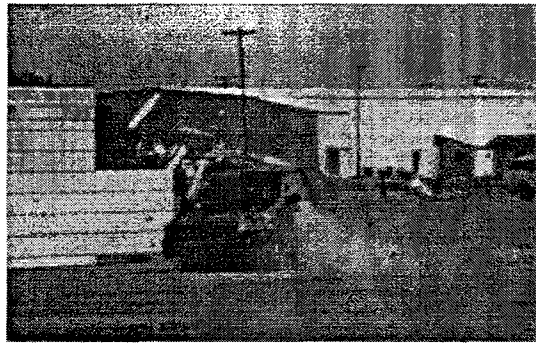
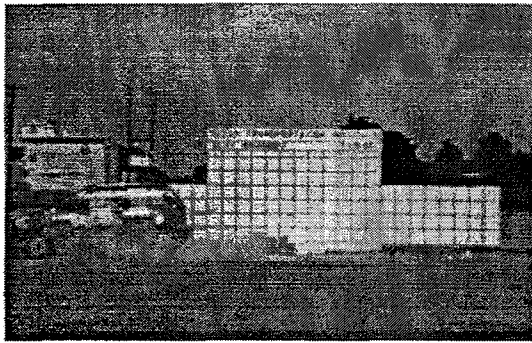
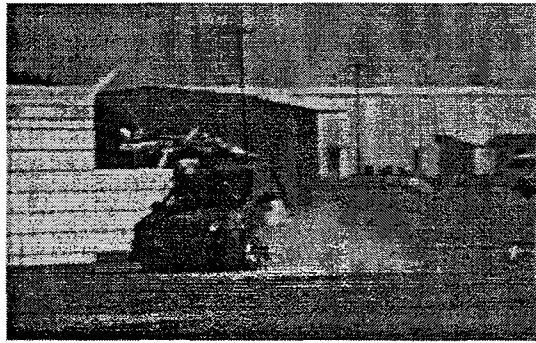
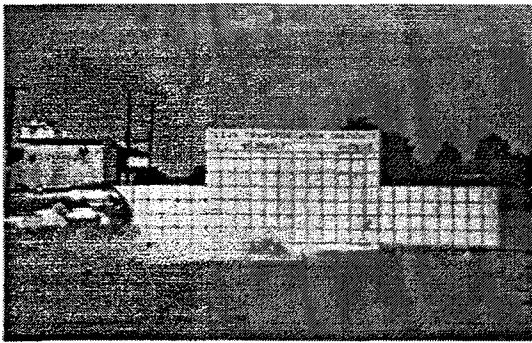
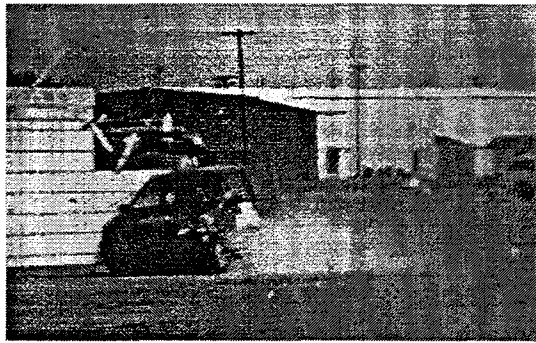
Figure 82. Sequential Photographs for Test No. 453880-7

As the vehicle impacted the barricade, the bottom panel began to break, and the vertical supports began to bend. At 39 msec, the bottom of the sign panel contacted the hood near the windshield. The supports lost contact with the bumper at 47 msec, and the sign panel contacted the windshield at 56 msec. At 130 msec, the sign panel lost contact with the windshield as the vehicle was traveling at 87.0 km/h, and the panel continued to travel in front of the vehicle. Prior to brake application, the vehicle was tracking straightforward. The vehicle subsequently came to rest 91 m down and 9.1 m to the right of the point of impact. Figure 82 shows sequential photographs of the test period.

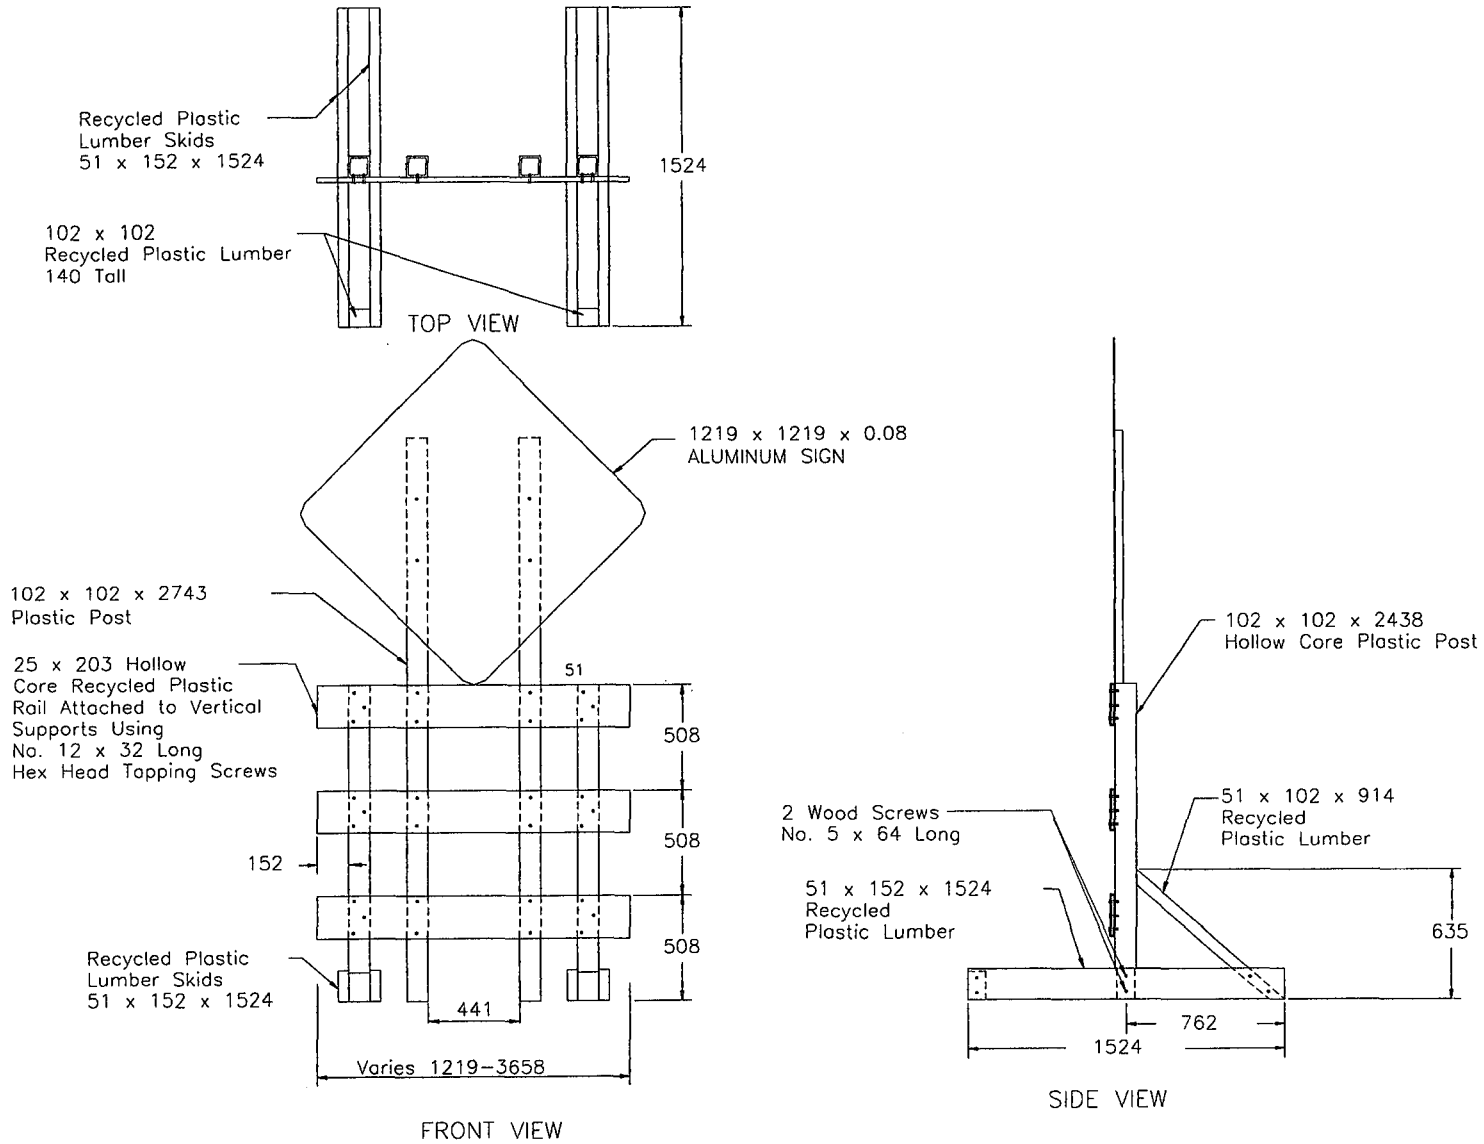
Figure 84. Schematic of Type III Barricade Fabricated from Hollow Core Recycled Plastic Material with Solid Recycled Base and Sign Panel (Test No. 453880-6)

It was observed in the high-speed film that the bottom corner of the aluminum sign panel bent and folded in a manner similar to that observed in a previous test with the perforated tubing using the same 1.52-m mounting height (test no. 453880-5). Therefore, although no intrusion into the occupant compartment was observed in this test, it is the opinion of the researchers that the potential for the corner of the sign panel shattering and penetrating the windshield should be addressed. As with the perforated tubing design, two options are available for eliminating this behavior:

The simpler and more economical of the two modifications is to lower the mounting height by 51 mm and to attach it to the horizontal cross member, as shown in Figure 84. In the opinion of the researchers, modification of the existing hollow core recycled plastic barricade design is not necessary for a 2.13-m mounting height, since the sign panel should not contact the windshield of the impacting vehicle.

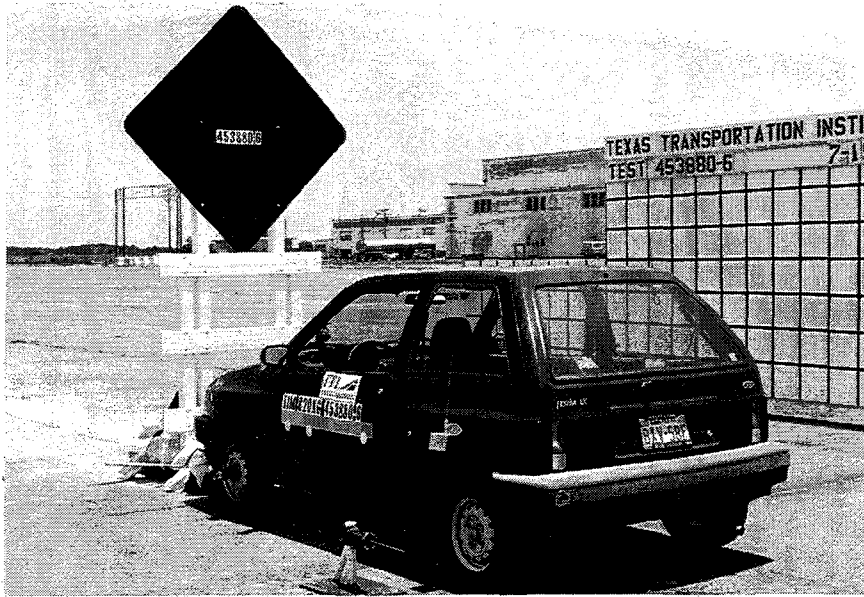
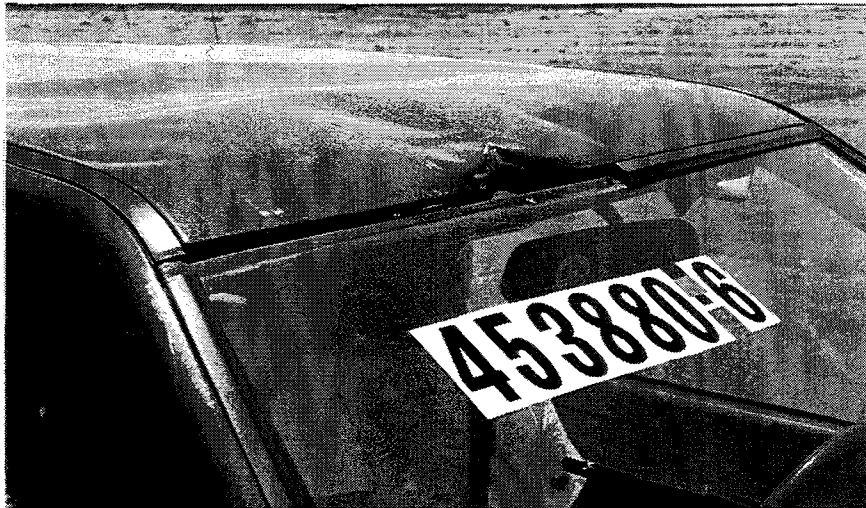
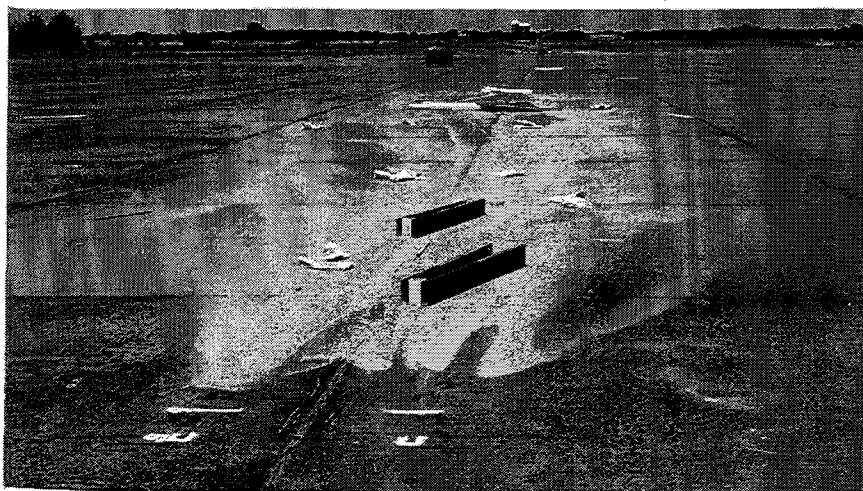
Figure 85. Vehicle and Barricade for Test No. 453880-6

As Figure 85 shows, the barricade shattered upon impact. Debris and sand were strewn along the path of the vehicle in an area 13.0 m wide and 83.2 m long. Figure 85 shows damage to the vehicle. Maximum crush to the exterior of the vehicle was 70 mm on the passenger side just above the windshield. There was scrapes on the hood and roof. There was no deformation or intrusion into the occupant compartment.

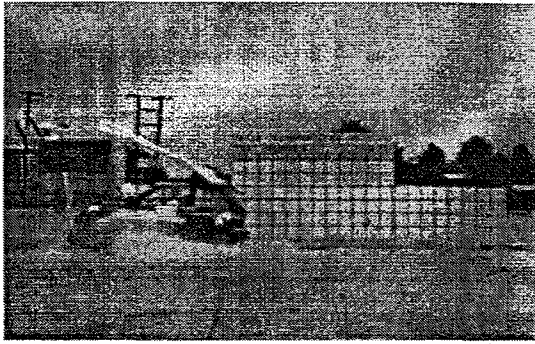
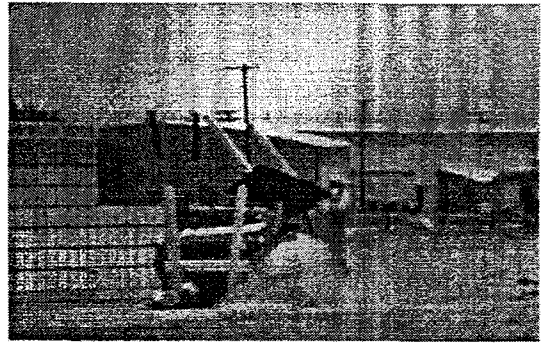
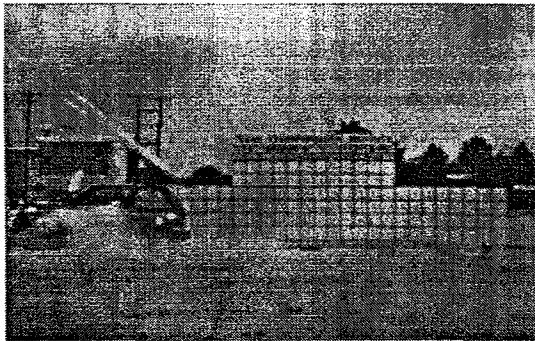
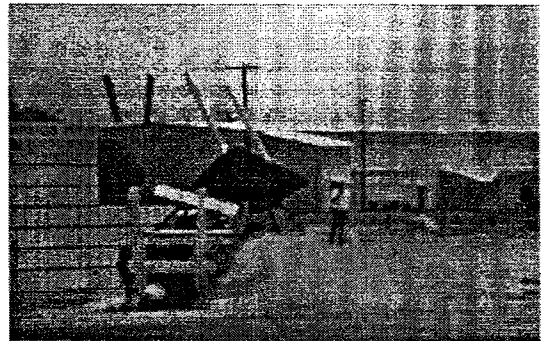
Figure 86. Sequential Photographs for Test No. 453880-6

separated from the base at 152 msec. The vehicle lost contact with the barricade at 199 msec, traveling at a speed of 87.2 km/h. Prior to brake application, the vehicle was tracking straight-forward. The vehicle subsequently came to rest 80 m down and 5.7 m to the right of the point of impact. Figure 86 shows sequential photographs of the test period.
