# **DEVELOPMENT OF THE MIDWEST GUARDRAIL SYSTEM (MGS) W-BEAM TO THREE BEAM TRANSITION ELEMENT**

## **MIDWEST ROADSIDE SAFETY FACILITY**

MwRSF Research Report No. TRP-03-167-07

November 26, 2007

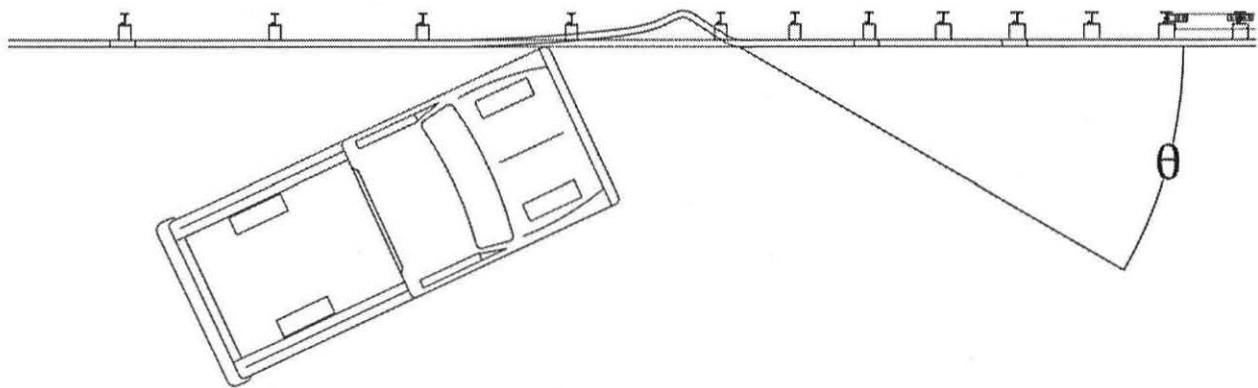
Figure 1. Critical Pocketing Angle

Although BARRIER VII (10) can predict the creation of a sharp bend in a guardrail system that could lead to pocketing, there are no objective criteria with which to measure the risk of serious consequences associated with pocketing. After reviewing crash tests of many guardrail systems, it was theorized that at a critical pocketing angle,  $\theta_p$ , could be defined such that at angles smaller than  $\theta_p$ , the bend in the guardrail would not cause serious pocketing. However, at angles more severe than  $\theta_p$ , where the difference between the guardrail and transition regions was more abrupt, the vehicle

would not be able to escape from the pocket and an undesirable vehicle response could be expected. The critical pocketing angle is defined as the angle between the guardrail region just in front of the impacting vehicle and the downstream section of rail. Note that this definition of  $\theta_p$  is only applicable where there is a sharp bend in the guardrail, and the pocketing angle is essentially a measure of the magnitude of that angle. It should also be noted that the depth of the pocket may also have a significant impact on the performance of a guardrail system. However, for the purposes of using BARRIER VII to design a guardrail stiffness transition, the authors have assumed that the depth of the pocket will always be sufficient to create a problem, provided the critical pocketing angle is reached, as shown in Figure 1.

Many guardrail and approach guardrail transition tests involving 2000P vehicles were carefully reviewed in order to identify the critical pocketing angle. Based upon this analysis, the critical pocketing angle was estimated to be approximately 23 degrees. Every test that exhibited a pocketing angle of 23 degrees or less resulted in a successful redirection of the 2000P vehicle,

whereas most tests with pocketing angles greater than 23 degrees exhibited significant pocketing and corresponding adverse vehicle behavior. For example, the pocketing angle from test no. MWT-2 was estimated to be 45 degrees. As a result of the pocketing, the rail ruptured and the test vehicle rolled over during the test.

Following the unacceptable performance of the initial 2000P test on the approach guardrail transition, it was necessary to determine the cause of the poor barrier performance and make design modifications to the barrier system in order to improve its overall performance (8). From an analysis of the test results, the test failed due to the abrupt stiffness change between the approach guardrail and the stiff transition system. Hence, it was determined that the W-beam to thrie beam transition element performed acceptably and that the approach to the transition element should be stiffened to eliminate the severe pocketing that was observed.

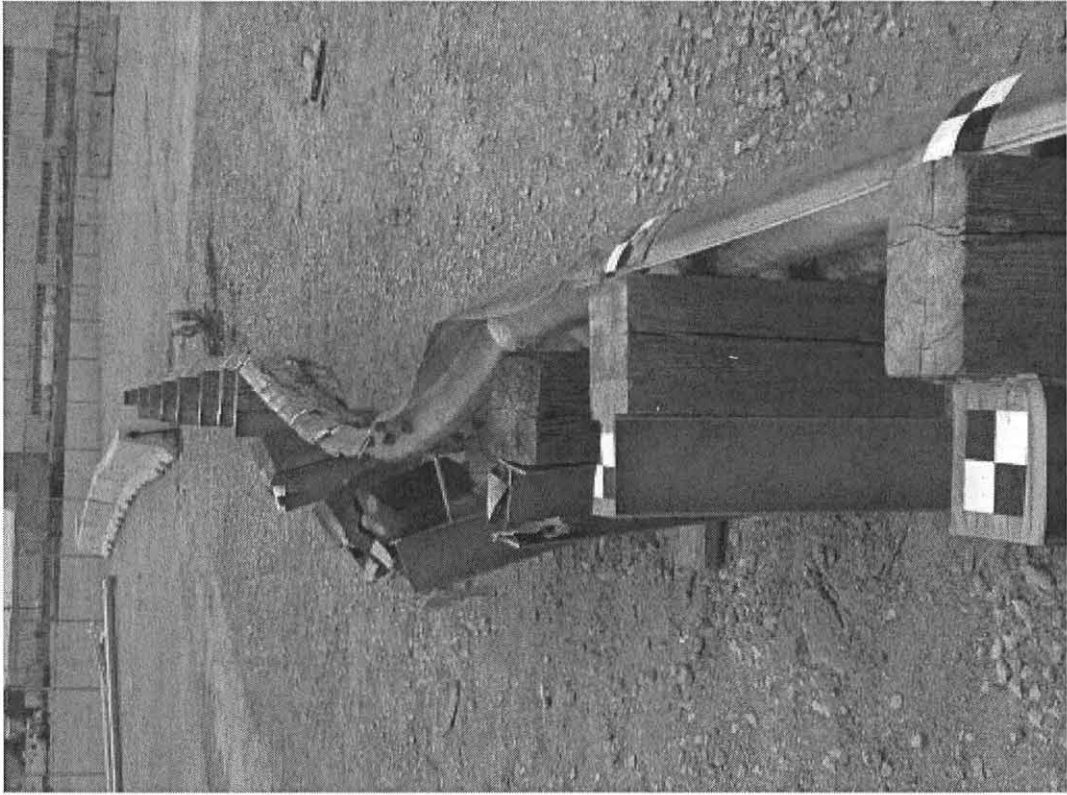
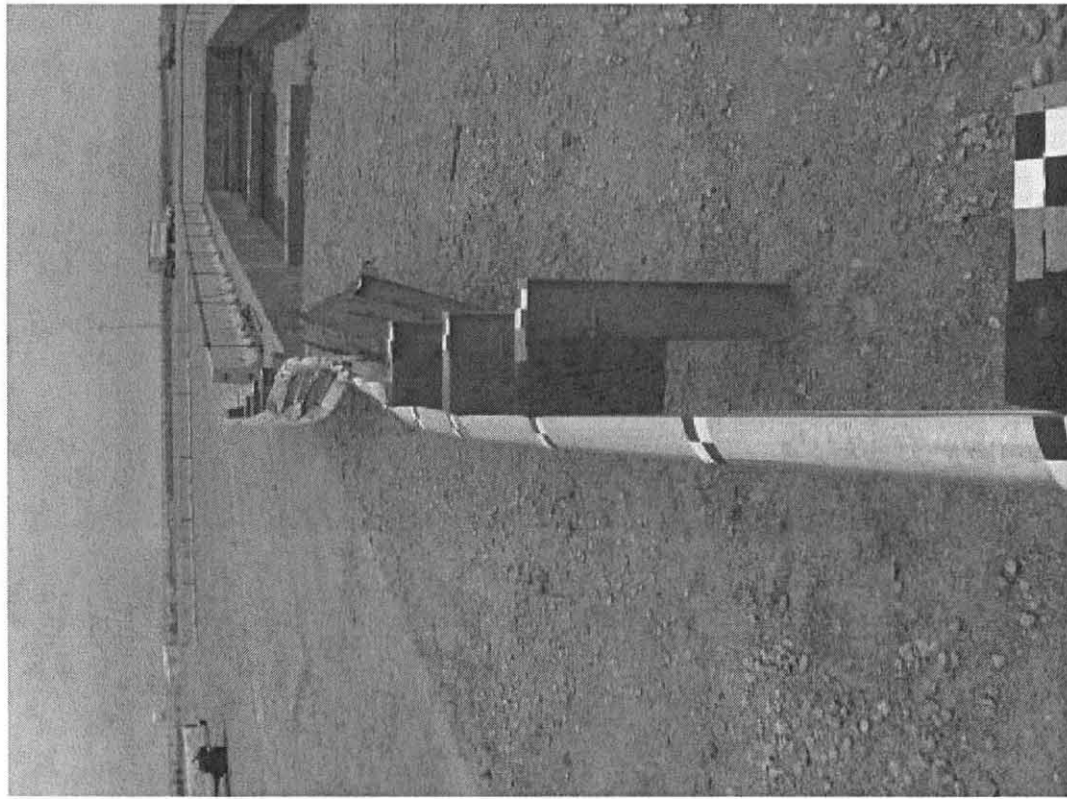
Figure 39. System Damage, Test MWT-3

Damage to the barrier was moderate, as shown in Figures 39 through 45. Barrier damage consisted of deformed guardrail and posts, contact marks on a guardrail section, and fractured wooden spacer blockouts. The length of vehicle contact along the approach guardrail system was approximately 5.7 m (18.75 ft), which spanned from 203 mm (8 in.) upstream from the centerline of post no. 9 through 203 mm (8 in.) upstream from the centerline of post no. 15.

The permanent set of the barrier system is shown in Figure 39. The maximum lateral permanent set rail and post deflections were 389 mm (15.3 in.) at the centerline of post no. 12 and 556 mm (21.9 in.) at the centerline of post no. 11, respectively, as measured in the field. The maximum lateral dynamic rail and post deflections were 620 mm (24.4 in.) at the centerline of post no. 12 and 649 mm (25.5 in.) at the centerline of post no. 11, respectively, as determined from the high-speed film analysis. The working width of the system was found to be 785 mm (30.9 in.).

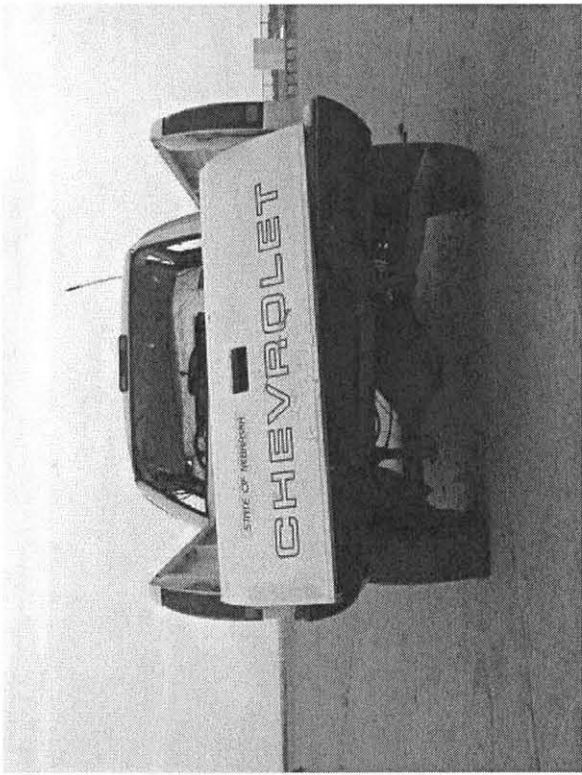
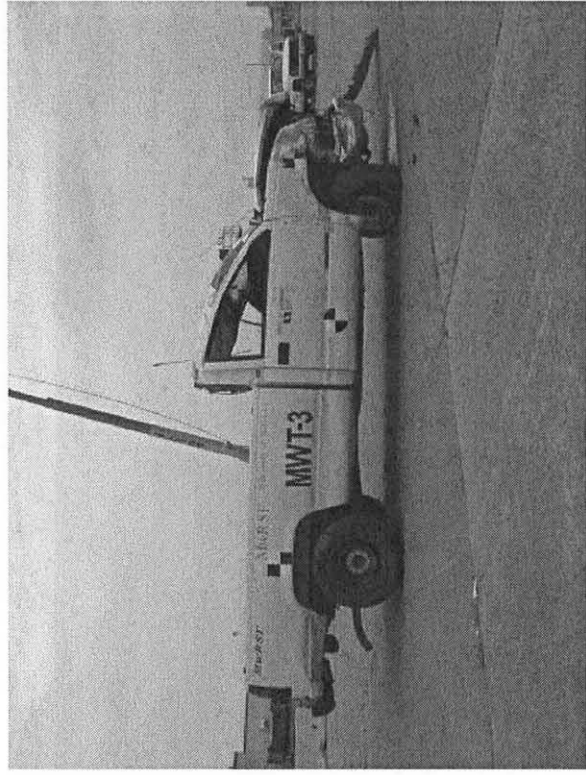
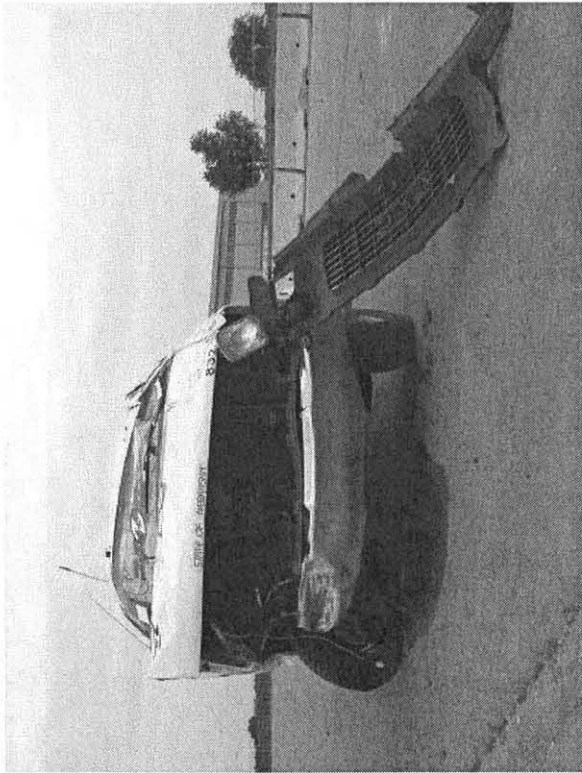
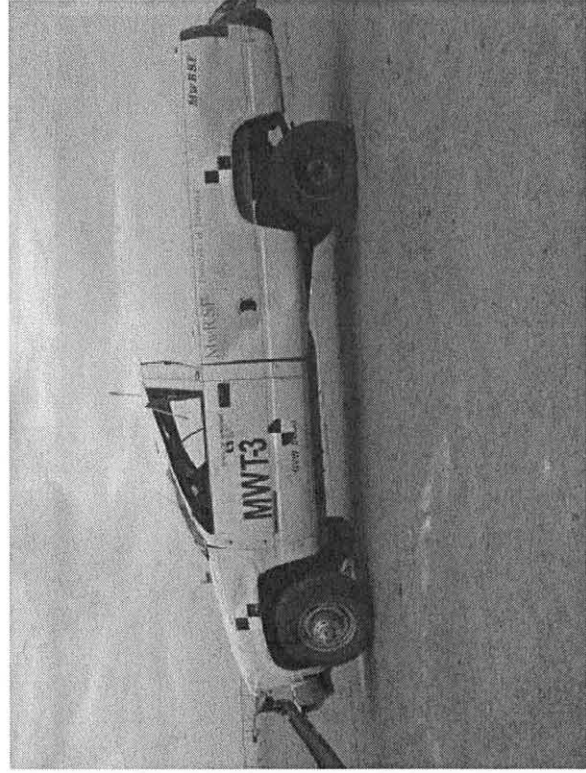
Figure 46. Vehicle Damage, Test MWT-3

Exterior and interior damage to the vehicle was extensive, as shown in Figures 46 through 49. Occupant compartment deformations to the roof were severe due to vehicle rollover. However, the floorboard and firewall deformations were minimal. Complete occupant compartment deformations and the corresponding locations are provided in Appendix C.

Most of the damage was concentrated on the front, both the left and right sides, and the roof of the vehicle due to rollover, as shown in Figure 46. The right-front corner of the vehicle was

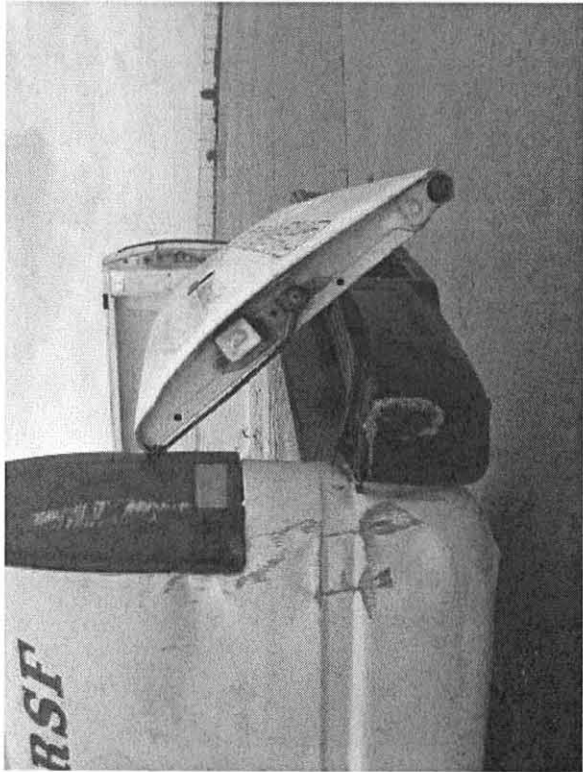
Figure 48. Vehicle Damage, Test MWT-3

The damage to the frame was minimal and focused mainly around the bumper bracket and frame horns. Deformations to the vehicle's body were evident on the right side in the shape of the guardrail. Left-side damage was limited to light scraping and box deformations due to rollover. The windshield was shattered but remained intact due to the safety layer, as shown in Figure 48. All other window glass shattered and was removed from the system.

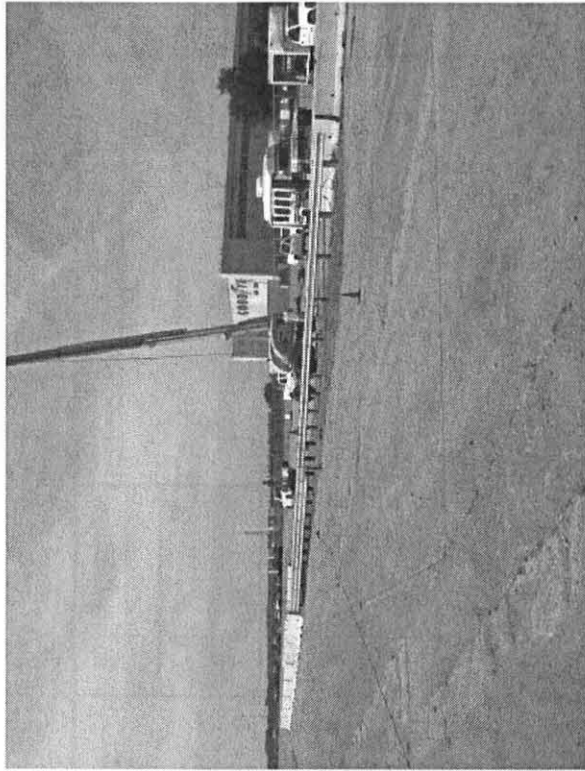
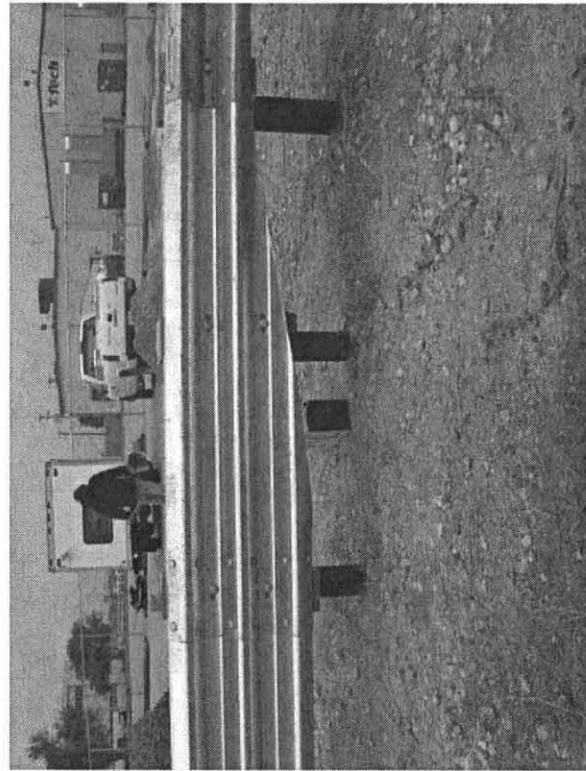
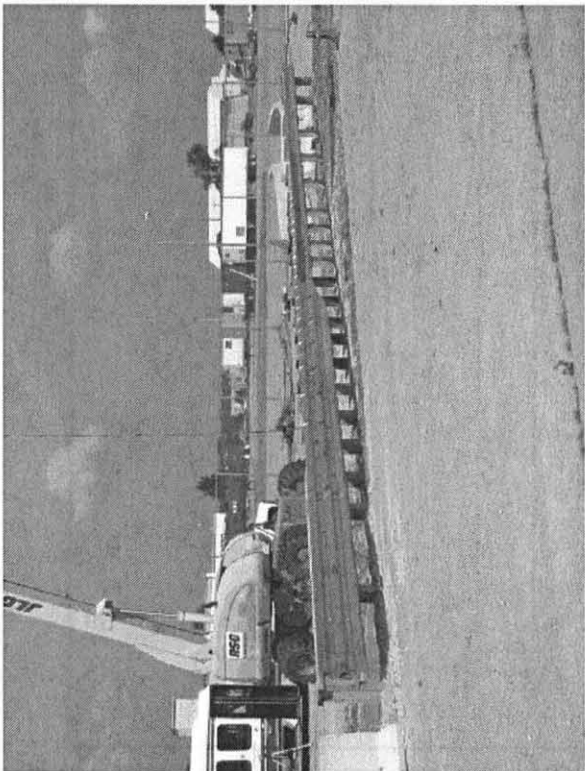
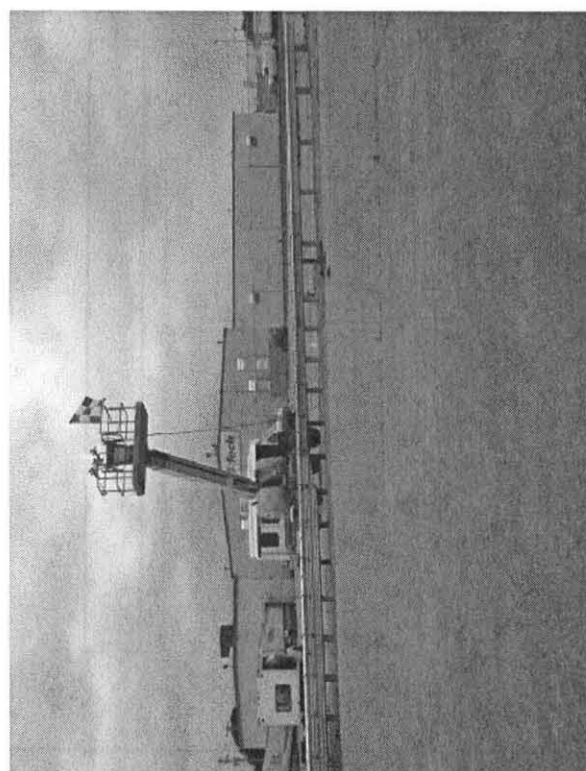
Figure 61. System and Transition Element (Design No. 2)

Additionally, the only asymmetrical W-beam to thrie beam transition element available was a segment fabricated by cutting a triangular piece from the bottom of a standard 2.67-mm (12-gauge) thick thrie beam rail. A 3.43-mm (10-gauge) thick flat plate was welded along a portion of the cut region to reduce the risk of the exposed edge slicing through the sheet metal on an impacting vehicle, as shown in Figure 61. Although, this element clearly included some undesirable stress concentrations, it was the only readily available alternative.

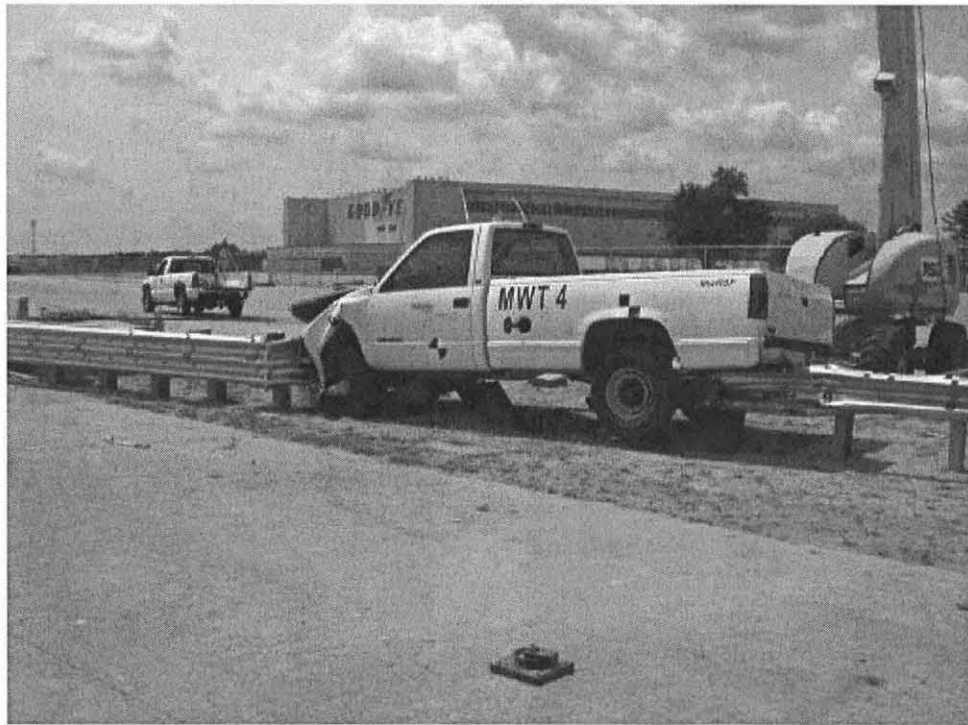
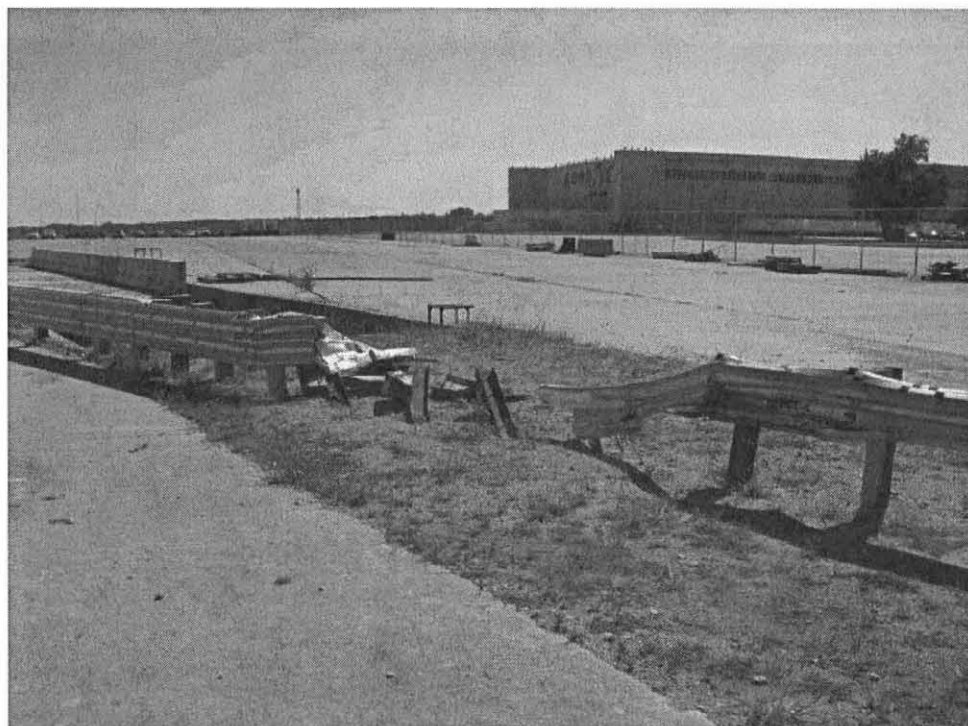
Figure 70. System Damage, Test MWT-4

Barrier damage was extensive as shown in Figures 70 through 76. Barrier damage consisted of deformed guardrail and posts, ruptured guardrail, fractured blockouts, and contact marks on a guardrail section. The length of vehicle contact along the approach guardrail system was approximately 5.9 m (19.5 ft), which spanned from 229 mm (9 in.) upstream from the centerline of post no. 9 through the centerline of post no. 15.

The guardrail damage consisted of significant contact marks and moderate deformation and flattening of the impacted section of W-beam and thrie beam rail between post nos. 9 and 14. The guardrail buckled at post nos. 8, 9, 14, 15, and 16 and 89 mm (3.5 in.) downstream of post no. 10. The guardrail bent around the blockouts at post nos. 9 and 10. The W-beam guardrail was torn

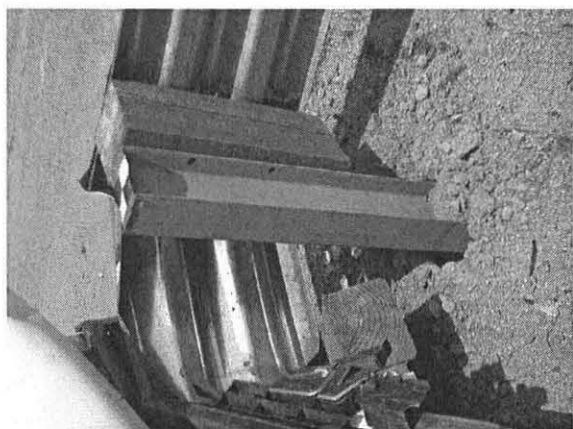
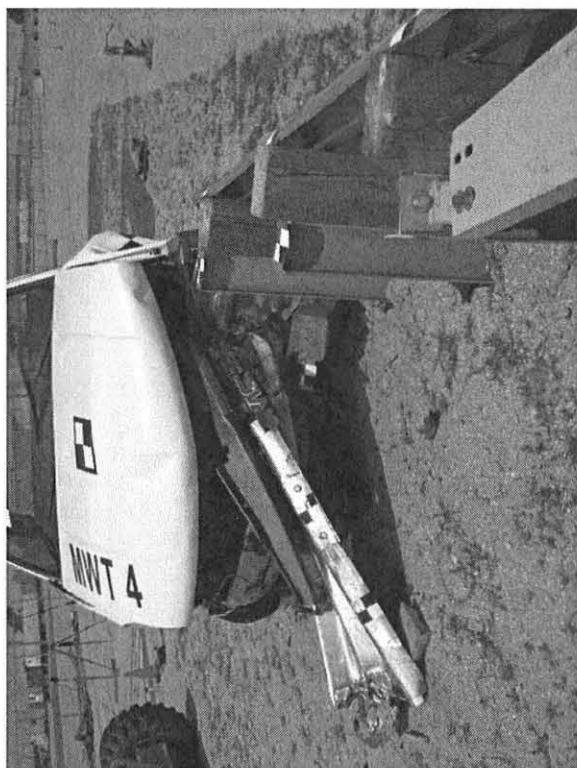
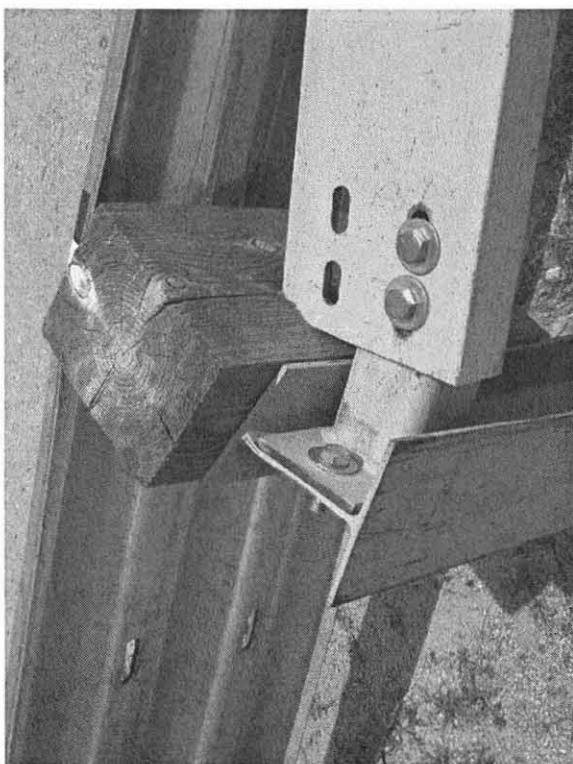
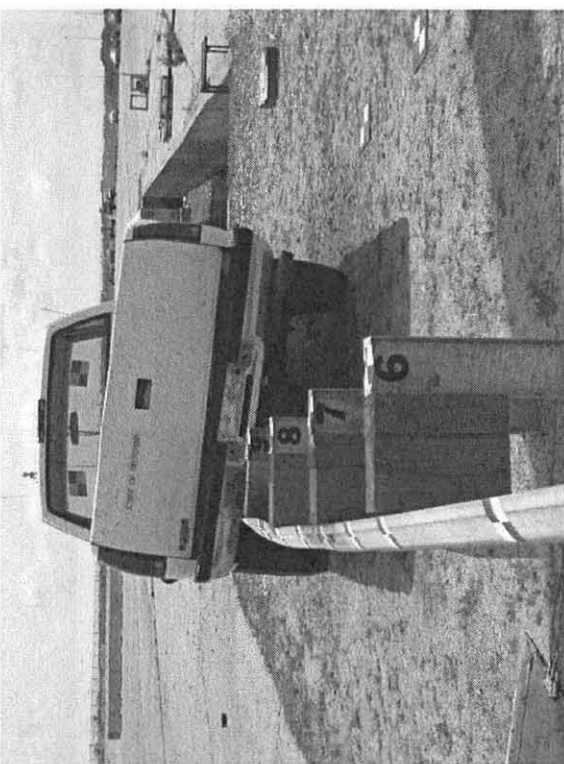
Figure 71. System Damage, Test No. MWT-4

Steel post nos. 3 through 7 twisted and rotated slightly downstream. Post nos. 8 through 10 rotated backward slightly and bent longitudinally downstream. Post nos. 11 through 14 rotated backwards and bent longitudinally downstream. Post nos. 11 and 12 also encountered contact marks on the upstream front flange and rear flange, respectively. Post nos. 15 through 21 bent slightly downstream, and post nos. 15 through 18 also rotated backward slightly. The upstream anchorage system moved slightly longitudinally, but the posts were not damaged.

The wooden blockouts at post nos. 9 and 15 through 17 encountered minor deformations due to rail interaction, while the wooden blockout at post no. 10 encountered more significant deformations. The wooden blockout at post no. 14 encountered moderate damage due to the post bolt pulling partially through the blockout. The wooden blockouts at post nos. 13 and 18 were fractured but remained attached to the post. The wooden blockouts at post nos. 11 and 12 disengaged from the system. The steel blockouts at post nos. 19 through 21 twisted slightly downstream. The blockouts at post nos. 3 through 8 remained undamaged.

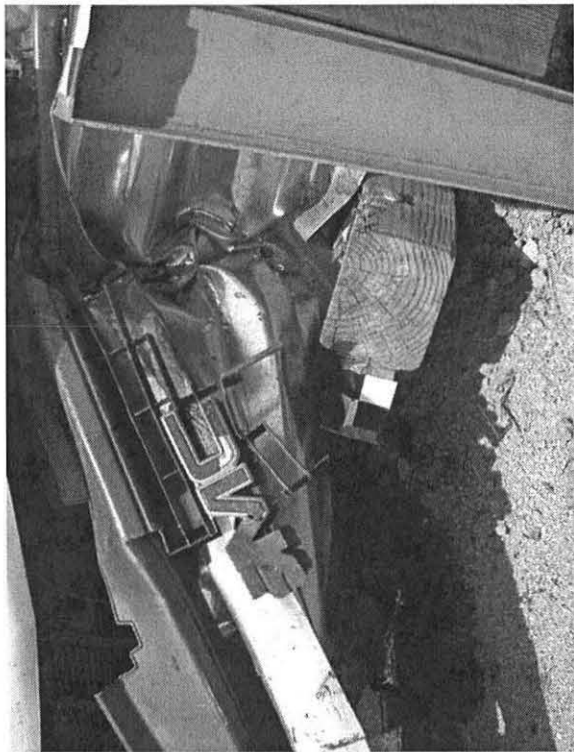
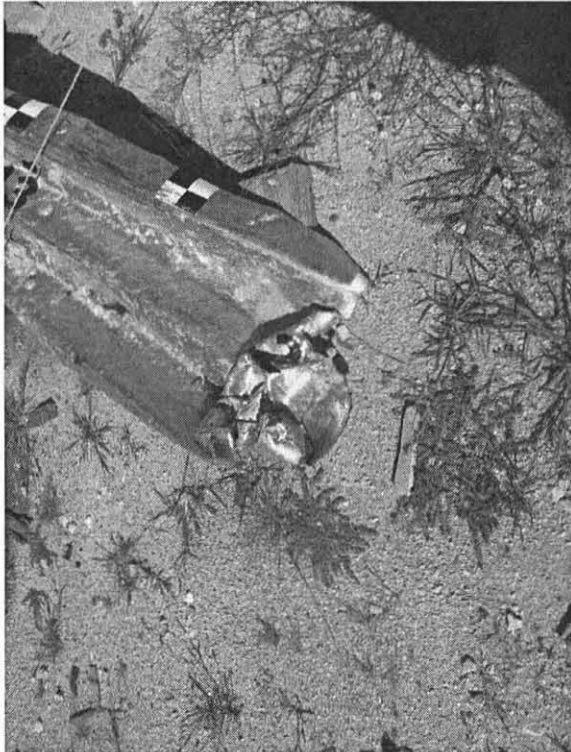
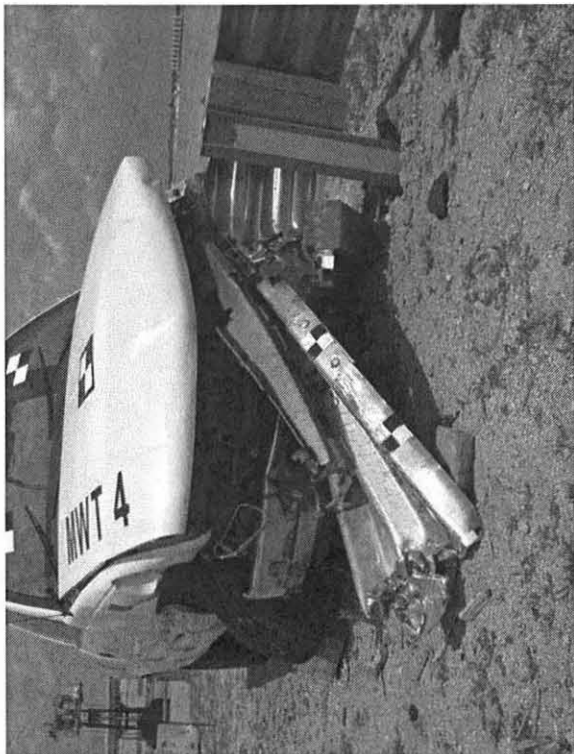
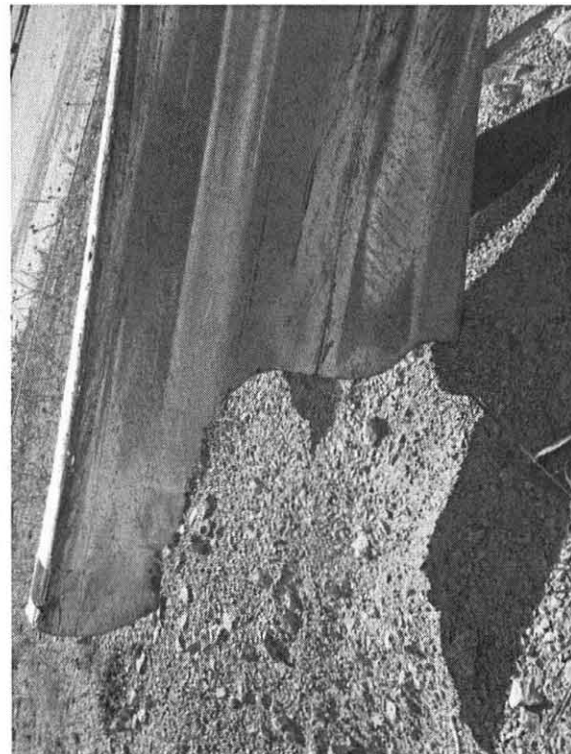
through the cross section, beginning at the bottom of the W-beam to thrie beam transition element 476 mm (18.75 in.) downstream of the centerline of post no. 11, propagating up vertically 267 mm (10.5 in.), then horizontally 305 mm (12 in.), and then vertically once again ending at the top of the W-beam rail at the centerline of post no. 12 as shown in Figure 72. The W-beam was pulled off of post nos. 6, 10, and 13. The W-beam guardrail sustained significant yielding around the post bolt slots at post nos. 3 through 5 and 7 through 12, and the post bolt slot at post no. 8 also sustained small tears. The thrie beam guardrail sustained significant yielding around the post bolt slots at post nos. 14 through 18. No significant guardrail damage occurred downstream of post no. 16.

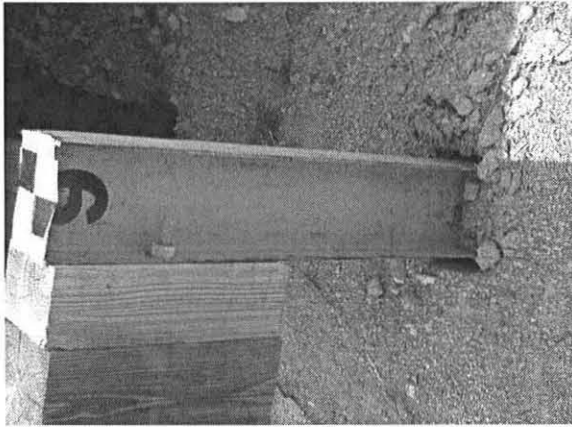
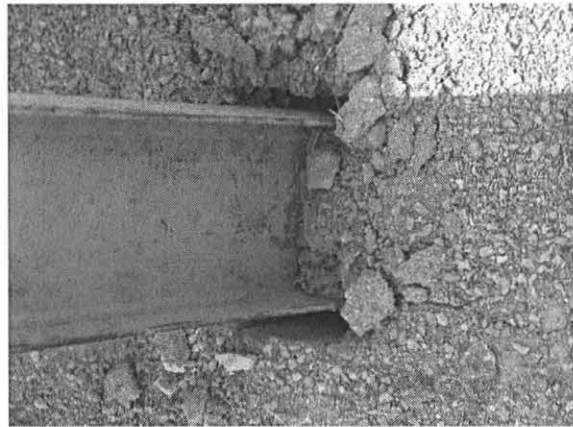
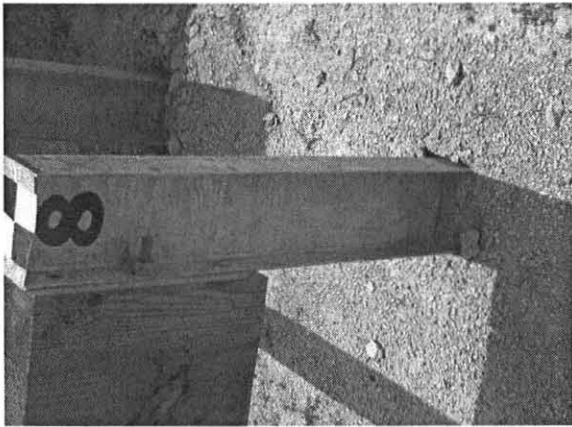
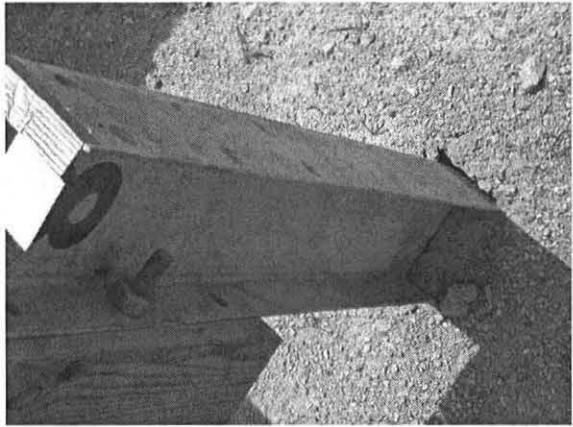
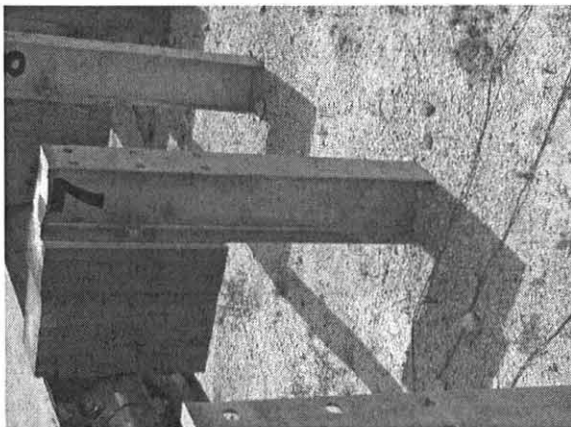
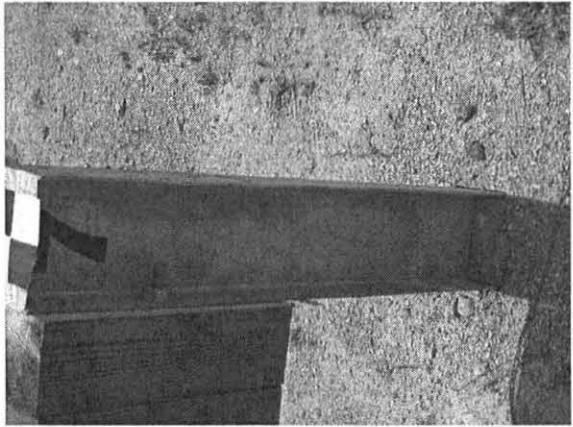
Figure 73. Post Nos. 1, 2, 5, and 6 Damage, Test MWT-4

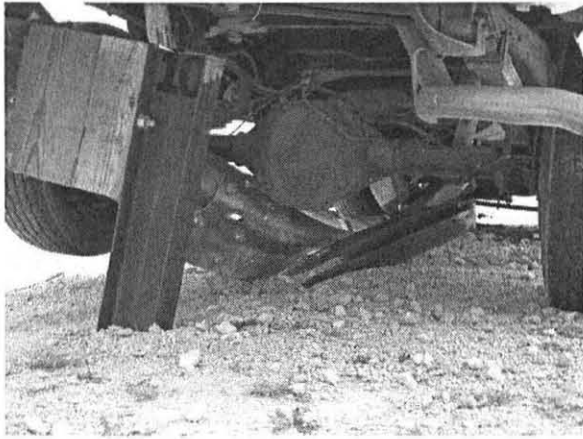
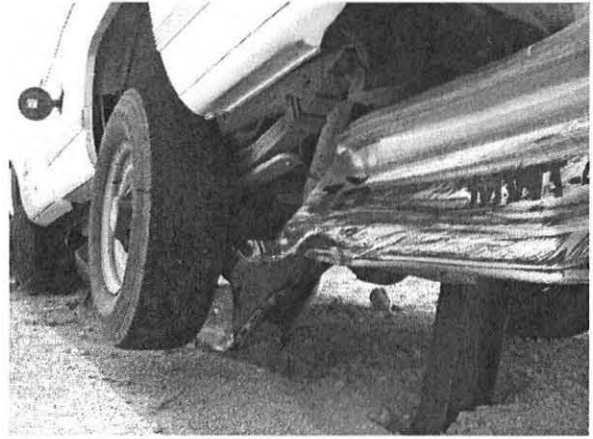
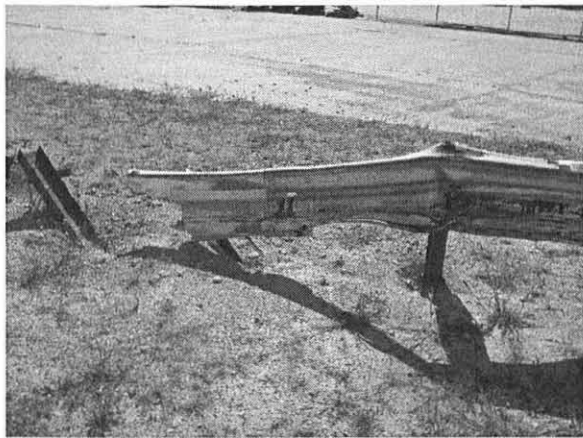
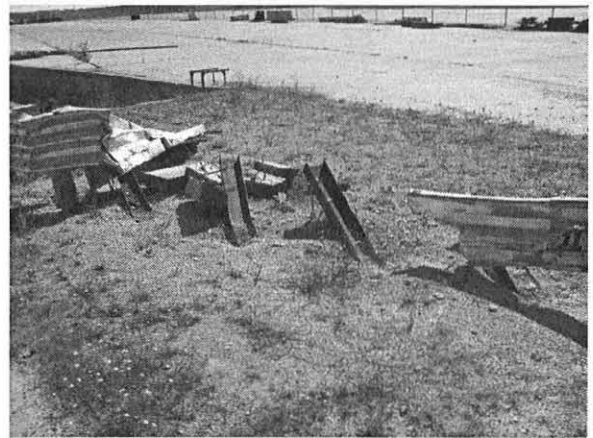
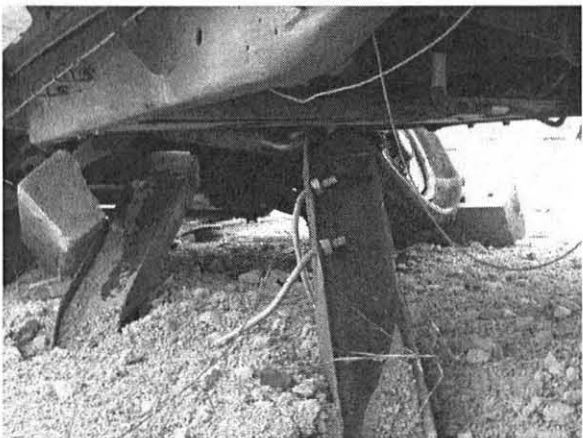
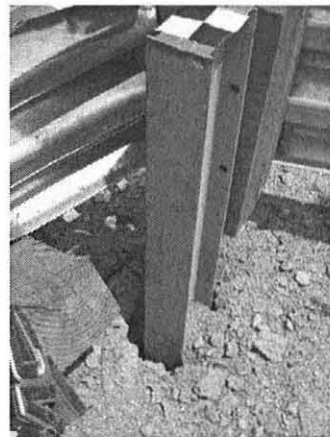
Figure 74. Post Nos. 7 through 9 Damage, Test MWT-4

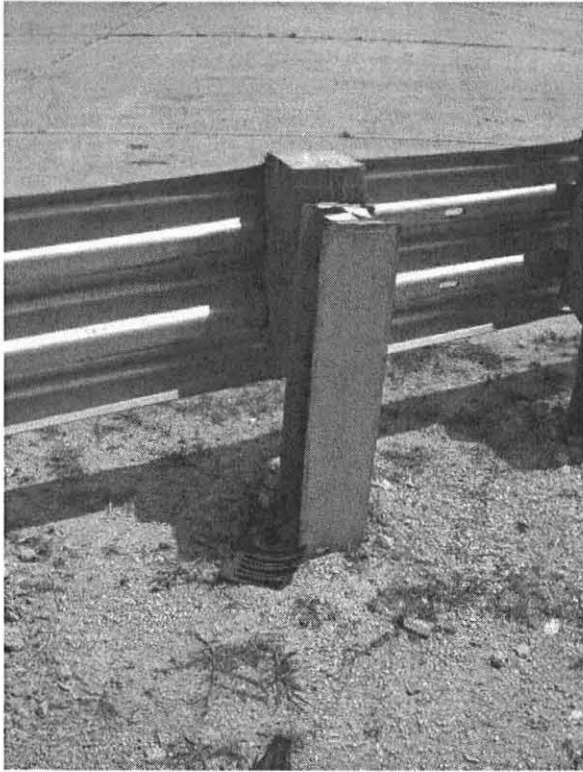
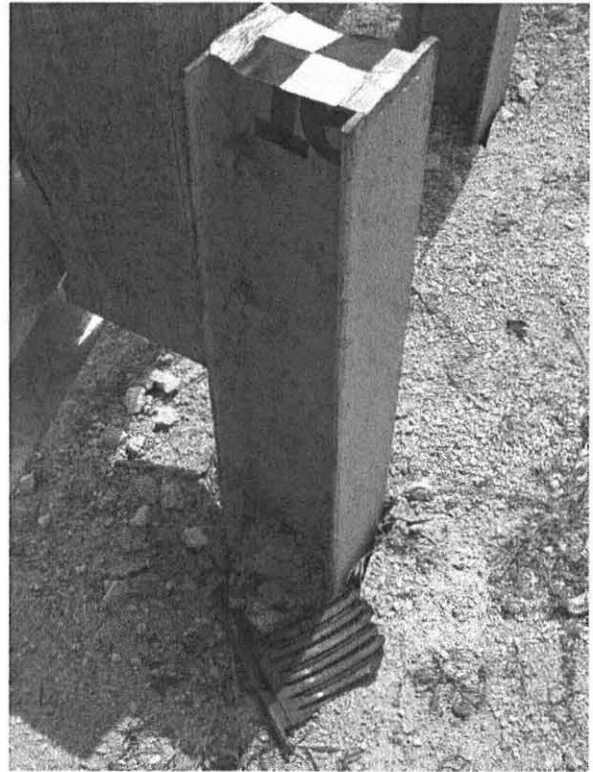
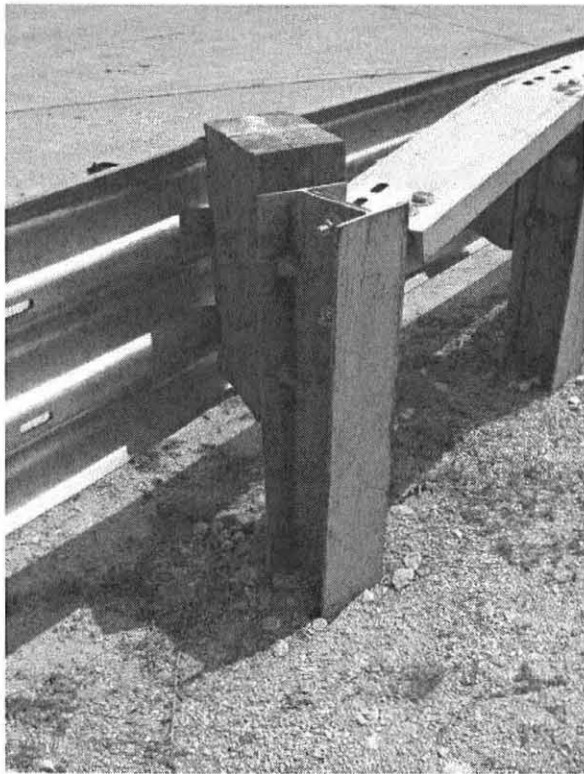
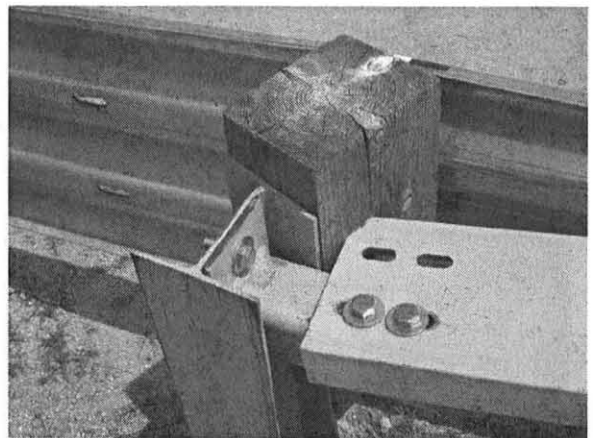
Figure 75. Post Nos. 10 through 15 Damage, Test MWT-4

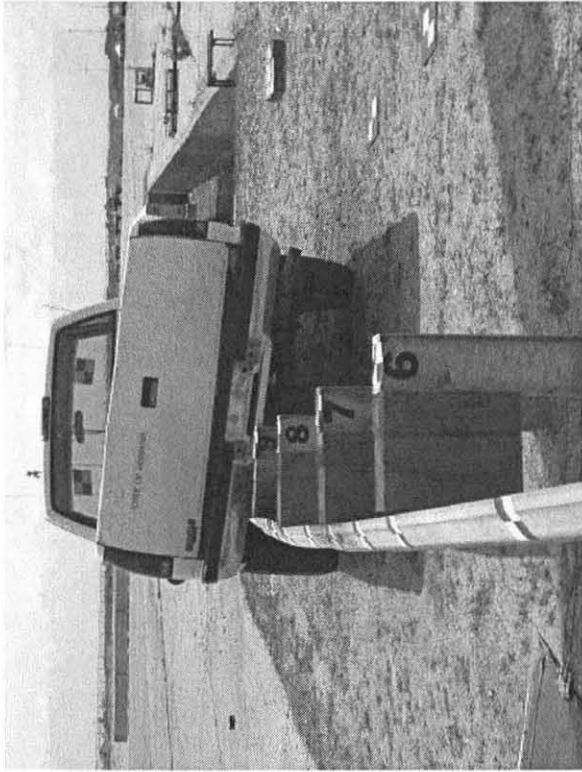
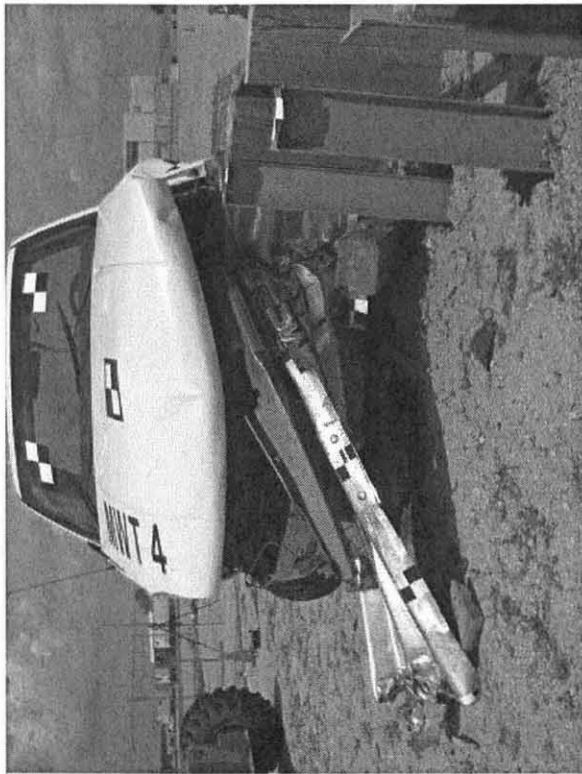
Figure 76. Post Nos. 16 and 17 Damage, MWT-4

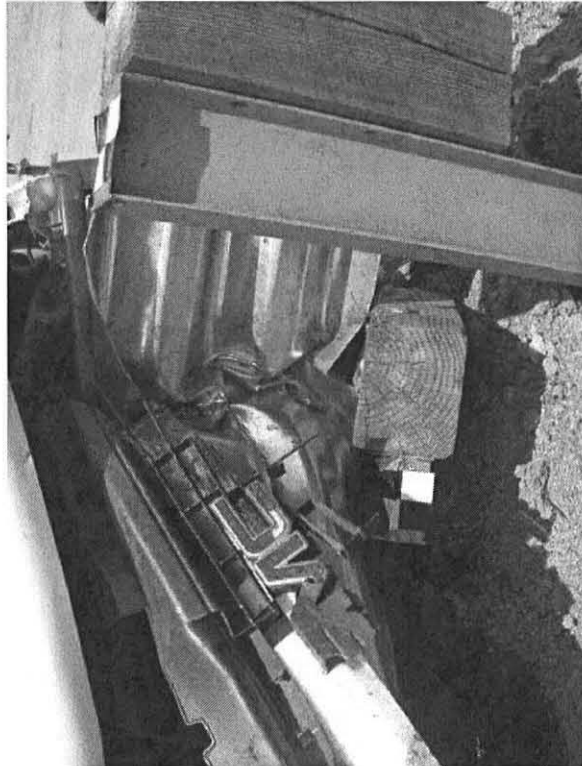
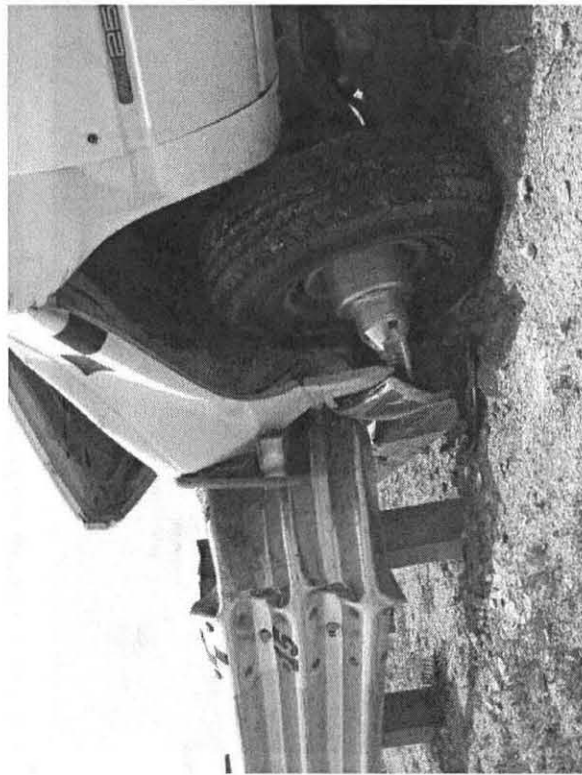
Exterior vehicle damage was moderate, as shown in Figures 77 and 80. Extensive occupant compartment deformations occurred with the penetration of the center of the floorboard, as shown in Figure 80. The drive shaft U-joint penetrated through and caused a 178-mm (7-in.) slice in the floorboard. A 64-mm (2.5-in.) dent was also found in the floorboard. Complete occupant compartment deformations and the corresponding locations are provided in Appendix C.

Figure 77. Vehicle Damage, Test MWT-4

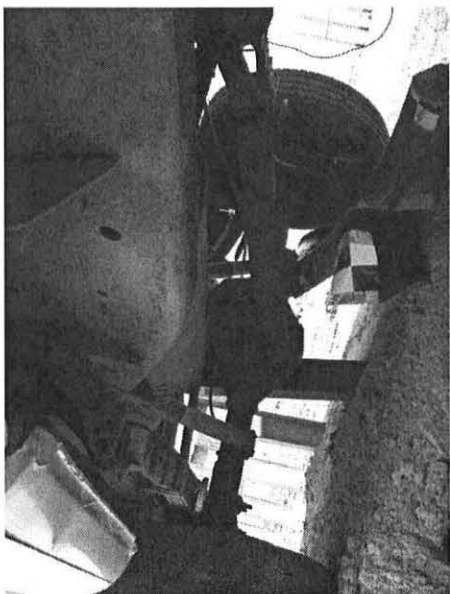
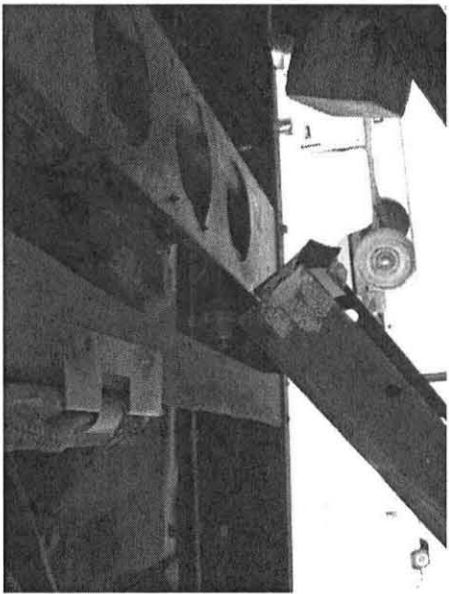
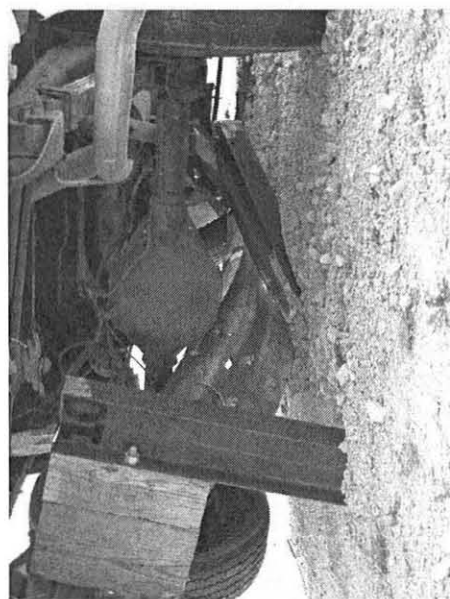
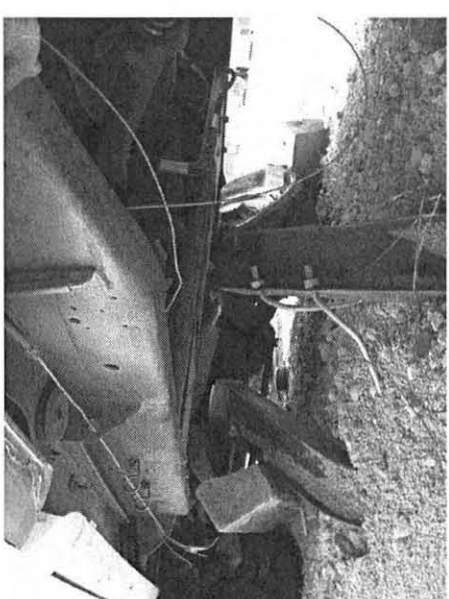
Figure 78. Vehicle Damage, Test MWT-4
