# **DEVELOPMENT OF THE MIDWEST GUARDRAIL SYSTEM (MGS) W-BEAM TO THREE BEAM TRANSITION ELEMENT**

## **MIDWEST ROADSIDE SAFETY FACILITY**

MwRSF Research Report No. TRP-03-167-07

November 26, 2007

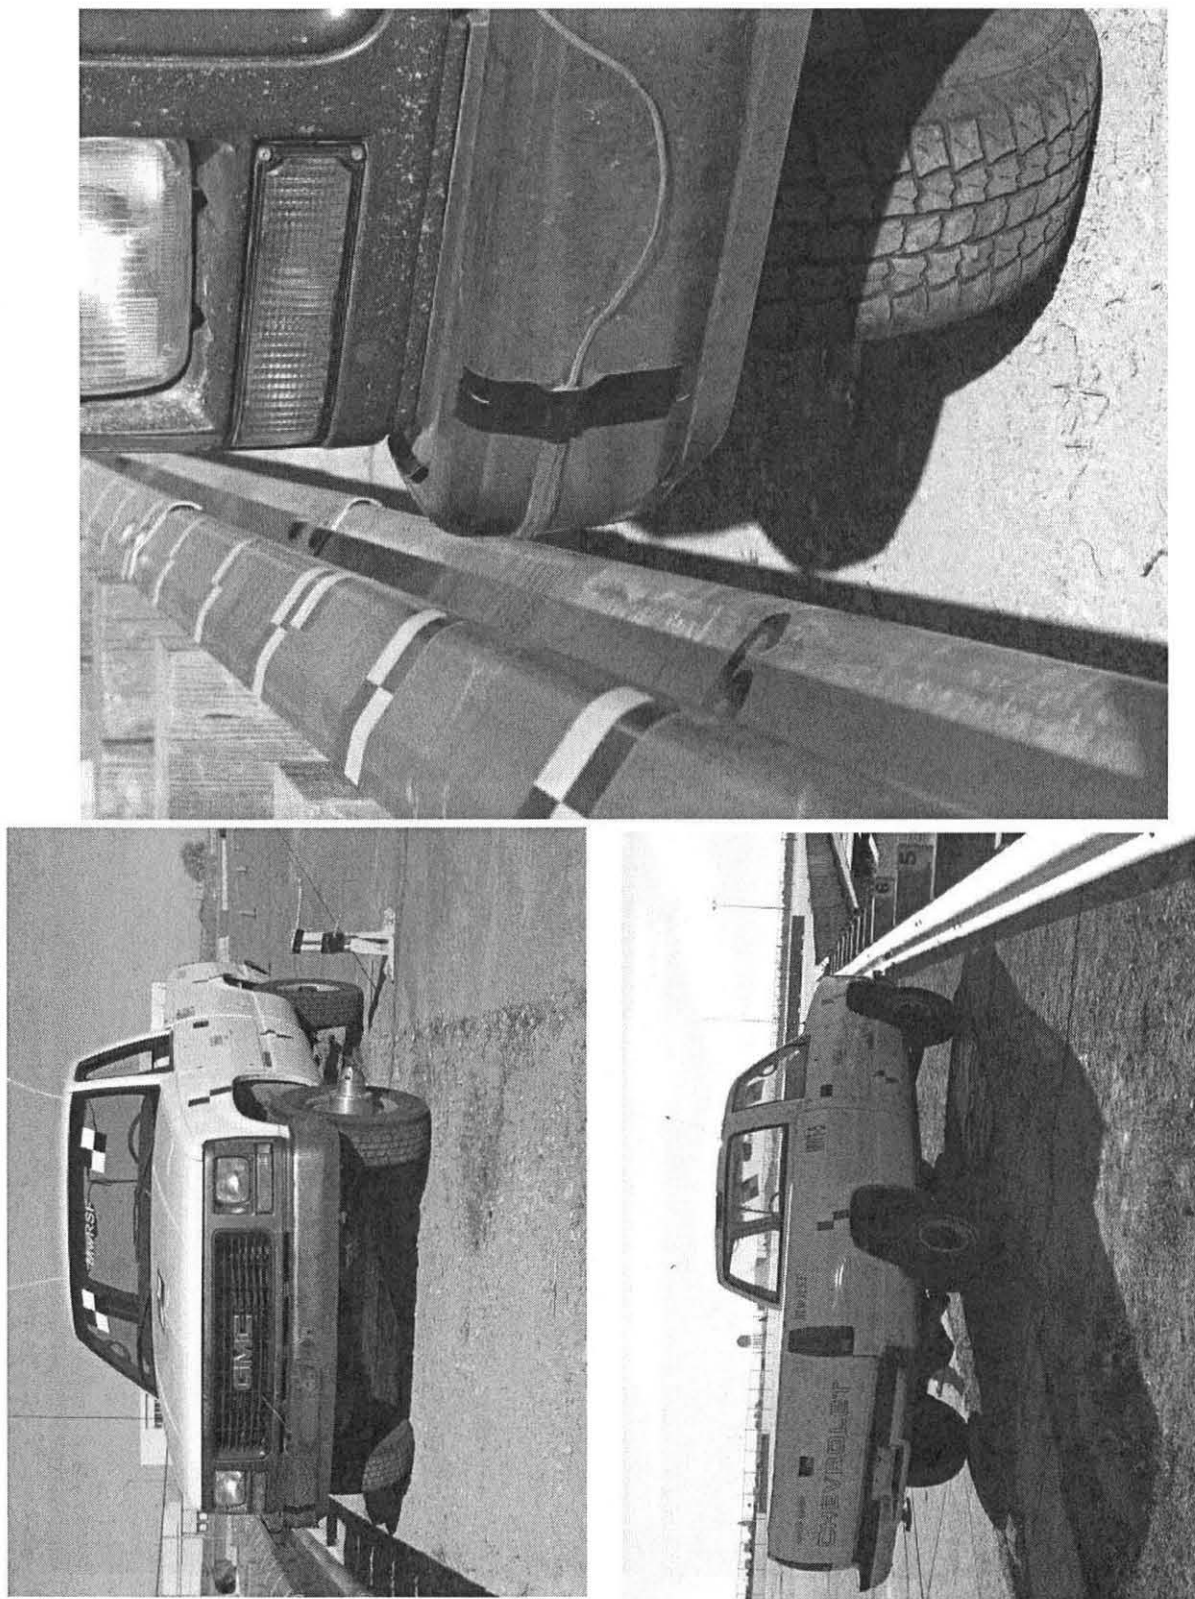
Figure 103. Impact Location, Test MWT-5

Initial vehicle impact was to occur between post nos. 8 and 9, or 330 mm (13 in.) upstream of the centerline of post no. 9, as shown in Figure 101. Actual vehicle impact occurred at the targeted impact location. At 0.016 sec after impact, the pickup bumper and the right-front quarter panel crushed inward towards the engine compartment. At 0.042 sec, post nos. 9 through 11 rotated backwards slightly, and the right-front right quarter panel crushed inward under the hood. At 0.066 sec, post nos. 11 through 13 rotated backward, and the guardrail flattened around the right-front quarter panel of the truck. At this same time, the hood protruded over the rail. At 0.082 sec, the rail buckled at post no. 12, and post nos. 10 and 11 continued to rotate backwards. At 0.096 sec, post nos. 10 and 11 deflected downstream, while post nos. 12 through 14 deflected upstream and rotated backwards. At this same time, the rail continued to flatten around the front of the vehicle. At 0.124 sec, the blockout at post no. 11 disengaged from the system and traveled downstream. By this time, the front bumper was located at post no. 12, and the right-front side of the vehicle continued to crush inwards. At 0.174 sec, the blockout at post no. 12 disengaged from the system and fell to the ground. At this same time, post no. 13 rotated backwards, and a buckle in the rail appeared at post

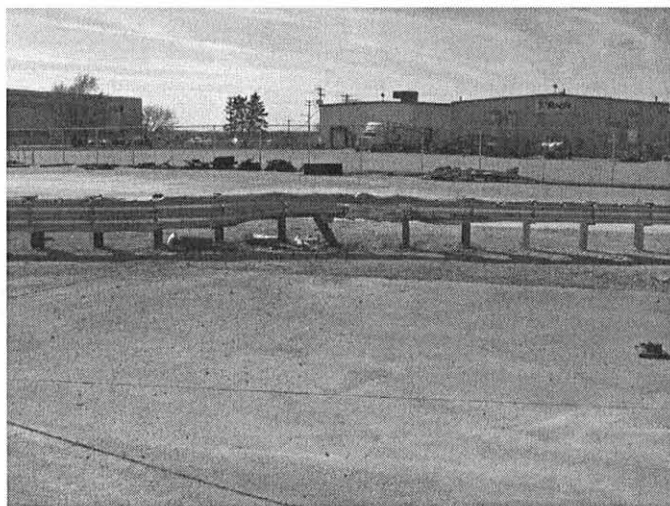
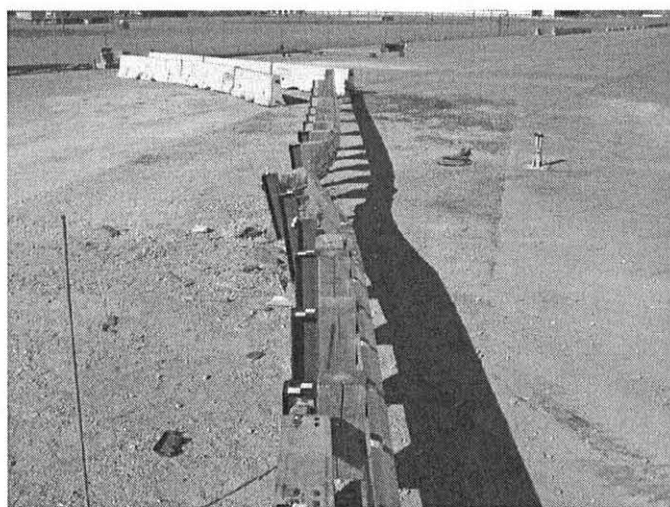
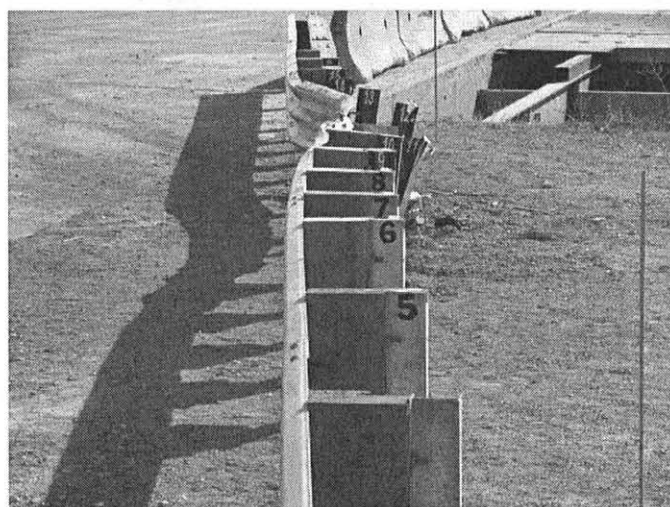
Figure 105. System Damage, Test MWT-5

System damage was moderate as shown in Figures 105 through 112. System damage consisted mostly of deformed guardrail and posts, soil damage, fractured wooden spacer blockouts, and contact marks on a guardrail section. The length of vehicle contact along the approach guardrail

Contact marks on the lower corrugation of the rail began 330 mm (13 in.) upstream of post no. 9 and continued through 762 mm (30 in.) downstream of post no. 14. Slight buckling of the rail was visible between post nos. 8 and 9. Flattening of the rail was found between post nos. 9 and 10. Slight rail buckling also occurred at the rail splice at post no. 13. The rail between post nos. 10 and 13 was deformed upward from vehicle contact. The rail was also deformed at the guardrail to post bolt at post no. 14, but the bolt did not pull through the rail. Slight deformation was visible at the rail splice at post no. 15. Guardrail to post bolt pullout occurred at post no. 11.

Minor soil gaps were visible around post nos. 1, 2, and 8 through 14. Post nos. 3 through 8 rotated slightly downstream. Post nos. 9 and 10 rotated backward. Post no. 11 rotated backward and downstream to approximately 60 degrees. Post nos. 12 through 14 also deflected downstream and backward, but to a lesser extent than post no. 11. Post nos. 15 through 21 were not visibly damaged. The wooden blockouts at post nos. 10 and 14 were fractured but remained attached to the post and rails. The wooden blockouts at post nos. 11 through 13 fractured and disengaged from the system.

The permanent set of the barrier system is shown in Figures 105 and 106. The maximum lateral permanent set rail and post deflections were 375 mm (14.75 in.) at the centerline of post no. 11 and 318 mm (12.5 in.) at the centerline of post no. 12, respectively, as measured in the field. The maximum lateral dynamic rail and post deflections were 605 mm (23.8 in.) at the midspan between post nos. 11 and 12 and 557 mm (21.9 in.) at the centerline of post no. 11, respectively, as determined from high-speed video analysis. The working width of the system was found to be 1,021 mm (40.2 in.).

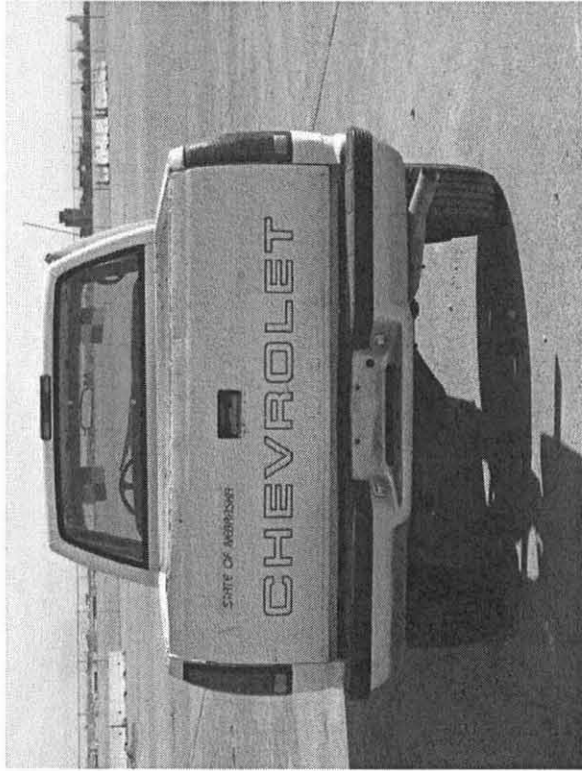
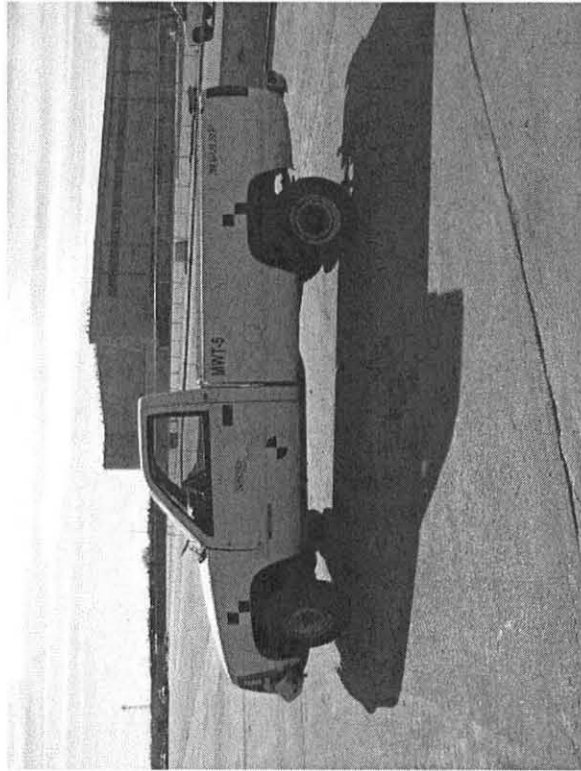
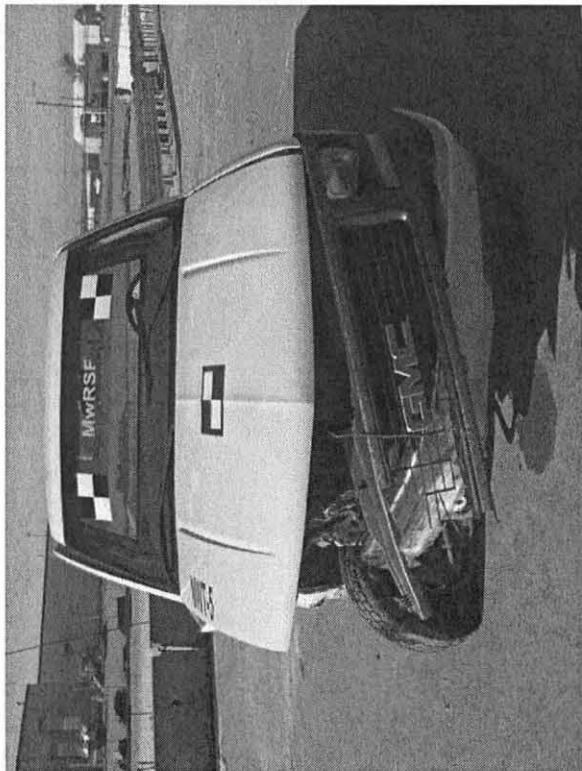
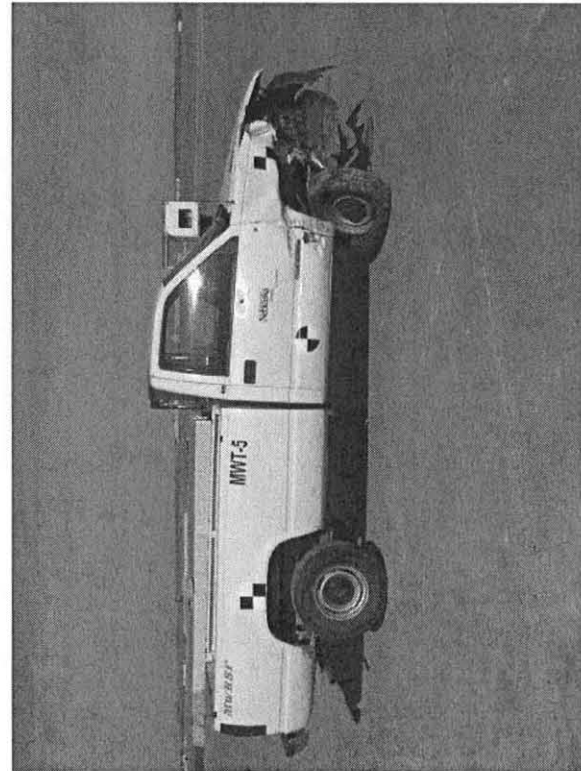
Figure 113. Vehicle Damage, Test MWT-5

Exterior vehicle damage was minimal, as shown in Figures 113 through 115. Occupant compartment deformations to the right side and center of the floorboard were judged insufficient to cause serious injury to the vehicle occupants, as shown in Figure 115. Maximum longitudinal deflections of 13 mm (0.5 in.) were located near the left-front side of the right-side floorboard. Maximum lateral deflections of 44 mm (1.75 in.) were located near the front center of the floorboard. Maximum vertical deflections of 32 mm (1.25 in.) were located at the front of the floorboard. Complete occupant compartment deformations and the corresponding locations are provided in Appendix C.

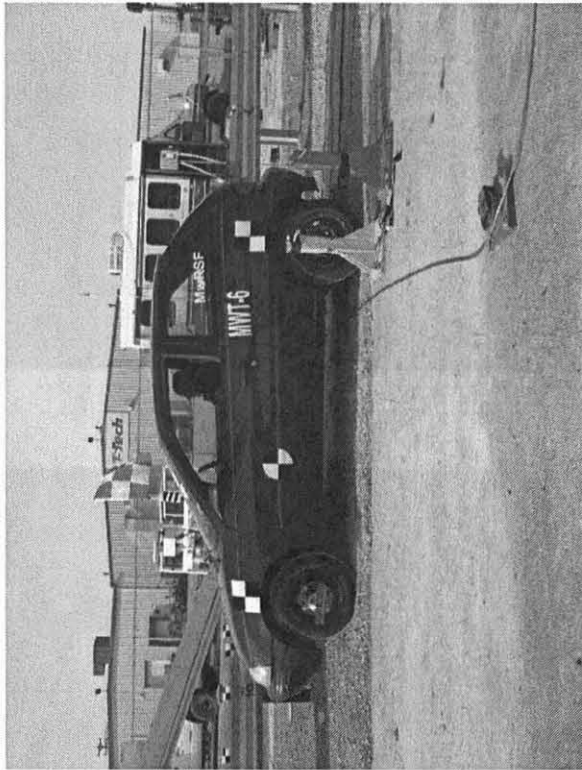
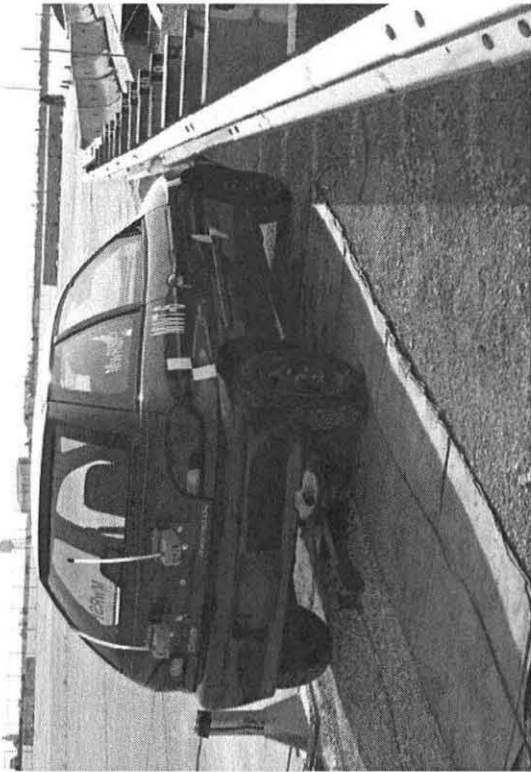
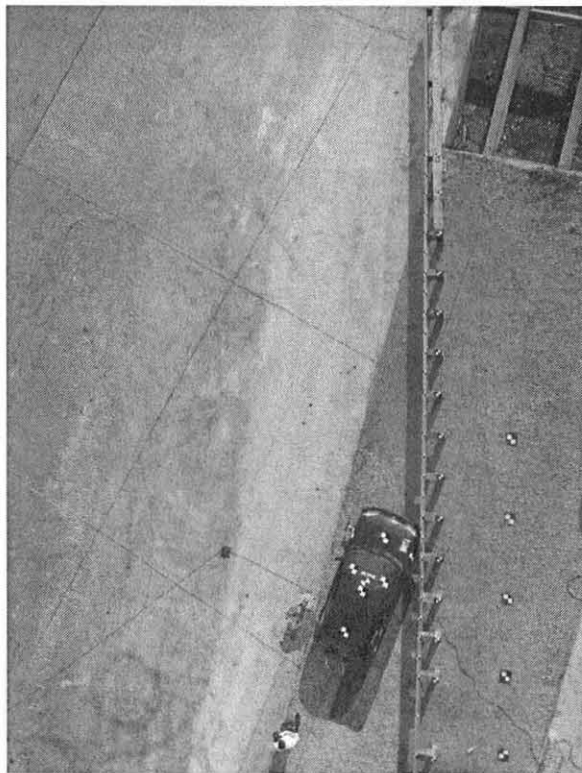
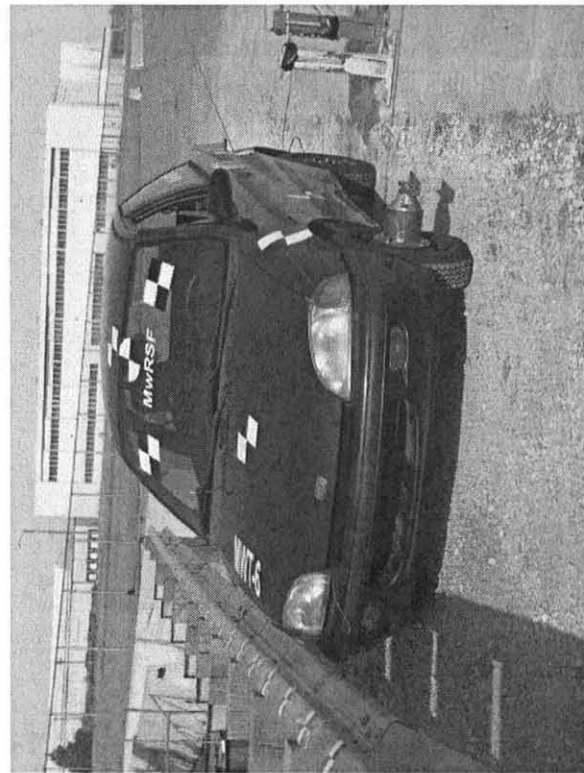
Figure 121. Impact Location, Test MWT-6

Initial vehicle impact was to occur between post nos. 9 and 10, or 318 mm (12.5 in.) upstream of the centerline of post no. 10, as shown in Figure 121. Actual vehicle impact occurred 235 mm (9.25 in.) upstream from the centerline of post no. 10. At 0.024 sec after impact, the right-front corner of the vehicle was located at the midspan between post nos. 10 and 11. At this same time, post nos. 10 and 11 deflected away from the vehicle. At 0.052 sec, the blockout at post no. 11 fractured, and the rail continued to deflect. At this same time, the front of the vehicle pitched downward. At 0.066 sec, the right-front corner of the vehicle was located at post no. 12. At this same time, the system continued to deflect through post no. 13. At 0.084 sec, the right-side window fractured, and the right-front tire protruded under the rail. At 0.116 sec, the right-front tire was located at post no. 13. At 0.128 sec, the right side of the hood was pushed back toward the windshield, and the system reached its maximum deflection. At 0.160 sec, the front of the vehicle was located at post no. 14. At this same time, the vehicle redirected toward parallel, and the right-front tire was no longer protruding under the rail. At 0.188 sec, the right-rear side of the vehicle

The permanent set of the barrier is shown in Figure 121. The maximum lateral permanent set rail and post deflections were 314 mm (12.375 in.) at the centerline of post no. 11 and 298 mm (11.75 in.) at post no. 12, respectively, as measured in the field. The maximum lateral dynamic rail and post deflections were 314.3 mm (12.375 in.) at the midspan between post nos. 11 and 23 and 307 mm (12.1 in.) at post no. 12, respectively, as determined from high-speed digital video analysis. The working width of the system was found to be 847 mm (33.3 in.).

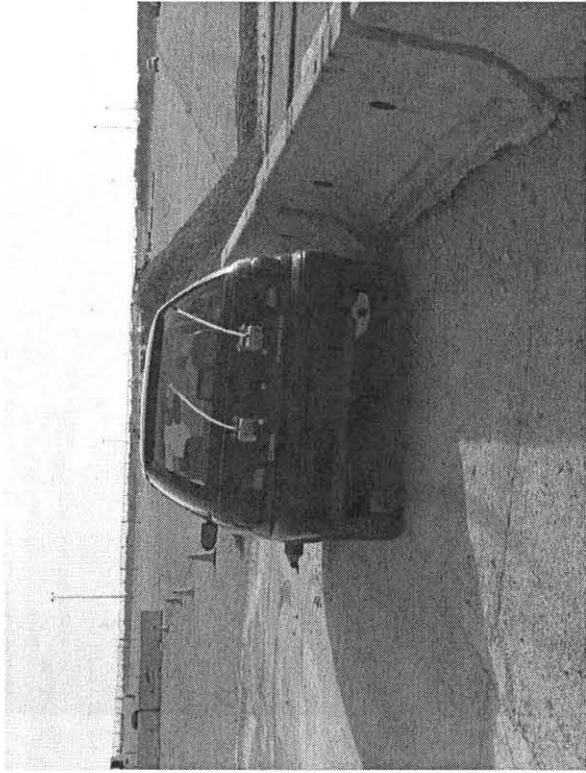
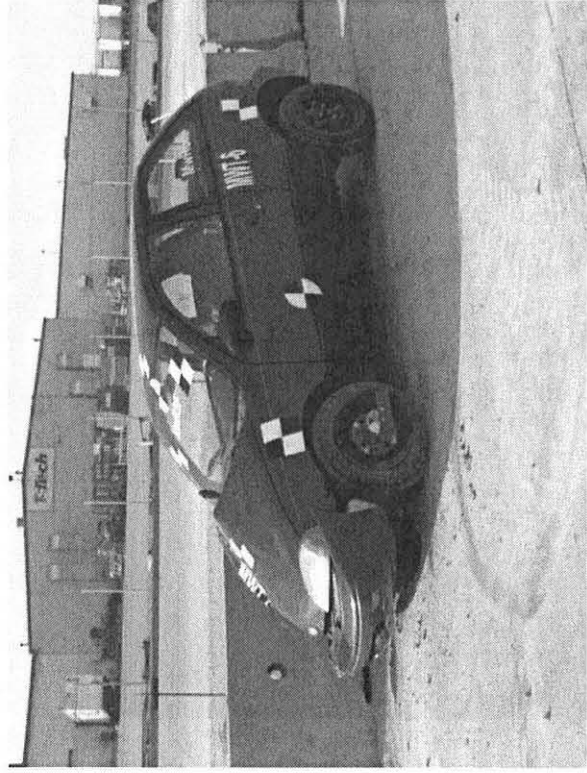
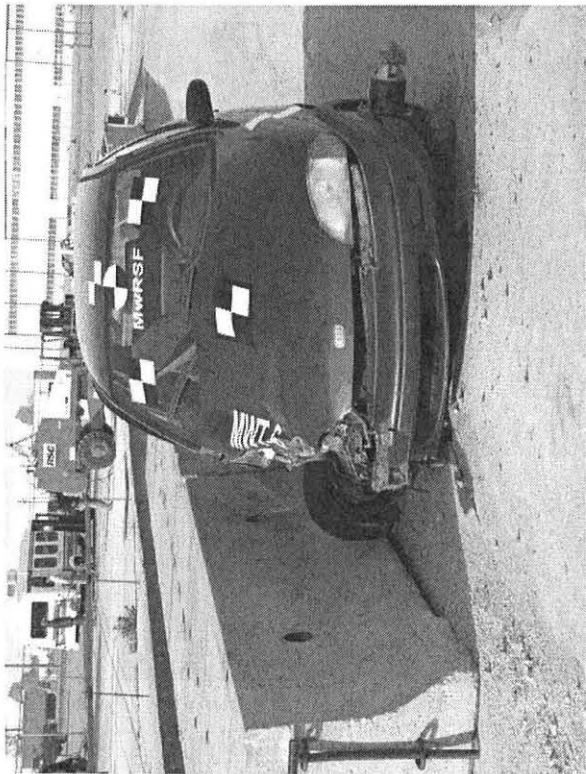
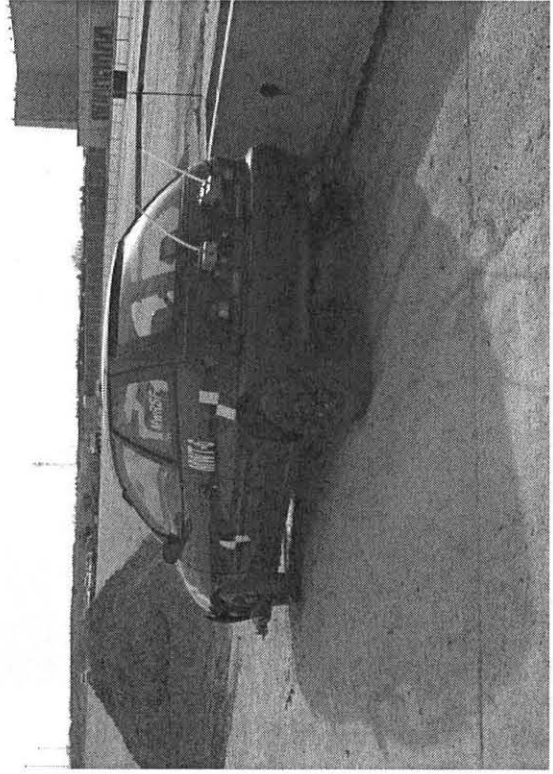
Figure 122. Final Location and Trajectory Marks, Test MWT-6

Barrier damage was minimal, as shown in Figures 121 through 126. Barrier damage consisted of deformed guardrail and posts, damaged blockouts, and contact marks on a guardrail section. The length of vehicle contact along the approach guardrail system was approximately 4.5 m (14.8 ft), which spanned from 235 mm (9.25 in.) upstream from the centerline of post no. 10 through the midspan between post nos. 14 and 15.
