PHASE III DEVELOPMENT OF A BULLNOSE GUARDRAIL SYSTEM FOR MEDIAN APPLICATIONS

MIDWEST ROADSIDE SAFETY FACILITY

MwRSF Research Report No. TRP-03-95-00

June 1, 2000

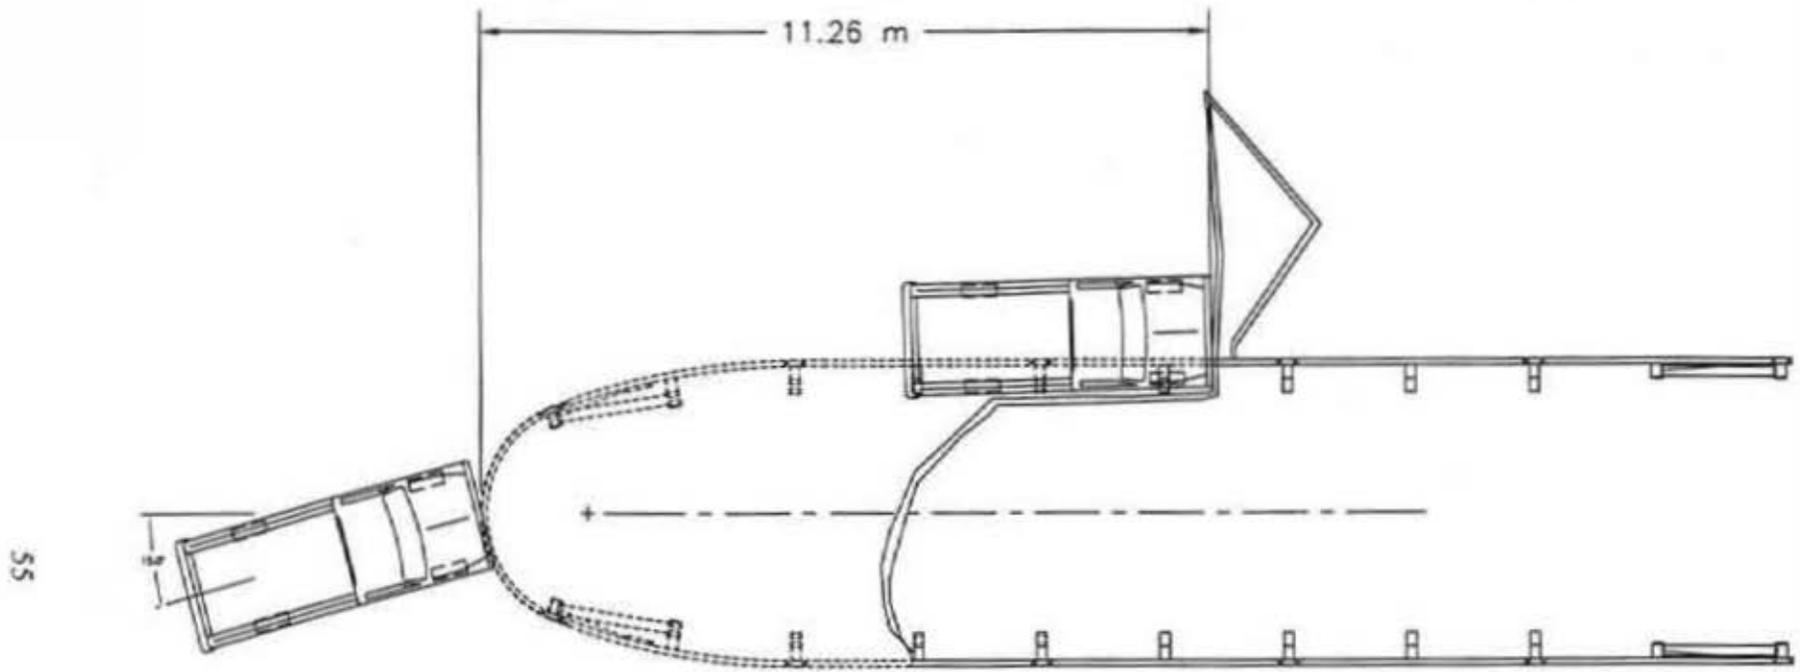
Figure 32. Vehicle Trajectory, MBN-5

with the front of the pickup truck. Shortly afterward, the pickup truck impacted the back side of the three beam guardrail near post no. 4 on the left side and pushed it outward. At 0.569 sec, the pickup truck continued to decelerate, hitting and breaking post no. 5 on the left side. The motion of the truck continued to push a large section of the guardrail outward and to the left, thus forming a large kink in the rail near post no. 4 on the left side. This action formed a sizeable wedge of guardrail on the left side of the barrier. The pickup truck continued to move forward, breaking post nos. 6 and 7 on the left side and coming to a stop as the front of the vehicle reached post no. 8 at 0.906 sec after impact. At this time, the wedge of guardrail had been pushed perpendicular to the centerline of the guardrail. The trajectory of the pickup truck during the crash test and the final position of the vehicle are provided in Figure 32.

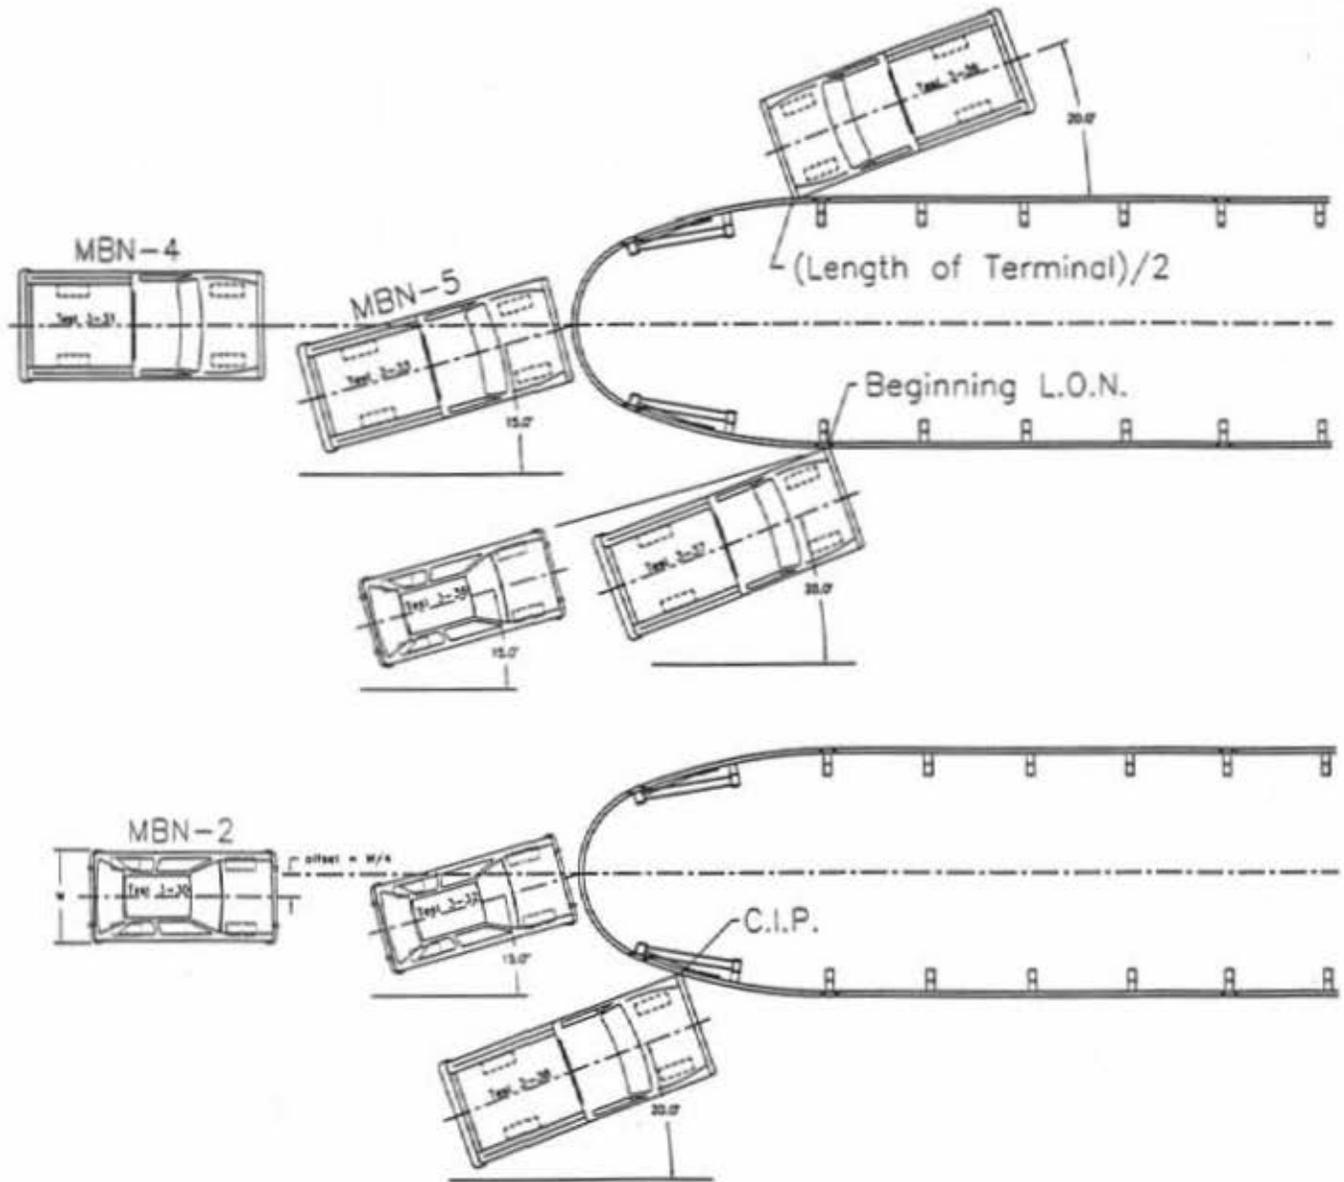
Figure 37. NCHRP 350 Test Matrix for Non-Gating Systems

beginning of the LON. A diagram showing the impact location for the eight crash tests is shown in Figure 37. It is noted that the Critical Impact Point (CIP) mentioned above is defined for non-gating terminals as the point along the installation where it unknown whether the guardrail will capture the impacting vehicle or redirect it.

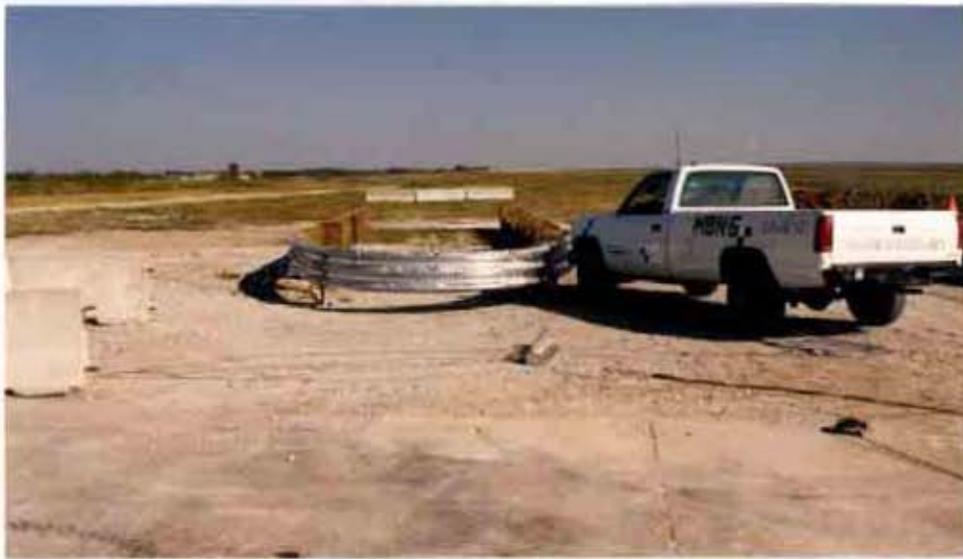
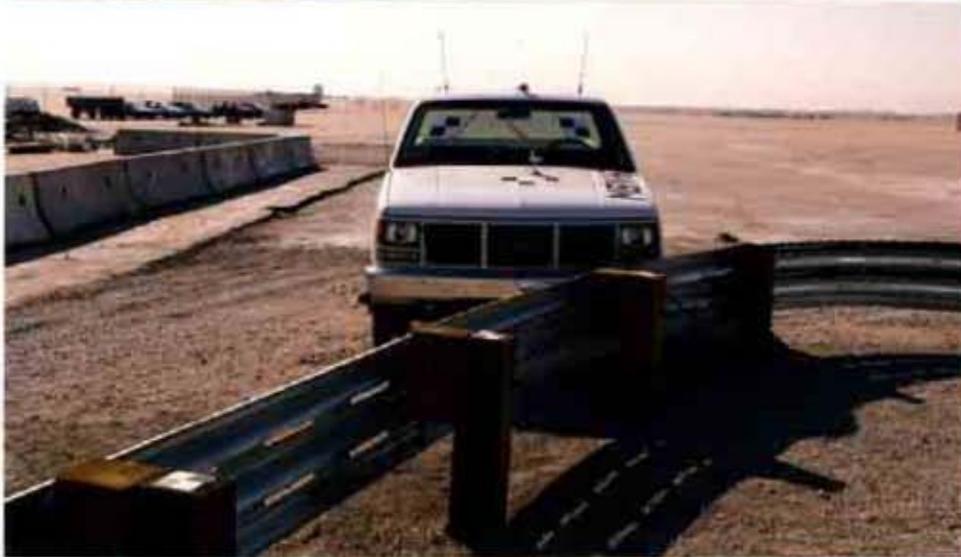
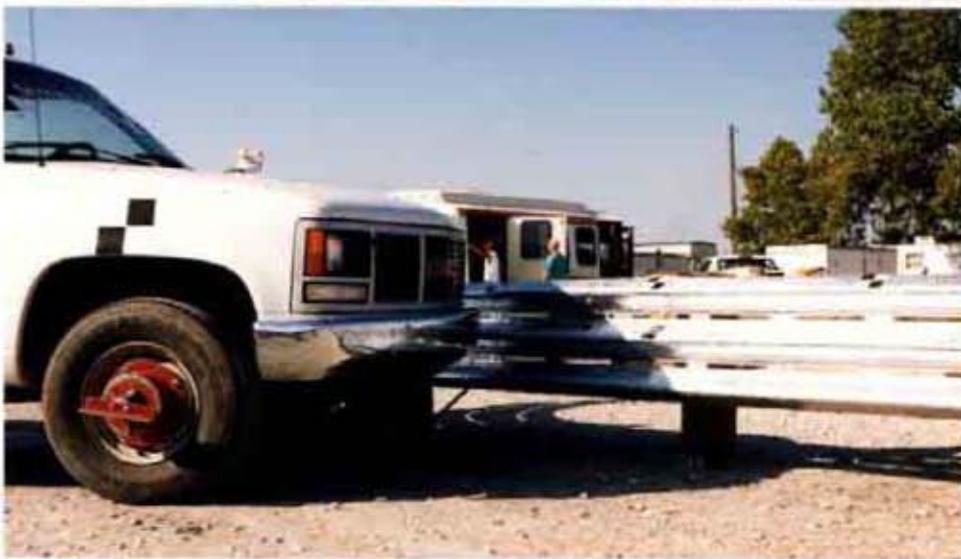
Figure 38. Impact Location, Test MBN-6

Test MBN-6 was conducted according to NCHRP Report No. 350 test 3-38 impact conditions. The 2,031-kg pickup truck impacted the bullnose barrier with the left-front corner of the vehicle aligned midway between posts nos. 1 and 2 on the right-side of the barrier, as shown in Figure 38, at a speed of 101.5 km/h and an angle of 20.4 degrees. A summary of the test results and the sequential photographs are shown in Figure 39. Additional sequential photographs are shown in Figure 40. Full-scale crash documentary photographs are shown in Figures 41 and 42. It is noted that the bullnose system design used for test MBN-6 remained unchanged from the configuration used in test MBN-5.

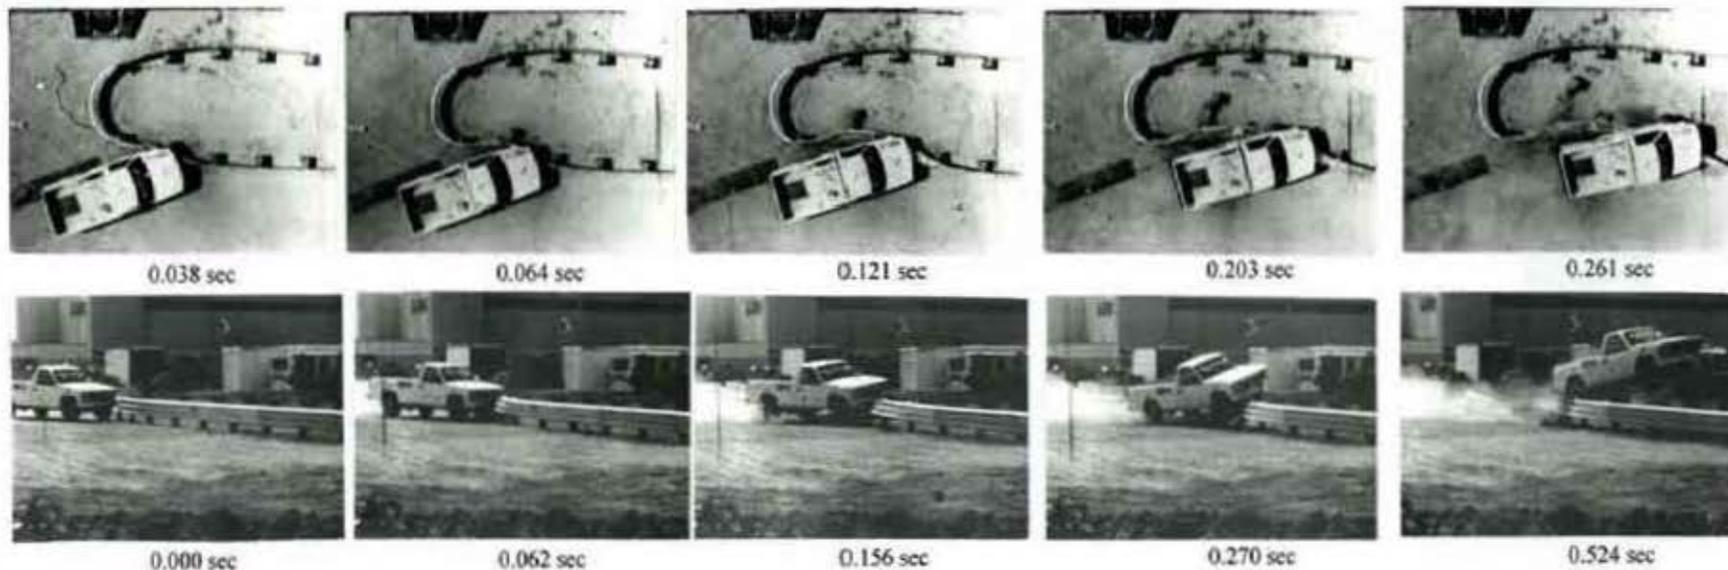
- Test Number MBN-6
- Date 9/16/98
- Appurtenance Bullnose Median Barrier
- Total Length 20,144 m
- Steel Thrie Beam
 - Thickness 12 gauge (2.66 mm)
 - Top Mounting Height 804 mm
- Wood Posts
 - Post Nos. 1 - 3, 10 - 11 140 mm x 190.5 mm x 1080-mm long BCT
 - Post Nos. 4 - 5 150 mm x 200 mm x 1980-mm long CRT
 - Post Nos. 6 - 9 150 mm x 200 mm x 1980-mm long
- Wood Spacer Blocks
 - Post Nos. 2 - 9 150 mm x 200 mm x 360-mm long
- Soil Type Grading B - AASHTO M 147-65 (1990)
- Vehicle Model 1991 Chevy 2500 2WD
 - Curb 2,055 kg
 - Test Inertial 2,031 kg
 - Gross Static 2,031 kg
- Vehicle Speed
 - Impact 101.5 km/hr
 - Exit NA

- Vehicle Angle
 - Impact 20.4 deg
 - Exit NA
- Vehicle Snagging None
- Vehicle Stability Unsatisfactory/Rollover
- Occupant Ridedown Deceleration (10 msec avg.)
 - Longitudinal 2.08 g's
 - Lateral (not required) 4.46 g's
- Occupant Impact Velocity
 - Longitudinal 6.22 m/s
 - Lateral (not required) 2.41 m/s
- Vehicle Damage Extensive (Rollover)
 - TAD^(L) NA
 - SAE^(L) NA
- Vehicle Stopping Distance 52.29 m downstream
5.98 m left of centerline
- Barrier Damage Moderate rail damage and five fractured posts
- Maximum Deflections
 - Permanent Set NA
 - Dynamic NA

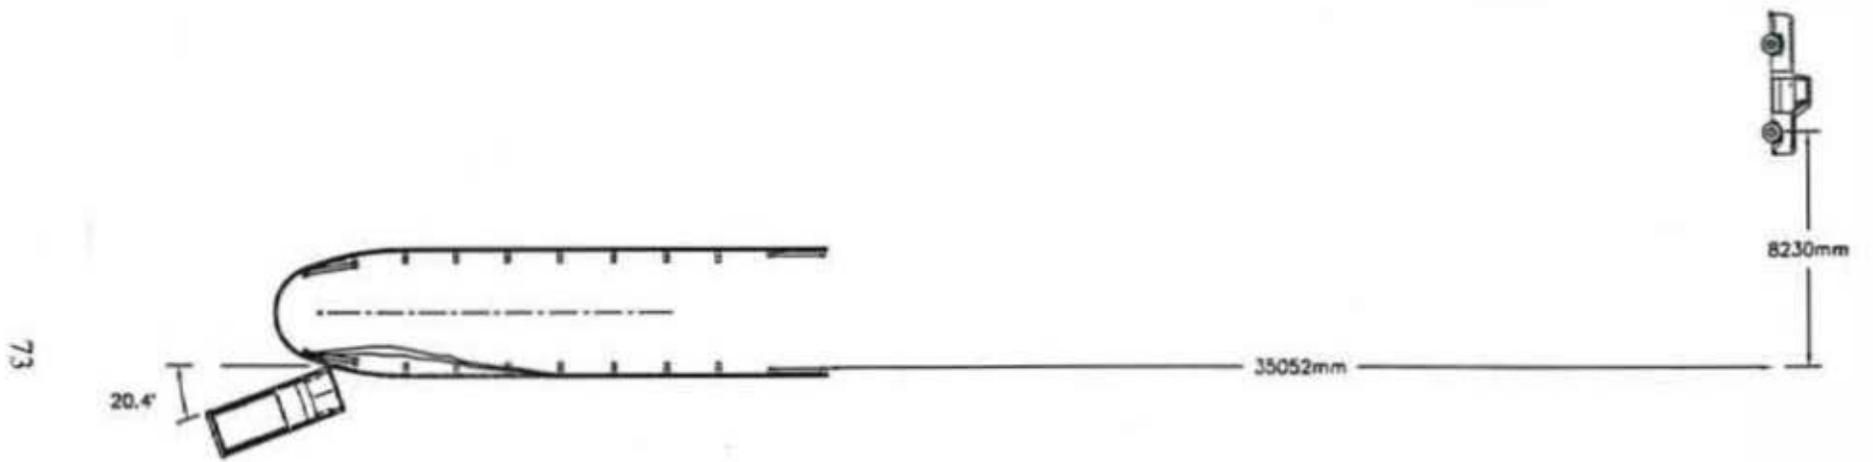
Figure 43. Vehicle Trajectory, Test MBN-6

however, it remained attached to the guardrail and pulled it downward in a similar manner to post no. 3. The right-front tire rode up the broken post no. 4 and onto the rail. At 0.253 sec, the entire front of the pickup truck had ridden up and over the top of the rail. The back wheel then traveled up and over the guardrail near post no. 2 on the right side. The pickup truck became completely airborne and lost contact with the guardrail at 0.384 sec. At 1.110 sec after impact, the truck returned to the ground, just clearing the installation and landing on its side. The truck slid to a stop 35.1-m downstream of the end of the installation. The trajectory of the pickup truck during the crash test and the final position of the vehicle are provided in Figure 43.

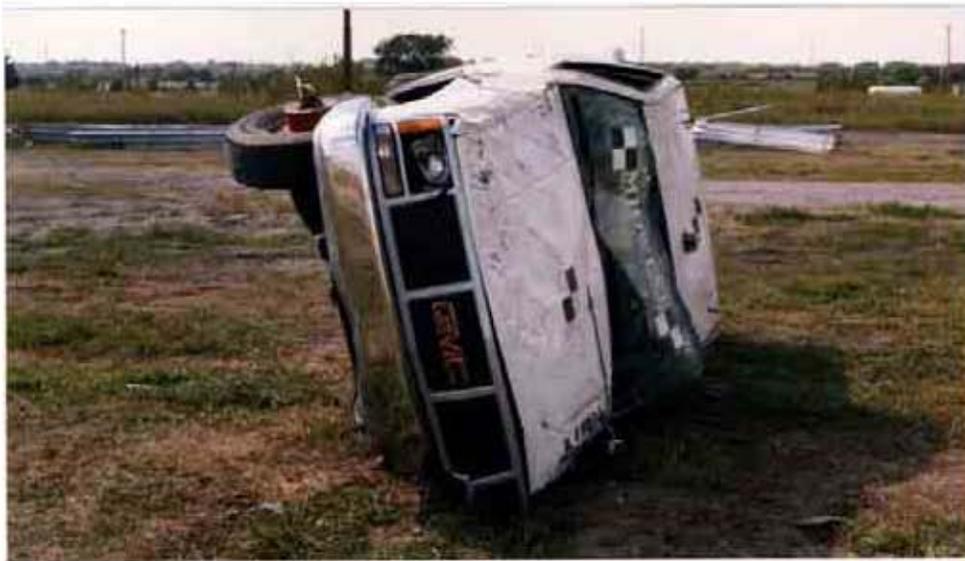
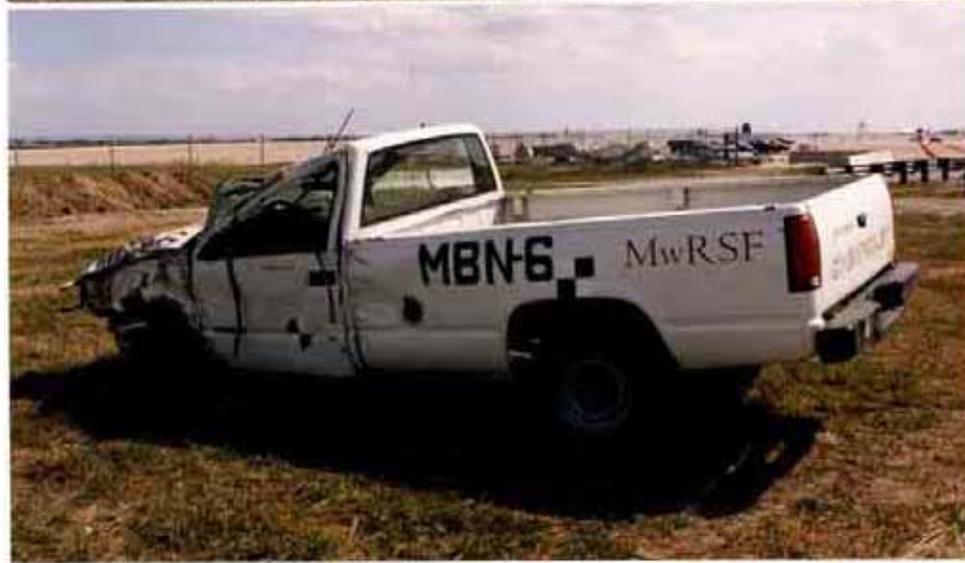
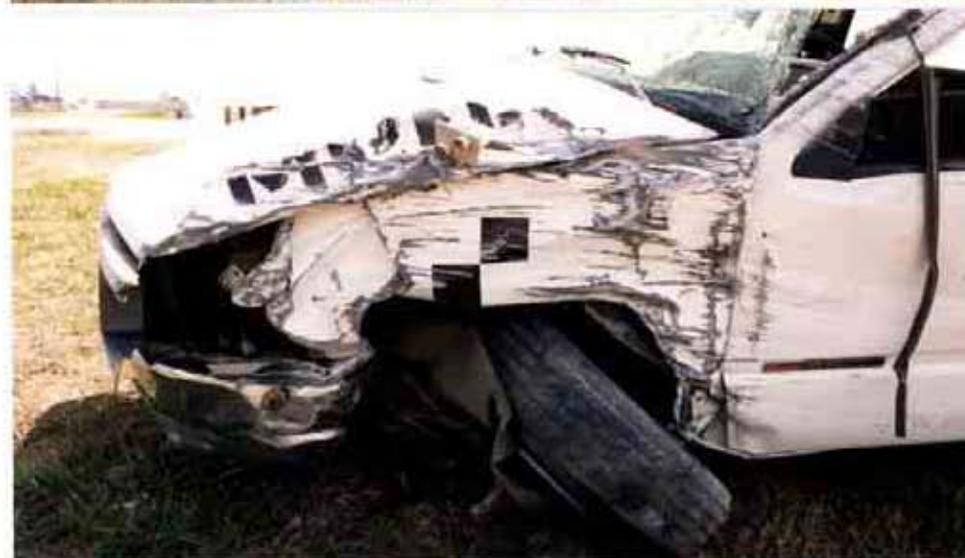
Figure 44. Vehicle Damage, Test MBN-6

The extensive vehicle damage, occurring as a result of the vehicle vaulting over the system upon impact, is shown in Figure 44. Significant undercarriage damage was observed on the vehicle along with extensive body damage. There was also considerable crushing of the pickup truck's interior occupant compartment. It is noted that it is difficult to determine the amount and extent of the damage caused by interaction with the guardrail as opposed to damage caused with vehicle vaulting and subsequent rollover of the vehicle.

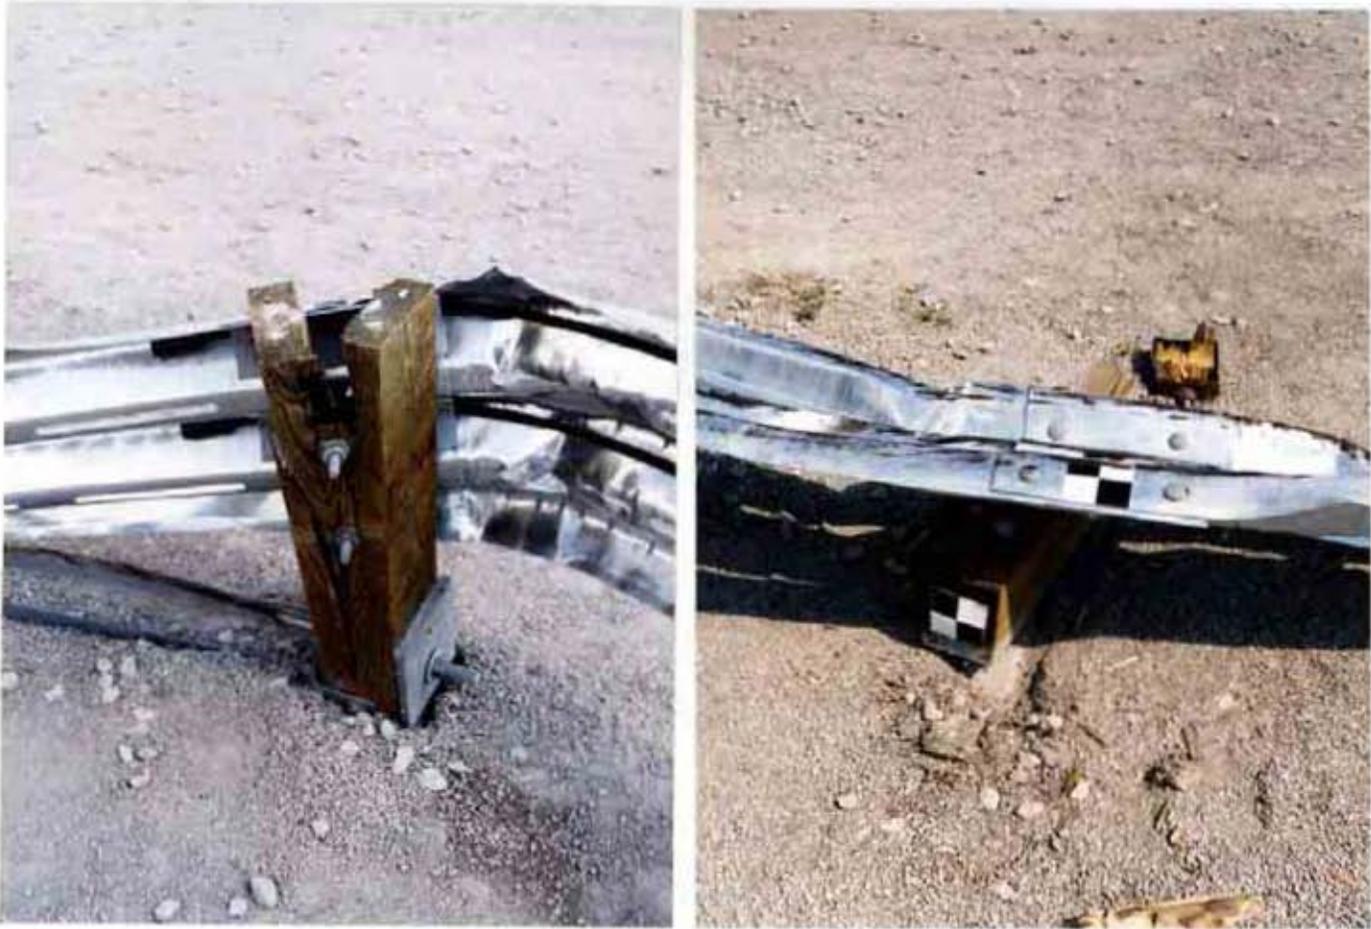
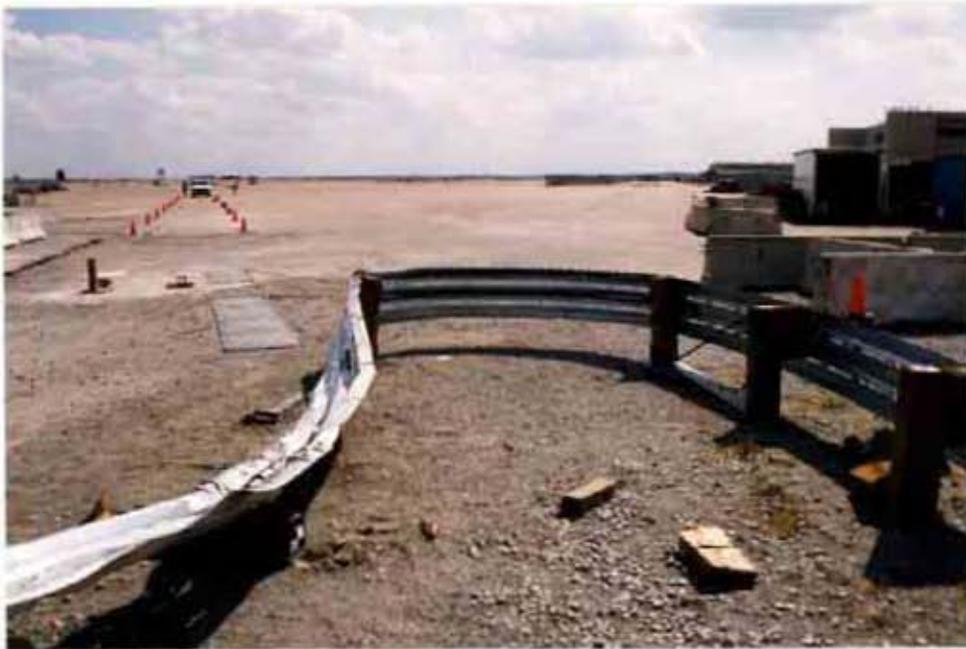
Figure 46. Barrier Damage, Test MBN-6

Barrier damage was moderate, as shown in Figures 45 through 47. All of the post damage occurred to the right side of the system. The first five posts on the right side of the system were fractured. Although post no. 1 was split down the centerline, starting at the top and ending at the top of the foundation tube, it did not break away completely. BCT post nos. 2 and 3 fractured through the holes at ground level. CRT post no. 4 was broken at the bottom hole. The fracture of post no. 5 was observed at both the top and bottom holes in the post. The bolts attaching post no. 4 and 5 to the

The damage to the three beam guardrail in the system was moderate due to the limited interaction of the impact vehicle with the system prior to vaulting. No major tearing of the guardrail was observed. Buckles in the rail were formed 279-mm upstream of post no. 1 and at post no. 6 on the right side of the barrier. The three beam between post nos. 1 through 6 was deformed and pushed down. No damage of the cables or the cable plates was found.

The failure of test MBN-6 to meet all of the safety performance criteria was directly attributed to the vaulting of the pickup truck. The pickup truck rode up the guardrail between post nos. 2 through 4 on the right side of the system. Two factors were believed to have attributed to the vehicle climbing and vaulting over the system. The first contributing factor which led to the failure of the system was a lack of sufficient guardrail tension developed upstream of the impact point. A second factor was that little lateral resistance was provided by the posts as post nos. 3 and 4 fractured on the right side. As these posts rotated and fractured, they remained bolted to the guardrail and pulled it down towards the ground.¹ The lack of tension and lateral resistance allowed the pickup truck to penetrate into the guardrail with increased rail deflection and rotation and without the vehicle being captured or redirected. This combination turned the guardrail into an effective ramp for the impacting pickup truck to climb up and vault over.

As a result of the failed test, design changes were necessary to allow the successful containment or redirection of the pickup truck. This meant that the three beam rail would need to remain upright and functional long enough in order to capture the front of the impacting vehicle, thus preventing vehicle climbing, vaulting, and rollover. These changes required that the rail tension and lateral stiffness be increased without adversely affecting the head-on impact performance of either the pickup truck or small car impacts.

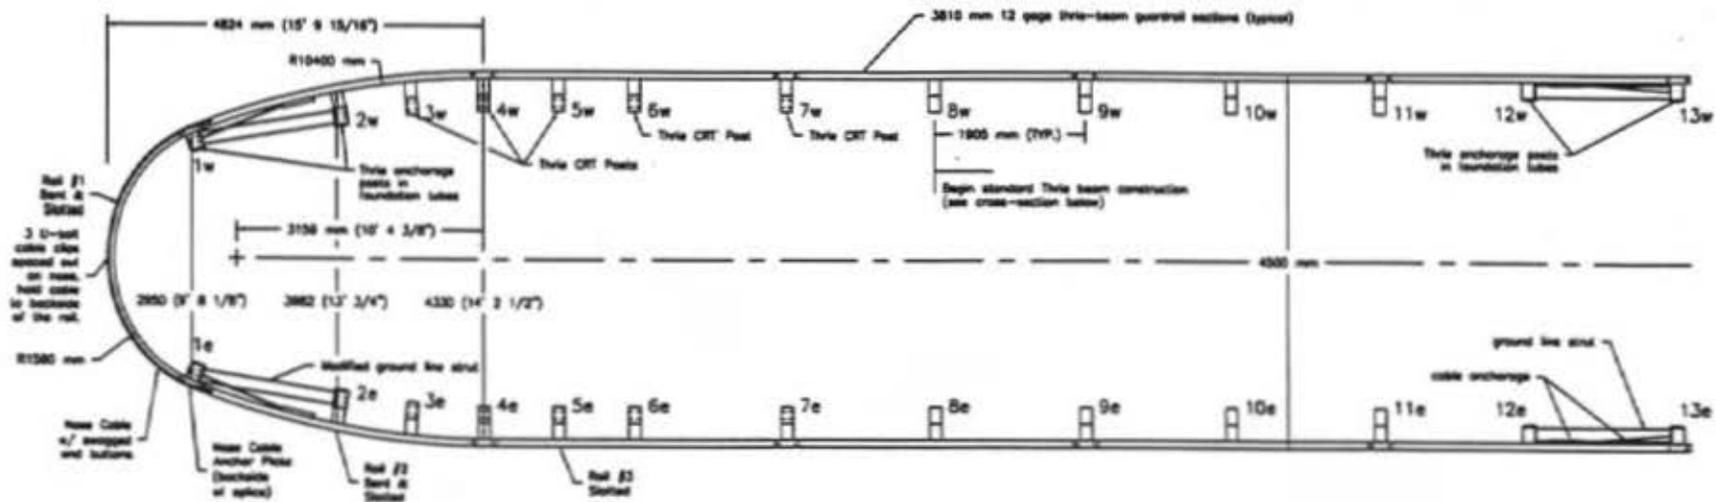
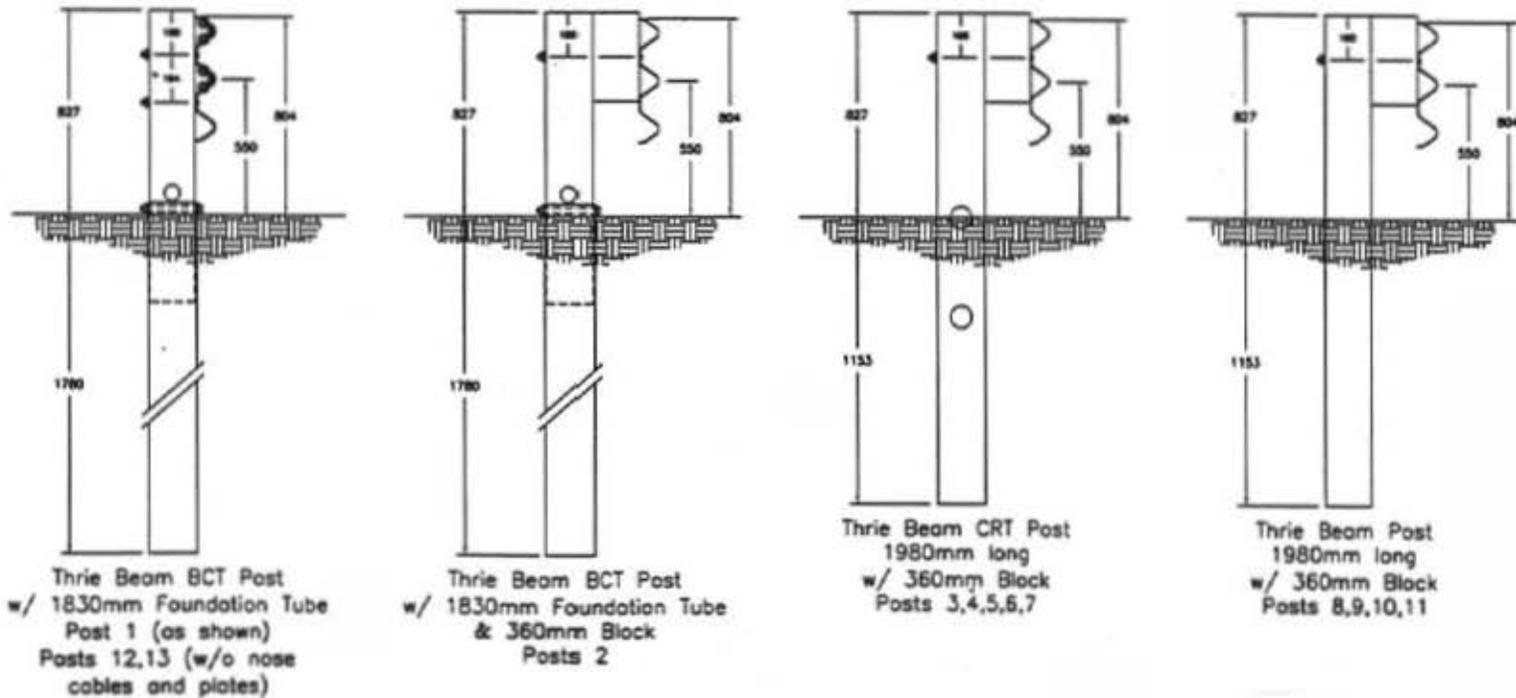
Figure 48. Bullnose Barrier Design, Test MBN-7

Four modifications were made to the bullnose median barrier prior to conducting test MBN-7. These changes were intended to strengthen the guardrail in the area of the critical impact point without sacrificing the ability of the nose of the system to safely bring the previously tested head-on impacts to a controlled stop. First, the third post on each side of the system was changed from a BCT post to a CRT post. Second, two CRT posts were also added to each side of the system. The two new posts were placed midway between post nos. 2 and 3 and midway between post nos. 3 and 4 in the previous design. These posts were added in order to increase the lateral resistance in the barrier system, thus increasing the rails ability to capture and contain the impacting vehicle. Thirdly, the SKT soil tubes used with post nos. 1 and 2 were changed to standard, non-proprietary foundation tubes to eliminate any perceived conflicts in their use in the final design. The final modification was made to the second section of three beam rail. The addition of new posts to the system made it necessary to change the slot pattern in rail section no. 2 in order to allow for proper connection of the rail to the posts. The modified design is shown in Figures 48 through 50.

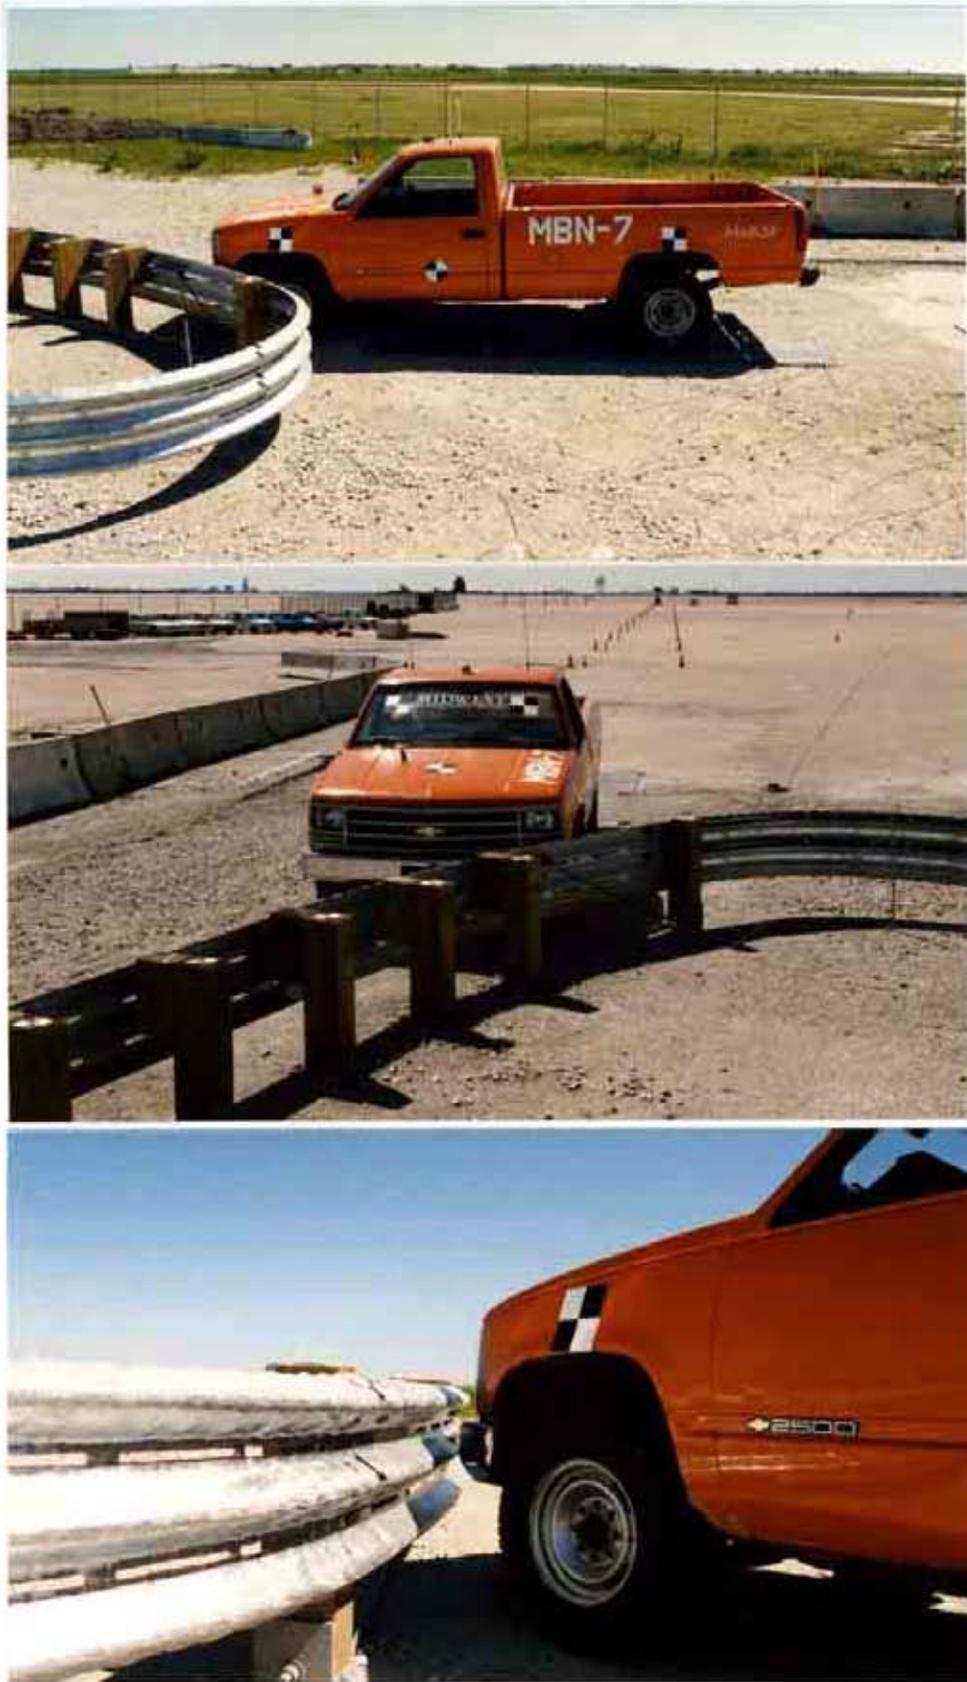
Figure 51. Impact Location, Test MBN-7

Test MBN-7 was conducted according to the NCHRP 350 test 3-38 impact conditions which are the same conditions used in test MBN-6. The 2,036-kg pickup truck impacted the bullnose barrier with the left-front corner of the vehicle aligned midway between post nos. 1 and 2, as shown in Figure 51, and at a speed of 100.0 km/h and at an angle of 24.9 degrees. A summary of the test results and the sequential photographs are shown in Figure 52. Additional sequential photographs are shown in Figure 53. Full-scale crash documentary photographs are shown in Figure 54.

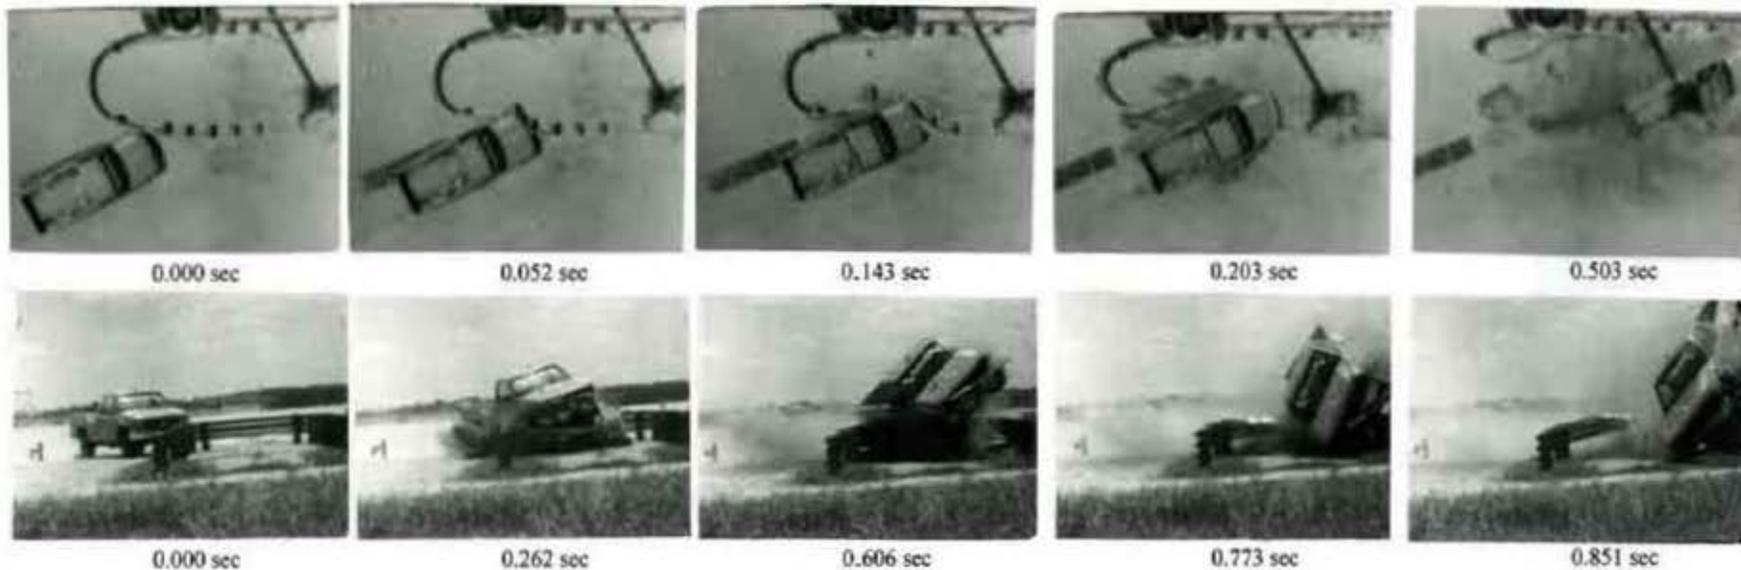
- Test Number MBN-7
- Date 5/24/99
- Appurtenance Bullnose Median Barrier
- Total Length 20,144 mm
- Steel Thrie Beam
 - Thickness 12 gauge (2.66 mm)
 - Top Mounting Height 804 mm
- Wood Posts
 - Post Nos. 1 - 2, 12 - 13 140 mm x 190.5 mm x 1080-mm long BCT
 - Post Nos. 3 - 7 150 mm x 200 mm x 1980-mm long CRT
 - Post Nos. 8 - 11 150 mm x 200 mm x 1980-mm long
- Wood Spacer Blocks
 - Post Nos. 2 - 11 150 mm x 200 mm x 360-mm long
- Soil Type Grading B - AASHTO M 147-65 (1990)
- Vehicle Model 1992 Chevy 2500 2WD
 - Curb 2,142 kg
 - Test Inertial 2,036 kg
 - Gross Static 2,036 kg
- Vehicle Speed
 - Impact 100.0 km/hr
 - Exit NA

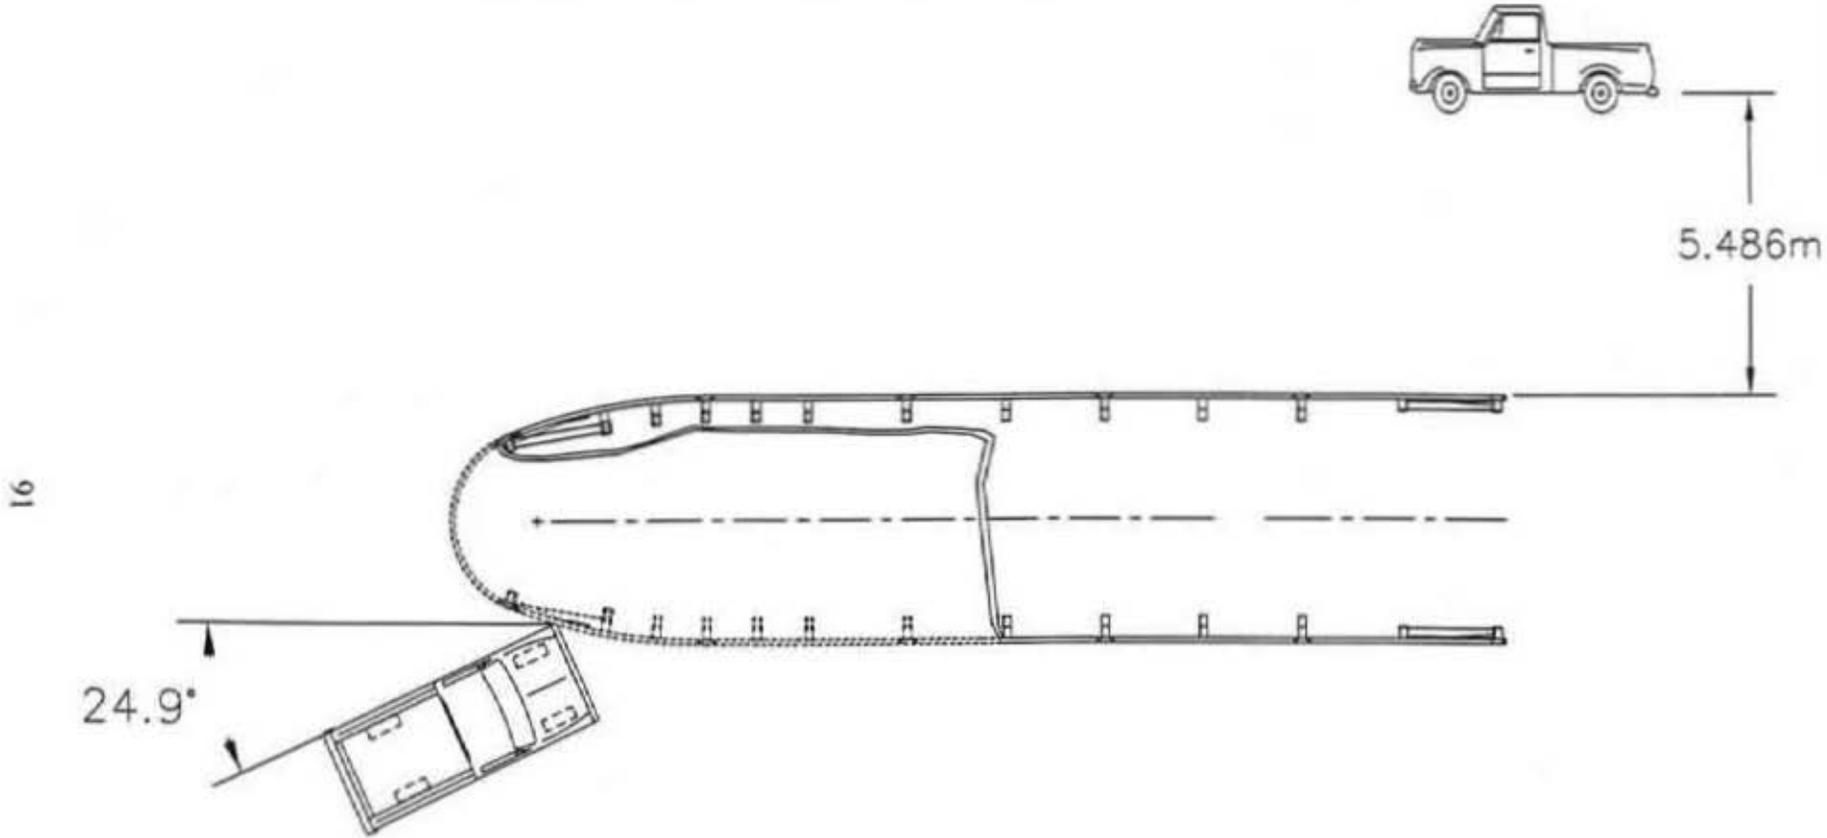
Figure 55. Vehicle Trajectory, Test MBN-7

over the rail until 0.597 sec after impact when the right-rear wheel of the pickup truck snagged on the guardrail while passing over it. This wheel snagging caused the front of the pickup to rotate down and toward the right. At 0.771 sec, the right-front side of the pickup contacted the ground after the right-rear tire disengaged from the rail. The momentum of the truck continued forward, rotating the back of the pickup forward over the right front of the truck, causing the vehicle to cartwheel across the system. The pickup truck then impacted the left side of the system as it continued to cartwheel, striking the top of the rail between post nos. 11 and 12 before coming to rest on its side approximately 5.5 m to the left of the system. The trajectory of the pickup truck during the crash test and the final position of the vehicle are provided in Figure 55.

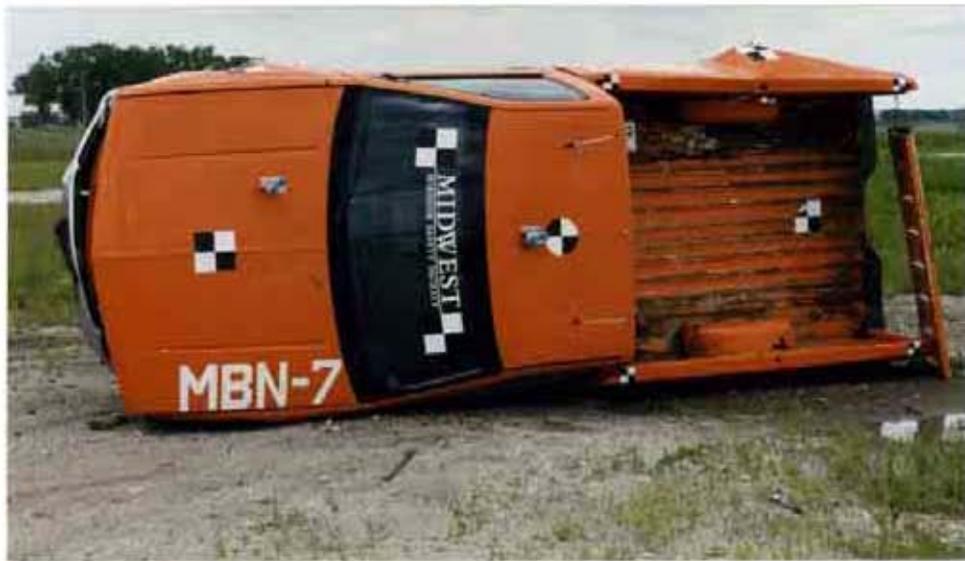
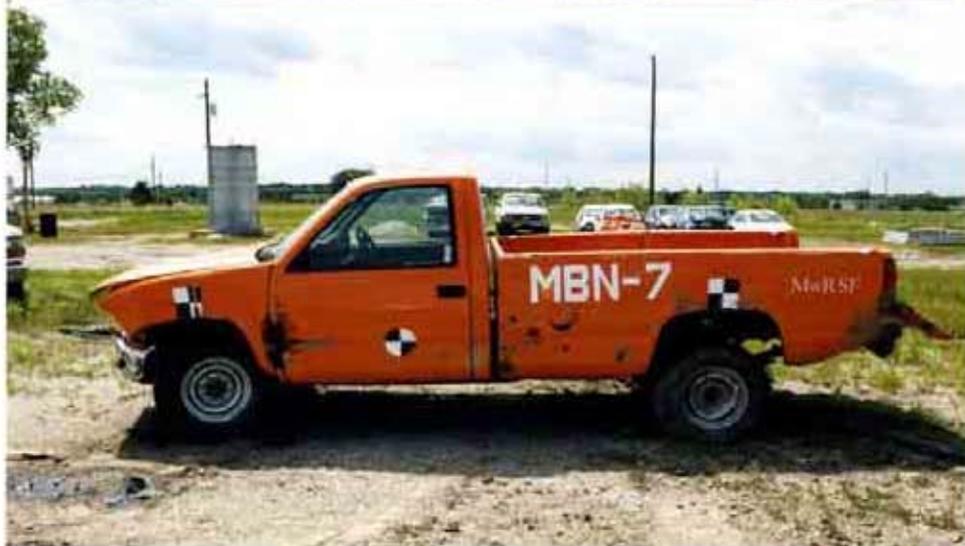
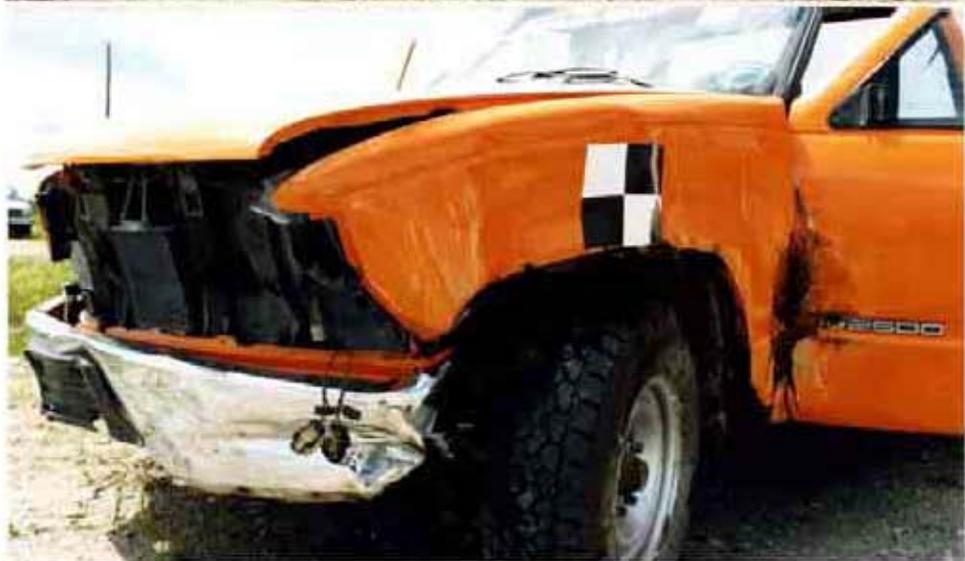
Figure 56. Vehicle Damage, Test MBN-7

The moderate vehicle damage, occurring as a result of the vehicle vaulting over the system and rolling over upon impact, is shown in Figure 56. Minor undercarriage damage was observed on the vehicle. The right side of the front bumper was bent inward and around the frame rails. Minor buckling of the right-front fender was also found. The right front of the frame was bent significantly; however, it was believed that this damage occurred during the rollover event and not during the impact with the guardrail. There was no crushing or damage to the pickup truck's interior occupant compartment. It is noted that it is difficult to determine the amount and extent of the damage caused by interaction with the guardrail as opposed to damage caused with vehicle vaulting and subsequent rollover of the vehicle.

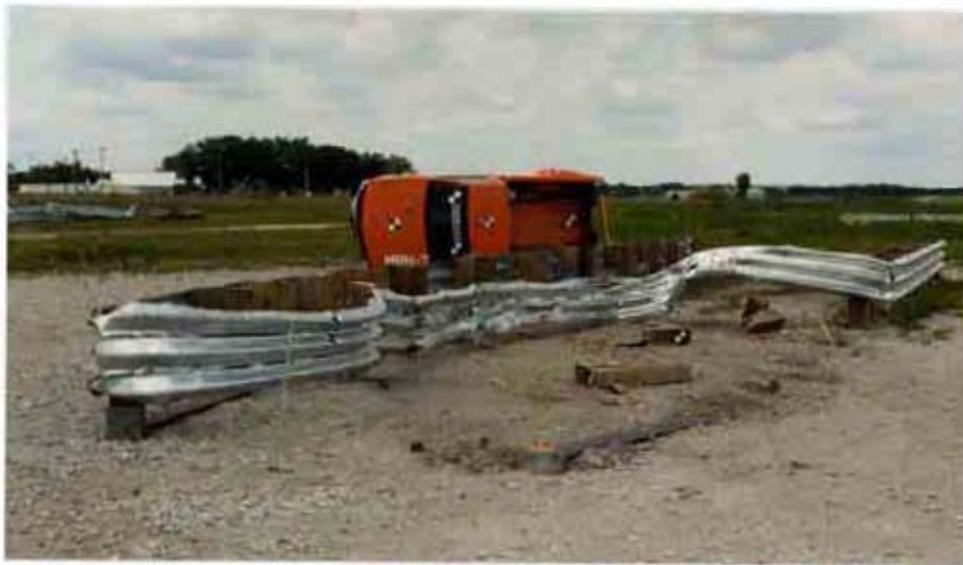
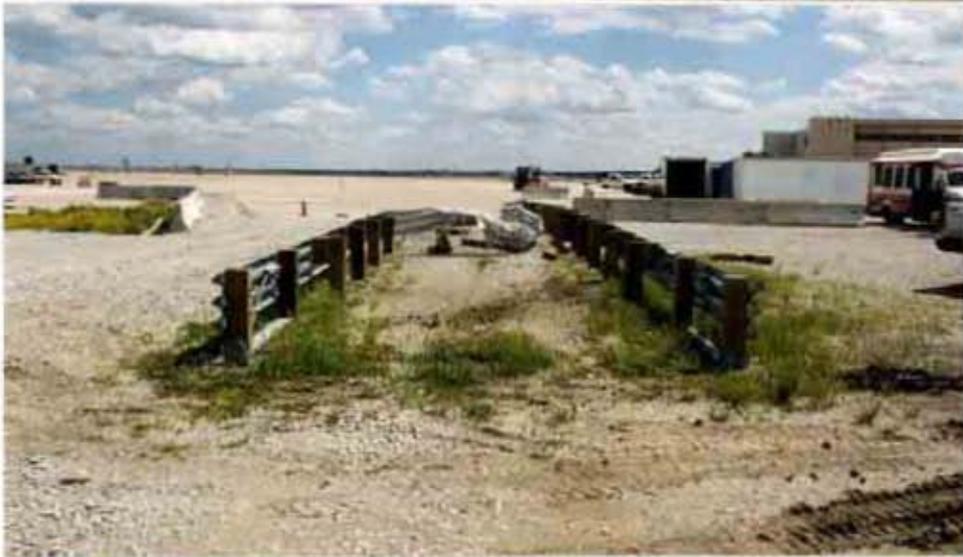
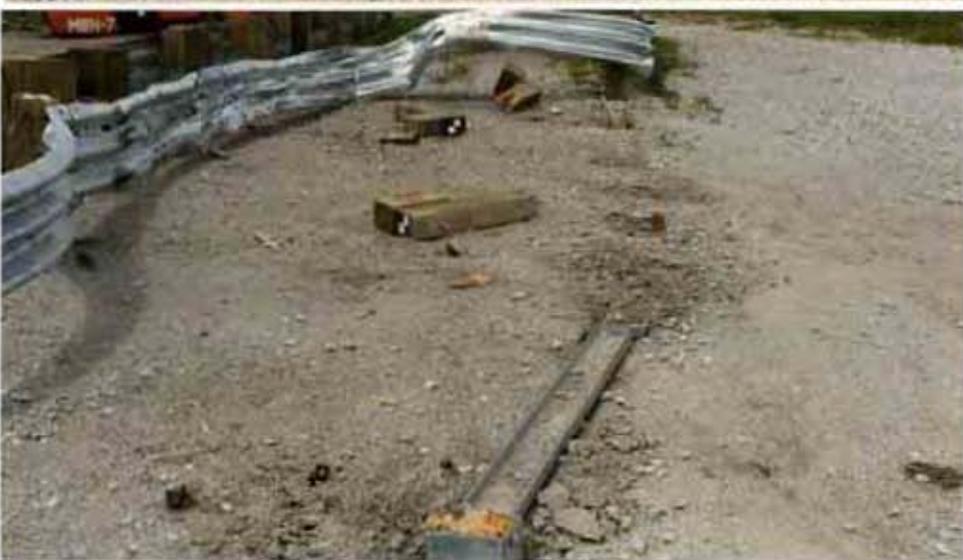
Figure 57. Barrier Damage, Test MBN-7

Barrier damage was extensive, as shown in Figures 57 through 59. All of the post damage occurred to the right side of the system. The first seven posts on the right side of the system were

As a result of the failed test, design changes were necessary to allow the successful containment or redirection the pickup truck. This meant that the thrie beam rail would need to remain upright and functional long enough in order to capture the front of the impacting vehicle, thus preventing vehicle climbing, vaulting, and rollover. These changes required that the rail tension and lateral stiffness be increased without adversely affecting the head-on impact performance of either the pickup truck or small car impacts. Subsequently, computer simulation modeling of the previous two failures was performed in order to investigate the design flaws in the bullnose system as well as to investigate potential solutions.
