PHASE III DEVELOPMENT OF A BULLNOSE GUARDRAIL SYSTEM FOR MEDIAN APPLICATIONS

MIDWEST ROADSIDE SAFETY FACILITY

MwRSF Research Report No. TRP-03-95-00

June 1, 2000

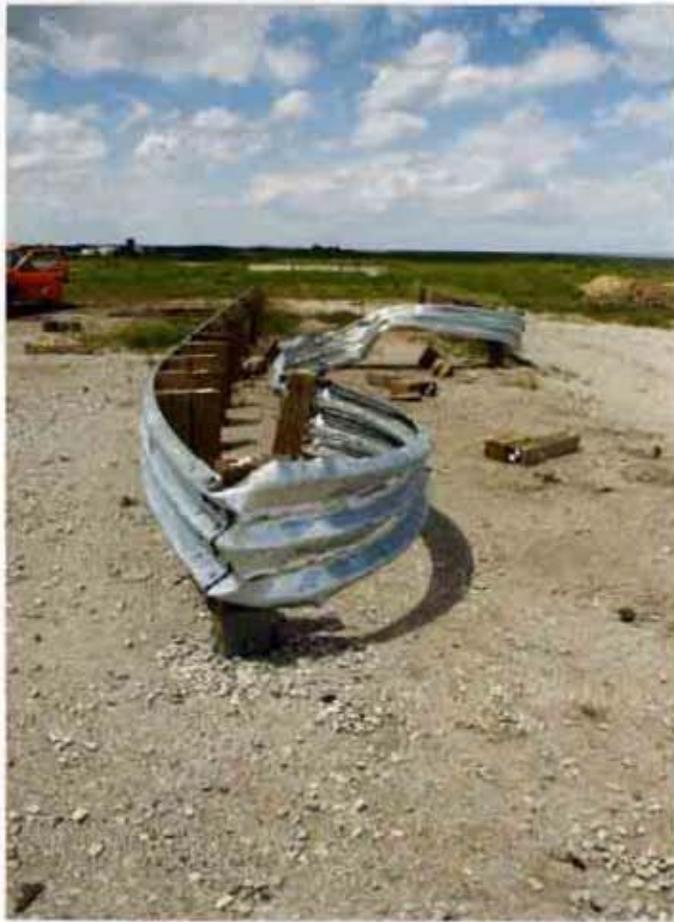
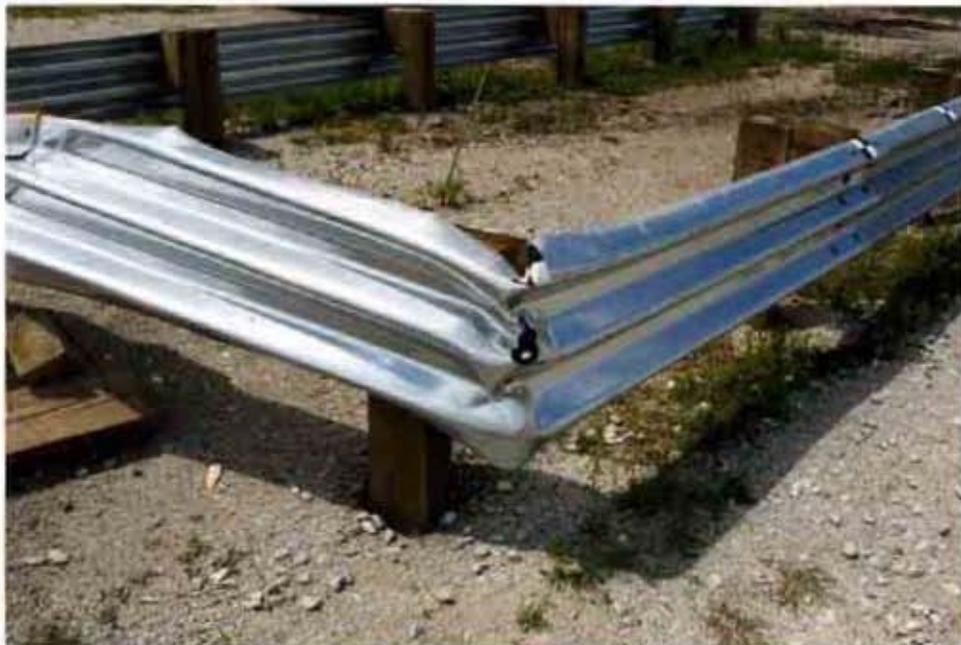
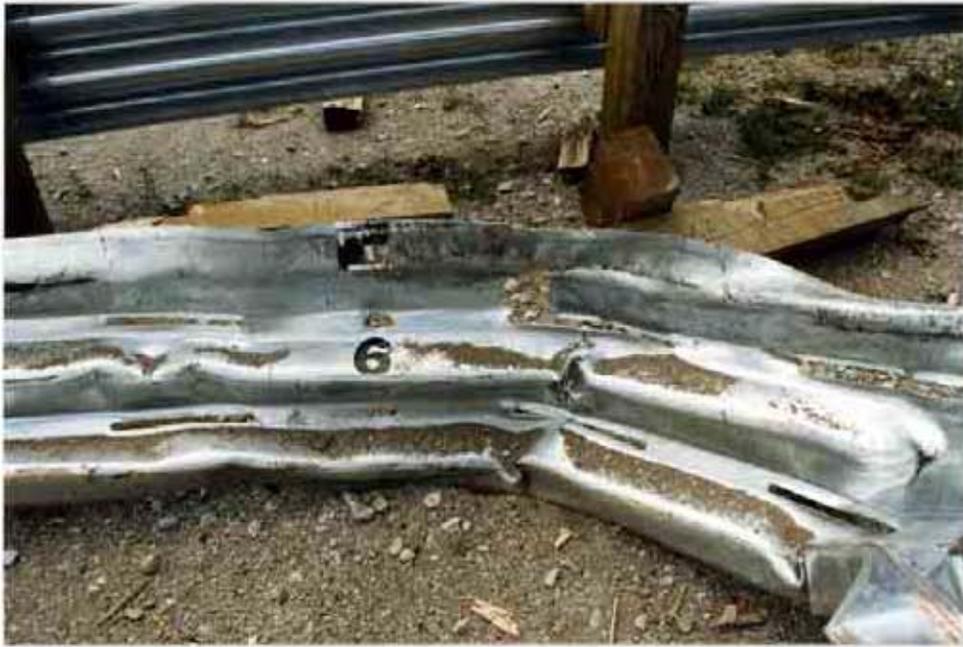
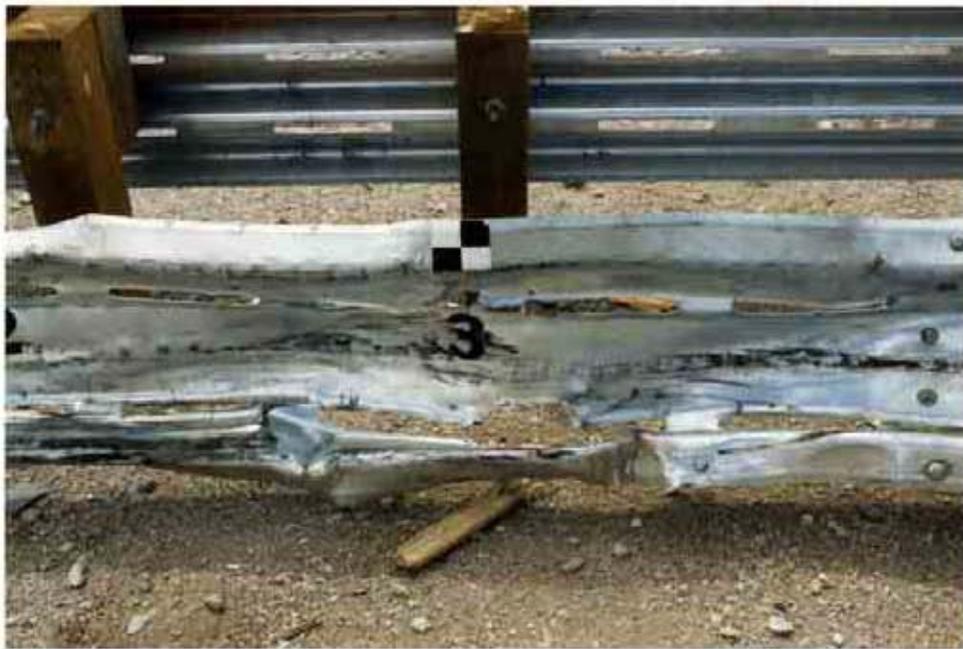
Barrier damage was extensive, as shown in Figures 57 through 59. All of the post damage occurred to the right side of the system. The first seven posts on the right side of the system were

Figure 57. Barrier Damage, Test MBN-7

Figure 58. Barrier Damage, Test MBN-7

Figure 59. Barrier Damage, Test MBN-7

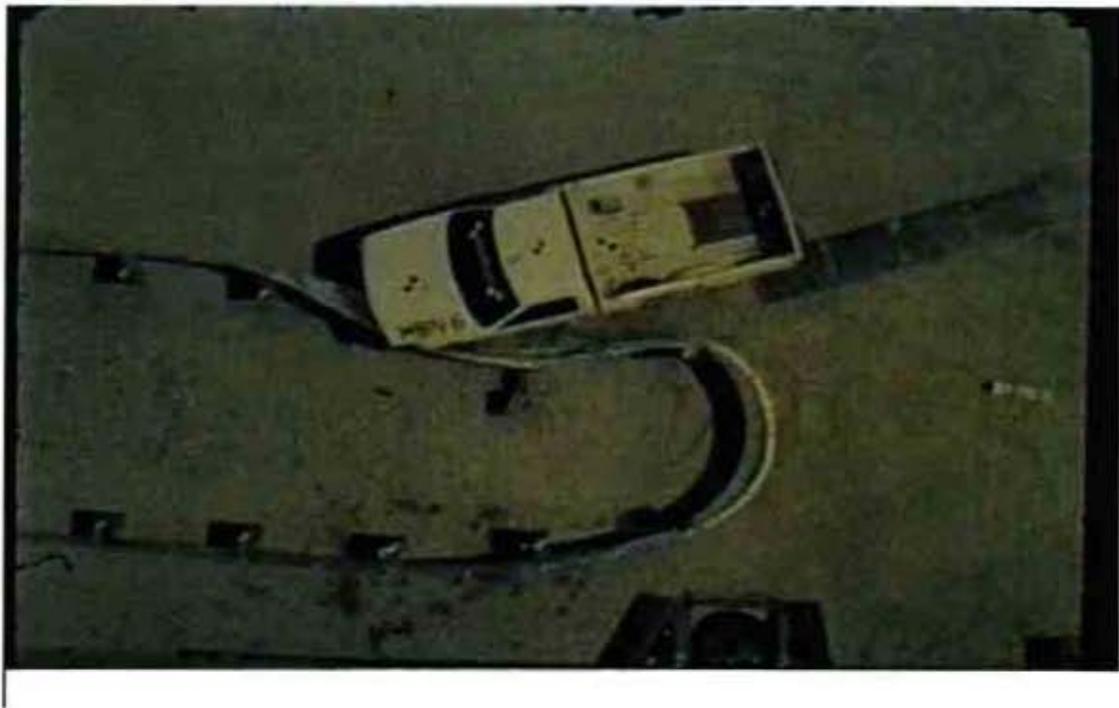
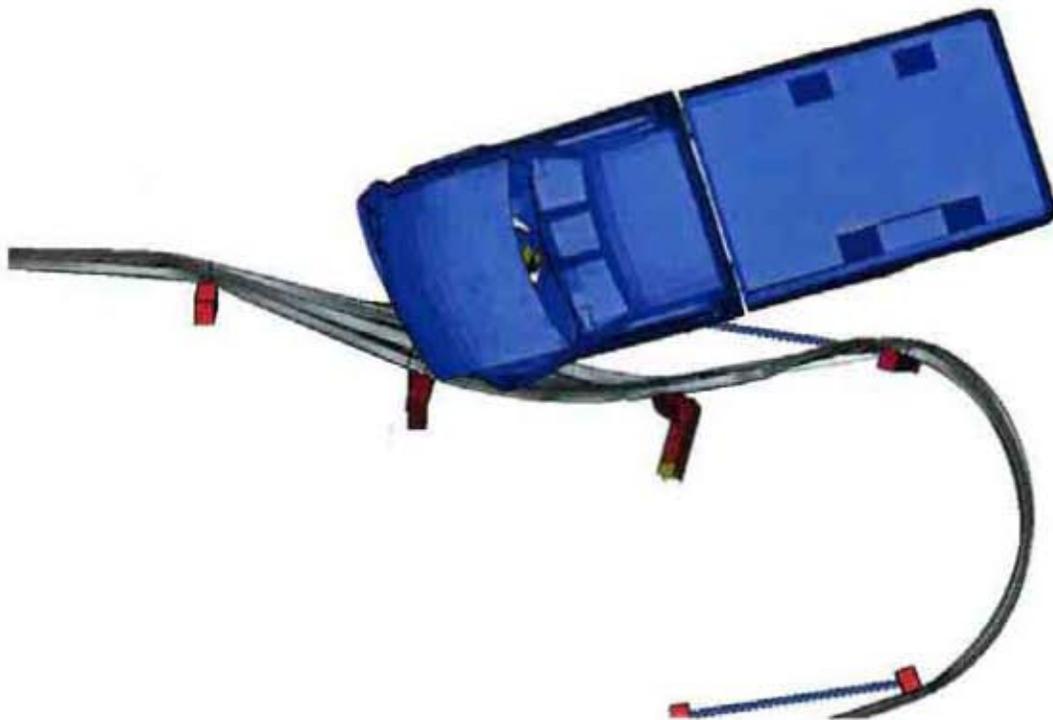
Figure 61. Ground Strut Influences Tire Behavior

system influenced the truck ride up the rail due to the tire impacting the ground line strut. A cut away view of this behavior is shown in Figure 61. Examination and comparison of overhead views of both the MBN-6 simulation and full-scale testing showed that when the vehicle reaches post no. 3 the rail rollover becomes evident, as shown in Figure 62. When the baseline model is modified by removing the ground line strut and replacing post nos. 1 and 2 with longer posts, the tire-strut interaction is eliminated. Simulation results of this modified model shows noticeable improvement in the rail behavior, as shown in Figure 63.

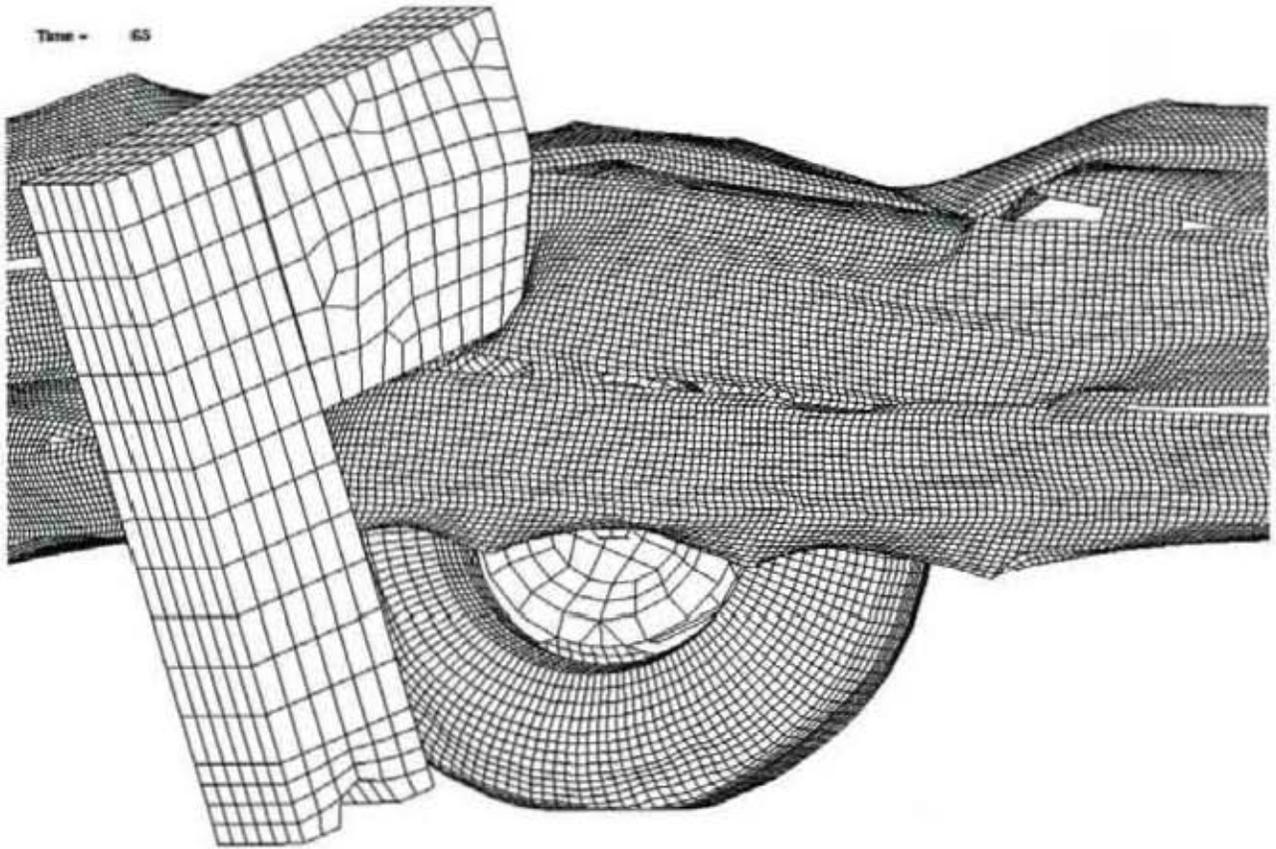
Figure 64. Chamfered Blockout Allows Rail to Wrap Around Tire

In addition to the ground line strut being removed, three additional modifications were made to the bullnose system model to improve its performance for the CIP impact. First, half-post spacing was used between original post nos. 1 and 4. This change added three new posts to each side of the system. Second, chamfered blockouts were used to improve the ability of the rail to wrap around the top of the tire and thus, get improved interlocking between the rail and the vehicle, as shown in Figure 64. Finally, double blockouts were used to reduce tire snag as well as to hold the rail higher for longer time as the post rotates during the impact. This is shown in Figure 65.

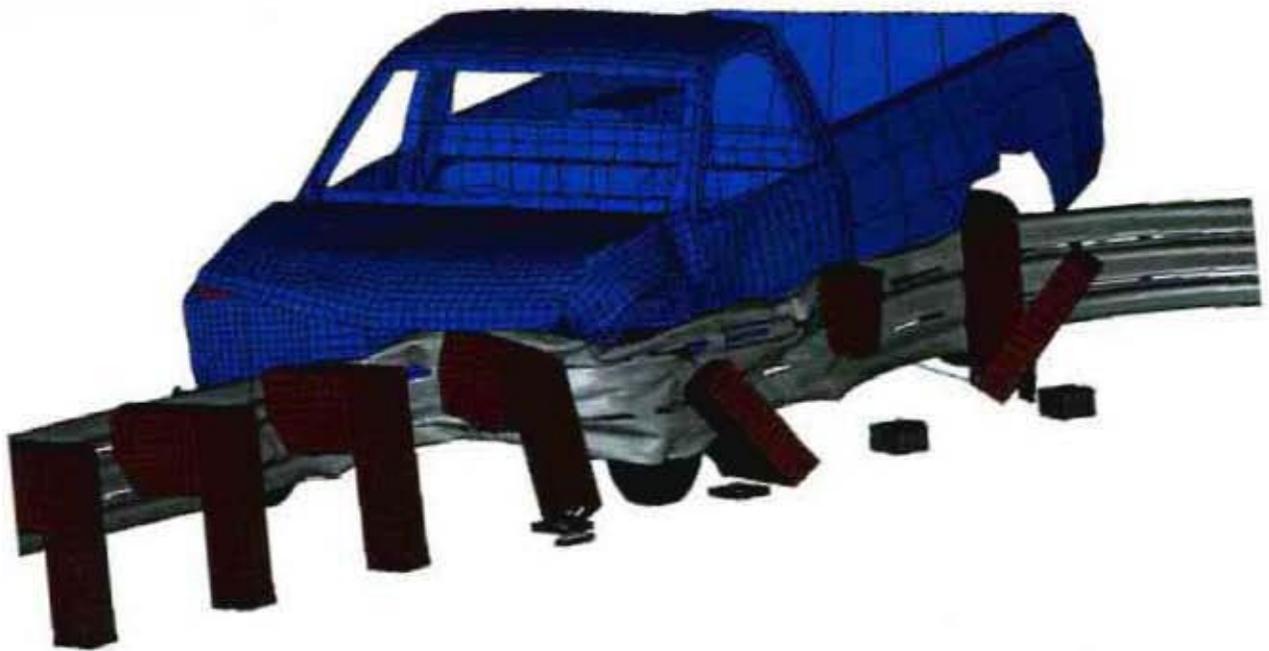
Figure 66. Model of Modified Design for Test MBN-8

Before running full-scale test MBN-8, the design modifications were made to the LS-DYNA model. The modified model is shown in Figure 66. Results indicated that the new design would safely capture the truck, as shown in Figure 67. Recall that the CIP test is defined as the impact condition where it was not known whether the bullnose would capture or redirect the vehicle. Physical testing later verified these results.

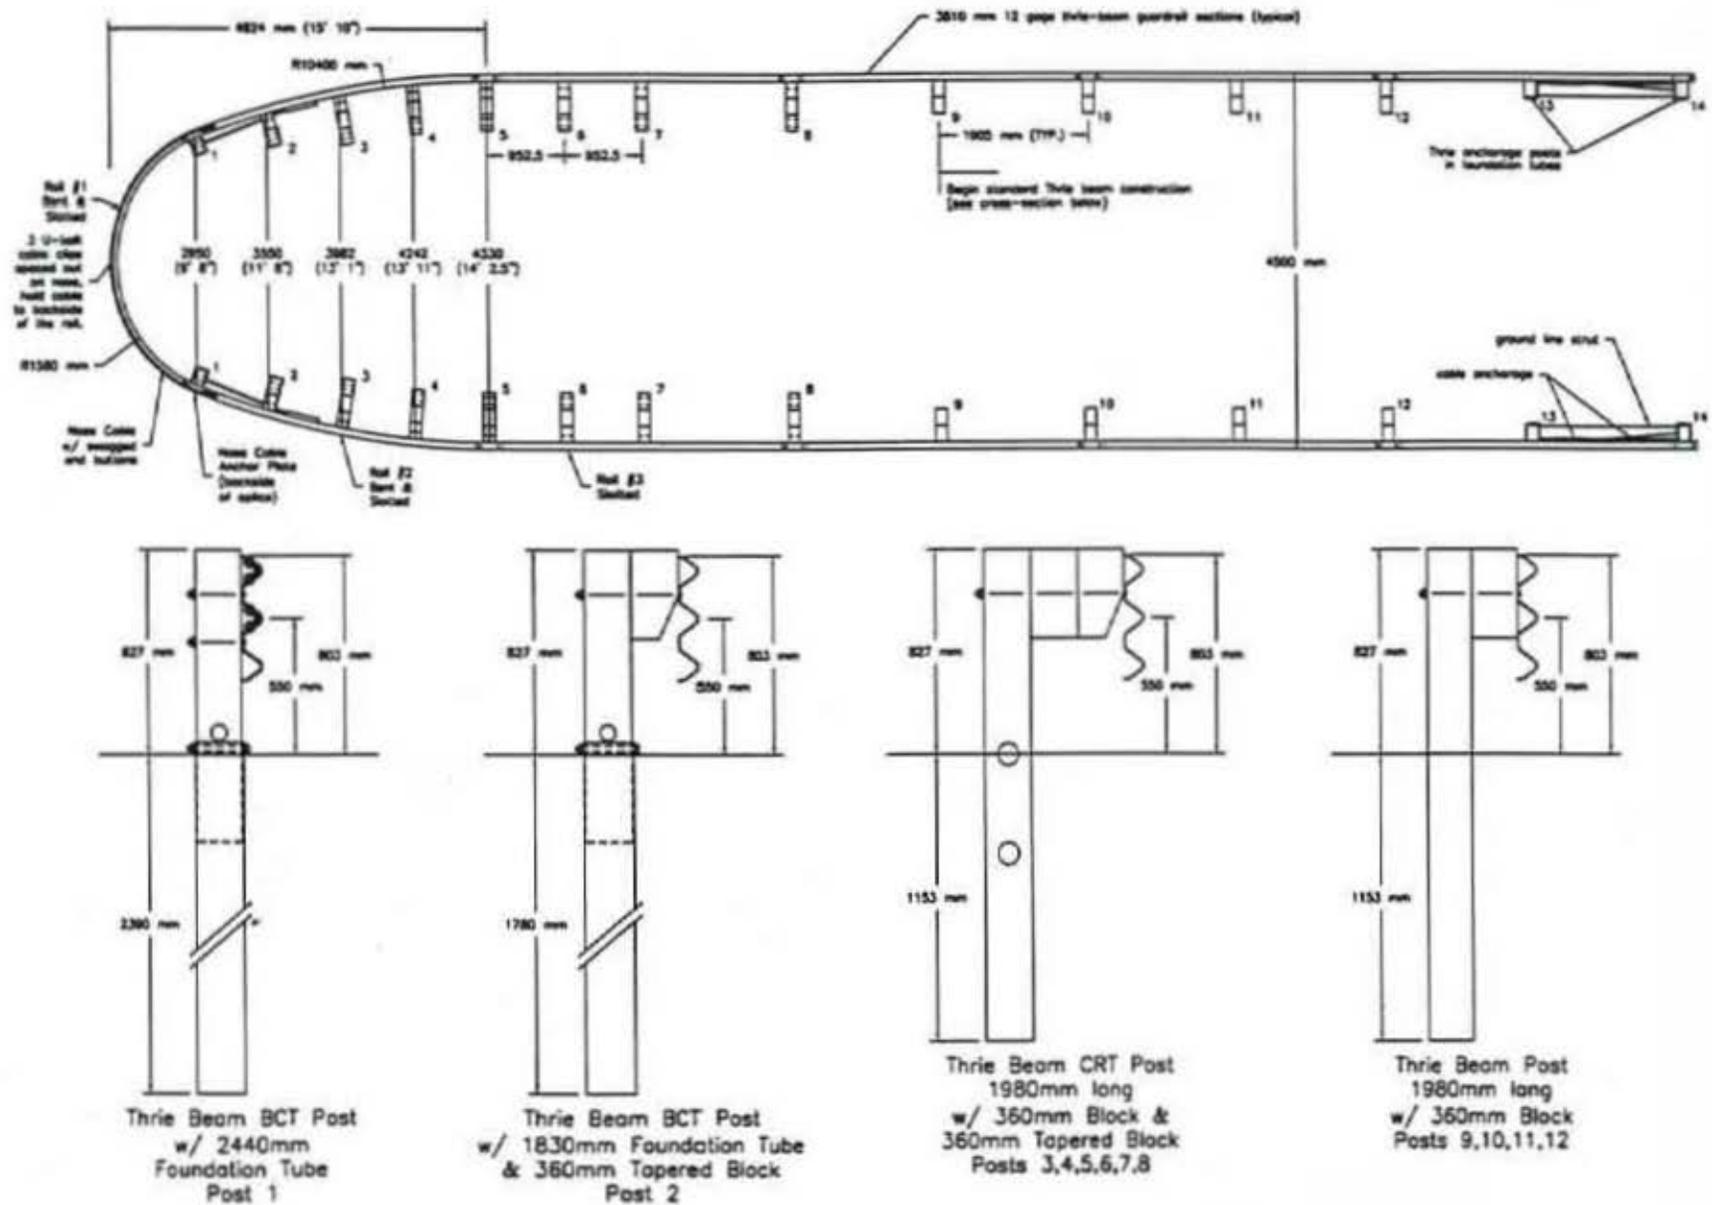
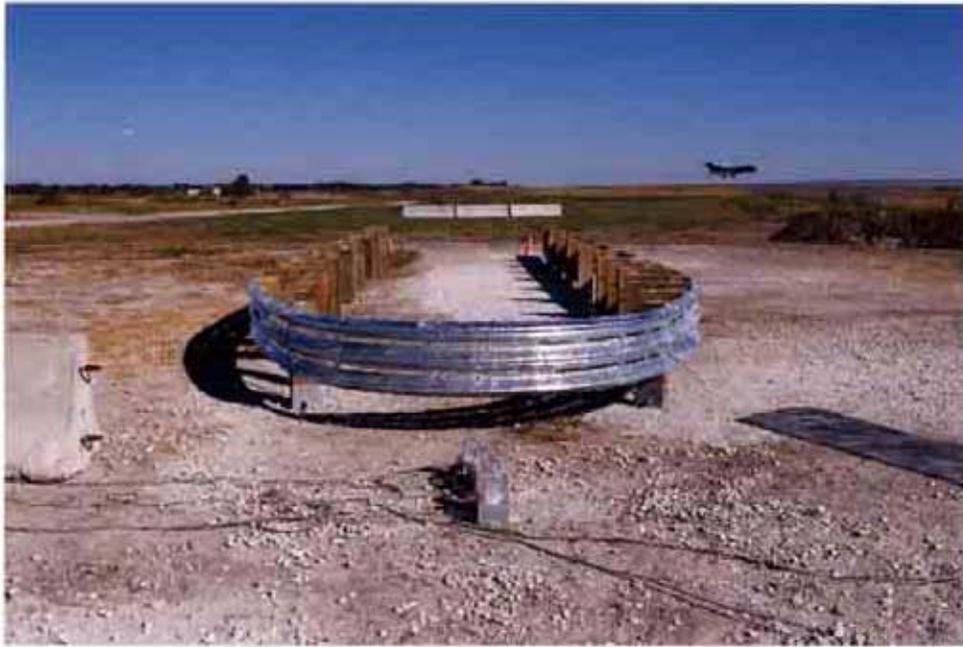
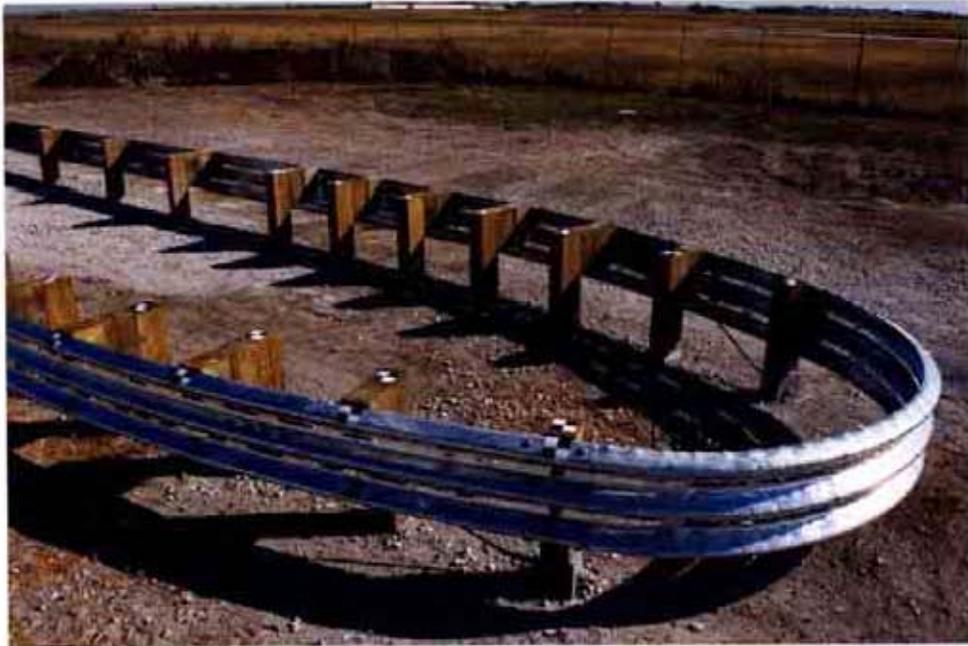
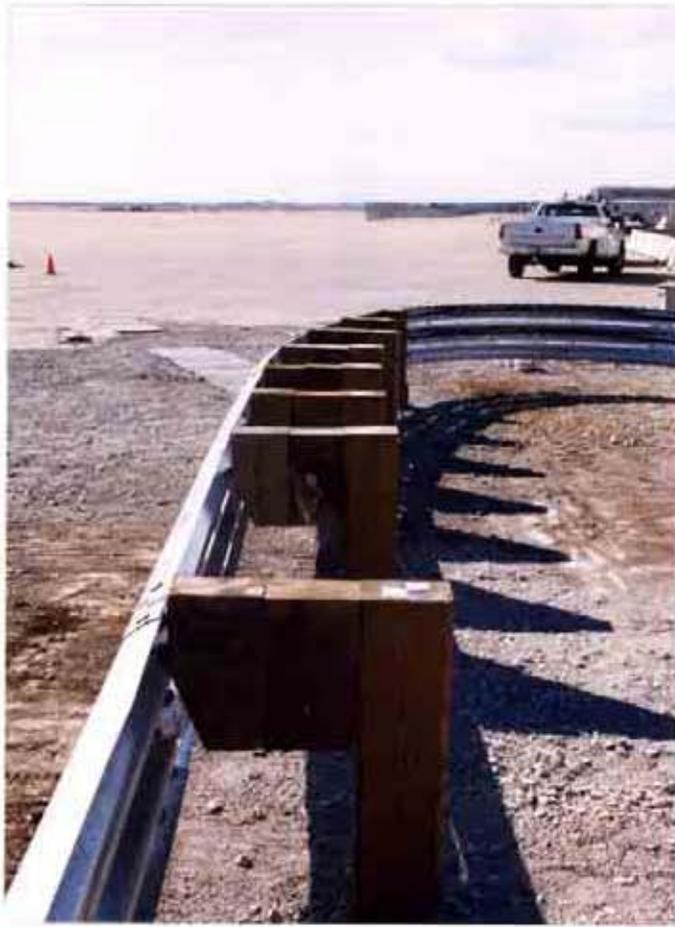
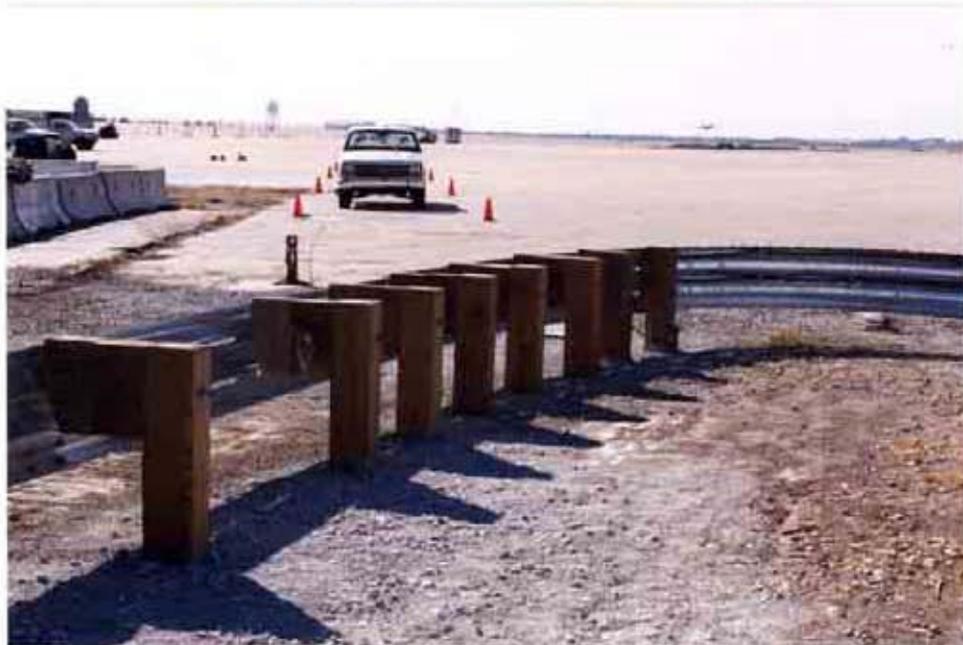
Four modifications were made to the bullnose median barrier for test MBN-8. First, the second post on each side of the system was changed from a CRT post to a BCT post. Second, an additional BCT post with a single blockout was also added to each side of the system. The new post was placed midway between post nos. 1 and 2 in the previous design. These two posts were added in order to increase the lateral resistance in the barrier system, thus increasing the rail's ability to capture and contain the impacting vehicle. Changes were also made to the blockouts used in the design. Post nos. 3 through 8 on both sides of the barrier were fitted with double blockouts in order to reduce wheel snag. In addition, the outside blockout on post nos. 2 through 8 were chamfered 25 degrees on the front face, beginning at the post bolt hole and continuing to the bottom. The purpose of the chamfered blockouts was to allow the thrie beam to fold back and wrap around the front tire of the impacting vehicle, thus aiding in vehicle capture. The final modification to the bullnose design was the removal of the ground line strut between post nos. 1 and 2 in the previous design. The ground line strut removal eliminated the interaction between the left-front vehicle tire and the ground line strut, thus reducing the potential for the vehicle to climb and vault the rail. The modified design is shown in Figures 68 through 70.

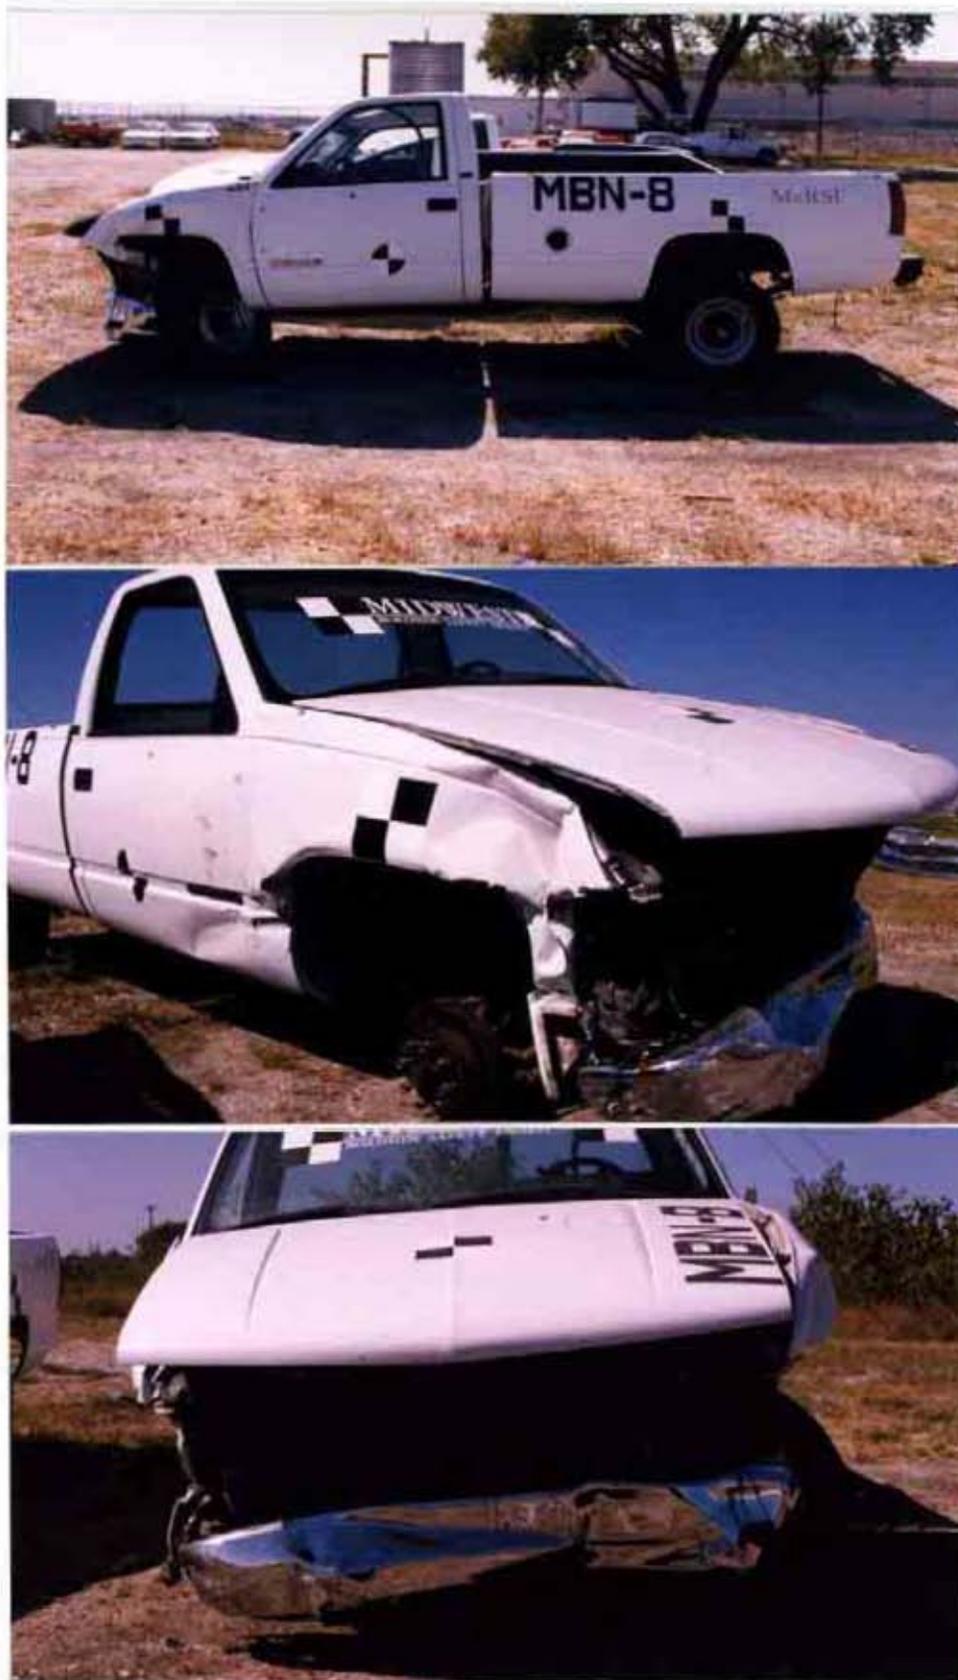
Figure 77. Vehicle Damage, Test MBN-8

Vehicle damage was moderate, as shown in Figure 77. The majority of the damage to the pickup truck occurred below the hood line. The front bumper and front end of the pickup truck were crushed inward across the entire width of the vehicle. The engine radiator was also flattened. The pickup truck's engine was shifted and twisted due to deformations to the front of the frame. The drive shaft was disengaged during the impact. The left-front fender of the pickup truck was bent down and inward around the left tire. The left-front tire was turned outward and pushed back into the wheel well. The tie rod on the left side was sheared off, and the front frame horn on the left side was bent almost 90-degrees downward. The front wheel on the right side was tore off during impact with the barrier. The right-front fender was crushed inward and downward due to the barrier impact. Minor cracking and chipping of the frame behind the right-front wheel was also observed. There was no crushing of the pickup truck's interior occupant compartment.

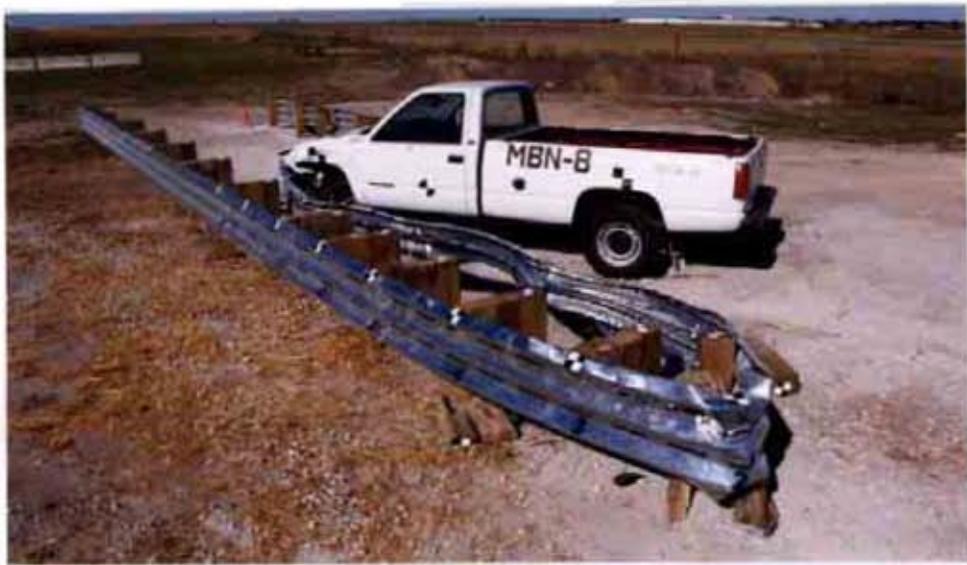
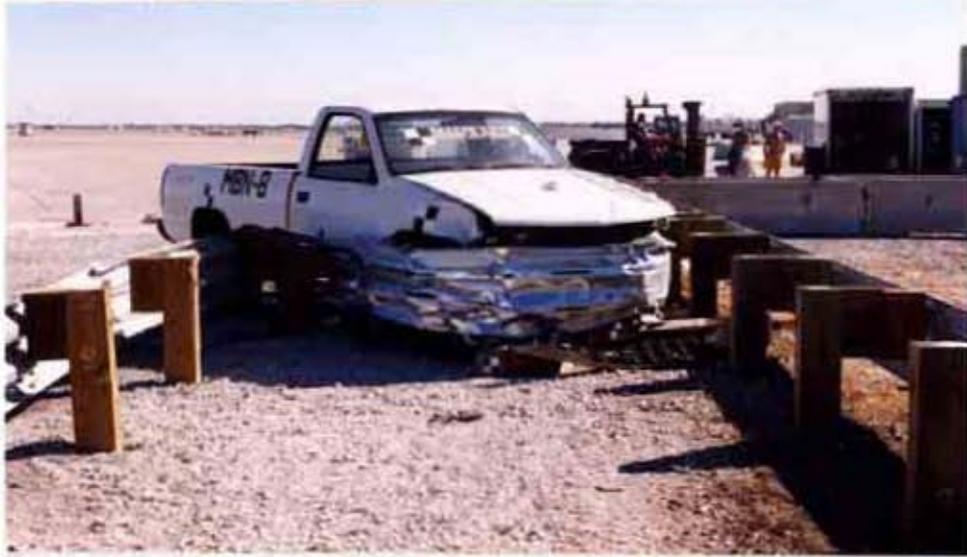
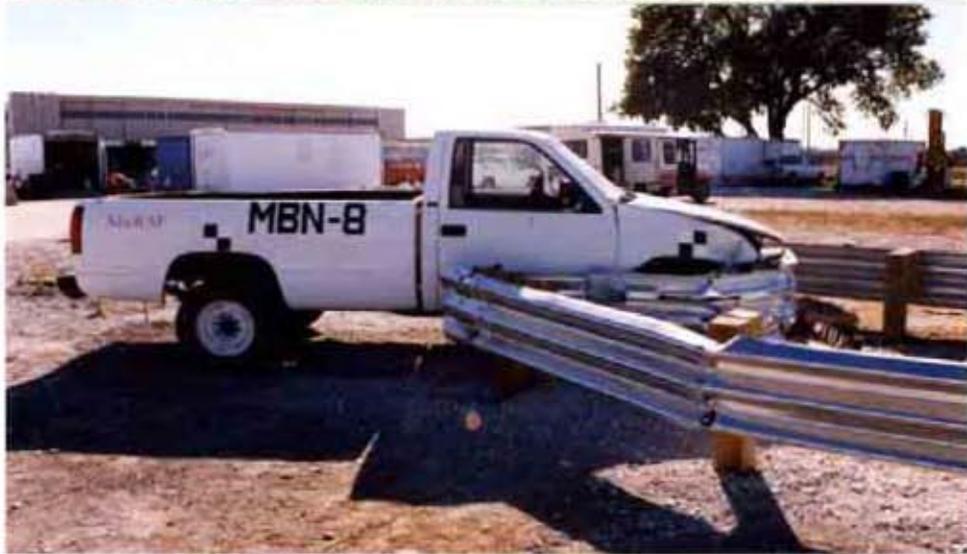
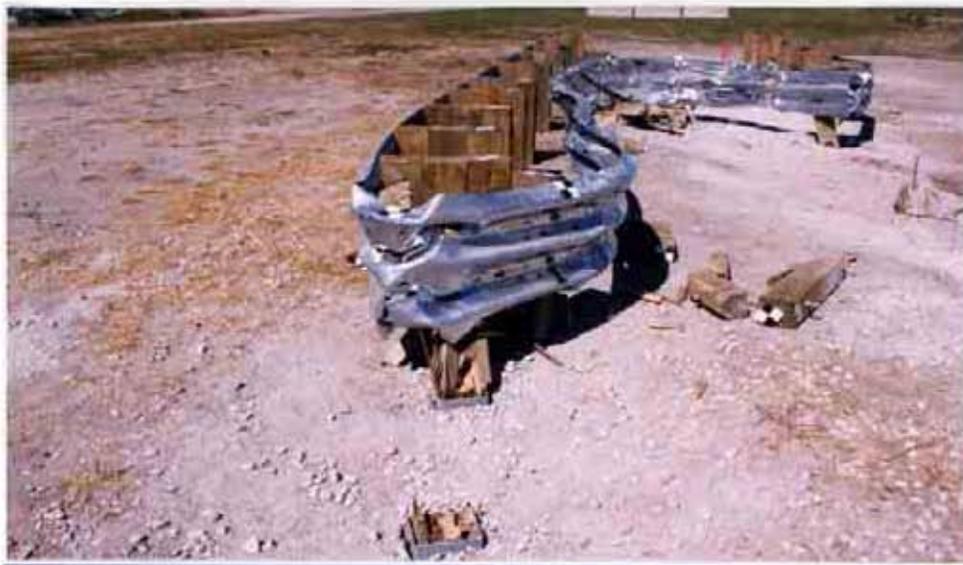
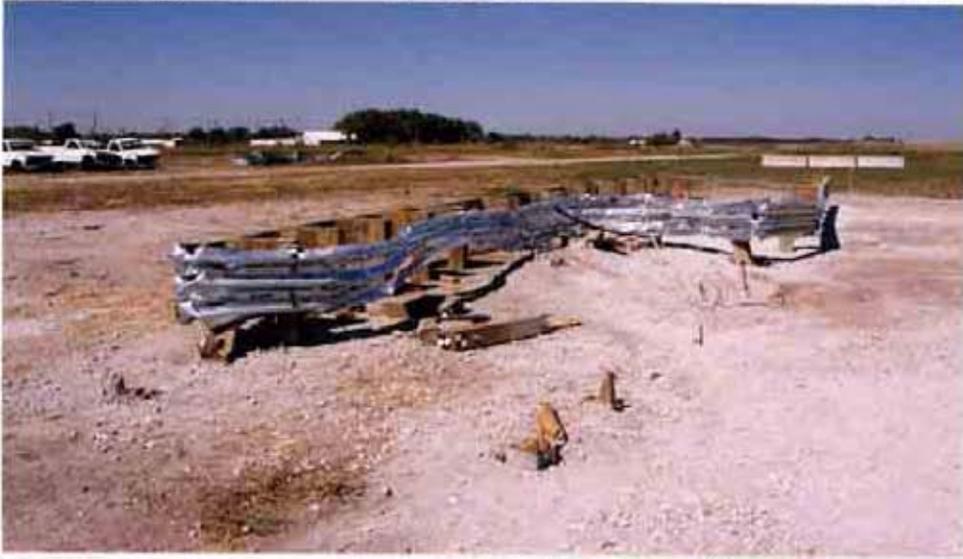
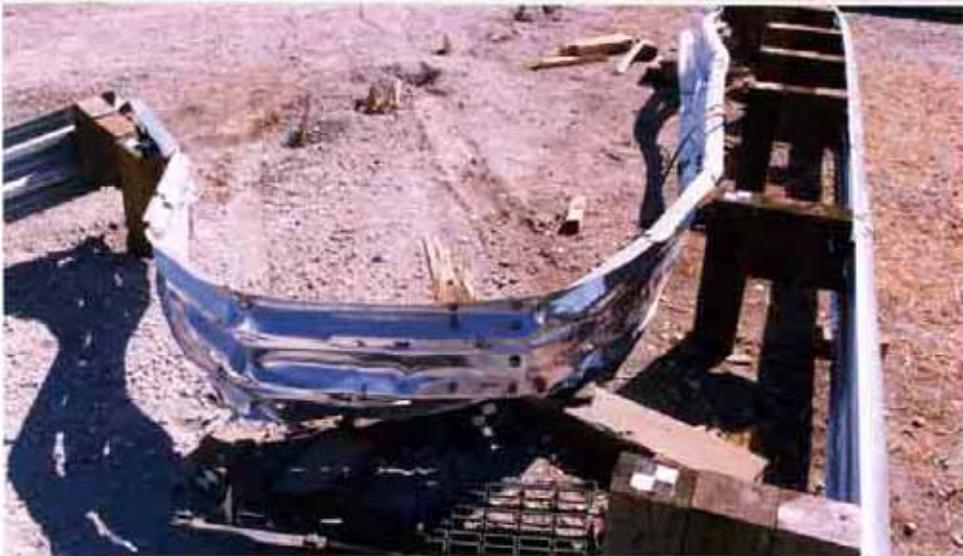
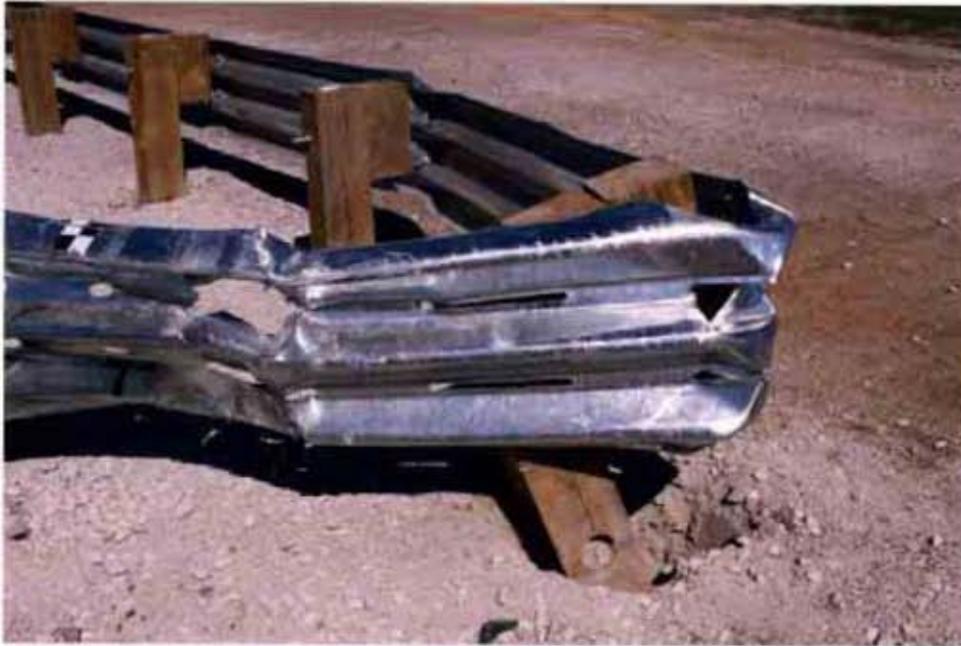
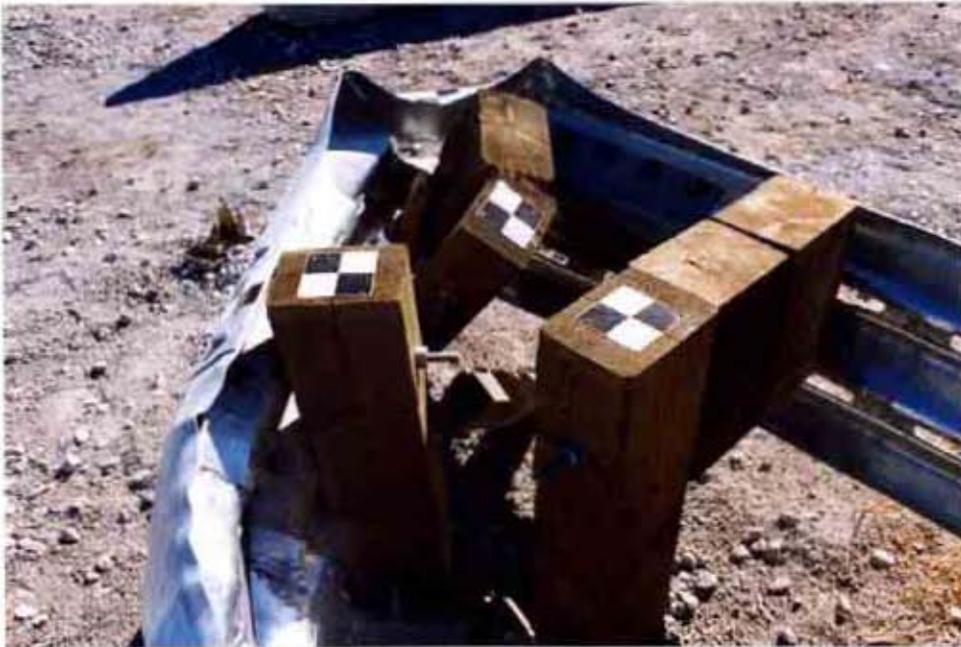
Barrier damage was extensive, as shown in Figures 78 through 80. Most of the post damage occurred to the right side of the system. Nine posts in the system were fractured. BCT post no. 1 on

the left side broke through the hole at ground line, while post no. 2 partially fractured but did not break off completely. On the right side, BCT post nos. 1 and 2 and CRT post nos. 3 and 4 were broken at the hole at ground level. CRT post nos. 5 through 7 on the right side fractured through the bottom hole. Post no. 6 was partially pulled out of the ground. No other posts in the system were fractured; however, post no. 8 on the right side had over 305 mm of permanent set deflection, as measured at ground line.

Figure 78. Barrier Damage, Test MBN-8

Figure 79. Barrier Damage, Test MBN-8

Figure 80. Barrier Damage, Test MBN-8

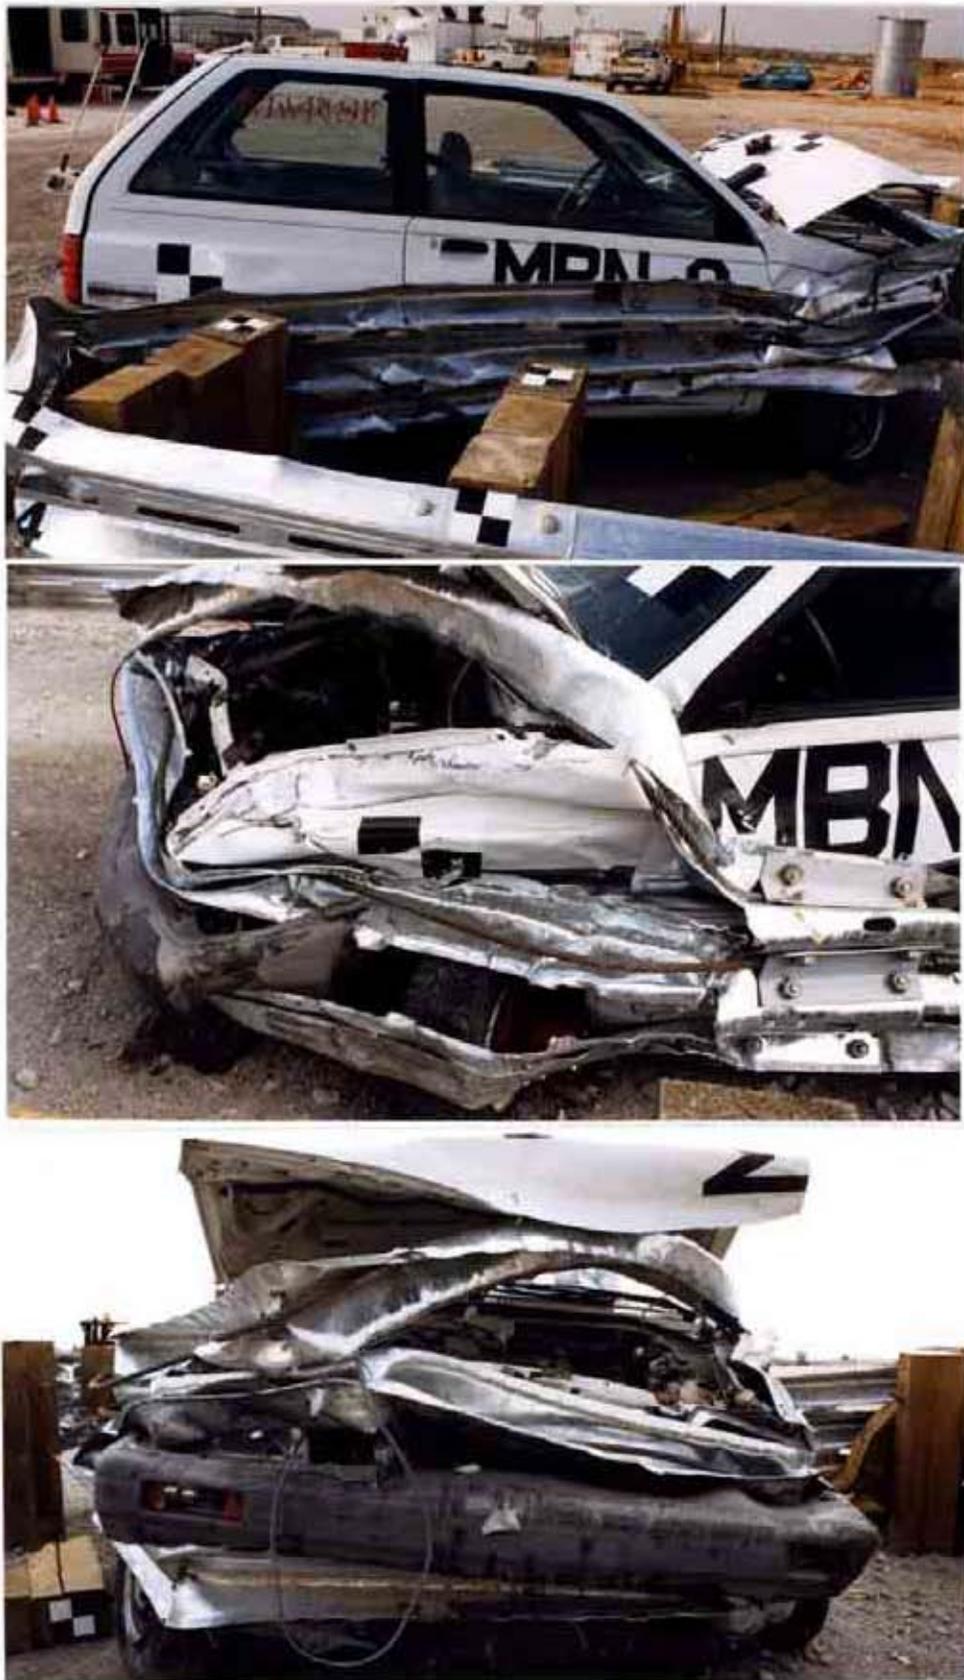
Figure 87. Vehicle Damage, Test MBN-9

Vehicle damage was moderate, as shown in Figure 87. The engine hood was pushed back and upward, causing it to bend and fold at several locations. The front end of the small car was crushed inward across the entire width of the vehicle. The radiator was flattened along with other engine components near the engine block. Minor bending of the front of the frame was also observed. The right-front fender was crushed all along its length and pushed back toward the door. The left-front tire was turned outward and pushed back into the wheel well. The left-front fender was also severely deformed inward. The left-side door buckled near the front region when it contacted the fender and was pushed backward. This door buckling caused the left-front window to shatter. Scratching and denting of the left-side door due to contact with the rail was evident as well. There was no crushing of the small car's interior occupant compartment.

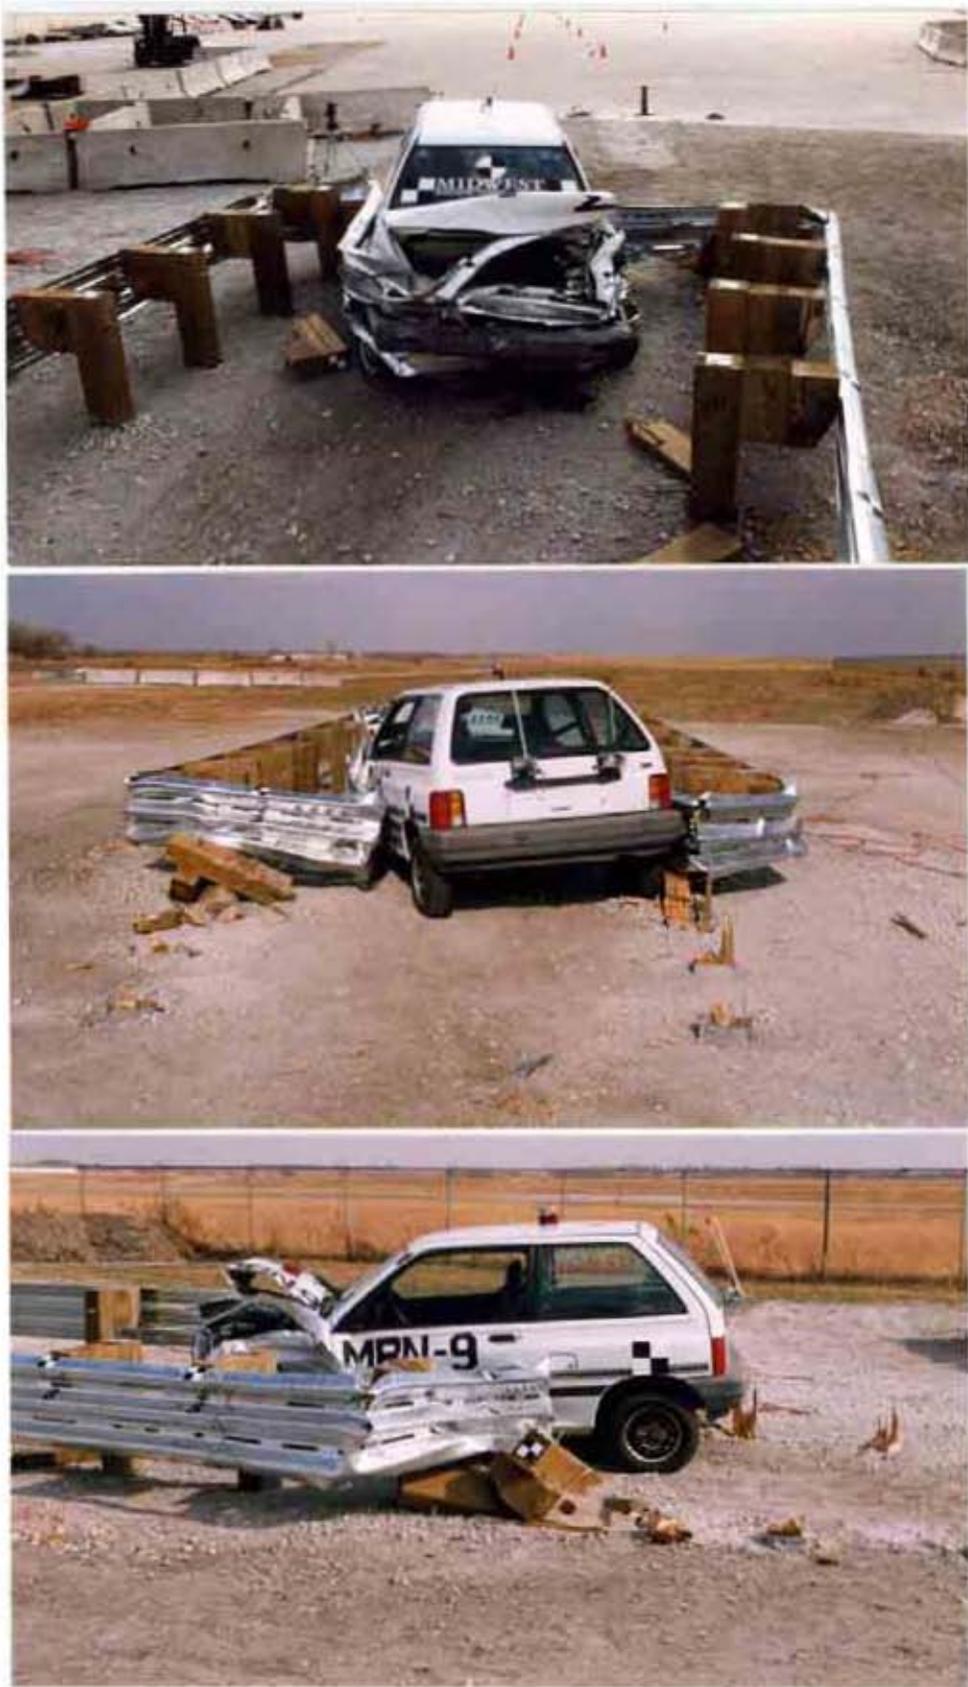
Figure 88. Barrier Damage, Test MBN-9

Barrier damage was extensive, as shown in Figures 88 through 89. A total of six posts in the system were fractured. BCT post nos. 1 and 2 on both sides of the system fractured through the hole at ground level. CRT post no. 3 on the left side broke at the top hole and was trapped between the
