PHASE III DEVELOPMENT OF A BULLNOSE GUARDRAIL SYSTEM FOR MEDIAN APPLICATIONS

MIDWEST ROADSIDE SAFETY FACILITY

MwRSF Research Report No. TRP-03-95-00

June 1, 2000

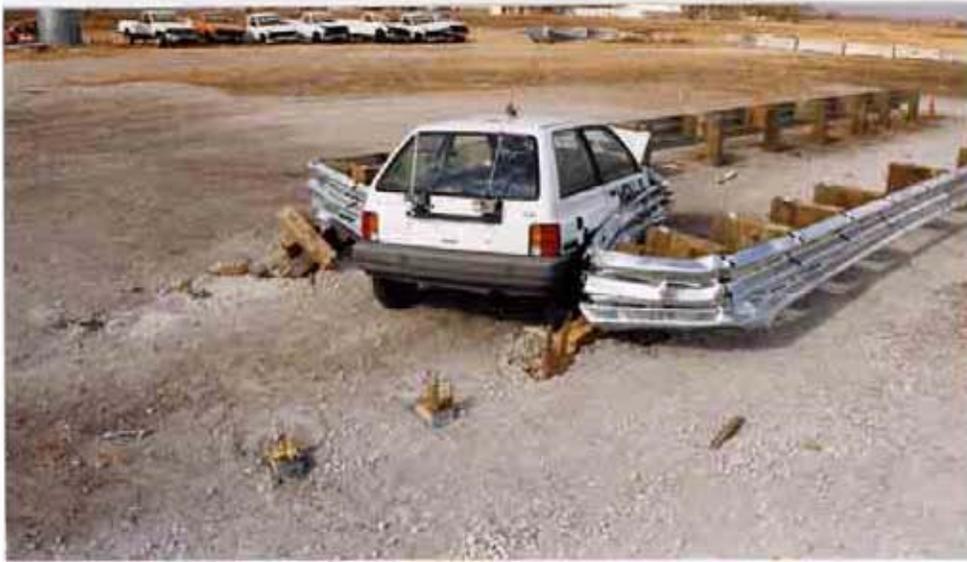
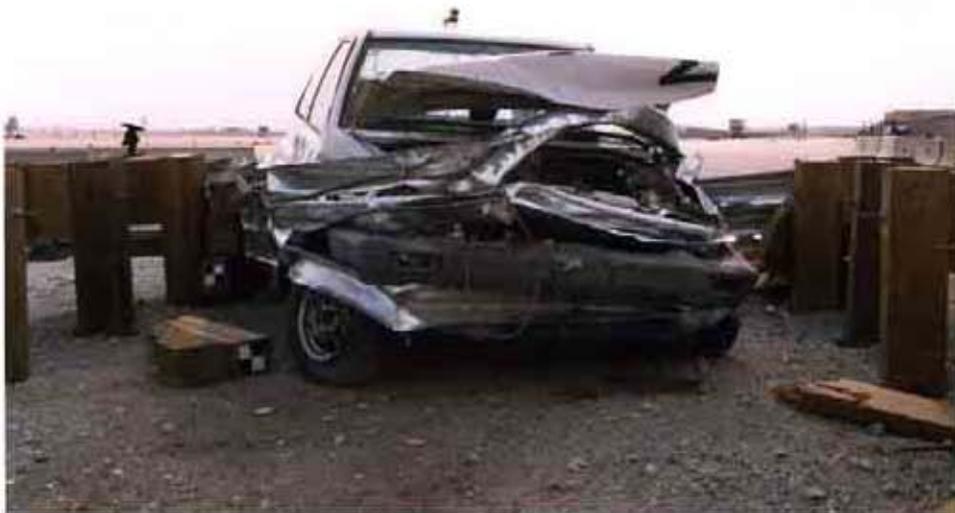
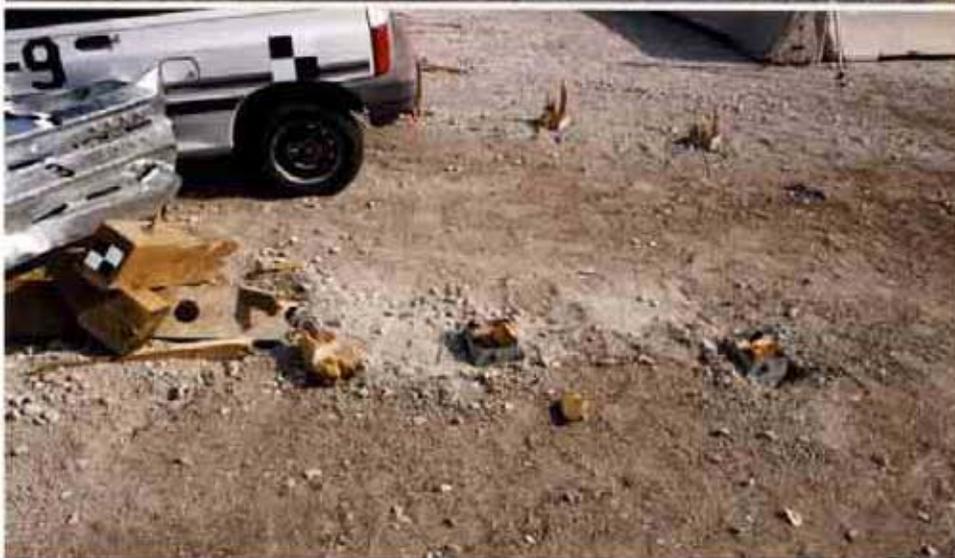
Figure 89. Barrier Damage, Test MBN-9

Barrier damage was extensive, as shown in Figures 88 through 89. A total of six posts in the system were fractured. BCT post nos. 1 and 2 on both sides of the system fractured through the hole at ground level. CRT post no. 3 on the left side broke at the top hole and was trapped between the

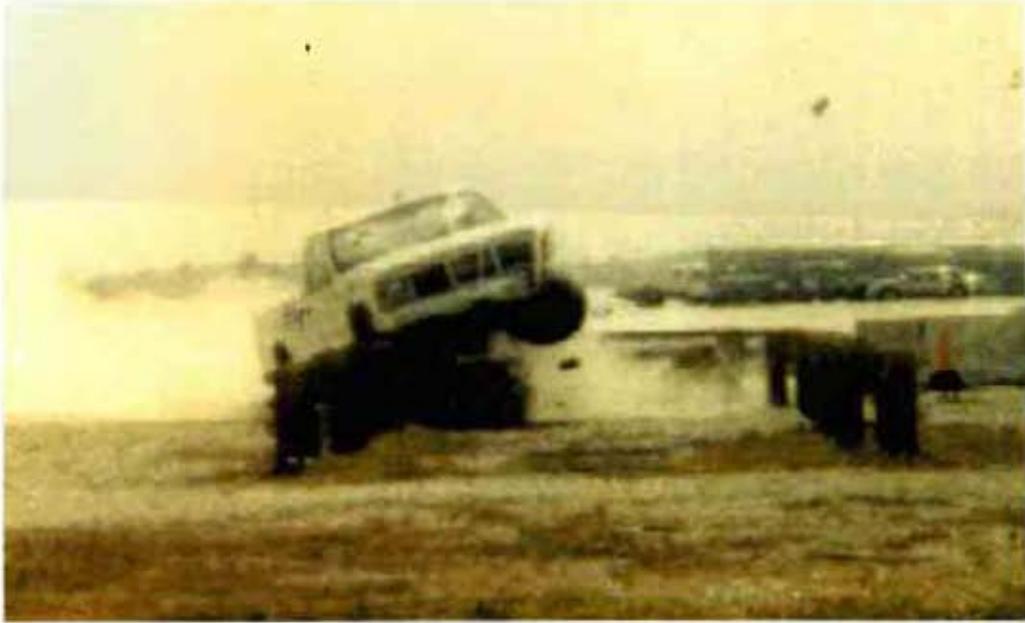
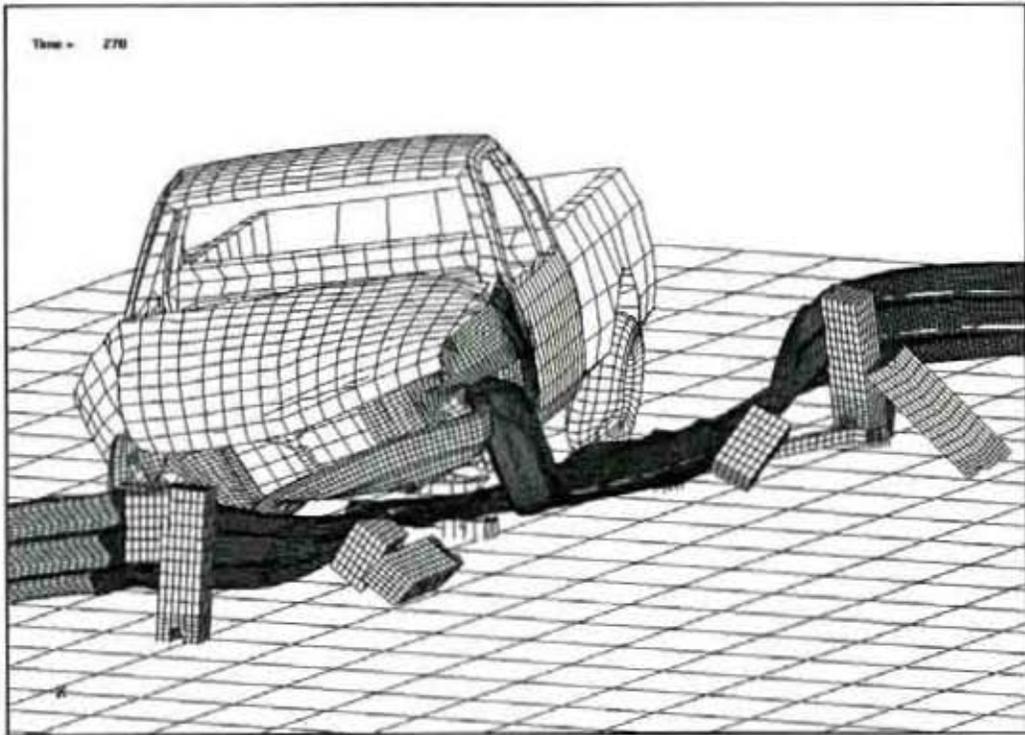
Figure 4. Redirection Impact - Truck Vaults Over Bullnose

Researchers were then presented with a new challenge when the newly designed bullnose system failed the 100 km/h redirection test with a 2000-kg pickup. The bullnose failed to contain the pickup and instead rolled back and formed a ramp causing the truck to vault into the air and over the system (see Figure 4). To determine the cause of the failed test, researchers again turned to simulation. Unfortunately the transition from simulating the head-on impact to the redirection impact required an extensive modeling effort. Not only did the model require major modifications, a series of contact troubles delayed the project several months.

After a series of modeling adjustments, the failed redirection test was reasonably simulated (see Figure 4). The simulation was ended at 278 ms due to another instability in the solution. However, because the failure phenomenon was clearly captured further simulation was deemed nonessential. Results showed posts 2 and 3 breaking early in the event, allowing the rail to roll back and form a ramp, which vaults the vehicle up and over the system.

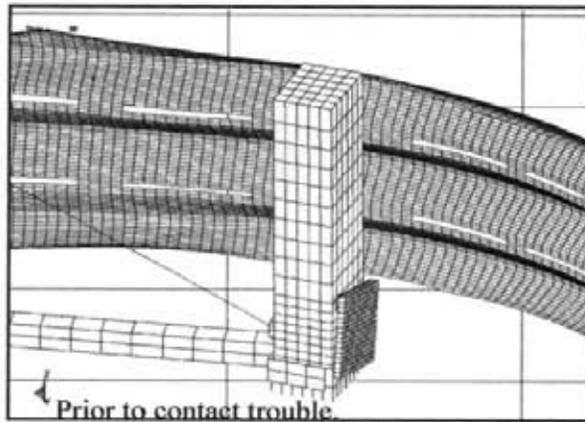
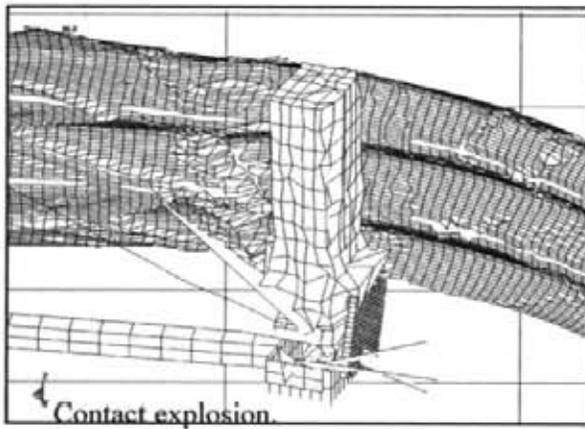
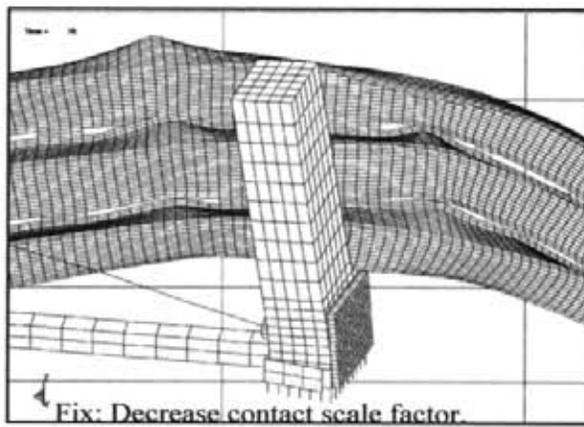
Figure 7. Cable Anchor - Post Contact

Figure 7 demonstrates the problem and fix. The cable anchor assembly is used to provide tension anchorage for the guardrail during redirection. One end of a cable is attached to the rail, the other end is attached to bracket at the base of post one. The tension force in the cable during an
