PHASE II DEVELOPMENT OF A BULLNOSE GUARDRAIL SYSTEM FOR MEDIAN APPLICATIONS

MIDWEST ROADSIDE SAFETY FACILITY

MwRSF Research Report No. TRP-03-78-98

December 18, 1998

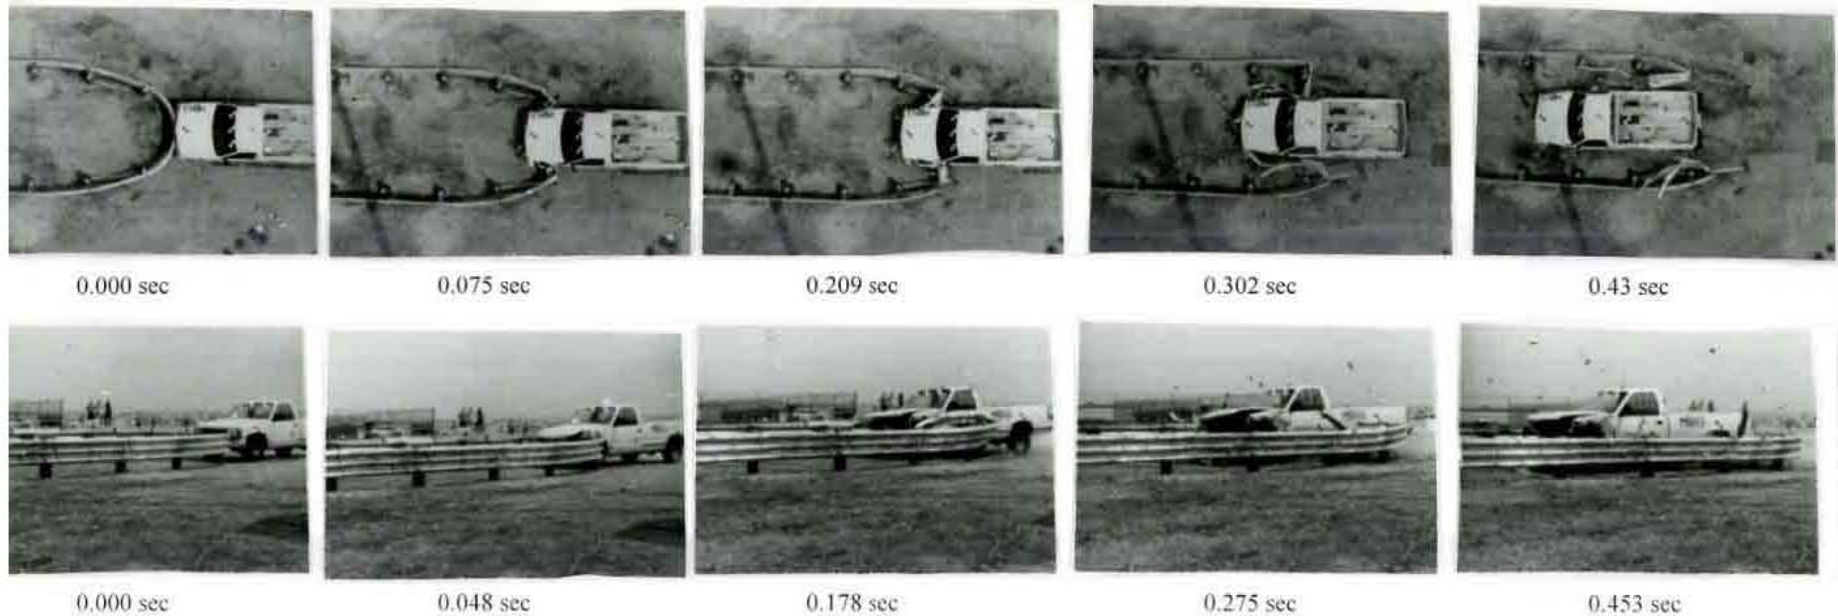
Figure 19. Summary and Sequential Photos, Test MBN-3

Following test MBN-3, a safety performance evaluation was conducted, and the bullnose barrier design was determined to be unacceptable for Test 3-31 according to NCHRP Report No. 350 criteria. The bullnose barrier did not contain or stop the test vehicle in a controlled manner due to the fracture of the thrie beam during the impact. However, it should be noted that the pickup truck did not override the thrie beam during the impact prior to the thrie beam fracture. Detached elements and debris from the test article did not penetrate or show potential for penetrating the occupant compartment. There was no deformation of, or intrusion into, the occupant compartment that could

- Test Number MBN-3
- Date 5/6/98
- Appurtenance Bullnose Median Barrier
- Total Length 20,144 mm
- Steel Thrie Beam (Nested)
 - Thickness 12 gauge (2.66 mm)
 - Top Mounting Height 804 mm
- Wood Posts
 - Post Nos. 1 - 2, 10 - 11 140 mm x 190.5 mm x 1080-mm long
 - Post Nos. 3 - 9 150 mm x 200 mm x 1980-mm long
- Wood Spacer Blocks
 - Post Nos. 1 - 8 150 mm x 200 mm x 320-mm long
- Soil Type Grading B - AASHTO M 147-65 (1990)
- Vehicle Model 1990 Chevy 2500 2WD
 - Curb 1,828 kg
 - Test Inertial 1,989 kg
 - Gross Static 1,989 kg
- Vehicle Speed
 - Impact 100.16 km/hr
 - Exit NA

- Vehicle Angle
 - Impact -1.08 deg
 - Exit NA
- Vehicle Snagging None
- Vehicle Stability Satisfactory
- Occupant Ridedown Deceleration (10 msec avg.)
 - Longitudinal 3.31 g's
 - Lateral (not required) 3.32/-4.57 g's
- Occupant Impact Velocity (Normalized)
 - Longitudinal 5.10 m/s
 - Lateral (not required) 1.36 m/s
- Vehicle Damage Moderate
 - TAD (17) 12-FD-4 // 3-RP-1
 - SAE (18) 12FDEW4
 - 03RPEW1
- Vehicle Stopping Distance 56.72 m downstream
20.54 m left of centerline
- Barrier Damage Extensive rail damage and
three fractured posts
- Maximum Deflections
 - Permanent Set NA
 - Dynamic NA

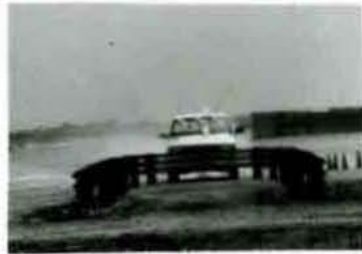
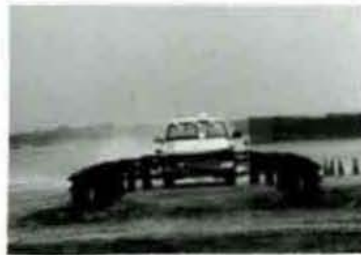
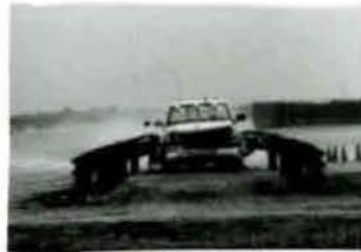
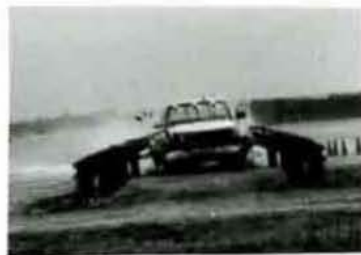
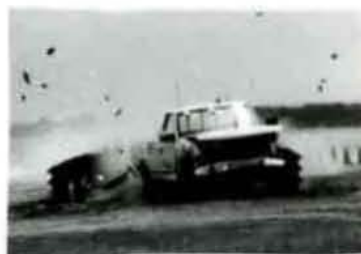
Figure 20. Additional Sequential Photographs, Test MBN-3

Following the initial impact with the pickup truck, the thrie beam rail immediately began to deform inward. At 0.054 sec after impact, a tear in the thrie beam rail began to occur in the middle hump just to the right of the centerline of the nose section. The middle hump was aligned directly with the bumper at impact and subsequently fractured. Unlike the middle hump, the upper hump of the rail did not fail immediately after impact. The bottom hump was impacted below the bumper and was pushed underneath the bumper and driven over by the front tires. As the pickup penetrated further into the barrier, post no. 1 on both sides was fractured as the beam wrapped around the posts at 0.076 sec. The first kink in the rail was formed downstream of the first rail splice on the right side of the barrier. At 0.200 sec, this kink impacted and dented the right-side door of the pickup. The pickup truck then continued to penetrate the system, kinking the rail at the cable box on the left side and forming a second kink at post no. 2 on the right side. As the rail wrapped around post no. 2 on both sides, high stresses in the top hump of the thrie beam, which was now carrying most of the impact load, caused the rail to tear. The tear occurred at 0.208 sec after impact at a location slightly to the left of the centerline of the bullnose. Post no. 2 on the left side of the barrier was also broken due to rail wrapping around the post. Following the rupture of the rail, the pickup truck proceeded

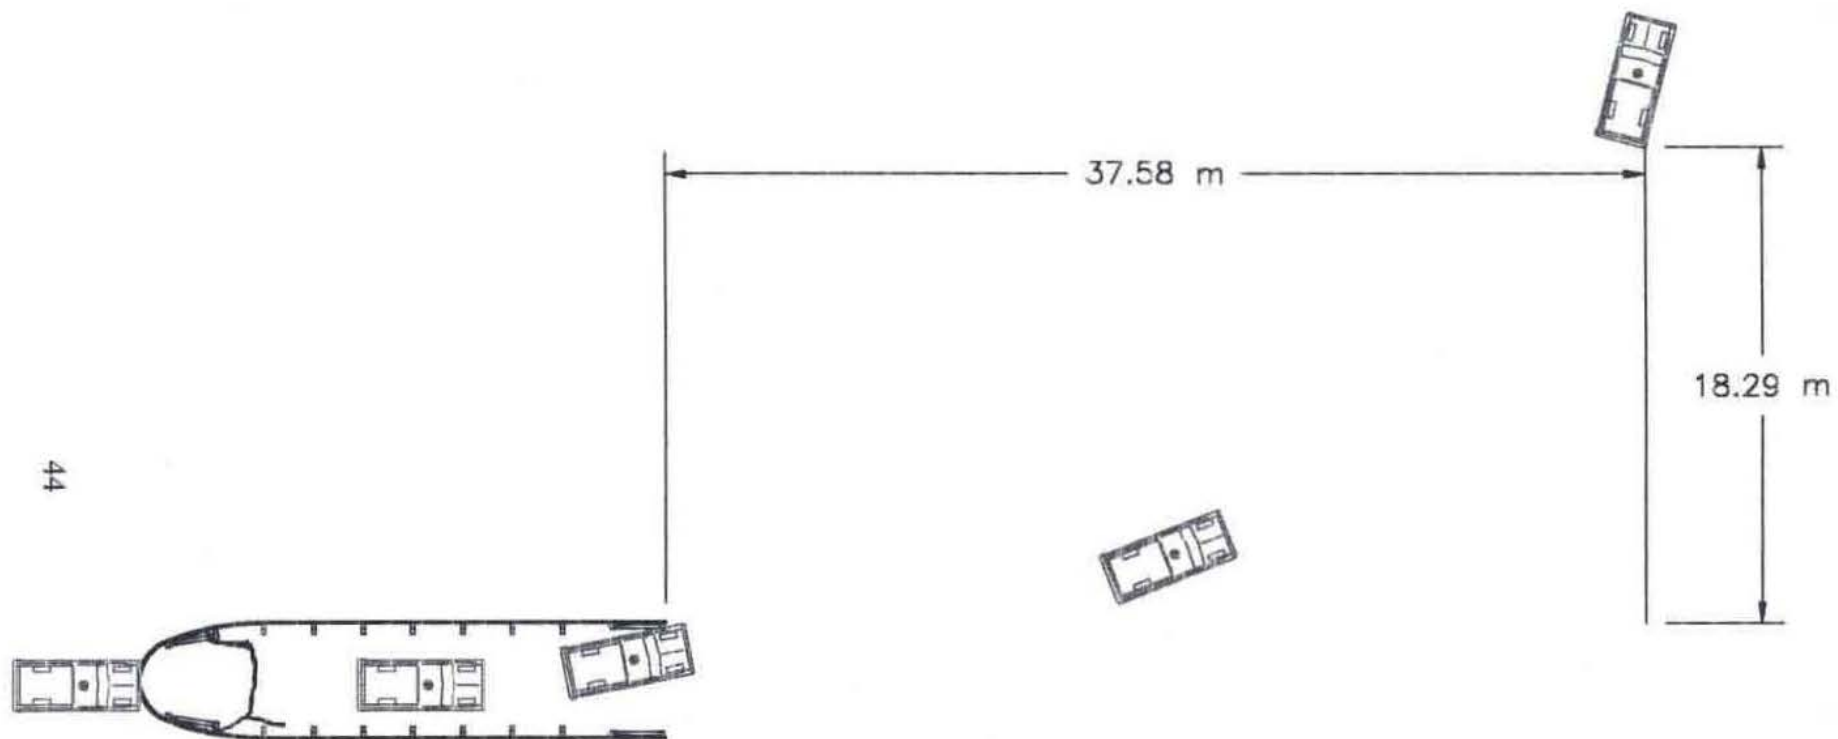
Figure 23. Vehicle Trajectory, MBN-3

through the middle of the bullnose barrier and fractured post no. 11 at 0.876 sec as it exited the bullnose barrier. Figure 23 shows the trajectory of the pickup truck during the crash test and the final position of the vehicle.

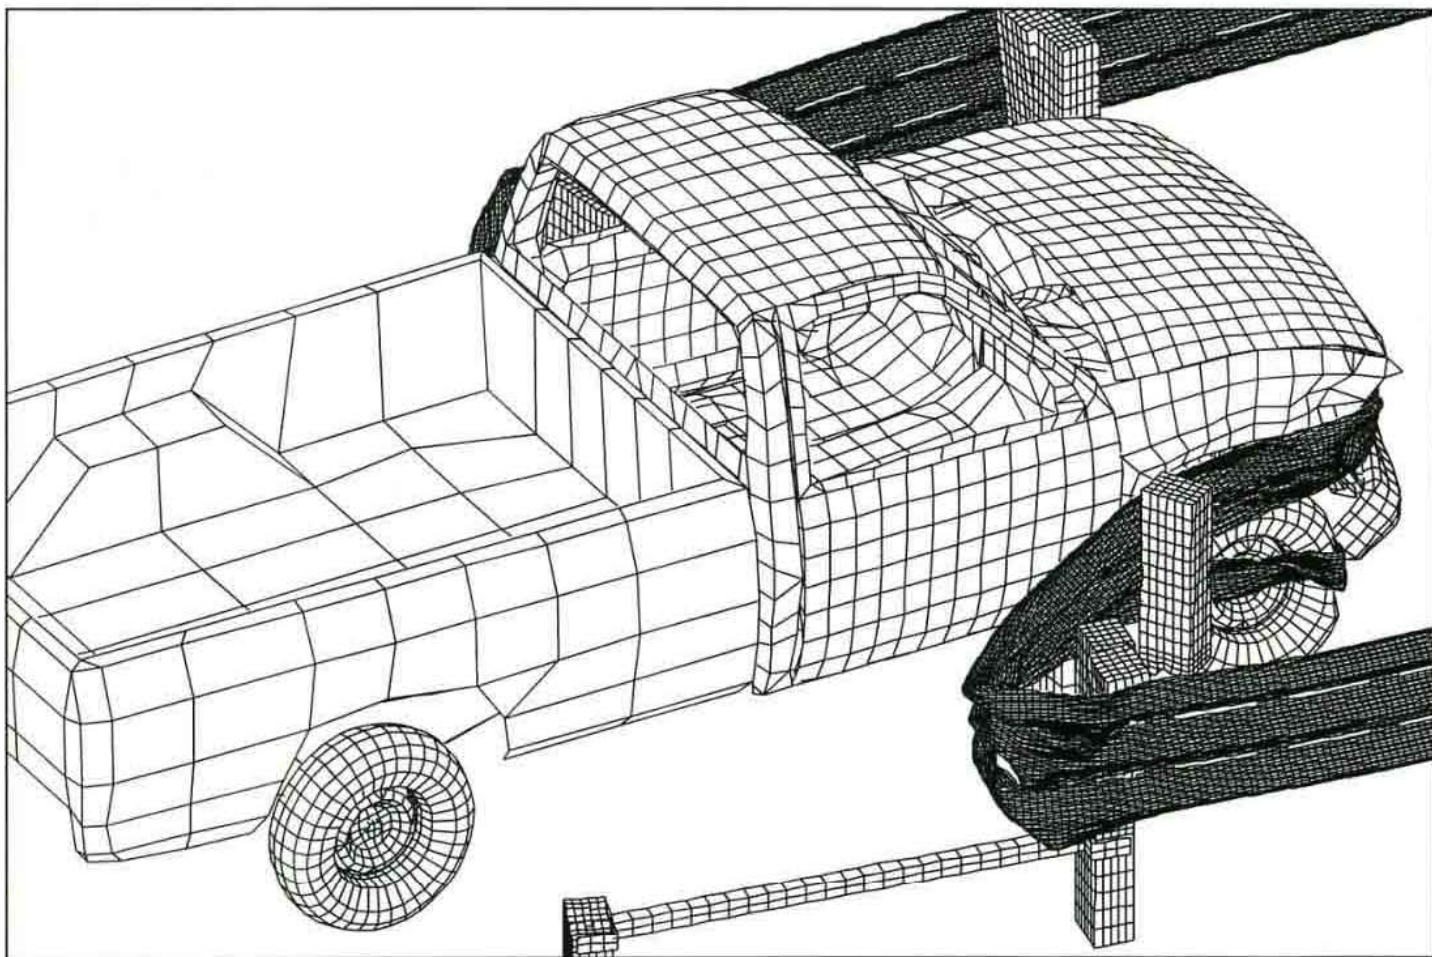
Figure 30. Lower Rail Catches on Tire

Using the material properties obtained from the component study and the refined rail mesh, the bullnose model was again simulated. This time, the tabs connecting the peaks of the thrie beam tore, allowing the rail to wrap around the front of the truck, as seen in Figure 30. However, as shown in Figure 30, the lower peak of the rail caught on the front tires. In the physical test, the rail was pushed down, and the front tires rolled over the lower rail section. It was thought that the difference between test and simulation results was due to the absence of a rotating tire in the model. Thus, capabilities for a rotating tire were added to the model.
