CONCEPT DEVELOPMENT OF A BULLNOSE GUARDRAIL SYSTEM FOR MEDIAN APPLICATIONS

MIDWEST ROADSIDE SAFETY FACILITY

MwRSF Research Report No. TRP-03-73-98

May 22, 1998

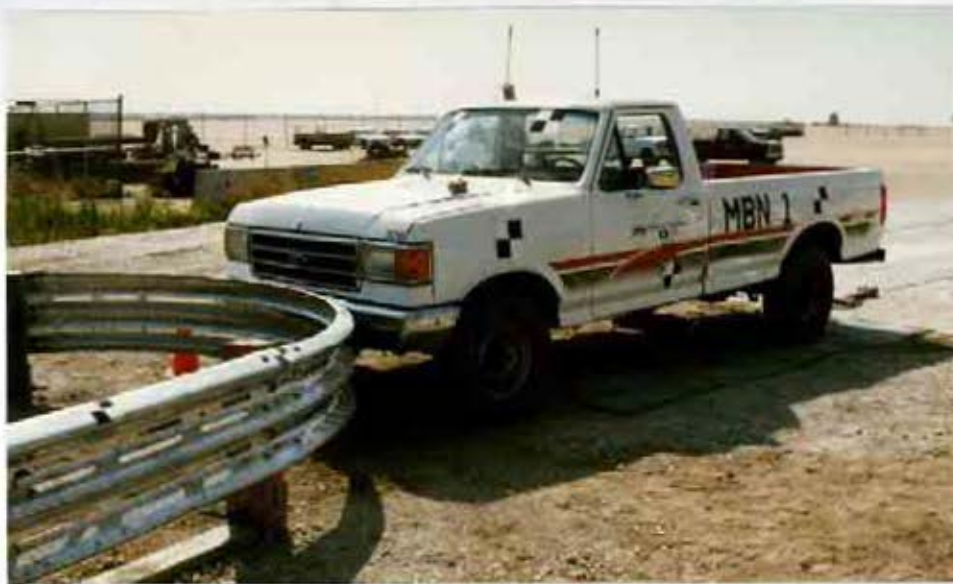
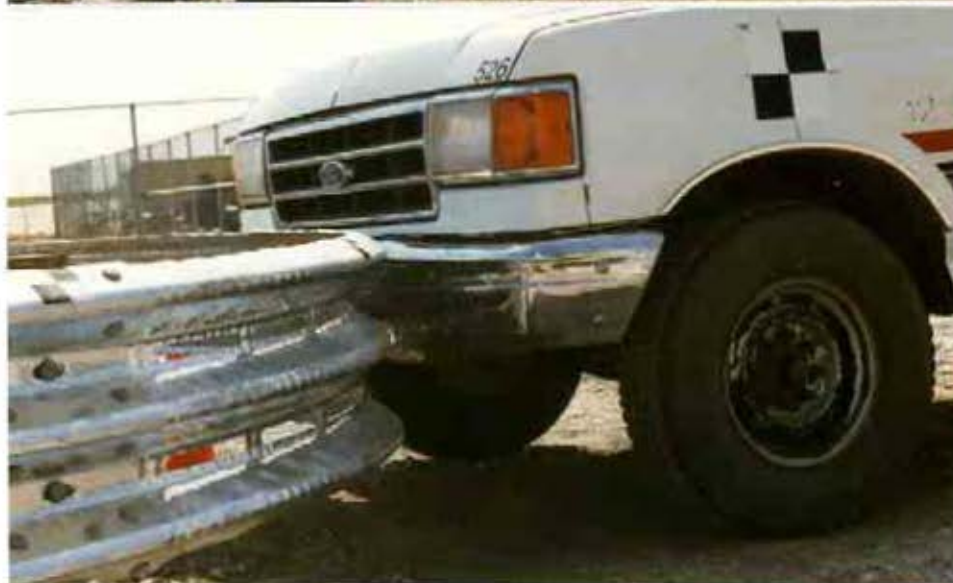
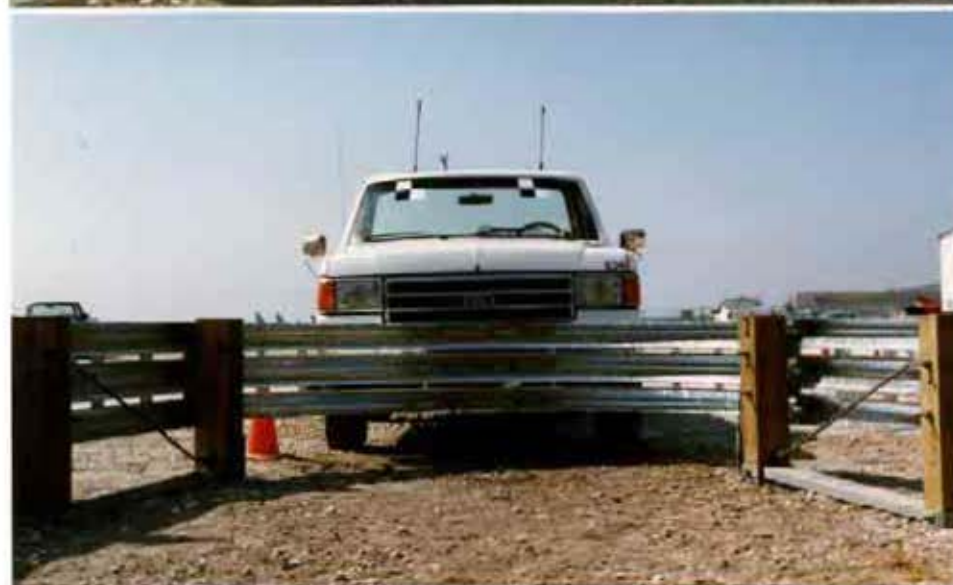
Figure 21. Impact Location MBN-1

The 1998-kg pickup truck impacted the bullnose barrier terminal at a speed of 101.4 km/h and an angle of 0.1 degrees, as shown in Figure 21. A summary of the test results and the sequential photographs are shown in Figure 22. Additional sequential photographs are shown in Figure 23.

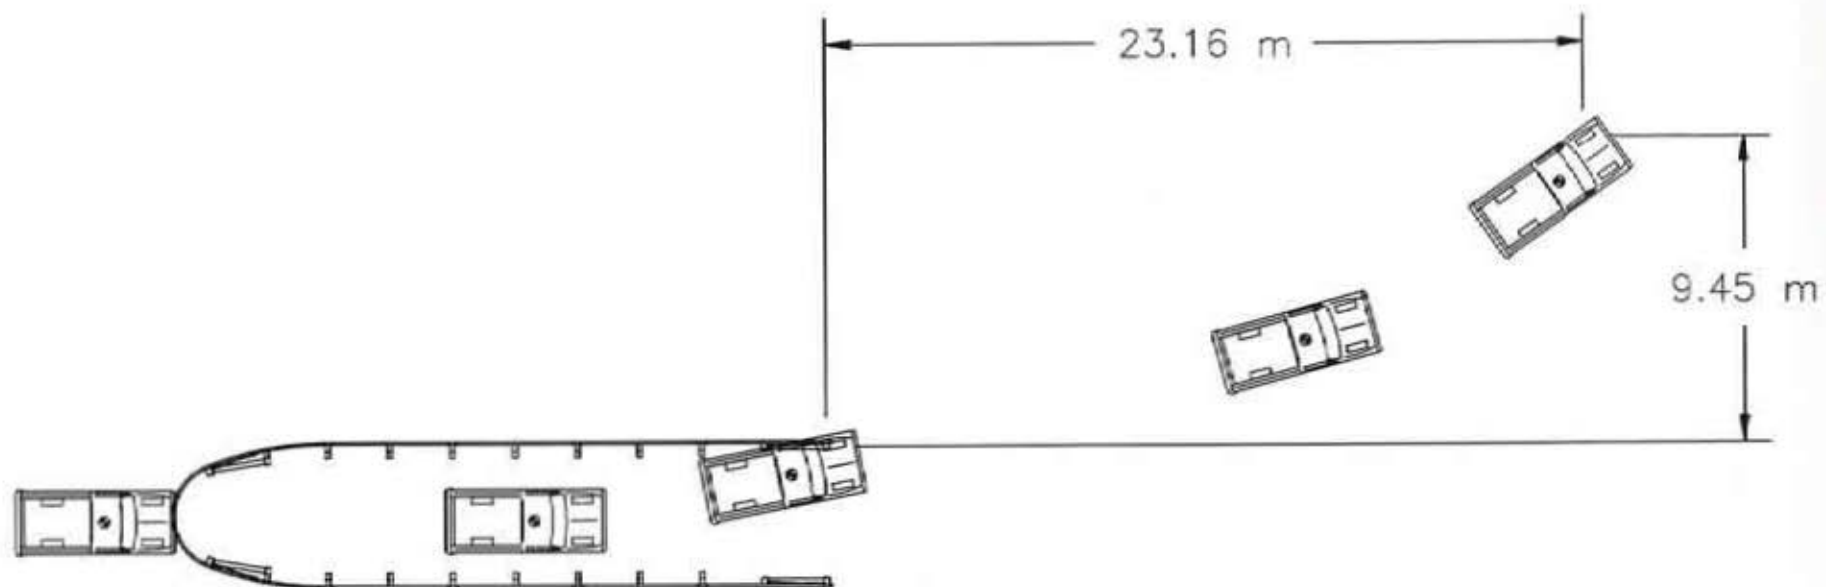
Figure 24. Vehicle Trajectory, MBN-1

Following the initial impact with the pickup truck, the thrie beam rail immediately began to deform inward. At 0.064 sec after impact, post no. 1 on both sides of the barrier fractured and the front quarter of the truck penetrated into the bullnose. The slotted thrie beam flattened across the front of the truck capturing the bumper and grill of the truck. A large “knee” or kink formed in the rail on the left side of the barrier between post nos. 1 and 2 at 0.11 sec after impact. As the truck continued to penetrate the barrier, post no. 2 on both sides of the barrier failed at 0.18 sec after impact. At this point, the front of the truck was even with post no. 3. The thrie beam snagged at post no. 3 on the right side of the barrier at a time of 0.31 sec after impact causing the thrie beam to rupture. At this time, the velocity of the pickup truck was 75.7 km/hr. This allowed the truck to continue traveling forward in the middle region of the barrier. At time 1.20 sec after impact, the truck impacted and fractured post no. 7 on the left side of the barrier as it exited the system. Figure 24 shows the trajectory of the pickup during the crash test.

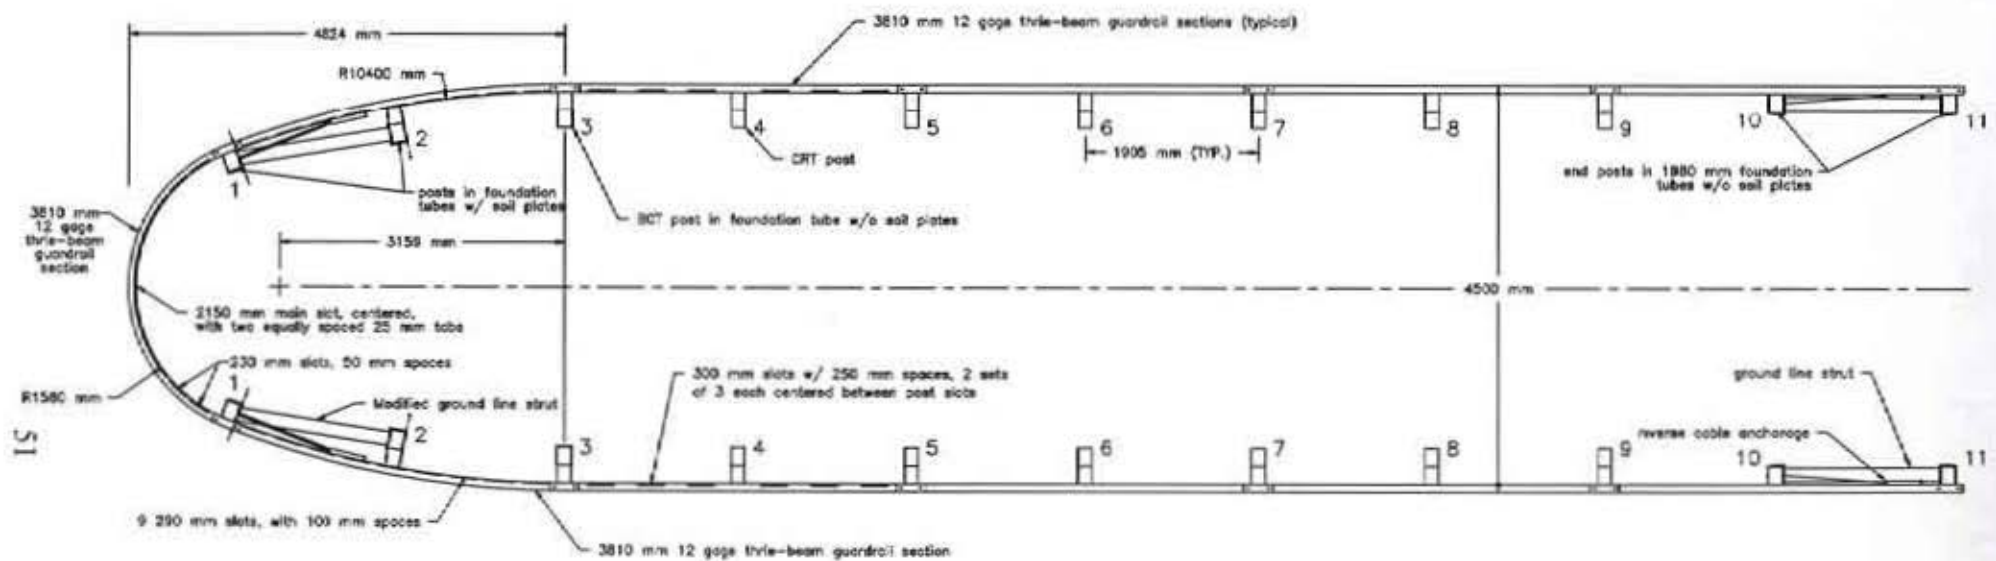
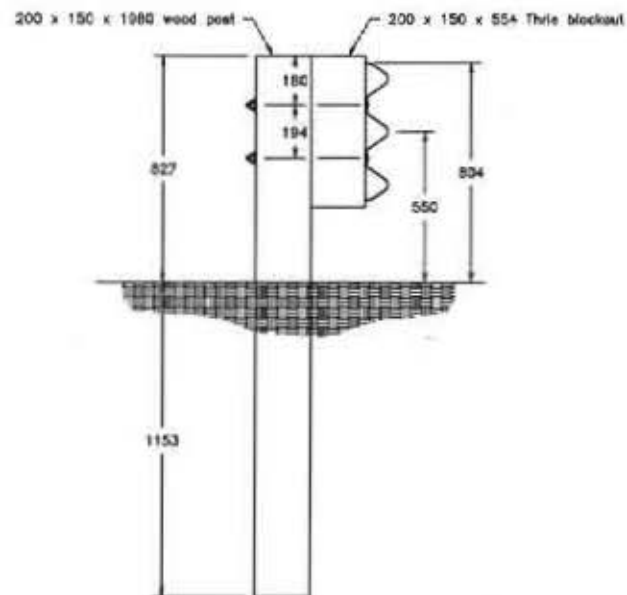
Figure 28. Bullnose Barrier Design, Test MBN-2

During test MBN-1, the first two posts on each side of the system fractured as planned, and the first two thrie beam segments buckled and deformed easily with the inclusion of the horizontal slots. However, when the thrie beam rail deformed around post no. 3 on the right side of the system, the post did not fracture, resulting in high stresses and strains being induced into the thrie beam rail. This high impulse loading led to the rupture of the thrie beam rail on the right side of the guardrail system without stopping the vehicle. In addition, even though post no. 3 on the left side of the system fractured, another potential problem was revealed as the stiff segment of thrie beam between post nos. 3 and 4 was deformed toward the left side of the vehicle as the vehicle penetrated the bullnose system. Since the thrie beam did not contain slots for weakening the rail in this region, the thrie beam kinked at post no. 4 and formed a knee at post no. 3. This knee revealed the potential for penetrating or snagging on an impacting vehicle although no actual vehicle contact occurred on the left side of the system.

Although the thrie beam fractured during test MBN-1 and did not capture the pickup truck,

the slotted thrie beam rail prevented the pickup truck from overriding the nose section of the system. Therefore, the researchers believed that the system could be significantly improved by weakening the buckling and bending strength of the thrie beam rail after post no. 3 as well as replacing post nos. 3 and 4 with posts that would fracture more easily. Following the failure of test MBN-1, modifications were made to the guardrail system. These modifications to the bullnose guardrail system consisted of changing of post nos. 3 and 4 to breakaway posts and incorporating slots in another section of the thrie beam rail. A schematic of the modified design is shown in Figure 28, and photographs are provided in Figures 29 through 30.

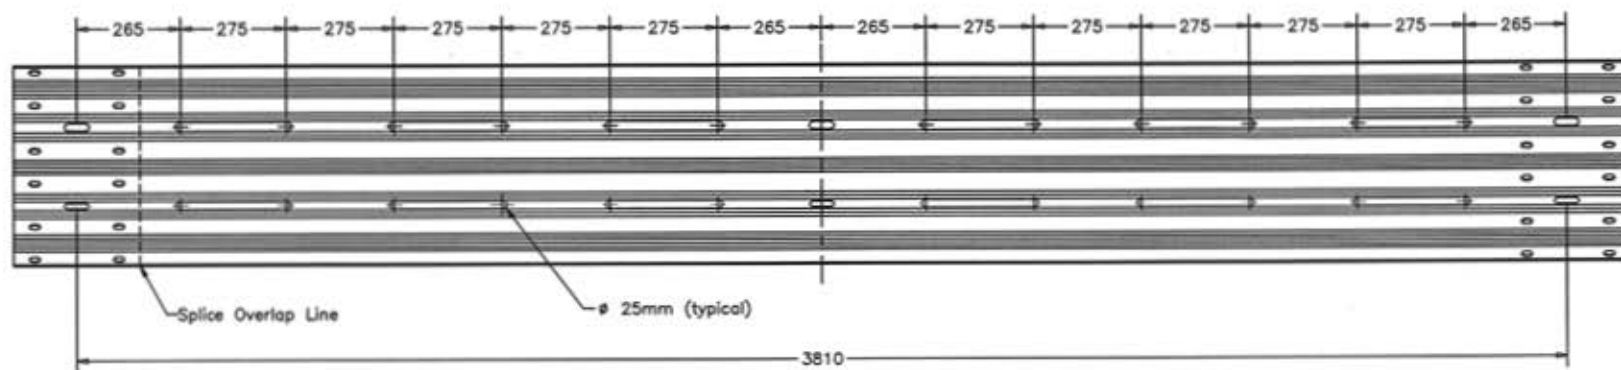
Figure 32. Rail No. 2 Detail Test, MBN-2

The slot pattern for rail section no. 2 on both sides of the bullnose barrier terminal was also modified slightly from the original design. The new slot pattern for rail no. 2 is shown in Figure 32. The slot pattern was changed to form eighteen 290-mm long slots, 9 in each valley. Each of the slots is separated by a 100-mm gap. The slot width remained 25 mm. The final major modification to the bullnose system was the addition of slots to rail section no. 3 on both sides of the system. The slot pattern of rail section no. 3 is shown in Figure 33. Twelve 300-mm slots were cut out of the valleys, six in each valley, with 250-mm spaces between them. The modification of the slots in section no. 2 and the addition of slots to section no. 3 serve to reduce the strength of the beam. Reducing the

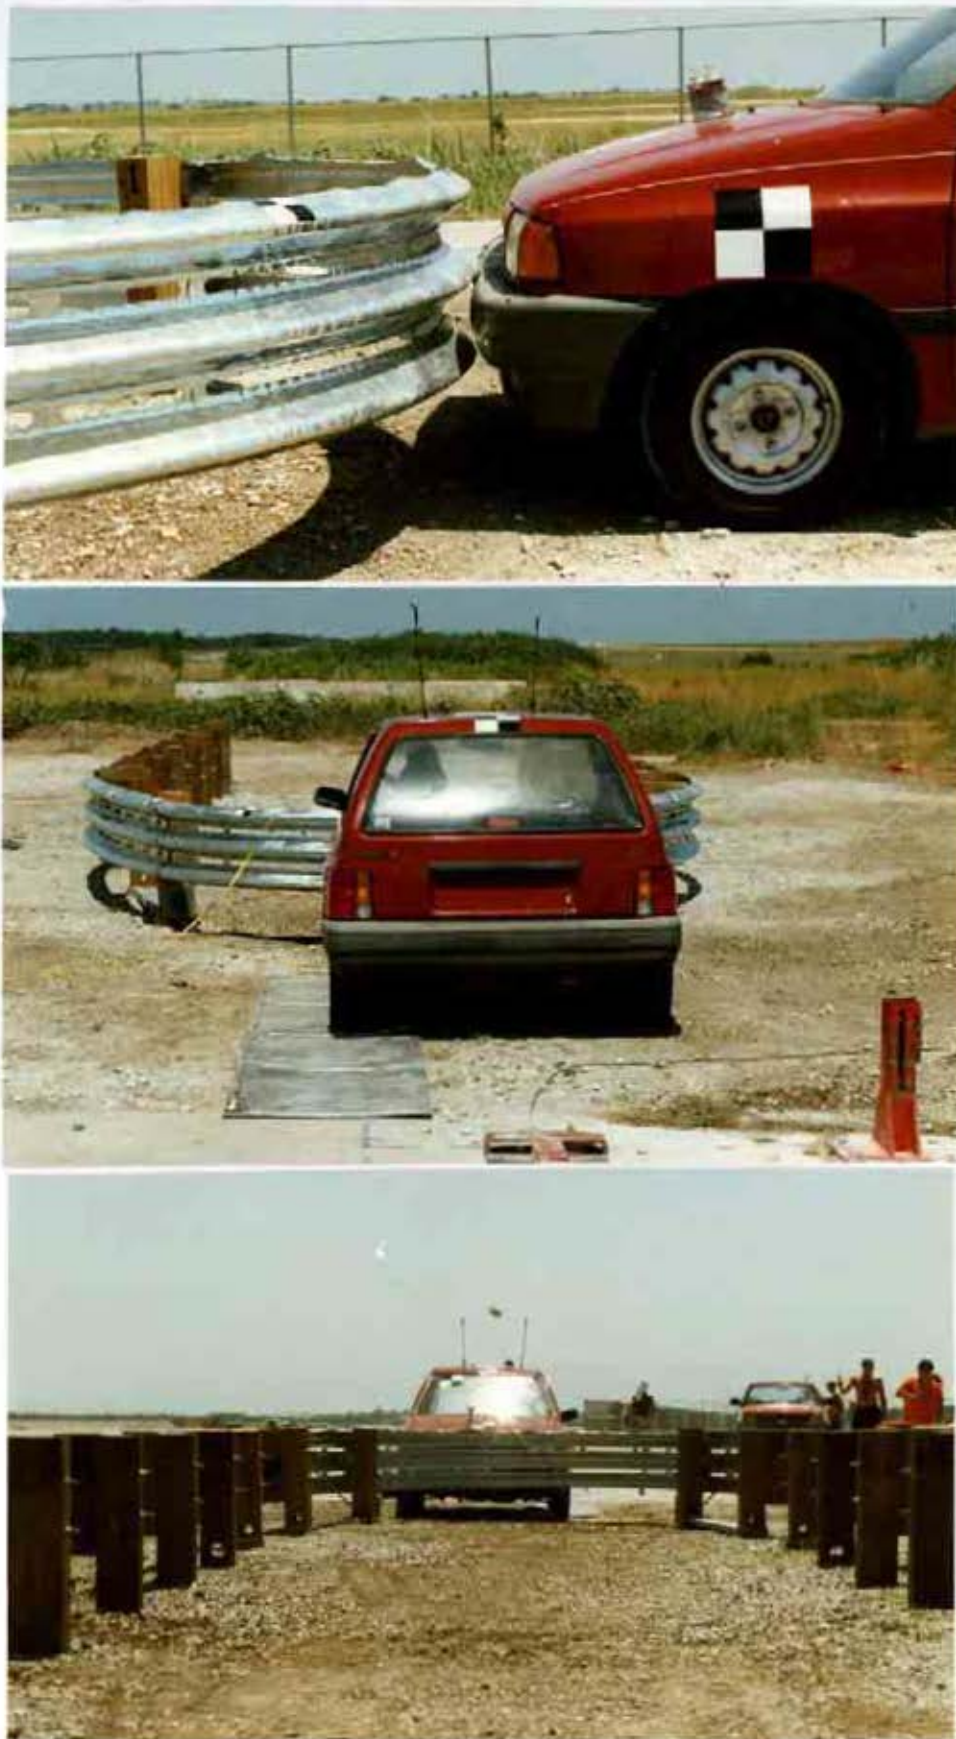
Figure 34. Impact Location Test MBN-2

It is noted that the actual impact angle of -3.4 deg was not within the allowable angle tolerance of ± 1.5 deg on a target impact angle of 0 deg, as provided in NCHRP Report 350. However, the authors believe that this error accentuated the vehicular yaw motion induced by the 1/4-point offset, thus making the crash test a more stringent impact condition by increasing the potential for rail penetration in the side of the car.

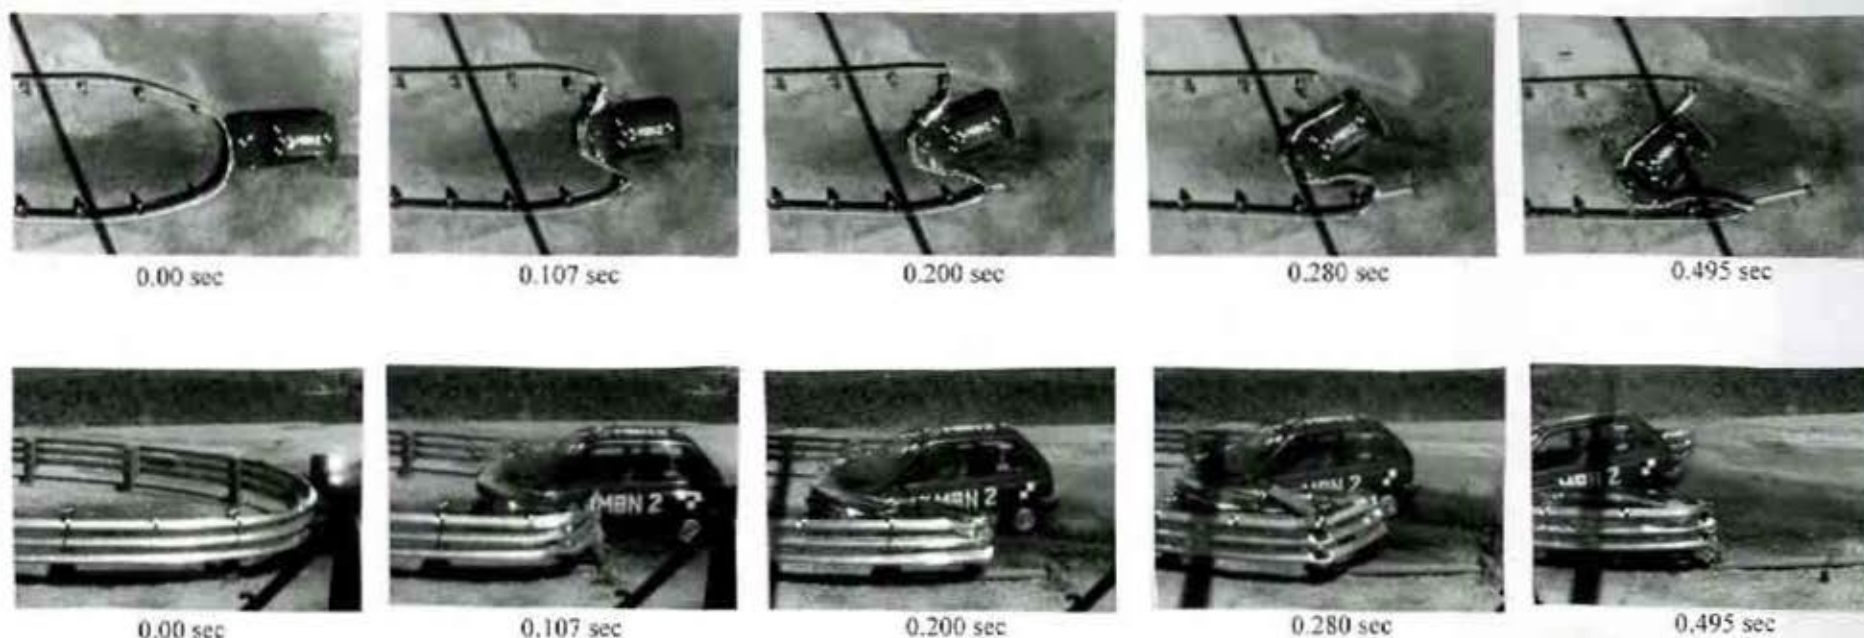
Figure 35. Summary and Sequential Photographs, Test MBN-2

The 886-kg small car impacted the bullnose barrier terminal at a speed of 103.3 km/h and an angle of -3.4 degrees with a 1/4-point offset. A summary of the test results and the sequential photographs are shown in Figure 35. Additional sequential photographs are shown in Figure 36. Full-scale crash documentary photographs are shown in Figure 37 through Figure 38.

• Test Number	MBN-2
• Date	7/25/97
• Appurtenance	Bullnose Median Barrier
• Total Length	20,144 m
• Steel Thrie Beam (Nested)	
Thickness	12 gauge (2.66 mm)
Top Mounting Height	804 mm
• Wood Posts	
Post Nos. 1 - 3, 10 - 11 (BCT)	140 mm x 190.5 mm x 1,080-mm long
Post No. 4 (CRT)	150 mm x 200 mm x 1,980-mm long
Post Nos. 3 - 9	150 mm x 200 mm x 1,980-mm long
• Wood Spacer Blocks	
Post Nos. 1 - 8	150 mm x 200 mm x 554-mm long
• Soil Type	Grading B - AASHTO M 147-65 (1990)
• Vehicle Model	1988 Ford Festiva
Curb	753 kg
Test Inertial	811 kg
Gross Static	886 kg
• Vehicle Speed	
Impact	103.3 km/hr
Exit	0.0 km/hr

• Vehicle Angle	
Impact	-3.4 deg
Exit	NA
• Vehicle Snagging	None
• Vehicle Stability	Satisfactory
• Occupant Ridedown Deceleration (10 msec avg.)	
Longitudinal	11.37 g's
Lateral (not required)	9.09/-9.98 g's
• Occupant Impact Velocity (Normalized)	
Longitudinal	9.60 m/s
Lateral (not required)	3.27 m/s
• Vehicle Damage	Moderate
TAD	12-FD-5 // 3-RBQ-4
SAE	12FDEW5 // 03RBEK9
• Vehicle Stopping Distance	6.55 m downstream
	1.58 m west of centerline
• Barrier Damage	Extensive rail damage and four fractured posts
• Maximum Deflections	
Permanent Set	7.11 m downstream
	0.97 m west of centerline
Dynamic	NA

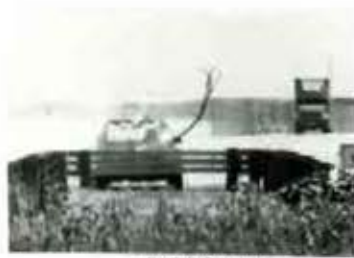
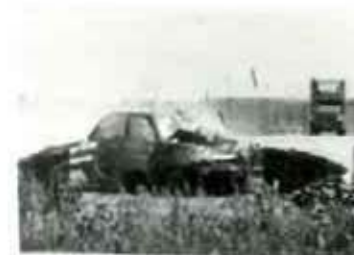
Figure 36. Additional Sequential Photographs, Test MBN-2

The nose section of the bullnose barrier began to deform immediately after the initial impact of the 886-kg small car. At 0.107 sec after impact, post no. 1 on both sides of the barrier failed and approximately one half of the small car had penetrated the bullnose barrier. The slotted nose sections of the beam rail wrapped around the front of the vehicle capturing the vehicle's bumper and grill. After the failure of post no. 1, the back of the vehicle began to rotate counterclockwise towards the right side of the barrier. Post no. 2 on the right side of the barrier failed at 0.196 sec after impact. A rail "knee" or kink formed in the beam rail on the right side of the barrier as the vehicle continued to penetrate and deform the barrier. The knee impacted the right-rear quarter panel of the small car at 0.282 sec after initial impact, deforming the right-side of the vehicle and shattering the rear window. At 0.542 sec, the vehicle was brought to a complete stop. The vehicle trajectory is shown in Figure 39.
