CRASH TESTING OF MICHIGAN'S TYPE B (W-BEAM) GUARDRAIL SYSTEM – PHASE II

MwRSF Research Report No. TRP-03-104-00

December 13, 2000

Michigan Department of Transportation's Type B (W-beam) longitudinal barrier system was constructed and crash tested. The barrier design was constructed with a 2.66-mm (12-gauge) thick W-beam rail totaling 53.34 m in length. The W-beam rail was supported by twenty-five W152x13.4 steel posts, each measuring 1,830-mm long, and four standard BCT posts, each measuring 1,080-mm long. Each of the steel posts had a 152x203 by 360-mm long standard wood offset blockout. Post spacings were 1,905-mm on center.

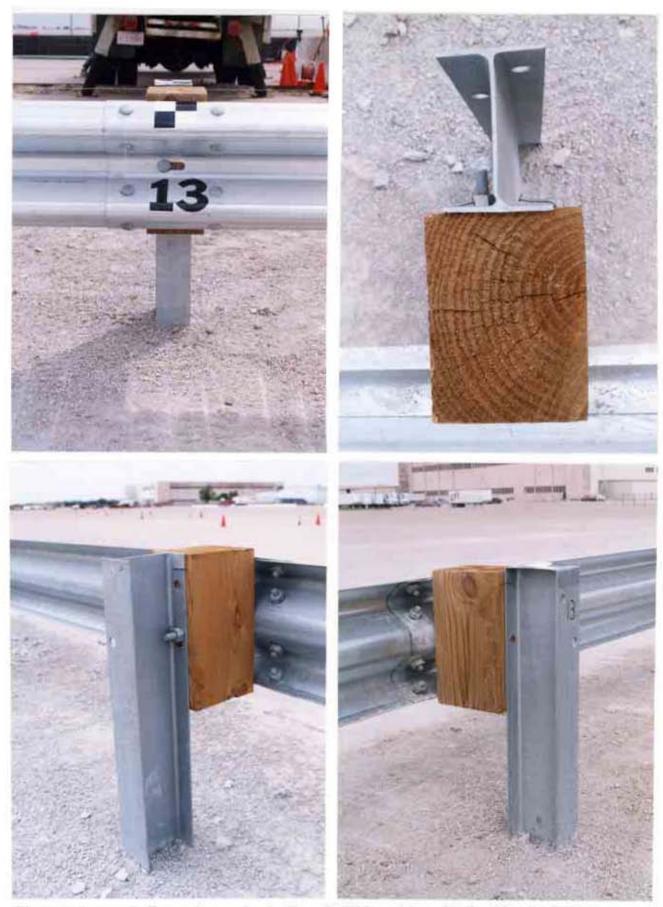
Figure 4. Post-to-Rail Attachment for the Type B (W-beam) Longitudinal Barrier System

blockouts at the system's steel posts. For each wood blockout, two 16-penny, ungalvanized nails were installed 25-mm down from the top of the front face of the post and along the upstream and downstream edges in order to prevent wood blockout rotation. The nails were driven 51 mm into the wood blockout and then the top 25 mm of the nail was bent around the post, as shown in Figures 1 and 4. MDOT's standard requires hot-dipped, zinc-coated nails.

Careful inspection of the damaged guardrail system and photos of the barrier prior to impact revealed that the post bolts were installed near the downstream end of the slot in the rail element. Testing of the post bolt pullout strengths has shown that bolts installed near the end of the slot generate higher forces before being pulled through the rail. This installation detail may have helped prevent the post bolt from becoming detached from the rail element.

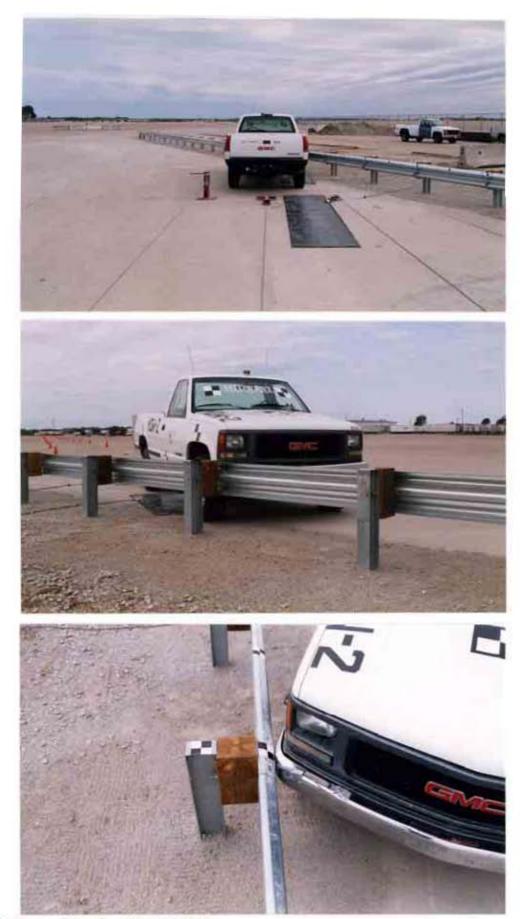
Figure 15. Impact Location, Test MIW-2

Initial impact occurred at the center of post no. 13, as shown in Figure 15. Upon impact with the guardrail, post no. 13 rotated backward. At 0.046 sec after impact, the right-front corner of the vehicle, which was at the midspan between post nos. 13 and 14, crushed inward. At 0.059 sec, post no. 14 quickly rotated backward. At 0.069 sec, the right-front corner of the vehicle continued to crush inward as post no. 13 had rotated backward to its maximum deflection. At 0.083 sec, the rightfront corner of the vehicle was at post no. 14, and post no. 15 began to show movement. At 0.129 sec, the right-front corner of the vehicle was at the midspan between post nos. 14 and 15. At this same time, post no. 14 reached its maximum deflection as the truck began to redirect. At 0.134 sec, the guardrail released from post no. 14. At 0.158 sec, the front bumper rose above the top of the rail. At 0.192 sec, the right-front tire impacted post no. 15 and was deflated. At this same time, the front end of the vehicle began to pitch upward and the left-front tire was airborne. At 0.220 sec, the front of the vehicle was at post no. 16. At 0.307 sec, the front of the vehicle was at post no. 17, and the rear bumper contacted the rail. At 0.383 sec, the right-rear tire impacted post no. 15 and was deflated. At 0.432 sec, the right-rear tire, which had been riding along the traffic-side face of the rail, lost contact and was located on the back side of the rail. At 0.44 sec, the vehicle reached its maximum pitch angle of approximately 14 degrees. At 0.458 sec, the left-rear tire was airborne. At 0.541 sec, the vehicle, which was partially airborne, began to roll away from the rail that was positioned along the longitudinal midpoint of the vehicle. At 0.640 sec, the vehicle was completely airborne and free from the rail. At 0.810 sec, the vehicle returned to an unpitched state. At 1.074 sec, the left-front tire contacted the ground. At 1.234 sec, the right-rear tire contacted the ground on the backside of the guardrail. At 1.480 sec, the right-rear tire became airborne behind the guardrail with the vehicle positioned on top of the guardrail. At 1.760 sec, the left-rear tire contacted the ground behind the guardrail. At 1.9 sec, the vehicle reached its maximum roll angle of approximately 24 degrees toward the rail. The vehicle's post-impact trajectory is shown in Figure 9. The vehicle came to rest 28.58-m downstream from impact and on top of the guardrail between post nos. 26 and 29 with the left-front tire located 0.61-m laterally away from the traffic-side of the rail, as shown in Figures 9 and 16.

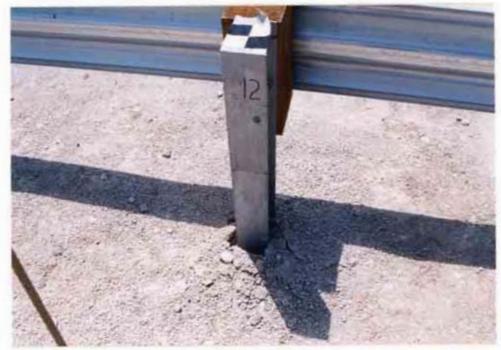
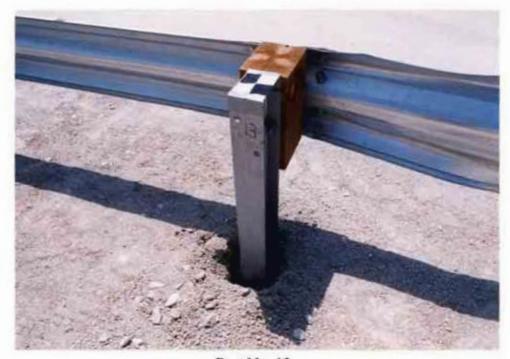
Figure 22. Final Post Position - Post Nos. 12 and 13, Test MIW-2

Steel post nos. 3 through 13 and 17 through 19 moved backward slightly. Three steel posts, post nos. 14 through 16, rotated in the soil and bent toward the ground. A 406-mm long tire contact mark was found along the front face of post no. 14. The top of post no. 15 was also slightly
