**Crash Testing of Standard South
Dakota Road Closure Gates**

**Study SD94-10
Final Report**

**Prepared by:
Midwest Roadside Safety Facility (MwRSF)
Center for Infrastructure Research
Civil Engineering Department
University of Nebraska-Lincoln
1901 Y Street, Building C
Lincoln, Nebraska 68588-0601
(402)472-6864**

January 1995

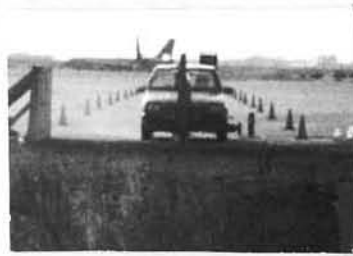
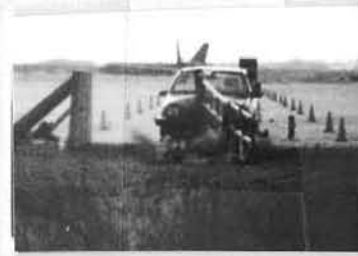
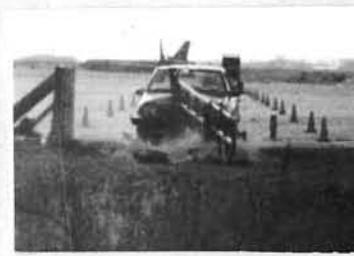
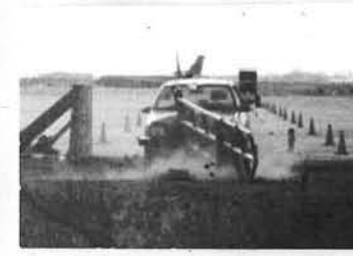
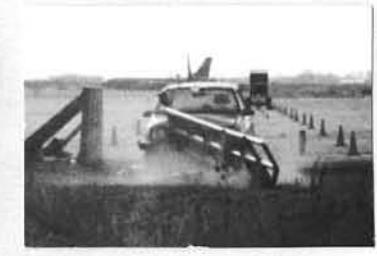
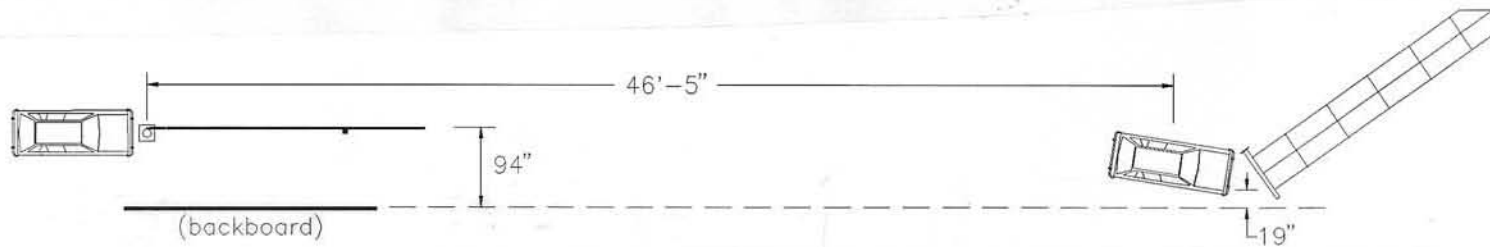
Figure 18. Summary of Test, SDG-1

In Test SDG-1, the 1986 Chevrolet Sprint impacted the road closure gate head-on in the stowed position at an angle of 0 degrees and 37.1 km/h (23.1 mph). The impact point on the vehicle was approximately at the center of the front bumper and was aligned with the center of the hinged connection between the gate post and the gate. A summary of the test including test results, sequential photos, and post-test trajectory is shown in Figure 18.

- Vehicle Stopping Distance 14.2 m (46.5 ft) from impact
- Road Closure Gate Damage Minor
- Vehicle Front-End Crush 20.3 cm (8 in)

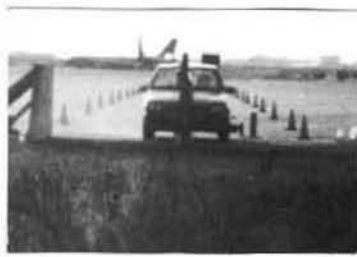
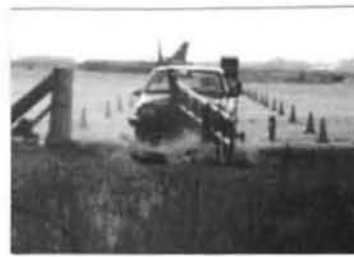
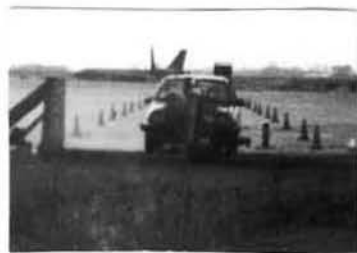
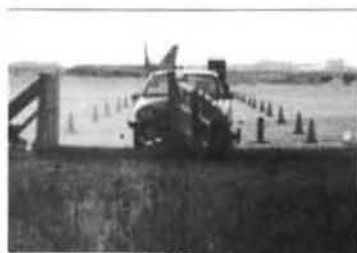
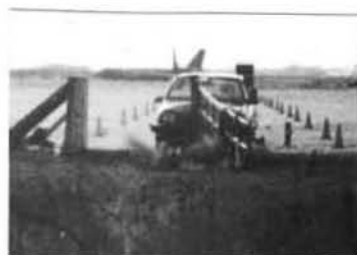
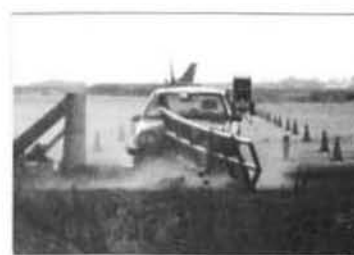
Figure 19. High-Speed Downstream Sequentials, SDG-1

High-speed film sequential photographs of the full-scale crash test are shown in Figures 19 and 20, and photographs of the full-scale test are shown in Figure 21. After the initial impact with the gate post, the front bumper crushed inward for approximately 0.024 sec before the gate post was disengaged from the breakaway support. Subsequently, the vehicle continued its forward movement while pushing the interlocked gate post in front of the vehicle. The gate post and gate were cleanly disengaged from the breakaway support without producing any significant vehicle angular rotations.

The warning lights disengaged at 0.079 sec, and the hold back post fractured at 0.128 sec, causing small positive and negative yaw rotations to the vehicle and gate, respectively. The vehicle reference system is shown in Figure 22. At 0.523 sec, the rear axle of the vehicle smoothly passed over the fractured frangible couplers. At 0.707 sec, the downstream end of the gate contacted the ground and began to dig into the soil. The vehicle continued to push the entire installation forward until the gate post slipped off the front end of the vehicle at approximately 2.46 sec. The vehicle came to rest approximately 14.0-m (46-ft) downstream of the breakaway support at 3.71 sec after impact, as shown in Figure 19.
