SAFETY PERFORMANCE EVALUATION OF MISSOURI'S GROUND-MOUNTED TEMPORARY SIGN STANDS – PHASE II

MIDWEST ROADSIDE SAFETY FACILITY

MISSOURI DEPARTMENT OF TRANSPORTATION

MwRSF Research Report No. TRP-03-158-05

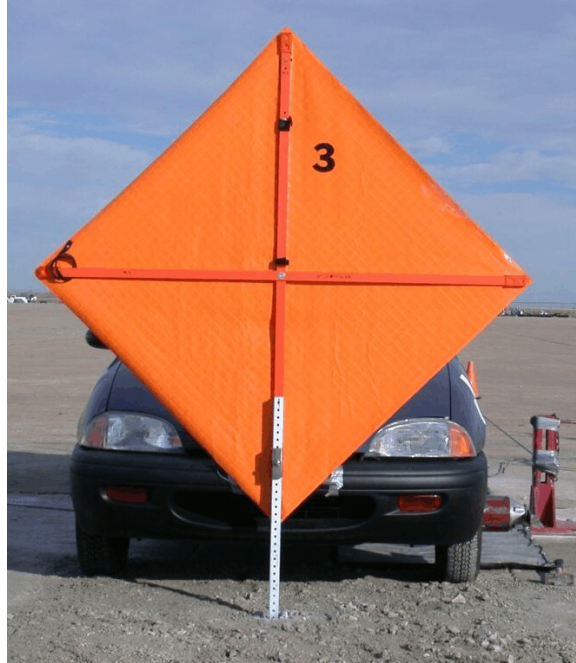
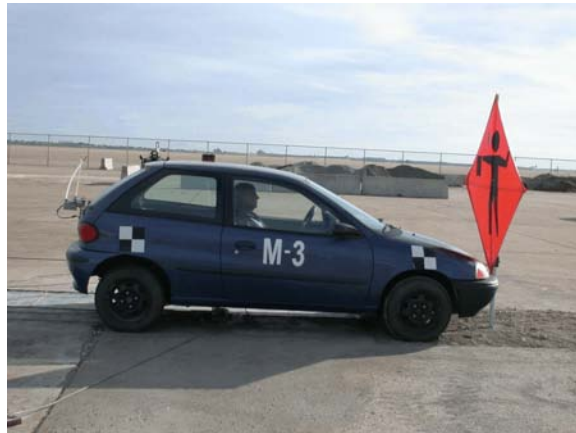
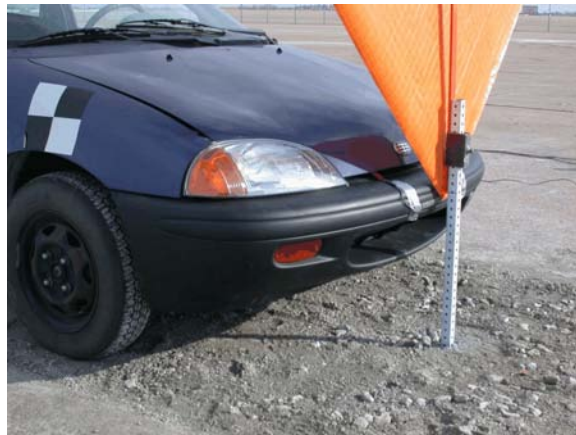
Figure 10. Impact Locations, Test M-3

The test vehicle impacted System No. 3 with the centerline point of the vehicle's bumper aligned with the centerline of the sign support, as shown in Figure 10. At 0.006 sec after initial impact, the sign post deflected away from the front of the vehicle and the sign panel's bottom corner. At 0.014 sec, the bottom third of the sign panel flexed around the front of the vehicle and pulled the top of the sign panel downward. At this same time, the sign post continued to deflect away from the vehicle and sliced through the soil. At 0.016 sec, the ends of the horizontal crossbrace flexed toward the vehicle. At 0.018 sec, the anchor pulled completely out of the ground and the vertical crossbrace encountered extensive flex toward the vehicle. At 0.022 sec, the vertical crossbrace member disengaged from the panel clip and sign post. At 0.034 sec, the horizontal crossbrace disengaged from the sign panel vinyl which was in contact with the hood. At this same time, the sign panel continued to rotate toward the vehicle. At 0.048 sec, the top of the sign panel vinyl contacted the windshield. At this same time, the sign post was airborne under the front of the vehicle. At 0.052 sec, the top of the vertical crossbrace contacted the central region of the windshield. At 0.060 sec, the middle hub connecting the two crossbraces contacted the hood, and the top of the vertical

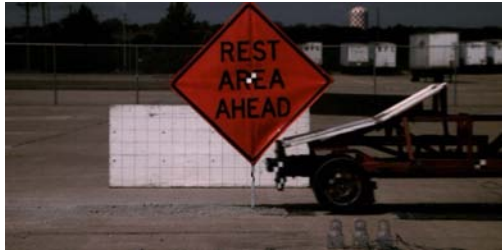
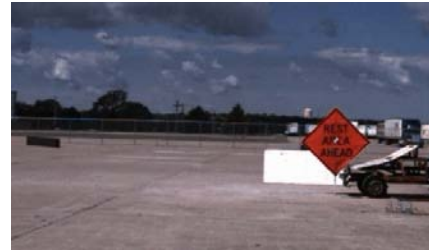
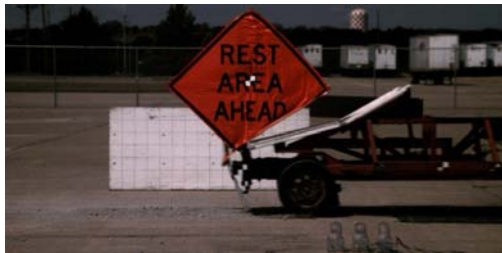
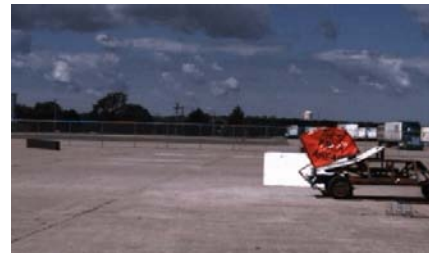
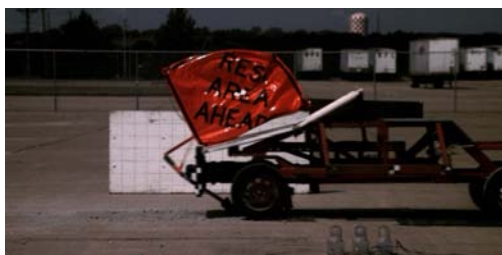
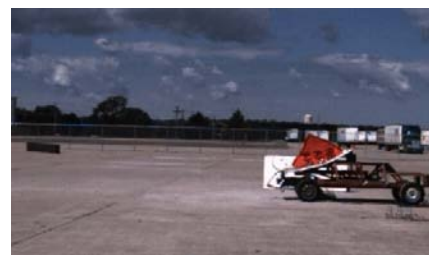
Following the compliant bogie test MOSBOG-11, an evaluation was conducted, and the modified work-zone traffic control device performed acceptably in the bogie crash test. The modified system performed as expected, with the vertical crossbrace remaining attached to the sign post until the vehicle passed over the system. If a small car would have been used in place of the bogie vehicle, the system would have deformed around the bumper at the front of the small car. Along with the deformation around the front of the small car, the sign panel and crossbraces would

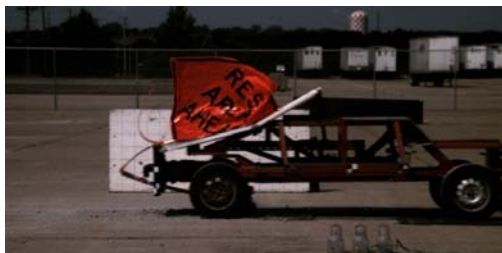
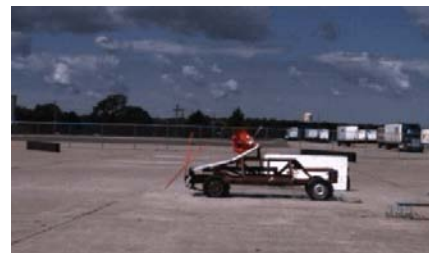
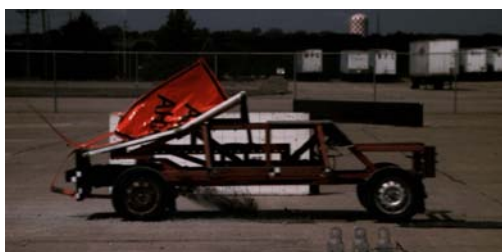
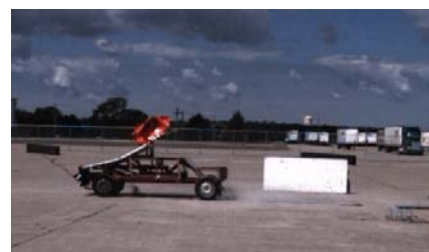
Figure 27. Sequential Photographs, Bogie Test MOSBOG-11 (90 degrees)

The 1,119-kg (2,467-lb) bogie vehicle impacted the modified sign support system oriented end-on to the vehicle at a speed of 104.4 km/h (64.9 mph) and at an angle of 90 degrees. Sequential photographs are shown in Figure 27. The bogie vehicle experienced a velocity change of approximately 5.4 km/h (3.4 mph).

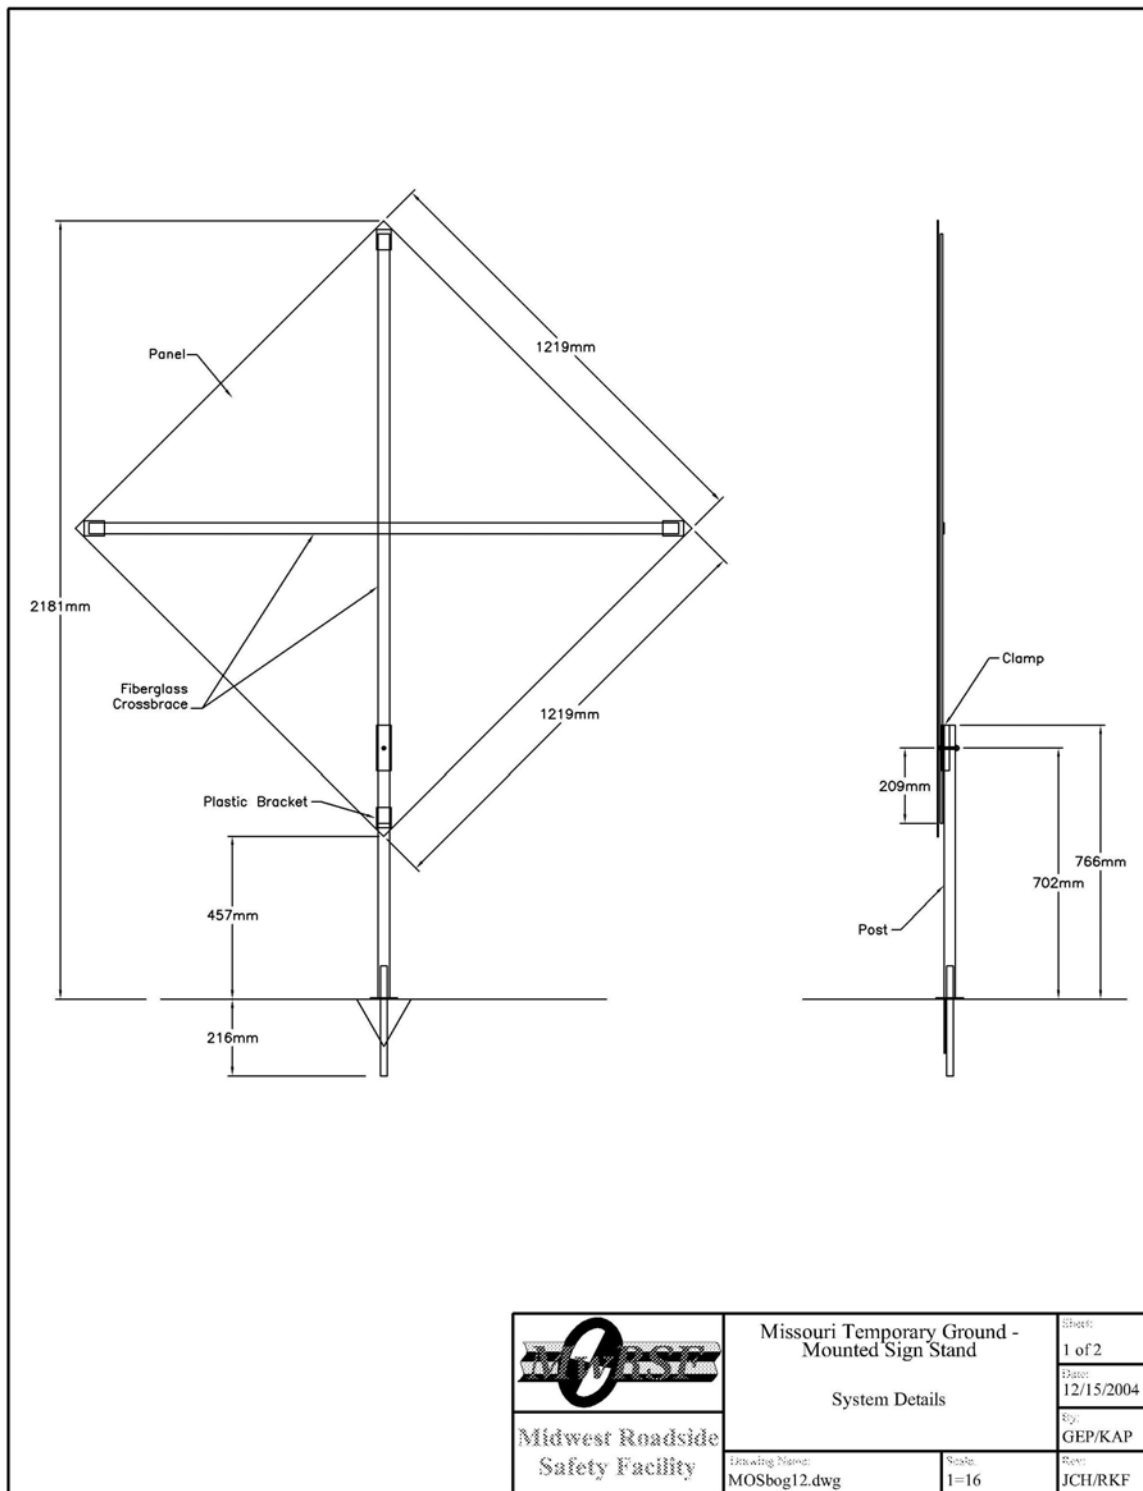
Figure 29. Ground-Mounted, Single-Post Sign System Design Details, Bogie Test MOSBOG-12

It should be noted that there was an extra hole drilled in the vertical fiberglass crossbrace near the top of the sign post. It is believed that this caused a stress concentration point and caused the vertical crossbrace to fracture completely. When compared to the results of the developmental bogie test MOSBOG-10 on an identical system, without an extra hole in the crossbrace, the vertical crossbrace did not fracture completely. It is believed that the system's performance would be similar to that of bogie test MOSBOG-10 without the extra hole as it was designed. Thus, the system performed in an acceptable manner with and without a hole drilled in the vertical fiberglass crossbrace slightly above the top of the sign post.

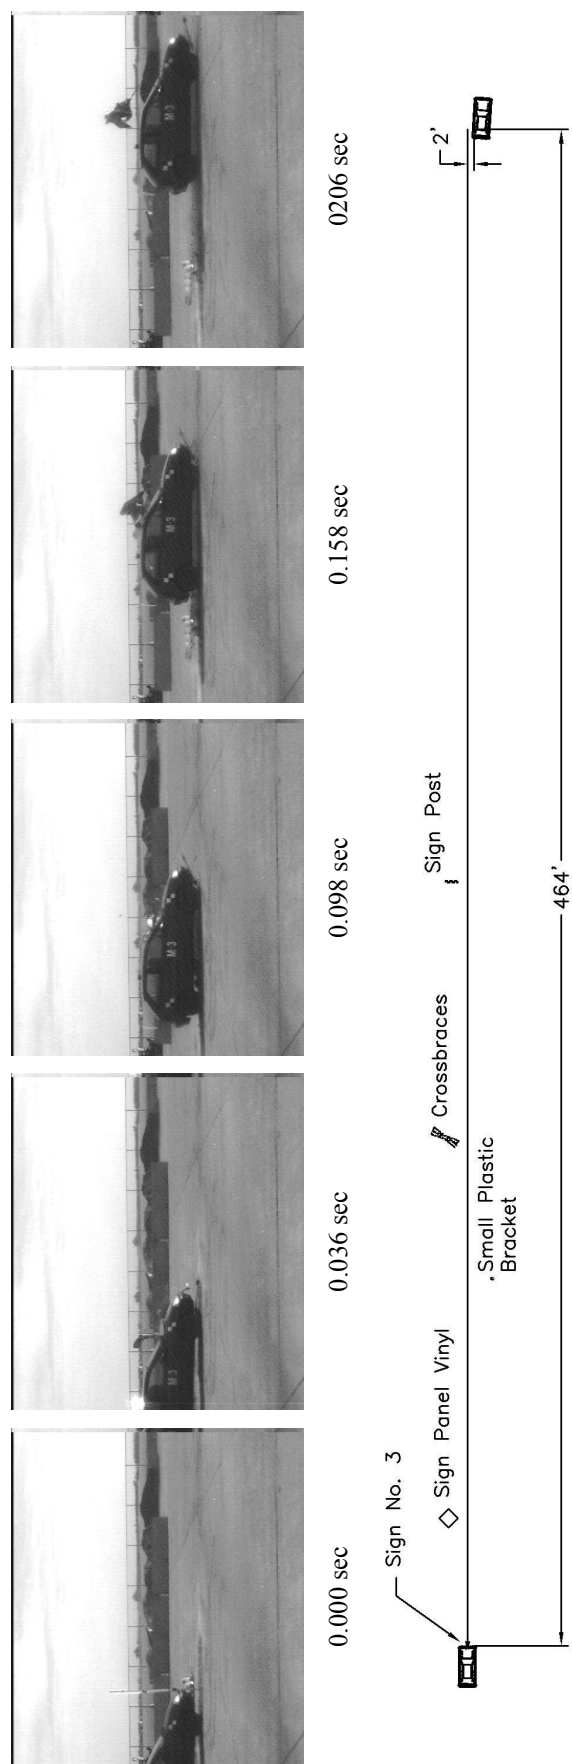
Figure C-1. Summary of Test Results and Sequential Photographs (English), Test M-3

● Test Number	M-3	● Vehicle Angle	
● System Number	3	Impact	0 deg
● Date	11/11/03	Exit	0 deg
● Test Article		● Vehicle Stability	Satisfactory
Type	Traffic Control Device – Ground-Mounted, Single-Post, Sign Support System	● Occupant Ridedown Deceleration (10 msec avg.)	
Stand Name	Modified SH-96-2	Longitudinal	NA
Sign Panel Name	Flexible Panel	Lateral (not required)	NA
Key Elements		● Occupant Impact Velocity (Normalized)	
Size and/or dimension	85.5 in. high after installation	Longitudinal	NA
Material	ASTM Steel Grade A36 Telespar Tubing	Lateral (not required)	NA
Orientation	Head-on with centerline point	● Vehicle Damage	Severe windshield cracking, and indentation
● Soil Type	Grading B - AASHTO M 147-65 (1990)	TAD ³⁰	I2-FC-1
● Vehicle Model	1996 Geo Metro	SAE ³¹	I2-FCW6
Curb	1,745 lbs	● Vehicle Stopping Distance	464 ft downstream
Test Inertial	1,797 lbs		2 ft right
Gross Static	1,963 lbs	● Test Article Damage	Moderate – Broke apart
