DESIGN AND EVALUATION OF AN OPEN COMBINATION TRAFFIC/BICYCLE BRIDGE RAILING SYSTEM

MIDWEST ROADSIDE SAFETY FACILITY

MwRSF Research Report No. TRP-03-162-07

February 9, 2007

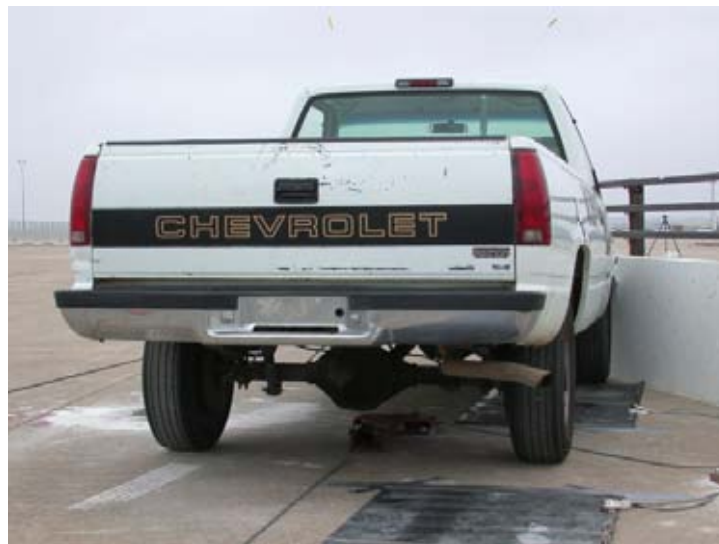
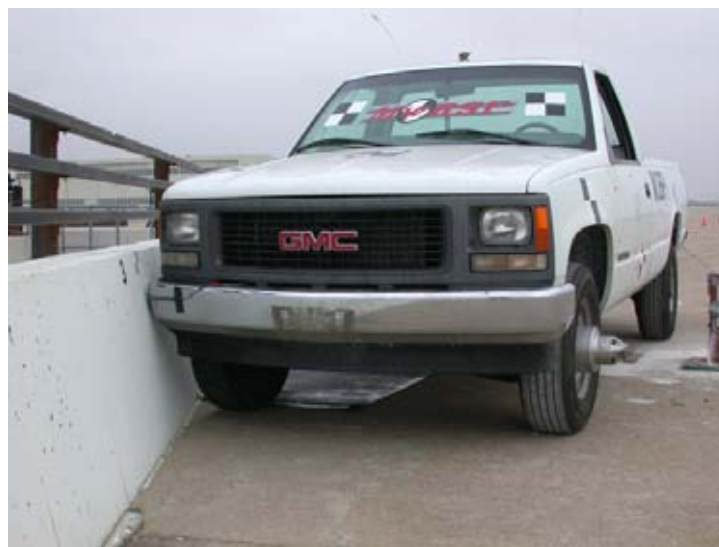
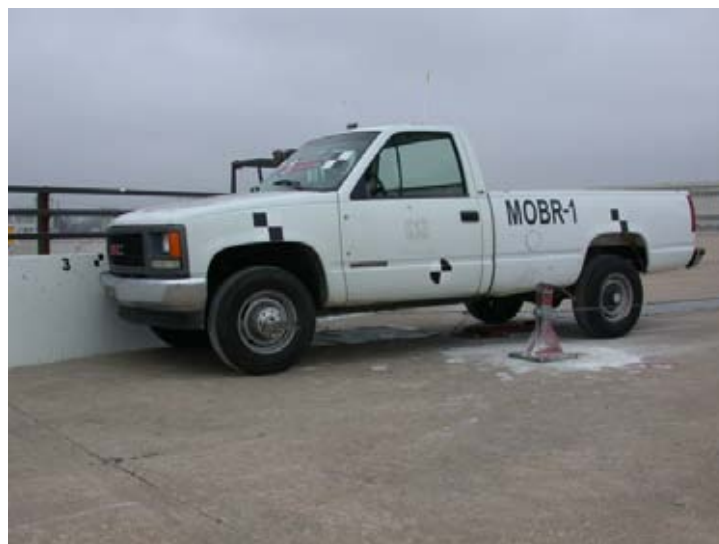
Figure 9. Test Vehicle, Test MOBR-1

Note any damage prior to test: None

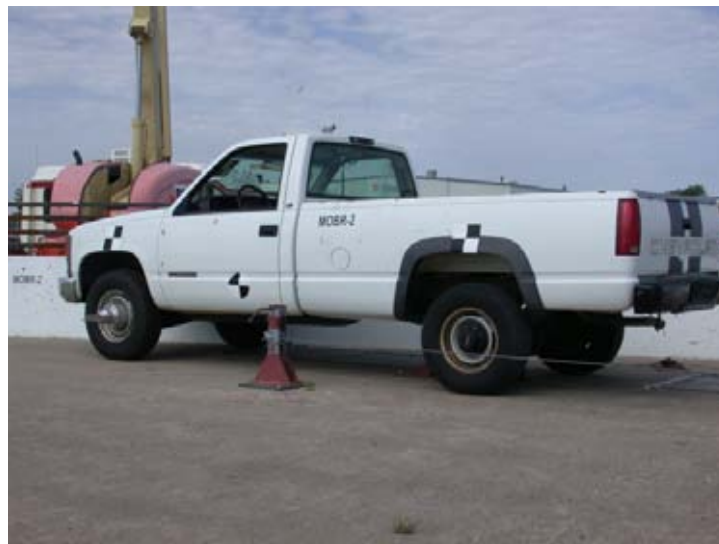
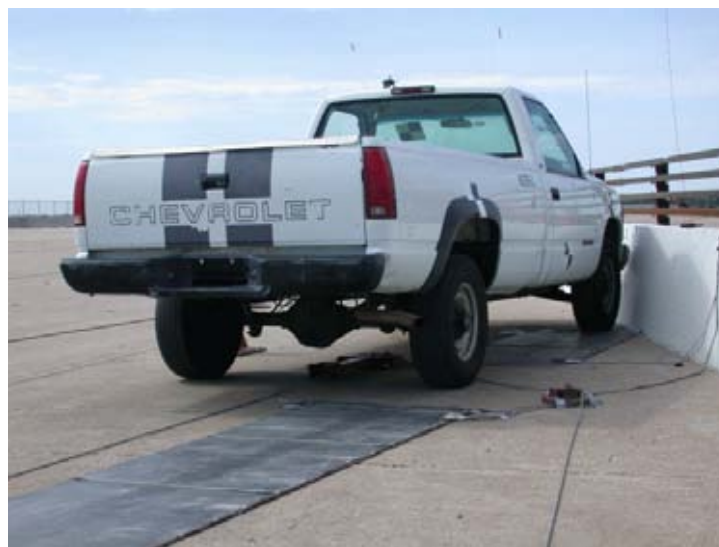
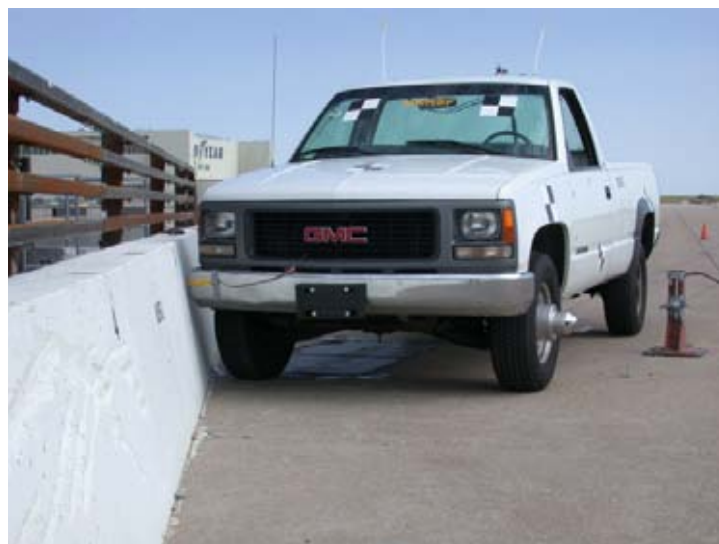
Figure 11. Test Vehicle, Test MOBR-2

Note any damage prior to test: Minor Cosmetic

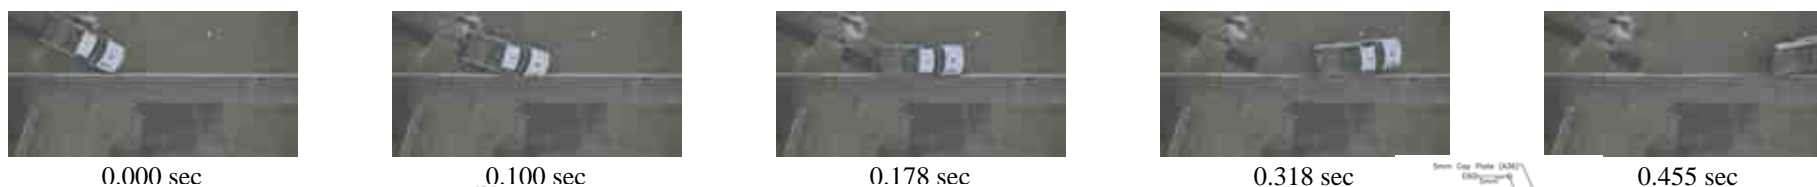
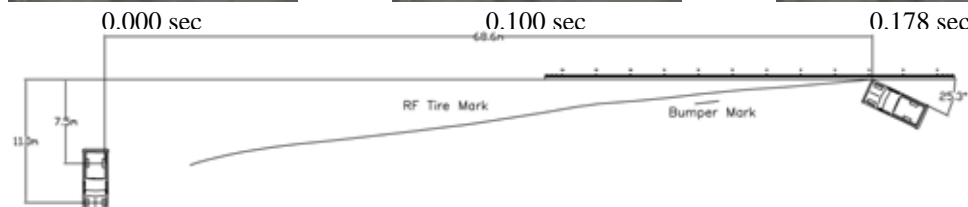
The analysis of the results for test no. MOBR-1 showed that the traffic/bicycle rail adequately contained, but did not safely redirect the vehicle since the vehicle did not remain upright after collision with the barrier. The rollover was caused by the right-front corner of the vehicle protruding under the longitudinal rails and preventing the vehicle from climbing the barrier. There were no detached elements nor fragments which showed potential for penetrating the occupant compartment nor presented undue hazard to other traffic. Deformations of, or intrusions into, the occupant compartment that could have caused serious injury did occur with the deformation of vehicle's roof. After collision, the vehicle's trajectory appeared to intrude into adjacent traffic lanes. Therefore, test no. MOBR-1 conducted on the combination traffic/bicycle rail was determined to be unacceptable according to the safety performance criteria of test designation no. 4-11 found in NCHRP Report No. 350 due to vehicle rollover.

| ! | Vehicle Damage | Extensive |
| ! | Test Article Damage | Minimal |

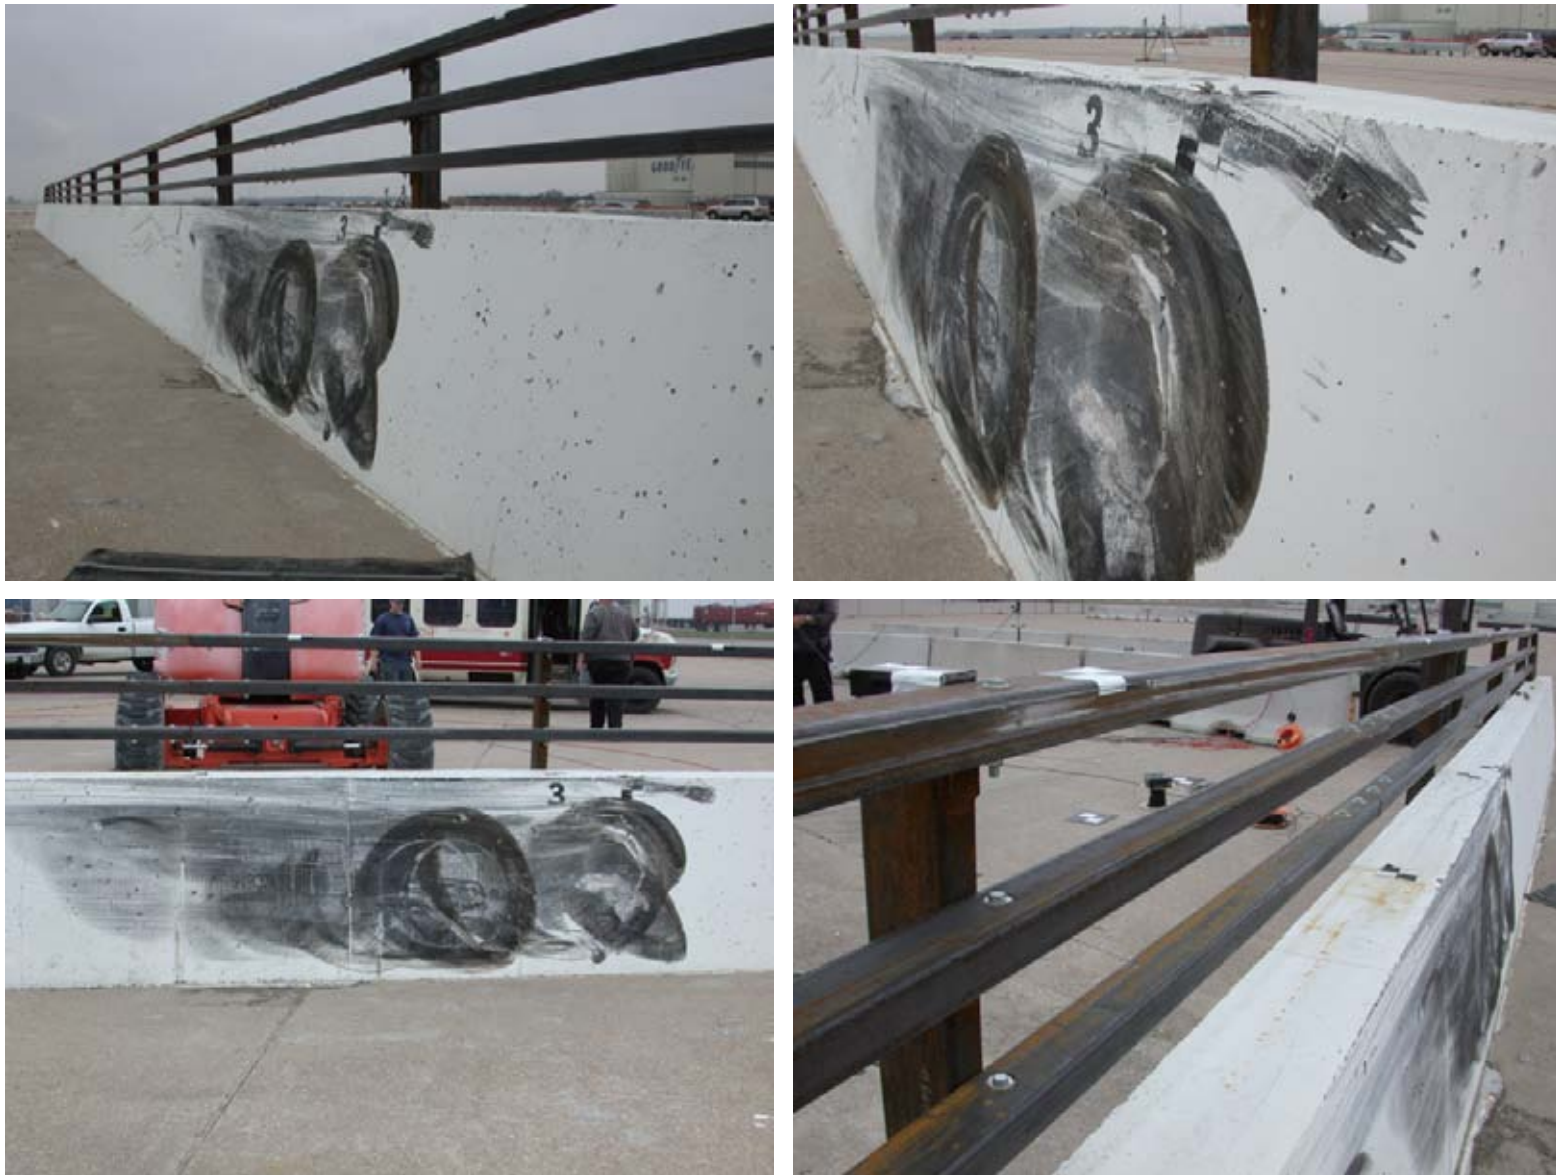
Figure 27. System Damage, Test MOBR-1

Damage to the combination traffic/bicycle bridge rail was minimal, as shown in Figures 27 through 28. Barrier damage consisted of contact and gouge marks on the concrete parapet, contact marks on the bicycle rail, and pull out of attachment bolts. The length of vehicle contact along the combination bridge rail was approximately 3 m (10 ft - 5 in.), which spanned from 533 mm (21 in.) upstream from post no. 3 through 460 mm (16 in.) upstream from the centerline of post no. 4.

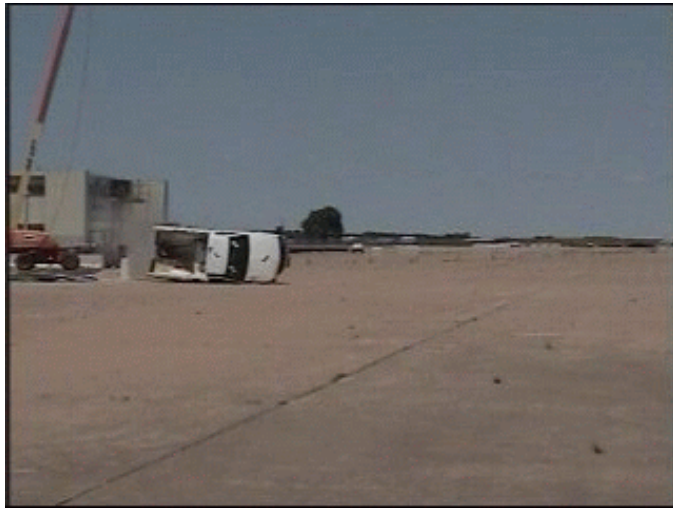
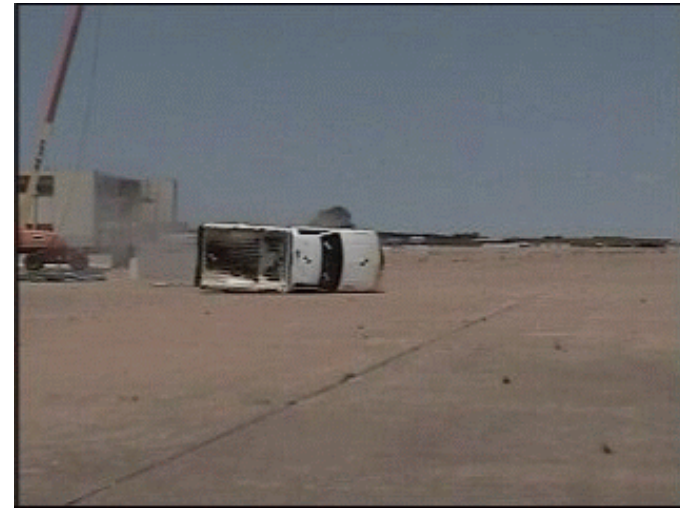
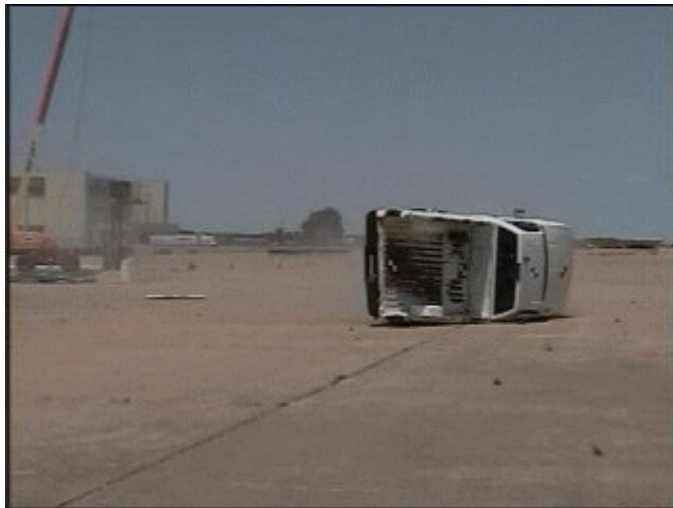
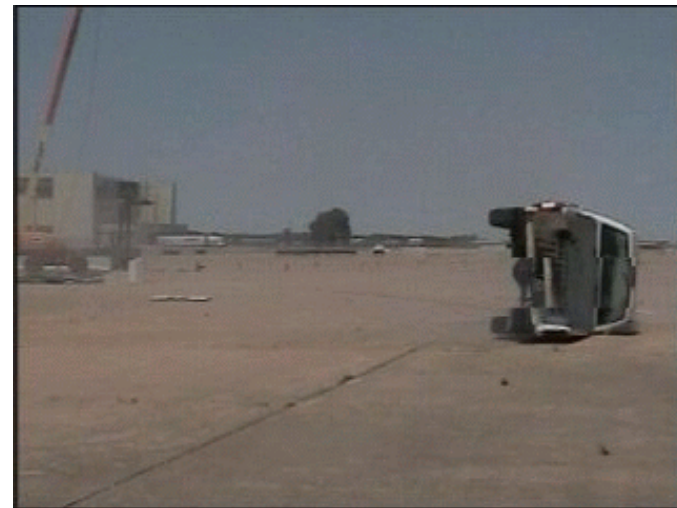
Figure 49. Documentary Photographs, Test MOBR-2

The 2,029-kg (4,473-lb) pickup truck impacted the combination traffic/bicycle bridge rail (System No. 2) at a speed of 102.7 km/h (63.8 mph) and at an angle of 25.6 degrees. A summary of the test results and sequential photographs are shown in Figure 42. The summary of the test results and sequential photographs in English units are shown in Appendix B. Additional sequential photographs are shown in Figures 43 through 48. Documentary and damage photographs of the crash test are shown in Figures 49 through 50.

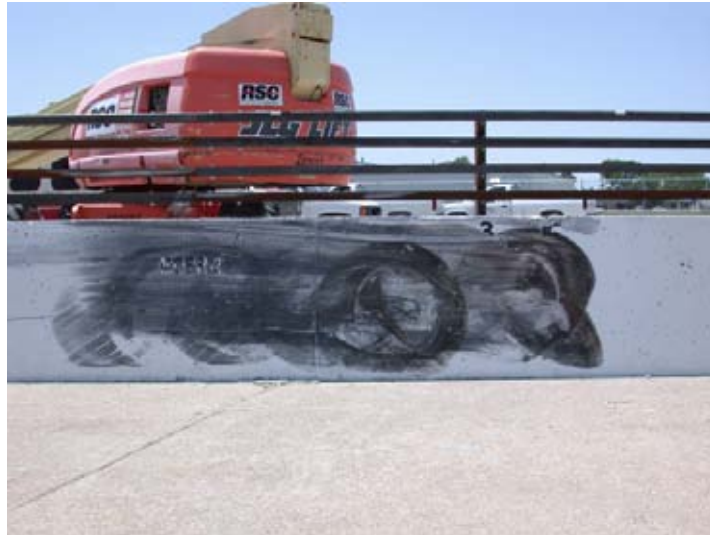
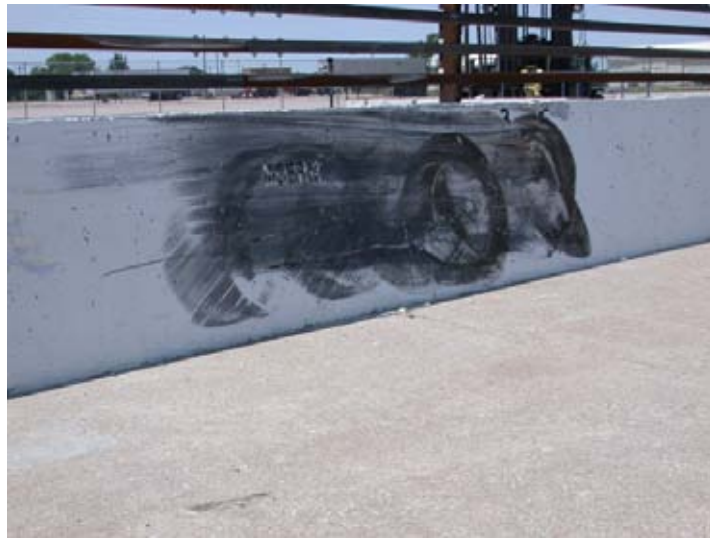
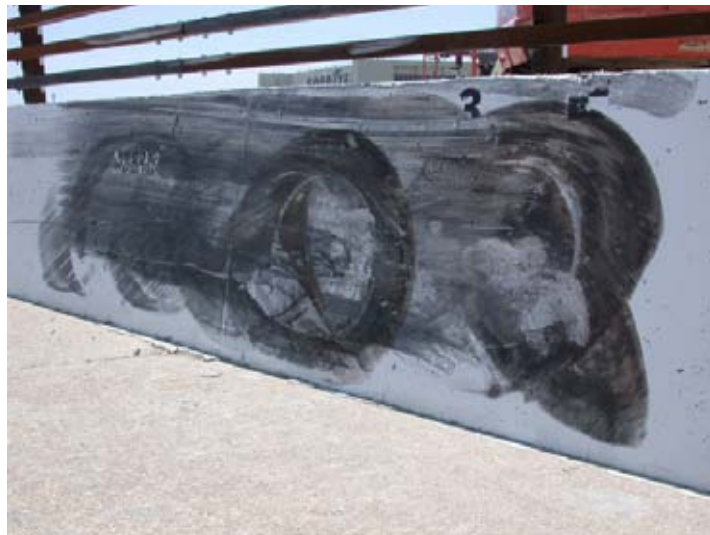
Figure 53. System Damage, Test MOBR-2

Damage to the combination traffic/bicycle bridge rail was minimal, as shown in Figures 53 and 54. Damage to the combination traffic/bicycle bridge rail consisted of contact marks and gouges on the concrete parapet and contact marks on the bicycle rail. Vehicle contact along the combination bridge rail was approximately 5.4 m (17 ft - 10 in.), which spanned 864 mm (34 in.) upstream from the centerline of post no. 3 through 1,524 mm (60 in.) downstream from the centerline of post no. 4. Tire marks began 559 mm (22 in.) upstream from the centerline of post no. 3, with a maximum

The permanent set of the combination traffic/bicycle bridge rail was negligible. The maximum lateral dynamic rail and post deflections were 30 mm (1 1/8 in.) and 25 mm (15/16 in.) at the centerline of post no. 4, respectively, as determined from high-speed video analysis. The working width of the system was found to be 333 mm (13 in.).
