PERFORMANCE EVALUATION OF THE MIDWEST GUARDRAIL SYSTEM – UPDATE TO NCHRP 350 TEST NO. 3-10 (2214MG-3)

MwRSF Research Report No. TRP-03-172-06

October 11, 2006

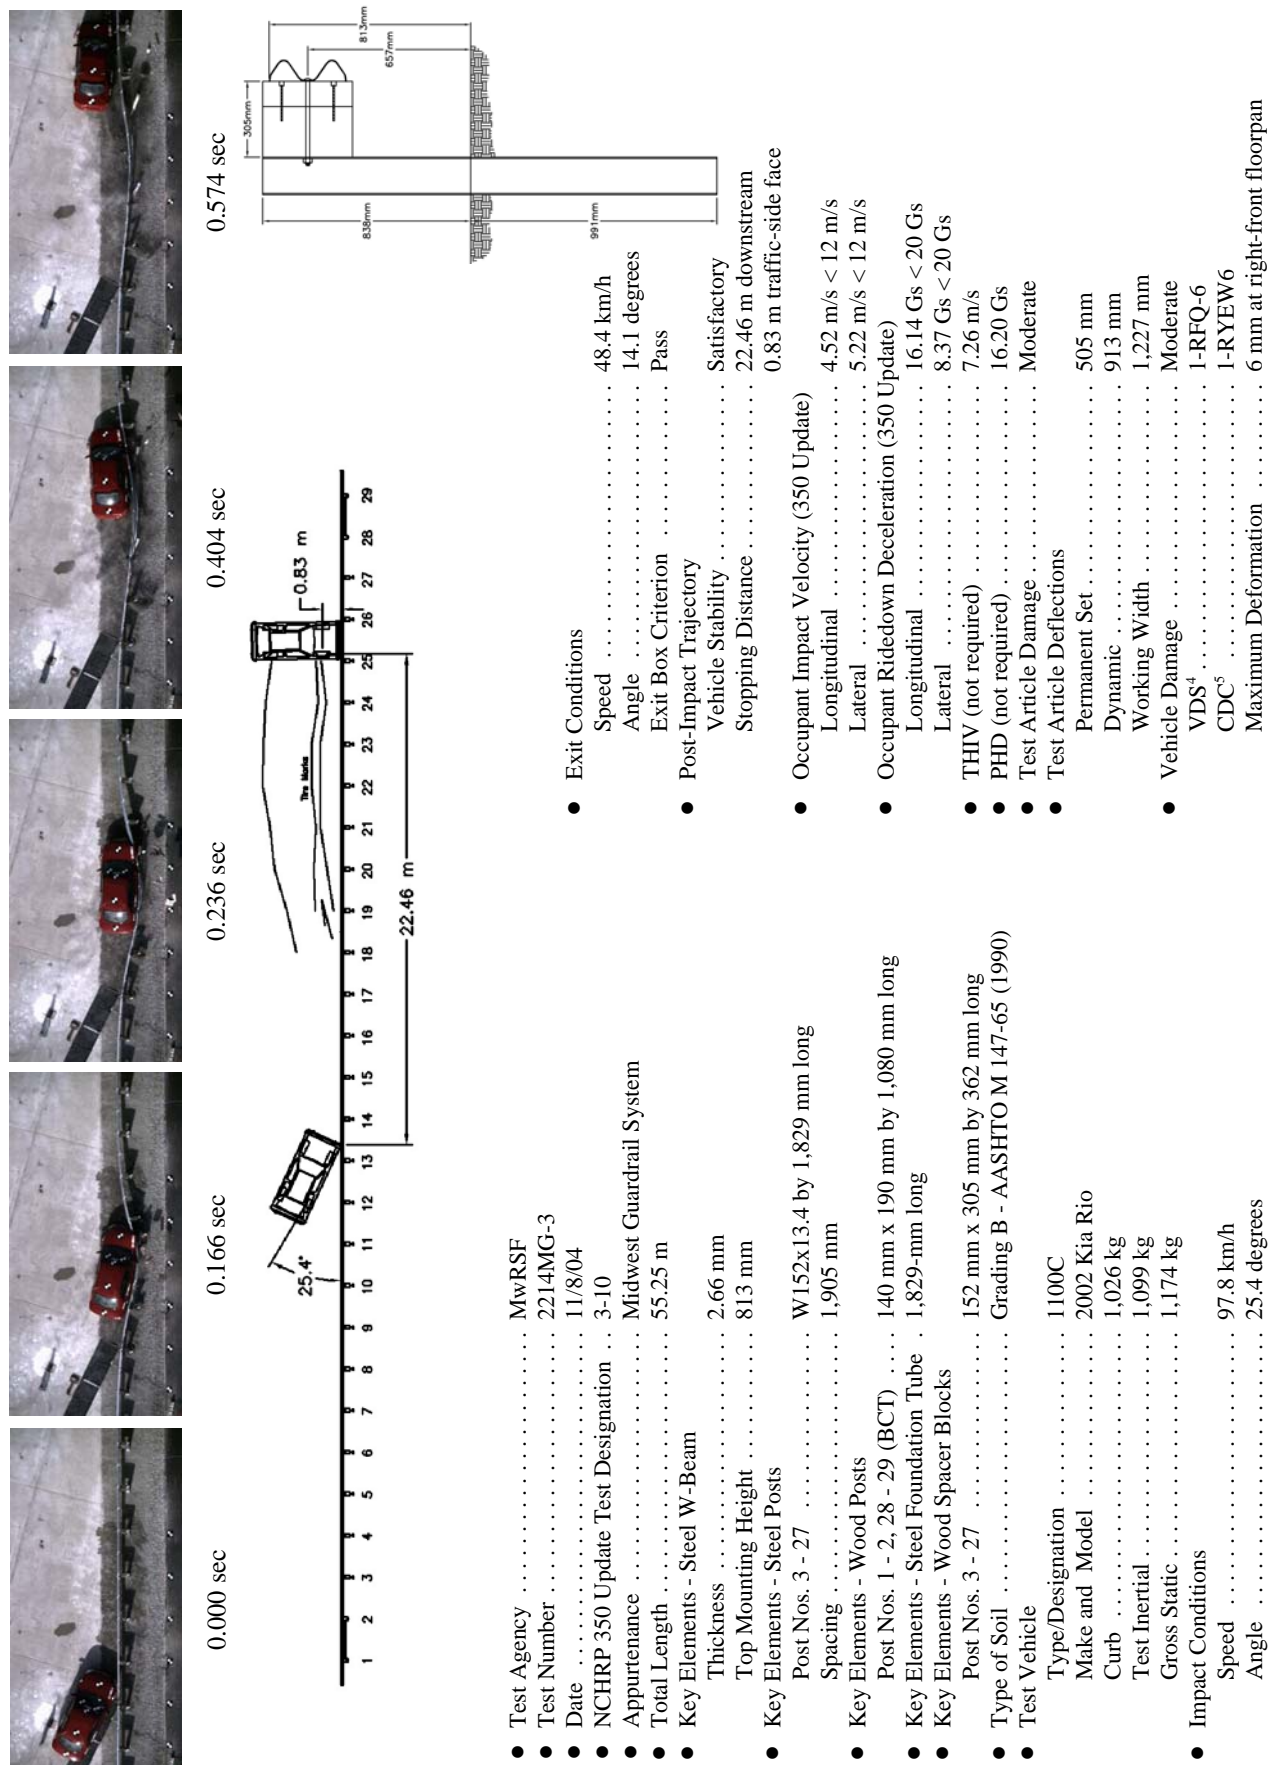
Figure 13. Summary of Test Results and Sequential Photographs, Test 2214MG-3

The analysis of the test results for test no. 2214MG-3 showed that the Midwest Guardrail System with maximum height tolerance impacted with the 1100C vehicle of the Update to NCHRP Report No. 350 adequately contained and redirected the vehicle with controlled lateral displacements of the barrier system. There were no detached elements nor fragments which showed potential for penetrating the occupant compartment nor presented undue hazard to other traffic. Deformations of, or intrusion into, the occupant compartment that could have caused serious injury did not occur. The test vehicle did not penetrate nor ride over the guardrail system and remained upright during and after the collision. Vehicle roll, pitch, and yaw angular displacements were noted, but they were deemed acceptable because they did not adversely influence occupant risk safety criteria nor cause rollover. After collision, the vehicle's trajectory revealed minimum intrusion into

adjacent traffic lanes. In addition, the vehicle exited the barrier within the exit box. Therefore, test no. 2214MG-3 conducted on the Midwest Guardrail System with maximum height tolerance was determined to be acceptable according to the TL-3 safety performance criteria found in the Update to NCHRP Report No. 350.

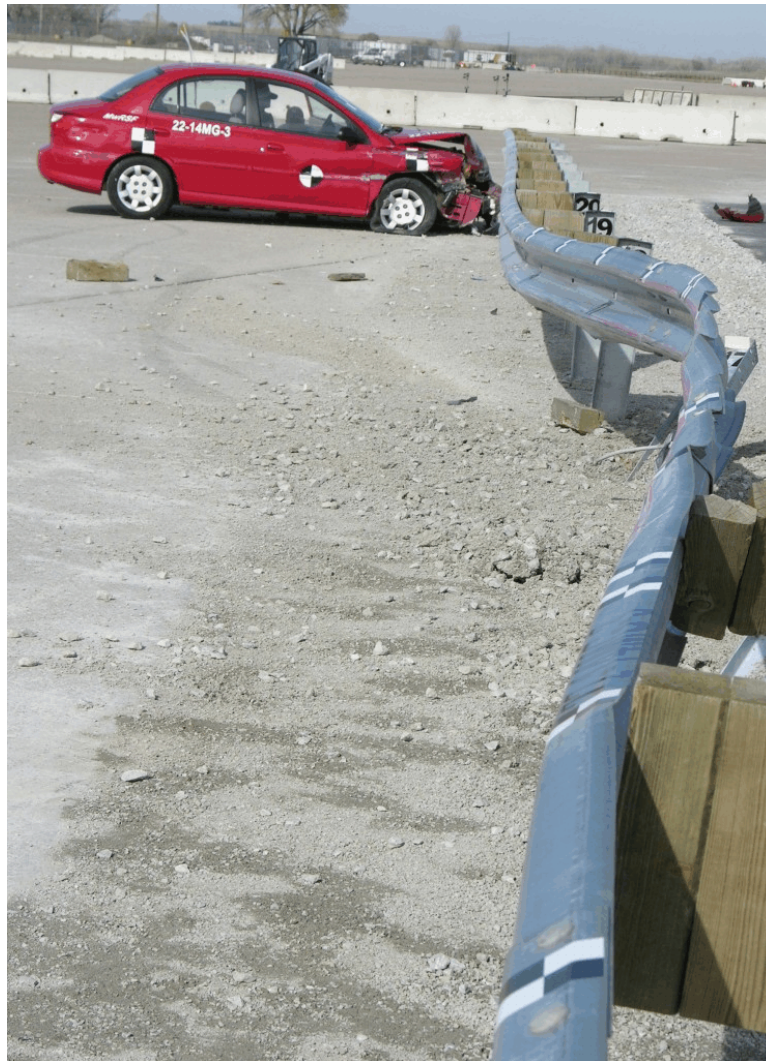
Figure 20. Vehicle Final Position and Trajectory Marks, Test 2214MG-3

was located at post no. 17 which was deflecting backwards. At this same time, the vehicle rolled CCW back toward the system. At 0.332 sec, the blockout at post no. 17 split and disengaged from the system. At 0.374 sec, the rear of the vehicle pitched upward. At 0.404 sec, the vehicle yawed back toward the system with the rear of the vehicle airborne. At 0.530 sec, the vehicle exited the barrier at a trajectory angle of 14.1 degrees and at a resultant velocity of 48.4 km/h (30.1 mph). At 0.636 sec, the vehicle continued to yaw back toward the system as it continued downstream. At 0.886 sec, the vehicle yawed to approximately perpendicular with the system. At 1.738 sec, the vehicle impacted the system again in a near perpendicular orientation. At 1.890 sec, the front of the vehicle crushed inward from the secondary impact. The vehicle came to rest with the front of the vehicle against and perpendicular to the rail at 22.46 m (73 ft - 8 in.) downstream from impact and 0.83 m (2 ft - 9 in.) away from the traffic-side face of the guardrail system. The trajectory and final position of the small car are shown in Figures 13 and 20.

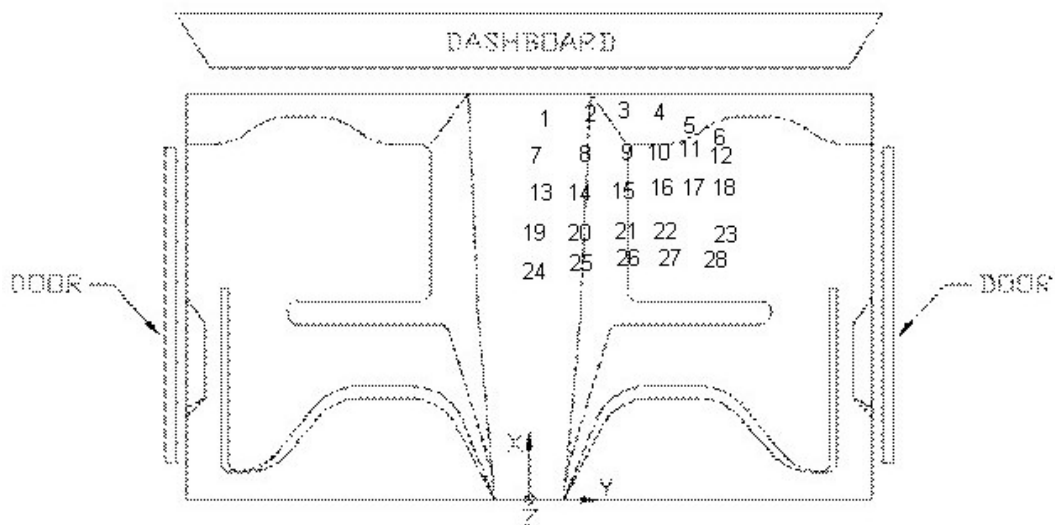
Figure C-1. Occupant Compartment Deformation Data, Test 2214MG-3

Exterior vehicle damage was moderate, as shown in Figures 26 through 28. Occupant compartment deformations to the right side and center of the floorboard were judged insufficient to cause serious injury to the vehicle occupants. Maximum longitudinal deflections of 6 mm (0.25 in.) were located throughout the right-side floor pan. Maximum lateral deflections of 6 mm (0.25 in.) were located throughout the right-side floor pan. Maximum vertical deflections of 6 mm (0.25 in.) were located near the center of the right-side floor pan. Complete occupant compartment deformations and the corresponding locations are provided in Appendix C.
