# **PERFORMANCE EVALUATION OF THE MIDWEST GUARDRAIL SYSTEM – UPDATE TO NCHRP 350 TEST NO. 3-11 (2214MG-1)**

MwRSF Research Report No. TRP-03-170-06

October 10, 2006

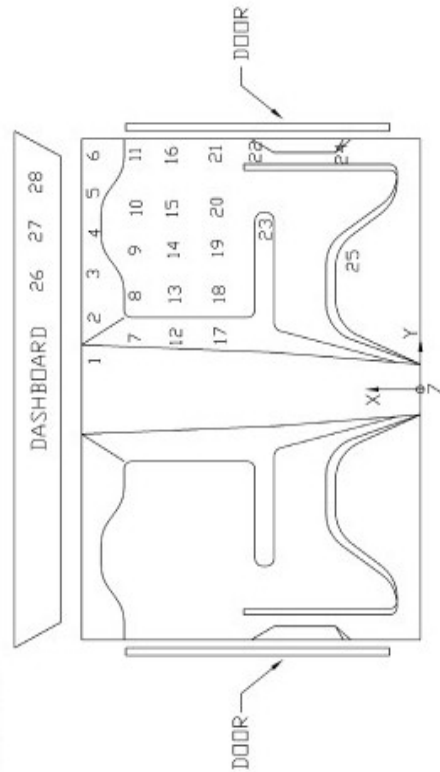
Figure C-1. Occupant Compartment Deformation Data, Test 2214MG-1

Exterior vehicle damage was moderate, as shown in Figures 29 through 32. Occupant compartment deformations to the right side and center of the floorboard, as shown in Figure 32, were judged insufficient to cause serious injury to the vehicle occupants. Maximum longitudinal deflections of 13 mm (0.5 in.) were located near the center of the right-side floor pan. Maximum lateral deflections of 25 mm (1.0 in.) were located near the center of the right-side floor pan. Maximum vertical deflections of 13 mm (0.5 in.) were located near the firewall at the right-front corner and center of the right side. Complete occupant compartment deformations and the corresponding locations are provided in Appendix C.

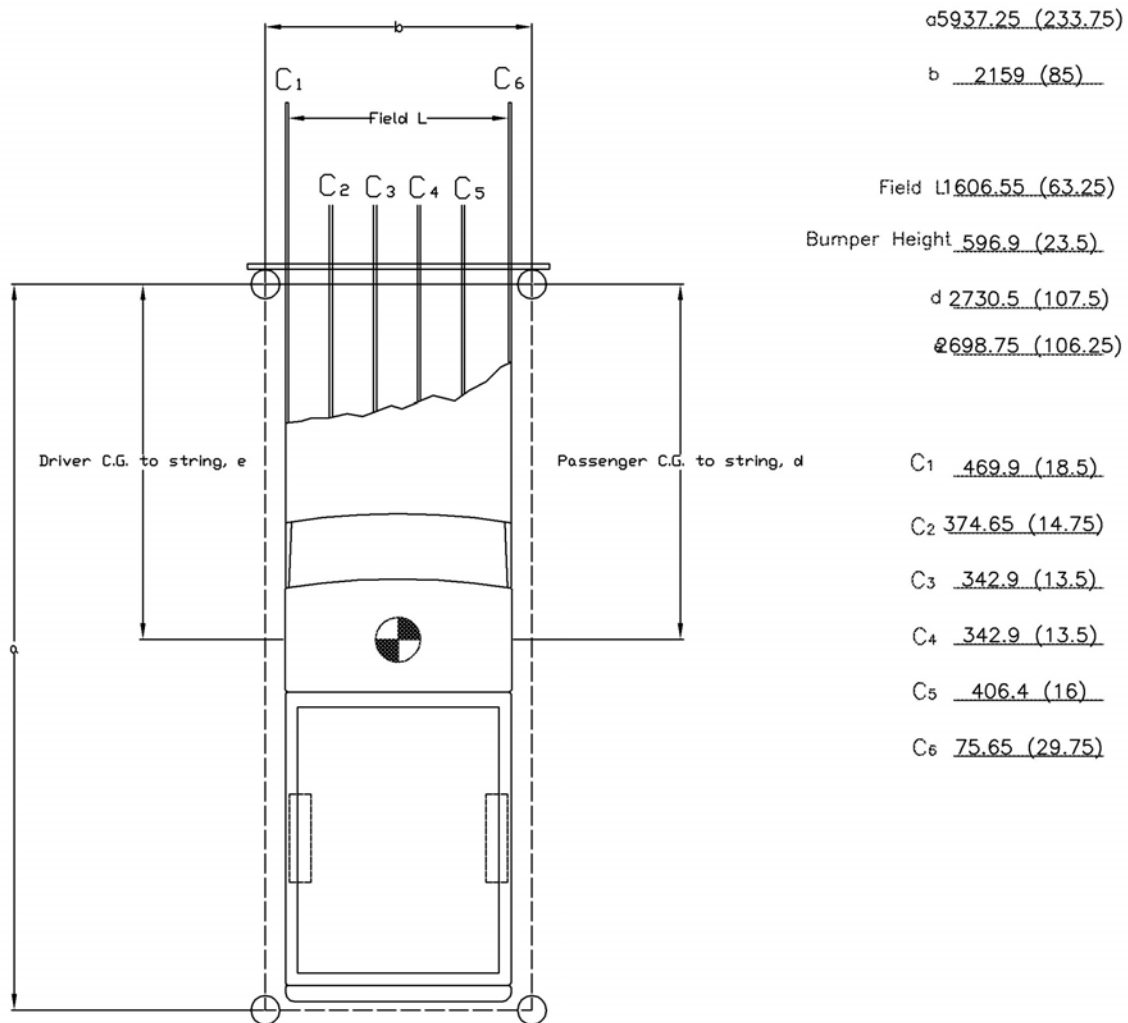
Figure C-3. NASS Crush Data, Test 2214MG-1

Damage was concentrated on the right-front corner of the vehicle. The right-front quarter panel was deformed inward and downward toward the engine compartment. The right side of the front bumper was flattened and bent back toward the engine compartment and contacted the lower frame rail. The box was bent upward and inward behind the right-rear wheel. The right side of the hood was bent slightly. The right-front wheel assembly deformed and crushed inward toward the engine compartment. The right-side ball joints and steering linkage were fractured. The upper control arm was bent. The right-front tire disengaged from the rest of the wheel assembly. The right-rear tire deflated. The right-side headlight and park light fractured and disengaged from the vehicle. All window glass remained undamaged. The left side and rear of the vehicle remained undamaged.
