NCHRP 350 DEVELOPMENT AND TESTING OF A GUARDRAIL CONNECTION TO LOW-FILL CULVERTS

MwRSF Research Report No. TRP-03-114-02

November 1, 2002

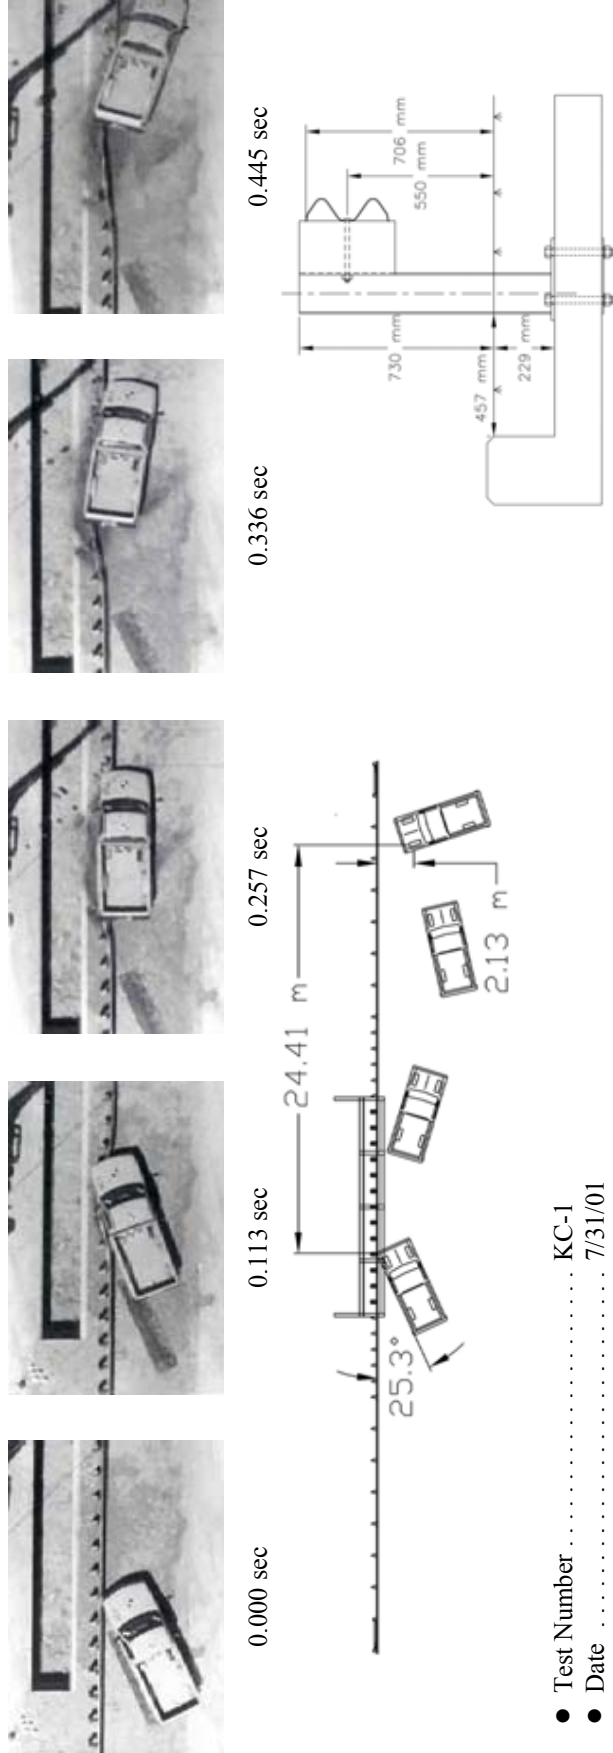
● Test Number	KC-1	● Vehicle Angle	
● Date	7/31/01	Impact	25.3 deg
● Appurtenance	W-beam guardrail with steel posts attached to culvert's top slab	Exit (trajectory)	19.5 deg
● Total Length	53.34 m	● Vehicle Snagging	Minor on post nos. 19 and 20
● Distance Between Posts and Headwall	457 mm	● Vehicle Pocketing	None
● Steel W-Beam		● Vehicle Stability	Satisfactory
Thickness	2.66 mm	● Occupant Ridedown Deceleration (10 msec avg.)	
Top Mounting Height	706 mm	Longitudinal	8.28 < 20 G's
● Steel Posts		Lateral (not required)	10.12
Post Nos. 3 - 14, 28 - 39	W152x13.4 by 1,829-mm long	● Occupant Impact Velocity	
Post Nos. 15 - 27	W152x13.4 by 946-mm long	Longitudinal	6.62 < 12 m/s
● Wood Posts		Lateral (not required)	4.99
Post Nos. 1 - 2, 40 - 41 (BCT) ...	140 mm x 190 mm by 1,080-mm long	● Vehicle Damage	Moderate
● Wood Spacer Blocks		TAD ¹⁷	1-RFQ-4
Post Nos. 2 - 39	152 mm x 203 mm by 356-m long	SAE ¹⁸	1-RFEE5
● Soil Type	Grading B - AASHTO M 147-65 (1990)	● Vehicle Stopping Distance	24.41 m downstream

● Vehicle Model	1994 GMC 2500 ¾-ton pickup	2.13 m traffic-side face	
Curb	1,750 kg	● Barrier Damage	Moderate
Test Inertial	1,993 kg	● Maximum Deflections	
Gross Static	1,993 kg	Permanent Set	401 mm
● Vehicle Speed		Dynamic	416 mm
Impact	103.3 km/hr	● Working Width	899 mm
Exit (resultant)	62.9 km/hr

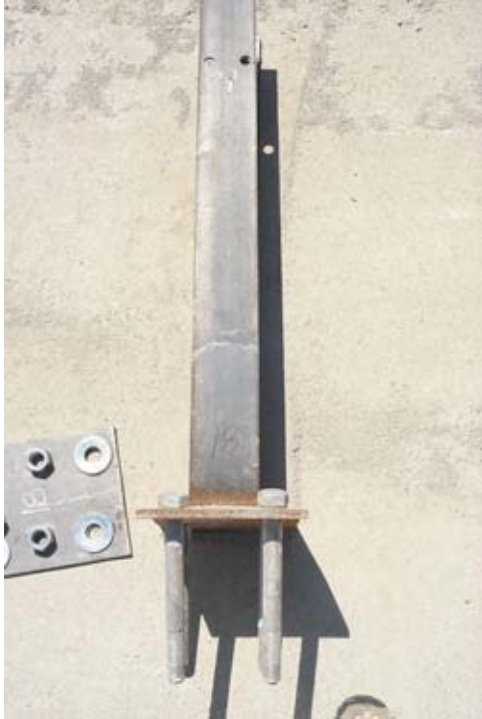
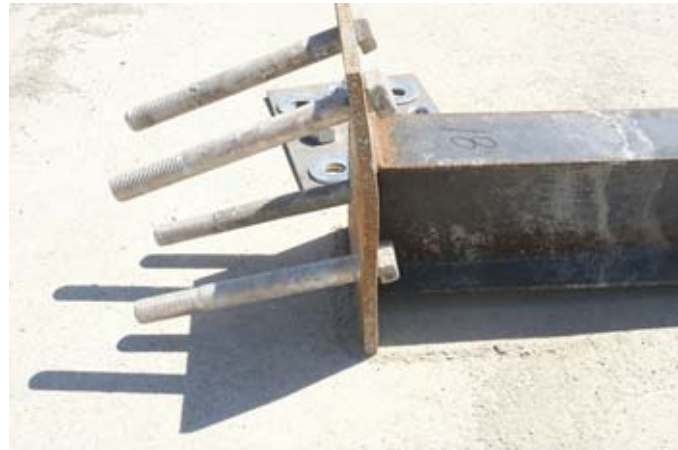
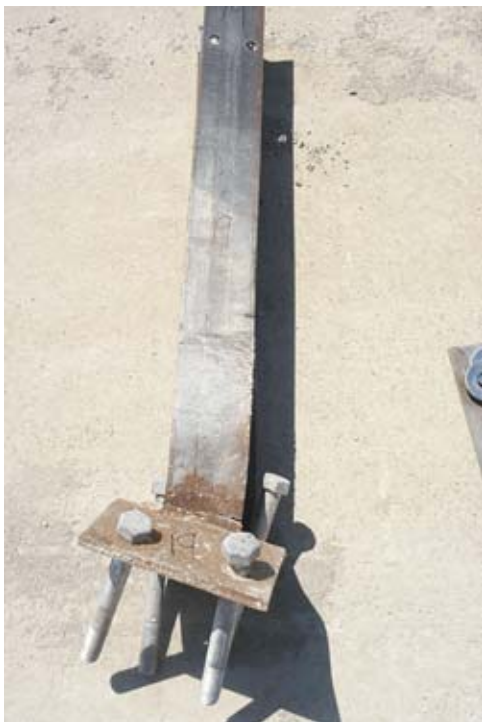
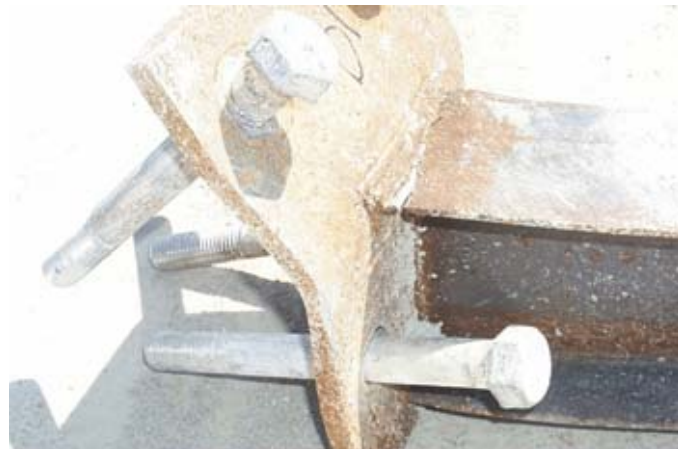
Figure 53. Post Nos.18 and 19 Damage, Test KC-1

Steel post no. 18 rotated backward slightly while steel post no. 19 bent laterally backward and longitudinally downstream. Steel post nos. 20 through 22 were bent longitudinally toward the ground in the downstream direction. Steel post no. 23 was bent longitudinally downstream but not as extensively as post nos. 20 through 22. Steel post no. 24 was slightly twisted and bent longitudinally downstream. Contact marks were found on the front face of post nos. 18 through 24. No significant post damage occurred to post nos. 1 through 17 nor 25 through 41. The upstream anchorage system was slightly moved longitudinally, while the downstream anchorage system remained unmoved. The posts in both the upstream and downstream anchorage systems were not damaged.

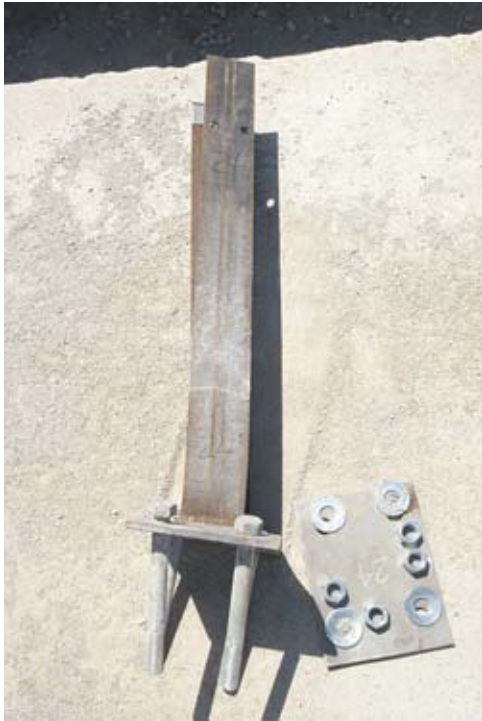
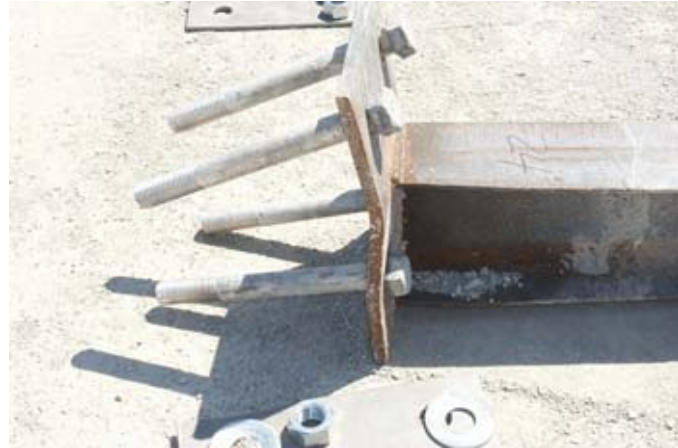
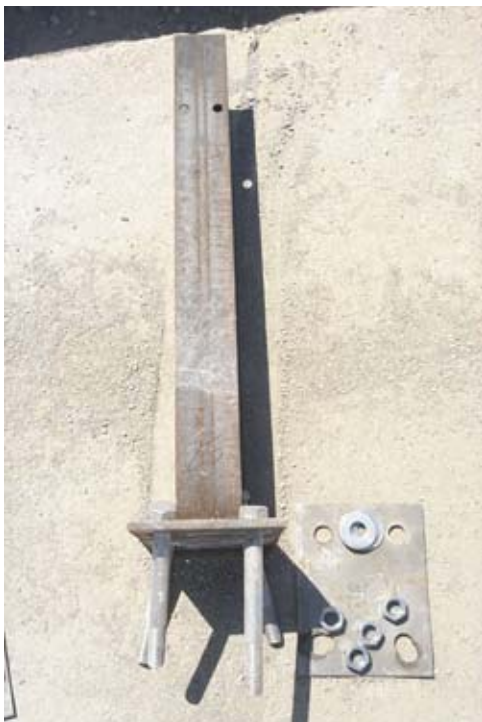
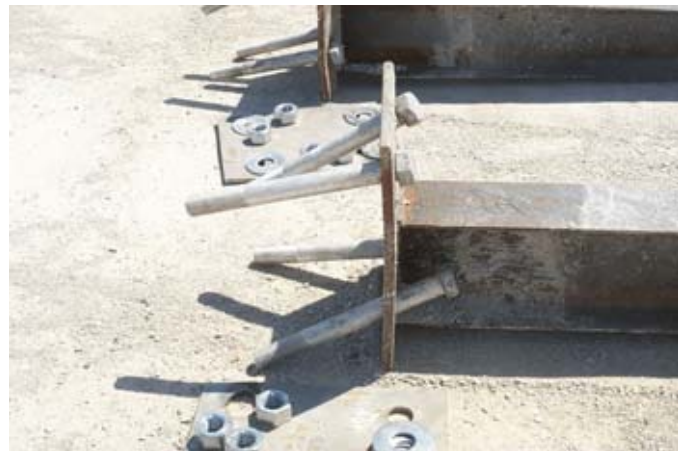
Figure 59. Post Nos. 24 and 25 Damage, Test KC-1

The permanent set of the guardrail and posts is shown in Figures 48 through 59. The upstream cable anchor end encountered slight permanent set deformations, as shown in Figure 62. The maximum lateral permanent set rail and post deflections were approximately 401 mm at the centerline of post no. 21 and 315 mm at post no. 19, respectively, as determined from high-speed film analysis. The maximum lateral dynamic rail and post deflections were 416 mm at post no. 19, as determined from the high-speed film analysis.

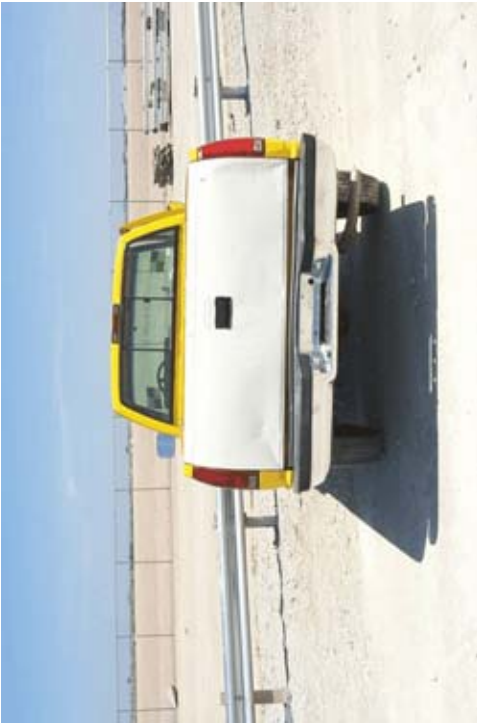
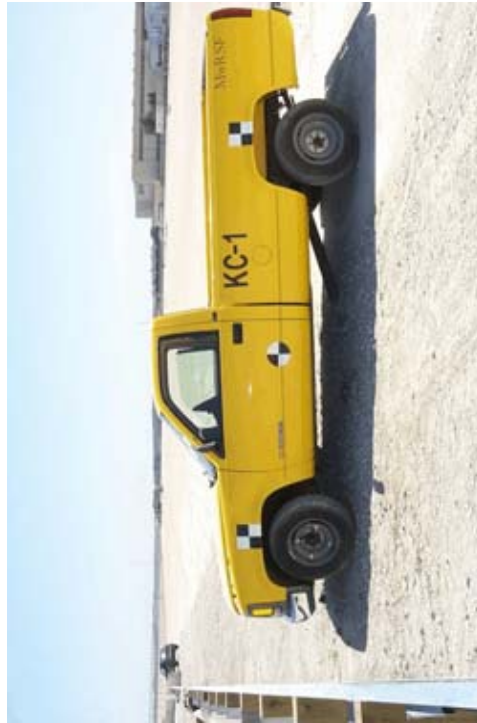
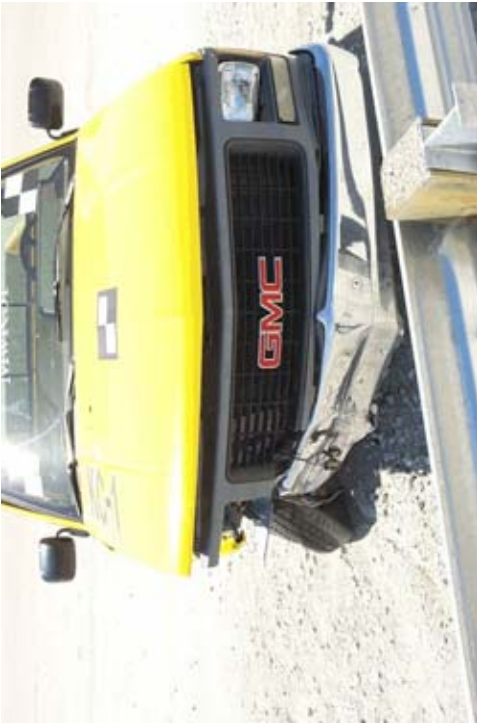
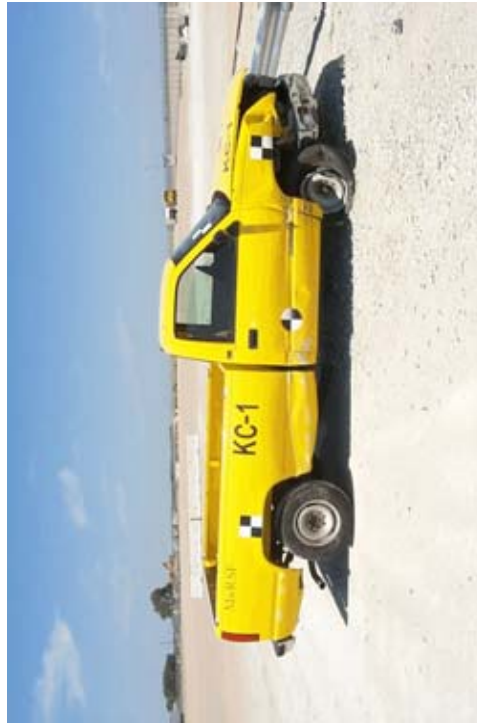
Figure 63. Vehicle Damage, Test KC-1

Exterior vehicle damage was moderate, as shown in Figures 63 through 65. Minimal occupant compartment deformations occurred with only slight deformations of the firewall. Occupant compartment deformations and the corresponding locations are provided in Appendix E. Contact marks were found along the lower portion of the entire right side of the vehicle. The right-front fender was deformed downward and inward toward the engine compartment. The right-front side of the bumper was deformed inward and contacted the upper A-frame control arm. A buckling point was found at the center of the front bumper. The right-front steel rim was deformed, and the tire was torn and deflated. Scuff marks were found on the right-rear tire side wall. The right-side headlight region was crushed inward toward the engine compartment, and the headlight broke. The

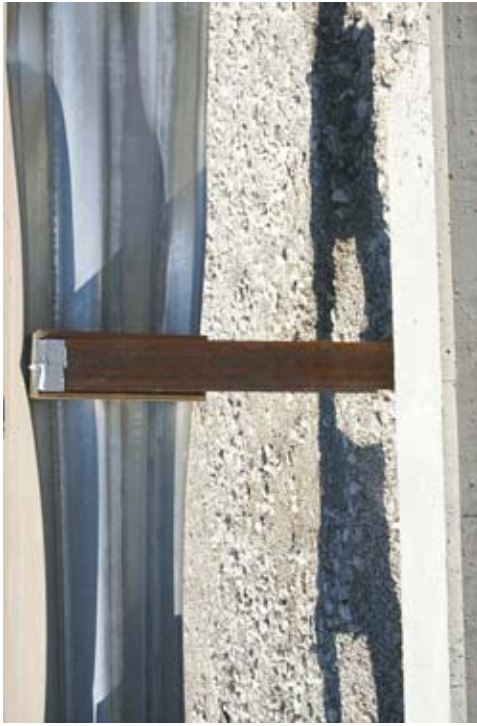
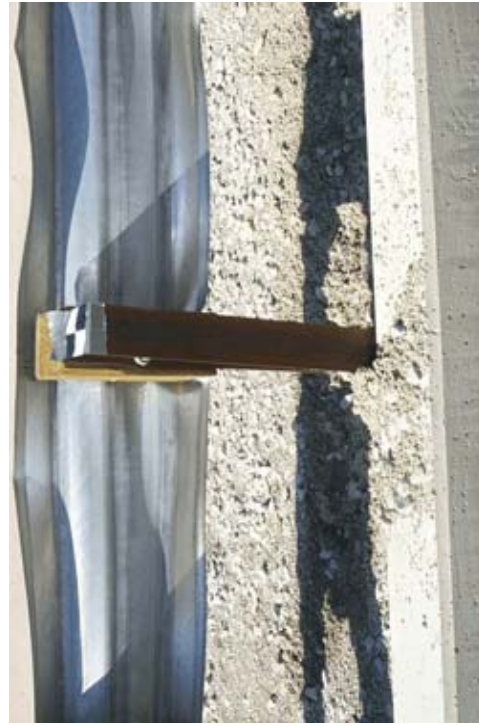
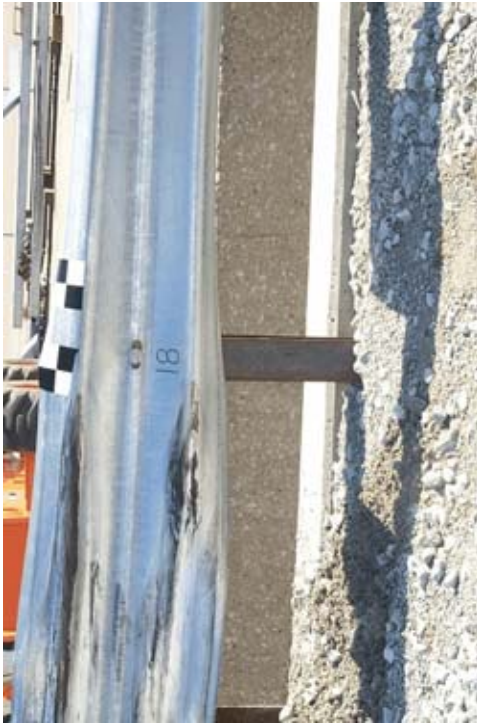
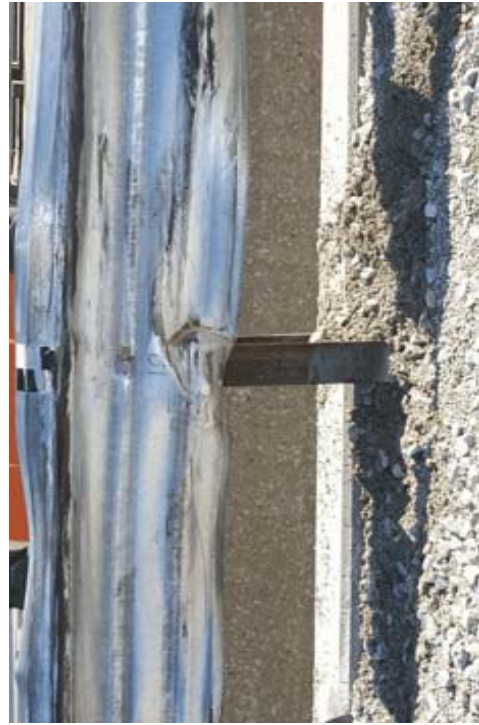
Figure 85. Post Nos. 18 and 19 Damage, Test KC-2

The permanent set of the guardrail and posts is shown in Figures 82 through 88. The upstream cable anchor end encountered slight permanent set deformations, as shown in Figure 89. The maximum lateral permanent set rail and post deflections were approximately 279 mm at the

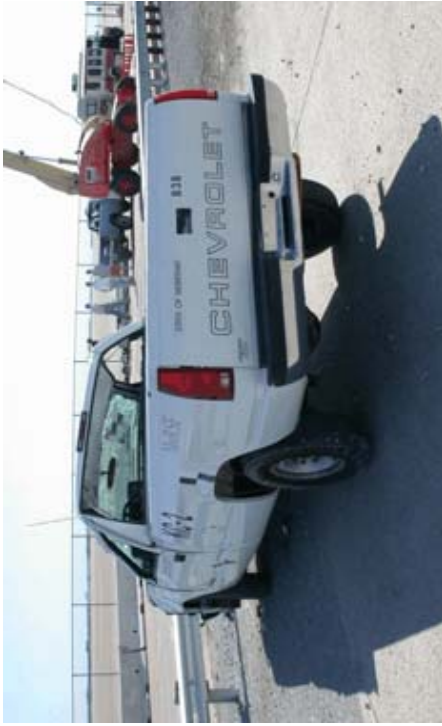
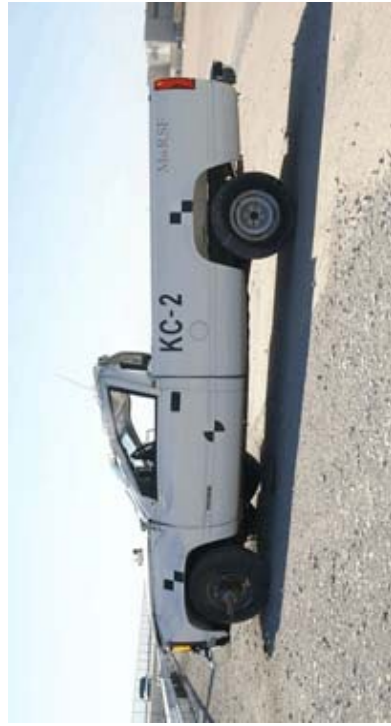
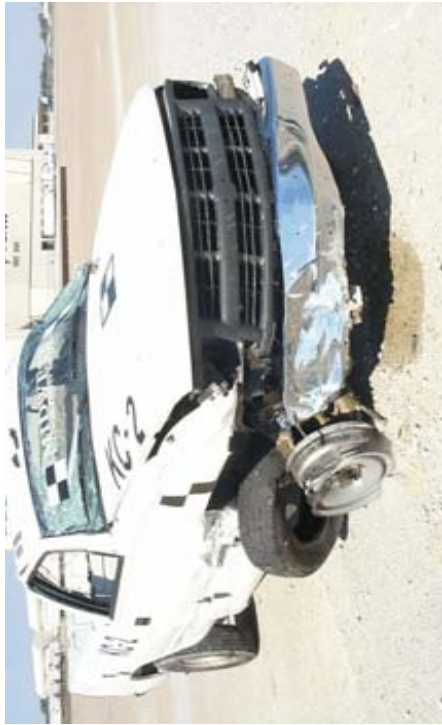
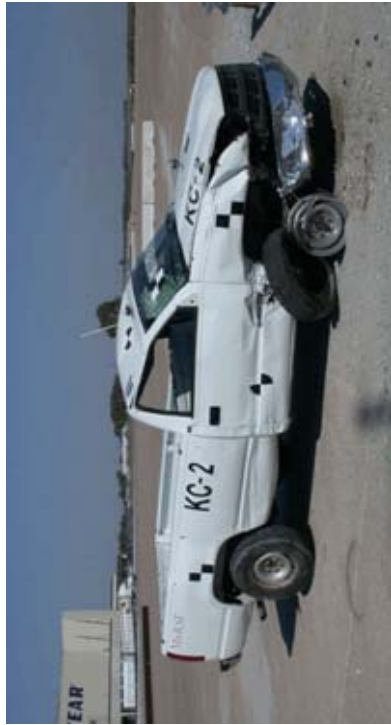
Figure 90. Vehicle Damage, Test KC-2

Exterior vehicle damage was extensive, as shown in Figures 90 through 92. Minimal occupant compartment deformations occurred with only slight deformation of the forward floorpan area. Occupant compartment deformations and the corresponding locations are provided in Appendix H. Light contact marks were found along the lower portion of the entire right side of the vehicle. The front corner of the right-front fender was deformed downward and inward toward the engine compartment. The sheet metal at the joint between the lower-front portion of the right-side door and the right-front fender was sliced open and then crushed inward. The right-front side of the bumper was flattened and deformed inward. A buckling point was found at the center of the front bumper. The right-front steel rim was severely deformed, and the tire was removed from the steel rim. The front, rear, right-side, and left-side window glass as well as the sheet metal on the roof and the left-side fender and door were severely crushed during vehicle rollover. The rear of the vehicle and the right-rear, left-front, and left-rear tires and steel rims remained undamaged.
